Explanation of circumstances leading to exceedance event

Background

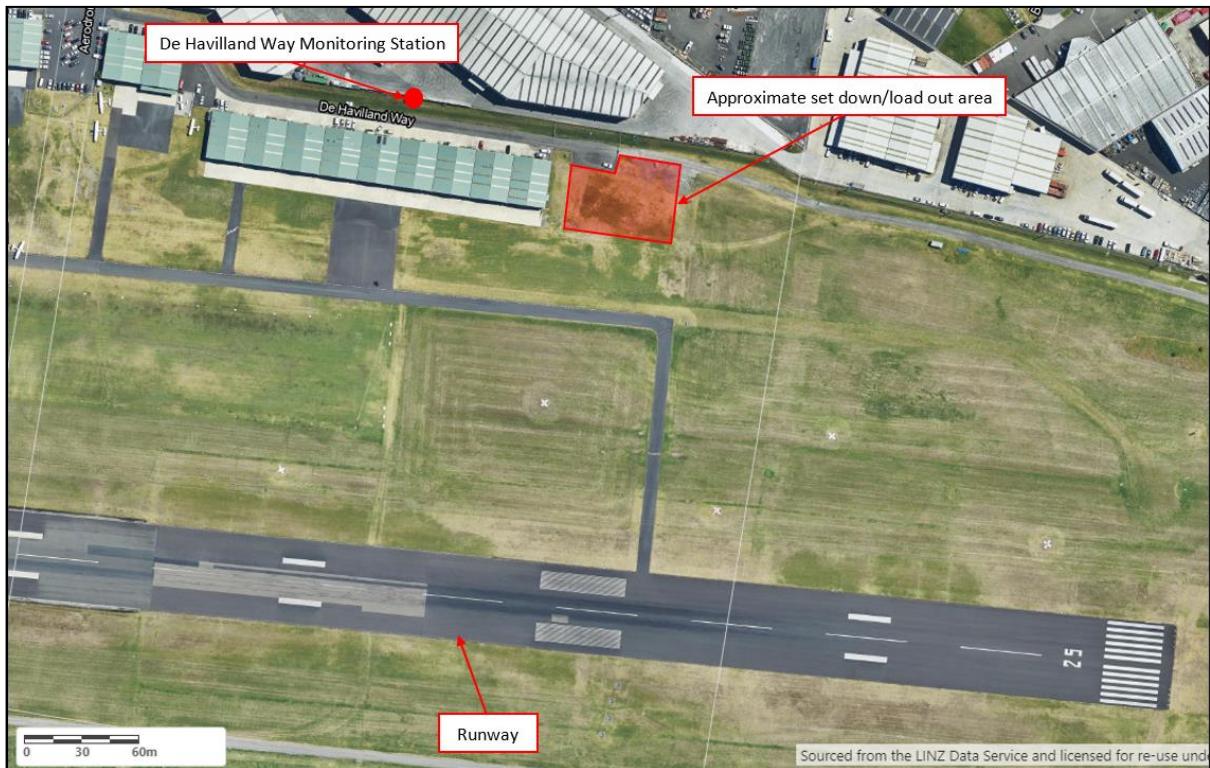
The set down area that the vehicles were driving to and from is a grassed area located close to the site entry and gravel “roadway” within the site (Figures 2a and 2b), so would generally be expected to be a low-dust surface. However, the grass being driven over was very dry at the time due to several months of very low rainfall (over the summer of 2020/2021, Tauranga had just 38% of its normal summer rainfall)¹.

The De Havilland 24 hour PM₁₀ record (Figure 5) has a seasonal pattern whereby elevated values do occur in the drier summer periods; this pattern is common for other sites within the airshed. Elevated PM₁₀ levels were recorded on three subsequent days (Table 2), at periods of time linked with activities associated with remedial work being undertaken on the Airport runway (Figure 6). These elevated periods occurred when wind directions were from the eastern arc (Figure 7), as opposed to the northern arc where elevated values have been normally recorded in the past. The De Havilland Way polar plot in Figure 3 shows that PM₁₀ values are typically subdued when winds are from the easterly quarter. Pollution roses (Figure 8) support the directional relationship for the exceedance events where elevated PM₁₀ values occur when the wind is coming from the set down area (Figure 2a and 2b), approximately 80m to the east of the monitoring site.

Figure 2a: Location of De Havilland air quality monitoring site location in relation to set down/load out area area

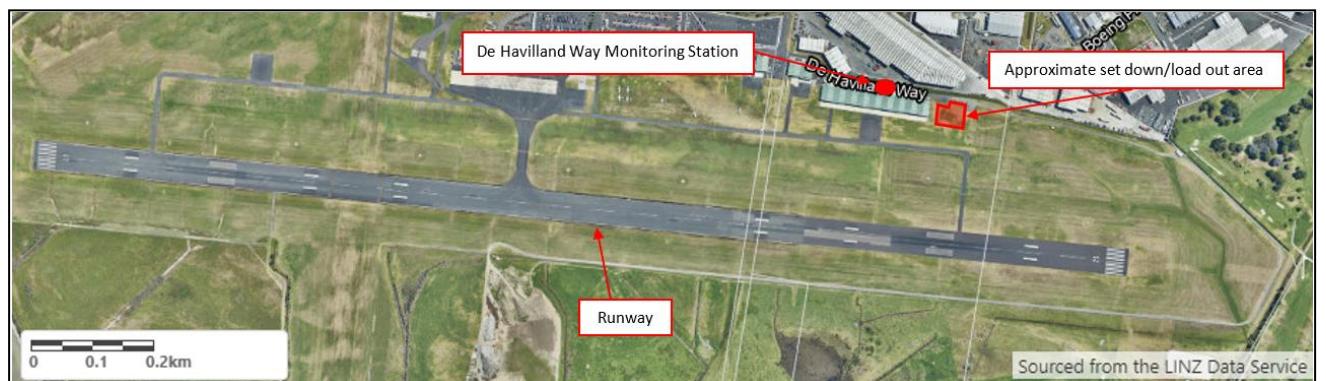
Figure 2b: Location of De Havilland air quality monitoring site location in relation to wider airport site

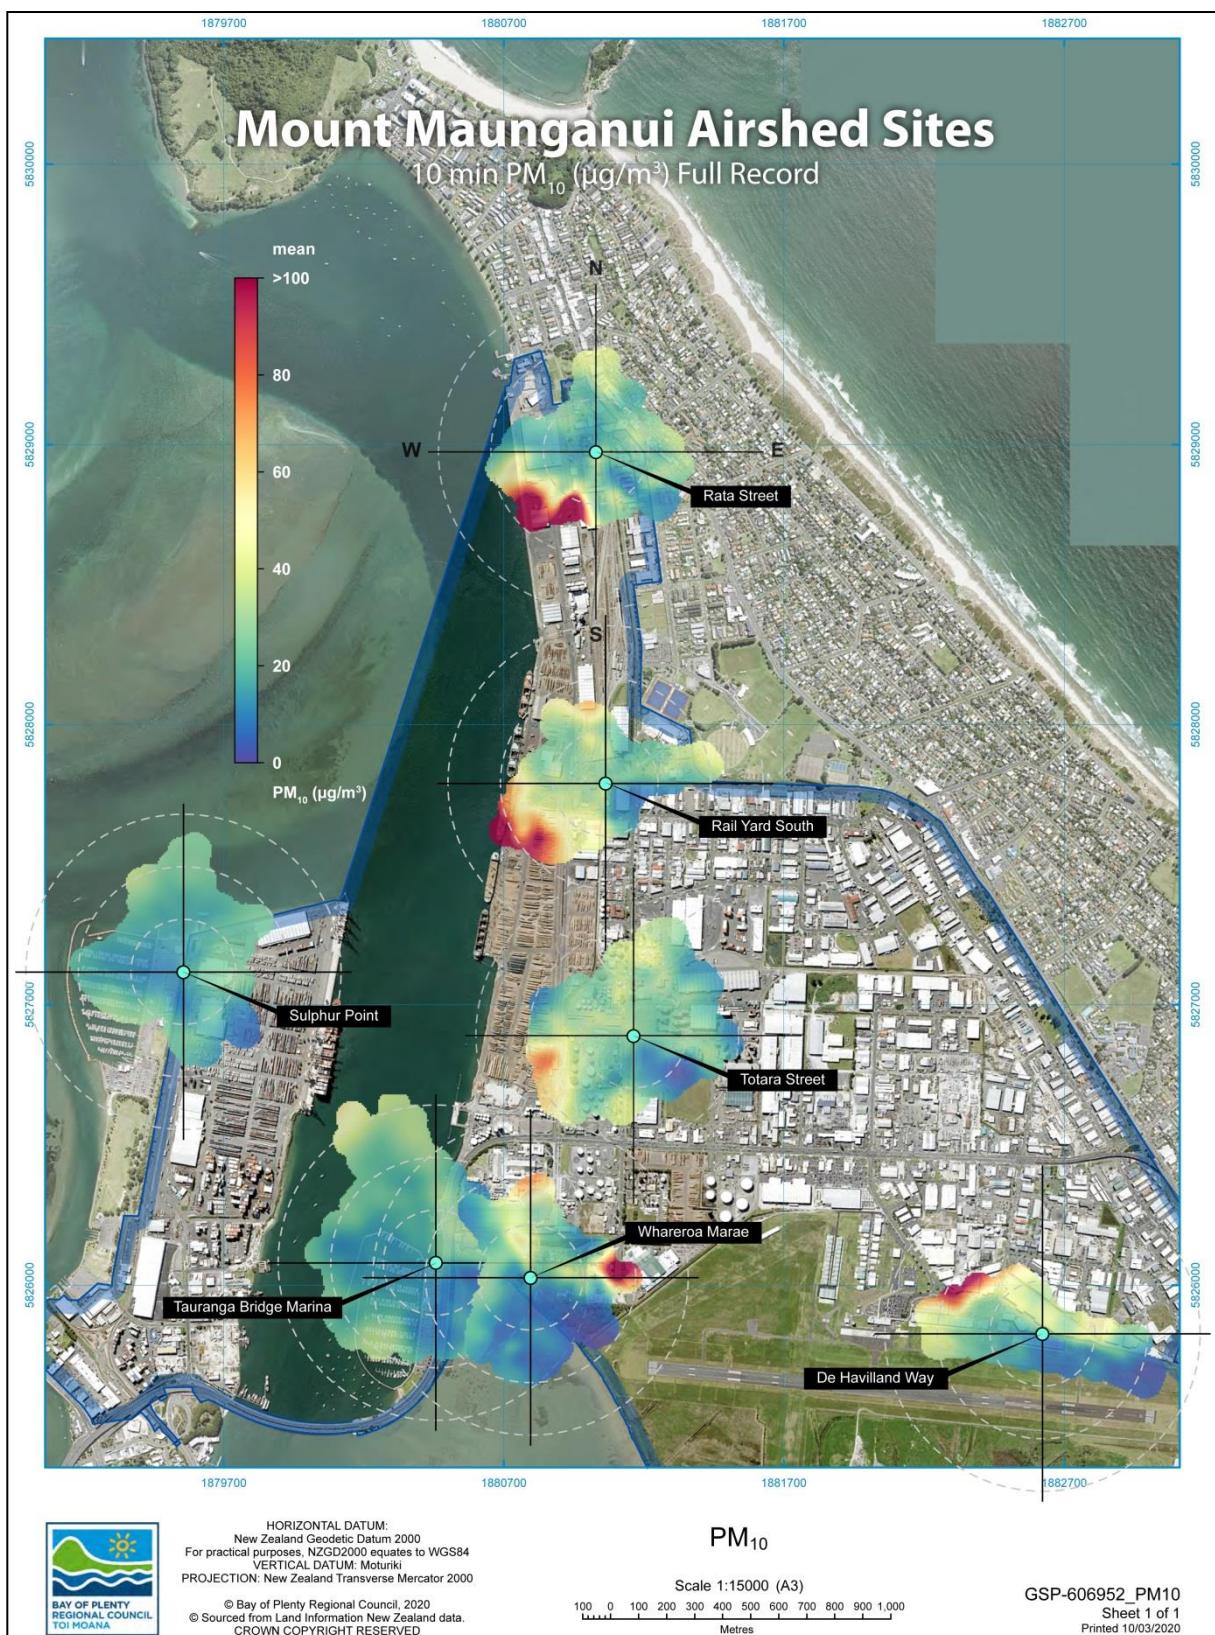
The exceedances were recorded at the nearby De Havilland Way monitoring station, one of a network of 10 air quality monitoring sites within the closely monitored Airshed (Figures 1, 3, 4a and 4b). None of the other nine monitoring stations within the Airshed recorded any exceedances over the nine week term of the work being carried out, emphasising the localised nature of the exceedance events.

Figure 3: PM_{10} patterns within the Mount Maunganui Airshed

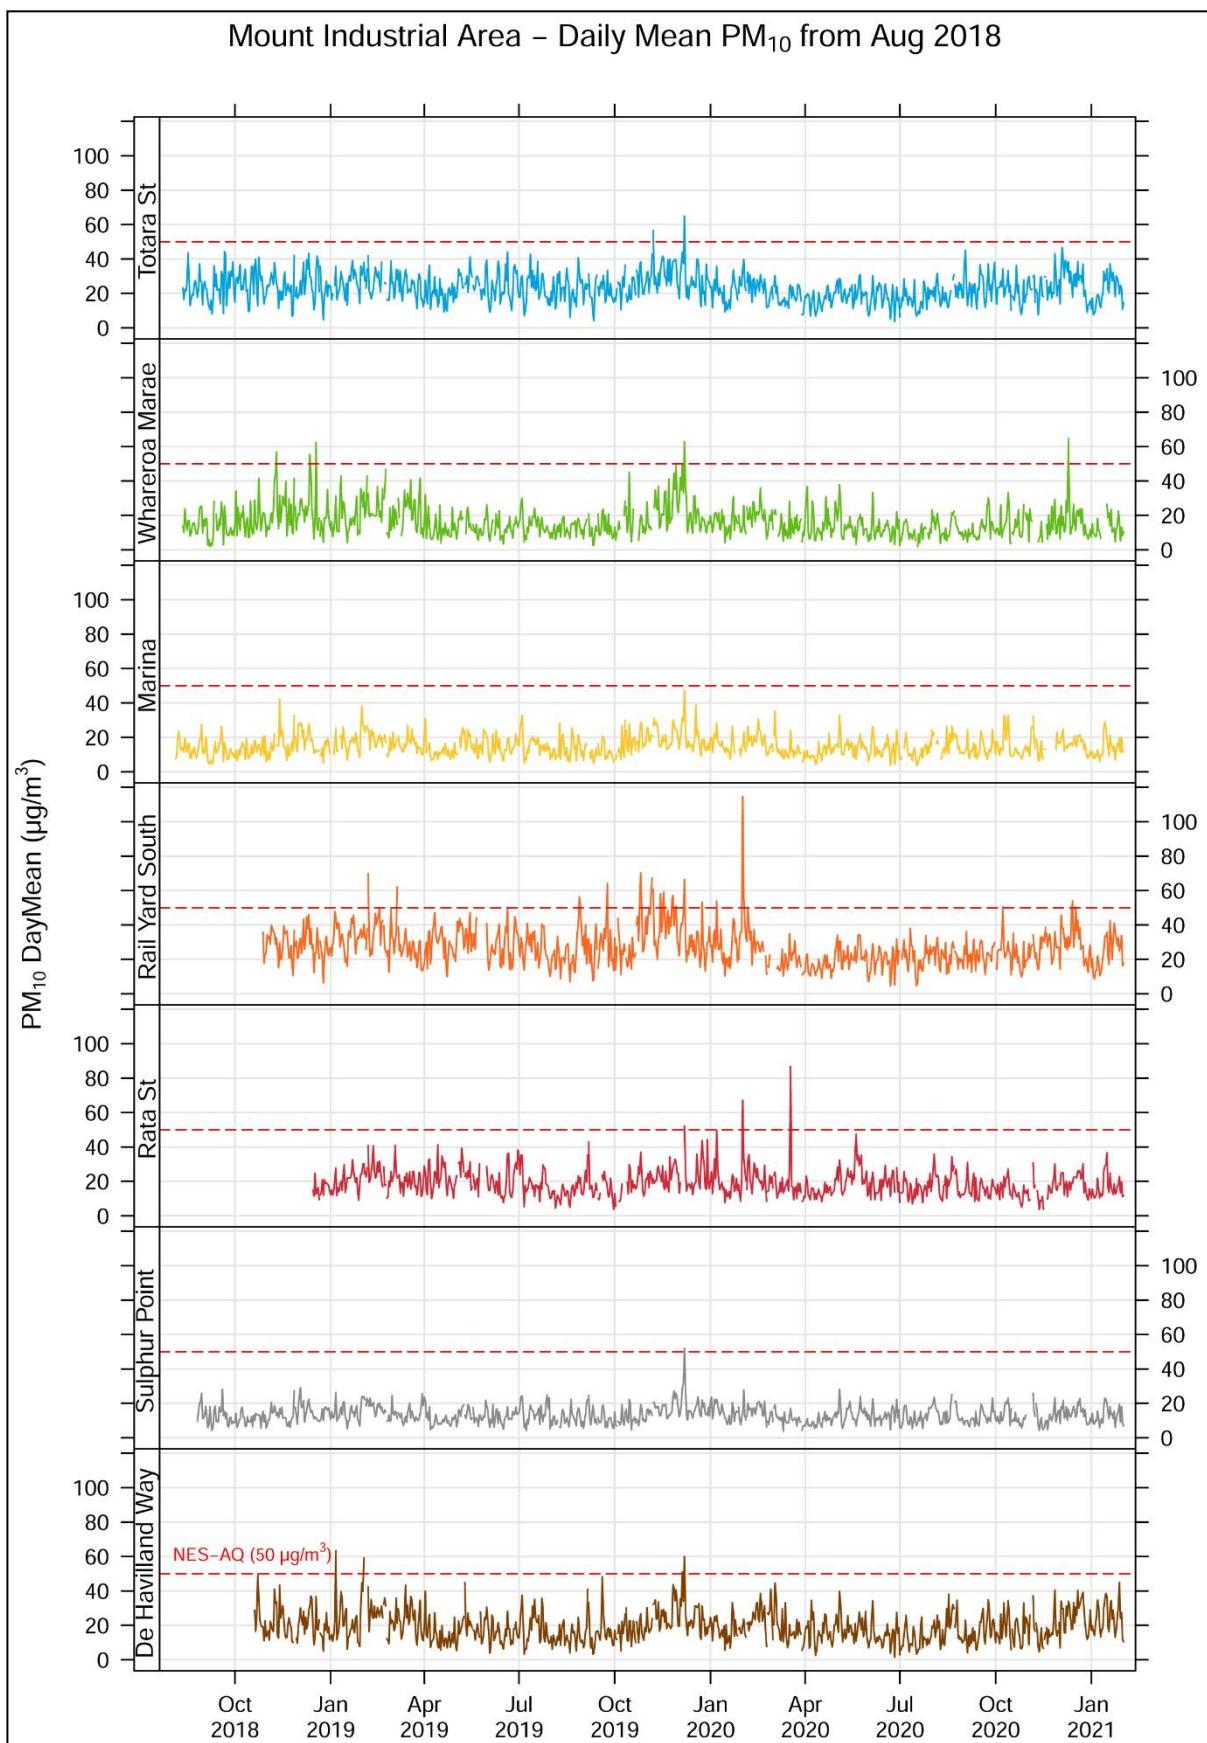
Figure 4a: PM₁₀ timeseries for the Mount Maunganui Airshed

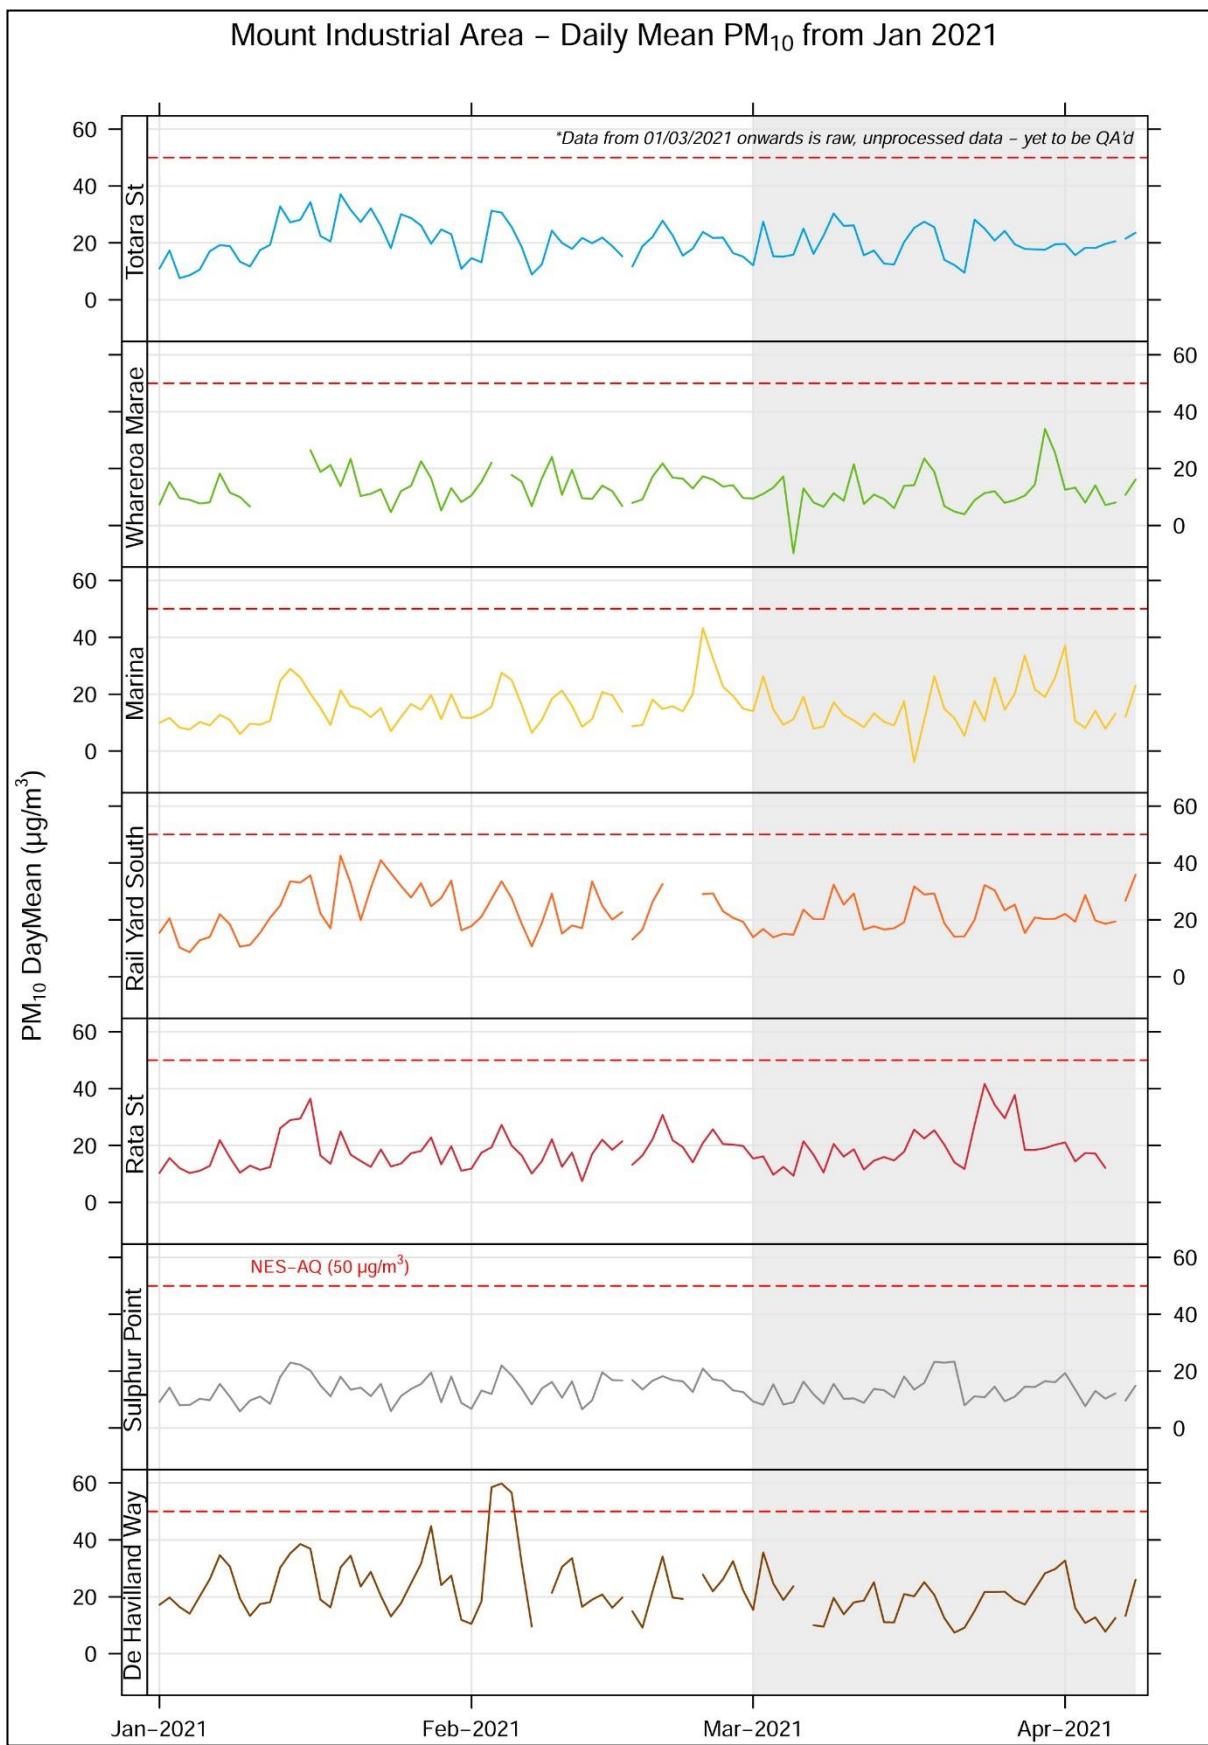
Figure 4b: PM10 timeseries for the Mount Maunganui Airshed - 5 January 2021 to 30 March 2021 (24 hour data)

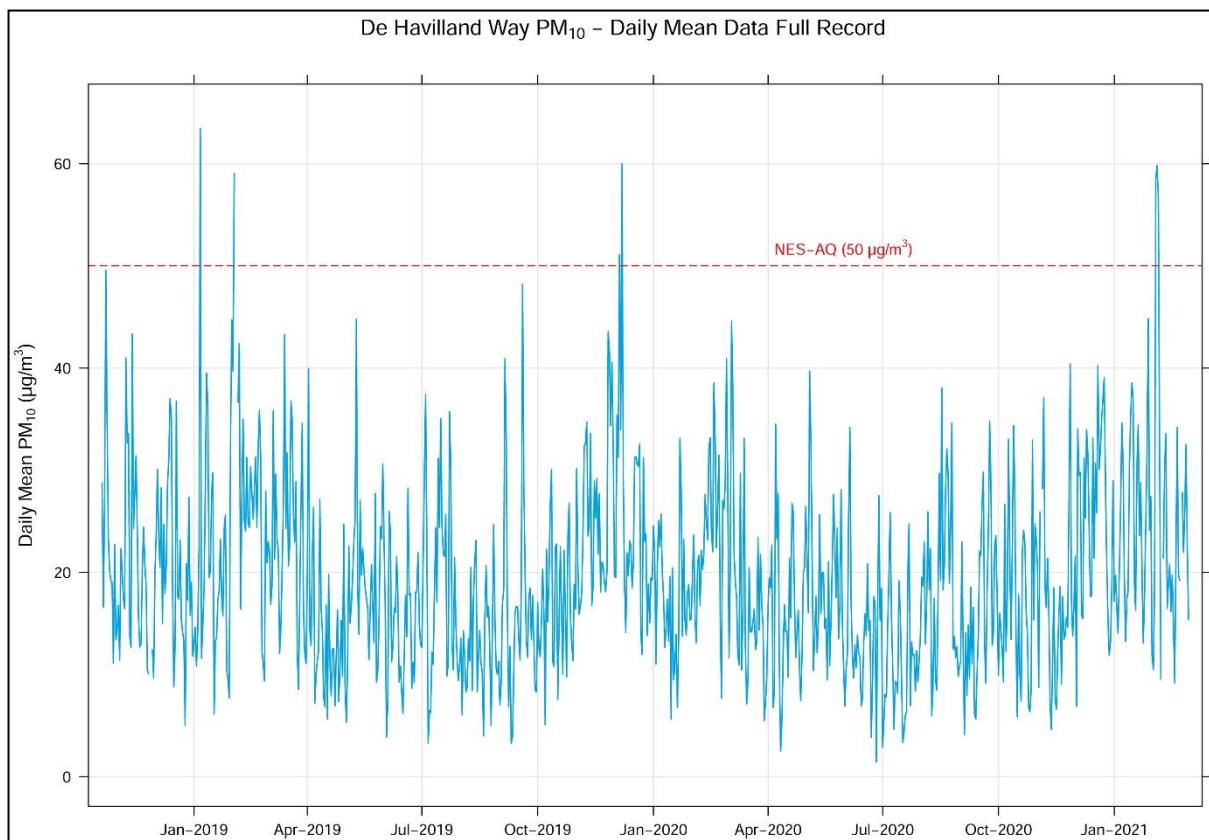
Figure 5: Full record PM₁₀ from De Havilland air quality monitoring site (24 hour data)
