Resource Management (National Environmental Standards for Air Quality) Regulations 2004 – Regulation 16A Exceptional Circumstances

APPLICATION FORM

Appendix 1 – Summary of monitoring reading showing exceedance event

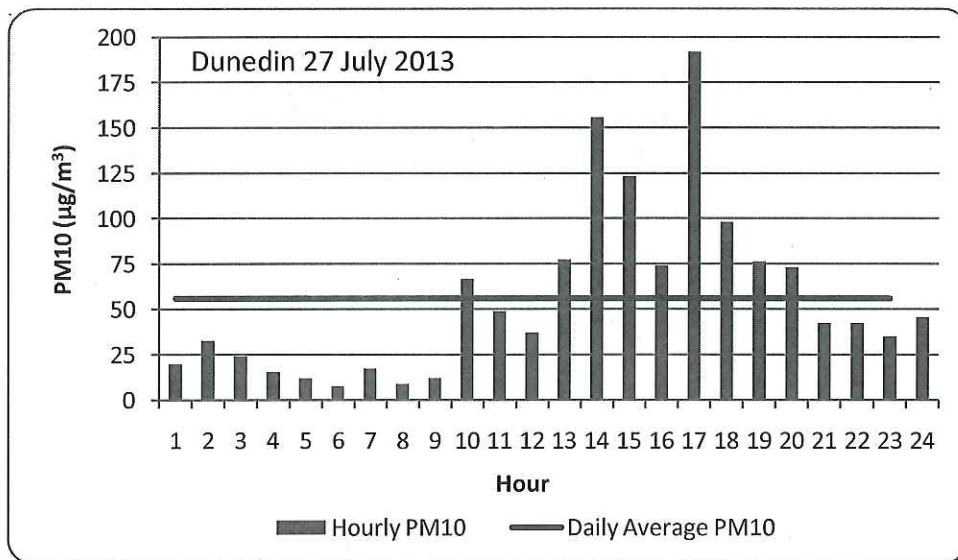
The graph below shows that hourly PM₁₀ values (shown by the blue bars) became elevated from between 9 and 10am and stayed relatively high throughout the day. Hourly PM₁₀ peaked at the site between 4-5pm at 192µg/m³. The daily average (56µg/m³) is shown in red.

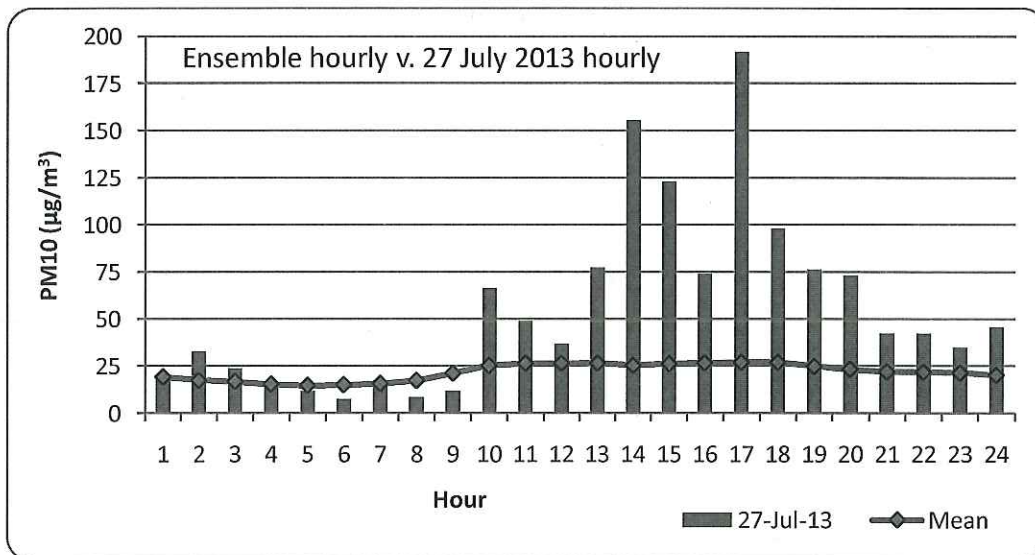
PM₁₀ data from 27 July 2013, graphed together with the ensemble hourly mean data is shown below.

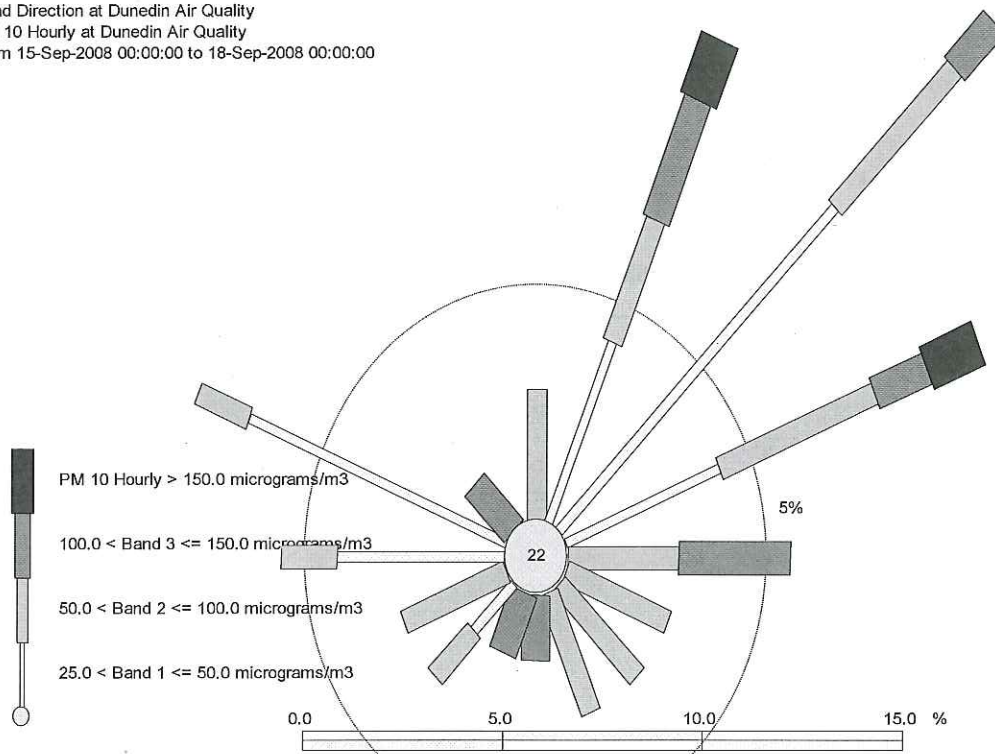
Wind Direction at Dunedin Air Quality
 PM 10 Hourly at Dunedin Air Quality
 From 15-Sep-2008 00:00:00 to 18-Sep-2008 00:00:00

A pollution rose of the 3-day September event indicates that the highest PM₁₀ hours took place when winds were from the northern to eastern sector; there are numerous industries as well as a quarry in that commonly upwind direction.

Almost all of the high PM₁₀ values occurred during daytime hours, beginning at the start of the workday; it is assumed that these are mostly influenced by industrial emissions. Wintertime inversion characteristics were most likely present at the time, thereby encouraging the stagnation of pollutants.

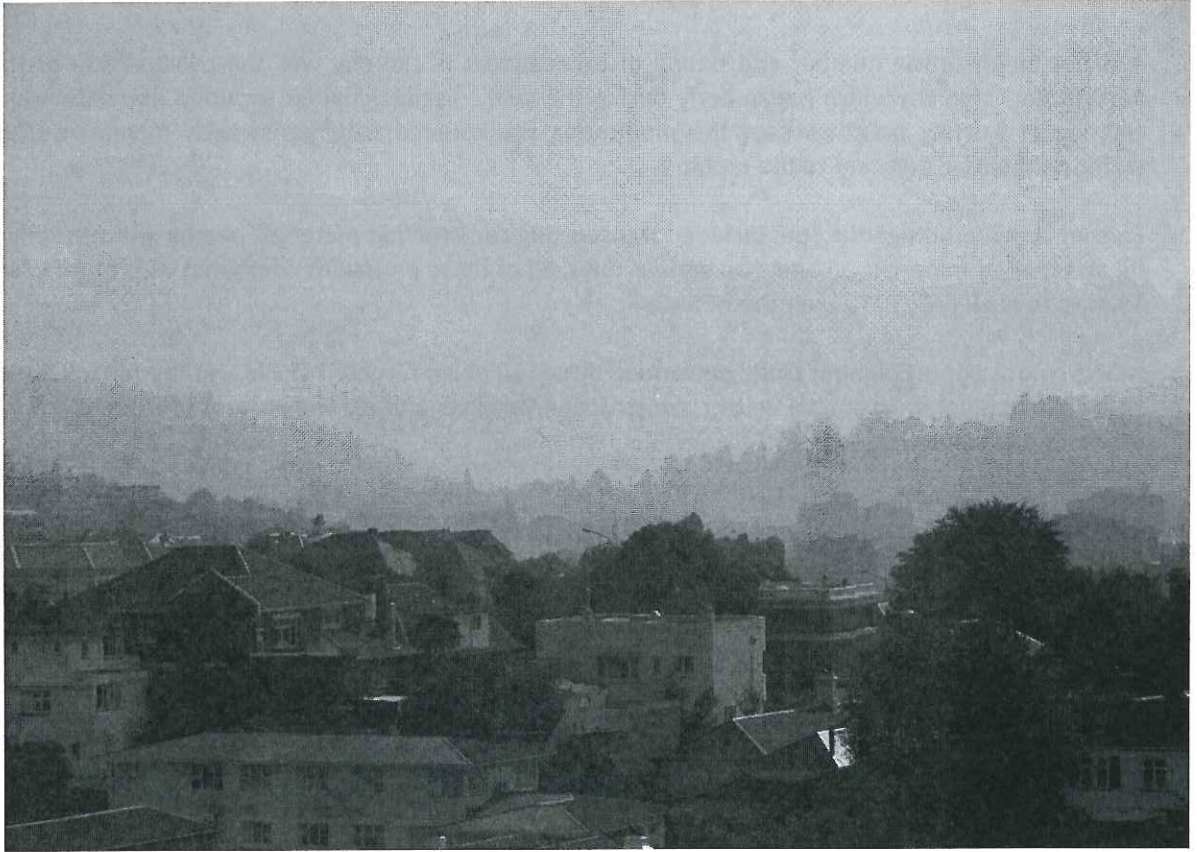
The 24 February exceedance was a direct result of a large forest fire to the northwest of the city on Mount Allan. Light northwest winds brought smoke across the city for several hours in the morning.

Smoke from the Mount Allan forest fire fills the city as shown in a photo taken from Unity Park, looking down to the city centre.

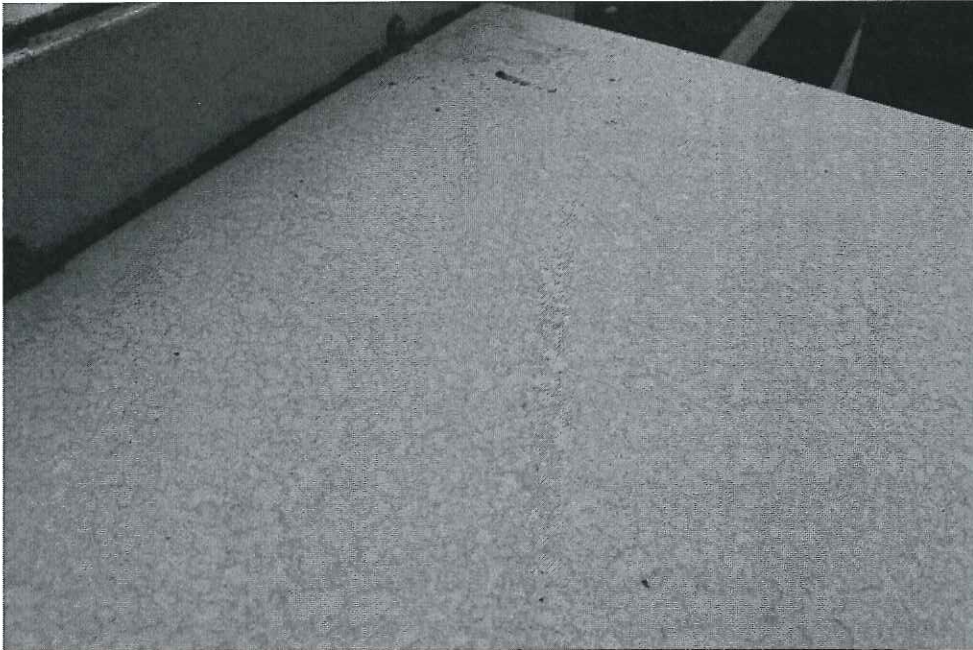
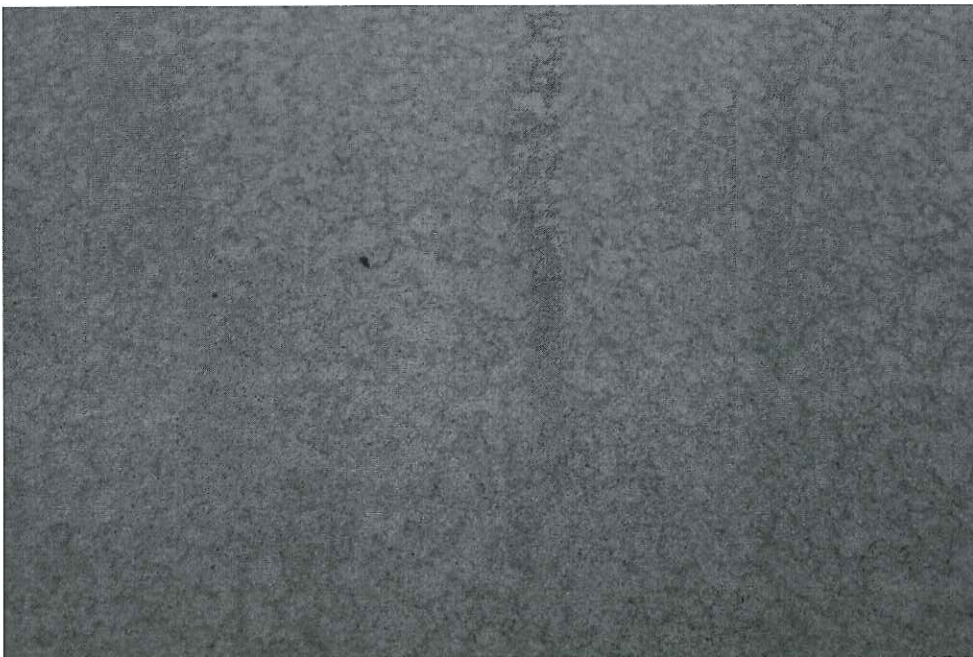
Also on 29 July 2013, ORC received the site audit report from the technician who serviced the monitor on Monday. He noted coffee deposits on the monitor and sensors as well as a strong coffee odour. The technician had been there two weeks earlier and not noted any such deposits on the monitor. Ms. Mills went to the monitoring site on Monday afternoon and took photos of the deposits (see below).

The photographs of the monitor were shown to Ms. Fraser and she noted that the coffee dust on their roof looked exactly the same. As the monitor is not usually coated in coffee dust, we concluded that it had occurred on the Saturday when the valve had failed.

Top of the air quality monitor cabinet, taken on Monday 29 July 2013. Distinct brown deposits are shown. They have been affected by 2 mornings of dew and are therefore somewhat dilute and run together.

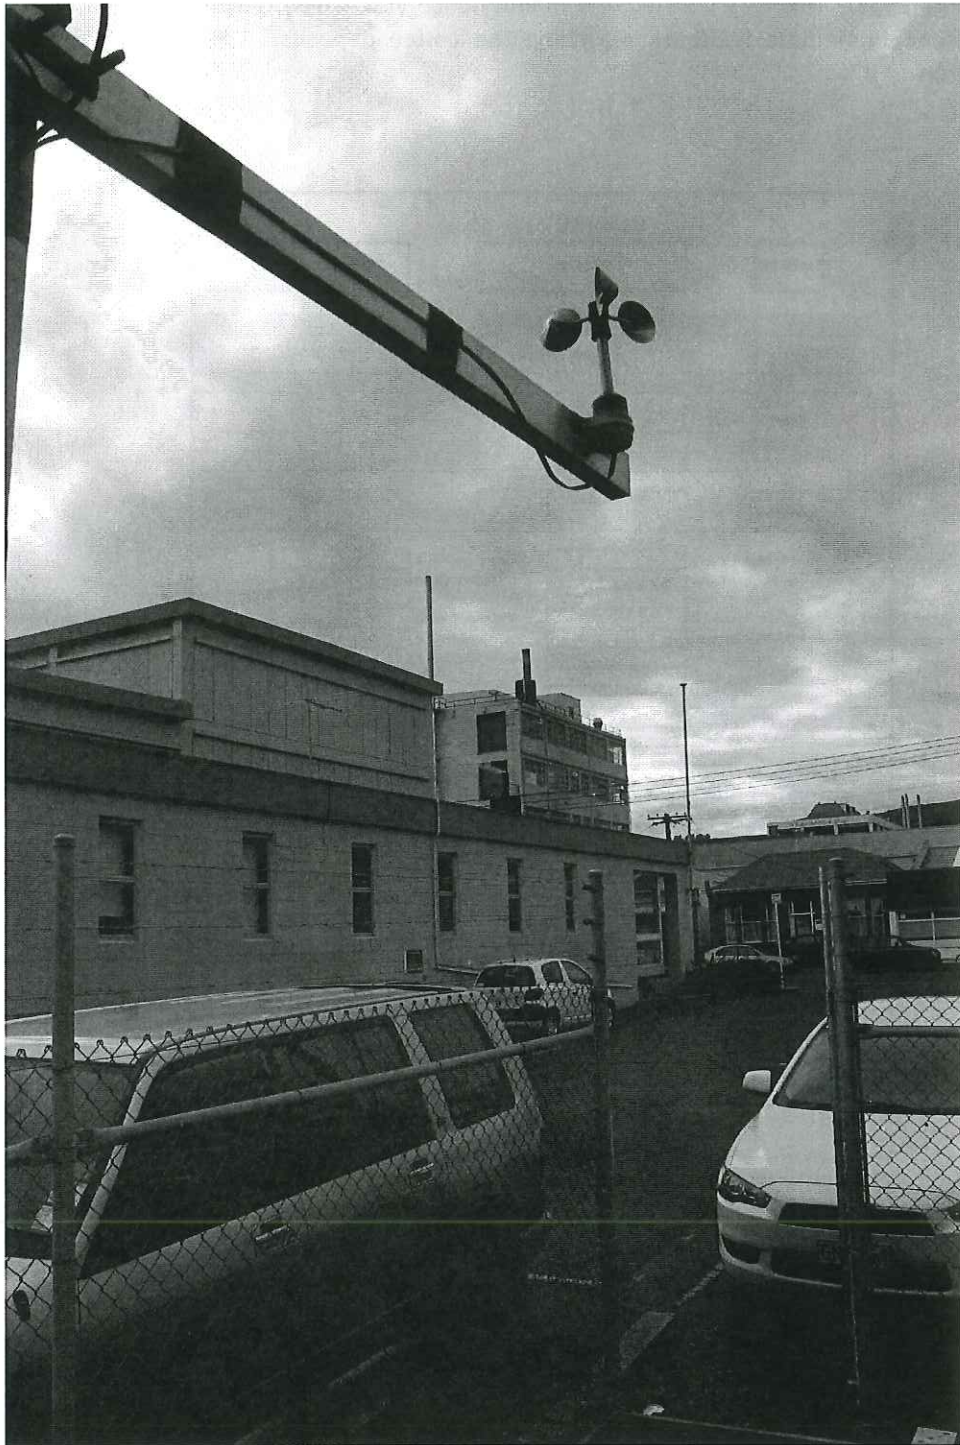
Proximity of Albany St. air quality monitor to Gregg's Coffee (multi-story building in the background with the two stacks). The distance is approximately 120 metres.

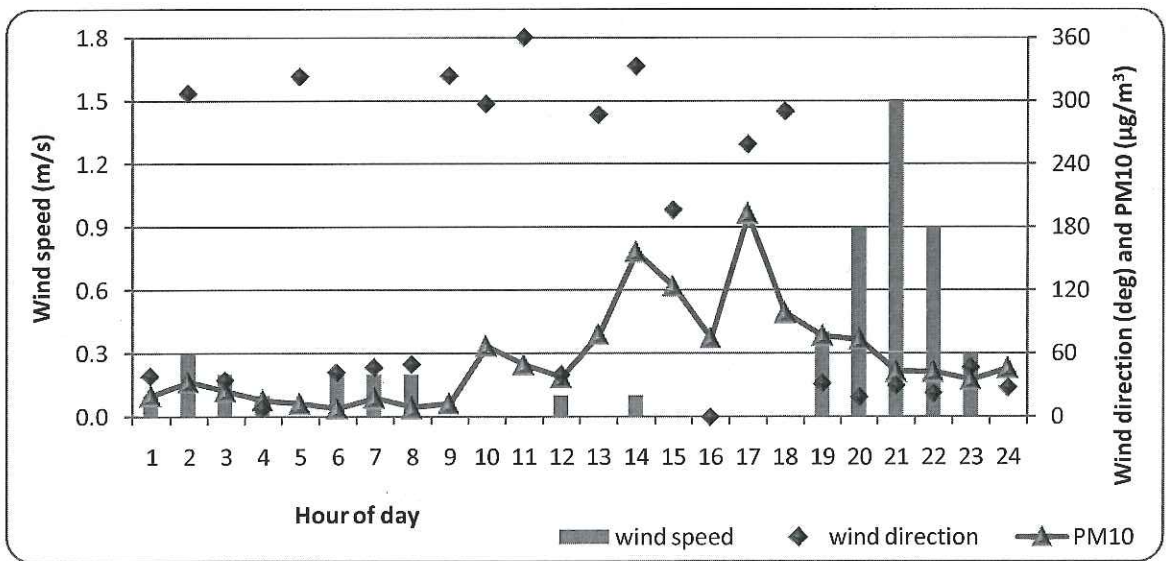
Using wind speed and direction sampled at the monitor itself, the next graph shows wind data and hourly PM₁₀ data through the day. As stated earlier, it was extremely calm through the day with a slight breeze picking up in the evening hours. PM₁₀ was high from about 9am – 5pm when winds were predominantly from the north and speeds almost nil.

Any fine particulate emitted could have remained suspended in the surrounding area during the day.

While it's impossible to know how much of a contribution Cerebos Gregg's stray emission made to hourly PM₁₀, just a 20% reduction in hourly PM₁₀ over the hours of 9am-5pm would have yielded a daily value of 49µg/m³. PM₁₀ may very well have been elevated to the high 40s that day due to very calm conditions in town, but other days with similar meteorological conditions have not failed the NESAQ. Given the high values of 2-3pm and 4-5pm, it is apparent to ORC that an 'event' took place that day.
