Project Ref: #2355055

**Silver Creek Geotechnical Letter to Supplement Fast Track Consent**

**GEOTECHNICAL FEASIBILITY ASSESSMENT OF THE MIDDLETON  
BLOCK FOR FUTURE RESIDENTIAL DEVELOPMENT**

REF: R4726-1B  
DATE: 26 JANUARY 2021

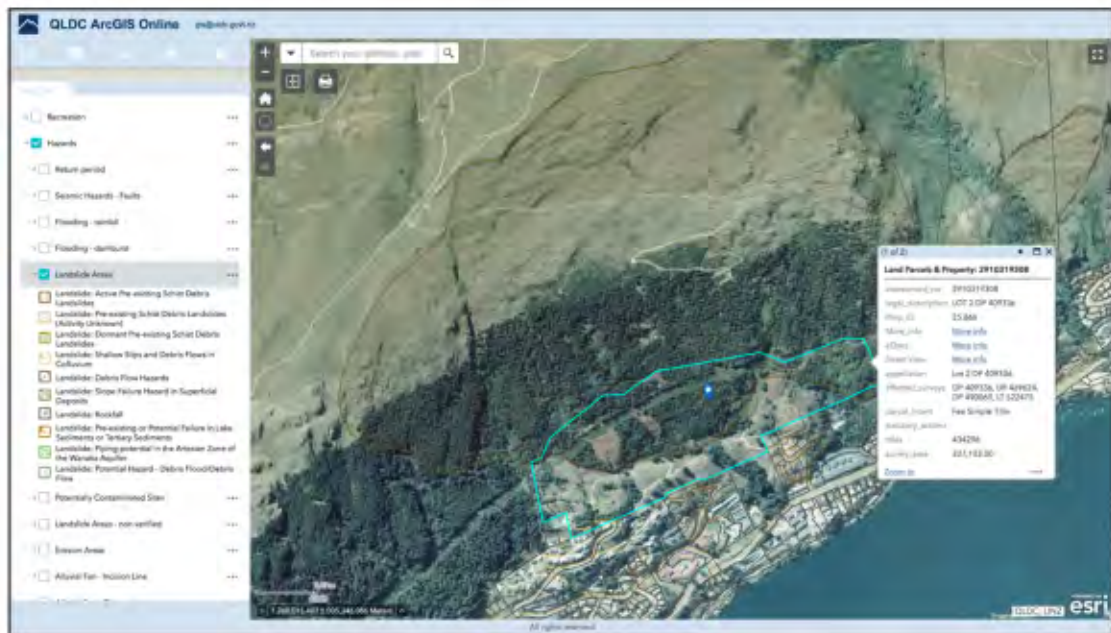
FIGURE 3: QLDC LANDSLIDE HAZARD MAPPING

The ORC and QLDC GIS hazard mapping shows the Queenstown Hill Landslide. The mapped extent of the landslide differs between the hazard maps, with QLDC indicating a landslide toe which approximately matches D Stossel (1999) and BGL (2018) and ORC providing a significantly larger footprint comprising both smaller and larger landslides. The landslide hazard mapping is presented below.

A significant lobe protrudes from the slopes within the central portion of the site. The lobe forms an approximate V shape on the lower edge and is readily identifiable on Figure 3 (Section 2.4 of this report). The southern edge of the lobe provides steep to very steep slopes and rock bluffs up to 10m high in places. The slopes are disturbed and disjointed and contain a number of large open cracks and displaced schist blocks as discussed later in this report.

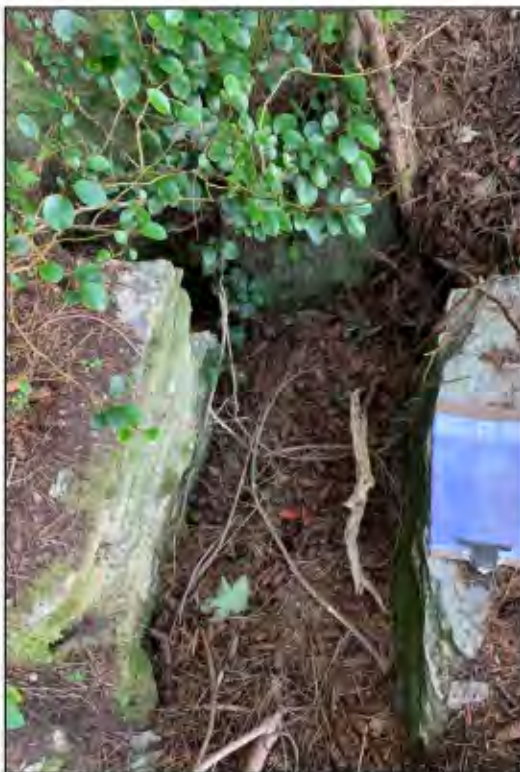
Figure 6a: Large crack partially filled with vegetation

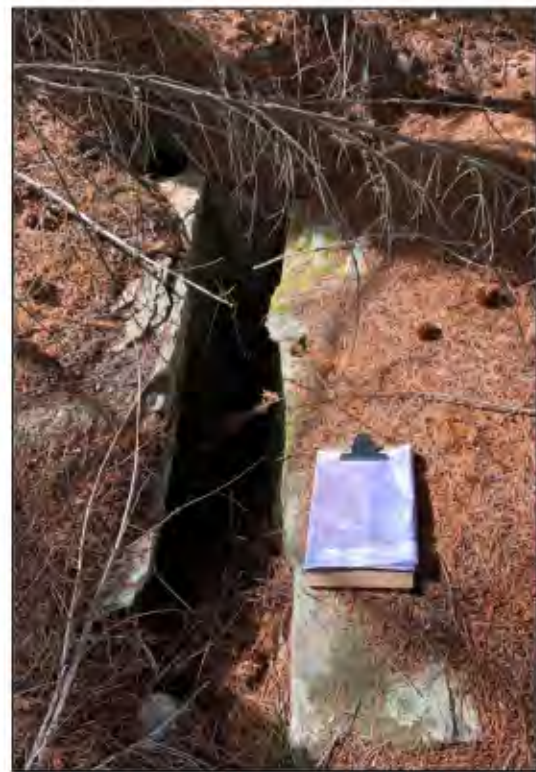
Figure 6b: Large crack > 5.0m deep

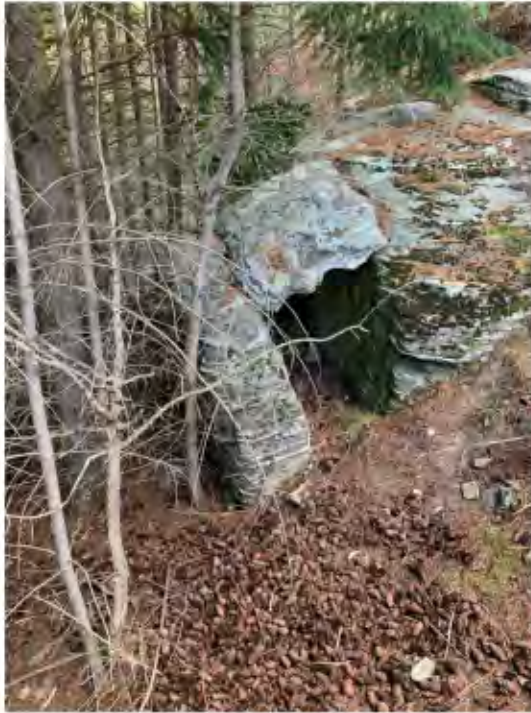
Figure 6c: Displaced schist blocks

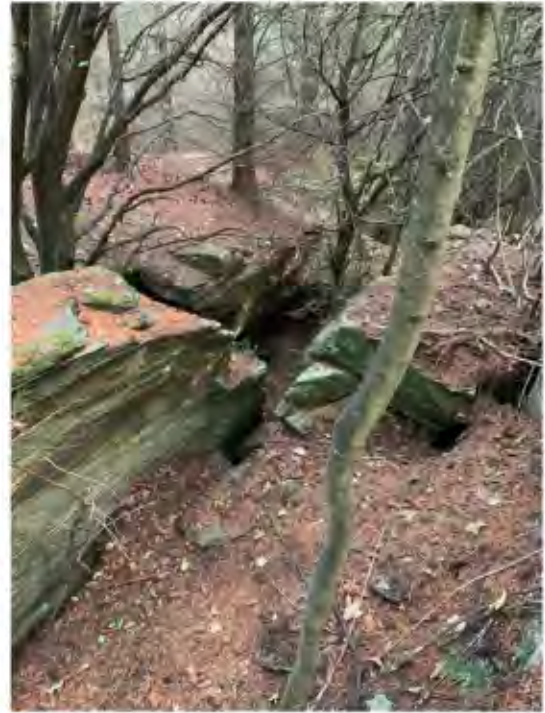
Figure 6d: Displaced schist blocks up to 35m wide (background block)

The toe of the landslide has been mapped and only signs of recent surficial movement were evident. This included sharp, angular, and unweathered cracks, large schist blocks with fresh faces and minor in-fill of deep cracks. The more recent movement is typically confined to within 50m of the steep lobe face and likely represents relaxation of the steep face (tensional forces) rather than movement of the landslide toe (compressional forces). The relaxation of the lobe face has likely been exacerbated by significant seismic events. Potential rock-fall hazard associated with the lobe is discussed later in this report.

The steep faces within the site, especially in the vicinity of the landslide toe, contain significant loose or partially detached schist blocks. These blocks may fall / roll down the steep slopes, particularly in the event of a significant seismic event.

Rock fall can be managed via a number methods including rock pinning, removal of loose boulders, slope planting, debris diversion structures, benches, retaining walls and catchment structures.

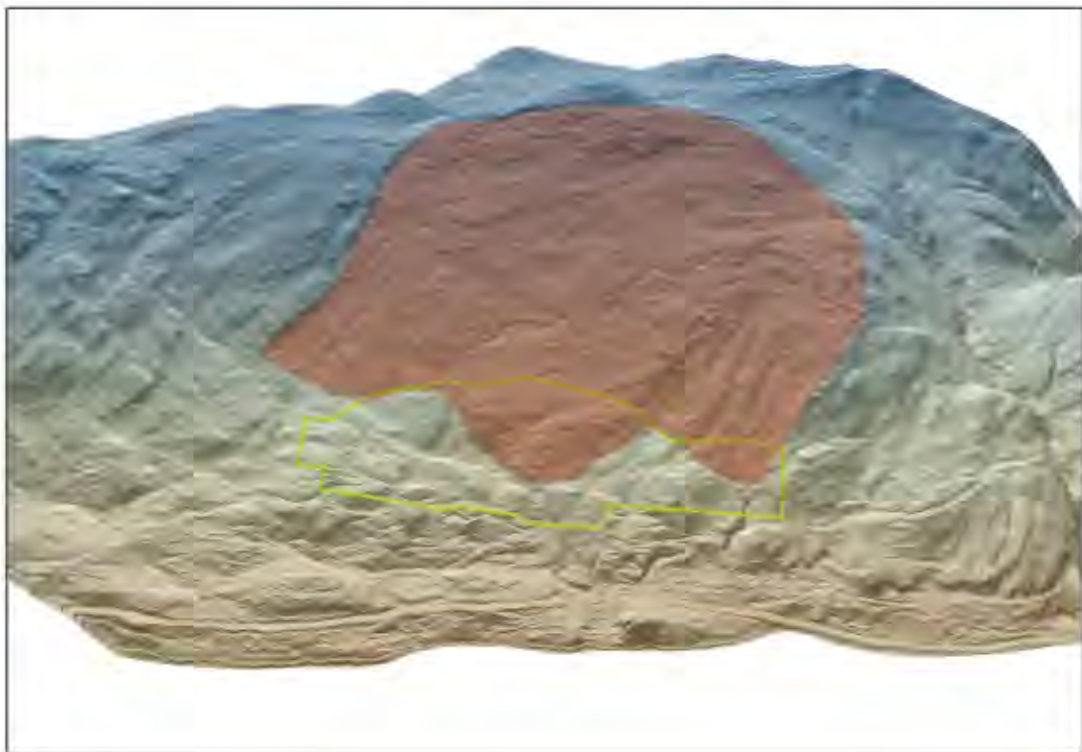
FIGURE 10: MAPPED EXTENT OF QUEENSTOWN HILL LANDSLIDE (RED SHADING)

- Landform evidence: the landslide presents in the LiDAR data, aerial photographs and site mapping as disturbed ground, irregular topography, scarps, tension cracks, displaced schist blocks and bulging as shown on Drawings 003 to 005.
- Schist Foliation: Over 220 foliation strike/dips have been recorded and show a correlation between the landslide zone (irregular / disturbed schist blocks) and the scatter of foliation strike /dips as shown on Figure 7 to Figure 9.
- Boreholes: The correlation with disturbed foliation and the landslide zone is also evident in the recovered borehole core which show larger variance with foliation dip within the landslide zone. The boreholes also show less shearing down-slope of the landslide and this zone of schist appears to have provided a “dam” to the landslide toe resulting in prominent compressional bulges along the toe of the landslide.
