470 Great South Road, Papakura – Ground Contamination Review

Project no: WWLA0472
 Document title: Preliminary and Detailed Site Investigation (Ground Contamination)
 Revision: 1
 Date: 3 November 2021
 Client name: Greg Hayhow
 Project manager: Wendi Williamson
 Author(s): Lauren Windross
 File name: s 9(2)(a)

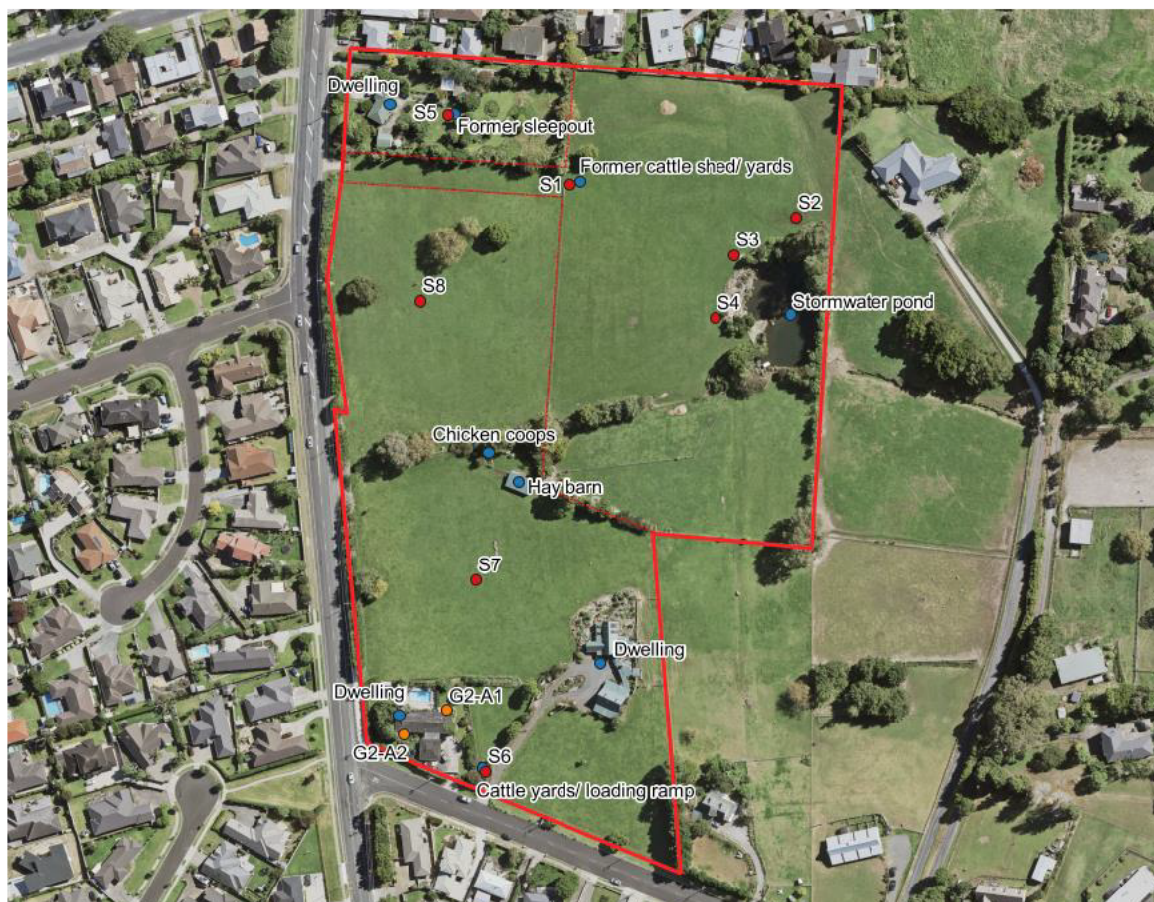
Overall, very little contamination is present at the site. Two 'hot spots' are present, within the current cattle sheds and immediately surrounding the concrete floor from the former sleepout/shed. These areas should be remediated in isolation prior to bulk earthworks commencing so that soil can be appropriately managed without cross contamination.

Figure 2: PSI/ DSI sampling plan. Site features shown with blue dots, samples with red and orange dots.

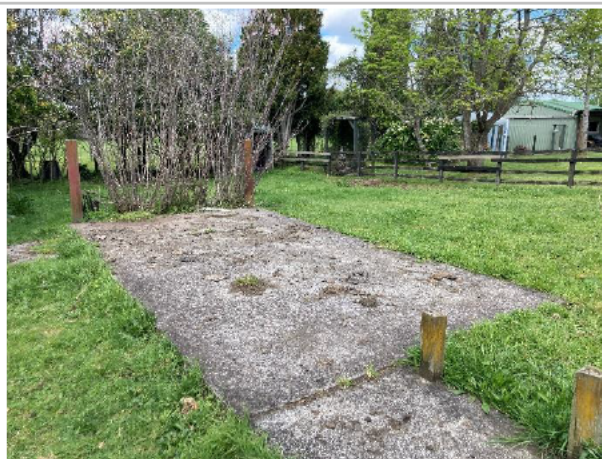
Photograph 2: Concrete pad from former sleepout

- Two areas showed concentrations of one or more metals above background concentrations:
 - Sample S5 (from the former sleepout) has elevated levels of arsenic, cadmium and lead. Lead concentrations slightly exceed environmental discharge criteria (322 mg/kg *c.f.* 250 mg/kg). Lead levels of this magnitude are commonly attributed to lead paint. While no flakes of lead paint were observed in the soil, it is possible that 'dust' remains from the original building. Elevated arsenic and cadmium are suggestive of storage of farm drench and fertiliser. It may be that the former 'sleepout' was actually a former storage shed for chemicals and farm equipment (or served both purposes at different times).

Hot spot remediation	<p>The two hot spots should be remediated during enabling works, prior to bulk earthworks commencing, either by removal offsite or onsite mixing.</p> <p><u>For excavation and removal off site</u>, separate erosion and sediment control may be required around each one to prevent cross-contamination of surrounding soils, depending on weather conditions at the time of work. Following removal of the concrete slab at the former sleepout/ shed, and timber structures at the cattle yards, a 400 mm scrape (or all of the topsoil) shall be removed via excavator and placed directly onto a truck for disposal to managed fill (for the cattle yards) and licensed landfill (for the sleepout/ shed). A 1 m buffer around each structure should also be removed. Care should be taken to ensure there are no spills of contaminated soil onto surrounding ground.</p> <p>Following removal, the contaminated land specialist will undertake validation soil sampling to confirm that contamination has been removed and that bulk earthworks can commence under standard earthworks controls.</p> <p><u>For onsite mixing</u>, topsoil in both areas can be stripped with other topsoil from the remainder of the site. The process of stripping the topsoil, loading it into a Moxy or similar vehicle, and stockpiling it on site, would likely be sufficient to enable it to become well mixed with clean topsoil, thereby reducing the contaminant concentrations to acceptable levels. Given the small volumes of contaminated soil in the context of the wider proposed works, this option is likely to be easy to achieve (a 6 parts clean to 1 part contaminated ratio is expected to be sufficient to reduce concentrations to background levels).</p> <p>The stockpiled soil would need to be validated by a CLS before it is able to be reused on site or disposed offsite as cleanfill. Mixing must be done in dry (but not dusty) conditions to ensure mixing is able to occur successfully.</p>

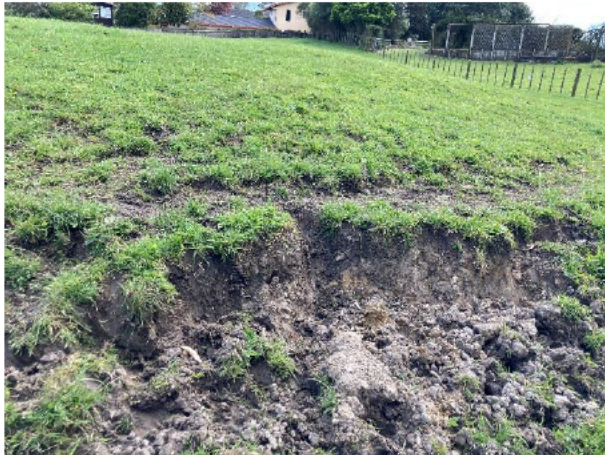
- The ground surrounding the pond is raised, suggestive of placement of excess spoil from the original pond excavation (**Photograph 5**).
- At the time of our walkover a septic tank leak had recently been discovered and fixed, immediately northeast of the pond on the neighbouring property (outside of the site). The overflow from the leak had drained onto 476 Great South Road and was ponding near the stormwater pond. Affected soil in the ponding area had begun to dry out. The source of wastewater in the septic tank is domestic and therefore not a ground contamination concern.

Photograph 5: Potential site-won fill north of the stormwater pond, location of sample S2

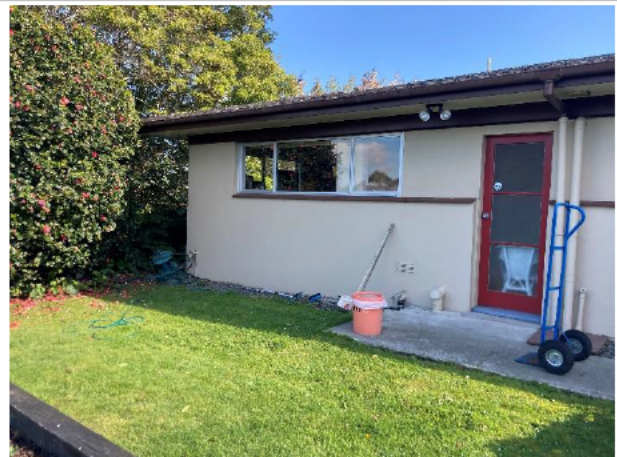
Photograph 7: Rear of the dwelling at 2 Gatland Road, location of sample 2G-A2

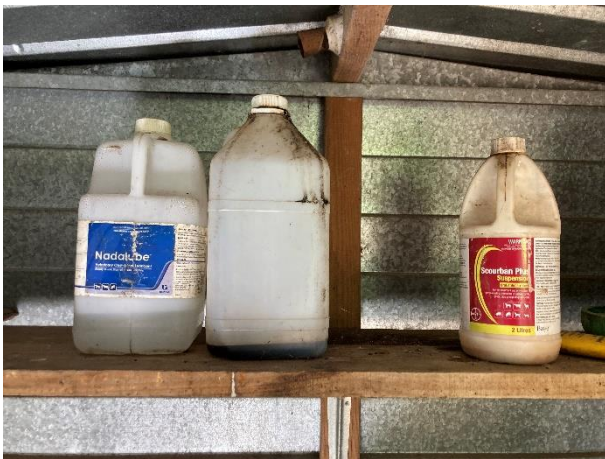
Photograph 10: Drench inside aluminium shed

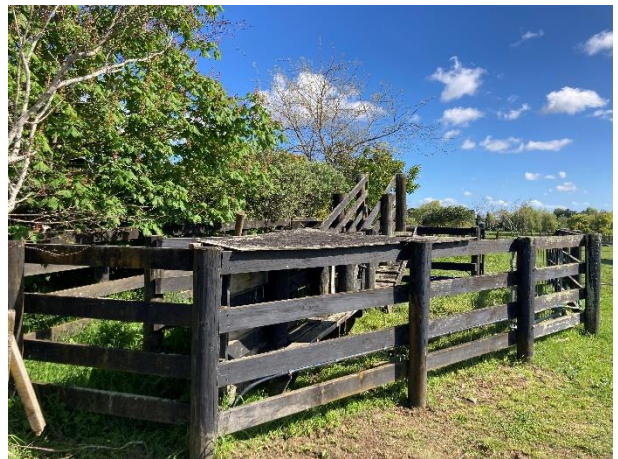
Photograph 11: Cattle yards and loading ramp
