Project Number 19079.000.001

Preliminary Geotechnical Investigation

*Metlifecare Whenuapai Village,
99 Totara Road, Whenuapai, Auckland*

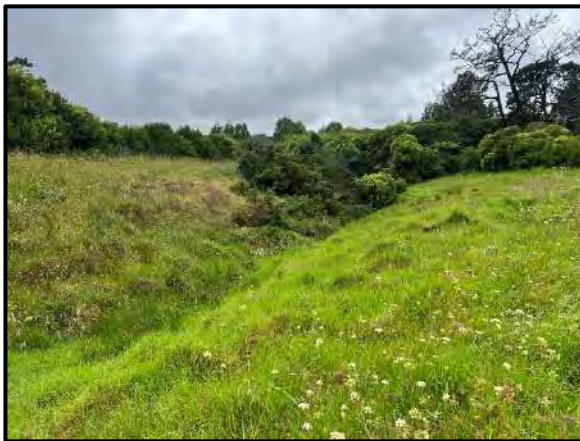
Photo 1: Existing gully in the north-eastern portion of the site. View Looking east from southern gully wall.

Indication of shallow instability was also observed on the sides of the north-eastern gully; however, we understand this is to be backfilled which should address the associated risk. Similar shallow instability was observed on the banks of the stream(s) in the south-eastern portion of the site. Based on observed ground conditions we do not expect any low angle or deep-seated instability in this area; however, we note that some structures are proposed near the stream bank which could present some risk of undermining due to stream bank regression. Therefore, the buildings should be appropriately set back from the stream, or the stream banks contoured to more stable batter angles and revegetated to aid stability.

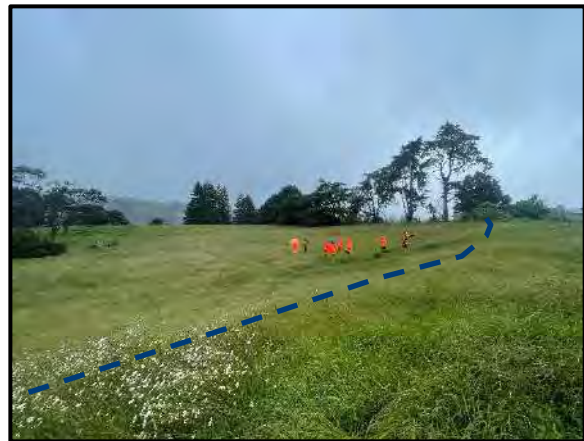
- A headland protrudes from the western end of the site into the Kotukutuku Inlet; it is approximately 50 m wide at the narrowest point.
- An historical headscarp / slumping feature was observed south of the western headland, oriented west-southwest. The southern end of the headscarp is best defined, becoming less so to the north. Erosion appears to have smoothed the headscarp and vegetation had re-grown suggesting no recent rupture events. However, curved tree trunks at the vegetated toe of the slope may indicate soil creep is actively occurring.

Photo 2: View looking north at headscarp in the south-western portion of the site. Approx. headscarp location shown by dotted line.

Two existing landslide features were observed, in the western portion of the site during our walkover which appear to have a relatively low angle, and therefore likely indicate a mechanism beyond typical coastal regression / undercutting (although coastal regression may also be contributing). These features are described in Section 6.1 and annotated on the plan in Appendix 1. Review of historical aerial photos suggest that these features may have been present prior to 1940, but certainly before 1963, and that there hasn't been any rapid movement of these since then. However, curving of tree trunks suggests that there may be ongoing and / or periodic creep occurring, particularly in the south-western landslide.

The preferred solutions should be determined in subsequent phases of the project in coordination with the client and pending results of proposed computational slope stability assessment. However, we recommend that an emphasis should be placed in the early design stages on unloading of slopes (i.e. prioritizing cuts over filling near slopes) and routing of overland flow away from existing slopes.

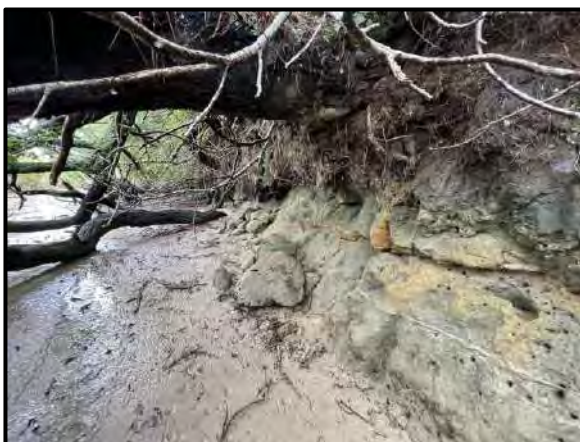
Photo 3: Sub-horizontal ECBF exposure on northern coastal margin.

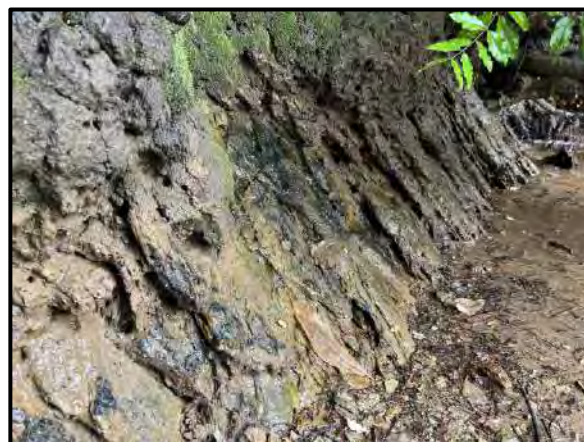
Photo 4: Sub-vertical ECBF exposure in north-western coastal margin.

Notably, outcrops on the western coastal margin (below the landslide features) were observed to have a bedding dip much steeper, and at a different orientation than outcrops in the eastern portion of the site (discussed in Section 6.1). This may be a contributing factor to the instability, or potentially a consequence of the instability. In the latter case this could suggest a deep-seated slip plane.

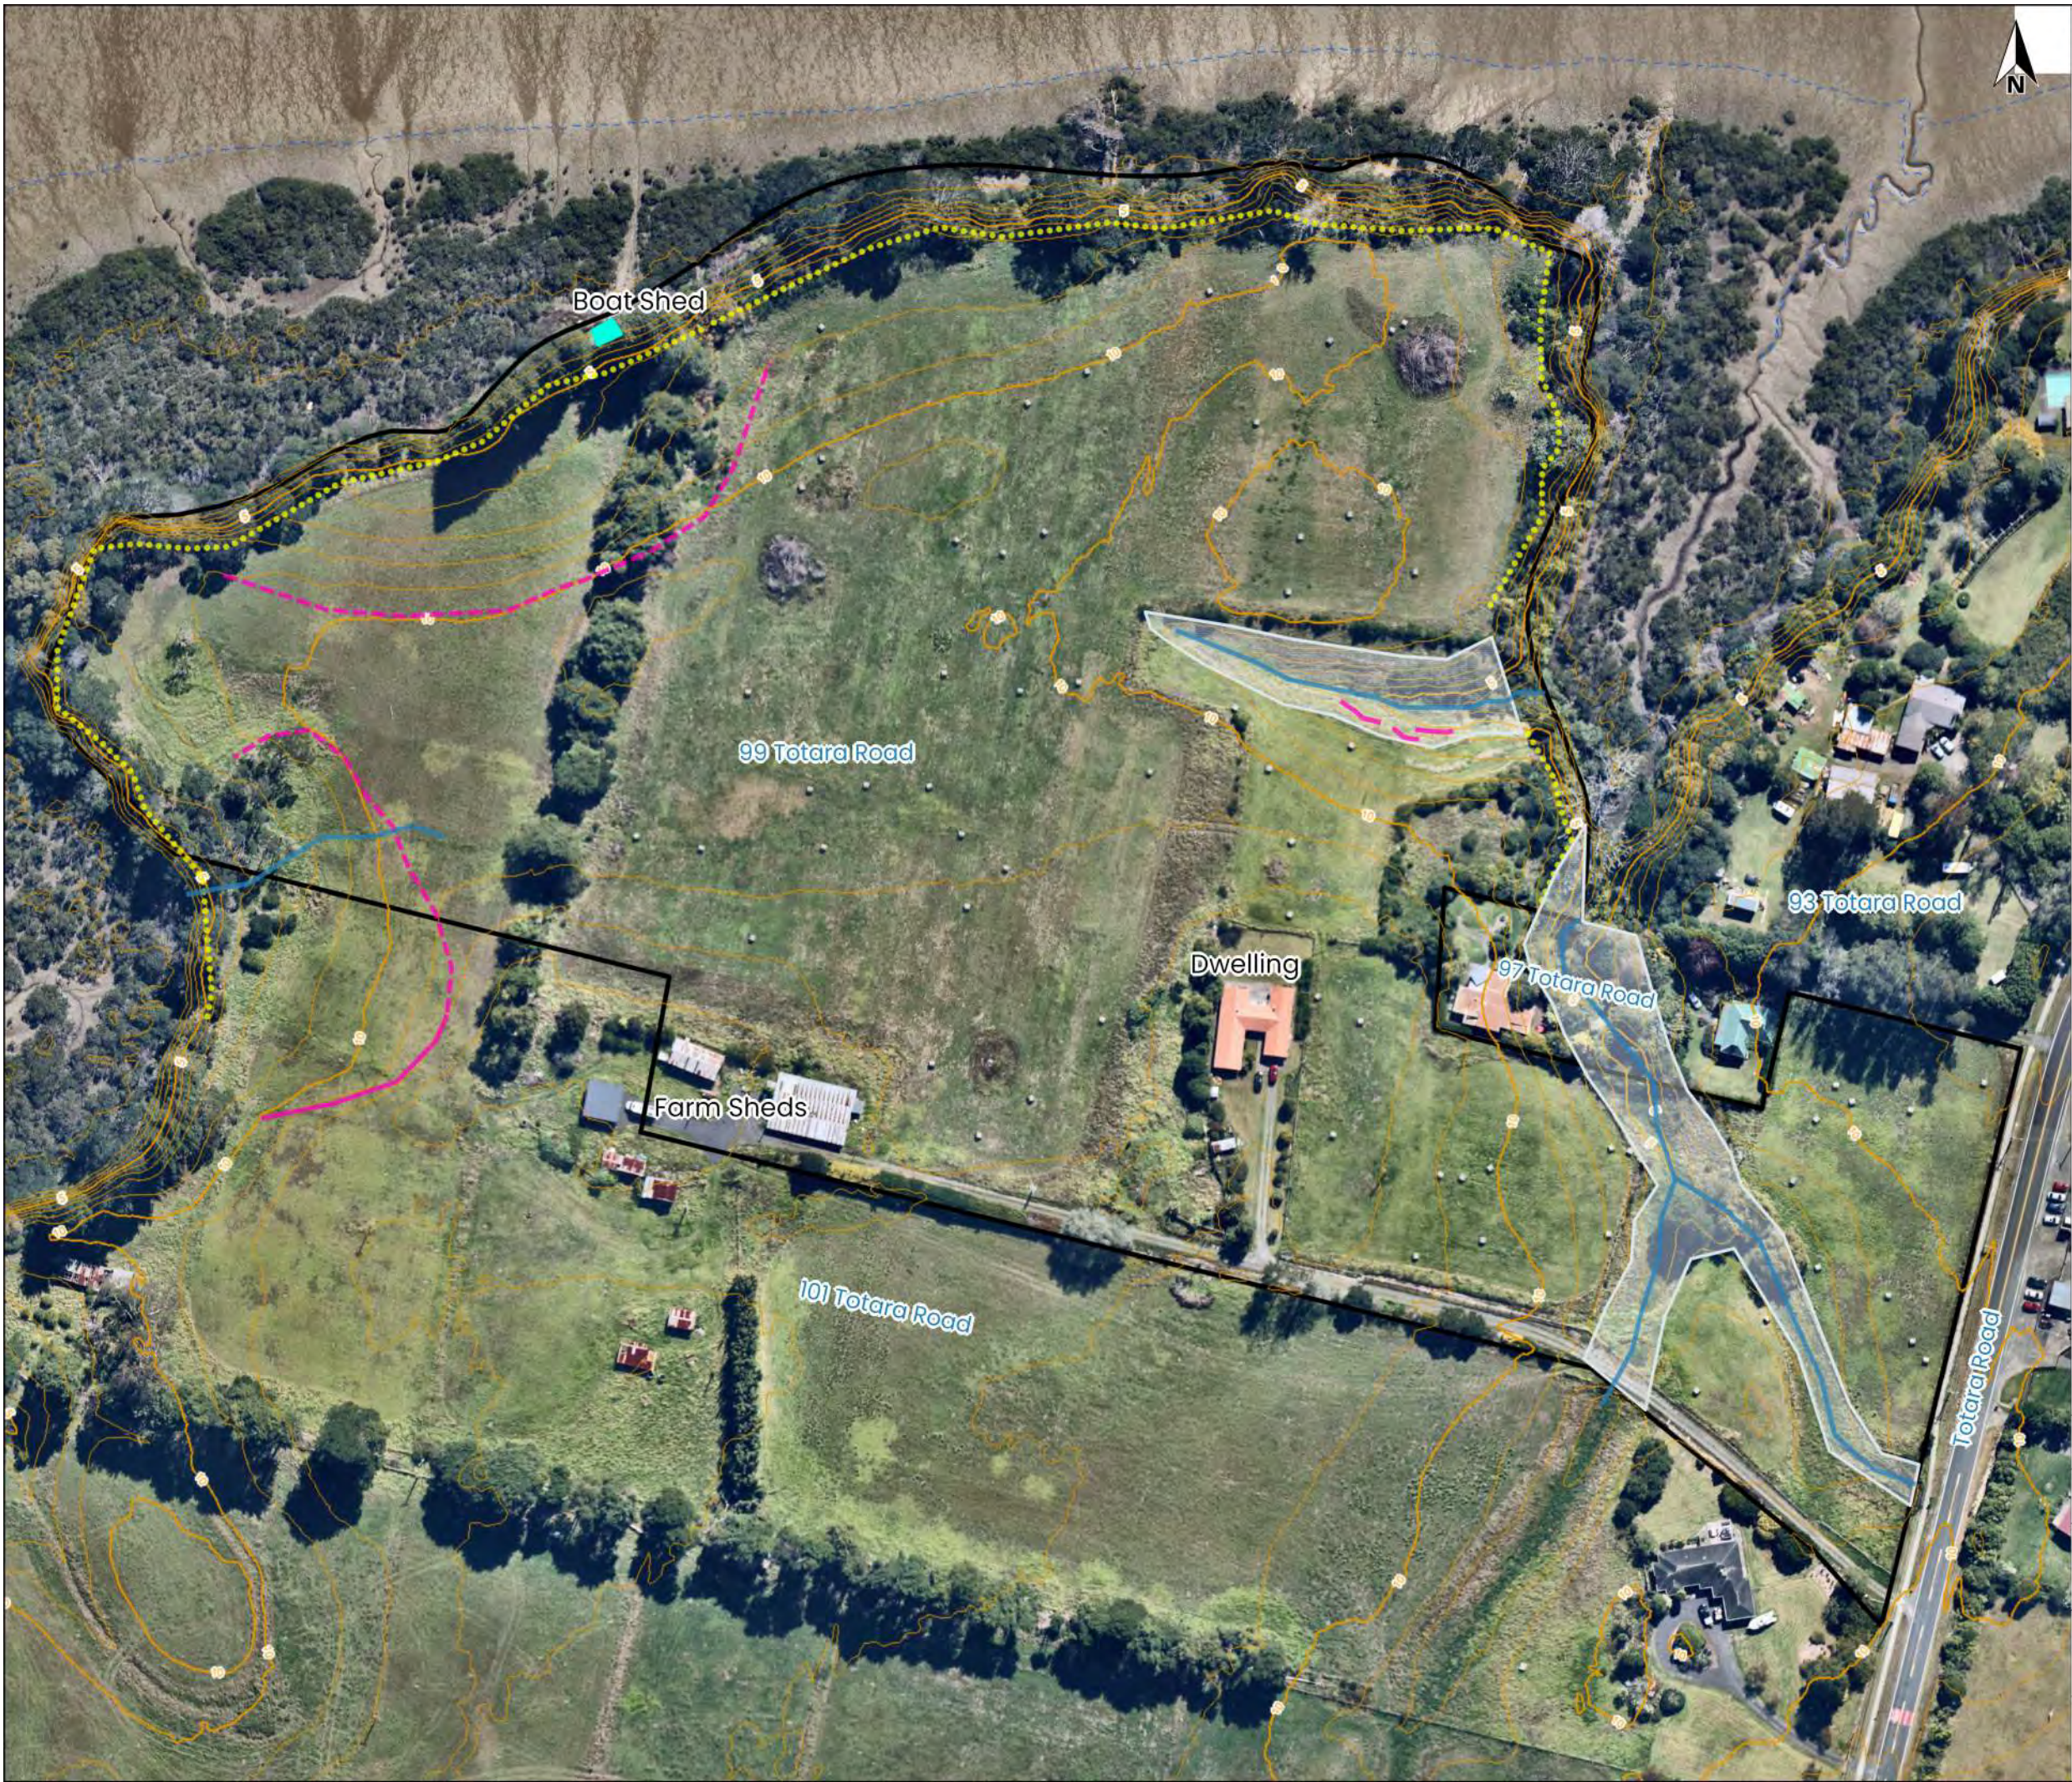
APPENDIX 1:
Site Features Plan

- The stream currently passes through a culvert beneath the existing accessway near the southern boundary.
- A west-east trending gully up to 4 m deep transmits much of the overland flow from the central portion of the site into the tidal inlet defining the north-eastern site boundary (Figure 1, Photo 1). The northern bank of the gully generally holds a slope of 1V:3H (18 degrees). The southern bank slopes at similar angles in the lower half, however the slope angle typically reduce to 1V:4H (14 degrees) for the top half of the gully wall. Several low height head scarp features were observed near the change in slope angle indicating active erosion.

- Another historical headscarp / slumping feature was observed north of the western headland, oriented north-west. The head scarp is not well defined due to erosion and re-vegetation. Mild curve to some tree trunks was observed at the toe of the slope which may indicate active soil creep.
