Arboricultural report

To: Paul Kleynhams, Project Engineer, Cato Bolam Consultants s 9(2)(a)
From: Andrew Barrell, Consultant Arborist Tree 3 Ltd s 9(2)(a)
Date: 13 April 2021
Re: Brigham Creek Road & Kauri Road, Whenuapai – trees in riparian yard and wetland area
Arboricultural assessment & recommendations

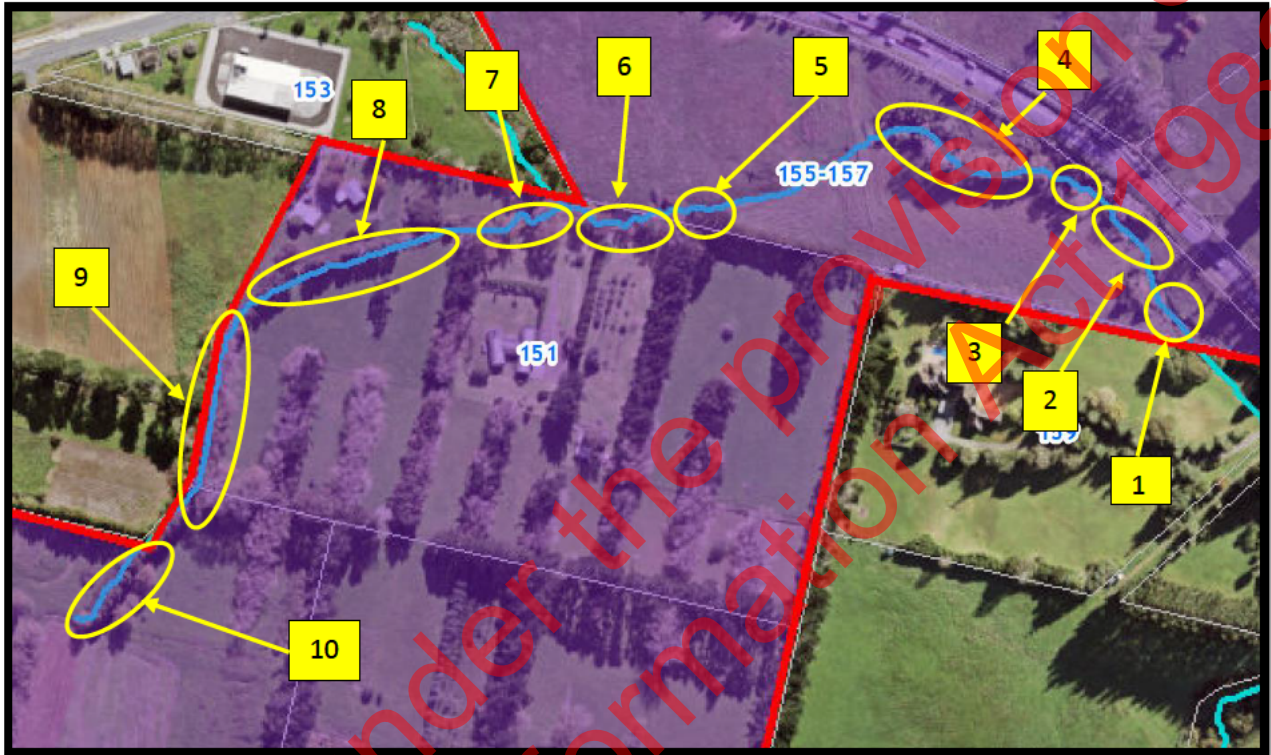
Figure 2 – Overview of vegetation assemblages.

- 9) Figure 2 is an annotated version of Figure 1 and provides a general overview of the vegetation assemblages around the riparian margin to the south of Brigham Creek Road; the wetland area to the north is shown separately in Figure 3. The following comments summarise and clarify the information shown in Figure 2 with regards to general information about species and scale of vegetation in each area and any associated impacts on watercourse integrity.

Vegetation description: This area contains mostly exotic weed species including bamboo (*Bambusa* species), brambles (*Rubus* species), privet (*Ligustrum* species) and willow (*Salix* species). The larger plants (willow and bamboo) are up to 8m tall and the remaining plant cover has created a dense coverage over the bank and into the actual watercourse itself.

Assessment: The lower vegetation is covering most of the bank either side of the watercourse and is also growing up through the lower branches of the willow trees, effectively shading the area beneath and providing ideal circumstances for weed colonisation to continue. It is also clogging up the watercourse which will cause silt to gather and more weeds to grow, effectively blocking the watercourse. The eventual outcome of this process is that the watercourse will become colonised by trees (likely to be willows) and cease to function as a watercourse.

Vegetation description: This area extends westwards from the existing crossing and consists of a dense blanket of honeysuckle (*Lonicera* species), bramble and remnants of a fallen willow tree.

Assessment: The dense coverage of weed species is encroaching into the watercourse and also climbing through the branches of the fallen willow. This encroachment compromises the functionality of the watercourse and will only get worse if not addressed as soon as reasonably possible.

Vegetation description: This area contains many mature exotic trees including poplars, willows, pine (*Pinus* species), wattle (*Acacia* species), alders, grevillea (*Grevillea robusta*), casuarina (*Casuarina cunninghamiana*) ranging up to 15m in height. In addition there are native trees including totara (*Podocarpus totara*), rimu (*Dacrydium cupressinum*), cabbage tree (*Cordyline australis*) and karo (*Pittosporum crassifolium*), up to 8m tall. The understory contains random pockets of assorted native regeneration as well as gorse (*Ulex europaeus*) and willow weed (*Persicaria maculosa*). There is also a fallen limb within the watercourse, originating from a nearby grevillea tree. This limb is approximately 8m long and has a maximum diameter of about 250mm. The western section of this area appears to have been planted with native species however there is a diverse range of both native and exotic mature species present, all of which are providing ecosystem service as described in earlier sections of this report.

Assessment: The mature tree cover is not compromising the functionality of the watercourse and is providing ecosystem services. Native regeneration is occurring within the shade of these trees however the willow weed in particular is established within the watercourse and will eventually clog it completely. The fallen limb will trap material and result in blockages to the water flow.

Vegetation description: Four mature pines in excess of 15m tall stand in this area along with poplars and willows up to 12m tall. There are three mature willow trees that have fallen over adjacent to these pine trees. The fallen willows have created a 1m-high berm with their root systems which has effectively blocked the watercourse. These willows have trunk diameters in excess of 400mm and are upwards of 8m tall.

Assessment: The willows are continuing to grow in their horizontal orientation and will only increase their spread over the surrounding area. The berm formed by their uplifted root structures will only consolidate further if no intervention occurs and the functionality of the watercourse will be irreparably compromised.

Recommended actions: Blanket clearance of weed species from this area will result in exposed banks and a clear waterway. This clearance should extend at least 3m from either bank, preferably further if possible, and appropriate riparian planting and erosion control measures should be established as soon as possible to consolidate the bank, prevent erosion and prevent future clogging of the watercourse by unwanted species colonisation.

Recommended actions: Removal of the willow weed and the fallen limb are priorities in this area. This should be carried out as soon as reasonably practicable and include removal of any other weed species that is encroaching into the watercourse. This clearance should extend as far from the edge of the watercourse as circumstances allow but should result in removal of invasive weeds from at least 3m from the stream edge to reduce the likelihood of recolonisation and be carried out in conjunction with appropriate replanting, erosion control and ongoing weed management.

Recommended actions: Removal of the willows and their elevated root structures are priorities in this area. This work should entail complete removal of all the stem and canopy material and also the root structures. Once this material has been removed from site the watercourse may be reprofiled and then replanted with appropriate riparian species and adequate erosion controls put in place. This should be carried out as soon as reasonably practicable.

24) The primary arboricultural management recommendations relate to the removal of the limb from the watercourse in Area 4 and removal of the three fallen willows and associated reprofiling of the watercourse in Area 5. The remaining recommendations relate more to maintaining the integrity and functionality of the watercourse and are focused more on ecological restoration processes than arboricultural principles.

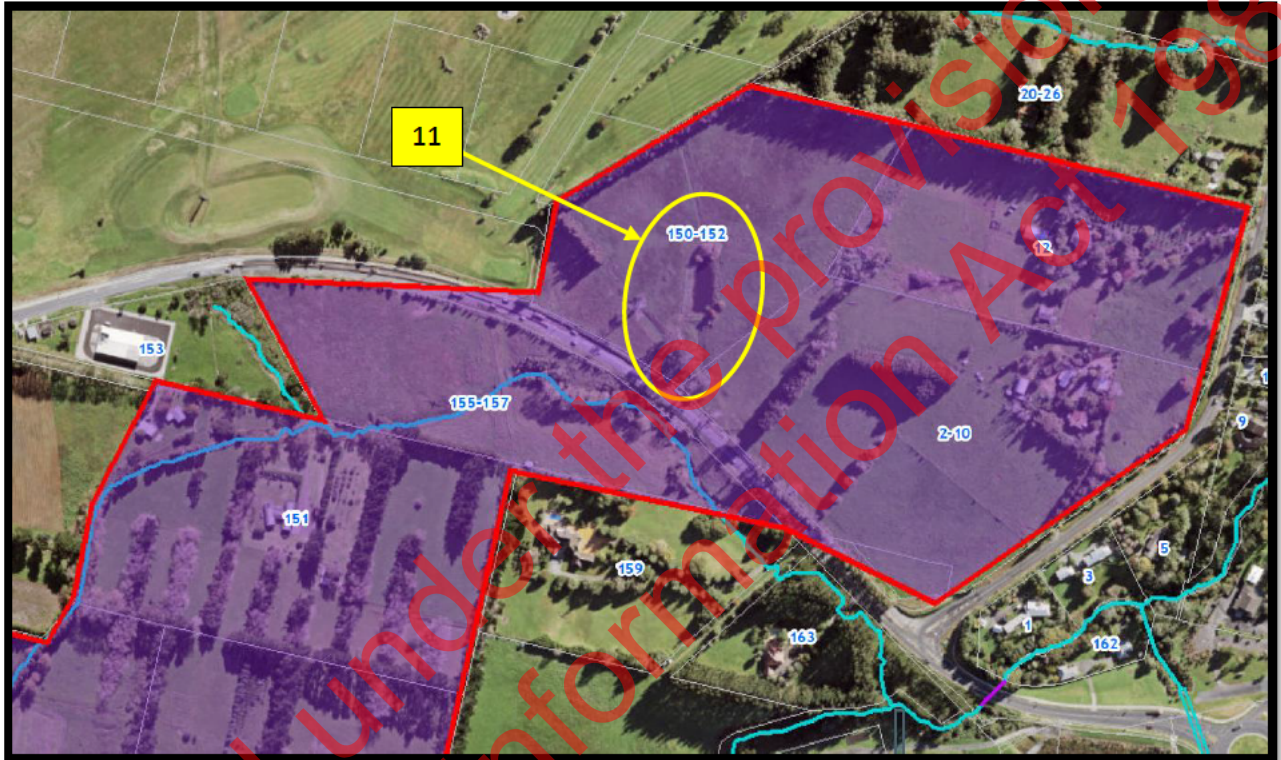
Figure 3 – Area 11, to north of Brigham Creek Road.

Vegetation description: Figure 3 below shows the area associated with a watercourse on the northern side of Brigham Creek Road. This is the only section of the site where the Auckland Council Geomaps viewer shows the presence of a significant overland flow path and as such the remainder of the site has been excluded from this assessment. There are 12 over-mature pine trees up to 25m tall and in varying stages of collapse, two swamp cypress (*Taxodium distichum*) approximately 8m tall, several willows and groundcover consisting of kikuyu grass (*Pennisetum clandestinum*), gorse, bramble, tobacco plant and great bindweed (*Calystegia sylvatica*).

Assessment: The general appearance of this area indicates it has been subject to grazing by stock for an extended timeframe and no indigenous plants or trees were observed in the area. Overall it consisted of random exotic tree and weed species, none of which would be considered appropriate for retention within a wetland environment.

Recommended actions: This area in effect represents a blank canvas with regards to restoration to any kind of viable wetland environment. All the vegetation present was exotic with no species observed that would be beneficial to establishing or maintaining an indigenous wetland environment therefore at this point in time there would be no adverse ecological impacts associated with removal of the existing vegetation on this section of the site with regards to effects on indigenous biodiversity. If it were to be restored to wetland status an appropriate restoration plan would be required from a suitably qualified ecological specialist.
