Restoration Options Whirinaki Drain EAM Environmental Consultants

RESTORATION OPTIONS Whirinaki Drain Whirinaki

PROJECT NO. EAM2282 REP- 02

JULY 2022

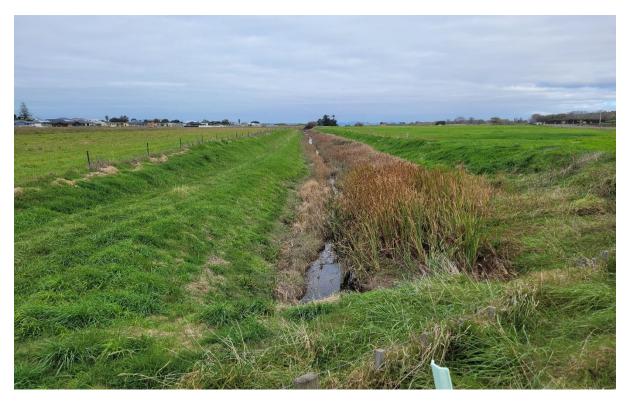
View downstream from the SH2 culvert. Raupo in the foreground true right is replaced by more salt tolerant species after approximately 20m.

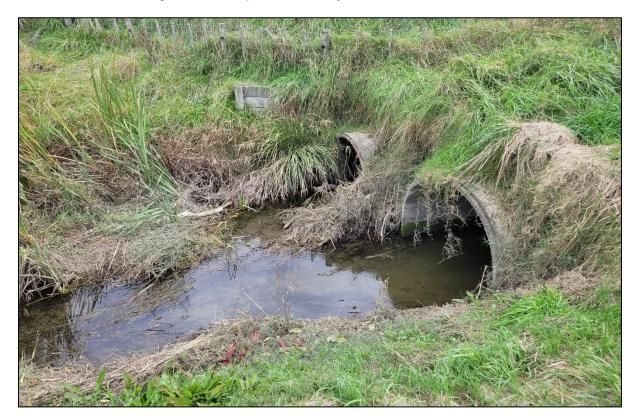
SH2 culvert and small growth of Raupo. This is likely to be the limit of the tidal influence.

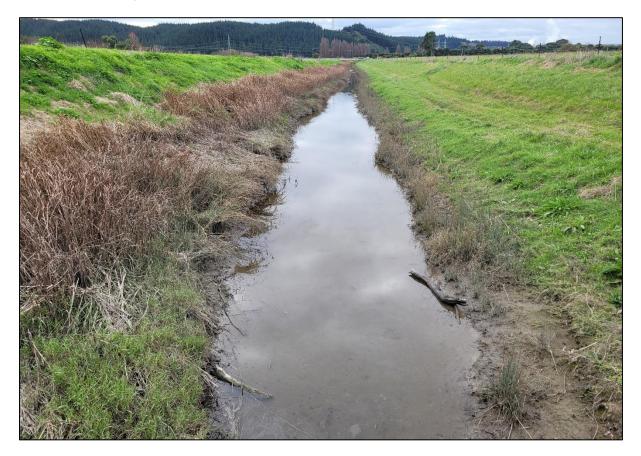
Upstream of the farm bridge the channel is wider with low velocity flows, filled with fine sediments and very little habitat provision.

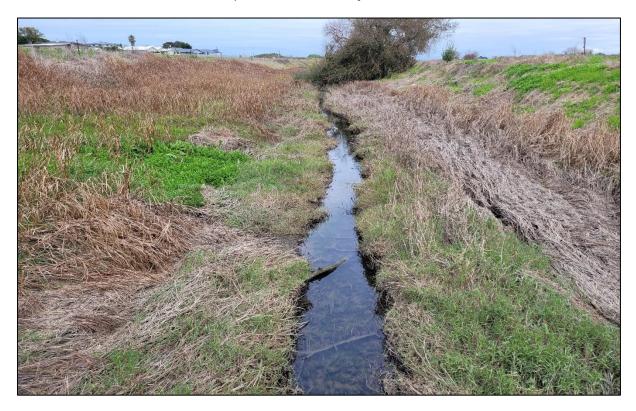
The drain narrows beneath the farm bridge. The increased velocity has flushed some of the fine sediments from this section and exposed coarse woody debris and cobbles.

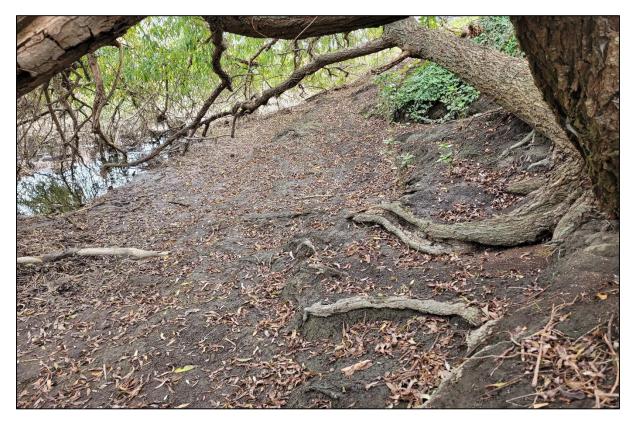
Good riparian cover on the true right of Whirinaki Drain from the lone willow providing shading and instream habitat.

- Do not remove the willow until some other woody vegetation is established. Preferably kill by the drill and fill technique to maintain at least the architecture of the tree for several years until other trees and shrubs establish.
- Maintain vegetation cover on the banks.
- Create habitat through targeted planting of bird supporting trees in the drain corridor.
- Consider predator control throughout the length of the drain to increase nesting success and minimise disturbance of feeding and resting birds.

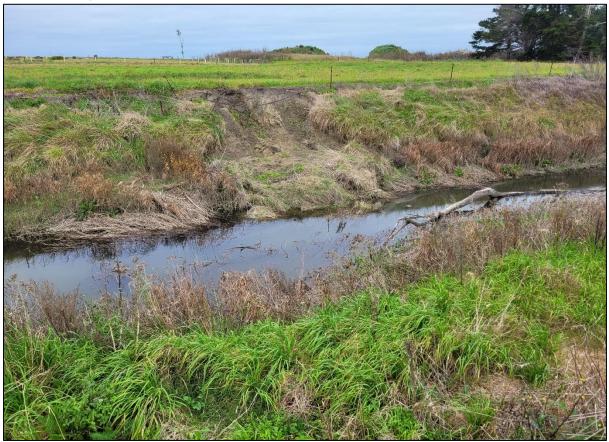
The drain is a linear, mechanically created form with little flow diversity. The banks are uniform battered slopes with a low terrace adjoining the flow in the upper section. The lower reach, effectively below the farm access bridge of the site, is less uniform with steeper banks and often some bank collapse and a discontinuous lower terrace. Two weir/ford structures impact the flow of both freshwater and tidal flows.

Bank slumping on the true left of the Whirinaki Drain.

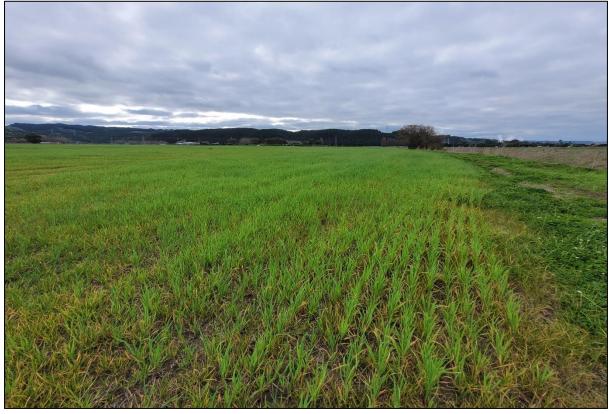
Landuse adjoining the Whirinaki Drain. Note the lack of any indigenous terrestrial habitat.

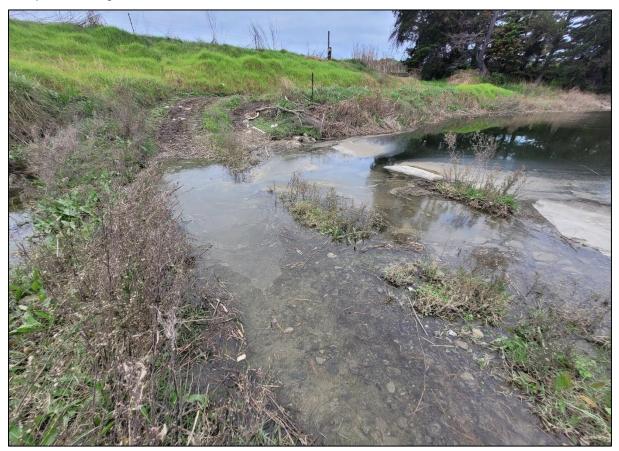
Very poor fish habitat is present in the survey reach. A single Longfin eel was found where the large willow tree provided overhead and instream habitat. The weir/ford structures will be creating a partial barrier to fish passage. Removal of vegetation along the drain length is impacting potential habitat.

Lower Weir/Ford at full tide. Note the shallow depth of water providing a small window of access for upstream migration.

- Remove weir/ford structures, monitor for erosion issues and address where undesirable.
- Some recontouring of the drain profile should be expected as it establishes a more natural form.
- Understand the drainage function requirements from the relevant local authority and if appropriate incorporate some sinuosity into the drain.

- Remove fish passage barriers.
- Increase the amount of instream habitat diversity with hardwood logs keyed into the banks.
- Riparian planting to eventually add coarse woody debris, terrestrial food sources and provide shading.

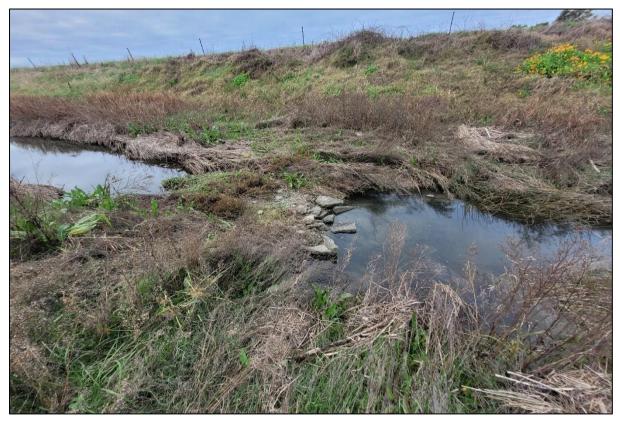
The upper Weir/Ford just prior to high tide. Water is moving through the interstitial space but not over this structure.

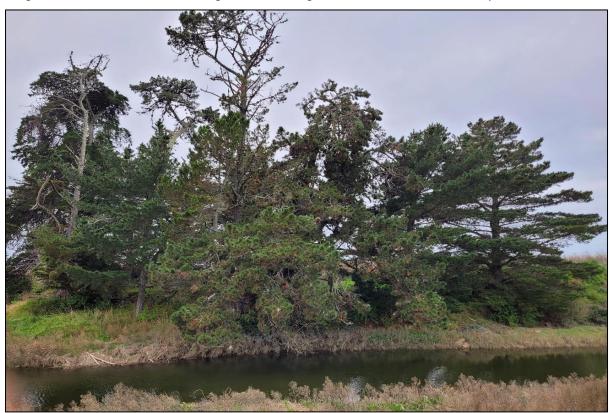
Large exotic trees at the Nukurangi Pa Archaelogical site. Pine and Macrocarpa
