**RE: Application under National Environmental Standards for Air Quality – Regulation 16A  
Exceptional Circumstances.**

# **Resource Management (National Environmental Standards for Air Quality) Regulations 2004 – Regulation 16A Exceptional Circumstances**

**Application for exceptional circumstances consideration:**

**Auckland Waterfront Nitrogen Dioxide (1-hour Average) (13 Exceedances)**

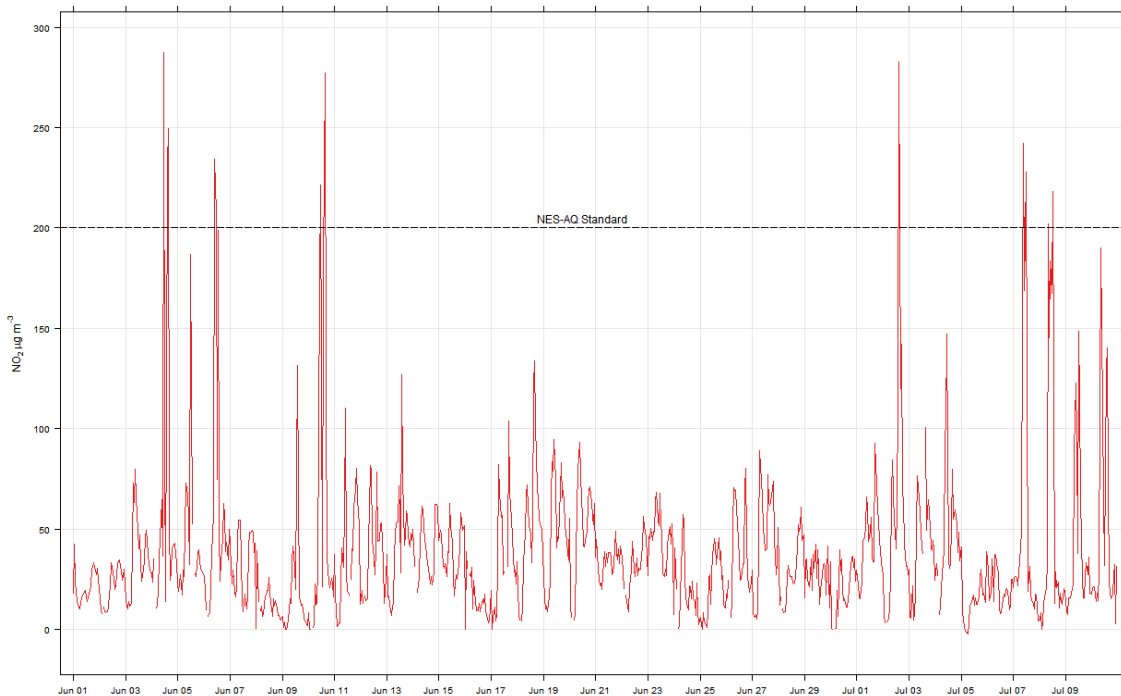
**Figure 2 NO<sub>2</sub> data (1-hour average) at Auckland Waterfront (00:00 01/06/2014 - 00:00 10/07/2014)**

The monitoring data accordingly shows sharp peaks in NO<sub>2</sub> concentrations, occurring late morning and late afternoon. The exceedance values are roughly twice the highest non-exceeding concentrations for the period of Figure 2. The concentrations between the morning and afternoon peaks are also elevated. The average NO<sub>2</sub> concentration between 01/06/2014 and 08/07/2014 was 37.07 µg m<sup>-3</sup>. The NO<sub>2</sub> peaks are also replicated in the NO data from the monitoring site, suggesting the dominance of a combustion source (Krivoshto et al. 2007).

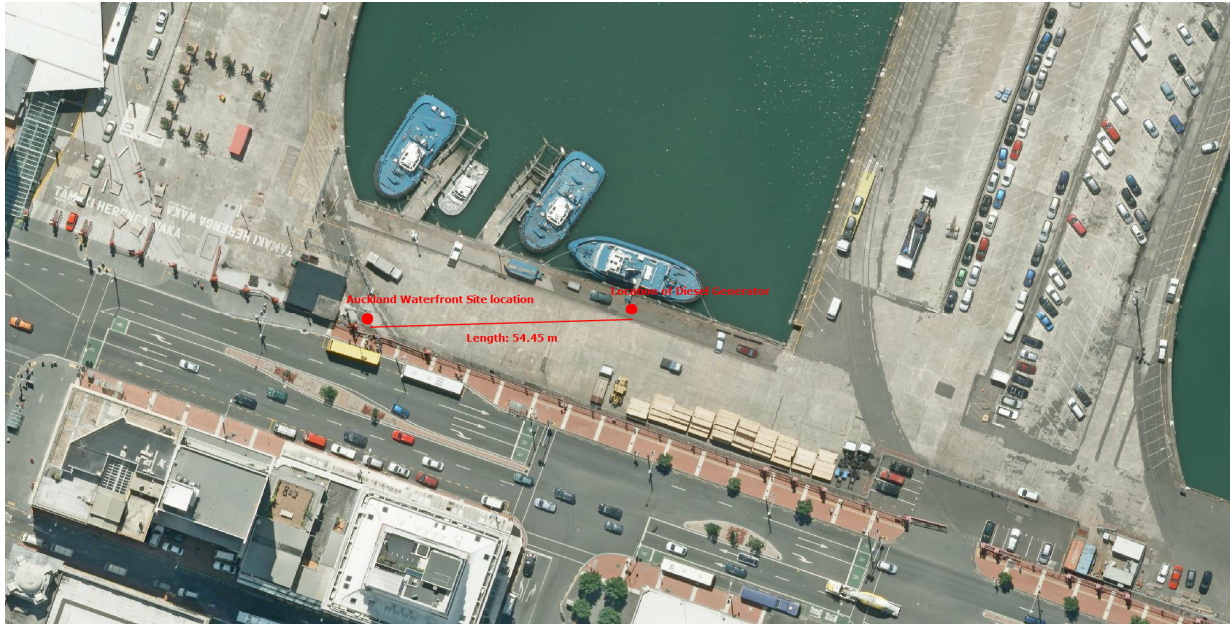
Figure 6 Location of the Auckland Waterfront site and the diesel generator

The project uses a range of construction techniques, and as part of this a diesel generator was positioned 54m East of the monitoring site, to provide power to the operation, and providing power and compressed air for shotcreting and associated works. The positioning of the generator here was unavoidable as POAL needed to maintain access around the site for construction activities and port operations, whilst ensuring health and safety was not compromised (see Appendix C). The location of the generator is shown in figure 6, and pictures of the generator showing its proximity to the monitoring site are provided in figure 10.

The location of the generator in relation to the monitor resulted in the emission plume from the diesel generator travelling directly towards the monitoring site in a North East wind. Furthermore, under these wind conditions the emissions from the generator would be prevented from dispersing efficiently by the buildings on Quay St (visible behind the monitoring site in the figure 10). In figure 7, the effect of these wind conditions is shown. In the left – hand pollution rose, concentrations from all quarters are roughly equal. During the period of exceedances, easterly winds resulted in not only higher concentrations, but concentrations over the NES-AQ. Under ‘normal’

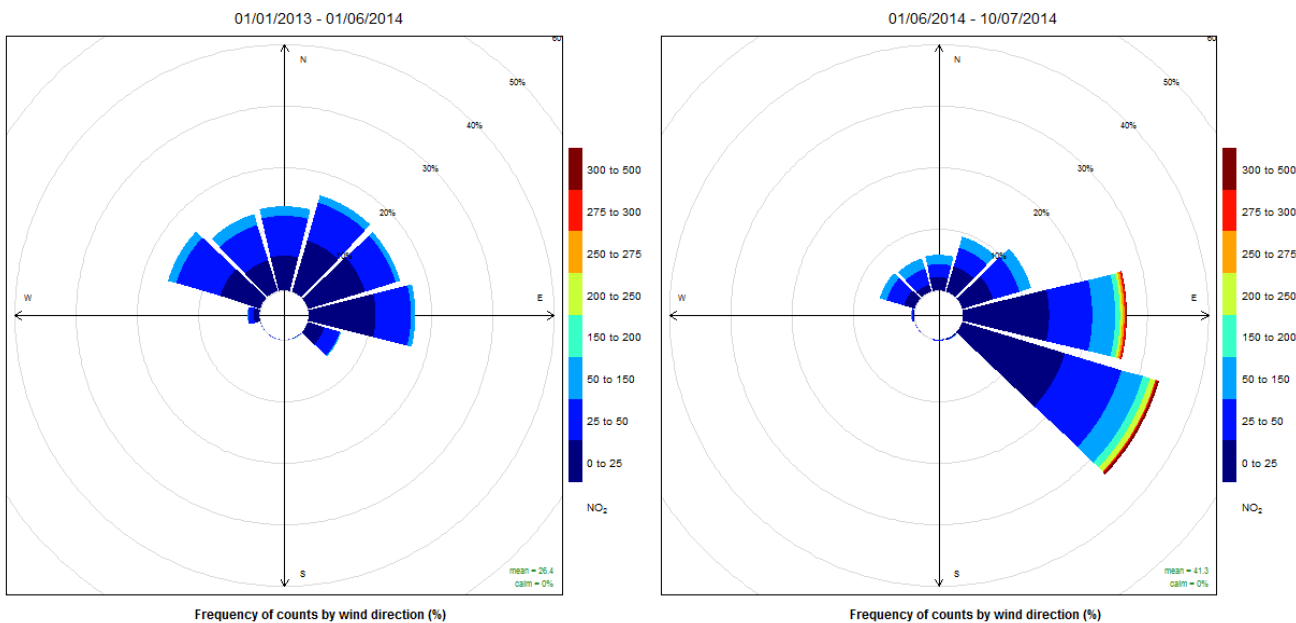
Figure 7 Pollution roses (1-hour averages) (NO<sub>2</sub>) for Auckland Waterfront 01/01/2013 - 01/06/2014 (left) and 01/06/2014 - 10/07/2014 (right)

conditions (i.e. the left hand pollution rose) easterly winds do not normally result in elevated concentrations or exceeding concentrations. The impact of the generator, as an additional point source, directly upwind in easterly conditions is clear. The influence of eddying off the buildings on Quay St is also clear, with elevated and exceeding concentrations from the southeast.

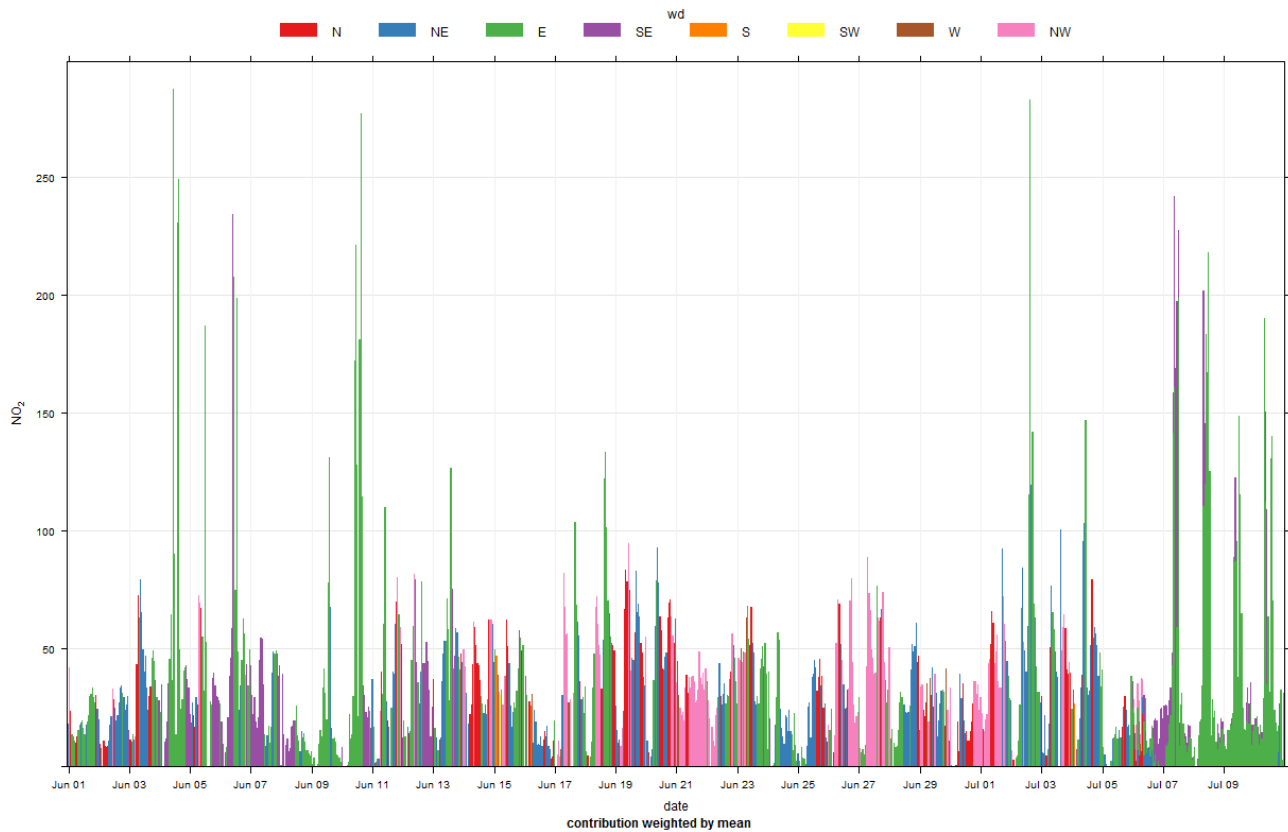
**Figure 8 Auckland Waterfront NO<sub>2</sub> data, classified by wind direction, 01/06/2014 - 10/07/2014**

The strong influence of the additional NO<sub>2</sub> source (the diesel generator) is also shown in figure 8. Classifying the NO<sub>2</sub> data by wind direction, shows that in wind directions apart from East and South east, concentrations remain low, at under half the NES-AQ. With the wind from the east, the monitoring site is directly downwind of the generator, and concentrations are either elevated or exceeding the NES-AQ.

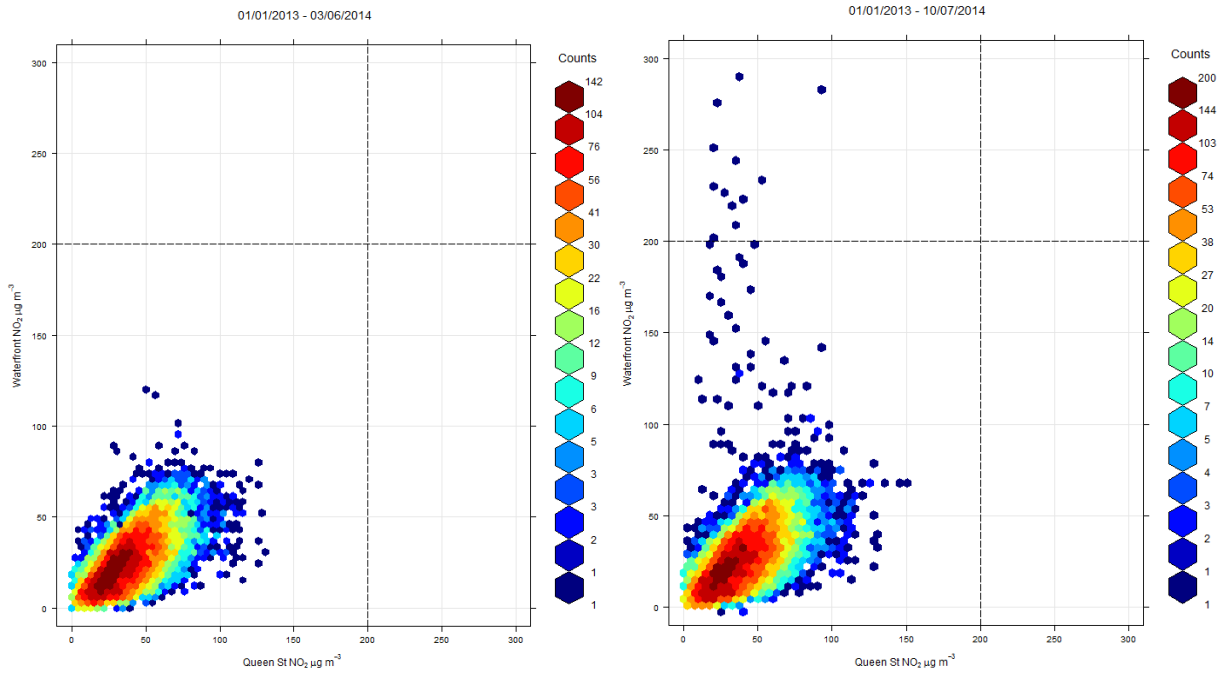
**Figure 9 Scatter plot with hexagonal binning for Auckland Waterfront and Queen St NO<sub>2</sub> data (1-hour average) 01/01/2013 - 03/06/2014 (left) and 01/01/2013 - 10/07/2014 (right). The dotted lines are the NES-AQ for each axis**

There is a strong relationship at lower ambient concentrations between Auckland Waterfront and Queen St (figure 9). Generally, concentrations at the two sites are very similar. Between 01/01/2013 and 03/06/2014, most NO<sub>2</sub> values recorded are closely related to each other, with large numbers of values concentrated around less than 50 µg/m<sup>3</sup>. There are some bins with only one count at slightly higher concentrations (100 – 150 µg/m<sup>3</sup>), which correspond with the maximum concentrations in figures 4 and 5. When the same data are plotted with the period of exceedances included (right hand plot), it is clear that the high concentrations recorded at Auckland Waterfront are not replicated at Queen St, in that there are a large number of outliers from the cluster of high counts at the lower concentrations. The influence of the temporary point source which this application contends has caused these exceedances is clear, in the large number of elevated and exceeding values seen in the right hand graph.

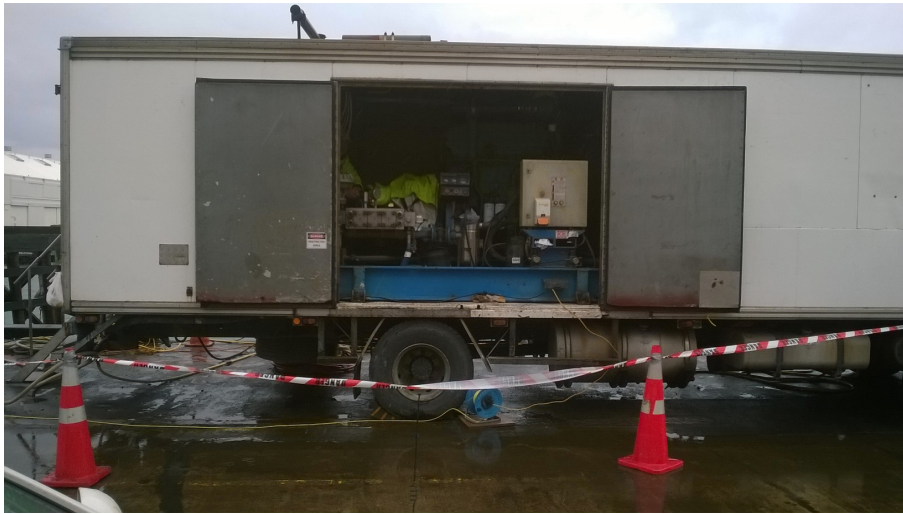
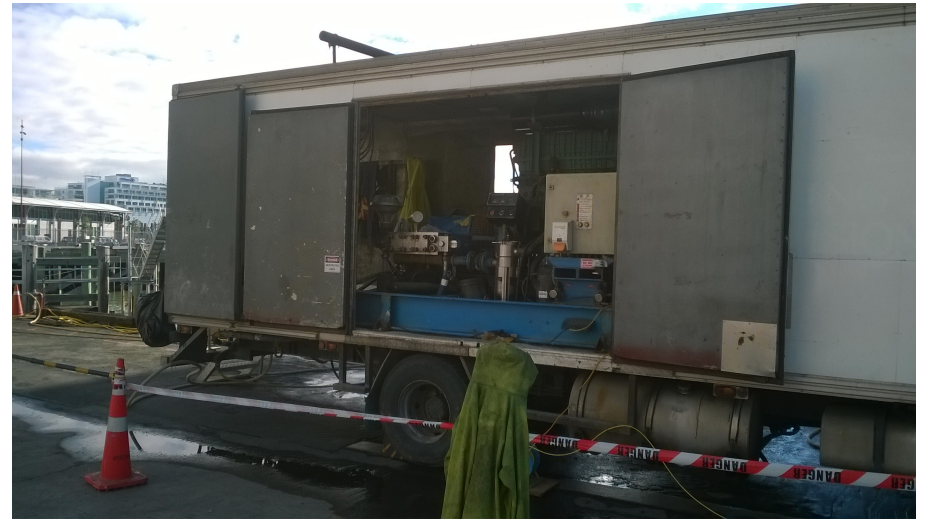
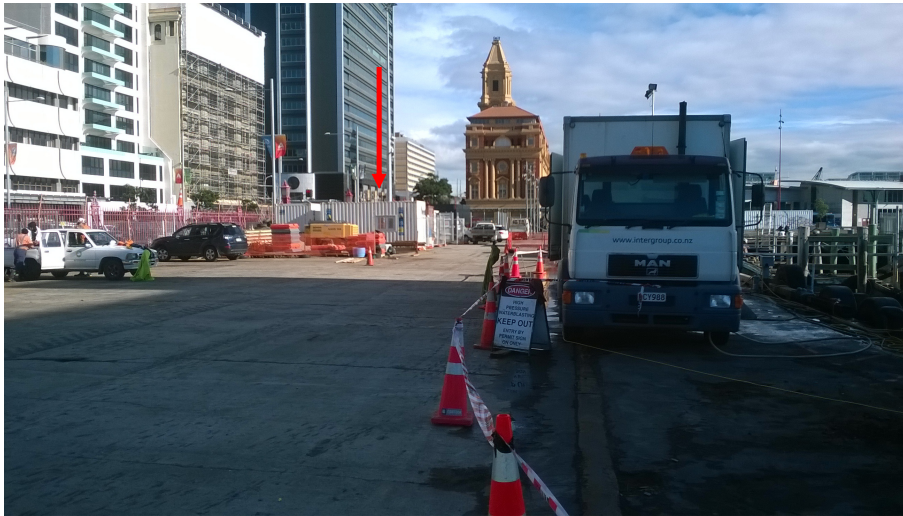
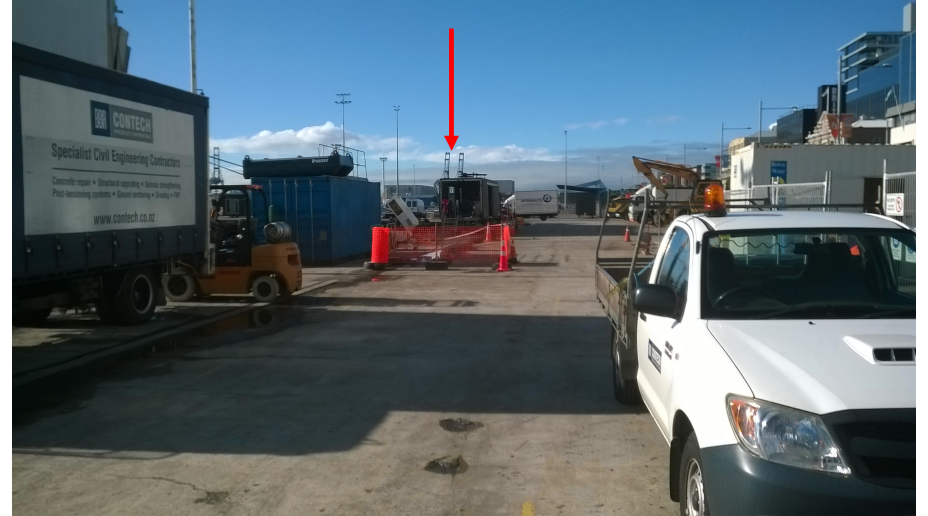
**Figure 10 Photographs of the diesel generator located near the monitoring site**

**Top left and Top Right: Views of the diesel generator on the Wharf at the Auckland Waterfront monitoring site. Note the exhaust mounted on the roof of the truck which houses the generator.**  
**Bottom Left: View from the generator to the monitoring site (obscured by white shipping container, indicated by arrow) looking West.**  
**Bottom Right: View from adjacent monitoring site to generator (indicated by arrow) looking East.**
