99 Totara Road, Whenuapai, Auckland

Submitted to: Metlifecare Limited

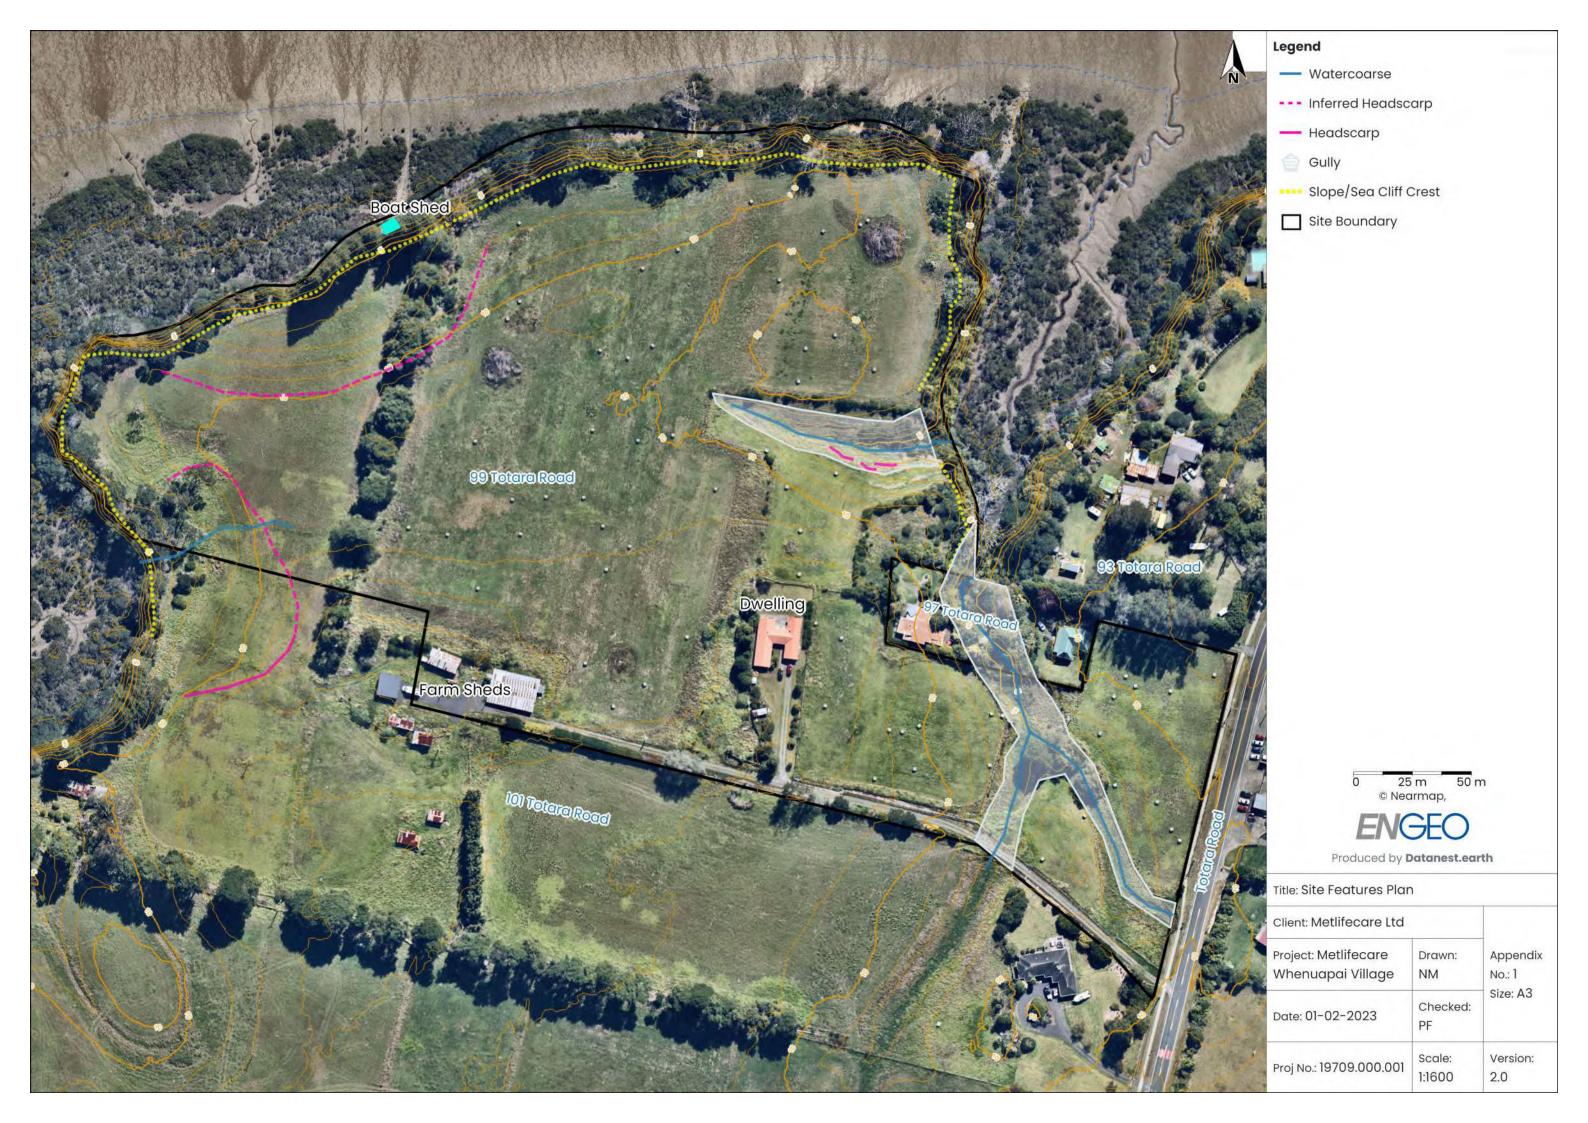
Site Features Plan

- The stream currently passes through a culvert beneath the existing accessway near the southern boundary.
- A west-east trending gully up to 4 m deep transmits much of the overland flow from the central portion of the site into the tidal inlet defining the north-eastern site boundary (Figure 1, Photo 1). The northern bank of the gully generally holds a slope of 1V:3H (18 degrees). The southern bank slopes at similar angles in the lower half, however the slope angle typically reduce to 1V:4H (14 degrees) for the top half of the gully wall. Several low height head scarp features were observed near the change in slope angle indicating active erosion.

- A headland protrudes from the western end of the site into the Kotukutuku Inlet; it is approximately 50 m wide at the narrowest point.
- An historical headscarp / slumping feature was observed south of the western headland, oriented west-southwest. The southern end of the headscarp is best defined, becoming less so to the north. Erosion appears to have smoothed the headscarp and vegetation had re-grown suggesting no recent rupture events. However, curved tree trunks at the vegetated toe of the slope may indicate soil creep is actively occurring.

- Another historical headscarp / slumping feature was observed north of the western headland, oriented north-west. The head scarp is not well defined due to erosion and re-vegetation. Mild curve to some tree trunks was observed at the toe of the slope which may indicate active soil creep.
