**Date:** 9 November 2020

**Job No:** 63907

**Subject:** 98 & 100-102 Totara Road, Whenuapai – Watercourse Classification

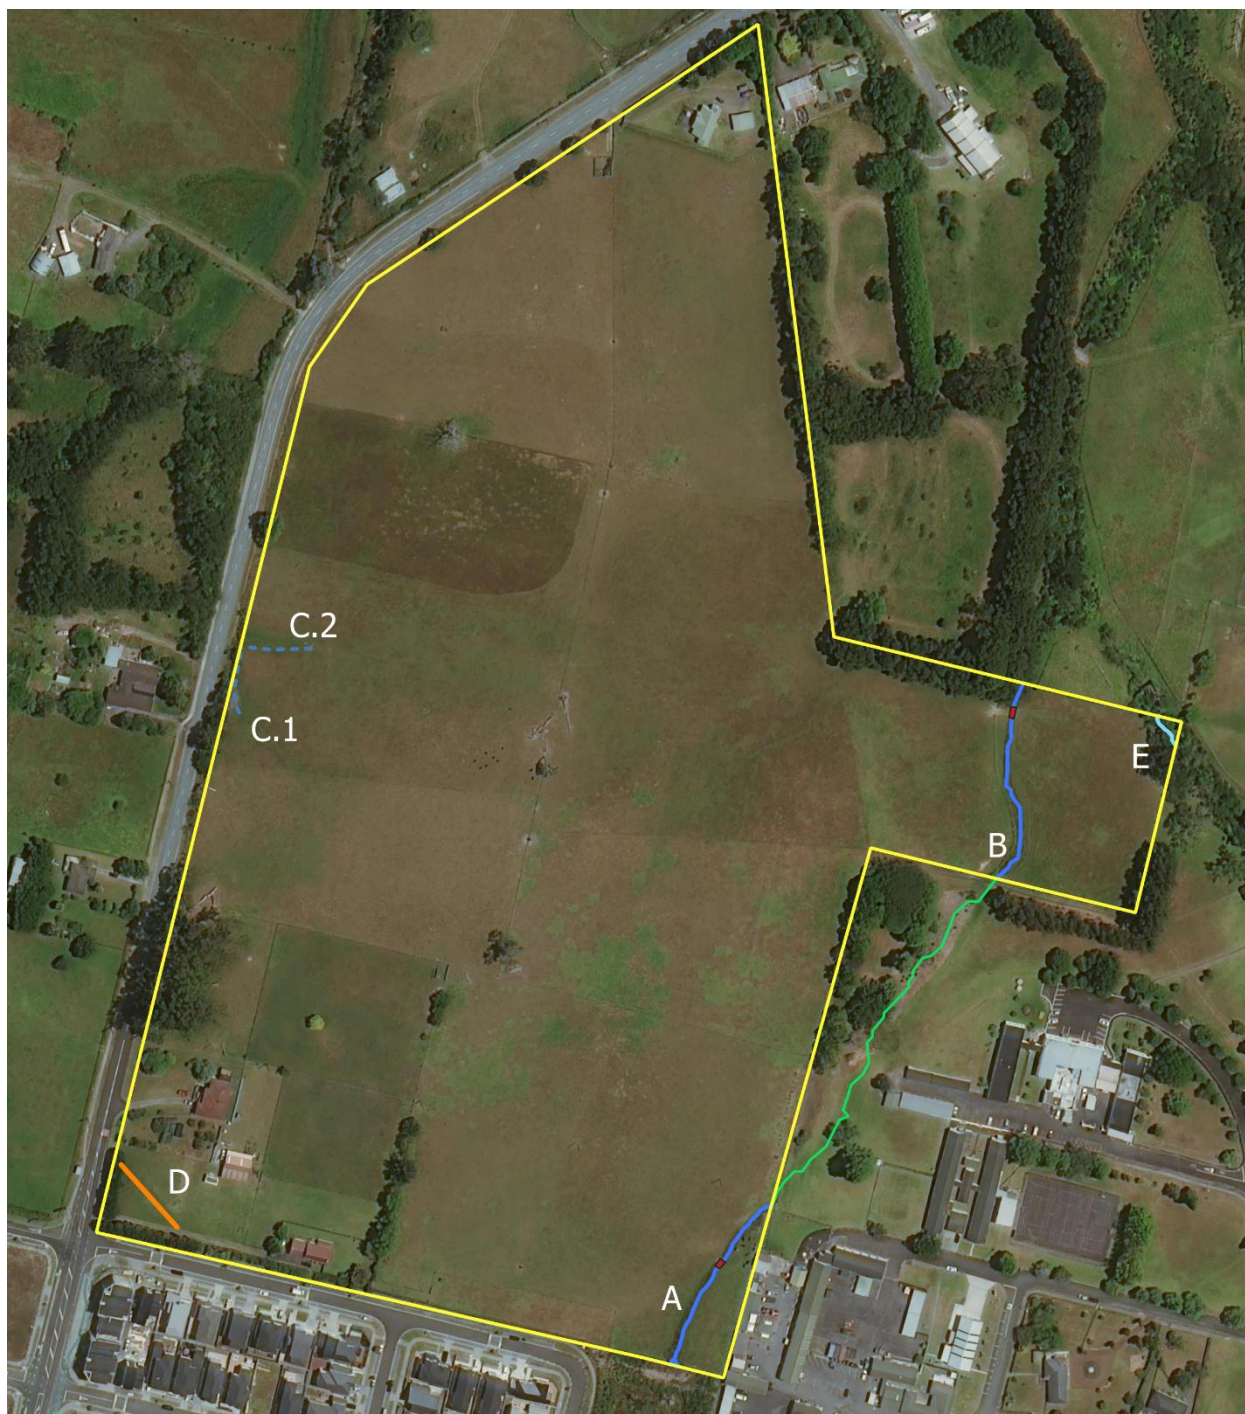
**Figure 3. Classified and ground-truthed watercourses at 98 and 100-102 Totara Road.**

Watercourses A and B were classified as modified intermittent streams under the AUP OP as they contained standing water 48 hours after a rain event, natural pools and no rooted terrestrial vegetation within the watercourse channel. Some portions of the three watercourses had well-defined channels, however due to bank damage from livestock had flattened these channels in places. Watercourse C was classified as ephemeral overland flow paths due to meeting only two intermittent stream criteria and was not classified as a wetland as it contained a dominance of terrestrial pasture species. Watercourse D was classified as an ephemeral artificial watercourse for the purpose of farm drainage as it contained no characteristics of a natural watercourse. Watercourse E was classified as a permanent stream. All other overland flow paths, as indicated by Auckland Council's GIS viewer (Figure 1) were ephemeral or absent. In regards to freshwater ecology, the following rules in the AUP OP apply to potential activities within the site:

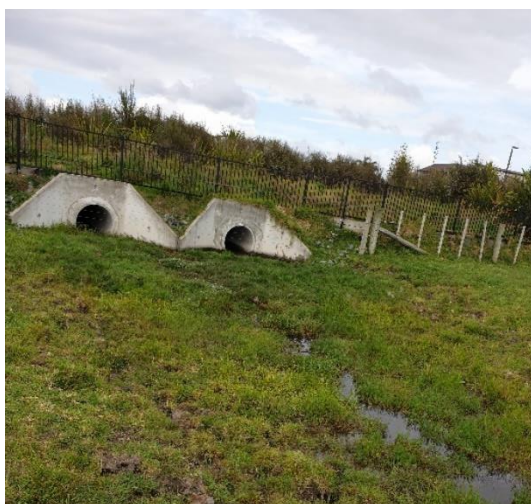
Watercourse A was entered the site at the south-western boundary of the property (Figure 3), through two culverts (Photo 1). The watercourse had a somewhat defined channel that had been degraded by stock access. It ran through the site for approximately 90m before flowing into the neighbouring property, then re-entering the site approximately 160m downstream (forming Watercourse B). The wetted width and depth of the channel was variable (between 0.1m to >1m wide and 0.05m to 0.20m deep) (Photo 2), mainly due to highly degraded banks caused by livestock pugging (Photo 3).

**Photo 1. The two culverts which Watercourse A enters the property through**

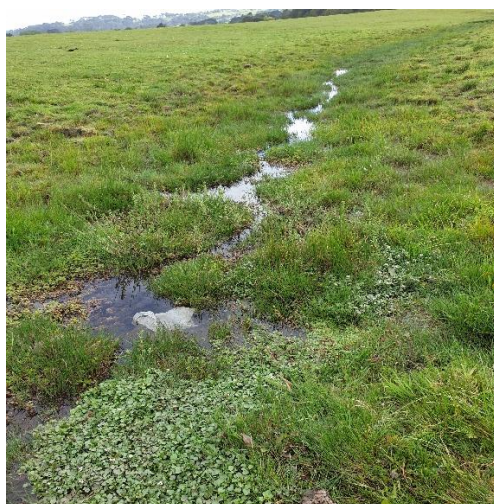
**Photo 2. A natural flow path with highly variable wetted width and pools can be observed in watercourse A**

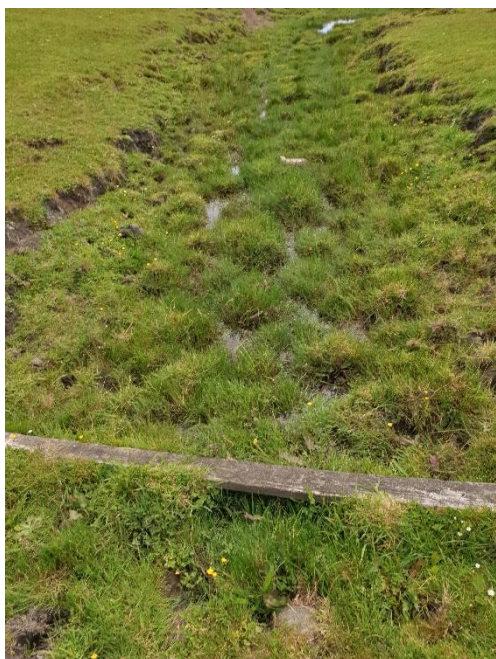
Watercourse A contained continuous, flowing water more than 48 hours after a rain event that would be expected to result in the flow of intermittent streams, had natural deep pools relative to stream depth and no rooted terrestrial vegetation within the channel. A stream channel can be distinguished (Photo 3). Channel banks are distinguishable however, degraded due to livestock), however livestock access has resulted in degradation to the channel form. Under the AUP OP, this stream meets four of the criteria of intermittent streams and has been classified as an intermittent stream modified through farming practices.

**Photo 3. Channel banks are distinguishable however, degraded due to livestock**

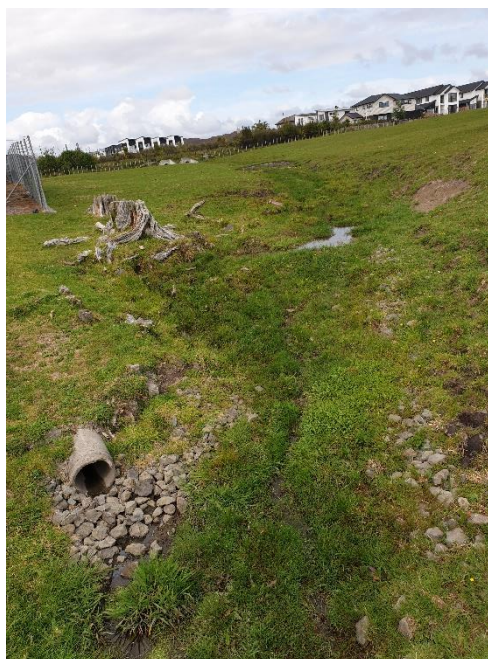
**Photo 4. Upstream view of Watercourse A with a stormwater pipe present**

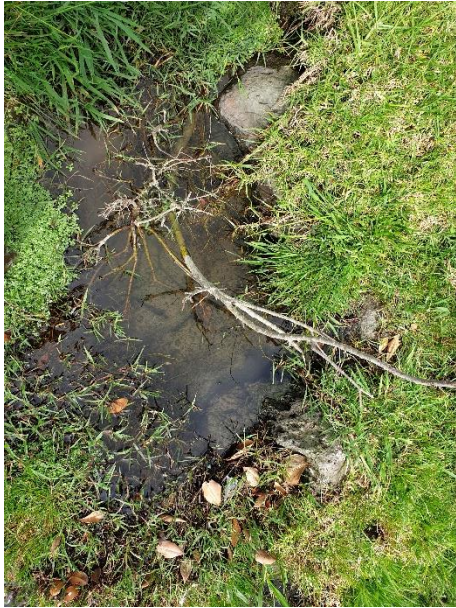
***Photo 5. Pool located <1m downstream of pipe.***

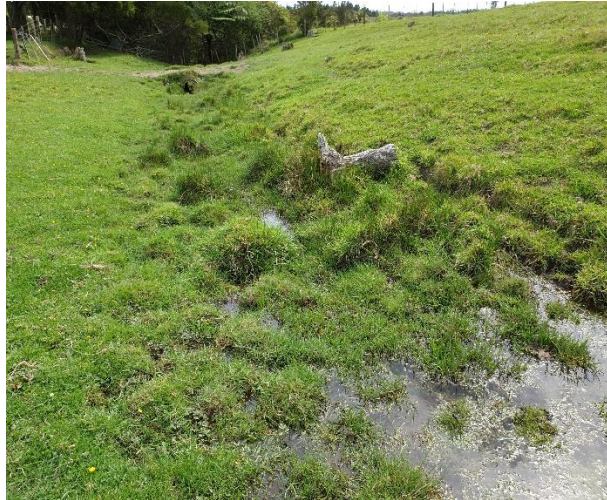
Watercourse B entered the site through a pipe and is a downstream reach of Watercourse A (Figure 3). Watercourse B flowed through the site for approximately 100m through highly variable hydrological conditions, with the wetted width of the channel ranging from 0.15m to >1.5m (Photo 6; Photo 10). Upstream, the low flow path was wide and the channel was not well-defined however a clear flow path could be observed with two large, deep pools. Whilst the channel was not well-defined in the upstream portion of the reach, this is likely due to channel damage through livestock access (Photo 8). One pool was located less than 1m downstream of the pipe (Photo 5) and the other approximately 64m downstream. The largest of these pools was the downstream pool and was approximately 2.5m wide and 0.20m deep (Photo 6). The dominant aquatic vegetation present included buttercup (*Ranunculus* spp.), water celery (*Apium nodiflora*), starwort (*Callitiche stagnalis*) and heavily grazed soft-rush (*Juncus effusus*), no riparian planting was established along Watercourse B. The riparian yard and channel banks were dominated<sup>1</sup> by terrestrial exotic pasture grass.

***Photo 6. The upstream portion of Watercourse B had highly degraded banks due to pugging. The second largest pool shown on the lower left-hand side.***

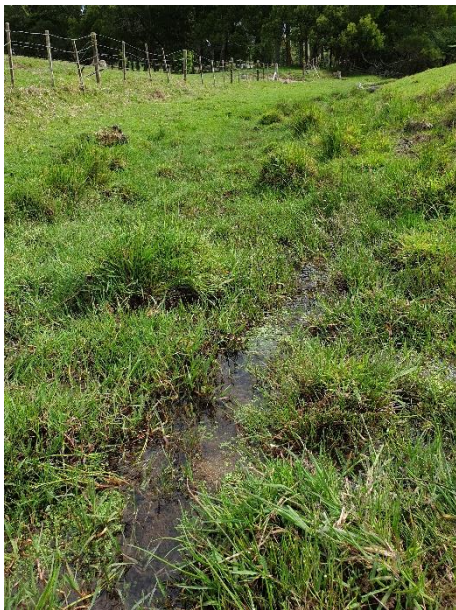
***Photo 7. A narrow flow path could be discerned, flowing through the roots of aquatic vegetation.***

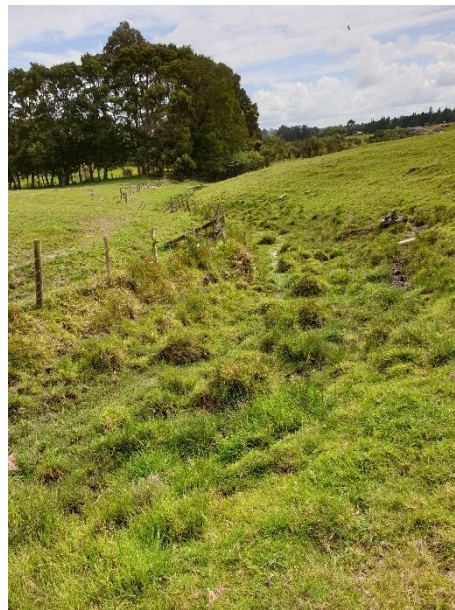
***Photo 8. The upstream portion of Watercourse B had degraded banks and a degraded channel.***

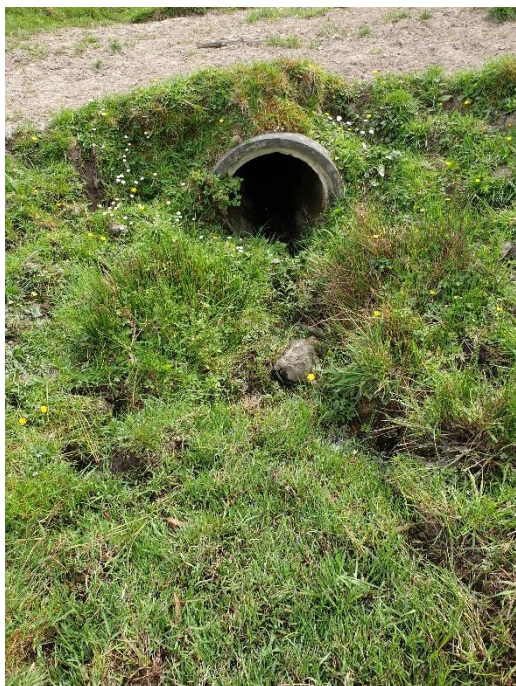
Approximately 70m downstream, the watercourse flowed through a culvert under a farm crossing (Photo 9) and the channel became well-defined and incised, with banks 0.5m high and 0.67m wide (Photo 10). The substrate within the channel of Watercourse B consisted of silt and a few large cobbles, and the banks were heavily pugged by livestock and damaged, particularly in the upstream portion of the reach. Watercourse B exited the site at the northern site boundary, into neighbouring property where relatively extensive riparian plantings are established and stock are excluded. Downstream in the neighbouring property, the stream channel was clearly defined. Watercourse B contained surface water 48 hours after a rain event, had natural deep pools, a well-defined channel throughout much of its length and no rooted

**Photo 9. Downstream channel after the culverted farm crossing with pugged ground.**

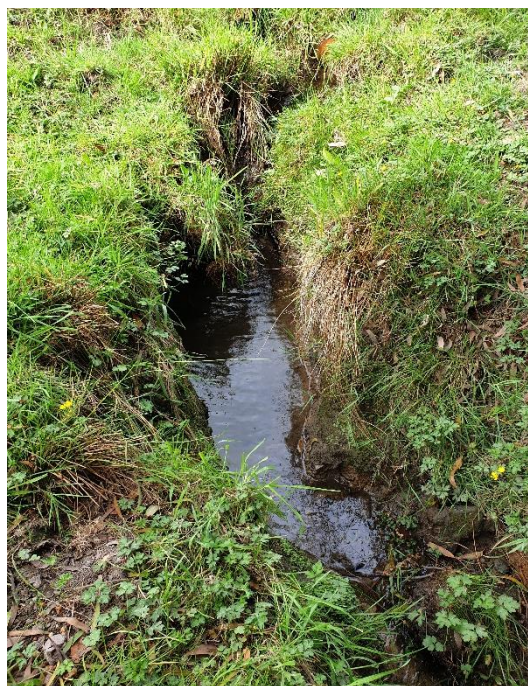
**Photo 10. Downstream portion of Watercourse B had banks which became more defined and incised.**

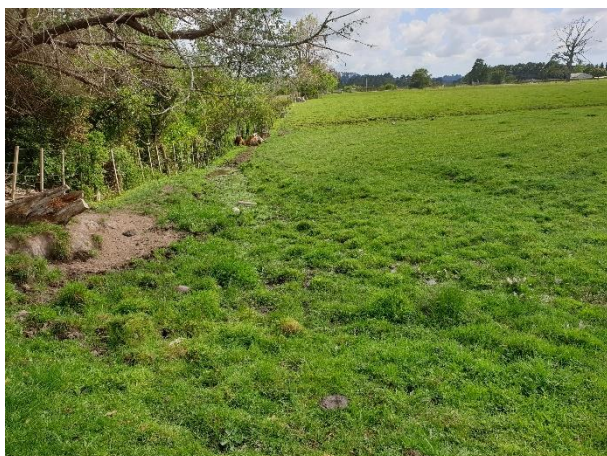
No discernible channel could be seen in the Watercourse C.1 and C.2 areas (Photo 11). Historic clay drainage pipes were observed in both channels which had been broken up as a result of stock. Where the clay drainage pipes were found, standing water accumulated in shallow puddles formed by livestock pugging. Some vegetation that can tolerate wet conditions was present along the narrow flow paths including buttercup (*Ranunculus* sp.), broad-leaved dock (*Rumex obtusifolius*), and small patches of starwort (*Callitriche stagnalis*). Kikuyu and other exotic pasture grasses were also rooted throughout and consisted of more than 50% of the vegetation cover throughout the area.

**Photo 11. Watercourse C.1 had no distinguishable channel.**

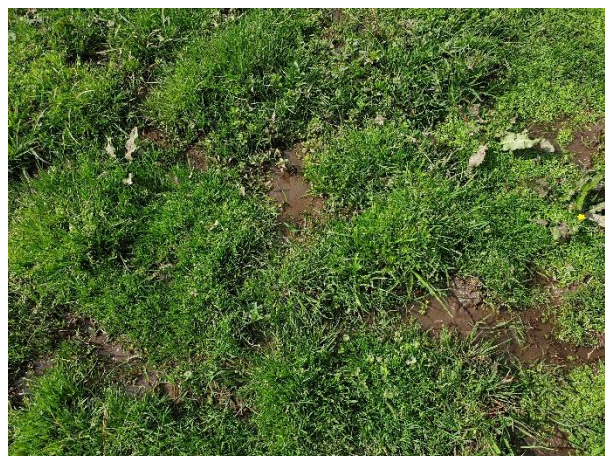
**Photo 12. Water was largely retained in pugged holes from live stock. Vegetation was predominantly pasture grass.**

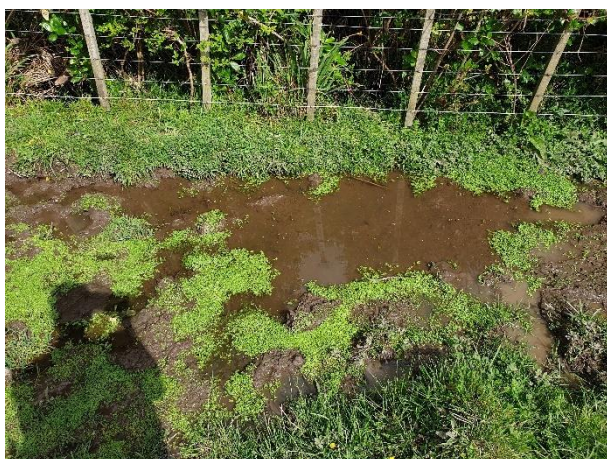
Within Watercourse C.1, approximately 19m downstream of the beginning of the pugging that contained standing water, a stagnant puddle could be seen with starwort growing throughout (Photo 13). This puddle has been induced from pugging and the formation of small earthbound along the fence line. The area became completely dry for approximately 10m below this puddle, until the confluence with Watercourse C.2.

**Photo 13. Stagnant puddle present in Watercourse C.1 before becoming dry**

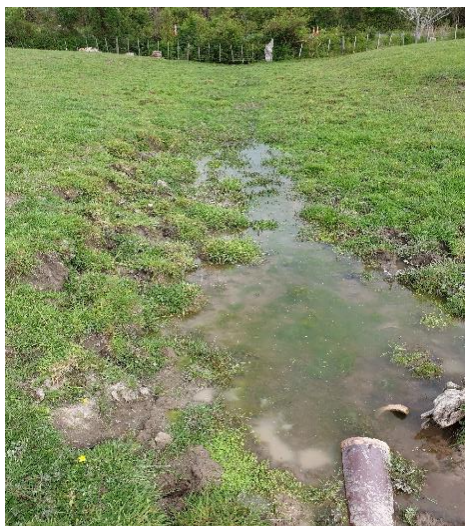
Watercourse C.2 had a stagnant shallow puddle present in the upper section that contained filamentous green algae (Photo 14). Broken clay drainage pipes were present at the upper end of the pool however, the inflow side could not be located. No water flowed from the pipe or the puddle and water was only retained in pugging caused by livestock for 35m before exiting the property (Photo 15). There were small

**Photo 14. Stormwater pipe and stagnant puddle at the top of Watercourse C.2**

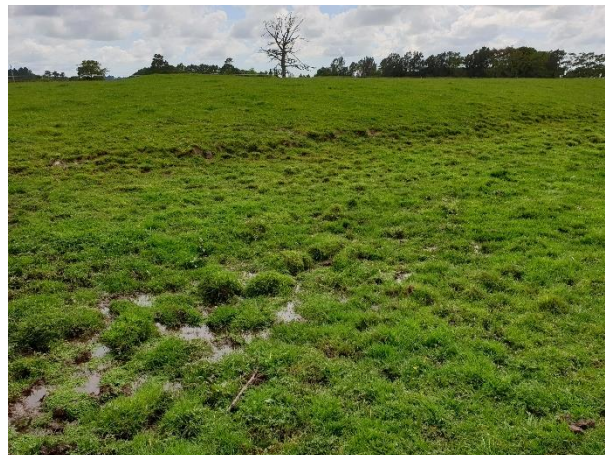
**Photo 15. Ground impression indicating where the ephemeral overland flow path for Watercourse C.2 runs.**

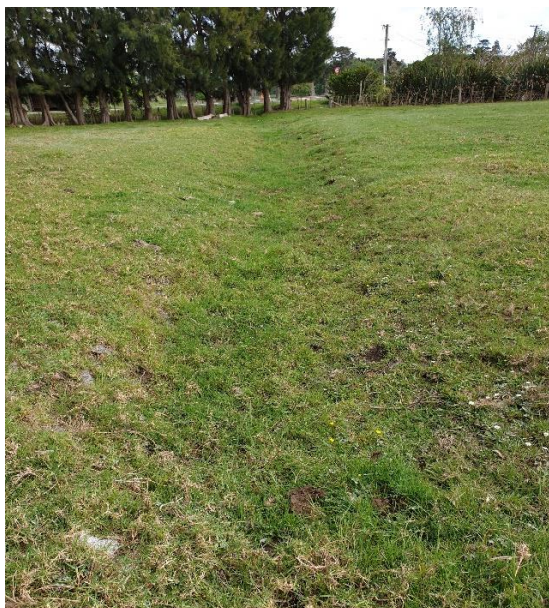
Auckland Council GIS Viewer indicated an overland flow path to be present in the lower south-western side of the property (Figure 3). During the site visit, this was deemed to be an artificially created depression, that was likely originally a farm drainage channel. The shallow depression was completely straight and the depth of the depression was consistent for the whole length (Photo 16). No water was present in the channel and rooted terrestrial vegetation could be seen throughout. The edges of the banks have been damaged through pugging by livestock (Photo 17). Furthermore, land contours do not indicate any naturally occurring flow paths and no head waters were historically present.

*Photo 16. View of Watercourse D looking towards Totara Road*

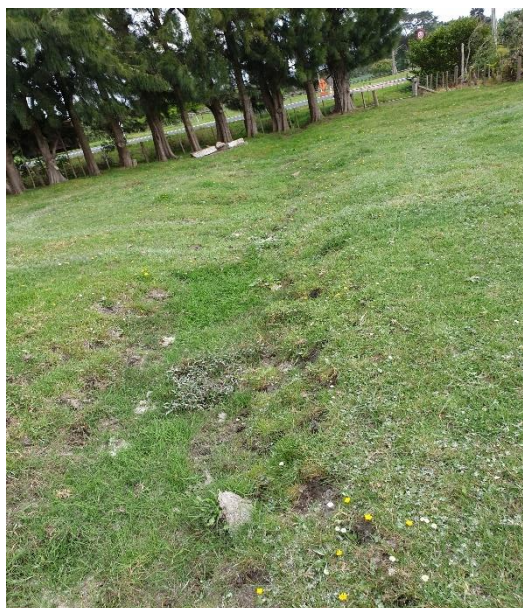
*Photo 17. Channel damage caused through pugging by livestock access*
