## 109 BEACHLANDS ROAD, BEACHLANDS

# PRELIMINARY GEOTECHNICAL INVESTIGATION

Neil Construction Limited AKS2020-0001AB Rev.0

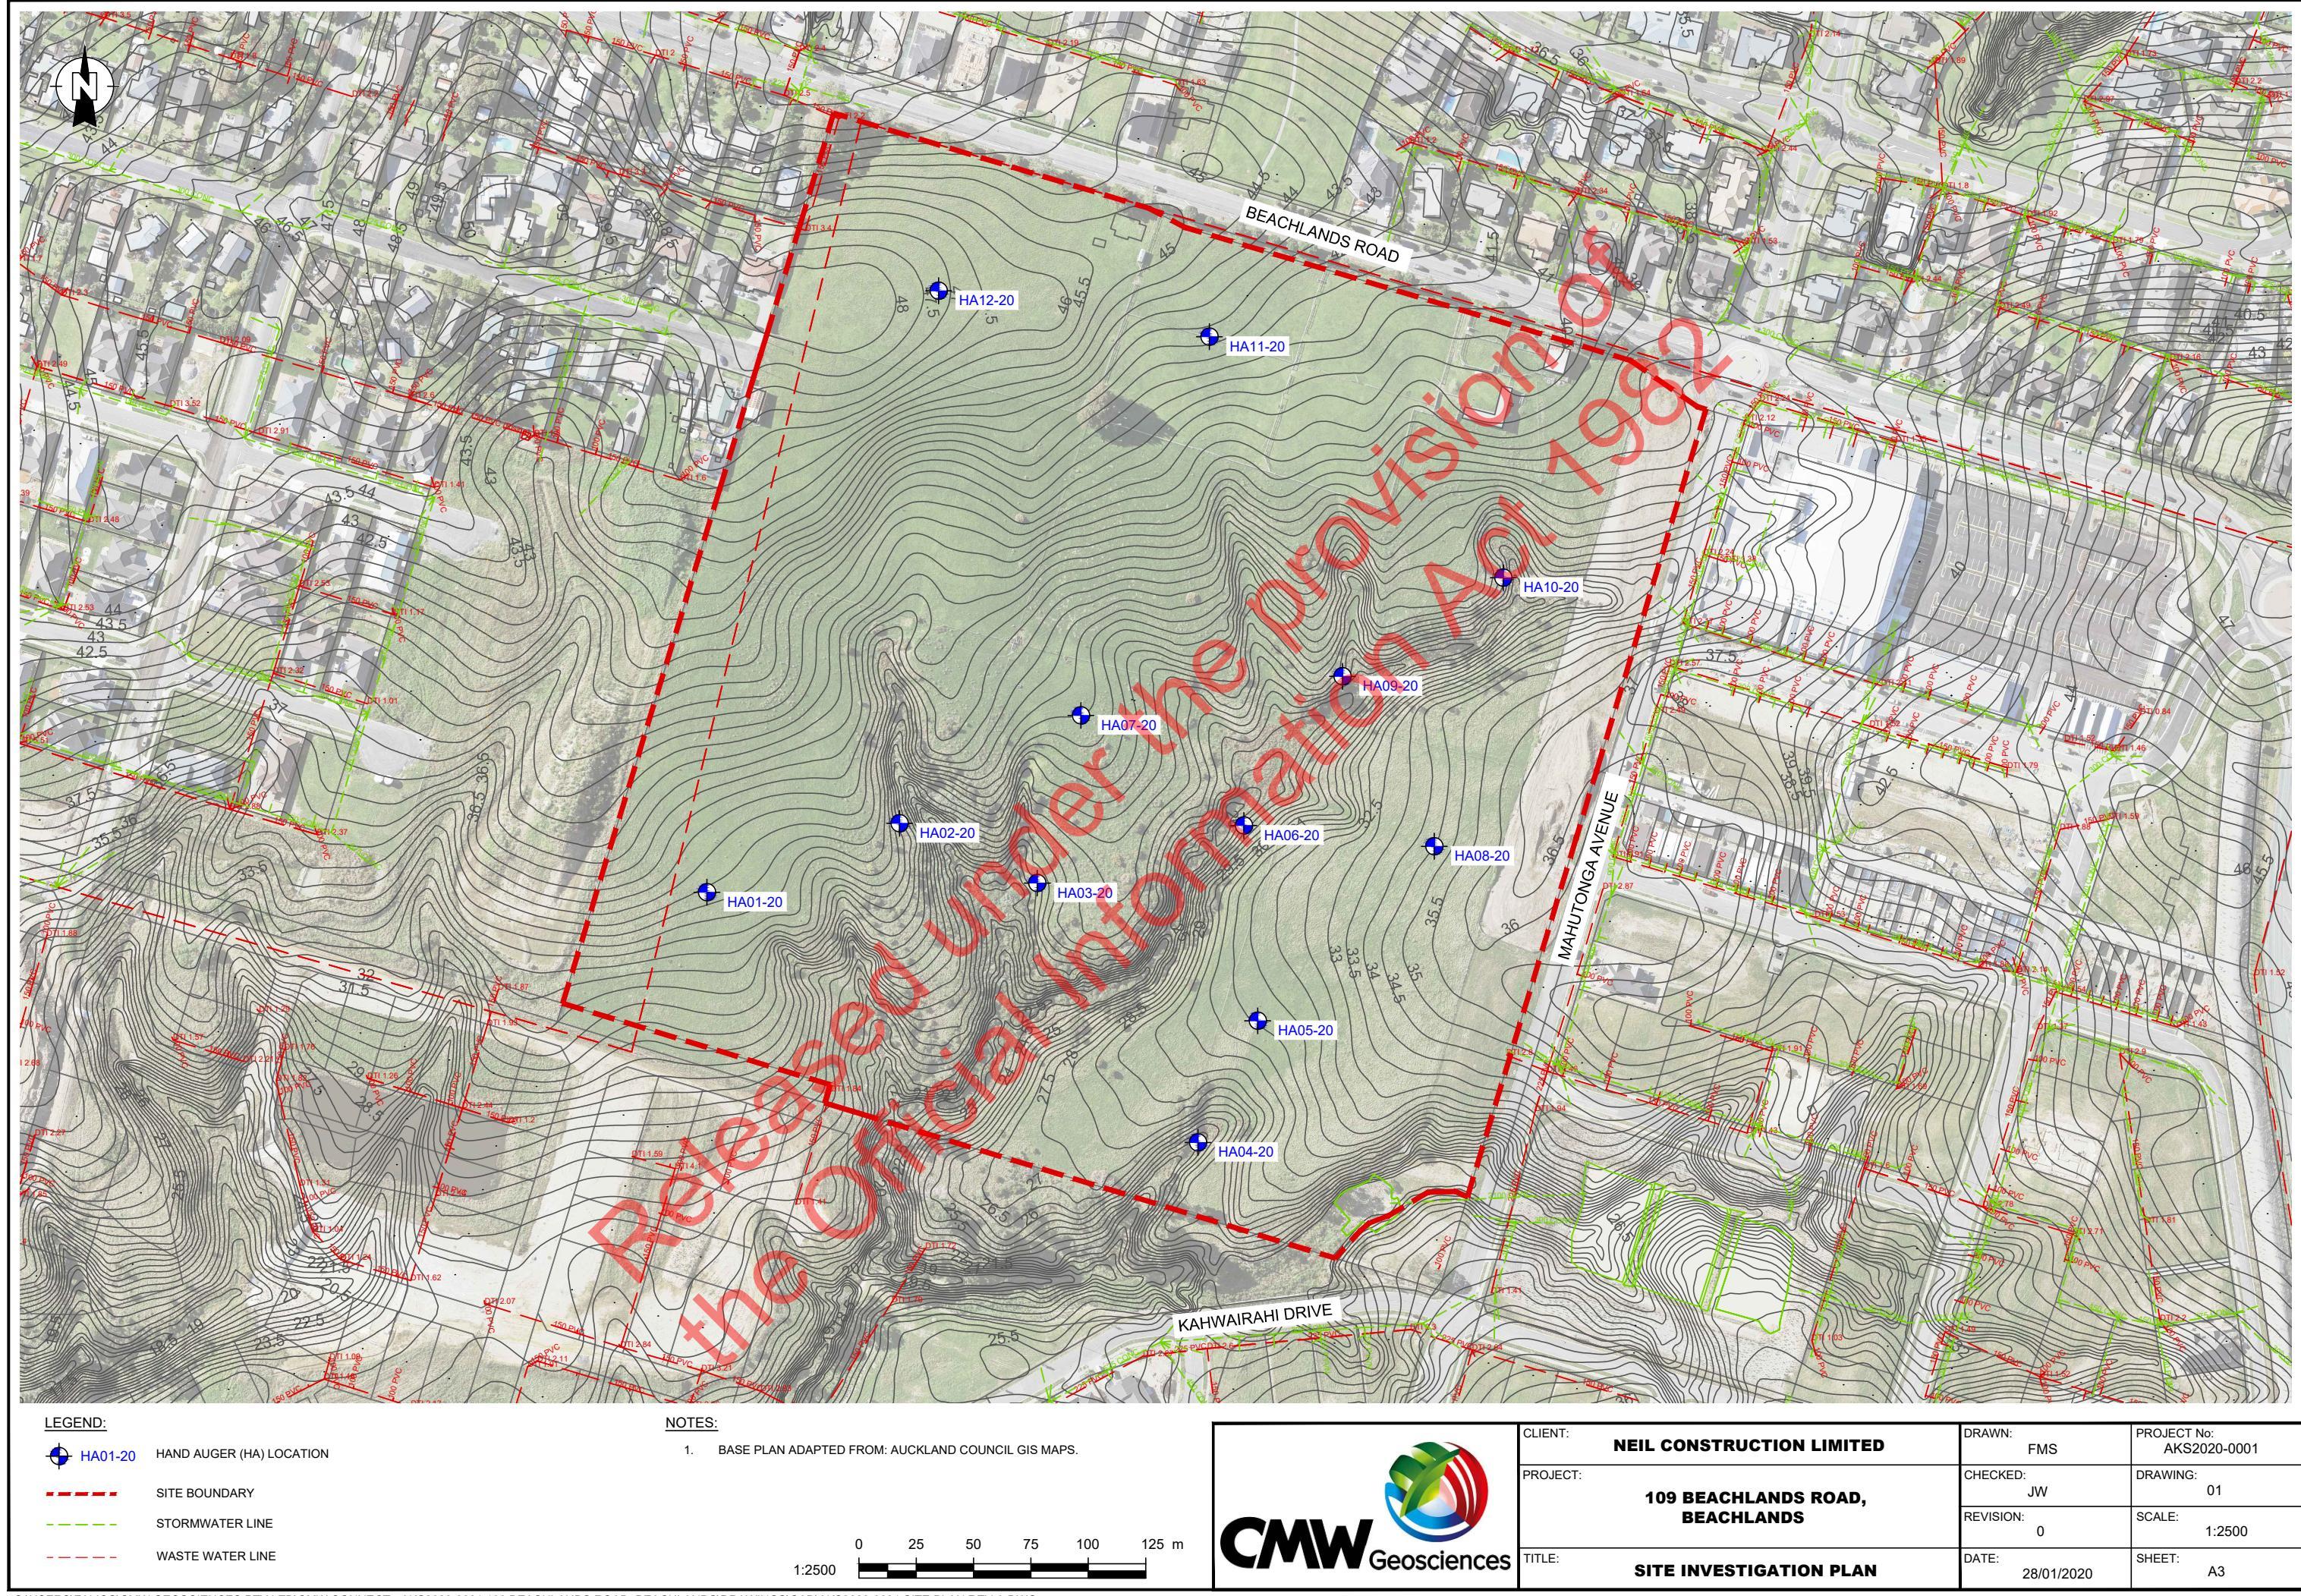
Drawings: Site Investigation Plan

The current general landform, together with associated features located within and adjacent to the site is presented on the attached Site Plan as *Drawing 01*.

The approximate locations of the respective investigation sites referred to above are shown on the Site Plan as **Drawing 01**. Test locations were measured using a hand-held GPS and elevations were taken from the current contours on Auckland Council GIS.

Minor landslide movement was only identified in the gully head upslope of HA02-20.

Shallow, rotational type instability has been noted in some gully head areas, particularly upslope of HA02-20. Based on the scheme plan provided to us, we anticipate that any associated risks will be remediated during normal earthworks across most of the site. Where gully areas are to remain, additional investigations and analyses will be required for the design of retaining walls or to assess the need for subsoil drains and/ or building line restrictions to limit the proximity of development to the steep slopes. Based on the high strengths of the soils, the low groundwater table and the relatively large lot sizes, these issues are not expected to be difficult to address during earthworks development, although care will be needed to assess stability conditions in the south eastern corner where a pond has been backfilled in the past.

Aerial photographic evidence shows that earthworks have been undertaken along a strip approximately 30m wide inside the eastern boundary. Much of this work may have been surficial and/or stockpiling, but it is evident that a gully feature that previously extended into the north eastern corner has been filled. The quality of any previous filling in this area will need to be assessed by review of any geotechnical reports relating to it and most likely by further investigations. Similarly, the backfilling of the pond in the south eastern corner may require further investigation, depending on the extent of development proposals for this area.
