**To:** Neil Construction Limited

**Job No:** 63907

**Subject:** 98 & 100-102 Totara Road, Whenuapai – Watercourse Classification

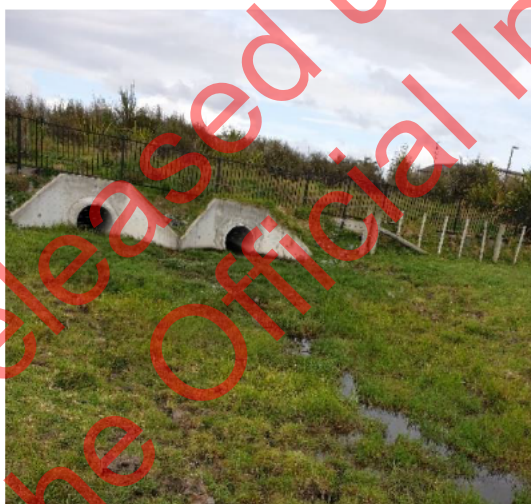
**Photo 1. The two culverts which Watercourse A enters the property through**

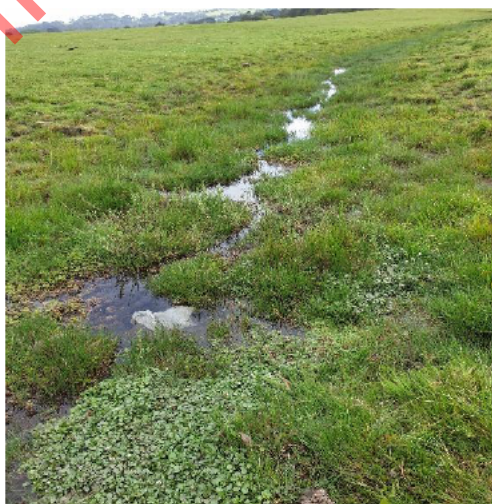
Watercourse A was entered the site at the south-western boundary of the property (Figure 3), through two culverts (Photo 1). The watercourse had a somewhat defined channel that had been degraded by stock access. It ran through the site for approximately 90m before flowing into the neighbouring property, then re-entering the site approximately 160m downstream (forming Watercourse B). The wetted width and depth of the channel was variable (between 0.1m to >1m wide and 0.05m to 0.20m deep) (Photo 2), mainly due to highly degraded banks caused by livestock pugging (Photo 3).

**Photo 2. A natural flow path with highly variable wetted width and pools can be observed in watercourse A**

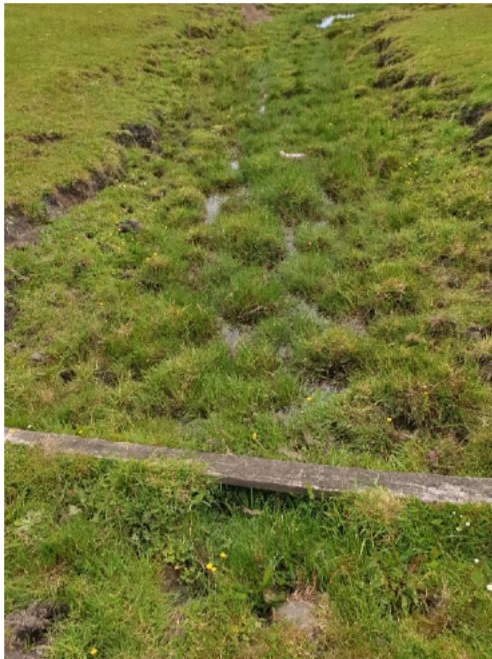
*Photo 3. Channel banks are distinguishable however, degraded due to livestock*

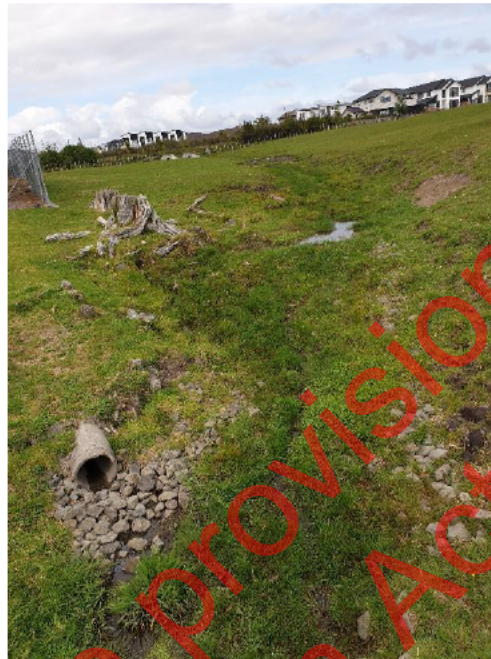
*Photo 4. Upstream view of Watercourse A with a stormwater pipe present*

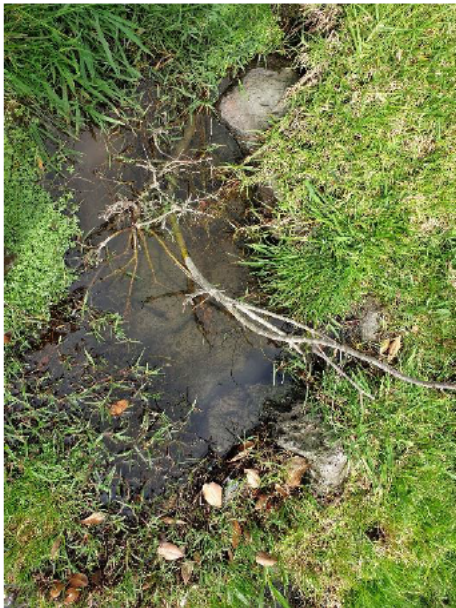
*Photo 5. Pool located <1m downstream of pipe.*

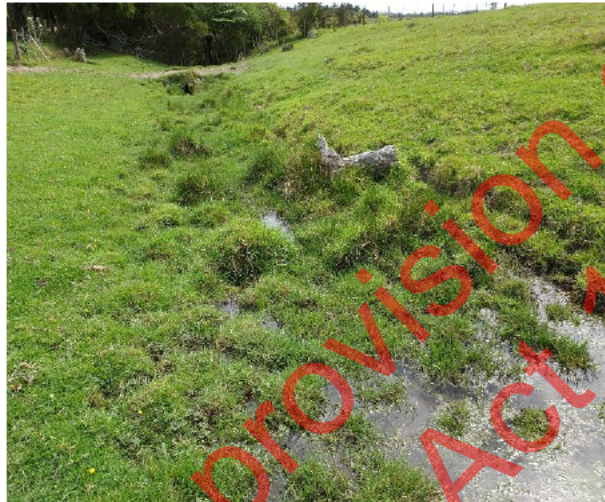
*Photo 6. The upstream portion of Watercourse B had highly degraded banks due to pugging. The second largest pool shown on the lower left-hand side.*

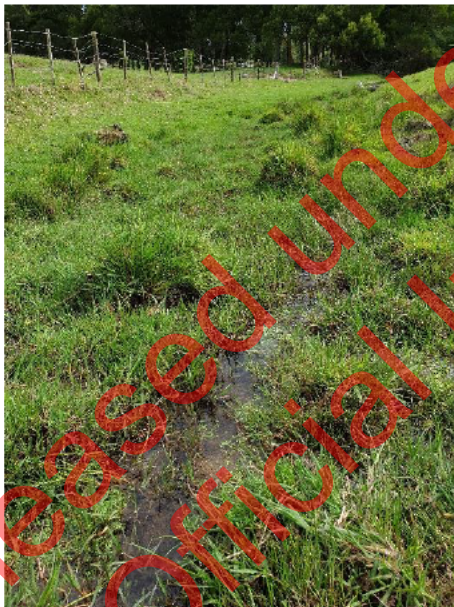
*Photo 7. A narrow flow path could be discerned, flowing through the roots of aquatic vegetation.*

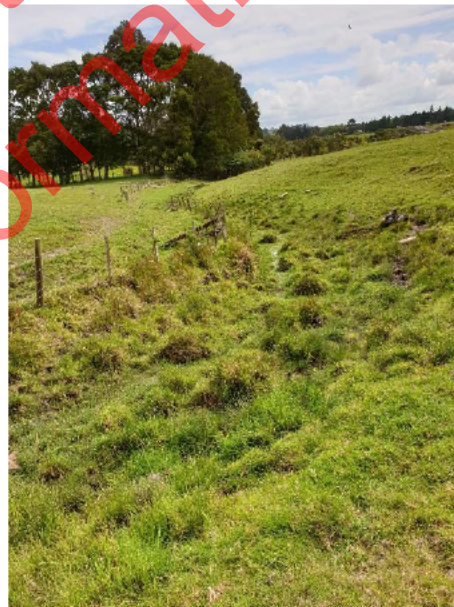
*Photo 8. The upstream portion of Watercourse B had degraded banks and a degraded channel.*

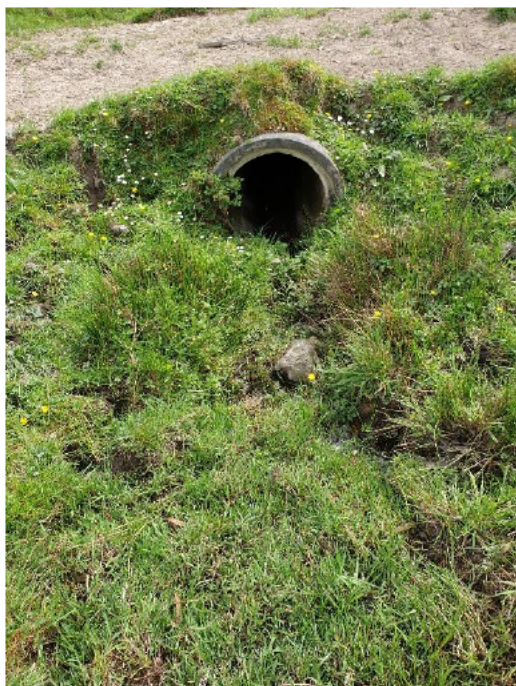
**Photo 9.** Downstream channel after the culverted farm crossing with pugged ground.

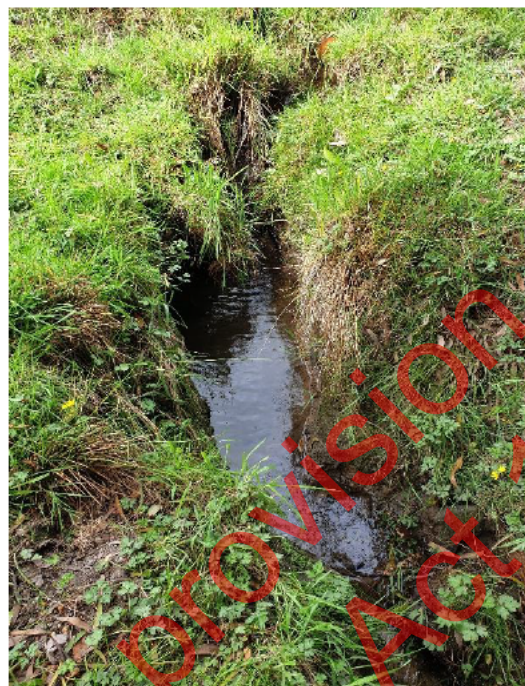
Approximately 70m downstream, the watercourse flowed through a culvert under a farm crossing (Photo 9) and the channel became well-defined and incised, with banks 0.5m high and 0.67m wide (Photo 10). The substrate within the channel of Watercourse B consisted of silt and a few large cobbles, and the banks were heavily pugged by livestock and damaged, particularly in the upstream portion of the reach. Watercourse B exited the site at the northern site boundary, into neighbouring property where relatively extensive riparian plantings are established and stock are excluded. Downstream in the neighbouring property, the stream channel was clearly defined. Watercourse B contained surface water 48 hours after a rain event, had natural deep pools, a well-defined channel throughout much of its length and no rooted

**Photo 10.** Downstream portion of Watercourse B had banks which became more defined and incised.

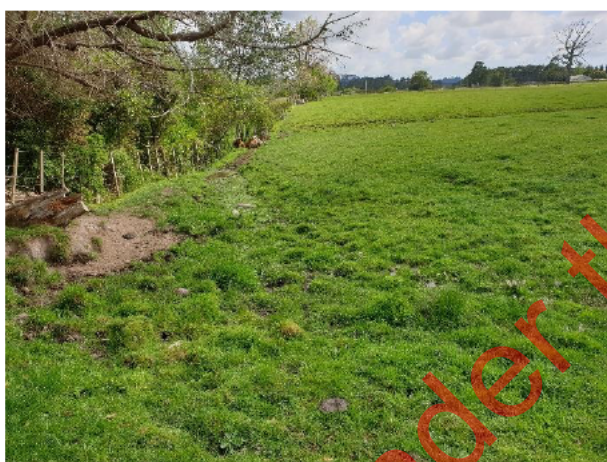
No discernible channel could be seen in the Watercourse C.1 and C.2 areas (Photo 11). Historic clay drainage pipes were observed in both channels which had been broken up as a result of stock. Where the clay drainage pipes were found, standing water accumulated in shallow puddles formed by livestock pugging. Some vegetation that can tolerate wet conditions was present along the narrow flow paths including buttercup (*Ranunculus* sp.), broad-leaved dock (*Rumex obtusifolius*), and small patches of starwort (*Callitriche stagnalis*). Kikuyu and other exotic pasture grasses were also rooted throughout and consisted of more than 50% of the vegetation cover throughout the area.

**Photo 11. Watercourse C.1 had no distinguishable channel.**

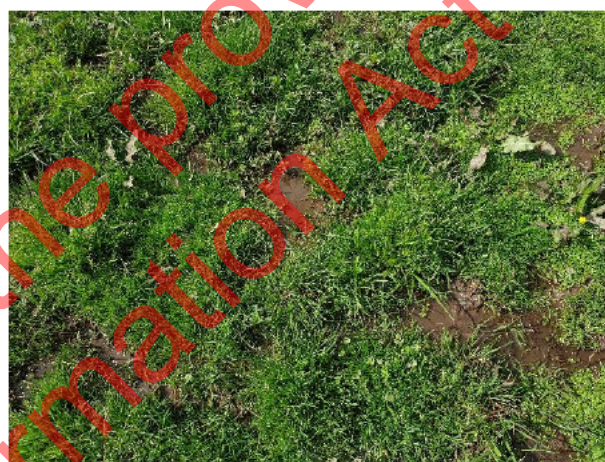
**Photo 12. Water was largely retained in pugged holes from live stock. Vegetation was predominantly pasture grass.**

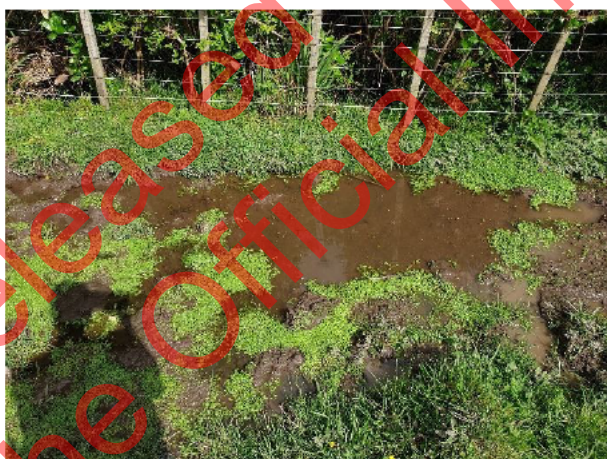
Within Watercourse C.1, approximately 19m downstream of the beginning of the pugging that contained standing water, a stagnant puddle could be seen with starwort growing throughout (Photo 13). This puddle has been induced from pugging and the formation of small earthbound along the fence line. The area became completely dry for approximately 10m below this puddle, until the confluence with Watercourse C.2.

**Photo 13. Stagnant puddle present in Watercourse C.1 before becoming dry**

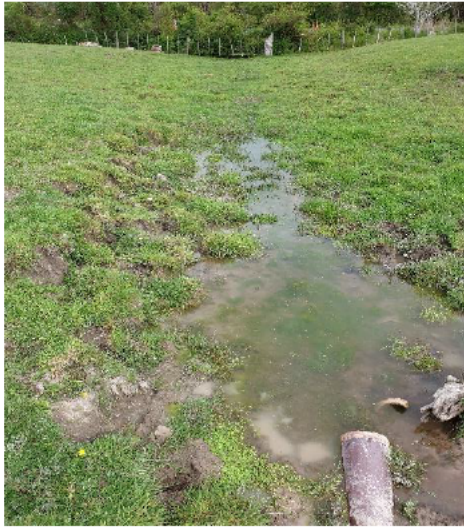
Watercourse C.2 had a stagnant shallow puddle present in the upper section that contained filamentous green algae (Photo 14). Broken clay drainage pipes were present at the upper end of the pool however, the inflow side could not be located. No water flowed from the pipe or the puddle and water was only retained in pugging caused by livestock for 35m before exiting the property (Photo 15). There were small

**Photo 14. Stormwater pipe and stagnant puddle at the top of Watercourse C.2**

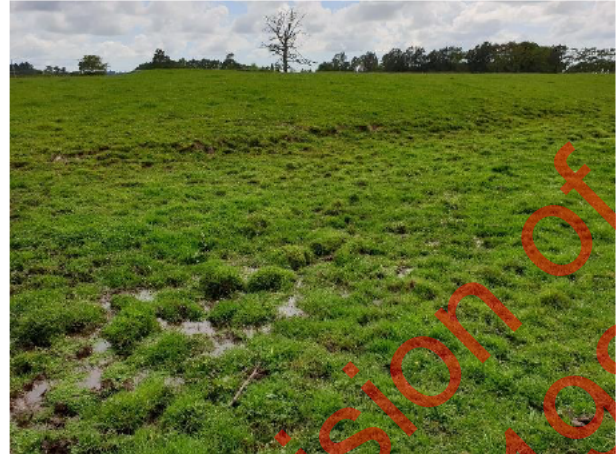
**Photo 15. Ground impression indicating where the ephemeral overland flow path for Watercourse C.2 runs.**

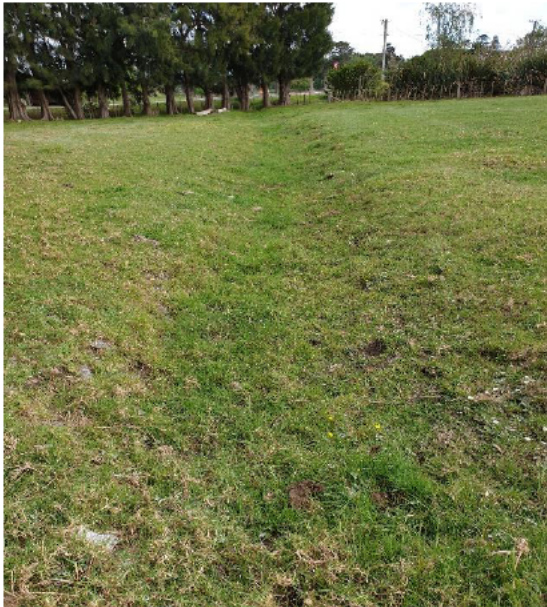
*Photo 16. View of Watercourse D looking towards Totara Road*

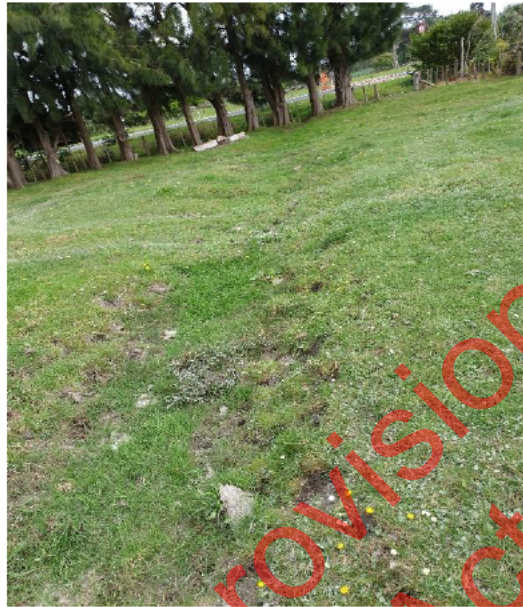
*Photo 17. Channel damage caused through pugging by livestock access*
