16 August 2019

Document Ref: AKL2019-0136AB Rev 0

**RE: PRELIMINARY GEOTECHNICAL ASSESSMENT REPORT FOR 102 TOTARA ROAD, WHENUAPAI**

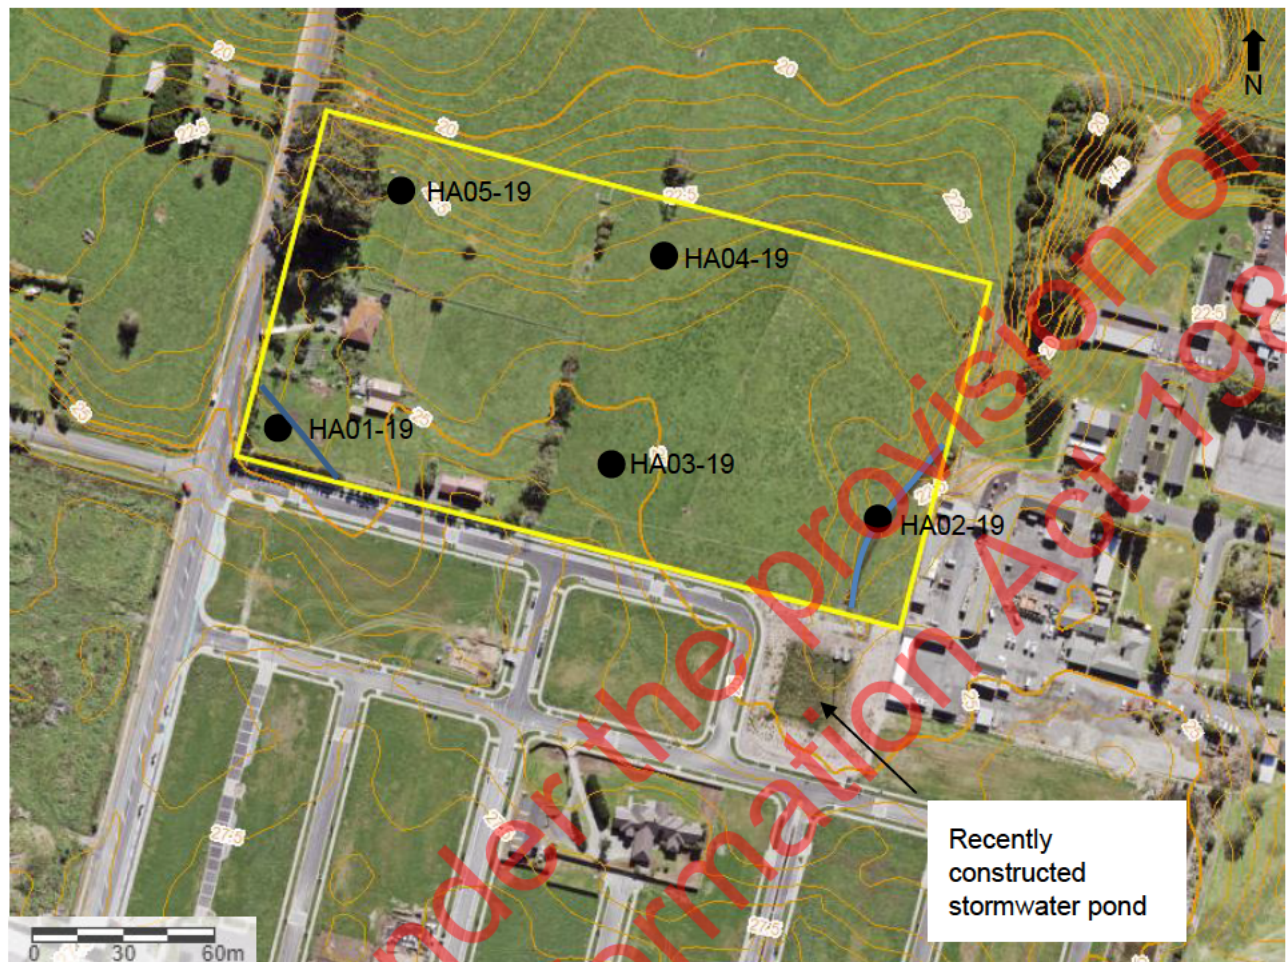
In the south east of the site there is a drainage channel with observed flowing water, fed from an outlet from a stormwater pond at the eastern end of McCaw Road. This drainage channel directs stormwater flow to a pipe which feeds through to the neighbouring property on the eastern boundary of the site.

In the south western corner of the site, another drainage channel appears to have been cut running north west to south east. Flowing water was also observed in this channel during the site work (13/08/19).

**Figure 1** Site plan, development area is highlighted in yellow, the black dots depict hand auger locations and the blue lines represent flowing drainage channels observed during the site walkover (image from Auckland Council Geomaps)

Recent alluvium was encountered in HA02-19 between 0.4 and 2.2 metres depth. The recent alluvium was unable to be recovered in the hand auger and is interpreted to be very soft and saturated. It is likely that this material was deposited via the existing drainage channel in this area.
