Resource Management (National Environmental Standards for Air Quality) Regulations 2004 – Regulation 16A Exceptional Circumstances

APPLICATION FORM

2 Details of exceedance event

Contaminant	SO ₂
Date of exceedance (application must be received within 3 months from date of the exceedance)	13 th December 2020
Relevant airshed	Awatoto

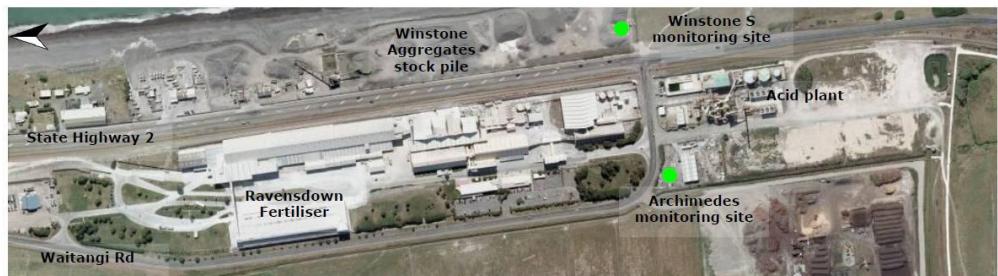
Winstone S, State Highway 51, Awatoto (Figure 1 – note that State Highway 2 has been renumbered to 51). The monitoring station is owned by Ravensdown Fertiliser Napier and monitoring is subcontracted to Watercare Services. The Winstone S site is separated from Ravensdown's property by State Highway 51, which lies to the west of the monitoring site. The site has the beach to the east, public recreation space to the south and land to the north that has been vacated by Winstone Aggregates and is not currently in use. The Thermo 43i SO₂ analyser is maintained in an air conditioned shed.

Figure 1: Ravensdown Fertiliser, Site Photo of Plant and Ambient Air Quality Monitoring Locations

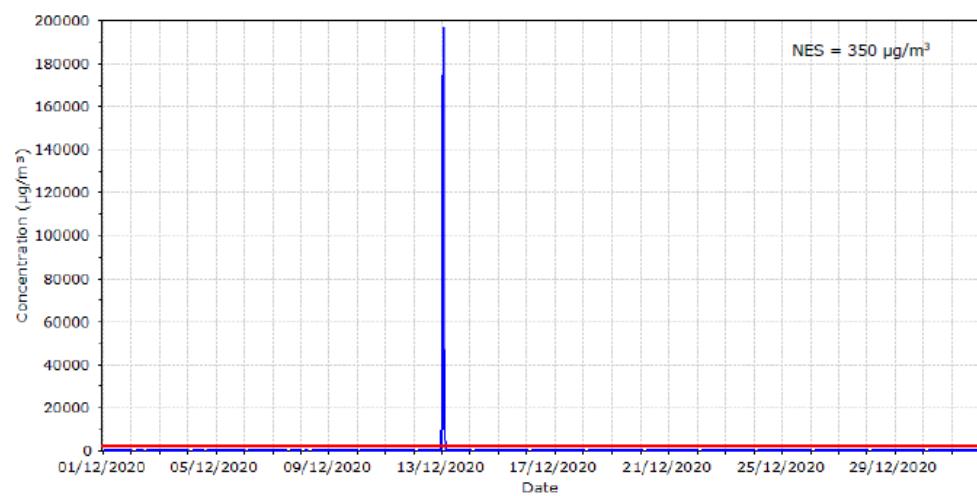
**Ravensdown Napier, Winstone S
Ambient Sulfur Dioxide (1-hour Averages)
December 2020**

Four exceedances of the SO₂ standard (570 µg/m³ – no exceedances allowed) occurred in the early hours of the 13th December 2020. These are listed in red below (data provided by Ravensdown and Watercare Services). The times listed are New Zealand Standard Time.

Date	Time	SO2 µg/m ³
		µg/m ³
13/12/2020	01:00	10243.2
13/12/2020	02:00	196535.2
13/12/2020	03:00	25926.8
13/12/2020	04:00	1380.8
13/12/2020	05:00	172.3
13/12/2020	06:00	71.9
13/12/2020	07:00	55.3
13/12/2020	08:00	39.1
13/12/2020	09:00	28.5

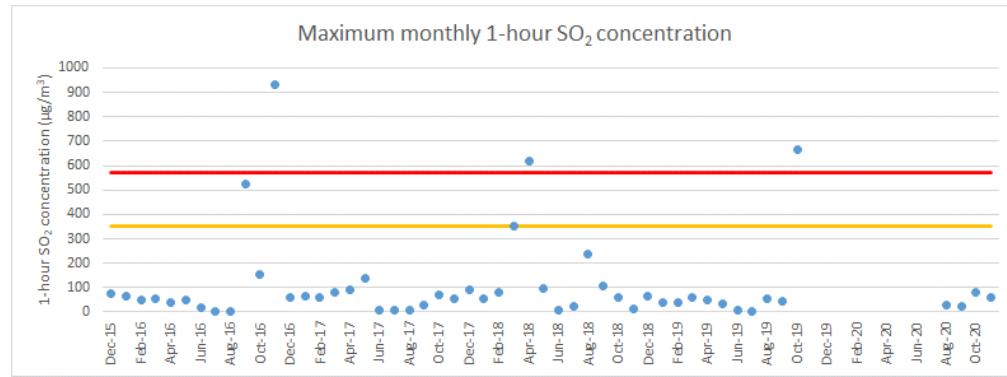
Ravensdown provides results to the Hawke's Bay Regional Council via monthly reports. Figure 2 is a graph of monthly maximum 1-hour SO₂ concentrations extending five years prior to the incident in December 2020. The site was out of action for an extended period during 2019/2020 when power cables to the site were cut and access had to be renegotiated with Winstones Aggregates.

Figure 2: Maximum monthly 1-hour SO₂ concentrations ($\mu\text{g}/\text{m}^3$) sourced from reports supplied by Ravensdown to the Hawke's Bay Regional Council.

Concentrations are typically within standards but there are occasions when exceedances have occurred. These are usually associated with fugitive SO₂ emissions from fires caused by system malfunctions. The exceedances are noted in a section below.

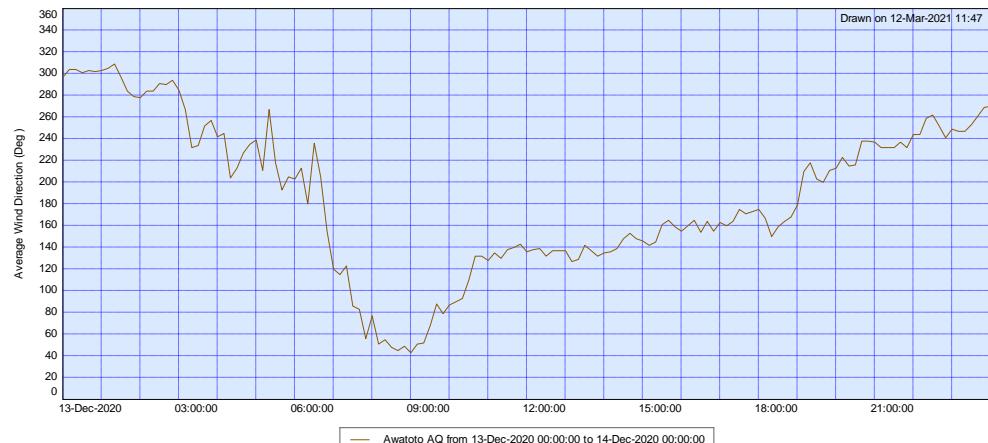
Wind direction, measured at the Hawke's Bay Regional Council particulate monitoring station in Waitangi Road Awatoto, during the early hours of the 13th December and during the time of the exceedance was from a westerly direction, i.e. from the Ravensdown sulphur storage sheds towards the SO₂ monitor (Figure 3). Wind speed varied between approximately 5 km/h to 16 km/h during the period of the exceedances.

Figure 3: Average wind direction (degrees) on 13th December 2020 recorded at the Awatoto Air Quality Monitoring Station in Waitangi Road, Awatoto.

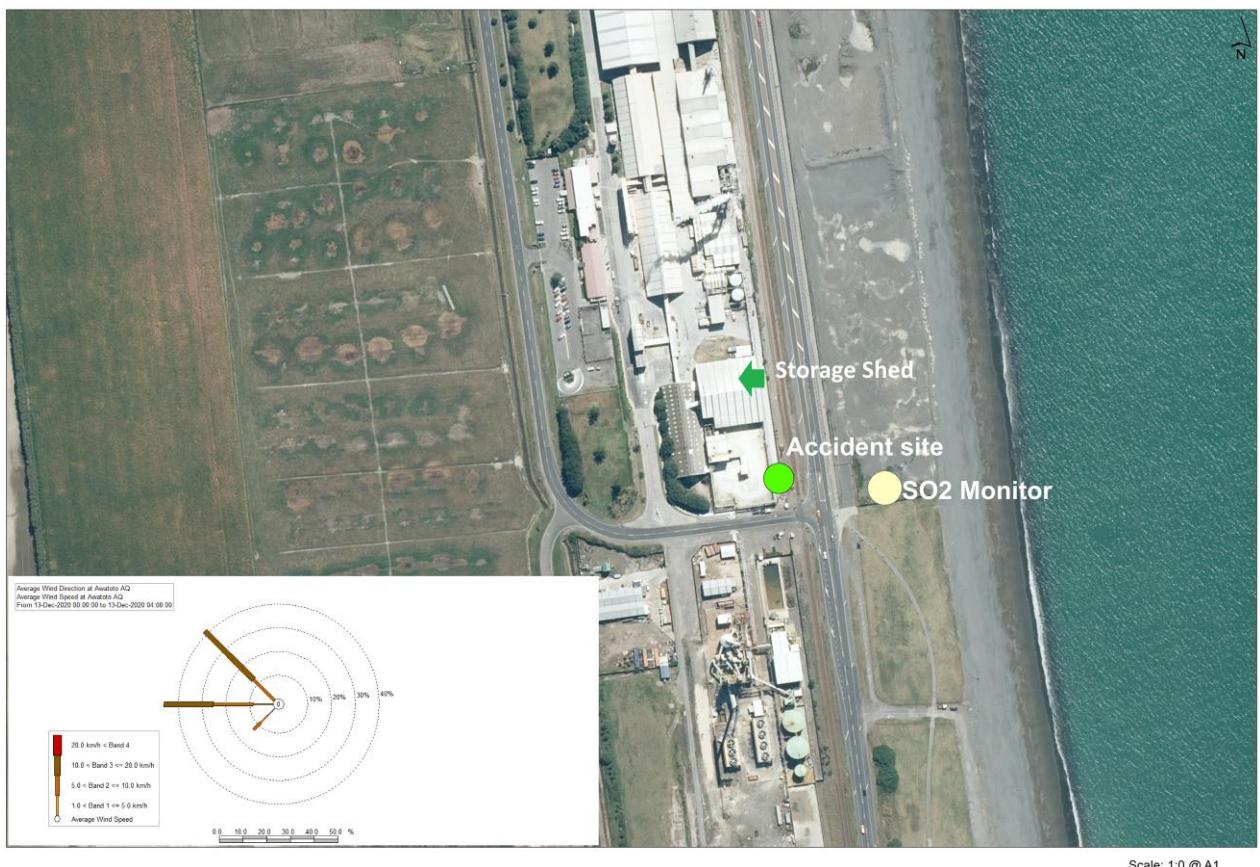
Figure 4 shows the vehicle's point of entry onto the property (Accident site) and the storage shed where it came to a halt. The SO₂ monitor lies to the west of the site and a wind rose for the hours from midnight to 4 am NZST is included on the map, as well as being shown in Figure 5 separately for clarity.

Figure 4: A map of the site of where the incident and SO₂ discharge occurred on 13th December 2021. The arrow at the top right corner of the map indicates the north direction.

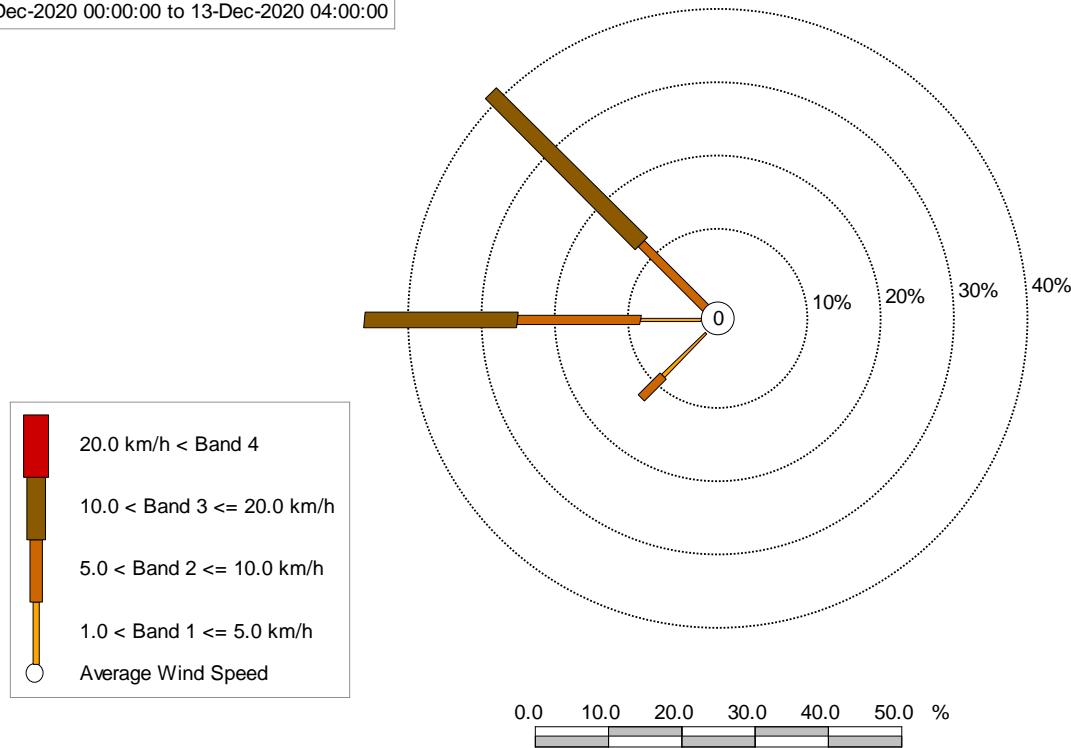
Average Wind Direction at Awatoto AQ
 Average Wind Speed at Awatoto AQ
 From 13-Dec-2020 00:00:00 to 13-Dec-2020 04:00:00

Figure 5: Wind speed and direction during the hours from midnight to 4 am NZST on the 13th December 2020.
