19-D-02771

The residential suburb of s 9(2)(a) of Christchurch. Several independent reports related to post-earthquake repairs were received by Environment Canterbury which showed evidence of metal and benzo(a)pyrene contamination in soils beneath properties.

The residential suburb of s 9(2)(a) of Christchurch. Several independent reports were received by Environment Canterbury which showed evidence of metal and benzo(a)pyrene contamination in soils beneath properties. Environment Canterbury undertook their own initial investigation across properties in the area in December 2016 and March 2017. This took the form of shallow soil sampling using a hand auger and an X-Ray Fluorescence (XRF) meter. The Environment Canterbury investigation found fill material comprised sandy silt with fragments of brick, glass, ceramic, and slag across twenty-three properties. Where laboratory analysis was undertaken, high concentrations of arsenic and lead were measured.

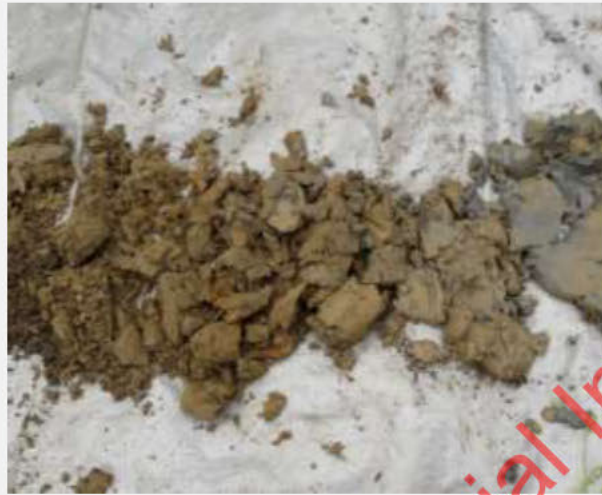
Image 1 – Natural Soil Condition

Images 1-6 display the typical ground conditions encountered during site works.

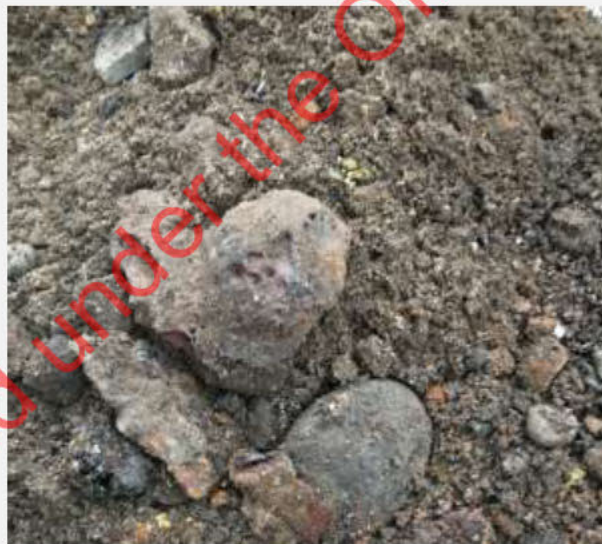
Image 3 – Foundry slag within fill material

The fill material is characterised by high lead and arsenic concentrations but additionally chromium, copper and zinc appear at high concentrations in the areas of fill material. Polycyclic aromatic hydrocarbon (PAH) analysis has been limited, but exceedances of human health criteria have been noted at several locations. The presence of slag would suggest that foundry waste may have been deposited in the fill material.

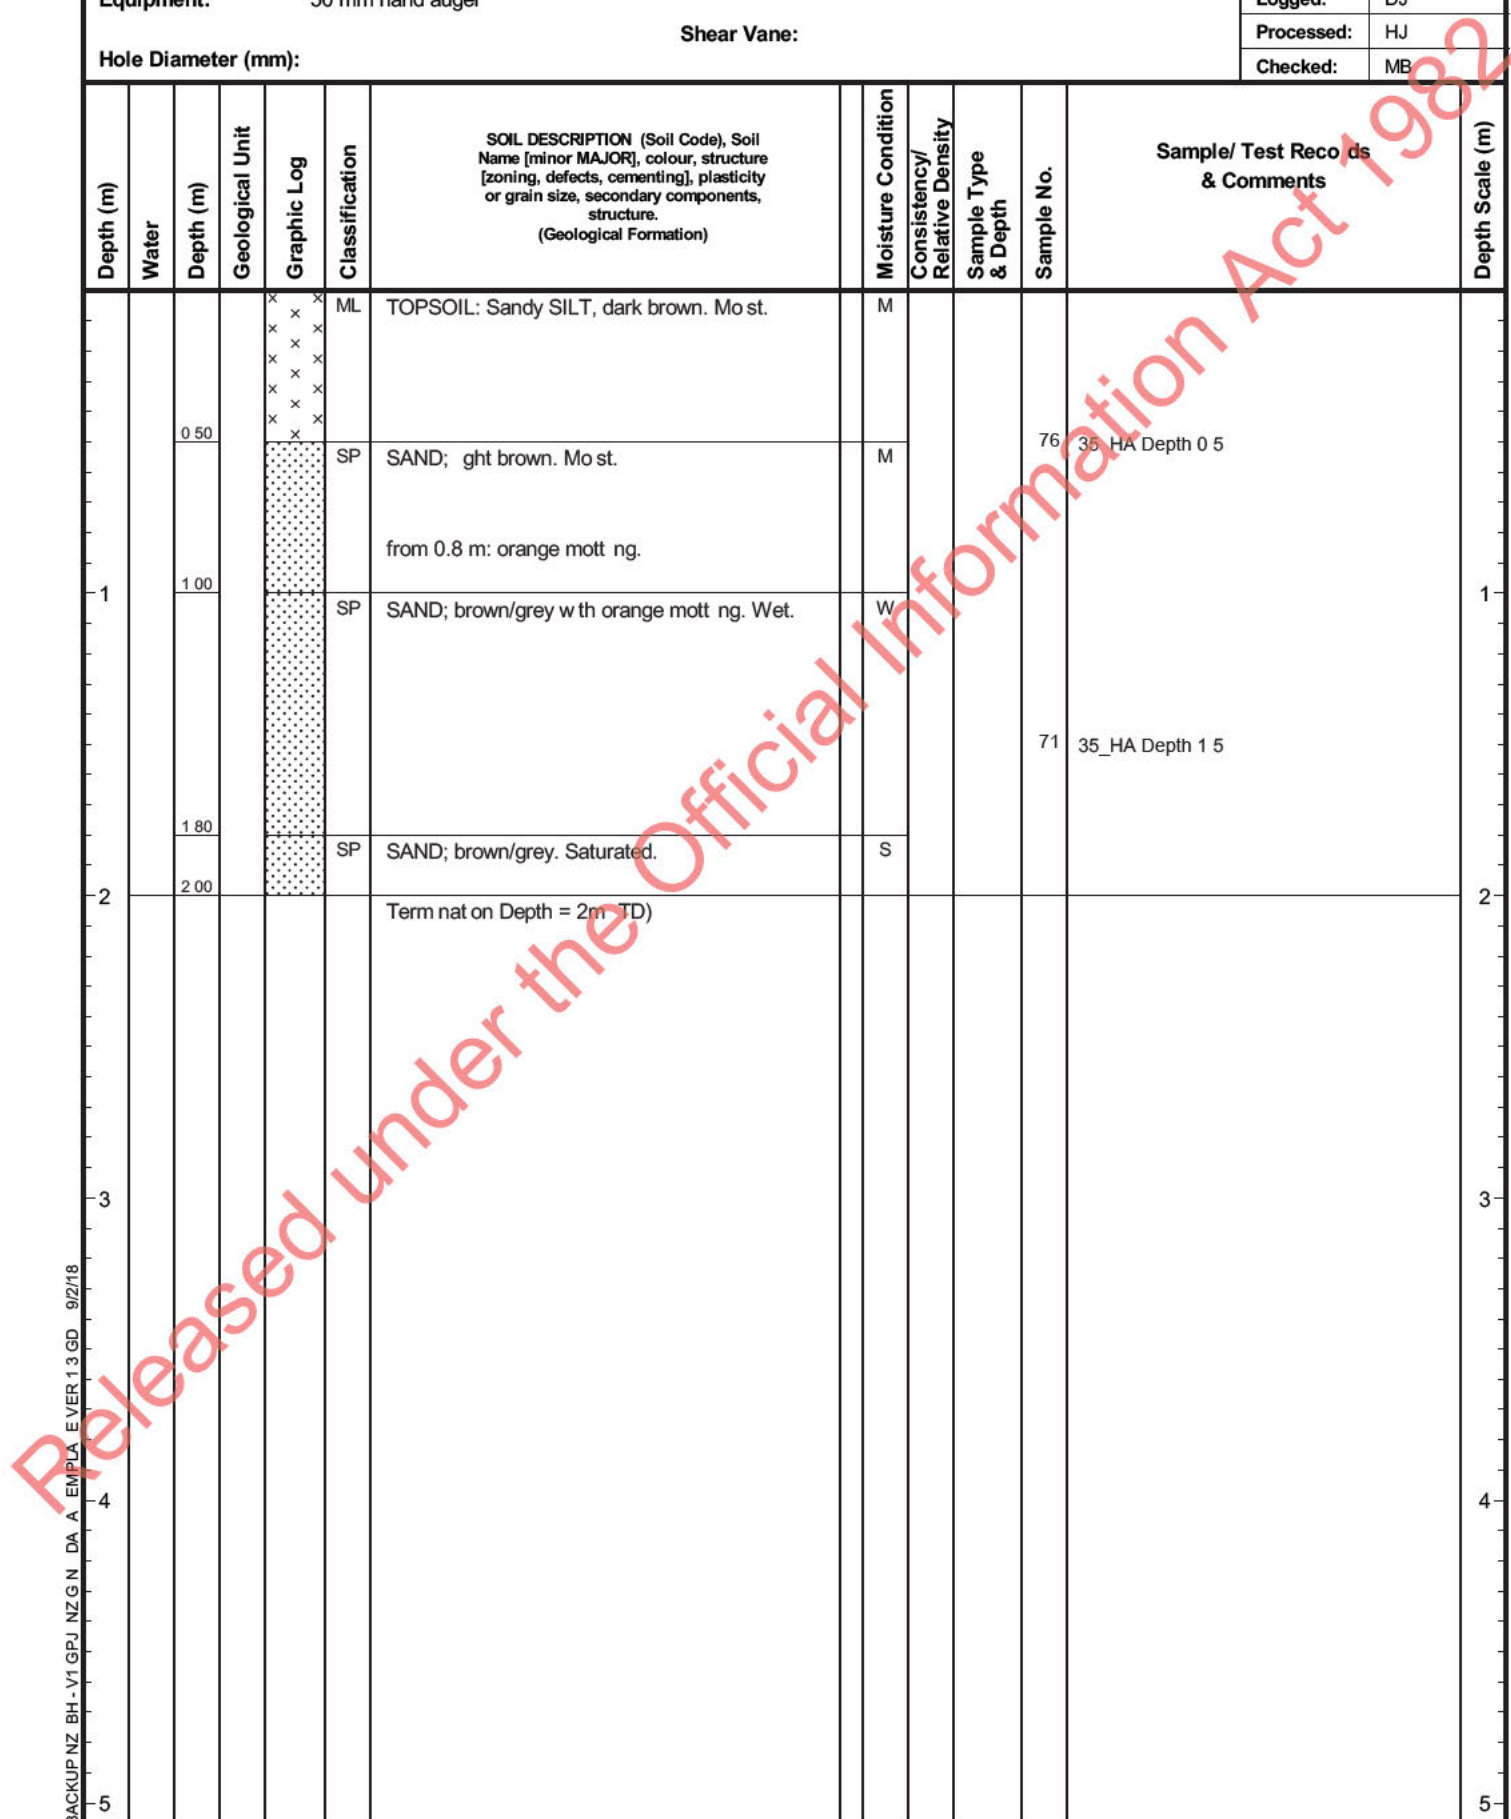
Depth (m)	Water	Depth (m)	Geological Unit	Graphic Log	Classification	SOIL DESCRIPTION (Soil Code), Soil Name [minor MAJOR], colour, structure [zoning, defects, cementing], plasticity or grain size, secondary components, structure. (Geological Formation)	Moisture Condition	Consistency/Relative Density	Sample Type & Depth	Sample No.	Sample/ Test Records & Comments	Depth Scale (m)
		0.50		x x x x x x x x x x x x x x x x	ML	TOPSOIL: Sandy SILT, dark brown. Mo st.	M					
		1.00		[Dotted pattern]	SP	SAND; ght brown. Mo st. from 0.8 m: orange mott ng.	M			76	35_HA Depth 0.5	
		1.80		[Dotted pattern]	SP	SAND; brown/grey w th orange mott ng. Wet.	W					
		2.00		[Dotted pattern]	SP	SAND; brown/grey. Saturated.	S			71	35_HA Depth 1.5	
						Term nat on Depth = 2m (TD)

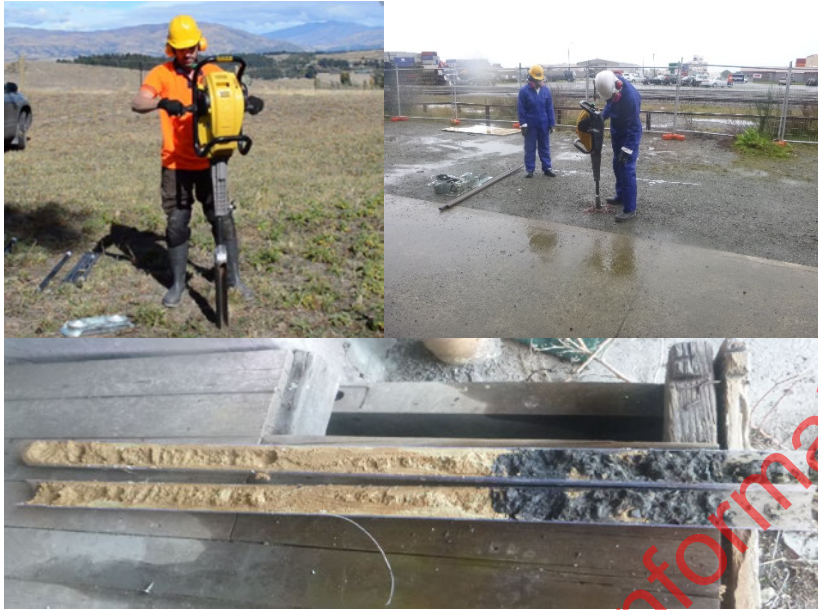
Figure 7: Window Sampling Equipment and Cores

We will use a window sampler to advance 13 bores and collect soil samples. The window sampler drives hollow steel tubes into the ground using a small petrol driven percussion hammer (see Figure 7). These locations are sited in areas of more difficult access for the rig as the window sampler is very mobile and can be carried onto sites.
