**From:** 9(2)(a)  
**Sent:** Sunday, 6 October 2024 7:34 pm  
**To:** Info at MfE <[infoatmfe@mfe.govt.nz](mailto:infoatmfe@mfe.govt.nz)>  
**Subject:** Attn: Hon Simmonds - Greymouth District - Support letter - RE: Taylorville Resource Park Ltd dump site.

Our concern stems from a long-standing issue with the original dump site where demolition materials, from sites such as Revingtons Hotel, a fire-damaged house, and the majority of the Grey Base Hospital demolition project were disposed of. The resource consent for this site (RC-2016-0067-01) was not renewed, and while operations ceased, the site was simply capped and left without proper remediation. This lack of remediation, combined with the opening of a new dump site just down the road, reflects a troubling pattern of behavior in the management of resource consents by the same landowner and contractor, now operating under a different company name.

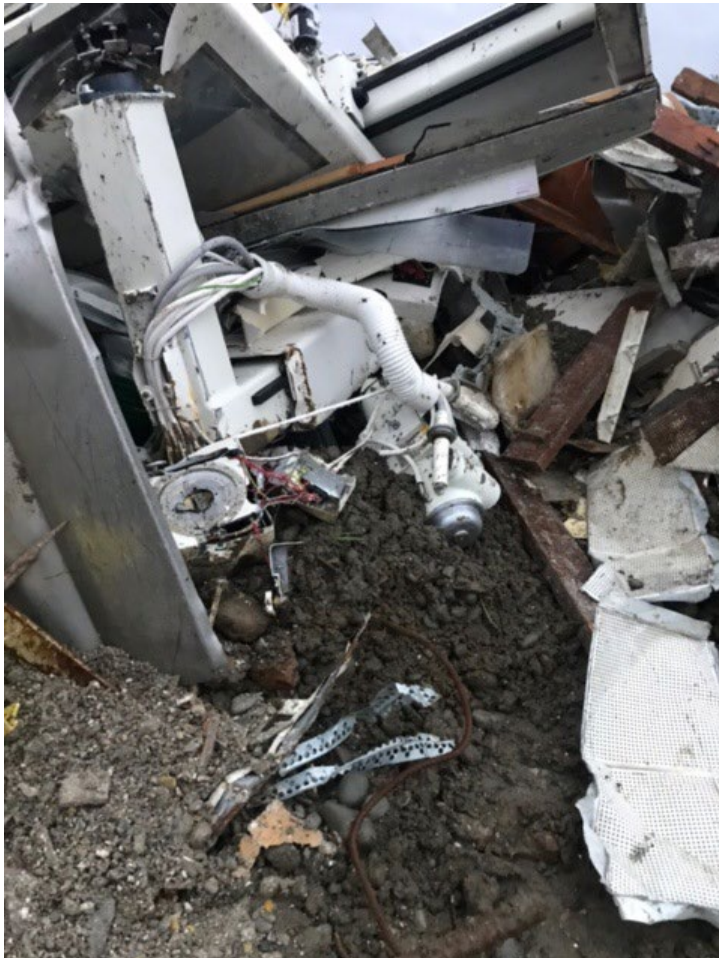
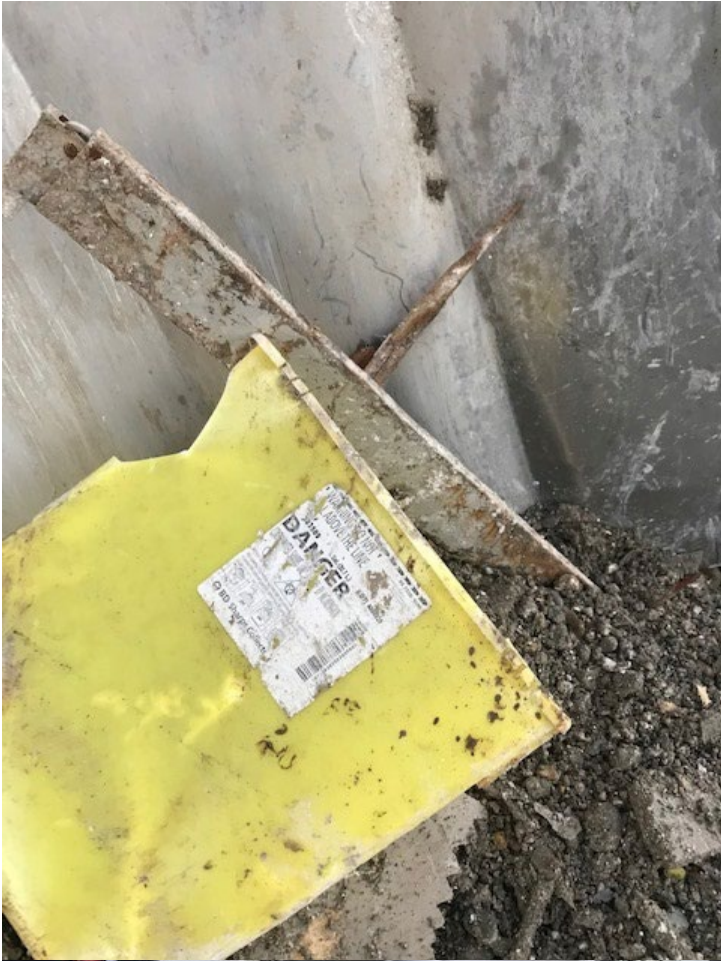
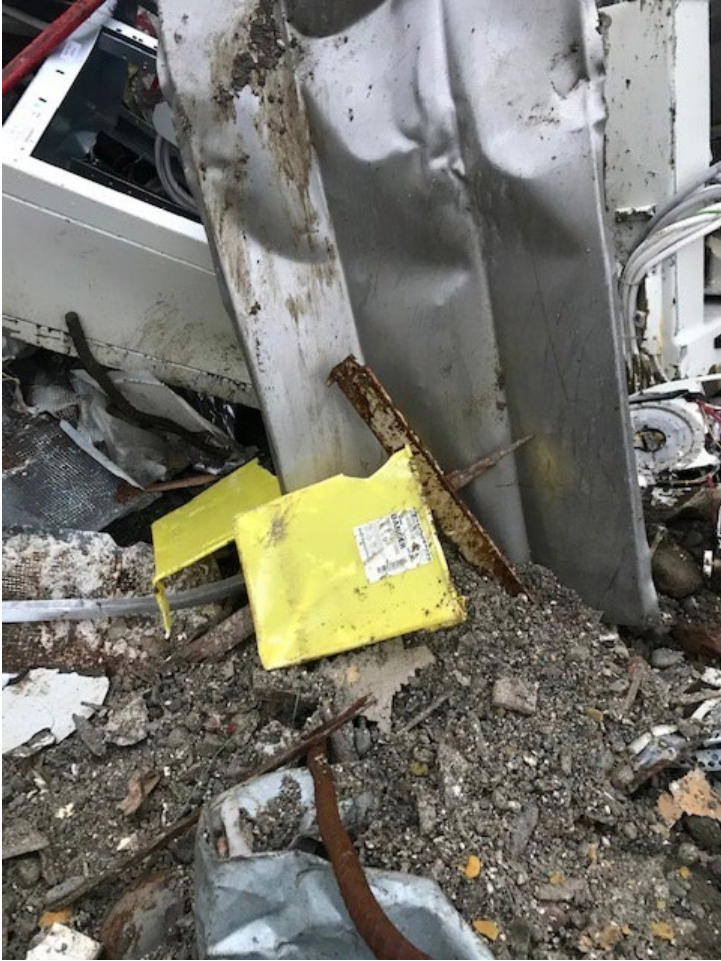
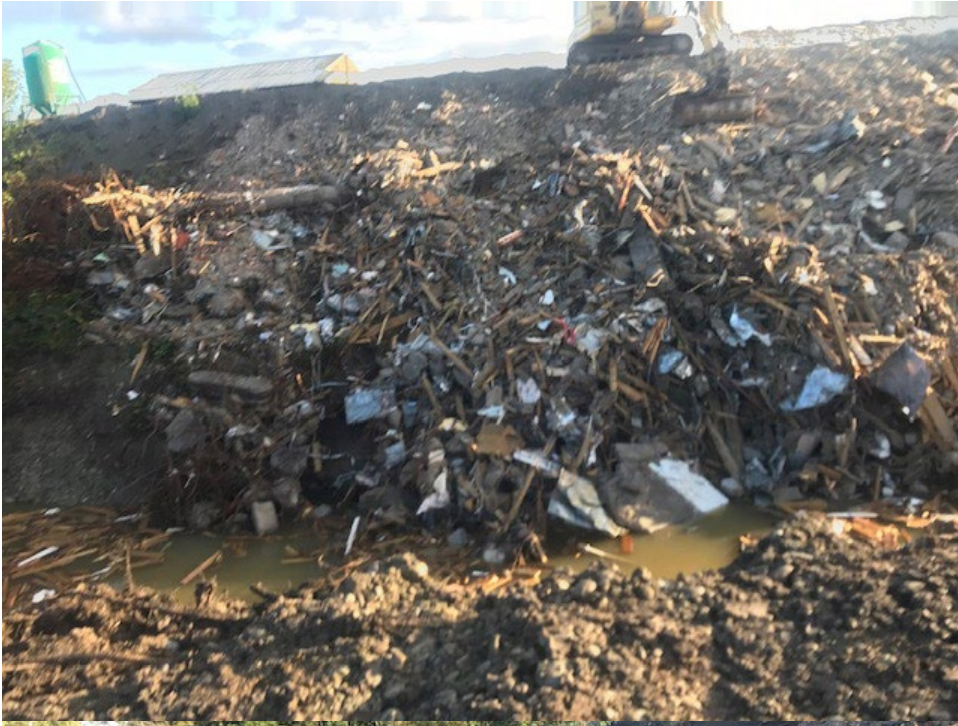
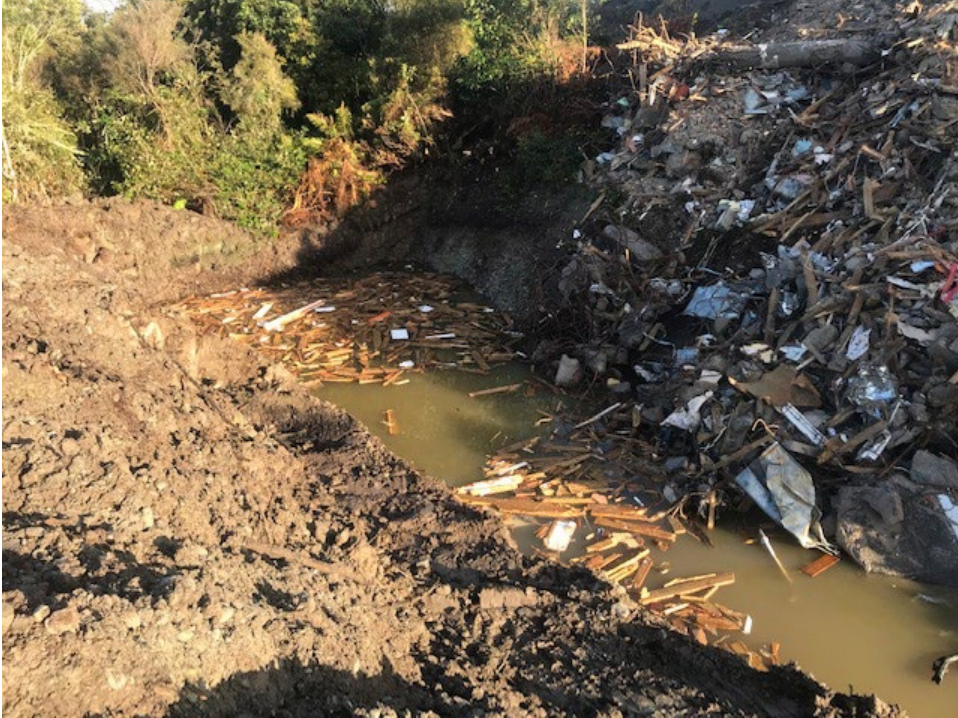
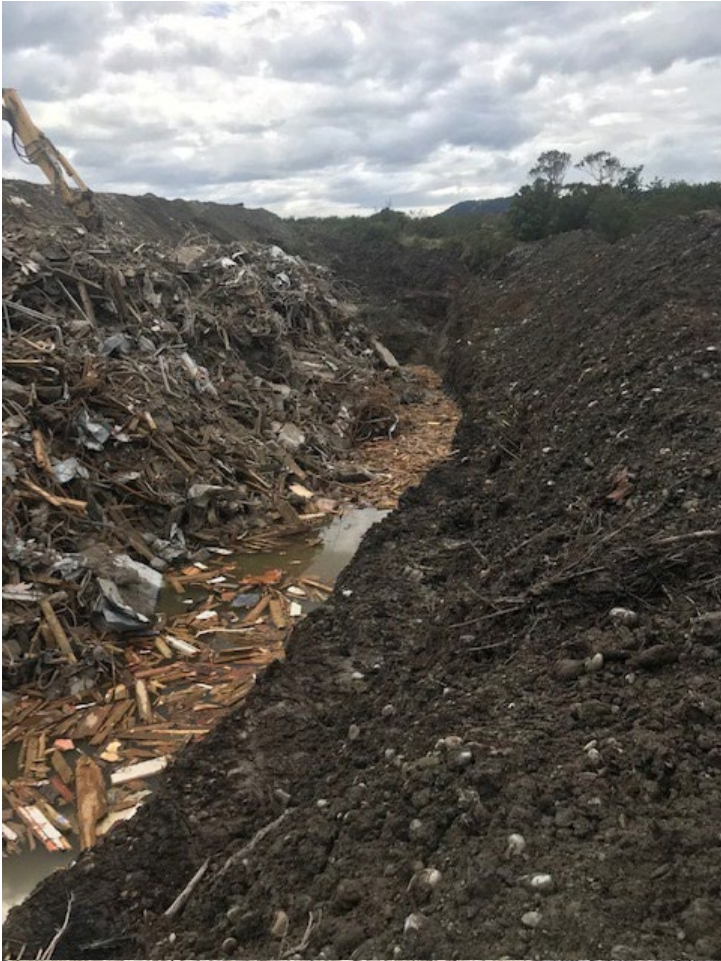
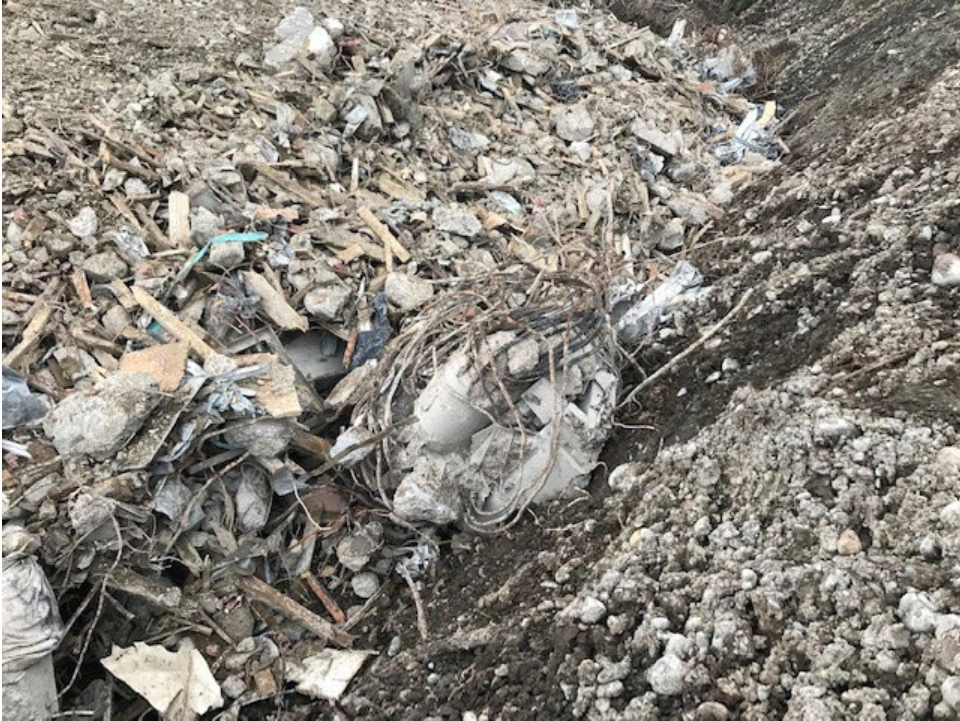
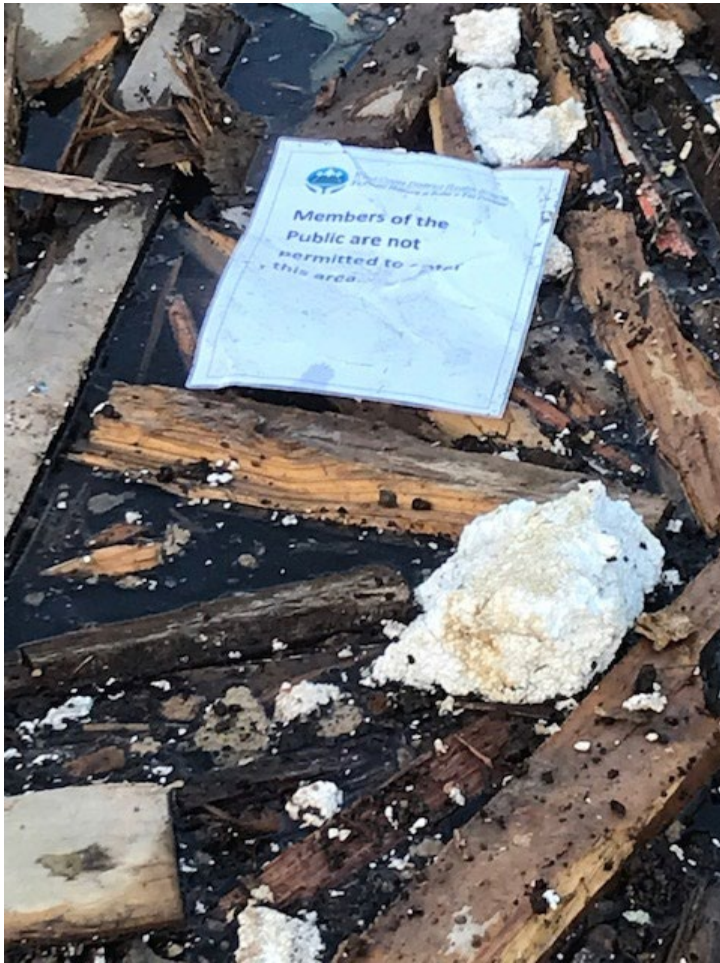
We would like to draw your attention to the following images, which capture what we consider to be the most severe and hazardous material present on site, in clear breach of regulations. These include the remains of an X-ray machine, biohazard bins, and demolition waste being pushed directly into a body of water. These photographs, taken on 20/05/2021, highlight the serious environmental and health risks associated with improper waste management at this site.

At a bare minimum, the original dumping site should have continuous water sampling and monitoring systems in place to track any leachate leaving the site. This is crucial for ensuring that the runoff from the site meets environmental and safety standards. Without these measures, there is no reliable way to assess or mitigate the long-term environmental risks posed by contaminants leaching into the district's water supply and adjacent properties.

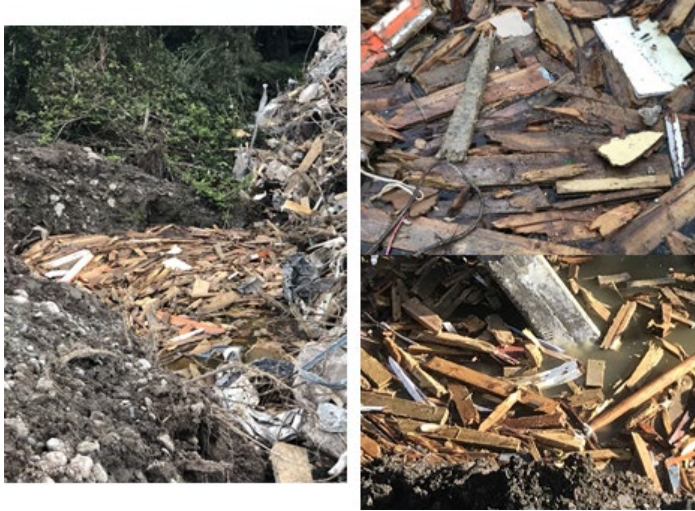
As you can clearly see from our photographic evidence that two of these bullet points (Concrete, including concrete with internal reinforcing (ie. Protruding reinforcing removed) and Residual metalwork not able to be removed through the stripping operation), are not being complied with.

One bullet point is contentious (Untreated Wood), as they clearly haven't separated out these other obvious breaches. It could be possible that treated and untreated timber could have been mixed together/not sorted correctly.

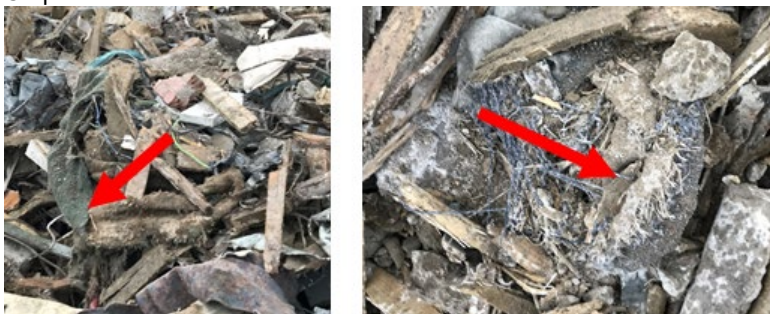
Carpet

2. As stated in "The Guide", Section 4.3.1 Unacceptable waste, Table 4.2:  
Outside the amendments that were stated in Form C and the initial resource consent these materials are all found clearly mixed in with the "clean fill" and we interpret this to be a breach of this resource consent.  
As stated in the Form C and Resource Consent they are not listed as accepted changes or additions to the accepted clean fill described in The Guide.

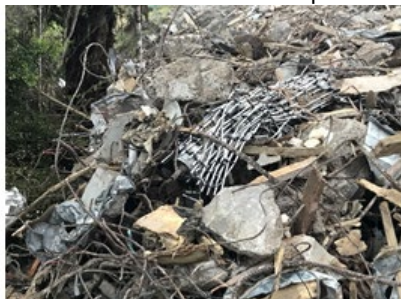
From our photographic examples, you will see that there is plenty of materials that we believe could very easily be separated out from the acceptable demolition material so that only residual amounts remain as stated in the amended requirements in the resource consent and these would be permitted.

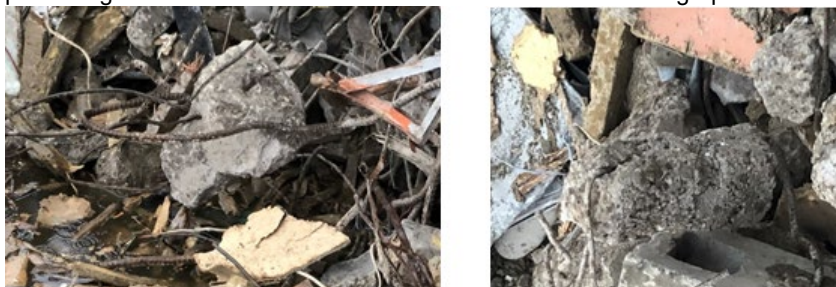
This is also one of the accepted clean fill items stated in The Guide, however you will see that concrete with protruding metal has not been removed as stated above. Photographic evidence provided

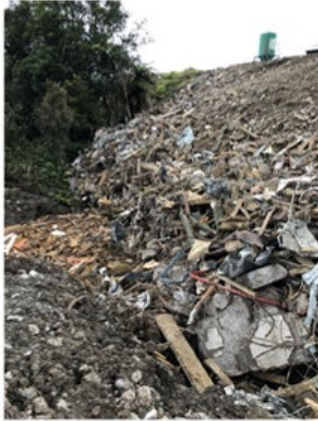
Before: Facing West, Near Trees

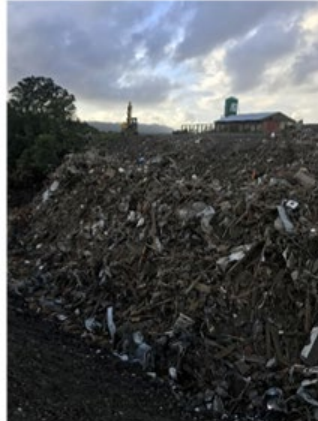
Before: Facing North, Looking at Tip Off Area

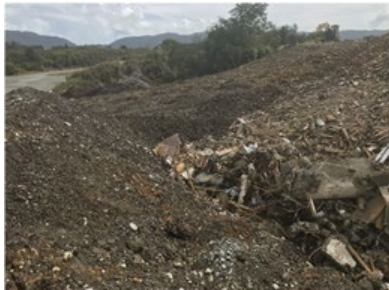
We interpret the act of covering the breach materials with clean fill to obscure what has been placed into the “clean fill” site to be in breach of this act.

After Saturday covering, Facing West

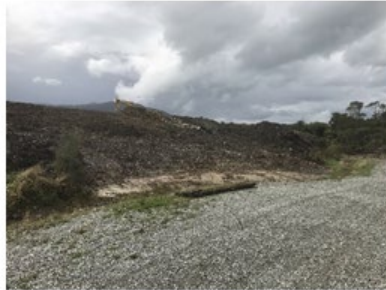
Covered Middle area Facing Tip Site
