LAKE NGAROTO RESTORATION

A CASE STUDY

< 2001 >

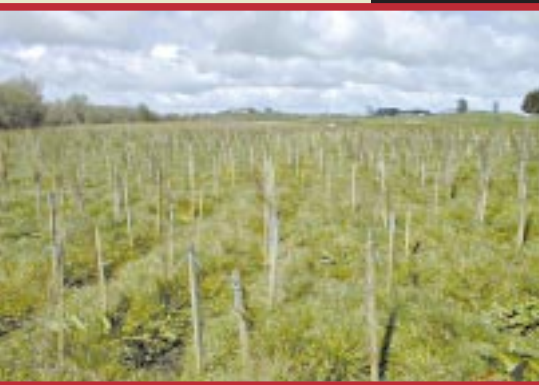
MANUKA PLANTED IN RETIRED GRAZING LAND

A trial planting of manuka *Leptospermum scoparium* was carried out. Each plant was individually staked so it could be located once the inevitable regrowth of the weeds took place. The stakes were specially purchased and of H3 treated radiata so they would last in the ground and be re-useable.

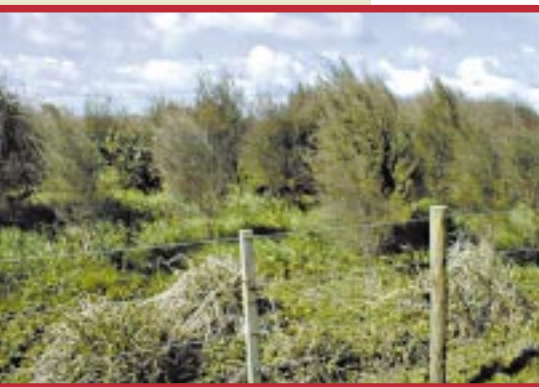
MANUKA PLANTED IN RETIRED GRAZING LAND

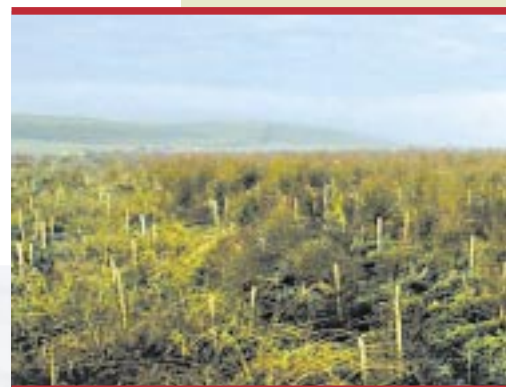
TWO SEASONS PLANTINGS

Nurseries were contracted to grow plant material for the following year (this has continued in subsequent years) – primarily manuka grown from seed sourced from another nearby peat lake. The plants were grown to root trainer size in the commercial nursery, then repotted into PB2 pots by the iwi group and Department of Corrections, and finally grown on for another year before planting.

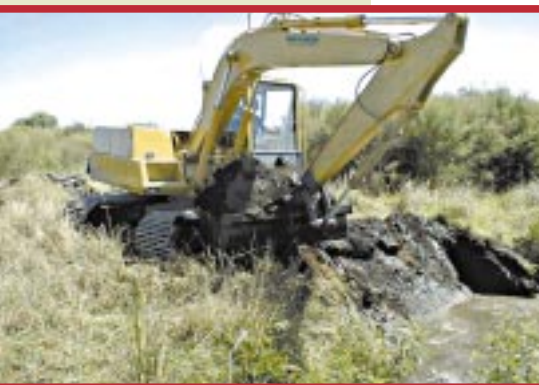
DIGGING THE SILT TRAPS

In March 1999, having obtained the necessary resource consents, the silt traps were constructed on all the inflows to the lake. Essentially these traps are just an enlargement of the drain or water course, both in width and depth, sufficient to allow the water flowing through the channel to slow and allow sediments to settle out. They were calculated to be large enough so that the water entering them would slow sufficiently for the bed load to be deposited in the trap.

The objective was to intercept the heavier silt moving along the floor of the drains, not necessarily the suspended silts, although it was hoped some of these would be trapped. (A prototype of this was built by the Department of Conservation during the early 1990s at Lake "B" north of Hamilton. It was very successful in intercepting a large percentage of the silt moving down the drain, although no scientific study of its effects was ever made. It certainly stopped a large proportion of the bed load of moving sediments which had been forming a delta in the lake at the point of discharge of the drain to the lake).

In March 2000, the silt traps were cleaned for the first time and an estimate made of the quantity extracted. All the drains had some limited silt removed, although in three cases this could only be described as a "trace". One drain, however, contained a large quantity of silt, and the drain above the trap was likewise filled with silt. The land above this was the only area within the immediate lake catchment where a paddock had been cultivated in the previous 12 months.

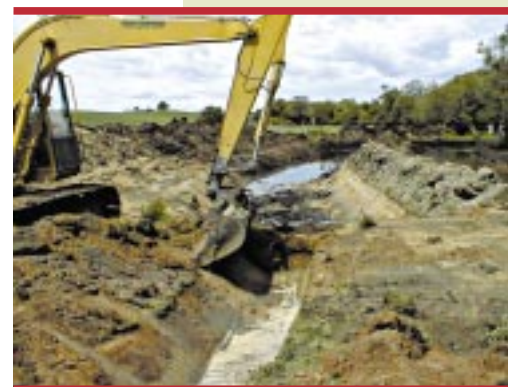
DIGGING THE NUTRIENT TRAP

One nutrient trap only was constructed on the largest inflow to the lake from nearby Lake Ngarotoiti. This had some initial stability problems that had to be rectified but it is now working effectively. Water quality testing results are not yet available.

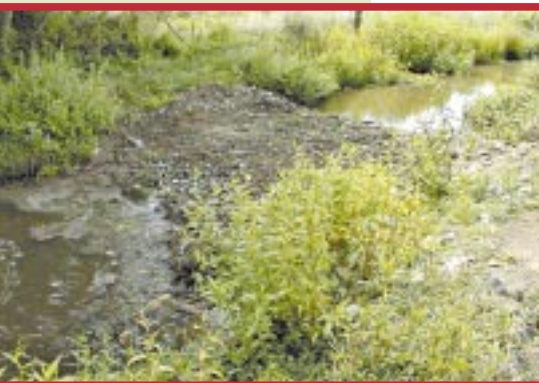
THE NGAROTOITI DIVERSION WEIR

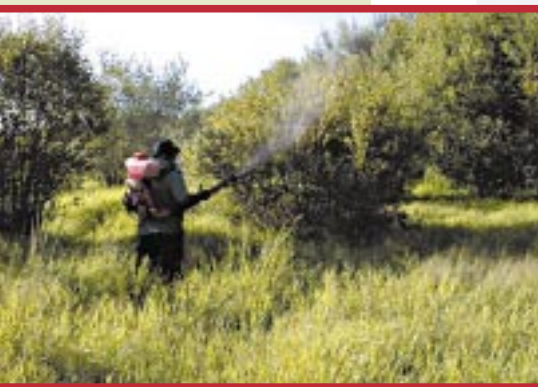
SPRAYING GREY WILLOW IN A SWAMP MEADOW

One area of swamp meadow that was being invaded with grey willow has had chemical control of the willow for two years now but will require one or two more years' work to achieve total control. As long as grey willow remains in other parts of the lake, the threat of re-invasion is very high. The ultimate removal of the grey willow is therefore imperative for the long-term success of the restoration plan.
