# **Managing Waterways on Farms**

**A guide to sustainable water and riparian  
management in rural New Zealand**

Published in May 2001 by  
Ministry for the Environment  
PO Box 10-362, Wellington, New Zealand

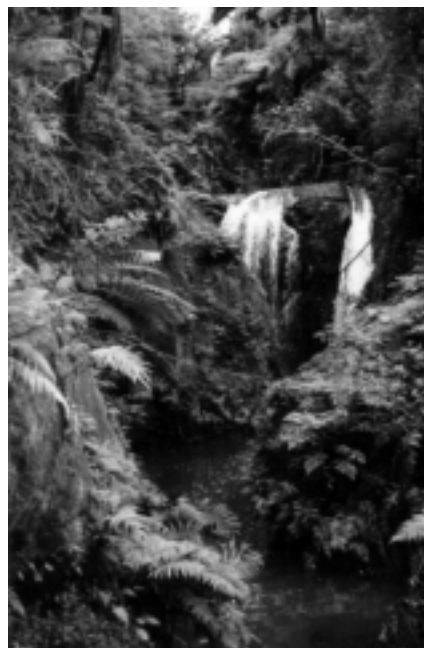
**Photograph 1:** In pre-human times the majority of New Zealand's lowland streams were heavily shaded by thick riparian vegetation. They were cool, meandering, stony bottomed and contained abundant invertebrate and fish life.

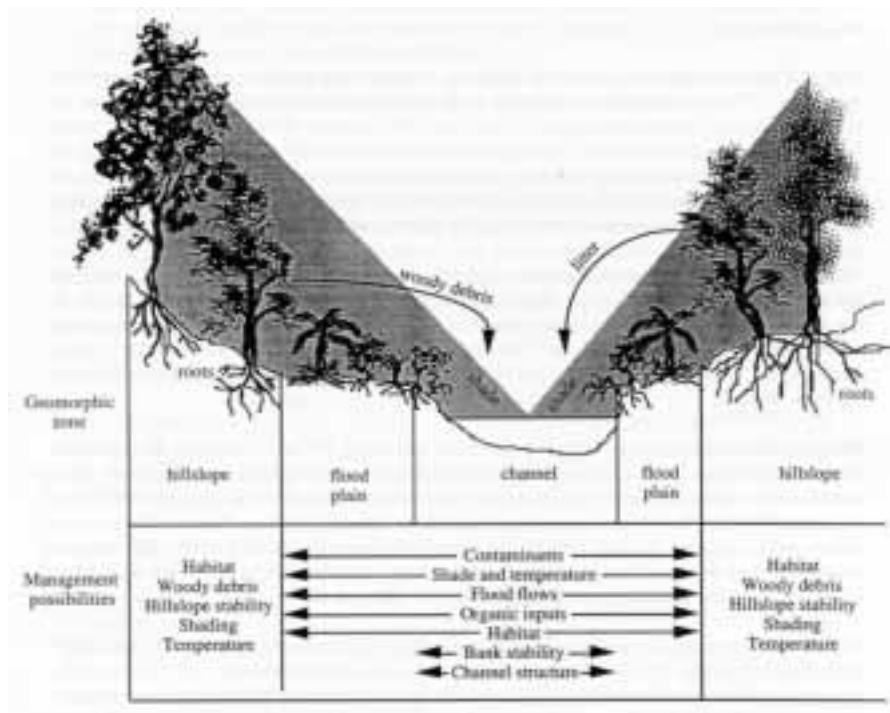
**Figure 1:** Conceptual diagram comparing the geomorphic zones and management issues of a typical drain and a natural stream (modified from Collier et al., 1995)

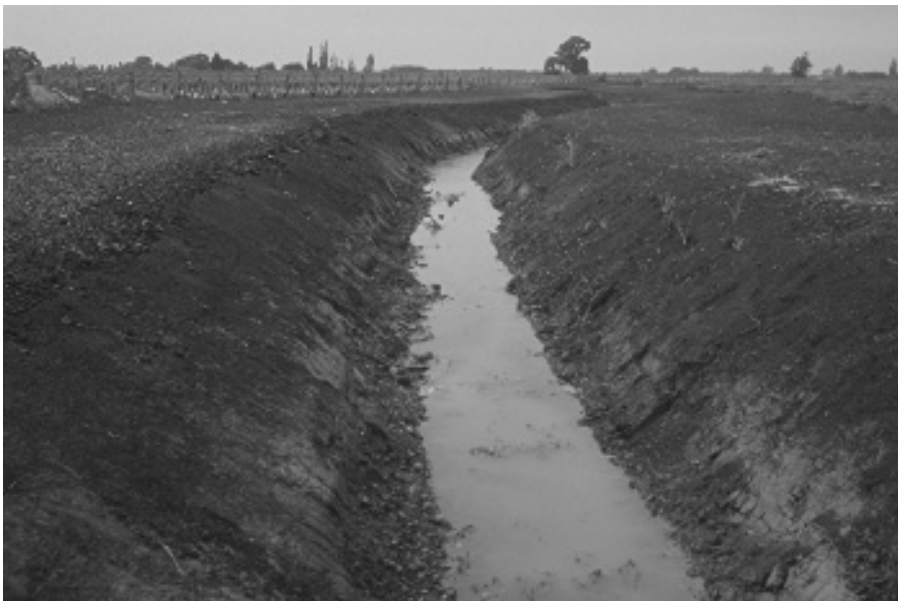
**Photograph 2:** A typically maintained drain, with loss of most fish and wildlife habitat.

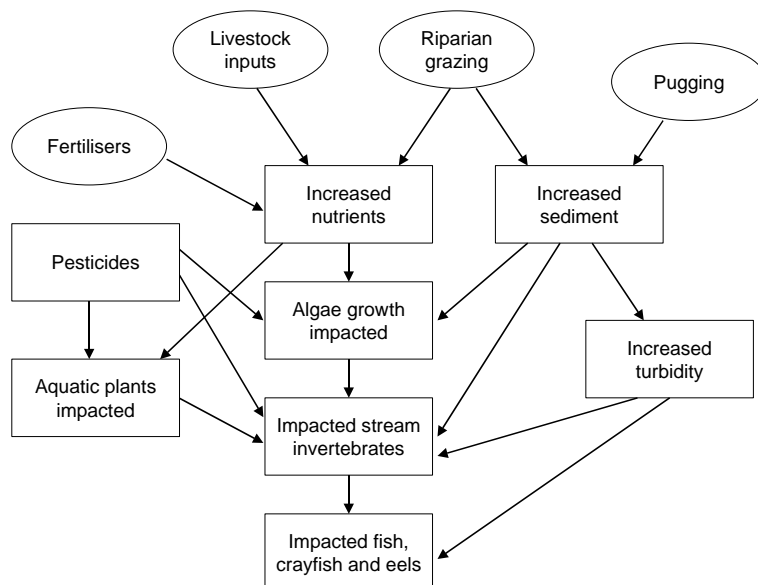
Figure 3: Summary of the effects of generalised agricultural activities on stream communities

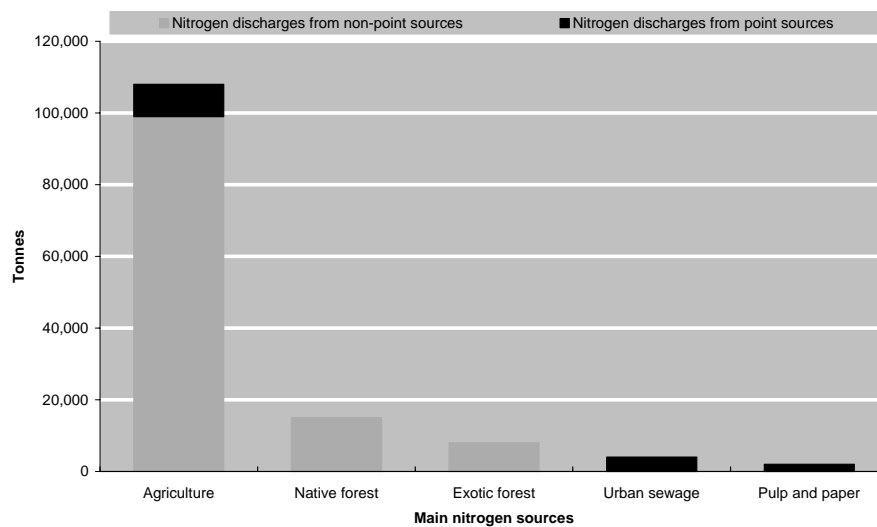
**Figure 4:** Estimated yearly nitrogen loadings to New Zealand surface waters (*MfE, 1997a*)

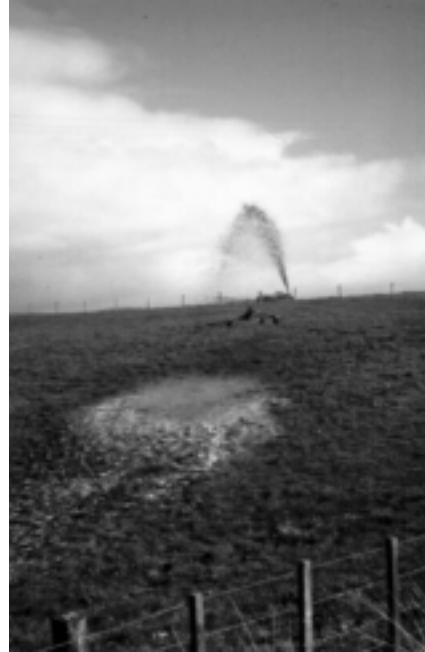
**Photograph 3:** Irrigation, especially on porous soils, can greatly increase nitrate leaching to groundwater which in turn can lead to stream water contamination. The spraying of effluent onto pasture increases the risks further, especially when irrigators are poorly managed or maintained, as is the case in this photo.

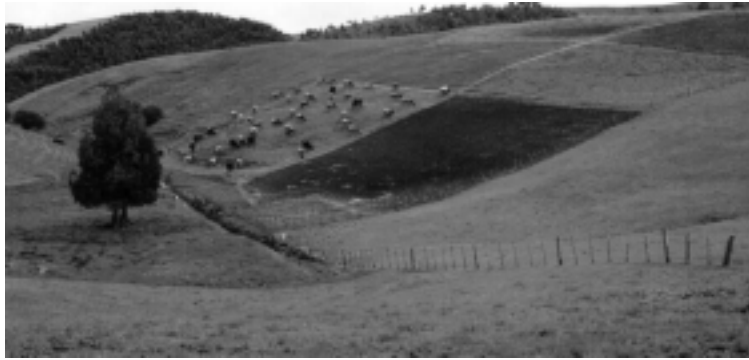
**Photograph 4:** High sediment concentrations in streams are far more likely to occur when pasture is damaged and pugging occurs, especially on slopes. Not only does it lead to soil loss but also to serious production loss. The pasture will take considerably longer to recover than pasture grazed in a more controlled fashion.

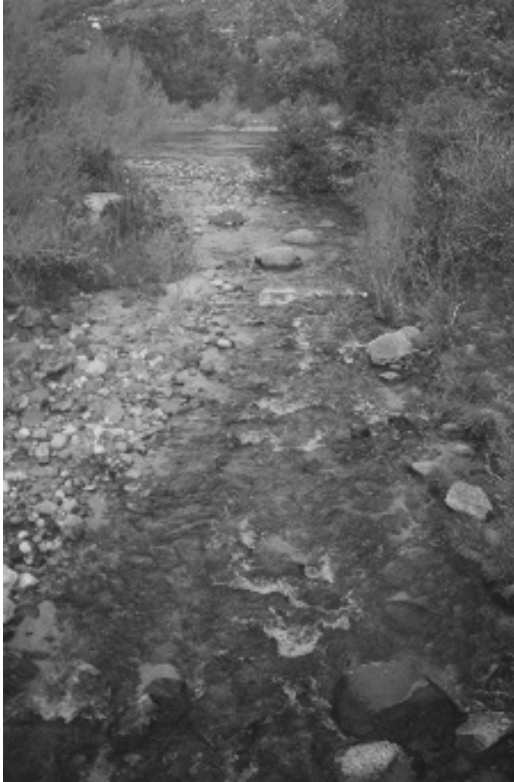
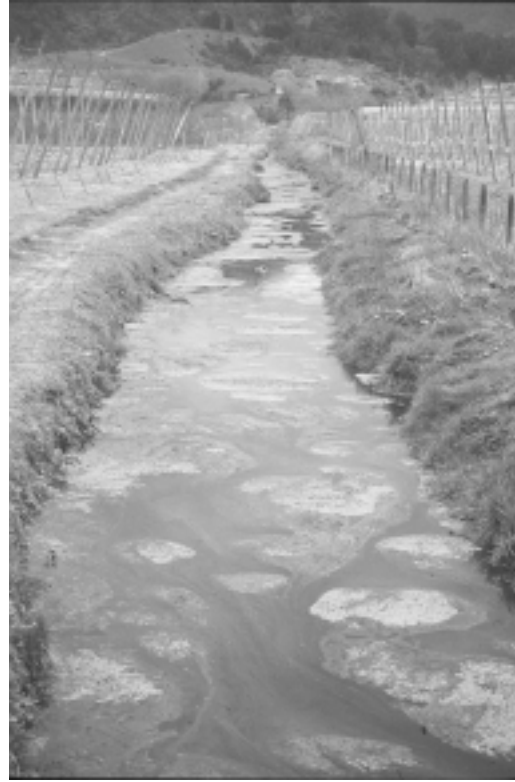
**Photograph 5:** Two farm waterways, one with clear, unturbid water, light algal growth and no sediment. The other has murky water, with heavy algal growths. The bed of the drain cannot be seen.

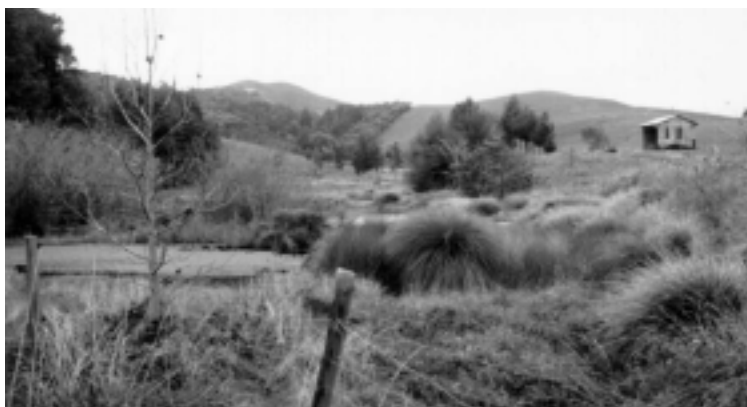
**Photograph 6:** Well vegetated, saturated wetlands serve many useful purposes. They are habitat for birds and fish; nitrates can be removed by denitrification; sediment and phosphorus can be filtered out of the water; and water can be stored during times of rain preventing flooding downstream.

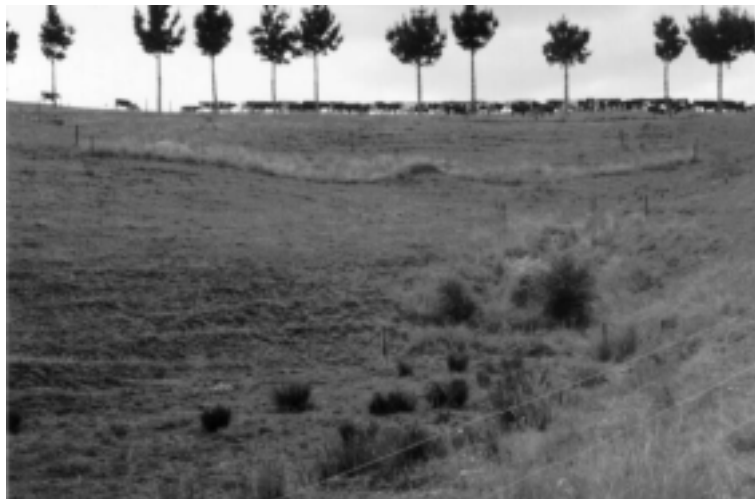
**Photograph 7:** Graham McBride, a dairy farmer west of Hamilton, has experimented with the construction of narrow ungrazed grass filter strips across a face prone to excessive surface runoff. He has noticed that the long grass significantly reduces the speed of surface runoff. The water emerges from the downslope side as a mere trickle compared to that entering the filter strip. This strip, because it is so narrow, will have little capacity to hold sediment, but by reducing the speed of water flow, it will reduce the erosive force of the runoff quite significantly.

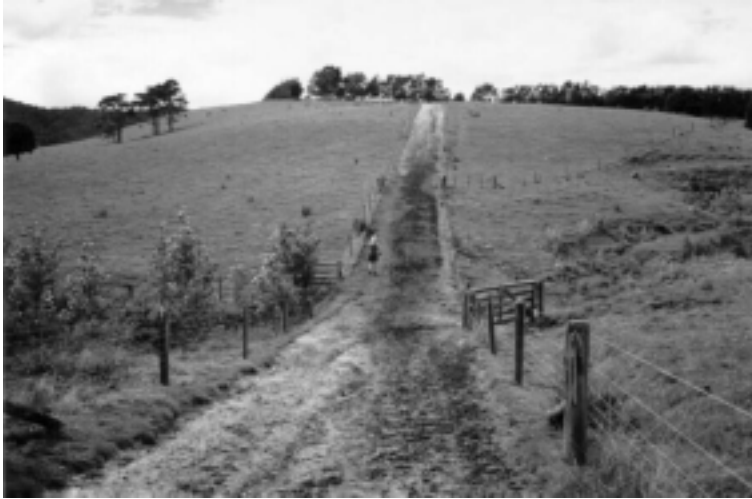
**Photograph 8:** Farm tracks can be a significant source of sediment and nutrient runoff. Frequent cut-offs are advisable on tracks such as this so that water and sediment are channelled off the track and back onto pasture before the volume and velocity of runoff become too great. Sediment traps along the sides of steep tracks will also reduce the velocity of water flow. Sediment traps must be regularly emptied if they are to function properly.

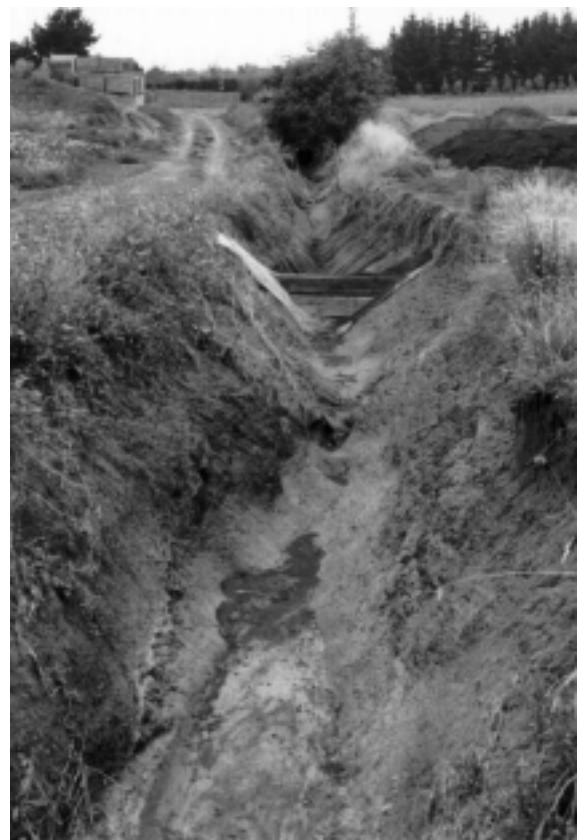
**Photograph 9:** Silt or sediment traps can be effective damage control devices where high amounts of sediment erosion can be expected. Cultivated areas, such as this vegetable growing property near Pukekohe, and forestry areas during harvesting are two situations where silt traps could be used. Silt traps must be regularly cleared of accumulated sediment to be effective.

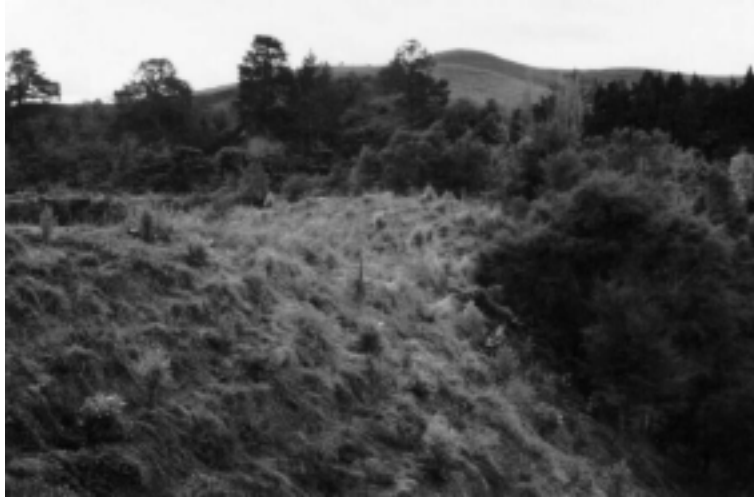
**Photograph 10:** Open pasture can be one of the most hostile environments in which to plant native trees and shrubs: exposure to wind, sun and frost, competition from thick and vigorous pasture grasses, and easily accessible to rabbits, hares and (when poorly fenced) to livestock. Spot spraying of planting sites before planting and regular releasing (up to 3–4 times per growing season on warm, fertile sites) is necessary.

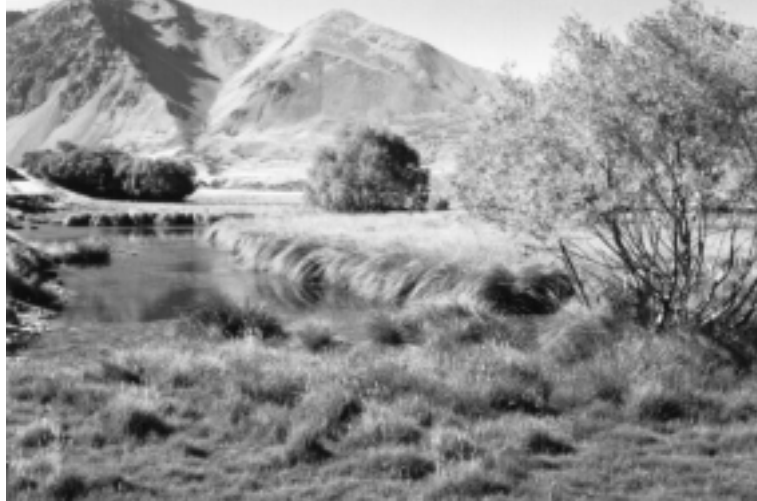
**Photograph 11:** *Carex* sedges such as these pictures beside the Ahuriri River in inland South Canterbury provide excellent shade, habitat and food for the occupants of streams and wetlands.

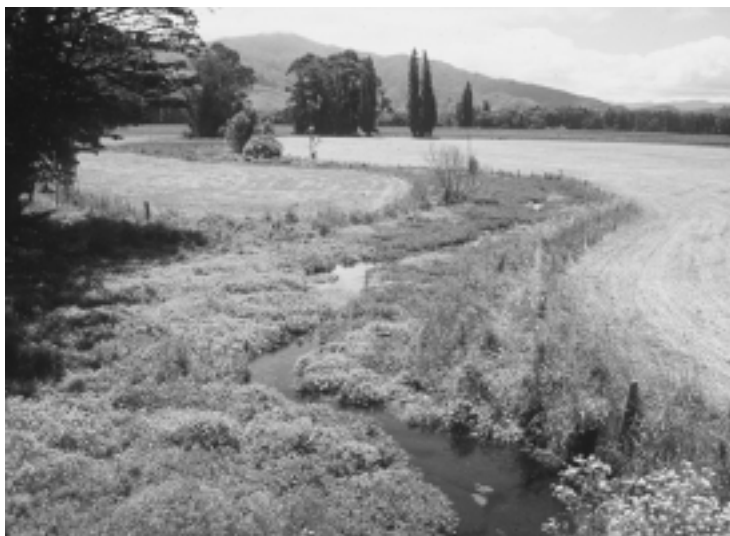
**Photograph 12:** Riparian buffer widths will vary with stream size and the type of farming occurring in the catchment.

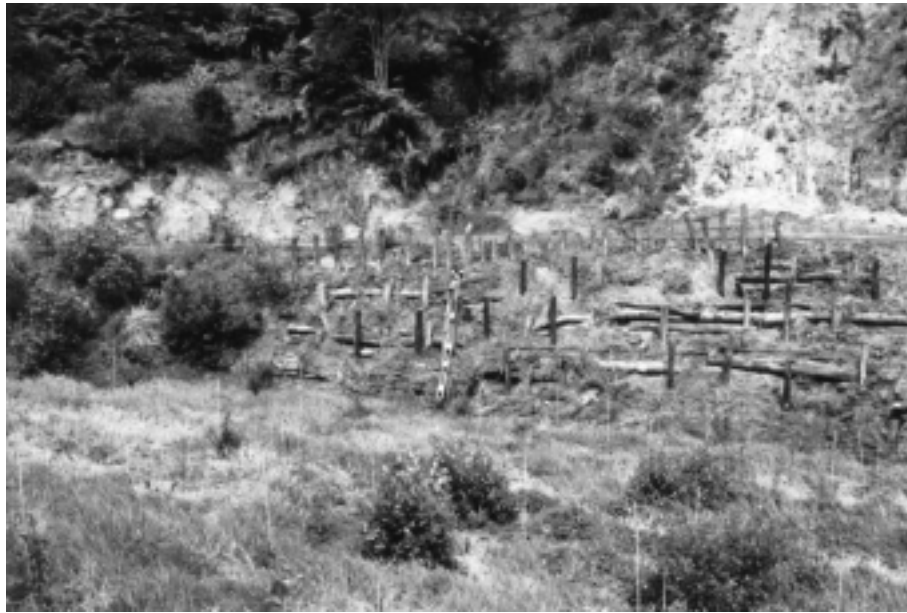
**Photograph 13:** Bamboo stakes are an effective way of marking the location of newly planted seedlings and of preventing the accidental spraying of seedlings when they become covered by weeds or long grass. The freshly positioned ponga logs on the slope have been placed there to stabilise the slope from erosion caused by the stream at its base (out of view). Freshly cut pongas are necessary to achieve a good survival rate. Once established the fibrous roots of the tree fern function well to repeal flood waters. Ponga survival can be improved by lying the logs down horizontally so that two-thirds of the trunk is buried in moist soil.

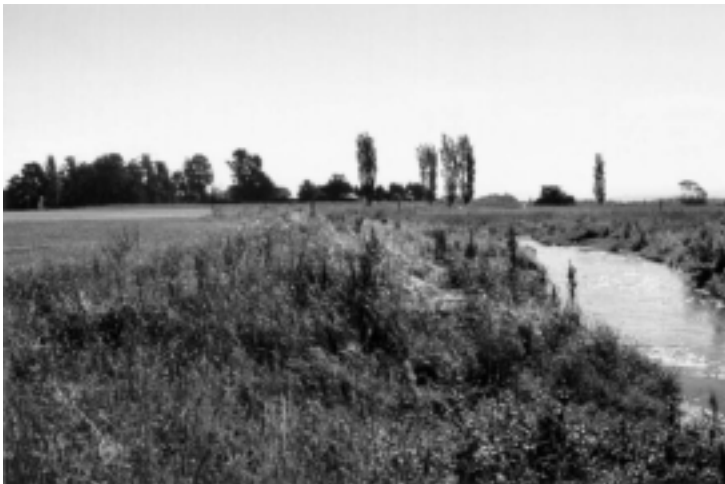
**Photograph 14:** “The wider the better.” This 10–15 metre wide filter strip of rank grass provides a very good buffer to surface runoff and to the impact of flooding (Waikakahi Stream, South Canterbury – see *Case Study 2: Dairying and Border-Dyke Irrigation along the Waikakahi Stream: A water management challenge*).

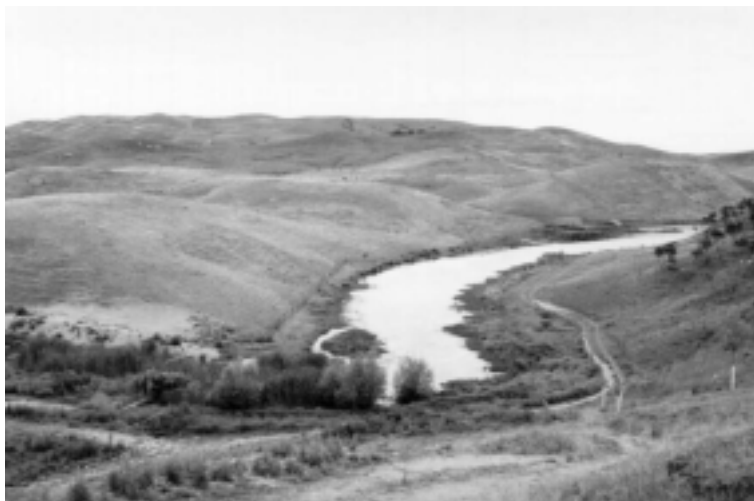
**Photograph 15:** Appropriately positioned ponds or lakes can serve many functions: they can trap sediment and nutrients, supply water, buffer against downstream flooding and erosion, provide habitat for wildfowl and fish, and enhance the aesthetics of an area.

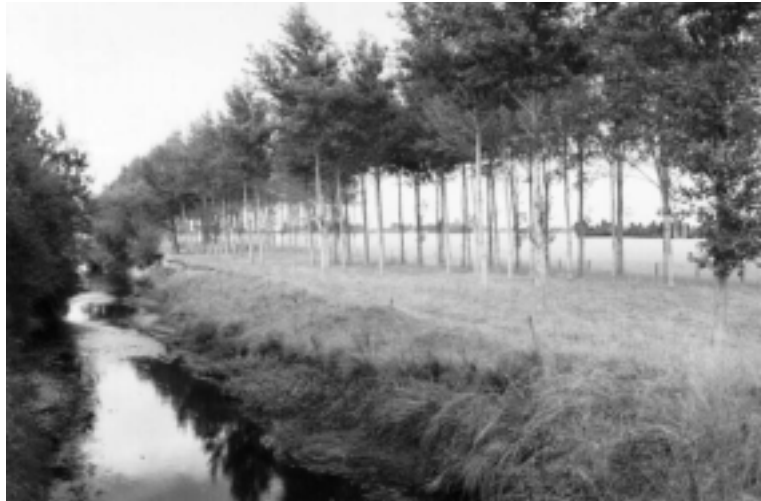
**Photograph 16:** Retired riparian margins offer some opportunities for timber production. Poplars have been planted at wide spacings and pruned on this Southland property for future timber production and continued summertime sheep grazing.

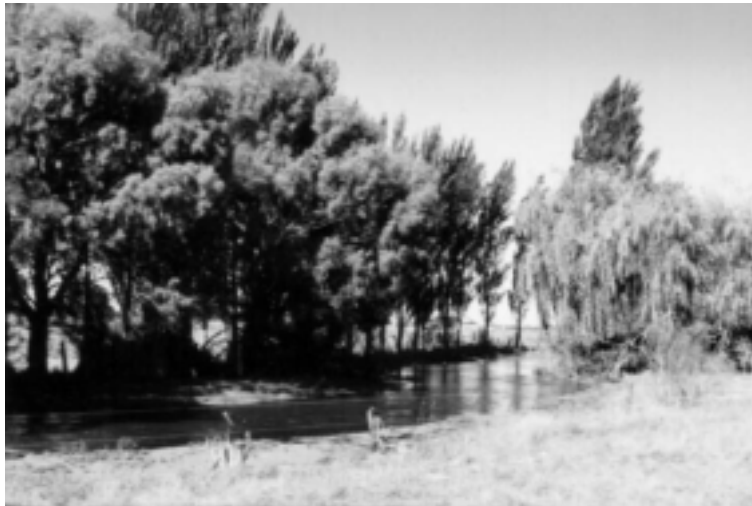
**Photograph 18:**  
Blocks of trees on the northern side of a stream can be quite effective at providing shade to the stream.

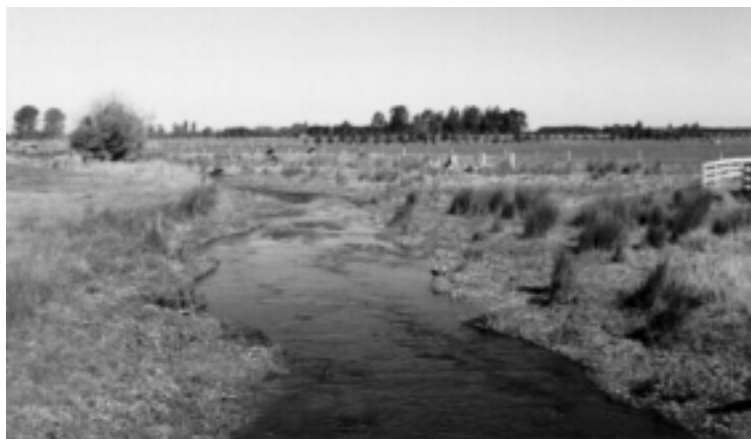
**Photograph 19:** Fenced off stream margin under grazing by young cattle. Occasional light grazing of riparian margins may serve to maintain a thick grass sward but grazing should be light and at times when the grass is least needed as a filter to surface runoff. In these cases it is recommended that stock be excluded from the stream water itself by temporary electric fencing.

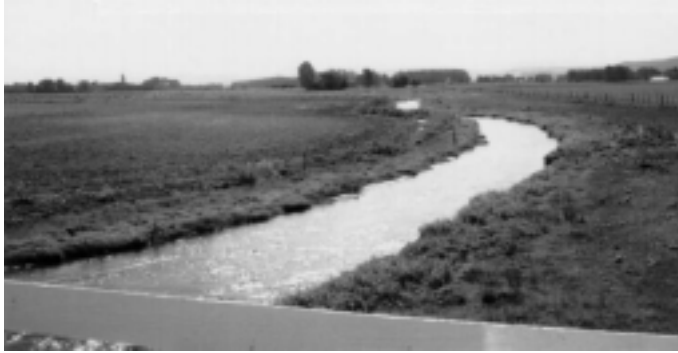
**Photograph 20:** Recently cultivated margins of Waikakahi Stream. Note small earth mound (bundling) along the left of the stream (also on the right), created to reduce direct runoff from paddocks to the stream.

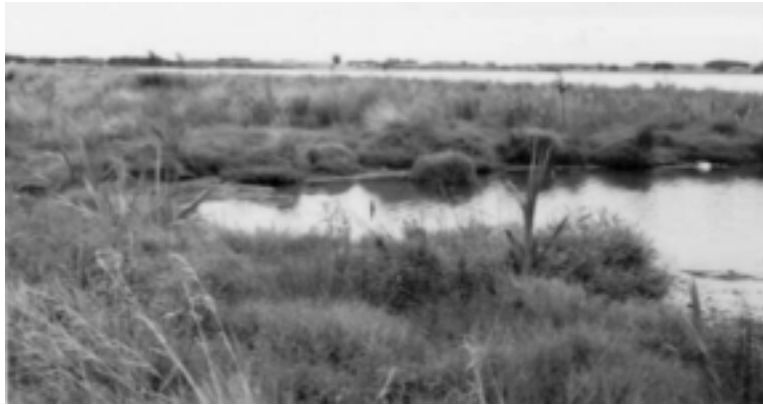
**Photograph 22:** Planted flax, some of the 100,000 planted in recent years, beginning to emerge above the lake margin grasses.

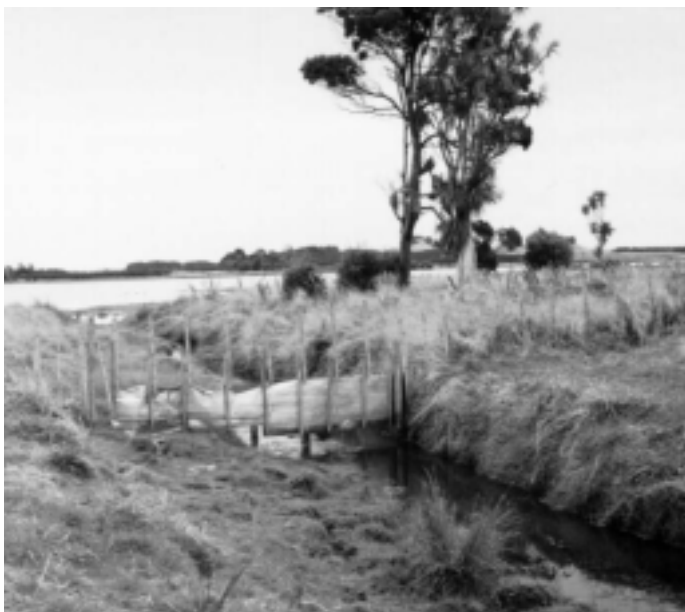
**Photograph 24:** Lake outlet of Patiki Stream. Only the last few metres are currently fenced from stock.

If the Patiki channel could be filled in for some of the last portion of its journey to the lake and the water encouraged to fan out over a wider area the grasses, sedges and flax growing over the lake margin would further slow the speed of water and filter and trap the sediment, nutrient and faecal particles before they reached the lake (as has been described above). This would require the retirement of some of the privately owned pastureland through which the stream flows, but would have the added benefit of protecting the cabbage tree stand from further physical damage.

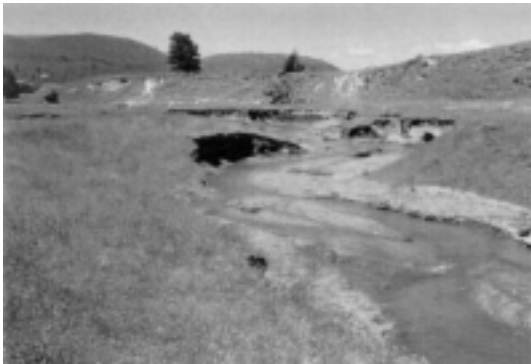
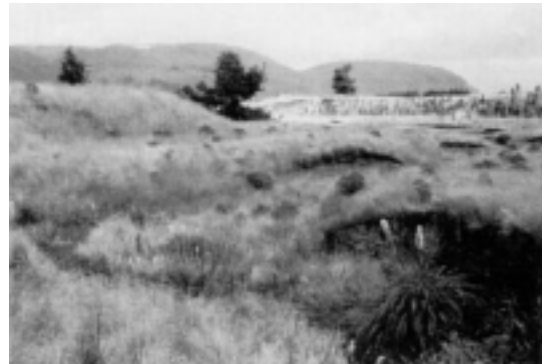
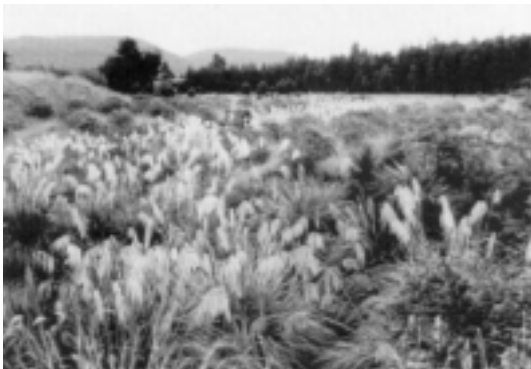
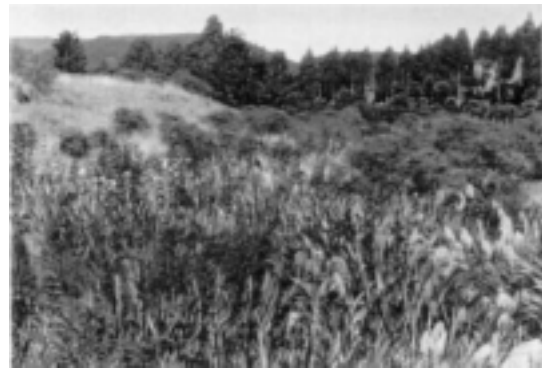
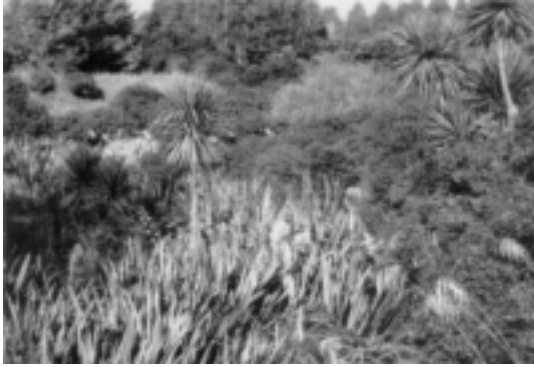
**Photographs 25–29:** Changes in the Whangamata Stream 1974–98. The photographs were taken standing on the Whangamata Road Bridge looking downstream over Section B (the 1974 photograph was taken from just to the left of the road bridge).

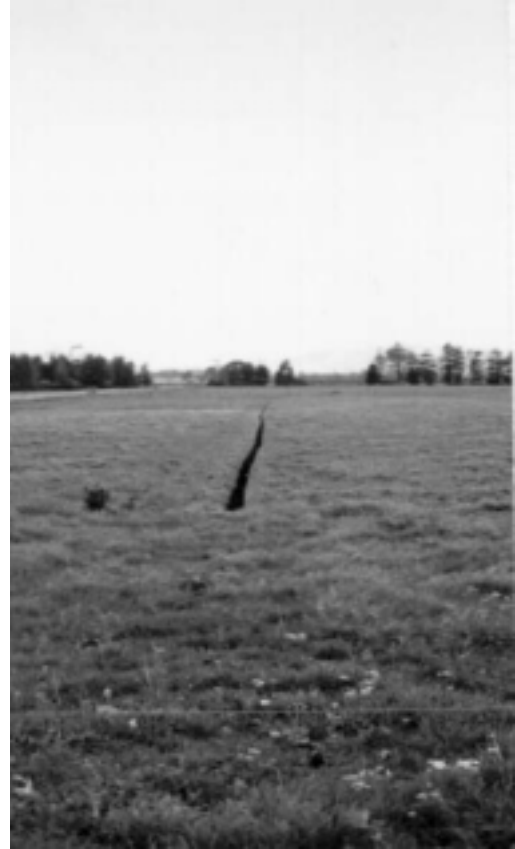
**Photograph 30:** Freshly cleared “spinner ditch” on the property of JD and RD Wallace. The spinner ditch sits at the lowest point of the 30 metre wide hump and hollow contours, and functions most effectively when it is kept shallow.

Hump and hollow contouring of paddocks encourages surface water and groundwater to move to the hollowed portions of the paddocks from where shallow spinner drains carry water to the larger secondary and main drainage systems. The hollows do not need to be fenced from stock but to prevent pasture damage from pugging it is important that the spinner drains are well maintained.

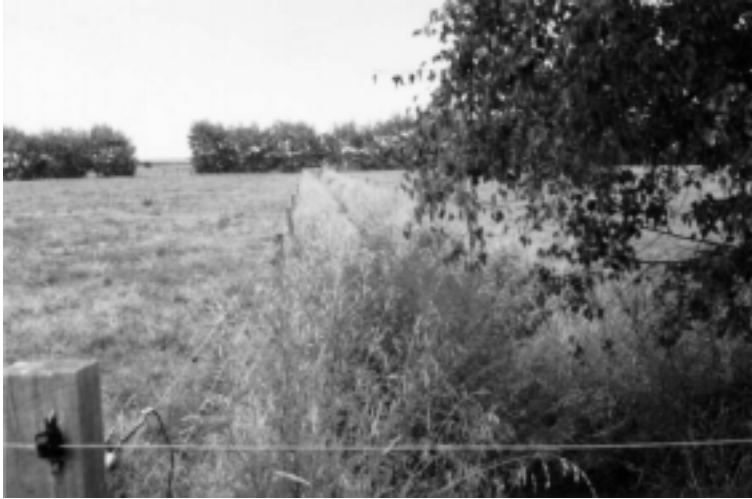
**Photograph 31:** Well fenced drain on Peter Buckley's property. Peter has planted shelter trees along the northern side of some of his drains which has reduced the amount of nuisance weed growth within the drains, probably as a result of the shade provided.

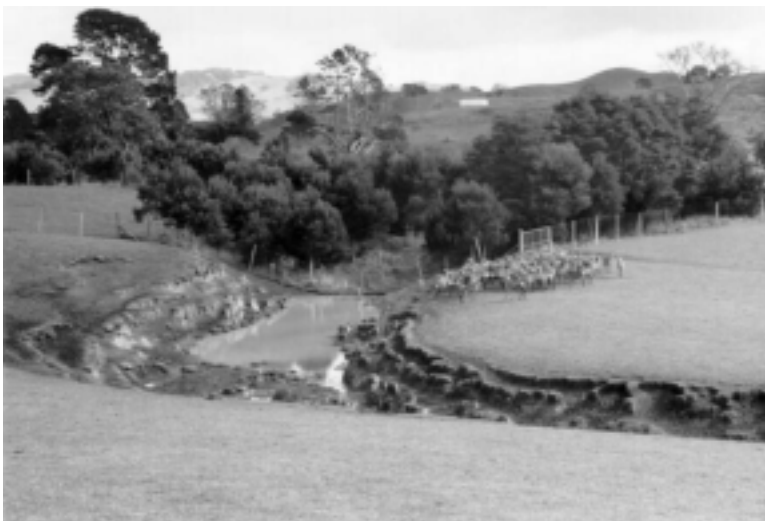
**Photograph 33:** This winter spring-fed depression has been cut out by deer and now generates a substantial sediment load each winter. On this Waikato property a wide (80–100 metre) grassy, permanently fenced riparian margin with thinned blackwoods above effectively traps most of the sediment, although in heavy rain the sediment load reaching the adjacent stream is significant.

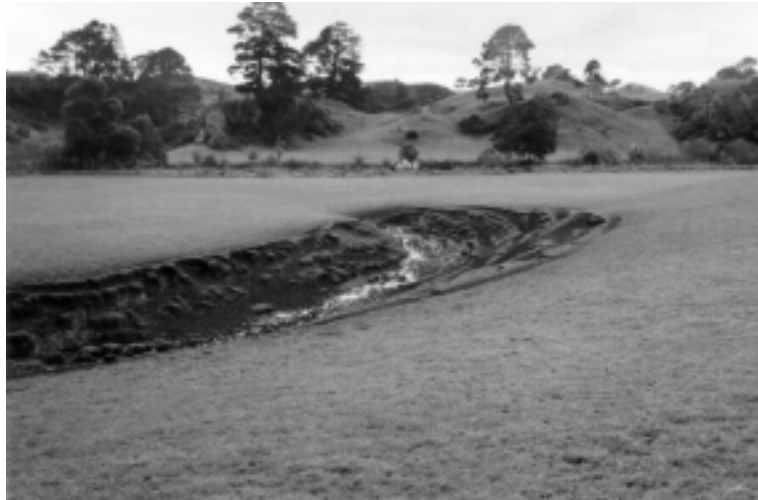
**Photograph 34:** Deer can cause extensive pasture damage and promote soil erosion when they are given access to waterways, saturated soils, springs and other areas where water accumulates. *(Photograph supplied by the Southern Regional Council.)*

Damage of this nature can be substantial – it can be extensive in area and significant in terms of its impact on pastures and waterways.

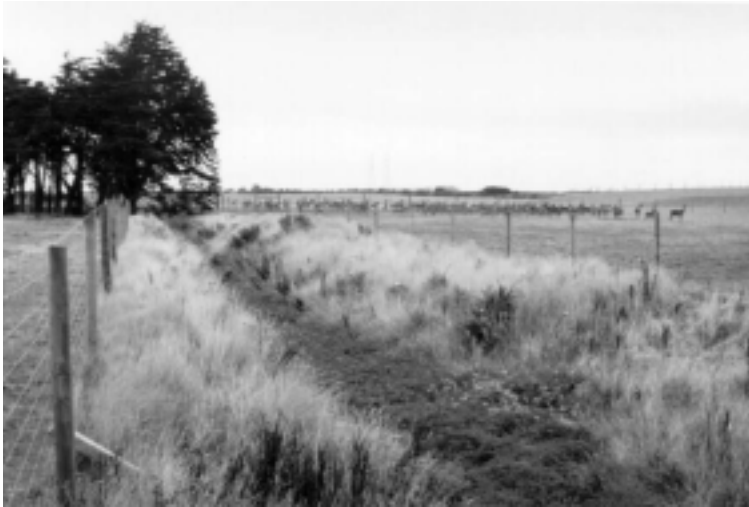
**Photograph 35:** A wide, well-fenced riparian filter strip on Trevor Manson's farm in Southland. One side has been planted with a row of tree seedlings for timber and shelter. Note the in-channel weed infestation. While the weed may promote some flooding, it serves well to strip the water of nutrients during summer in particular. This channel has the appearance of a drain, but as is typical of many parts of lowland New Zealand, this is a naturally occurring stream that has been stripped of its riparian vegetation and straightened to expedite water flow.

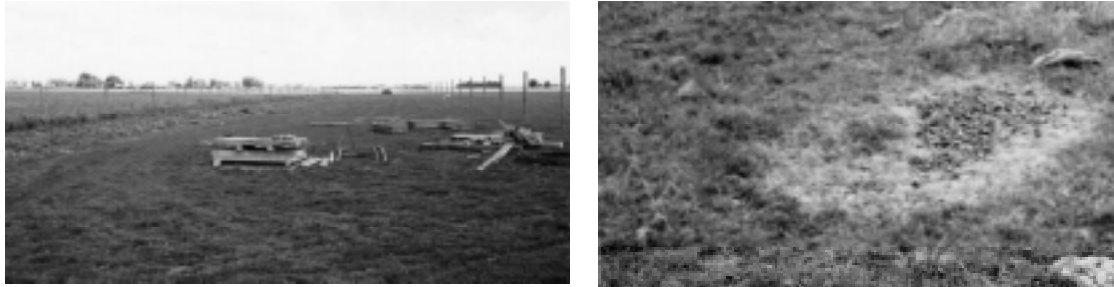
**Photographs 36 and 37:** Neville Cunningham is experimenting with 30 metre wide races on his deer farm near Winton. A double fence on the left of the drain/stream (on the left of the picture) protects a tree row. Neville's intention is to use the race for short-term grazing. Gravel-filled soakage pits such as that shown below are located in the race to collect and channel away surface runoff before it can accumulate.

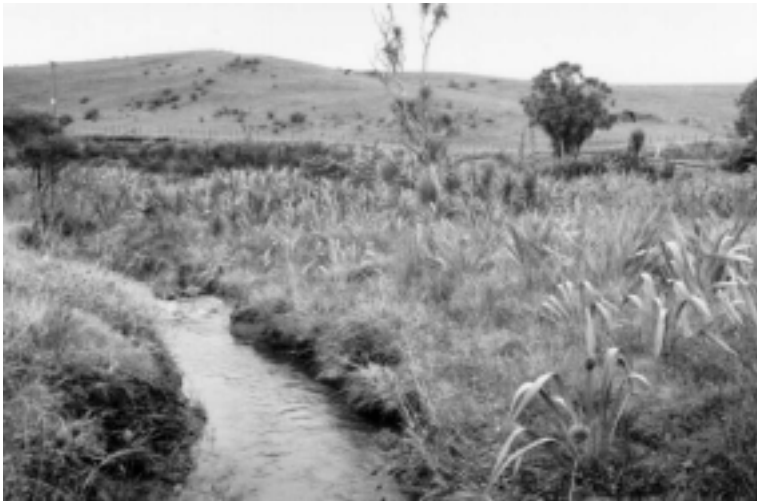
**Photograph 38:** The Wainui Stream now flows through a wide, revegetated riparian zone. Flax, cabbage tree and other native riparian species now occupy the land along its entire length. Five years ago it was grazed pasture to the water's edge.

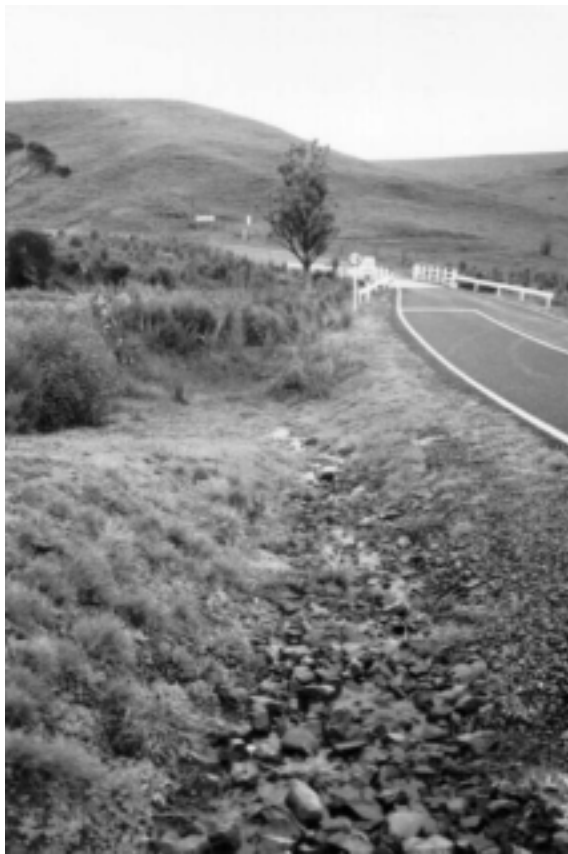
**Photograph 40** Whaingaroa Harbour Care has also exerted its pressure on the local district council to improve its stormwater runoff. Here a gravel lined drain channels runoff through a grass and flax filter before the water enters the stream.

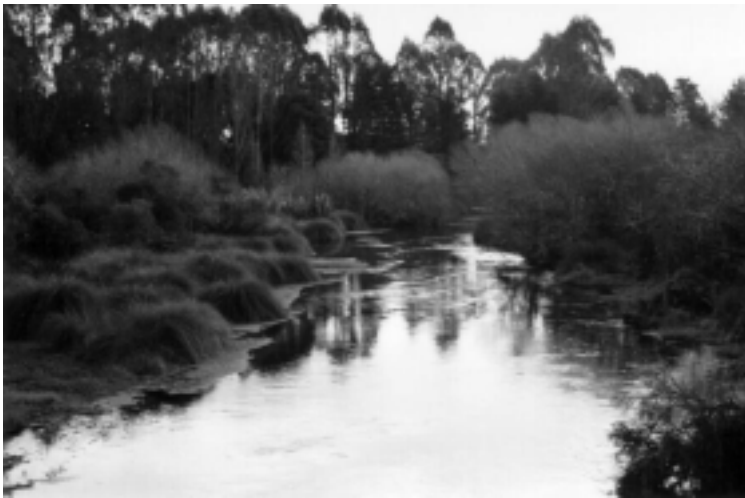
**Photograph 41:** Government-funded catchment schemes led to substantial riparian retirement and revegetation in the 1970s and this has greatly reduced the levels of erosion and sediment transport. Reporoa Basin rivers such as the Torepatutahi are now protected by extensive plantings of willow in the channel and exotic timber species on the flanks.

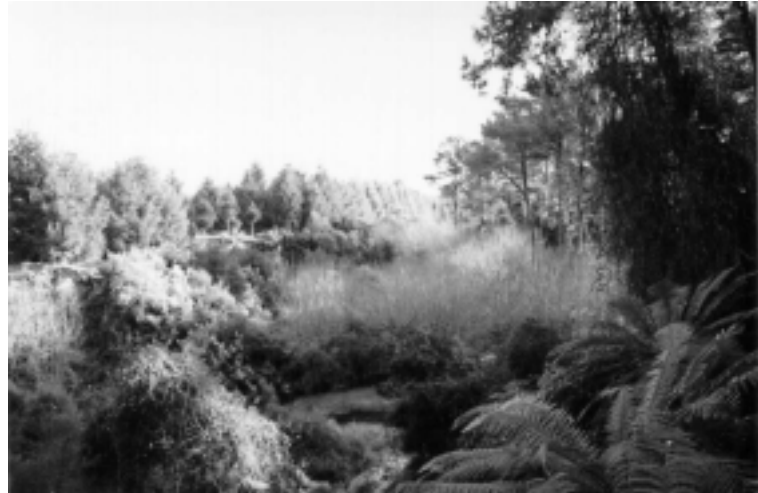
**Photograph 42:** While the initial willow and poplar performed well to stop much of the in-channel erosion, they are now the cause of some problems. Some of the plantings are now showing signs of senescence and are collapsing onto fences and congesting stream channels. Their removal will require considerable effort and expense.

Some of the willow and poplar plantings are now showing signs of senescence (due to leaf rust) and are collapsing onto fences and congesting stream channels. The willow and poplar stands have remained largely untended which has accentuated the degree of stand degradation. Both willows have proved to be the most short-lived and are now causing the greatest problems, collapsing and blocking channels. Their removal will be required in several areas to reduce the likelihood of flooding and increased bank erosion.

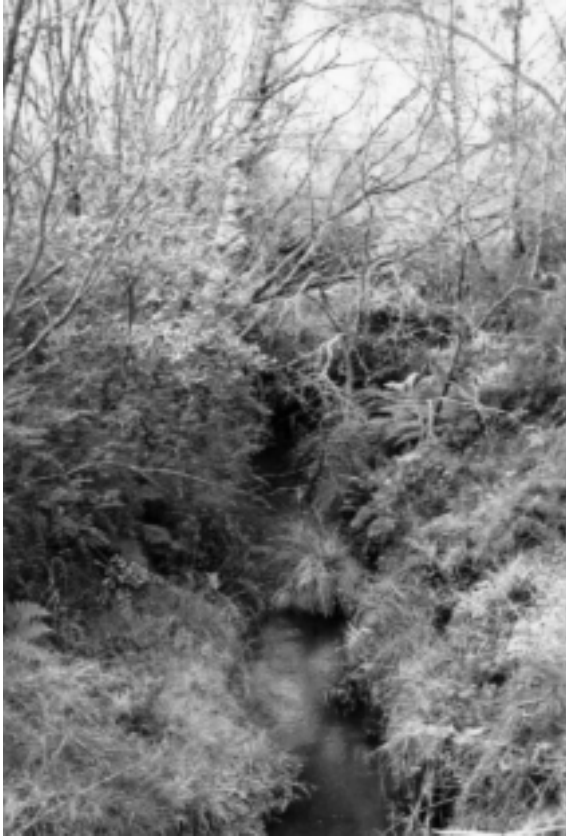
**Photograph 43:** Fifteen to 20 years after the streams were retired and planted in exotic tree species, native shrub and tree species are now gradually starting to appear under the willow canopies. The Reporoa Basin experiences very hard frosts and many attempts to establish native seedlings in the open have failed. The more open canopies of the senescing willows appear to provide favourable habitat for native colonising species.

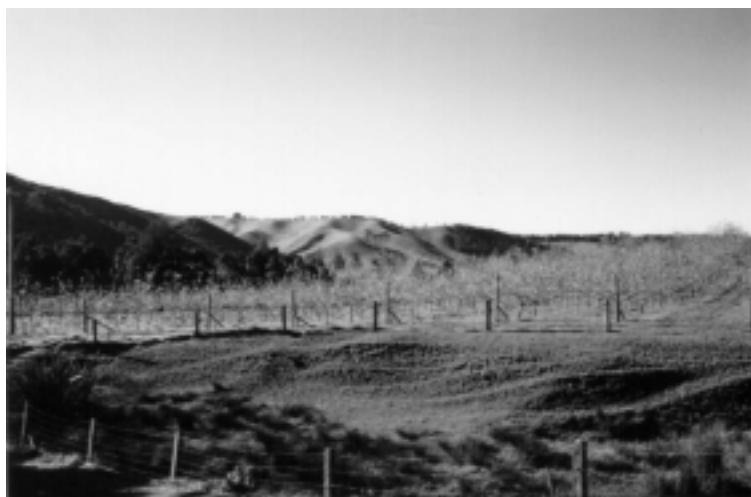
**Photograph 45:** Across-contour tree rows and the application of heavy fertiliser dressings on the ground beneath the trees increases the risk of fertiliser loss by surface runoff and subsequent contamination of stream water. Pesticides may also be carried to streams by surface runoff. With-contour tree rows and grass filter strips along stream margins can reduce the likelihood of water contamination.

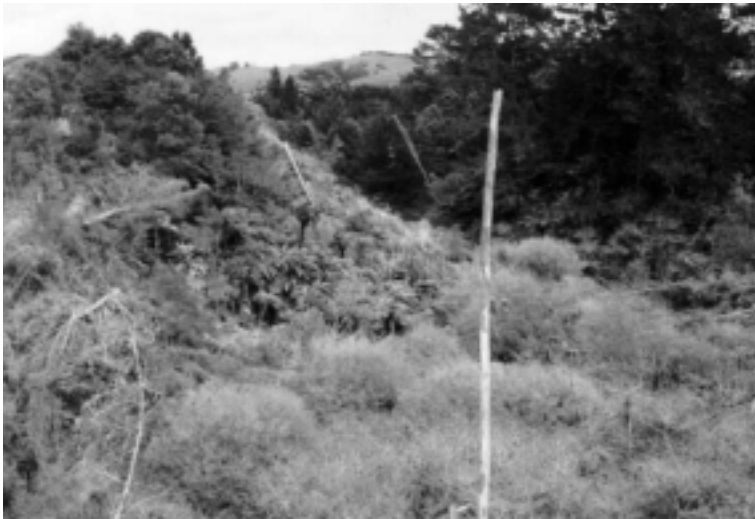
**Photograph 46:** Much of the valley floor was covered with willow and old man pine trees. The willows were cut, stacked and burned. The pines were felled, cut into segments and left to rot on the forest floor, providing much needed organic matter to the soil.

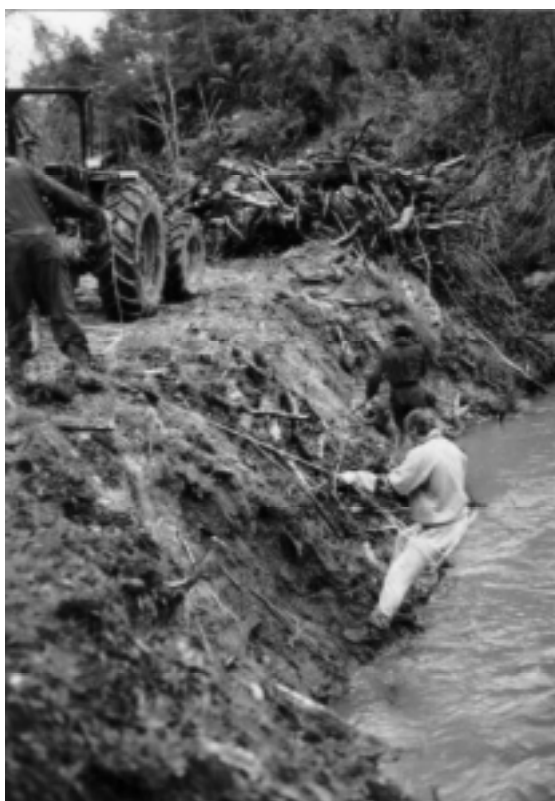
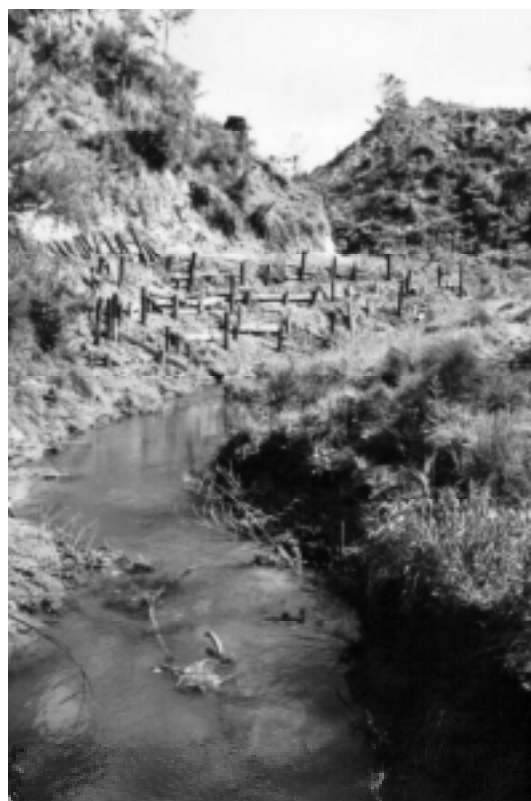
**Photographs 47 and 48:** A variety of practical techniques were tested to improve the ease of planting and its likelihood of success. **Photograph 47:** The steep river banks and rapidly fluctuating stream flow required careful species selection and improvisation. *Carex secta* was used almost exclusively on steep banks within the flood zone because of its capacity to withstand flooding. **Photograph 48:** Horizontally and vertically placed fresh ponga logs and imbedded horizontally placed blackwood logs were used to anchor a collapsing segment of stream bank. Fifty percent of the ponga logs regenerated and their fibrous root systems will serve well to repel the stream in the future.

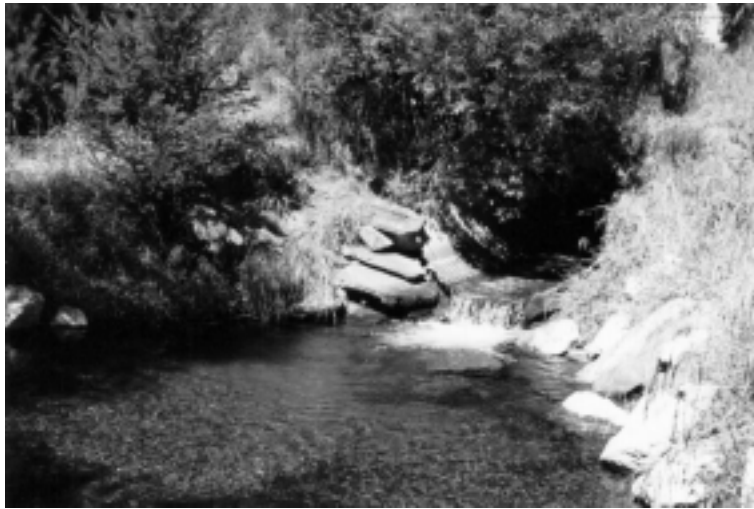
**Photograph 50:** Bridges and culverts reduce sediment contamination and streambed disturbance but should be constructed in such a way that allows aquatic fauna to pass up and downstream freely. Sediment traps on the approaches to bridges and culverts will reduce the amount of sediment reaching the stream.

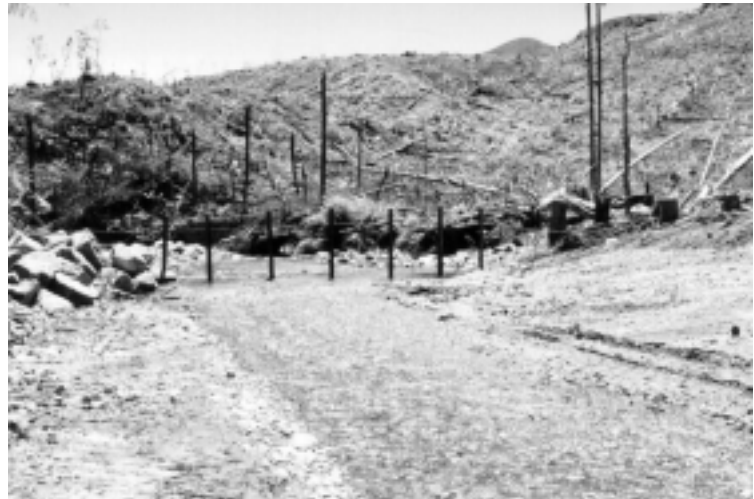
**Photograph 51:** Logs and debris can cause serious problems when carried downstream, especially in steep catchments and with high and intensive rainfall as is the case in the Coromandel Peninsula. Lengths of railway track have been driven into the streambed at 1–3 metre spacings and have been connected with steel cabling to intercept and hold any large debris floating downstream during floods. Diggers periodically clear the structure of snared debris.

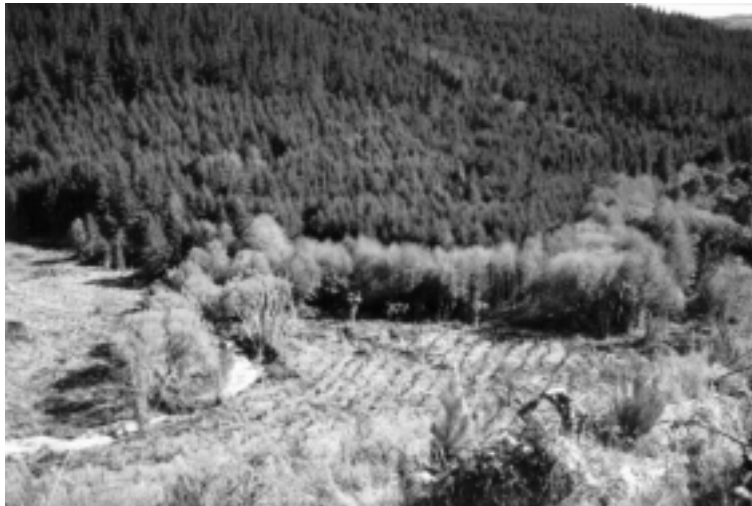
**Photograph 52:** The retention of a margin of native or exotic riparian vegetation wherever possible is recommended to provide shade to the stream and a buffer to forestry operations on the surrounding land. Weyerhaeuser forests, Nelson.

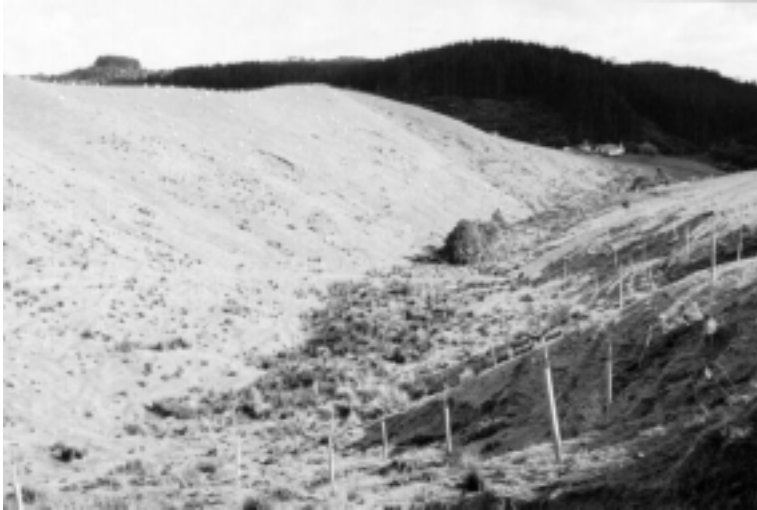
**Photograph 55:** Gently sloping valley bottoms such as this one in the Hays Creek catchment are ideal for trapping sediment and phosphorus and slowing down the speed of water flow provided the valley bottom is fenced from stock and allowed to develop a thick growth of weeds and rushes. The near face has been recently planted with poplars to stabilise the soil erosion.

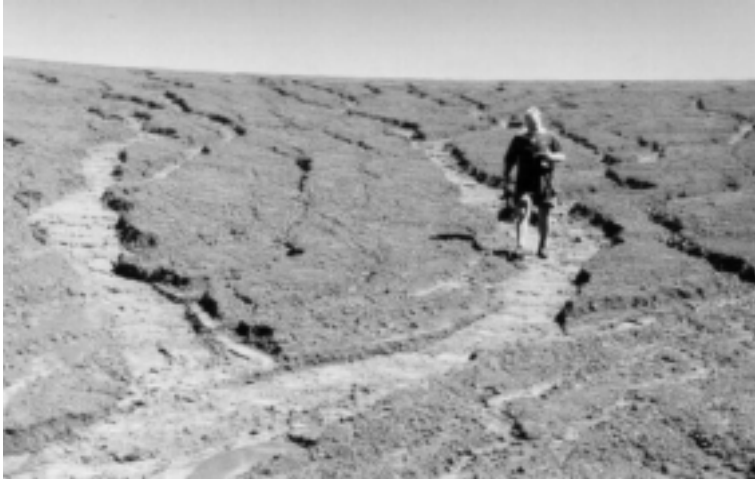
**Photograph 56:** Deep scouring on a 10° slope near Bombay following the January 1999 storm. Note that the soil has been eroded down to a soil pan created by repeated tillage. (Photograph supplied by Tony Thompson, ARC.)
