# **Managing Waterways on Farms**

**A guide to sustainable water and riparian  
management in rural New Zealand**

Published in May 2001 by  
Ministry for the Environment  
PO Box 10-362, Wellington, New Zealand

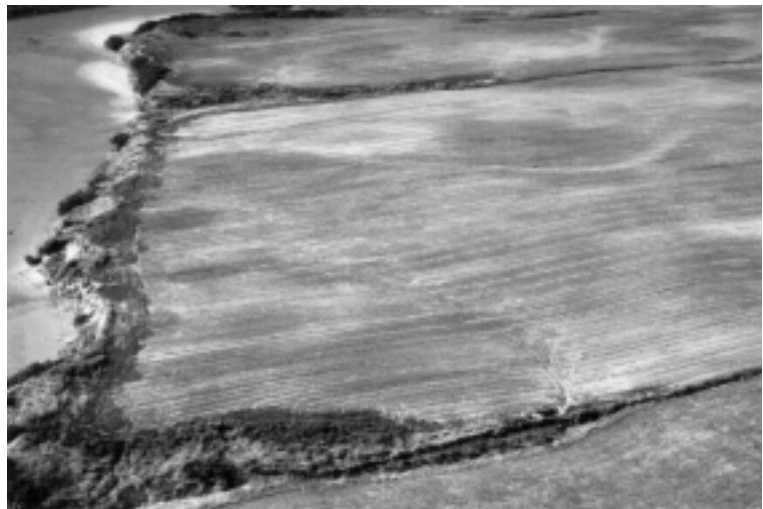
**Photograph 57:** Large-scale cultivation virtually to the edge of the Manukau Harbour and its tributary drains and streams can result in very high sediment loadings into the harbour during rain. Note the narrow area of bunding and no cultivation along the harbour edge. This will be preventing some sediment entering by this route. However surface runoff is clearly passing directly into the side stream where there is no bunding.

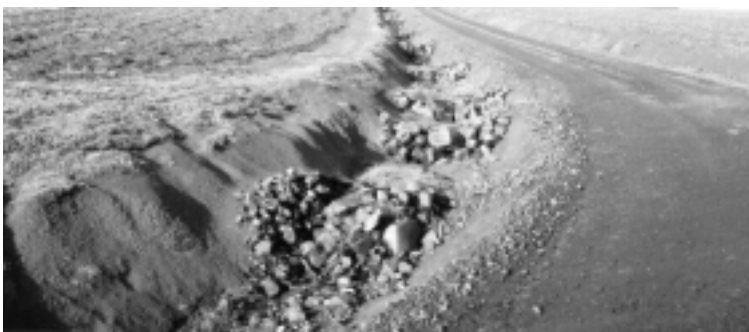
**Photograph 58:** Silt traps on AS Wilcox & Sons’ property near Mercer. Silt traps of this nature work well in trapping sediment and slowing down water flow, *provided* they are regularly maintained and emptied of accumulated soil.

AS Wilcox & Sons has installed a network of silt traps for trial at its Mercer property. While this practice does not reduce soil loss from the cropping area it is likely to reduce sediment levels reaching the stream below. Sediment traps such as these require regular maintenance (ie, removal of sediment) in order to function properly. Wilcox has also installed a large pond as a silt trap at the base of its property and planted the banks of a feeder stream with native flax, *Carex*, and native trees and shrubs.

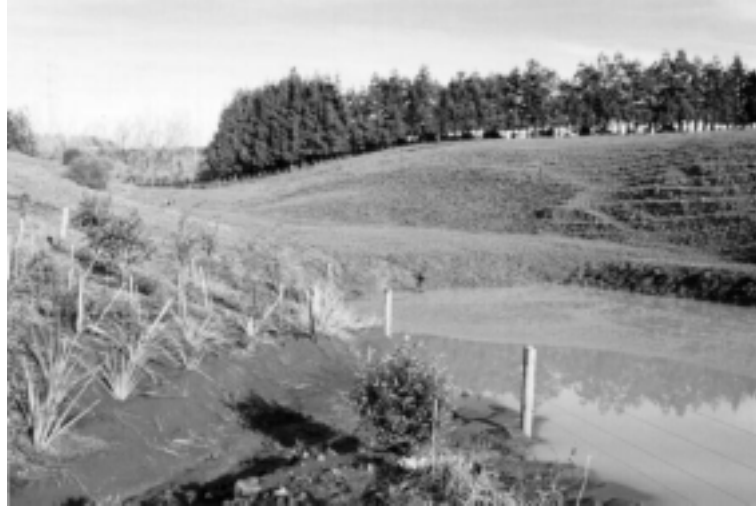
**Photograph 59:** Sediment ponds such as this one at AS Wilcox & Sons can effectively trap much of the sediment lost from the productive areas. While sediment traps and ponds are effective management tools, they do not prevent the erosion of soil from productive land. Management practices which lead to the prevention of soil loss are most needed in the Pukekohe vegetable growing area.

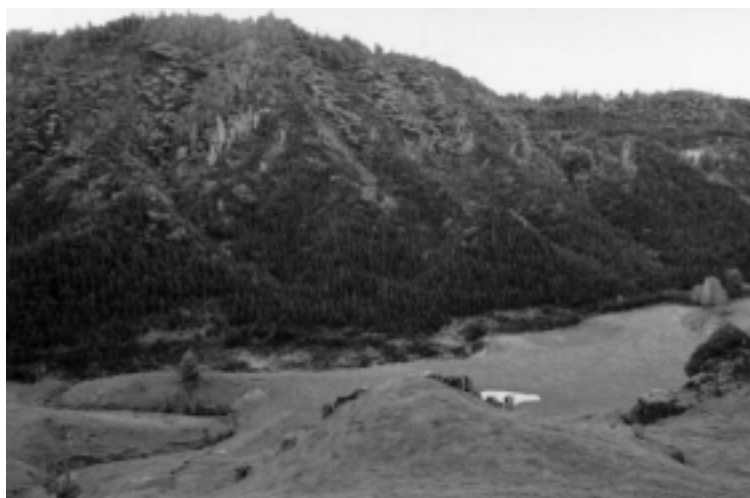
**Photograph 60:** Chris Kay has planted over 200 ha of his retired land in pines for later timber harvest. Chris will receive all of the proceeds from the timber harvested in return for retiring the land from grazing, paying one-third of the establishment costs and all of the fence maintenance and silviculture costs.

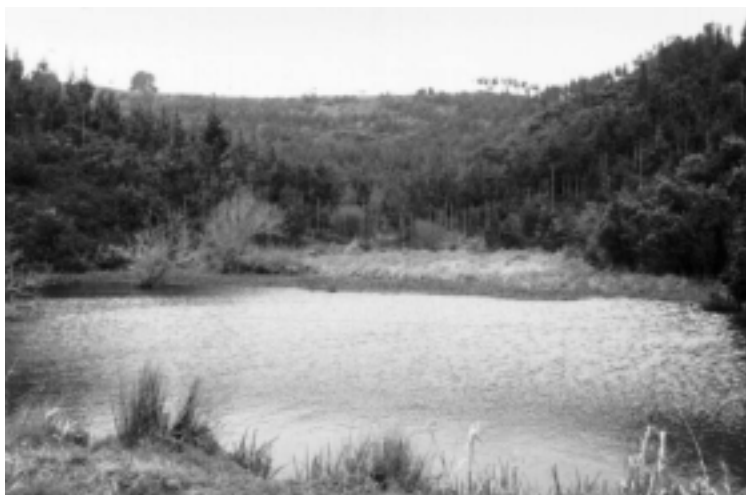
**Photograph 61:** Chris Kay has constructed this retention dam at the base of a valley to trap sediment washed in surface runoff and reduce the velocity of runoff during heavy rain.

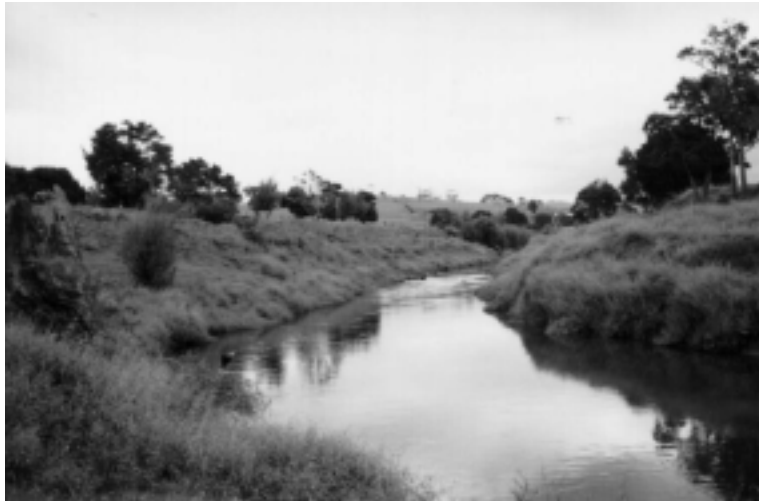
**Photograph 63:** The Mangakahia River, Northland. An entrenched, steep banked and erosion prone river channel that is largely devoid of riparian vegetation and prone to frequent flooding.

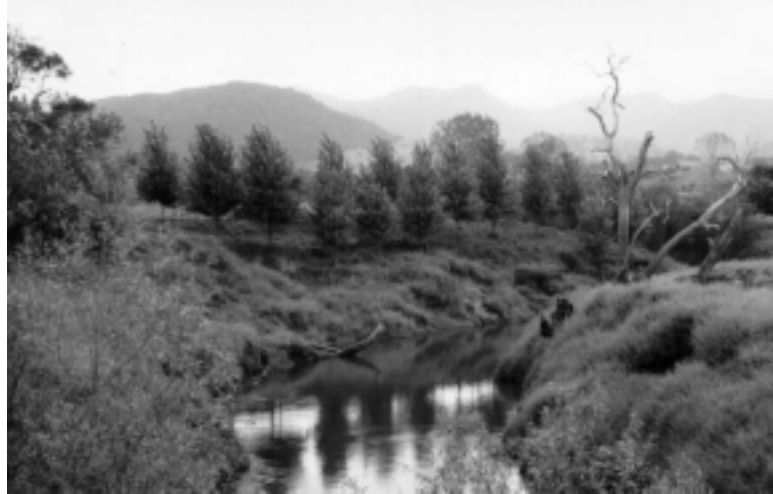
**Photograph 64:**  
Riverbank and slump erosion are significant management problems for the Frasers.

The actions of vegetation removal, cultivation, livestock and surface runoff carrying sediment, both on the farm and from upstream, have led to an accumulation of sediment in the channel causing it to narrow. Research suggests that if it was possible to eliminate all or most of the sediment input from upstream then the river would gradually widen its channel by carving out the accumulated sediment from the river banks and carrying it downstream and out to sea. In catchments where forestry is being established in the upper catchment and riparian retirement is occurring on the farmland the volume of sediment entering the river system is becoming considerably reduced. This in itself is a good thing but the side effect is that in a low sediment input regime the river will attempt to revert to its old wider channel shape and will erode away increasing amounts of silt from the banks. This is likely to become an increasingly common occurrence on farmland where efforts to improve water quality are taking effect.

The river bank erosion is likely to be more pronounced alongside the Fraser property because of the lack of any tree or shrub cover to anchor the bank sediment. Weeping willows used to occupy the channel but they mysteriously died. Now it is extremely difficult to establish any vegetation because of the regularity and extent of flooding. Even fast-growing poplars and willows struggle to anchor the loose sediment in time to withstand the next flood. Sediment anchoring trees are most required on outside bends where erosion is greatest, but of course, this is where the plants have the greatest problem remaining anchored.

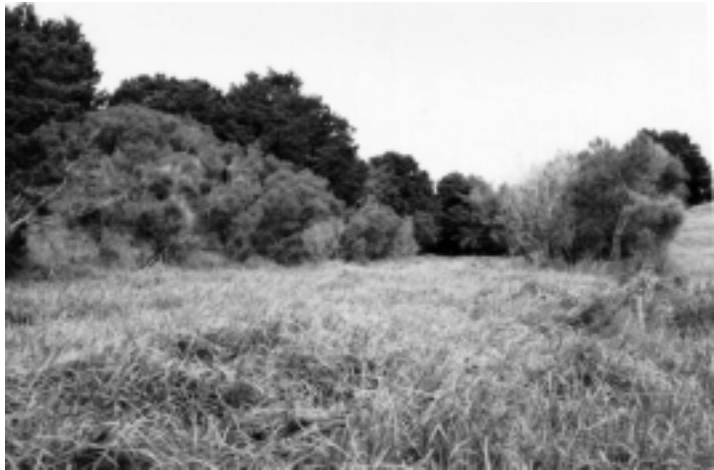
**Photograph 66:** Large, flat, grassy wetlands such as this are excellent processors of nutrient and sediment. Much of the nitrate entering this wetland will be converted to atmospheric nitrogen by the process of denitrification, and the thick vegetation will slow down the speed of flowing water allowing sediment particles to settle out. Andrew Fraser has installed subsurface drainage on his river flats to increase pasture utilisation during the winter. The drains feed directly to the river carrying nutrients, sediment and faecal bacteria with them. If the subsurface drains could instead feed into the wetlands, few of these contaminants would then reach the river.

Andrew has fenced off a remnant block of native bush and a wetland area on his property. On the rest of his flats he has installed a network of novaflow drainage piping in an attempt to reduce the tendency for pugging and pasture damage in the winter. The new drainage appears to be working well but the drains have their outlets at the river bank, by-passing the wetland areas and feeding nutrient and sediment rich water directly to the river. If the drainage pipes could feed to the wetland or at least to a surface drain before entering the river there would be some opportunity for the wetland vegetation to filter and absorb the nutrients and sediment before the water enters the river.

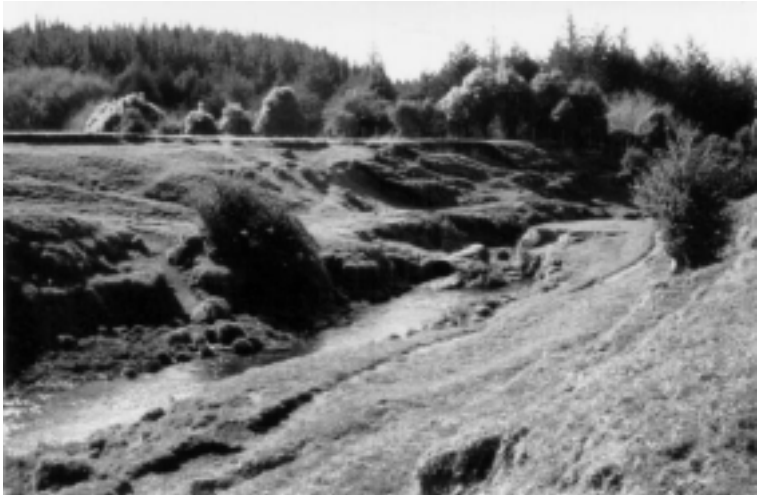
**Photograph 67:** Most of the Ngongataha Stream margins have been retired as part of the Upper Kaituna Catchment Control Scheme. Much of the stream's margins looked like this small unfenced portion prior to the commencement of the scheme. Note the straight stream channel and the unstable steep banks. Compare this to Photograph 64, a reach of the same stream not more than 100 metres away that has been fenced for many years.
