# **He Pataka Wai Ora Methods and Results**

He Pataka Wai Ora Project Team (Kāti Huirapa Rūnaka ki Puketeraki / University of Otago)

This document contains the methods and results from the He Pataka Wai Ora Project and will be updated as further information becomes available.

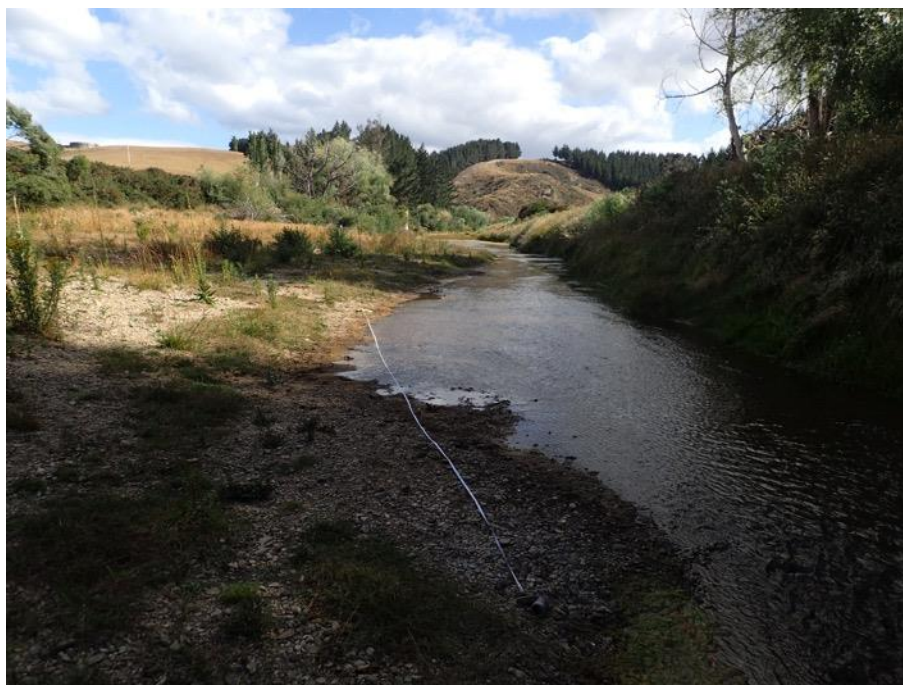
*Figure 2: Ten metre transect line along the Waikouaiti River indicating the sampling area for site characteristics and the wider ecological survey.*

Ten-metre transects along the river, encompassing the entire width of the river, were established at each sampling site (Figure 2). Photos were taken of each site at three different points along the transect: upstream, the cross section and downstream. The stream bed composition (substrate type), was estimated at freshwater and estuarine mahinga kai sites using a modification of the 'Wolman walk'. The surveyor walked down the 10 m strip of the river and at 10 haphazardly chosen points the substrate type was recorded. Substrate types were classified according to categories defined in the SHMAK manual: bedrock, boulders (> 25 cm), large cobbles (12 – 25 cm), small cobbles (6 – 12 cm), gravels 0.2 – 6 cm, sand, mud/silt, man-made, woody debris, water plants (rooted in stream bed; Biggs *et al.* 2002).

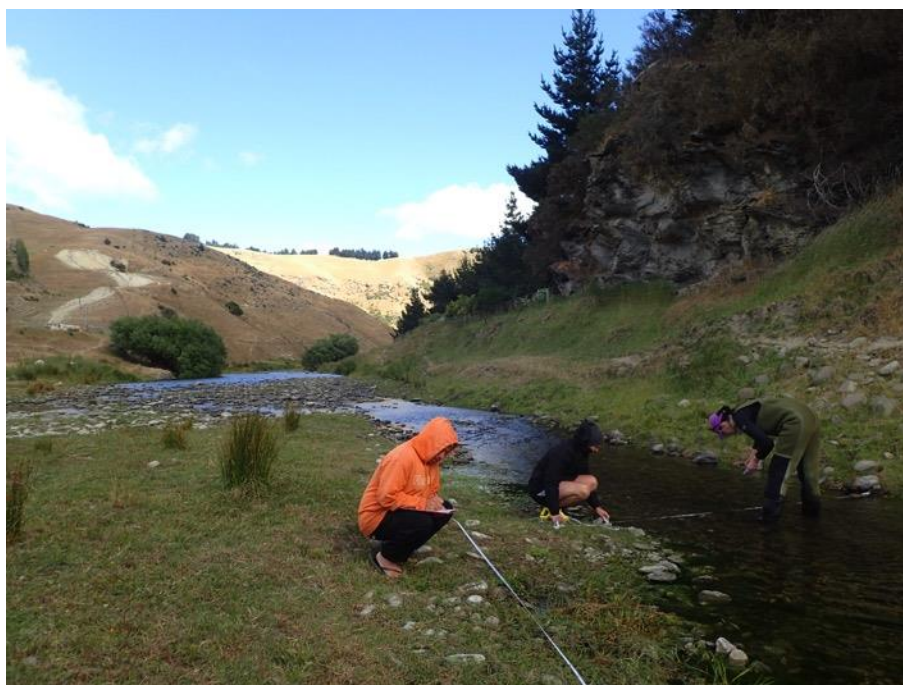
*Figure 3: Measuring the width of the river at the upper end of the 10m transect line.*

River width (m) and depth (mm) were measured at wadeable freshwater sites only at 0, 5 and 10 m along the transect line. Depth measurements were taken at the true left (the left side of the river when facing downstream), centre, and true right (the right side of the river when facing downstream), with width measurements taken between wetted edges (Figure 3).

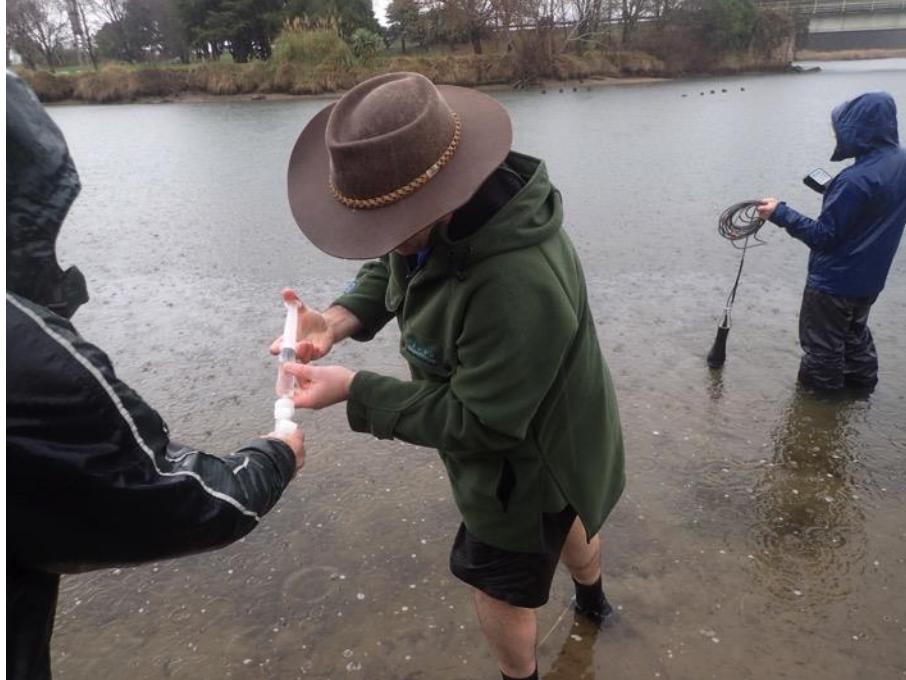
*Figure 4: Taking water samples for nutrient analysis (foreground) and using a multiparameter probe to measure the physical and chemical parameters (background) within the Waikouaiti River.*

Temperature ( $^{\circ}\text{C}$ ), pH, conductivity ( $\mu\text{S}/\text{cm}$ ) and dissolved oxygen ( $\text{mg}/\text{L}$ ) were measured using a multiparameter probe (U-50 Horiba; Horiba Instruments Incorporated, Irvine, USA). The multiparameter probe was lowered upright into the river, perpendicularly to the river flow, in areas of undisturbed flowing water (Figure 4). If there was low or no flow at a site, the multiparameter probe was moved through the water to avoid localised depletion of dissolved oxygen. The multiparameter probe remained in the water until the parameter values stabilised and five measurements were taken; the average of these measurements was recorded. The U-50 Horiba was calibrated to a marine environment for conductivity. When the U-50 Horiba was unavailable, a YSI 6600 V2 Sonde multiparameter probe (YSI Incorporated, Ohio, USA) was used instead. At the freshwater sites conductivity was also measured with a portable conductivity meter (TDSscan 3, Eutech). This provided a second measure of conductivity and is a low cost option compared the U-50 Horiba.

At each site, three replicate water samples were taken using a Luer-lock syringe and then filtered on-site using a Whatman GF/C glass microfiber filter in a 25 mm Swinnex filter holder (Figure 4). Before use, the equipment was all acid-washed (10% HCl) and prior to sampling, was rinsed with 30 ml of water from the site. The three samples were filtered into 25 ml acid-washed tubes, placed in a chilled bin with icepacks and then frozen immediately on return to the field station (<3 hours) to be analysed later at the laboratory. Analysis of water samples was done using a QuickChem 8500 Automated Ion Analyser (Lachat Instruments, Milwaukee, USA). Nutrients of interest were nitrate ( $\text{NO}_3^-$  and  $\text{NO}_2^-$ ), ammonium ( $\text{NH}_4^+$ ), and phosphate ( $\text{PO}_4^{3-}$ ). Nutrient concentrations were reported as  $\text{mg}/\text{L}$  of Total Oxidised Nitrogen ( $\text{NO}_x$ ), Ammoniacal Nitrogen ( $\text{NH}_4$ ) and Dissolved Reactive Phosphorus ( $\text{PO}_4$ ), these categories correspond to those reported by Land Air Water Aotearoa (LAWA; <https://www.lawa.org.nz/>).

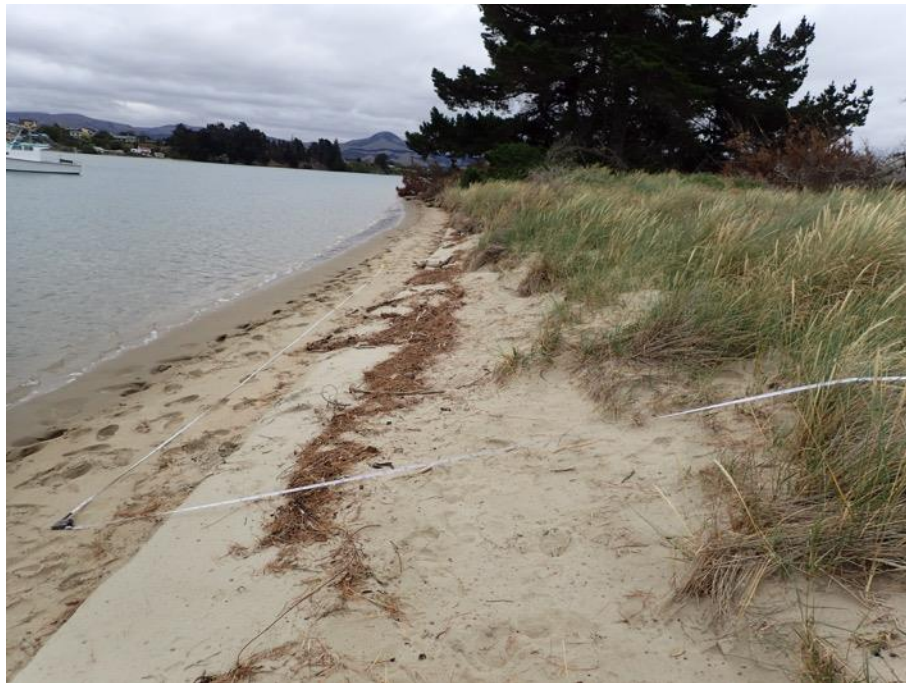
*Figure 5: Riparian vegetation survey within a 10 m x 10 m area carried out along the Waikouaiti Estuary.*

The riparian vegetation survey covered the length of the 10 m transect and a 10 m wide strip of riparian vegetation (10 m x 10 m area); this area included the stream margin transect (Figure 5). The stream margin survey area included the

length of the 10 m transect line and extended to a width of 10 cm away from the wetted edge of the river. The vegetation in this strip was identified to species level and percentage cover was recorded. The general visual survey was done by standing on the bank of the river, facing away from the river, within the 10 m x 10 m area where the riparian vegetation survey occurred. All vegetation, bare ground or artificial structures that could be seen was classified into percentage cover (to the nearest 5 %) of 10 categories. The categories recorded were native trees; wetland vegetation; tall tussock grassland (not improved); introduced trees (willow, polar); other introduced trees (conifer); scrub; short tussock grassland (improved); rock, gravels; pasture grasses and weeds; bare ground, roads, buildings (Biggs *et al.* 2002).

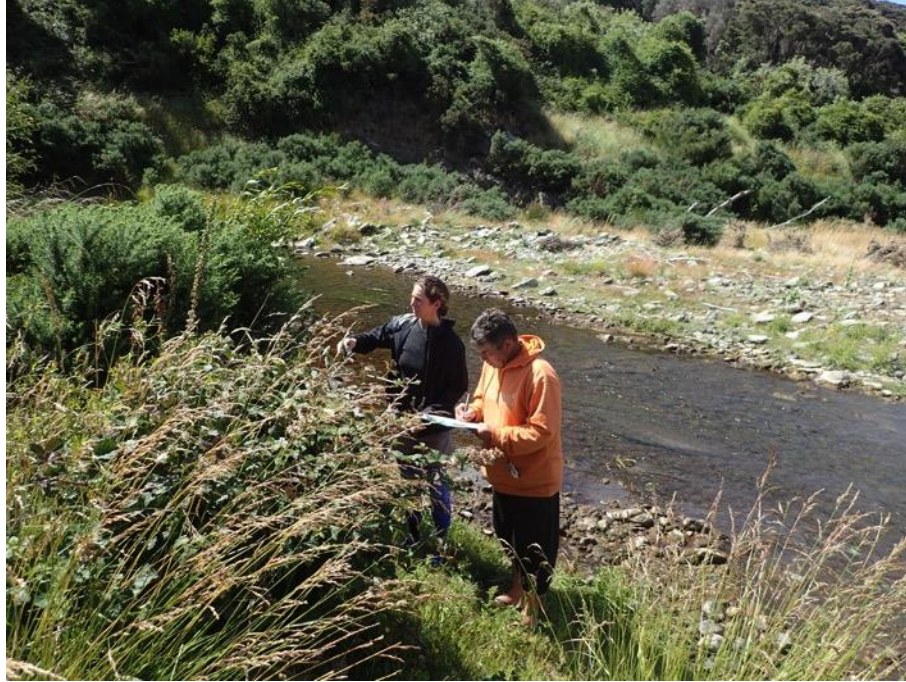
*Figure 6: General vegetation survey being conducted on the bank of the Waikouaiti River by Gretchen Brownstein and Brendan Flack.*
