EVANS FAMILY TRUST

996 STATE HIGHWAY 2, WHIRINAKI

GEOTECHNICAL REPORT

INITIA REF P-001359 REV 1

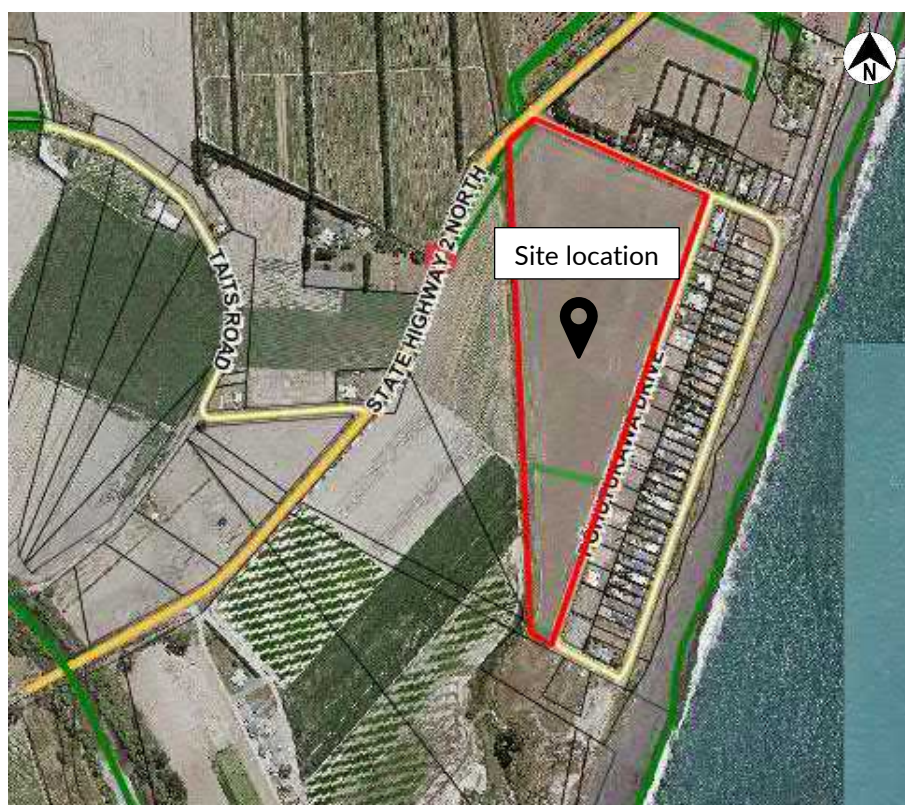
Figure 1.1: Site Location

The site is located between North Shore Road in the north, Pohutukawa Drive in the east and a large stream/drainage channel in the west.

The site is legally described as SECS 44 PT 25 BLK XII PUKETAPU SD LOT 8 DP 381095 LOT 101 DP 505383 LOT 1 DP. The area is relatively flat, with a total area of approximately 10ha. The site is currently used as farmland.

The site is surrounded by residential developments to the north and east of the site. The stream is present along the western edge of the site. The stream bank comprises clayey silt with sand lenses up to 1.0m thick.

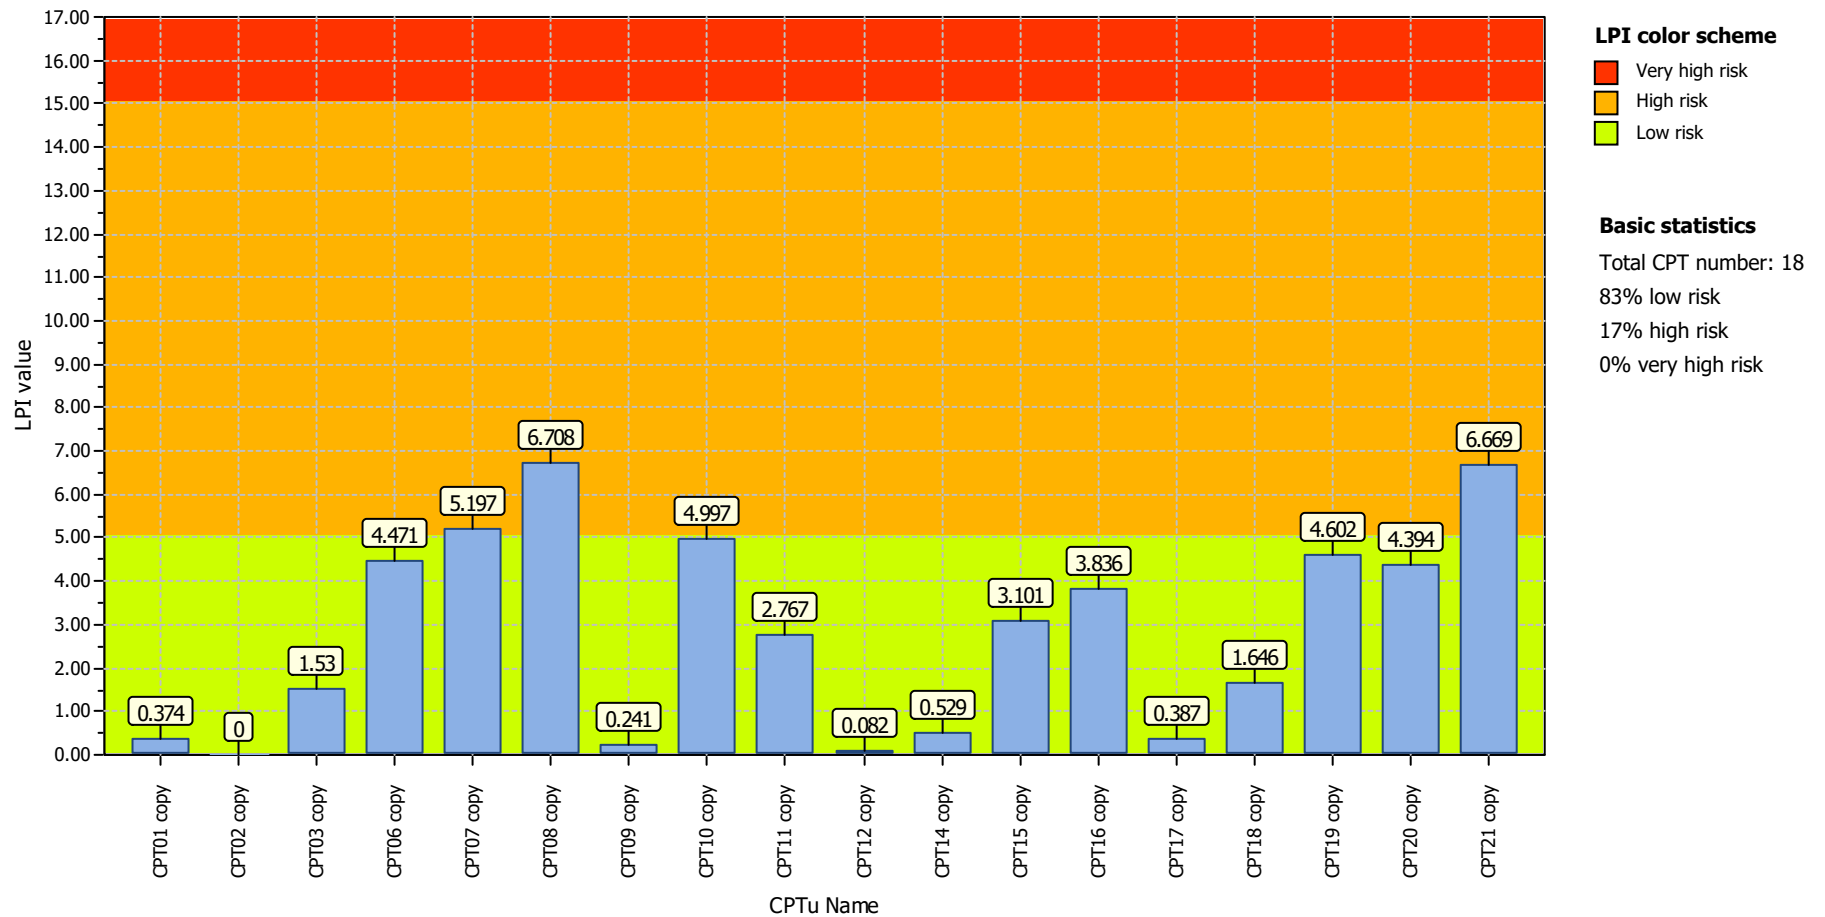
Overall Liquefaction Potential Index report
