TRIG & BRIGHAM CREEK ROAD

69 Trig Road, 151 Brigham Creek Road, 155-157

Brigham Creek Road

GEOTECHNICAL INVESTIGATION REPORT

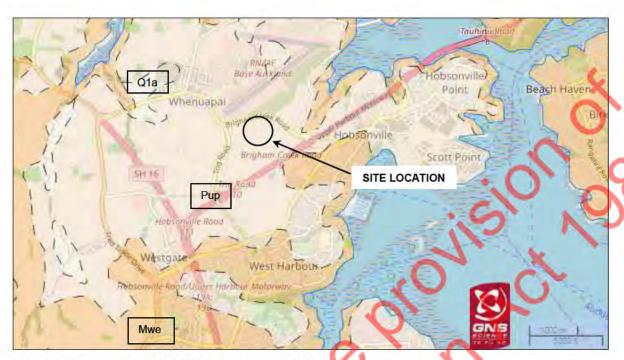
Figure 2: Regional Geology (GNS Science Geology Map)

These alluvial deposits include pumiceous mud sand and gravel with muddy peat and lignite, rhyolitic pumice (including non-welded ignimbrite, tephra and alluvial pumice deposits) and massive micaceous sand beds. Below these upper soil layers, the deeper geological formation is reported to comprise, interbedded muddy sandstones and siltstones of the East Cast Bays Formation (Mwe) within the Waitemata Group.

The main geotechnical hazards within the Puketoka Formation strata are low bearing capacity and settlement from soft/organic soils.

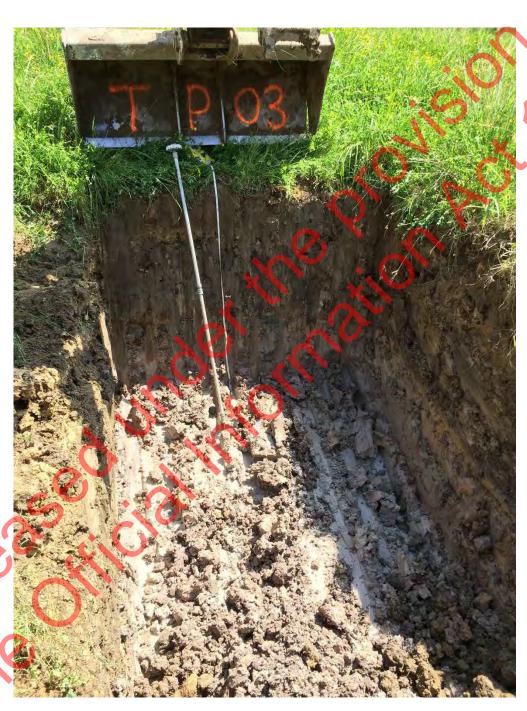
Dimensions: 3.0m x 2.0m

Termination Depth: 2.0m

Remarks: Groundwater seepage observed at 1.2m.

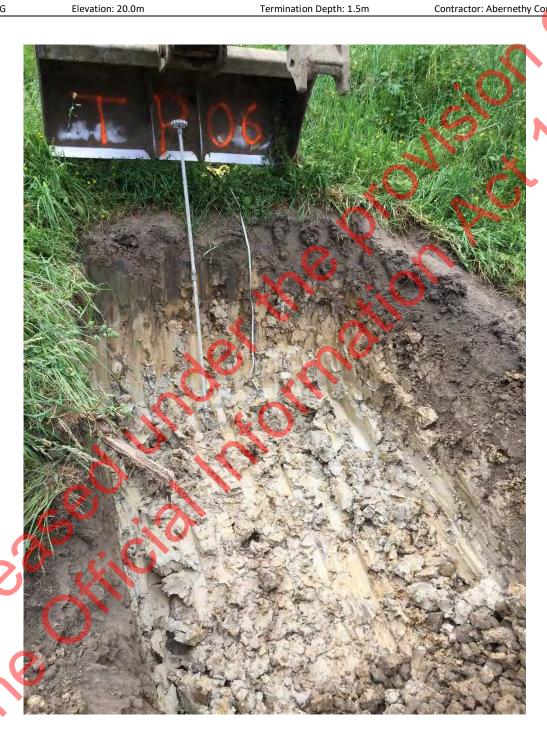
TP06-19 - TEST PIT EXCAVATION

Dimensions: 3.0m x 2.0m

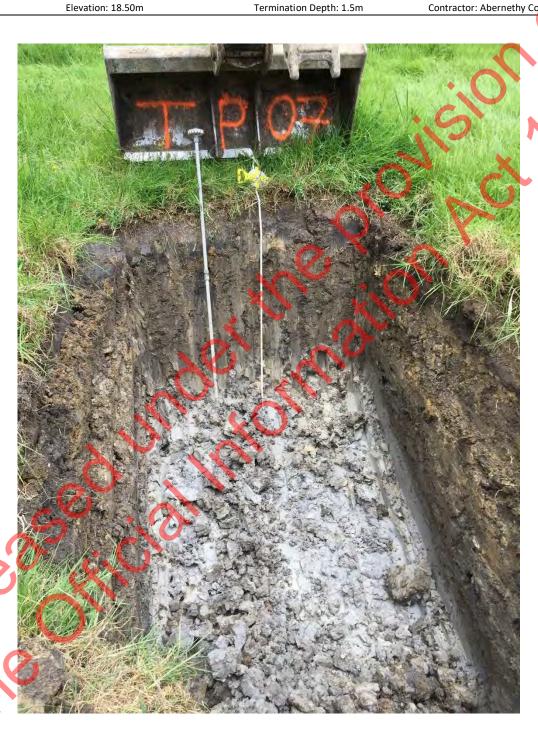
TP07-19 - TEST PIT EXCAVATION

Dimensions: 3.0m x 2.0m

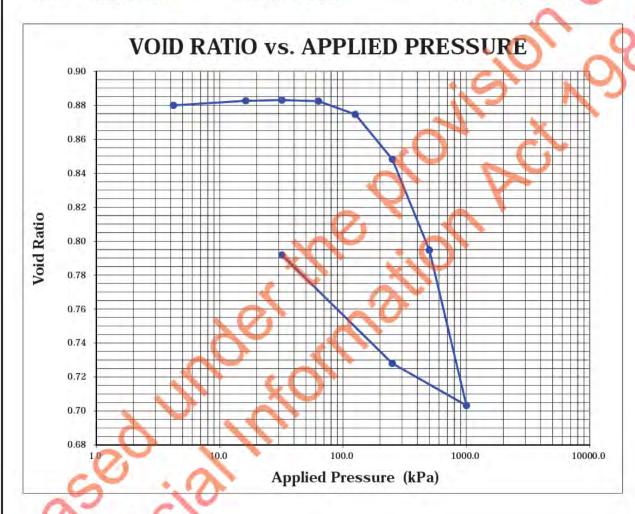
Borehole No: MH01-19 Sample No: TUBE Depth: 5.00 - 5.50m

ONE DIMENSIONAL CONSOLIDATION	Tested By:	TH	December 2019
Test Method: NZS4402:1986:Test 2.1 - Water Content	Compiled By:	TH	11-Dec-19
Test Method: NZS4402:1986:Test 7.1 - Consolidation	Checked By:	JF	12-Dec-19

Results of the laboratory oedometer testing show that the soils are over-consolidated meaning that for the proposed fil embankment / foundation pressures, these soils are not expected to settle significantly, with settlement expected to follow the unload-reload compression (Cr) line.

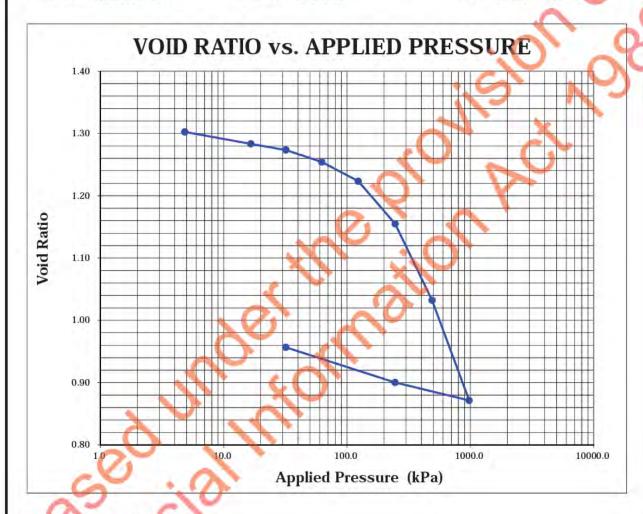
Borehole No: MH02-19 Sample No: TUBE Depth: 3.45 - 3.95m

ONE DIMENSIONAL CONSOLIDATION	Tested By:	TH	Dec 2019
Test Method: NZS4402:1986:Test 2.1 - Water Content	Compiled By:	TH	9-Dec-19
Test Method: NZS4402:1986:Test 7.1 - Consolidation	Checked By:	JF	12-Dec-19

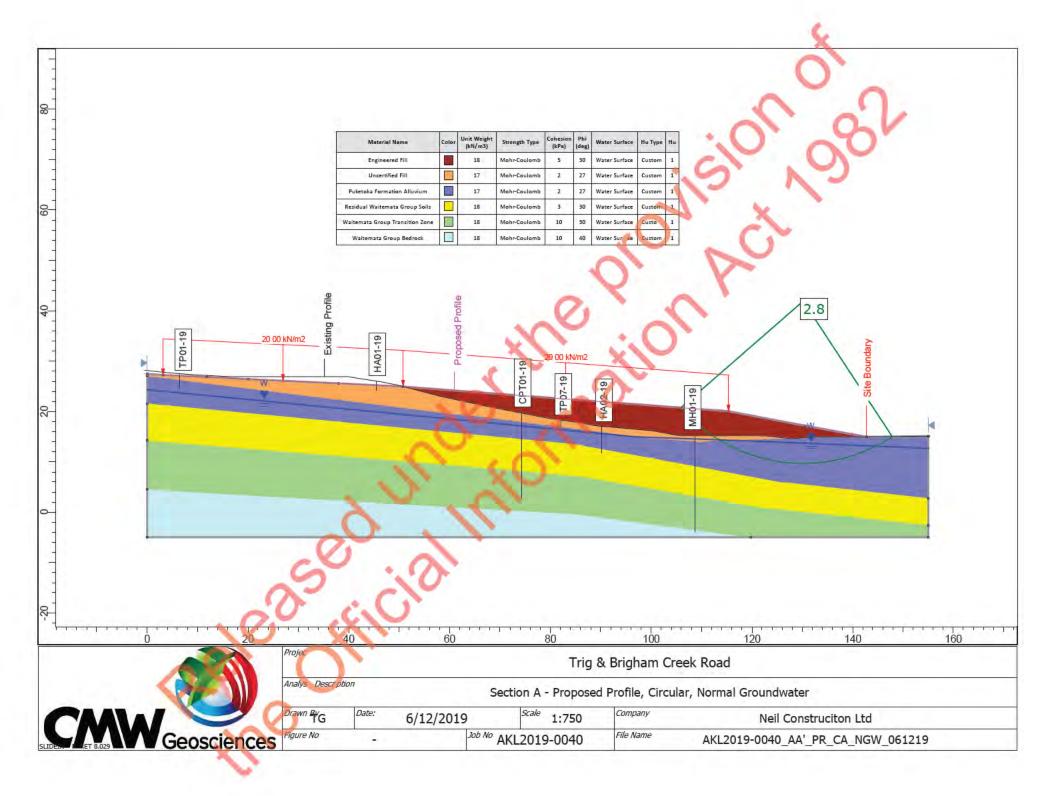
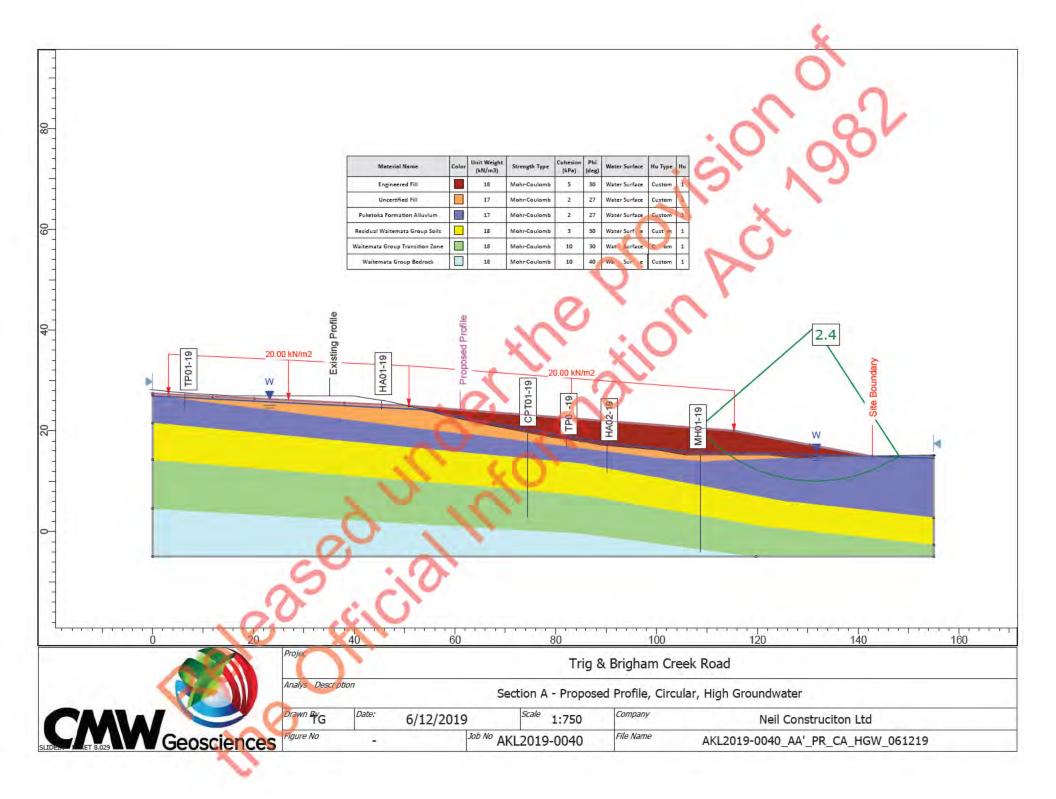
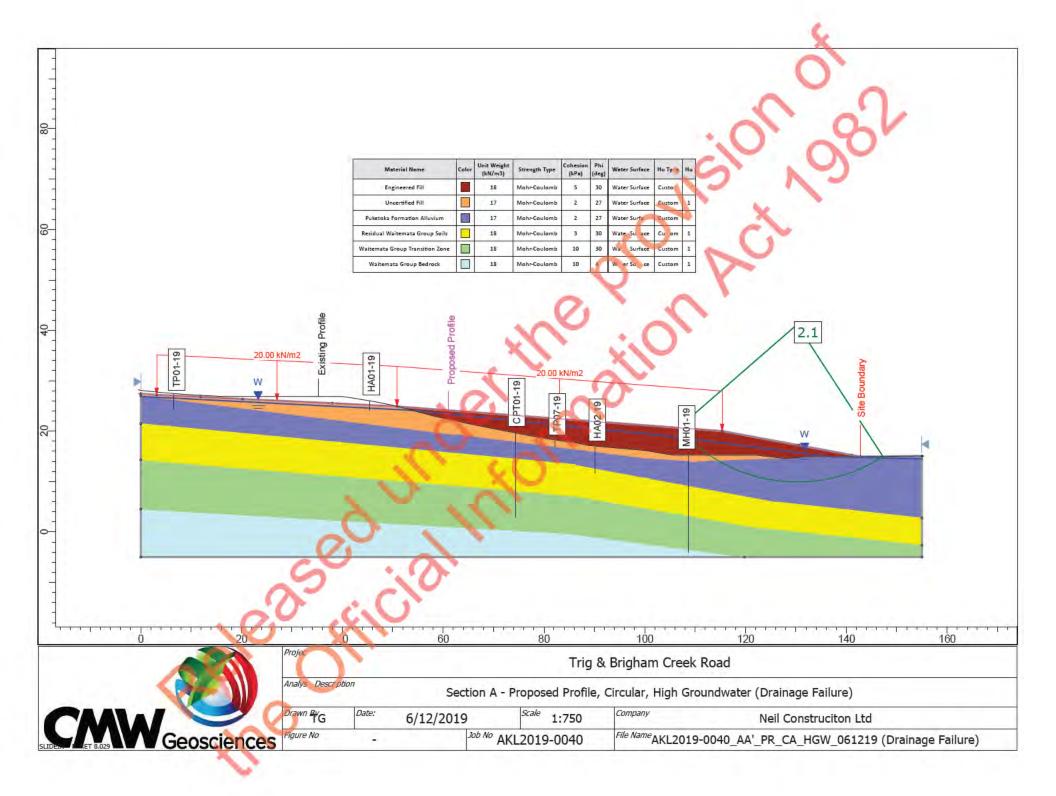
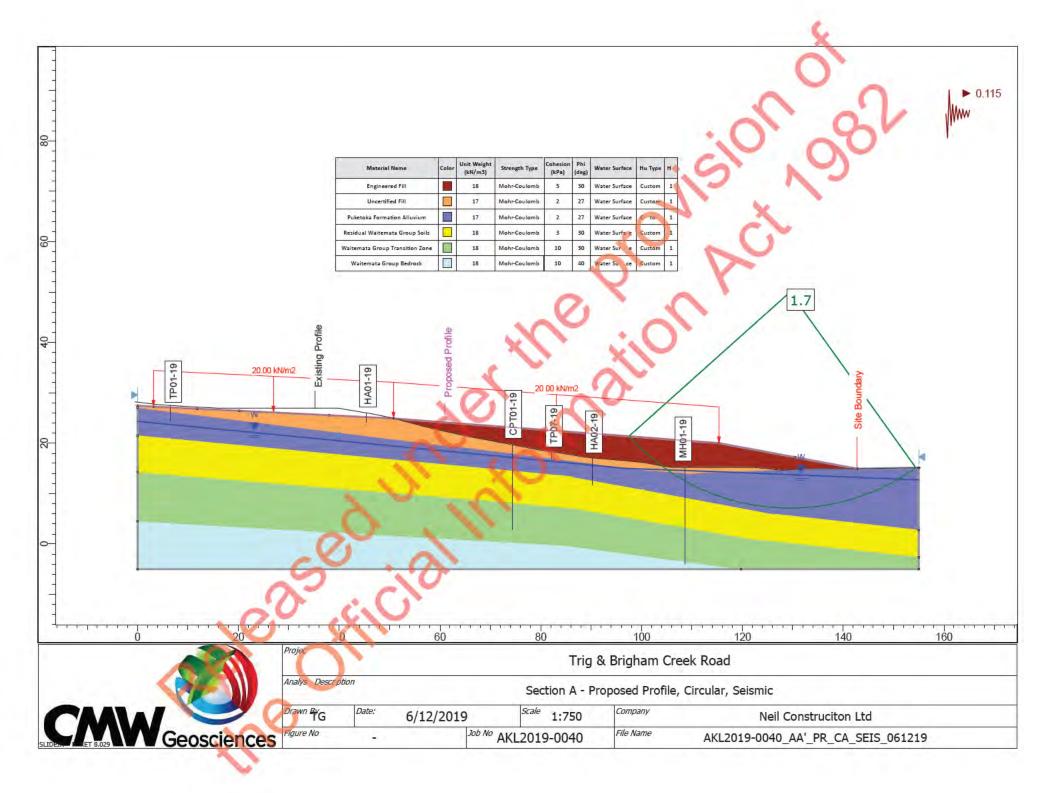
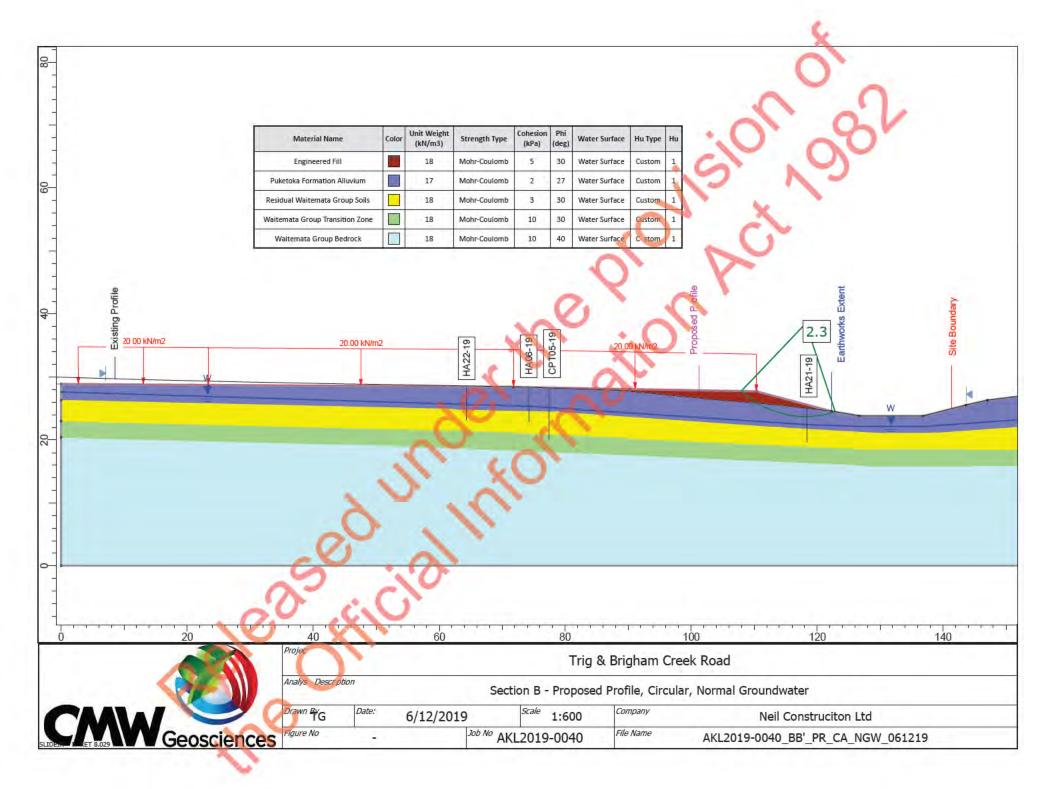
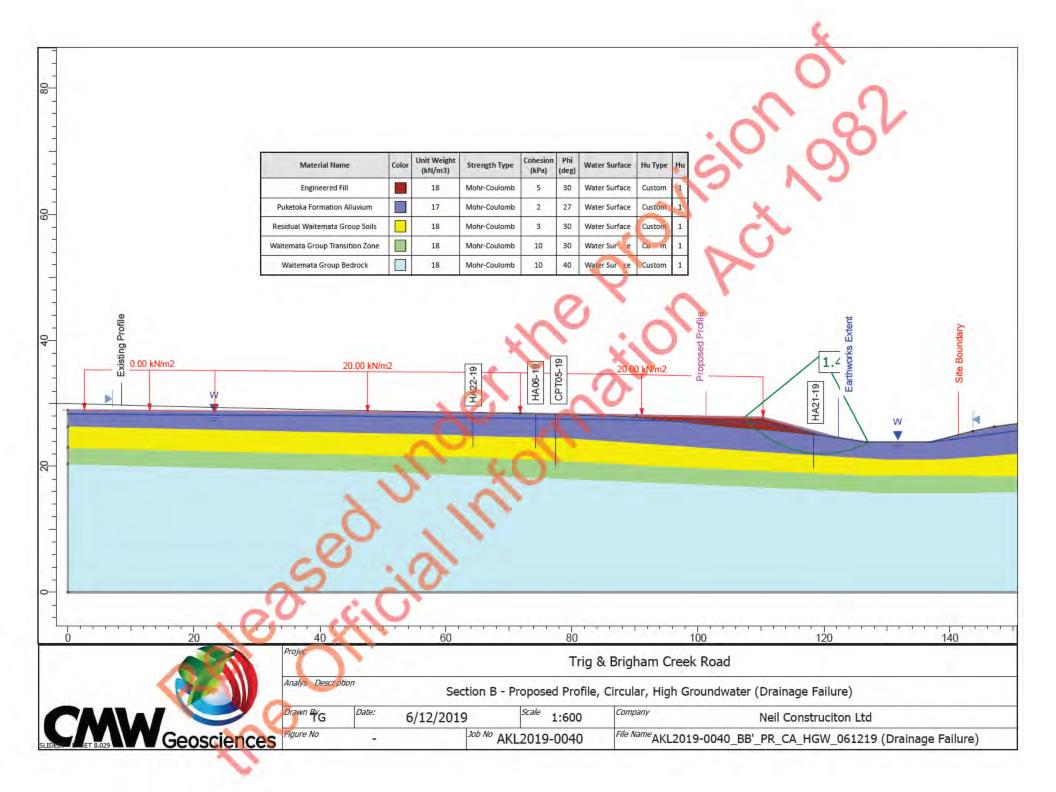
Section	Case	Failure Mode	Min. FS	Acceptance Comments
A	Existing Contour - Normal ground water table	Circular	2.6	у
	Existing Contour - Highly saturated (GW @ 0.5m)	Circular	1.5	y
	Existing Contour - Seismic, Normal GWT	Circular	1.7	y
	Proposed Contour - Normal ground water table	Circular	2.8	v
	,	Circular		У
	Proposed Contour - Highly saturated	Circular	2.4	У
	Proposed Contour - Highly saturated (Drainage Failure)	Circular	2.1	У
	Proposed Contour - Seismic, Normal GWT	Circular	1.7	У
В	Existing Contour - Normal ground water table	Circular	5.0	У
	Existing Contour - Highly saturated (GW @ 0.5m)	Circular	3.0	у
	Existing Contour - Seismic, Normal GWT	Circular	2.4	У
	Proposed Contour - Normal ground water table	Circular	2.3	+ 60
	Proposed Contour - Highly saturated	Circular	1.6	
	Proposed Contour - Highly saturated (Drainage Failure)	Circular	1.4	y
	Proposed Contour - Seismic, Normal GWT	Circular	1.7	V
С	Existing Contour - Normal ground water table	Circular	4.8	У

Existing Contour - Highly saturated (GW @ 0.5m)	Circular	3	У
	Existing Contour - Seismic, Normal GWT	Circular	2.3	y
	Proposed Contour - Normal ground water table	Circular	2.3	У
	Proposed Contour - Highly saturated	Circular	1.7	y
	Proposed Contour - Highly saturated (Drainage Failure)	Circular	1.5	
	Proposed Contour - Seismic, Normal GWT	Circular	1.6	у
D	Existing Contour - Normal ground water table	Circular	.1	У
	Existing Contour - Highly saturated (GW @ 0.5m)	Circula	1.9	У
	Existing Contour - Seismic, Normal GWT	Circular	2.0	У
	Proposed Contour - Normal ground water table	Circular	1.8	у
	Proposed Contour - Highly saturated	Circular	1.4	У
	Proposed Contour - Highly saturated (Drainage Failure)	Circular	1.3	У
	Proposed Contour - Seismic, Normal GWT	Circular	1.4	У
	Troposed contoal Scisinic, Normal CVV	Cir buildi		,
	A (// / X )			
·				
	X V

Slope stability a alyses were undertaken using the Morgenstern-Price method of slices under both circular and translational failure mechanisms using the proprietary software SLIDE Version 8.0. Earthquake loads were calculated in accordance with NZS 1170.5 and NZTA Bridge Manual (BM) Section 6.2.2 for earthquake loads for the assessment of slope stability. An ULS design earthquake return period of 150 years as recommended within the Auckland Council Code of Practice (ACCoP) has been assumed in the assessment. The peak ground acceleration (PGA) for stability analyses was calculated as 0.115g.

Results show that the slope stability factor of safety criteria are achieved for the proposed landform and assessed ground model conditions described above. However, detailed design will need to take in a account soil creep and proposed working loads. If loads greater than 20kPa are proposed, further analyses will be required.
