**Project Number #19375.000.001**

**Combined Preliminary and Detailed Site Investigation**

182 - 184 Kepa Road and 8 Kurahaupo Street,  
Orakei, Auckland

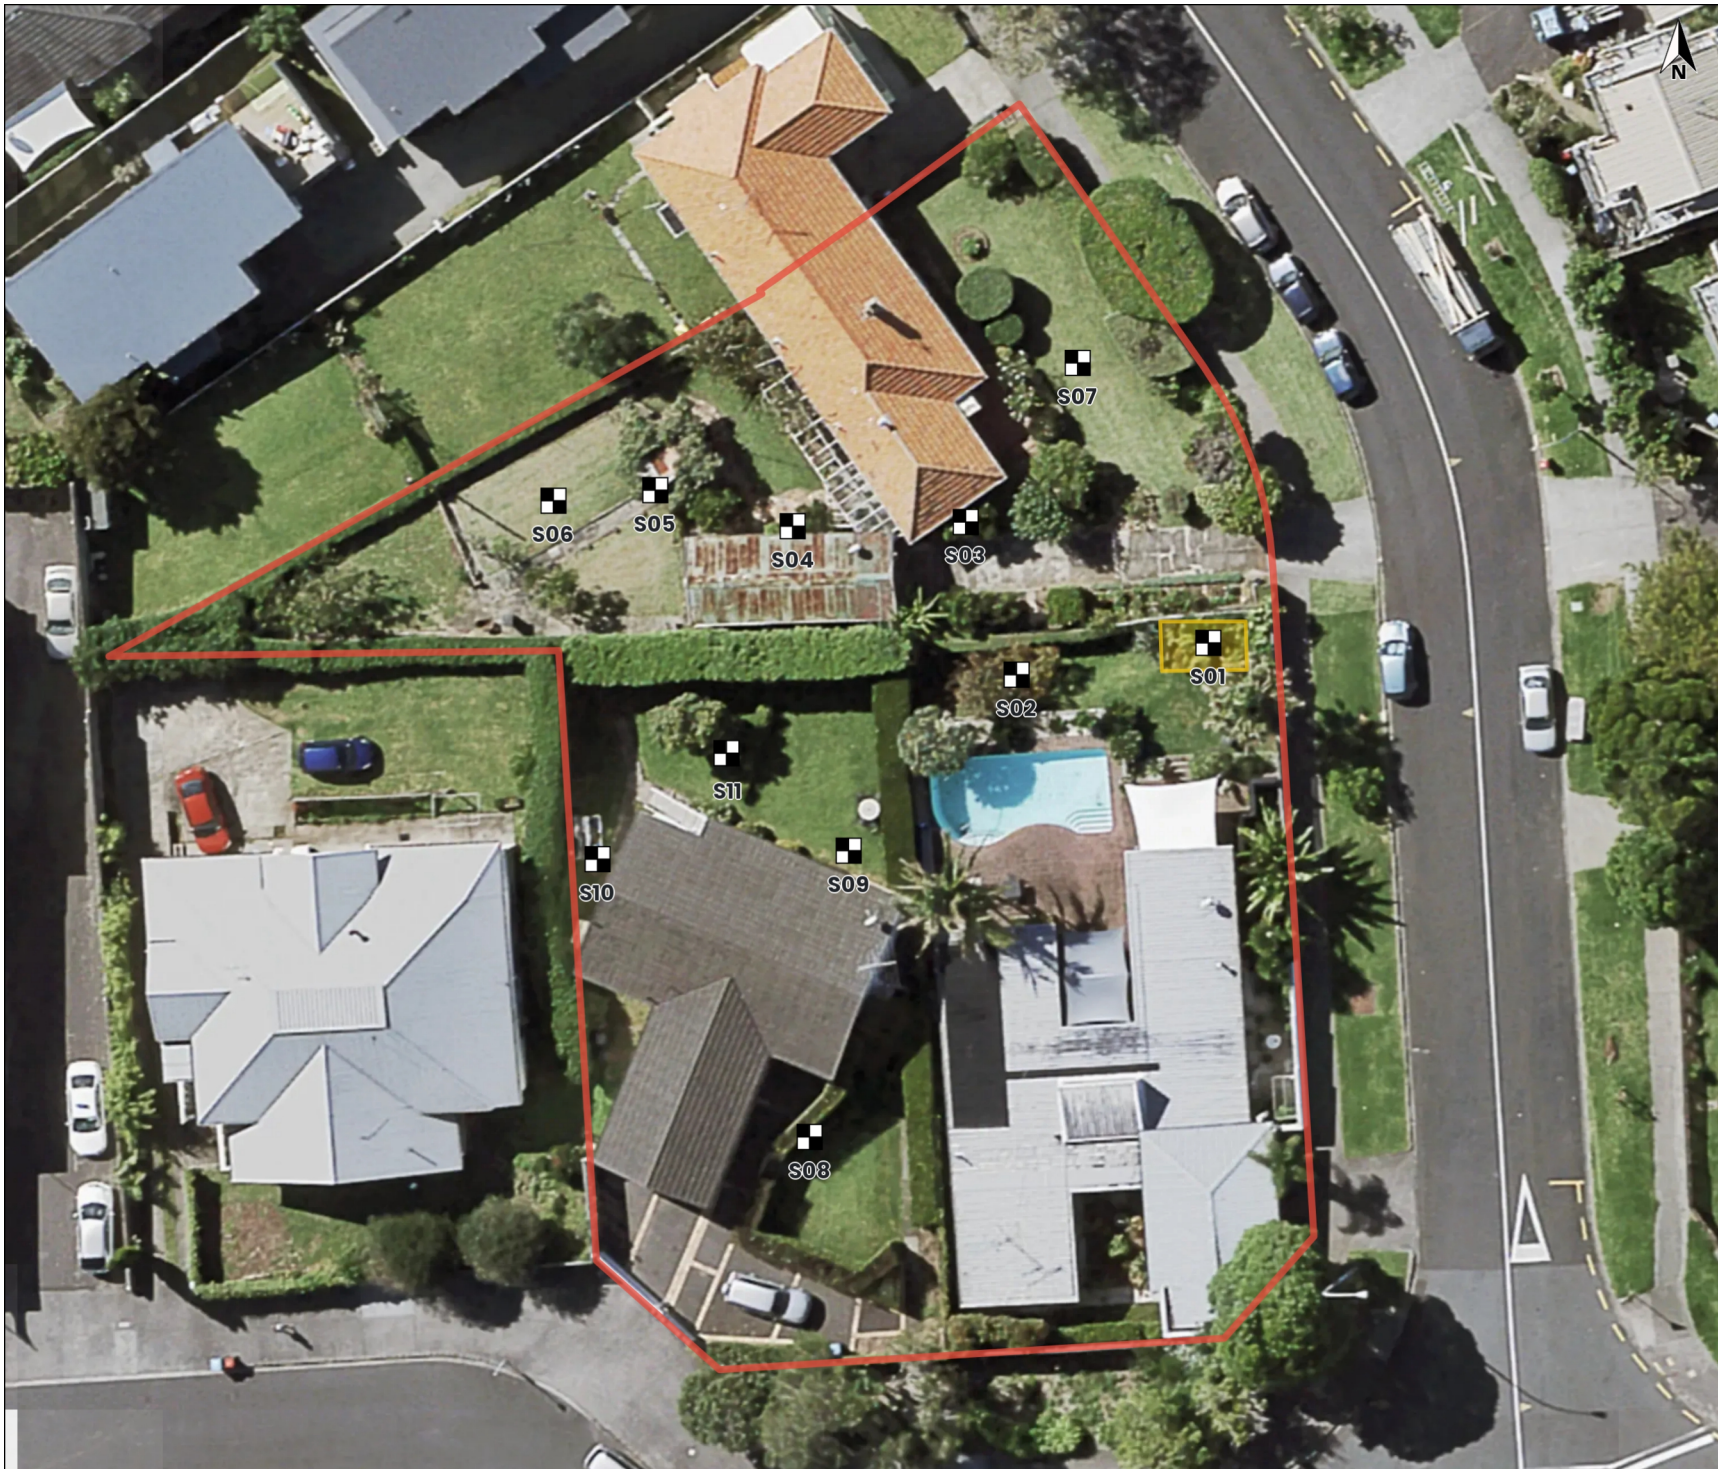
- Legend**
- Site Boundary
  - Sample locations
  - Potential historical building location

Table 6 provides a summary of the soil samples collected and analysed. Refer to attached Figure 1 for sample locations.

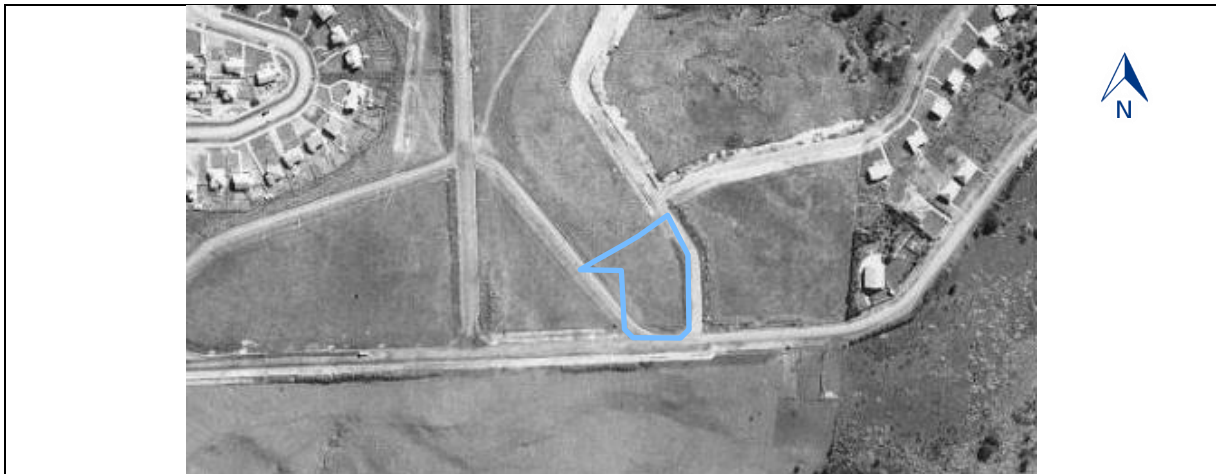
1940 (Retrolens)

The site appears undeveloped in the 1940 image (earliest available image). Kepa Road borders the site to the south and Kurahaupo Street to the east. A third road is observed adjacent to the western boundary (this road has been partly removed and realigned further south by 1959). By 1959 the duplex and outbuildings at 8 Kurahaupo Street has been constructed. Earthworks are occurring at 184 Kepa Road, and a small shed is present in the northeast corner. The dwellings at 182 and 184 Kepa Road are constructed prior to the 1968 image. No obvious changes to the site are observed – until 2006, when a small shed appears in the north-eastern portion of 182 Kepa Road. The site generally remains in this configuration until present day.

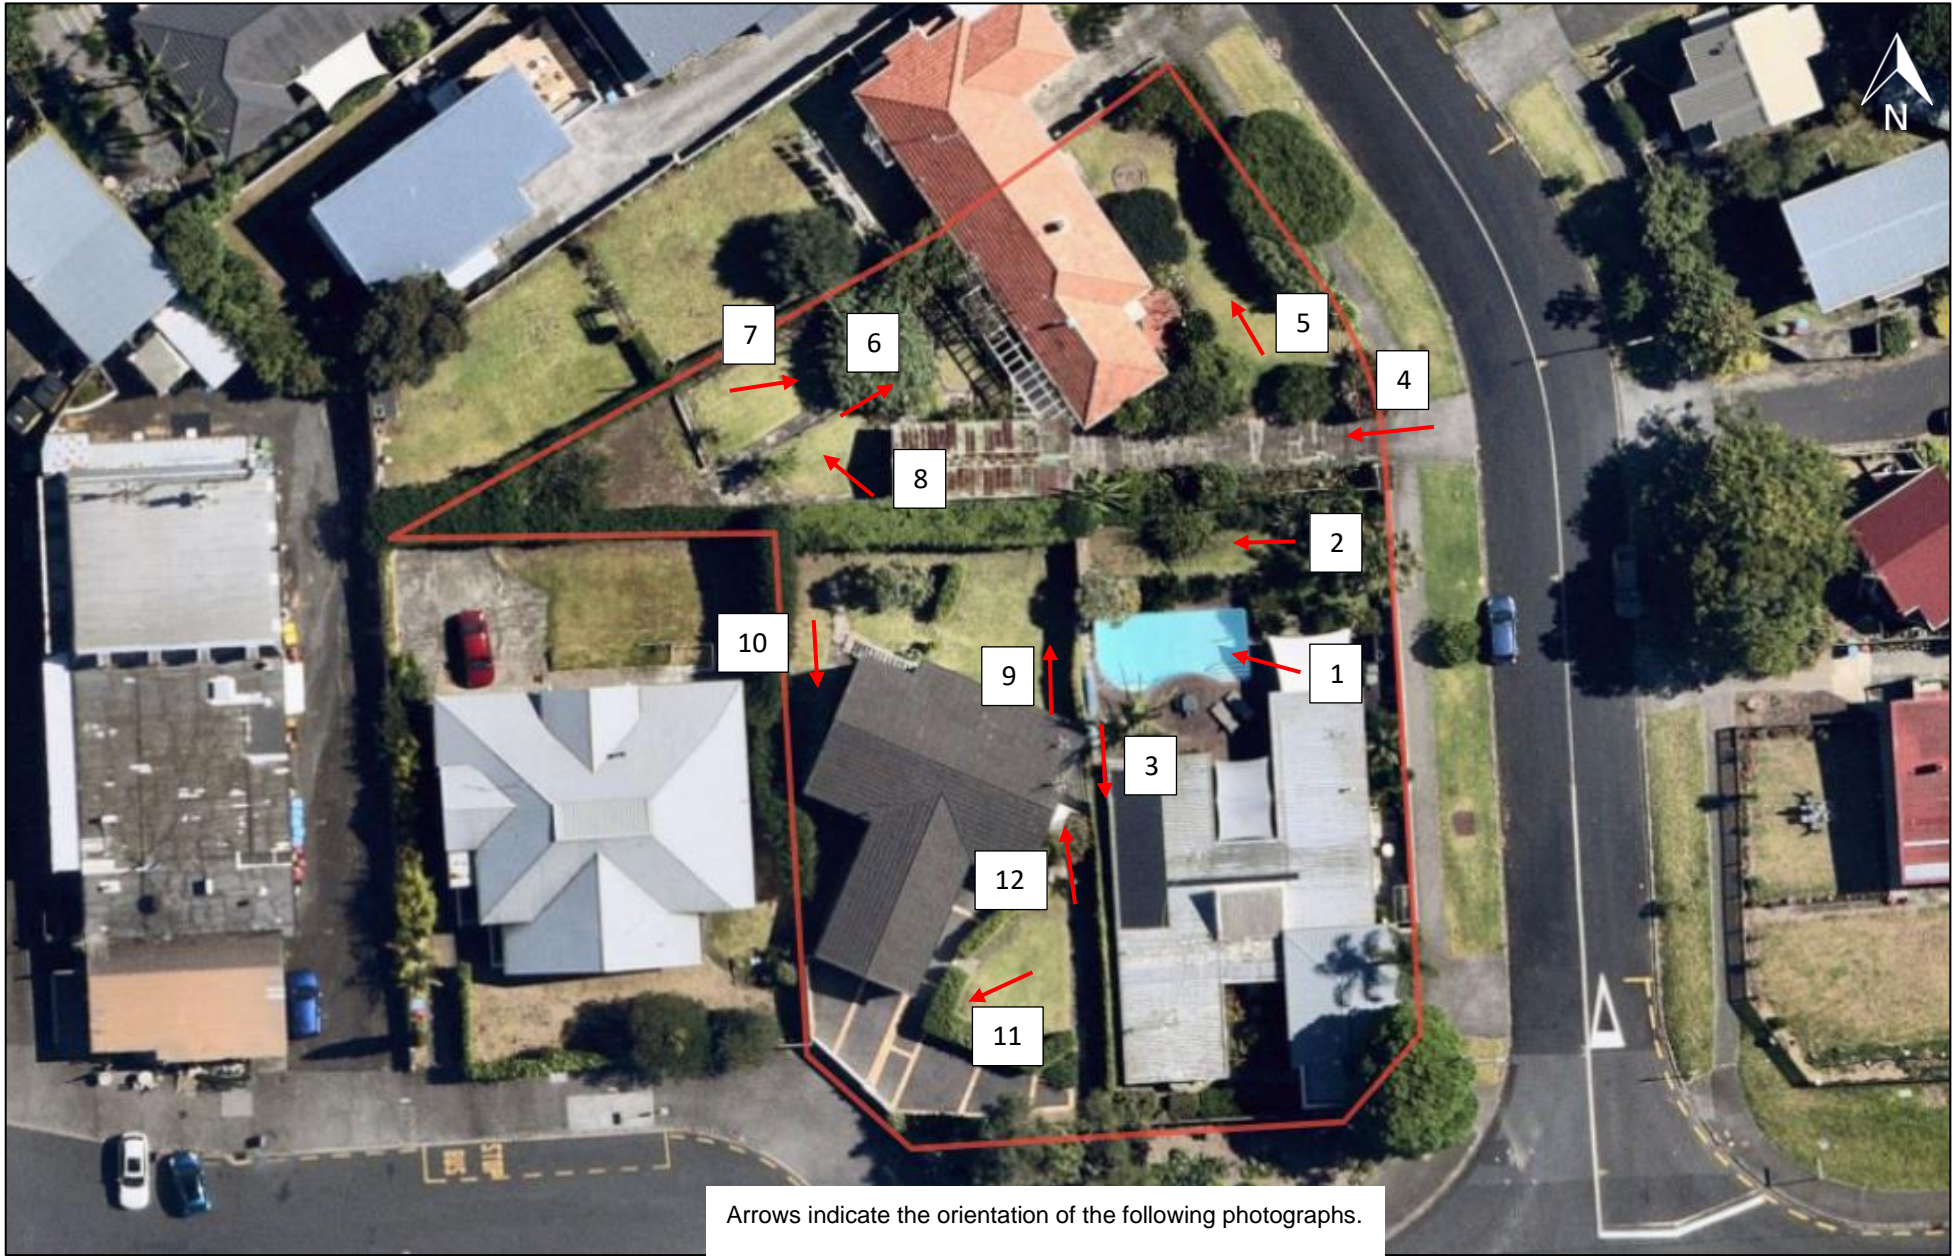
Arrows indicate the orientation of the following photographs.

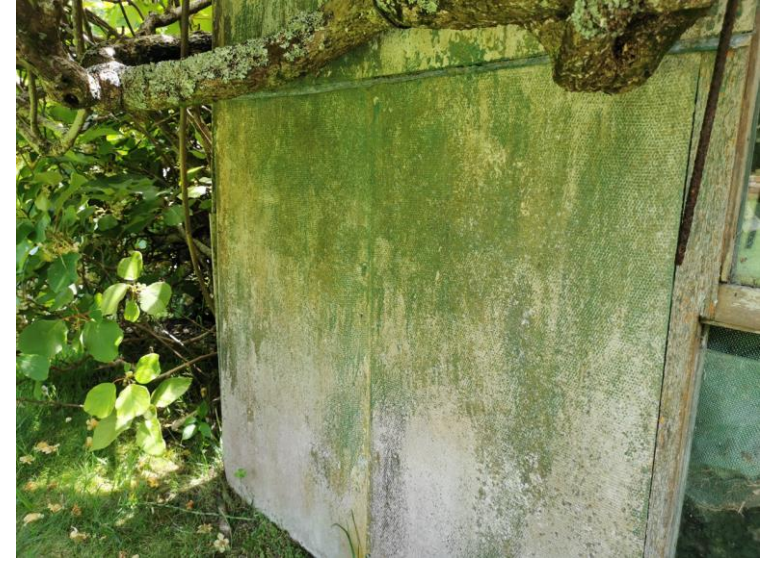
Photograph 6: Dilapidated shed in center of 8 Kurahaupo Street
