Report Title	Geotechnical Investigation - 182-184 Kepa Road, 8 Kurahaupo Street, Orakei			
Project No.	19375.000.001 Doc ID 02			
Client Contact Aaron Ghee			Aaron Ghee	
Distribution (PDF) Sanctum Projects Ltd				
Date	Revision Details / Status	Author	Reviewer	WP
26/11/2021	REV0 – Issued to Client	KW/JC	PF	VB
29/11/2021	REV1 - Update	KW/JC	PF	VB

ENGEO Ltd was requested by Sanctum Projects Ltd to undertake a geotechnical investigation of the property at 182-184 Kepa Road, 8 Kurahaupo Street, Orakei, Auckland (herein referred to as 'the site').

The purpose of this investigation is to prepare a geological model for the site and outline potential geotechnical constraints to the development as well as to support an application for resource consent for a new five- to eight-storey residential development at the site.

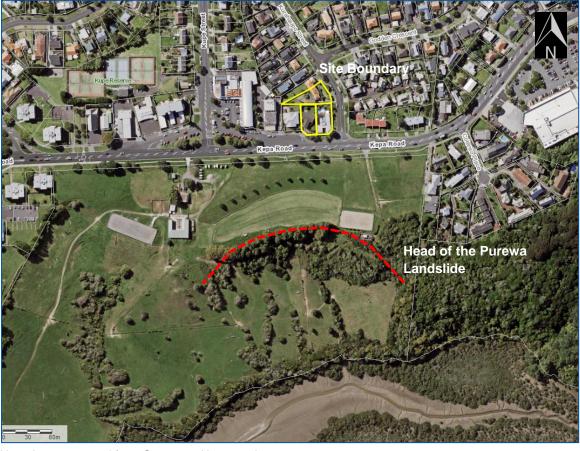
Figure 1: Kepa Road Landslide Location

The Kepa Road Landslide Zone is located on the north-eastern bank of the Orakei Basin. Holocene landslide deposits associated with the Purewa Landslide are mapped approximately 120 m to the south of the site (Figure 1). This material is described as landslide and rockfall detritus, derived from more than one geological unit, and likely contains volcanic, alluvial and ECBF materials.

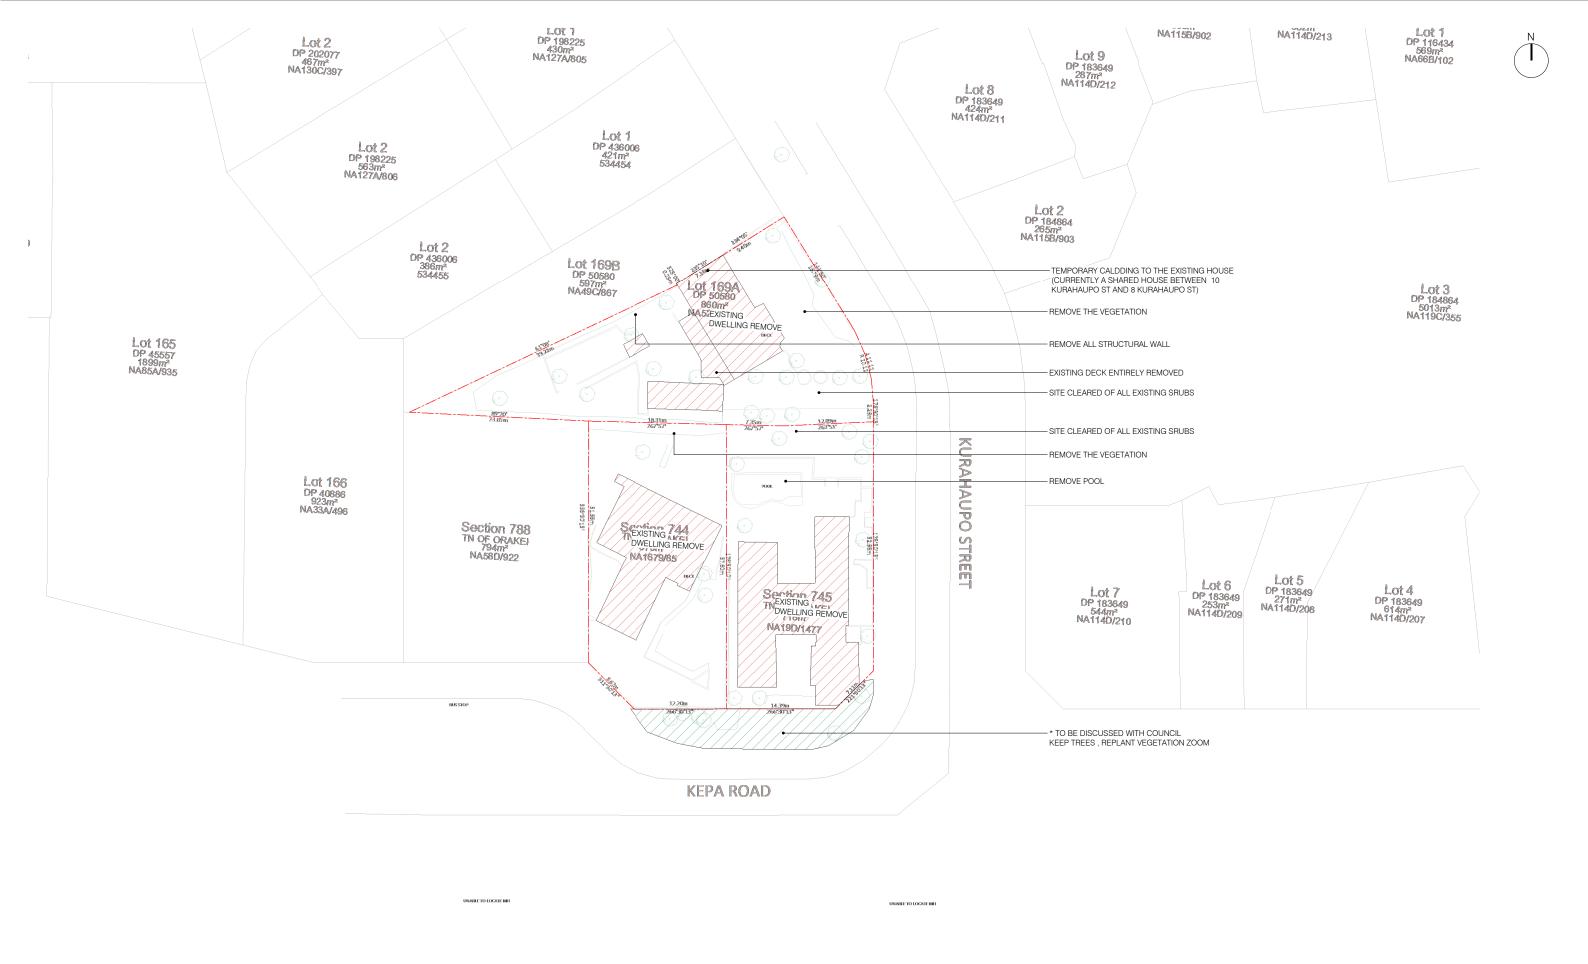
1 | SITE - DEMOLITION EXCAVATION PLAN

SITE DEMOLITION + EXCAVATION PLAN

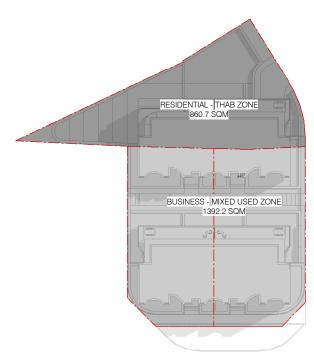
1 | METRIC - SITE AREA

RESIDENTIAL - THAB ZONE AREA | 860.7 SQM

BUSINESS - MIXED USED ZONE AREA | 1392.2 SQM

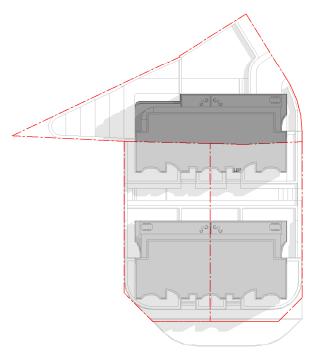
2 | METRIC - BUILDING COVERAGE

RESIDENTIAL - THAB ZONE BUILDING COVERAGE AREA $\,\mid$ 317.9 SQM THAB ZONE AREA $\,\mid$ 36.9% (MAX 50% \mid COMPLY)

BUSINESS - MIXED USED ZONE BUILDING COVERAGE AREA $\,|\,$ 694.7 SQM MIXED USED ZONE $\,\%\,\,|\,$ 49.9% (N/A)

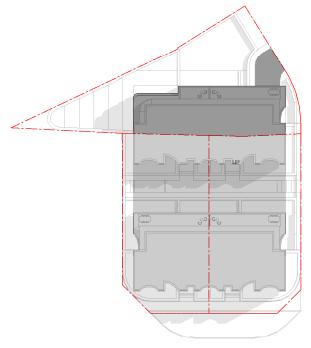
3 | METRIC - IMPERVIOUS AREA

RESIDENTIAL - THAB ZONE IMPERVIOUS AREA | 355.3QM THAB ZONE AREA %| 41.3% (MAX 70% | COMPLY)

BUSINESS - MIXED USED ZONE IMPERVIOUS AREA $\,|\,$ 1040.9 SQM MIXED USED ZONE % $|\,$ 74.7% (N/A)

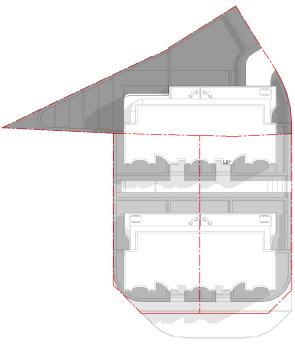
4 | METRIC - LANDSCAPE AREA

RESIDENTIAL - THAB ZONE LANDSCAPE AREA | 505.4 SQM THAB ZONE AREA %| 58.7% (MIN 30% | COMPLY)

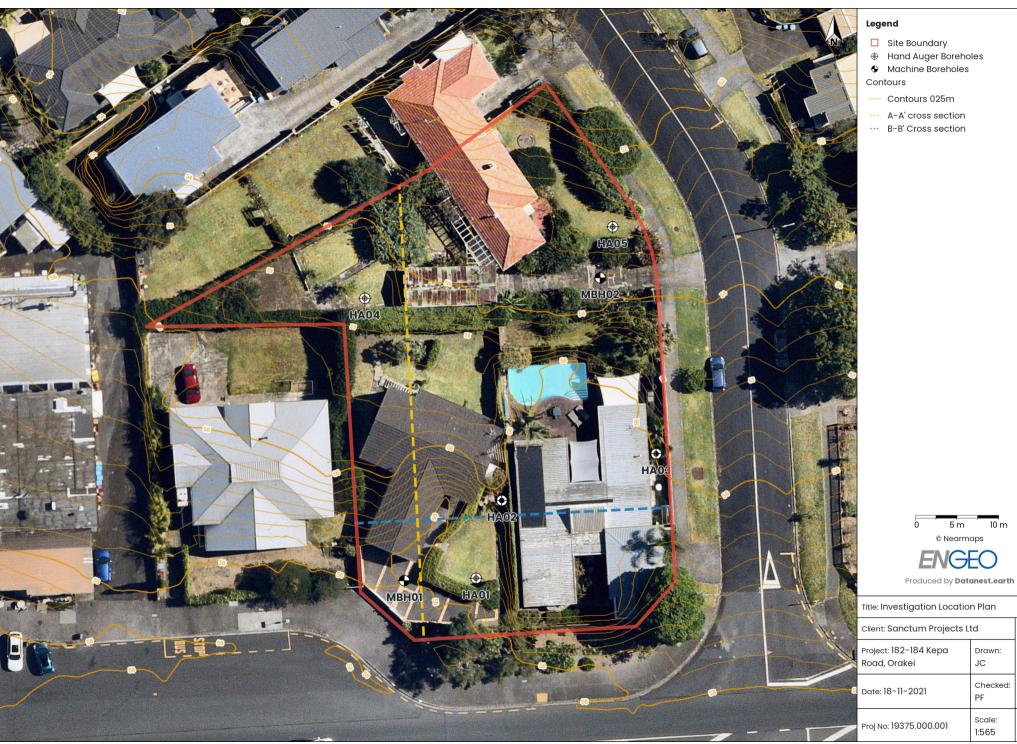
Investigation Location Plan

- Site Boundary
- Hand Auger Boreholes
- Machine Boreholes

- Contours 025m
- --- A-A' cross section
- --- B-B' Cross section

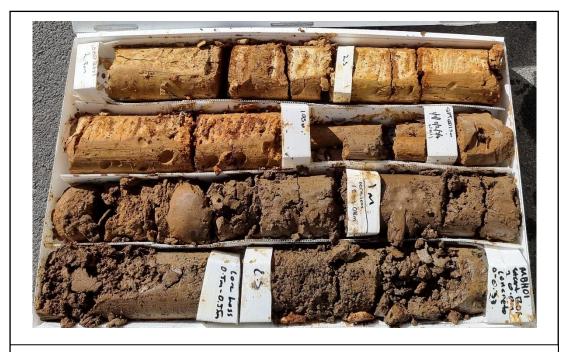
Figure 1: 0.00 m – 2.80 m

MBH01 Core Photos

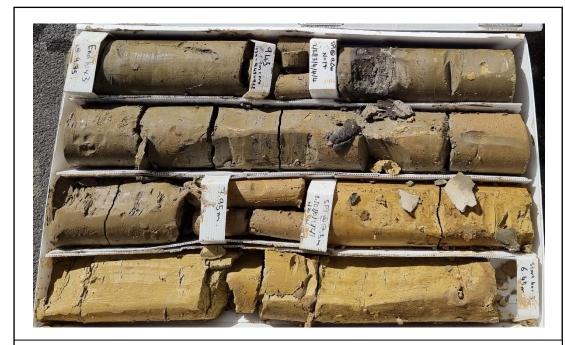
Figure 3: 6.45 m – 9.75 m

MBH01 Core Photos

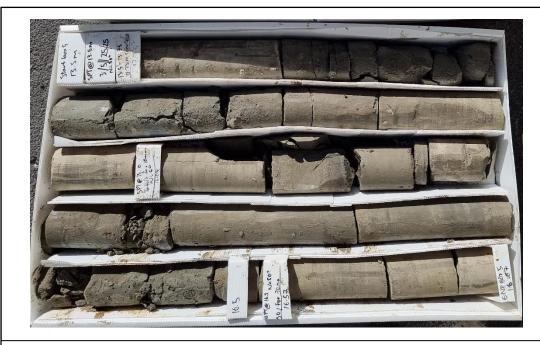
Figure 5: 13.50 m – 16.87 m

MBH01 Core Photos

Very weak ECBF bedrock was encountered from 48.25 mRL in MBH01 in the southern part of the site and from 44.4 mRL in the north. The rock generally comprised of interbedded siltstone and sandstone. The rock was encountered to beyond our maximum testing depth of 19.65 m bgl and was generally found to increase in strength with depth.

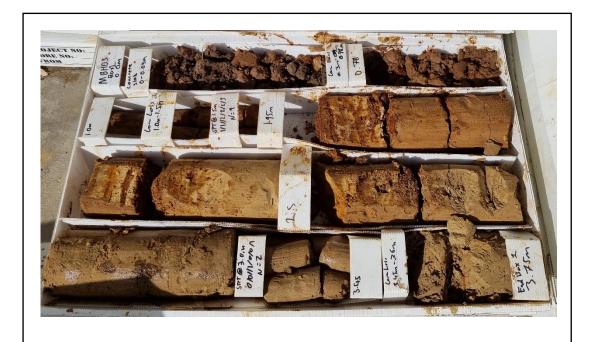
Figure 1: 0.00 m – 3.75 m

MBH02 Core Photos

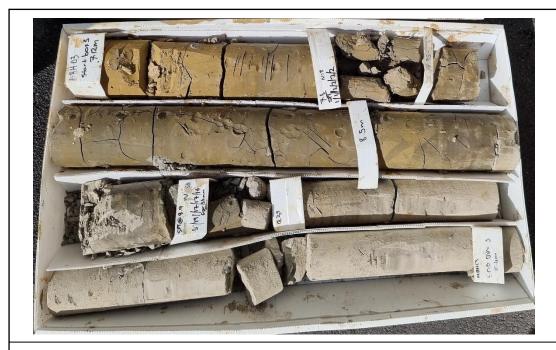
Figure 3: 7.12 m – 10.40 m

MBH02 Core Photos
