ACTION PLAN: BREAM BAY CATCHMENT

FOR: PIROA CONSERVATION TRUST

Date of Issue: 16 August 2024

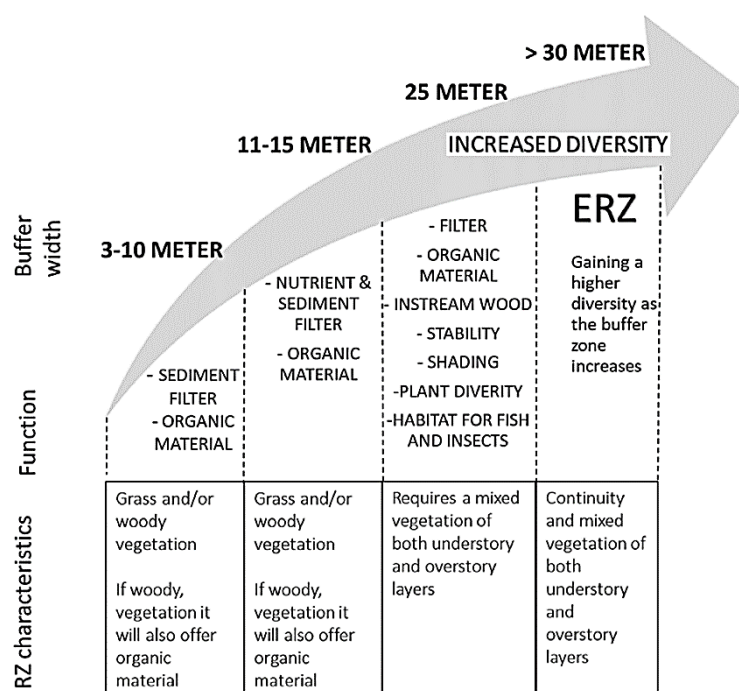
Figure 1 . Conceptual framework extracted from Lind et al. (2019), whose original legend says: ‘The ‘step-by-step ERZ framework’ combines the concept of “Ecologically Functional Riparian Zones”, the literature review and results from the meta-analysis. RZ=Riparian zones.’

Riparian zones of 3–10m with woody vegetation (i.e. trees and/or shrubs) will control sedimentation and increase organic material input.

Riparian zones of 11–15m with woody vegetation will have the same function as the narrower zones but will also filter nutrients. Steeper slopes and finer soils can be compensated for by adjusting towards a wider buffer width within each category. Consideration also needs to be taken of the specific hydrological pathways.

Riparian zones over 25m will also be sufficient to re-generate larger trees and consequently shade, influence the water temperature, and ensure bank stability. The floral and faunal diversity will increase with increasing buffer width, but if a high diversity of both plants and animals is the main goal, in many cases more than a 30m wide zone on both sides of the waterway is needed.

In a meta-analysis of dozens of studies overseas, Lind *et al.* (2019) found interesting width values for the effectivity of different services, as per Figure 1. The number of ecological services increases with the buffer width (Figure 1), and the catchment groups should ultimately decide the width of riparian margin based on their general goal for each area, in collaboration with the different landowners. BEnviro is suggesting, in general, a riparian margin of fifteen metres utilising mixed planting, although if allowed, a wider buffer should be opted for.

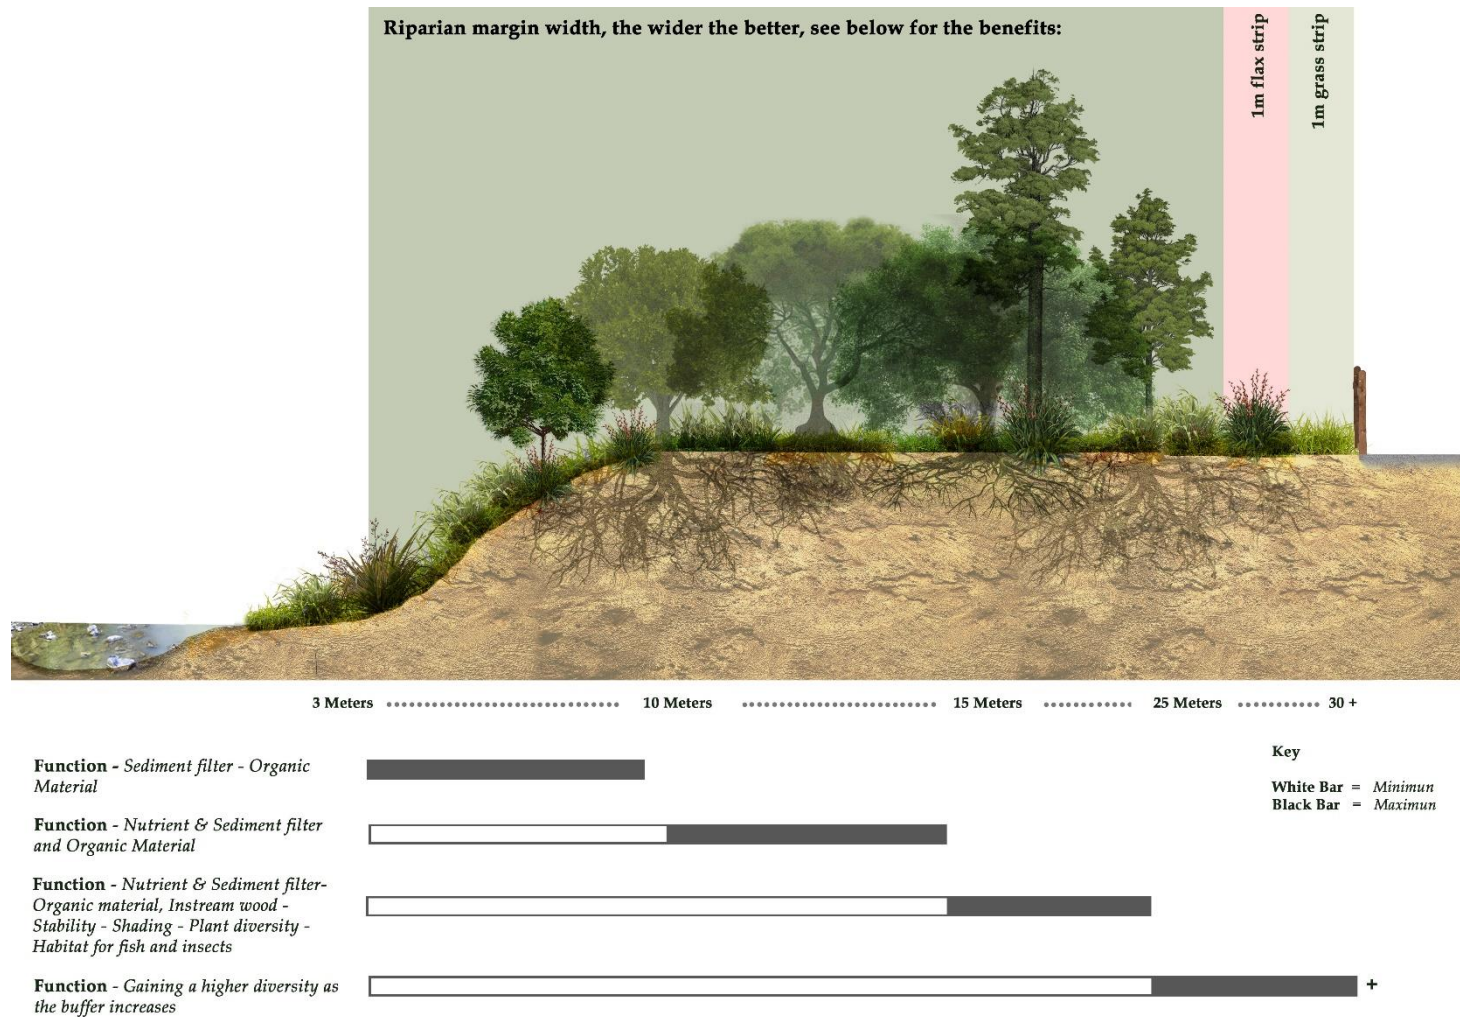
Figure 2 BEnviro's modified conceptual framework extracted from Lind et al. (2019)

Below we provide a summary diagram displaying the benefits of a wider riparian margin.

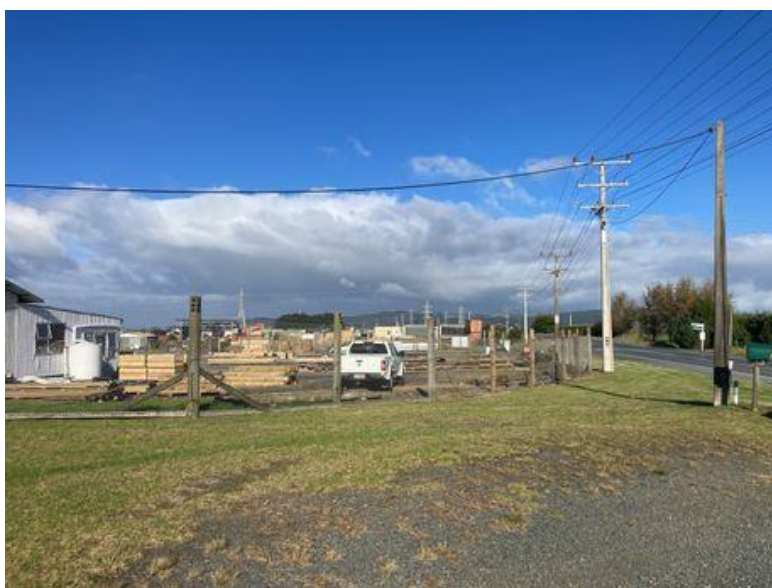
Figure 4 Photo displaying an industrial facility in the low-lying areas of the Ruakaka Catchment.

BEnviro recommendation is for PCT to communicate with the relevant Council to ensure that auditing of these sites is being conducted and that the sites are operating based on their EMPs.

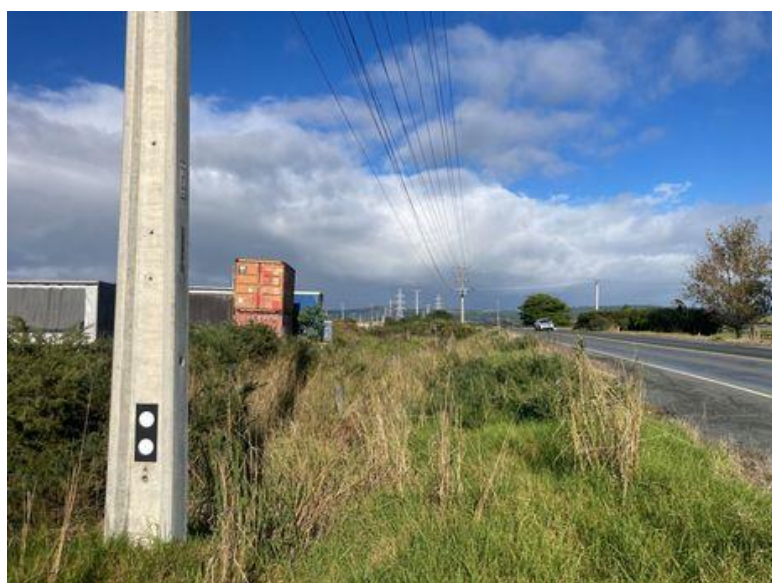
Figure 5 Photo displaying an artificial channel, or stormwater drains alongside Marsden Point Road, Ruakaka.

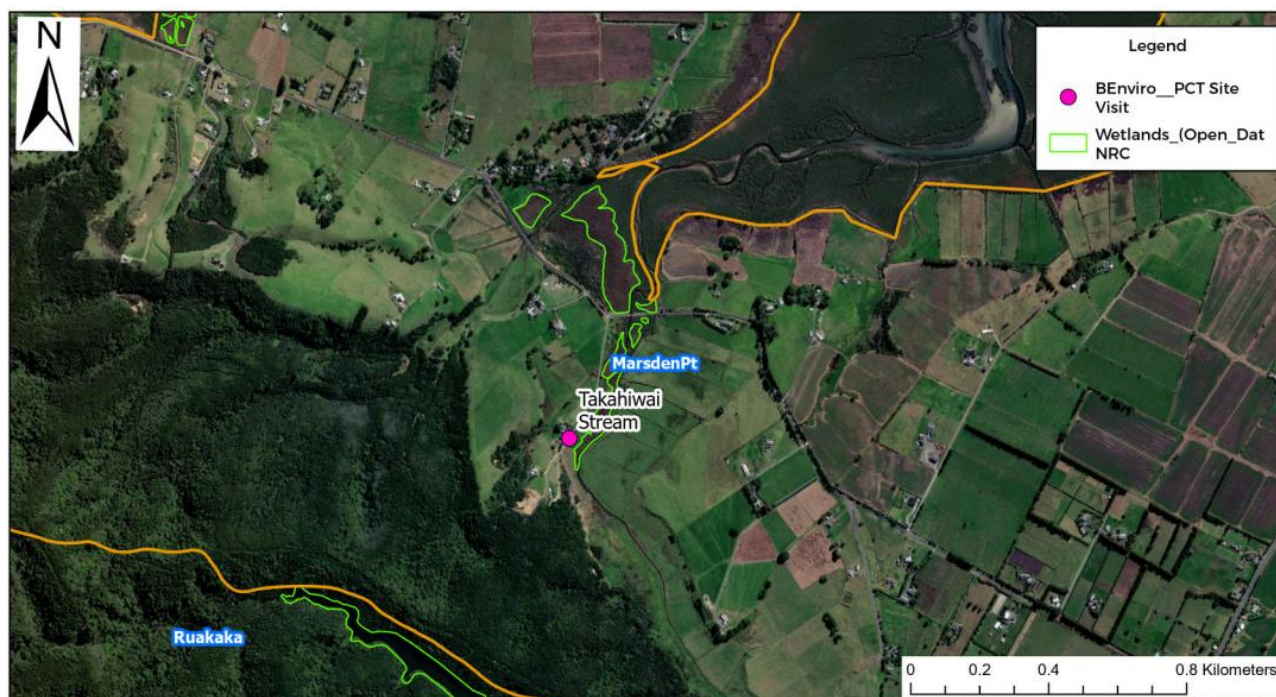
ACTION PLAN: TAKAHIWAI STREAM

Takahiwai Stream	
	Map demonstrates site location for future fencing and planting in the Marsden Point catchments.	
BEnvironmental Limited All Rights Reserved www.benviro.co.nz		Date: 25/06/2024 Compiled by: MB Reviewed by: NM

Address:	219 Takahiwai Road, Takahiwai, Whangarei, Northland, 0171
ID:	Takahiwai Stream
Catchment Name:	Marsden Point
Main Issues Found in the Reach/Catchment:	Stock Access, Flooding, Artificial Drainage, Pampas
Status of Work by Community Group(s)	Ongoing
Community Group Comments:	The local iwi have engaged in significant planting activities, and they are also planning to fence most

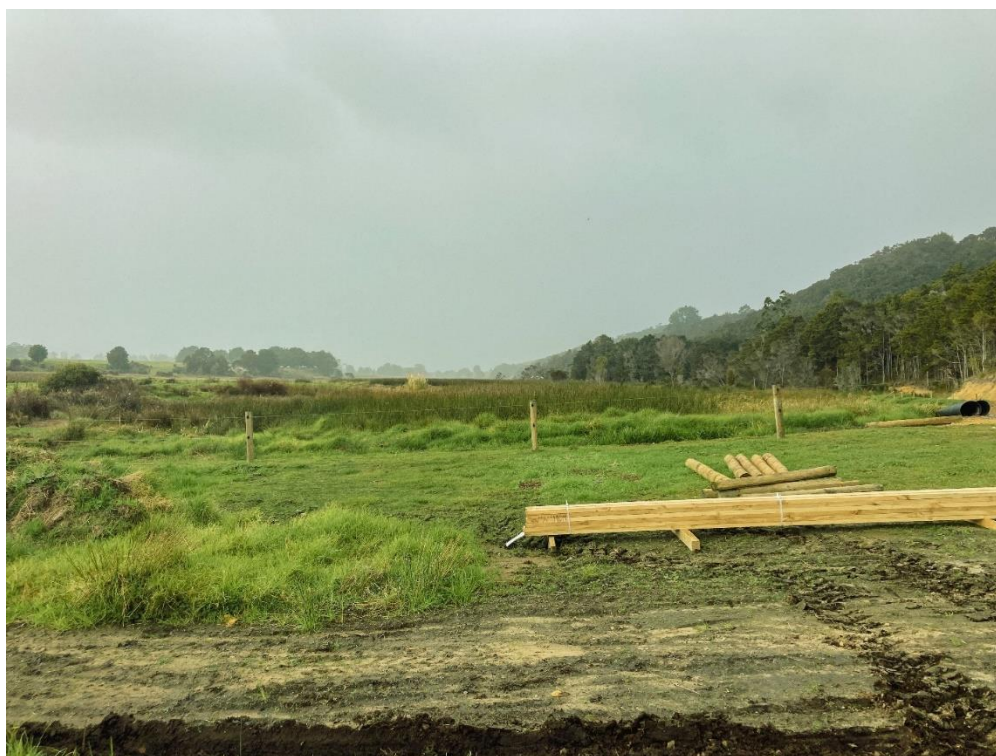
Figure 6 Photo of the flat area at the bottom of the Takahiwai Stream.

Enhancement Comments from Specialists:	<p>As part of the restoration of the wetland the land owner could consider planting the following species inside the fenced areas alongside the streams:</p> <p><i>Cyperus ustulatus</i>, <i>Plagianthis regius</i>, Kōwhai (<i>Sophora</i> spp.), <i>Carex secta</i>, <i>Carex virgata</i>, <i>Baumea articulata</i>, <i>Baumea juncea</i>, <i>Baumea rubinosa</i>, <i>Cordyline australis</i>, <i>Phormium tenax</i>, <i>Eleocharis sphacelata</i>, Kahikatea (<i>Dacrycarpus dacrydioides</i>), <i>Schoenoplectus validus</i>, Titoki (<i>Alectryon excelsus</i>), Karaka (<i>Corynocarpus laevigatus</i>), and Kohekohe (<i>Didymocheton spectabilis</i>).</p>

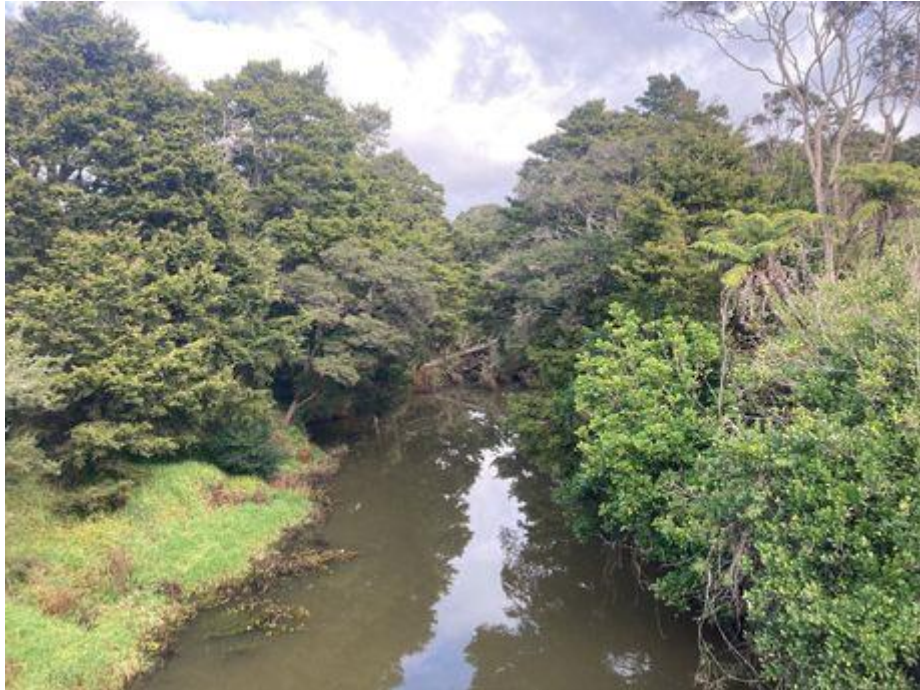
Current Biodiversity Value (Including Catchment Context)	<p>with the aim of increasing the number of areas known as suitable for spawning habitats.</p> <p>The Ahuroa River in this location provides for spawning habitat. This location is found downstream from a catchment that requires several catchment management approaches, such as environmental compliance of industries, and improvement of discharge from pastoral land.</p>
Potential Biodiversity Value (Including Catchment Context)	<p>This area has the potential to provide suitable spawning habitat for Galaxiidae. However, an all-encompassing catchment management approach is needed, to improve water quality.</p>
Enhancement Comments from Specialists:	<p>To enhance the quality of water in the upper catchment, which ultimately flows into the lower regions where spawning occurs, it is crucial to enforce compliance among industries situated in the upper catchment area. It is recommended that the PCT engage in dialogue with the Northland Regional Council to ascertain whether monitoring of these companies is being carried out and if the operators are adhering to their respective Environmental Management Plans (EMPs). If the quality of water can be enhanced, it has the potential to increase spawning intensity, meaning that each female can lay a greater number of eggs due to reduced stress caused by poor water quality.</p>

Figure 7 Photo facing upstream, showing banks able to sustain spawning habitat through suitable microhabitats comprising of overhanging vegetation, leaf litter and macrophytes (both exotic and native).

Success Measure Recommended by Specialist:	<p>Water quality improvements and monitoring of spawning frequency yearly.</p>

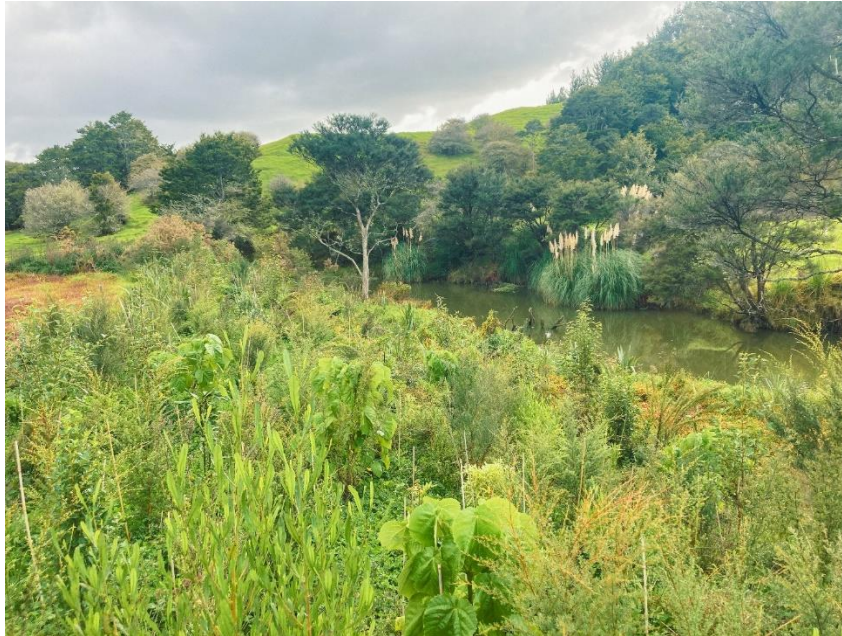
Address:	174 Millbrook Road, Waipu, Northland, 0582
ID:	Mid Millbrook- Spawning Site
Catchment Name:	Millbrook
Main Issues Found in the Reach/Catchment:	Planting density for trees was too high.
Status of Work by Community Group(s)	Completed
Community Group Comments:	The catchment group has said that measures have been taken to control pests, specifically rats and mice.

Figure 8 photo showing riparian planting undertaken by catchment group facing upstream.

In future plantings consider lower canopy density.

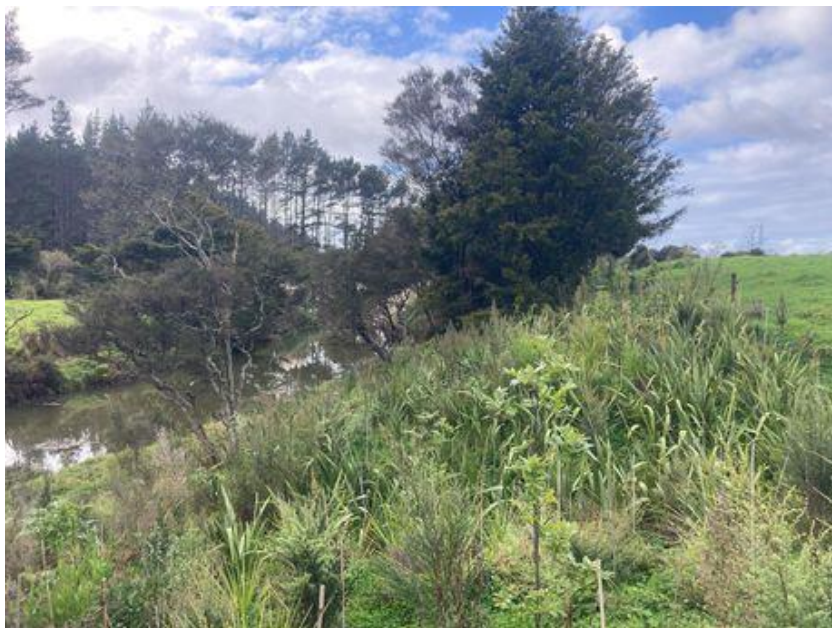
Figure 9 photo showing riparian planting undertaken by catchment group facing downstream.

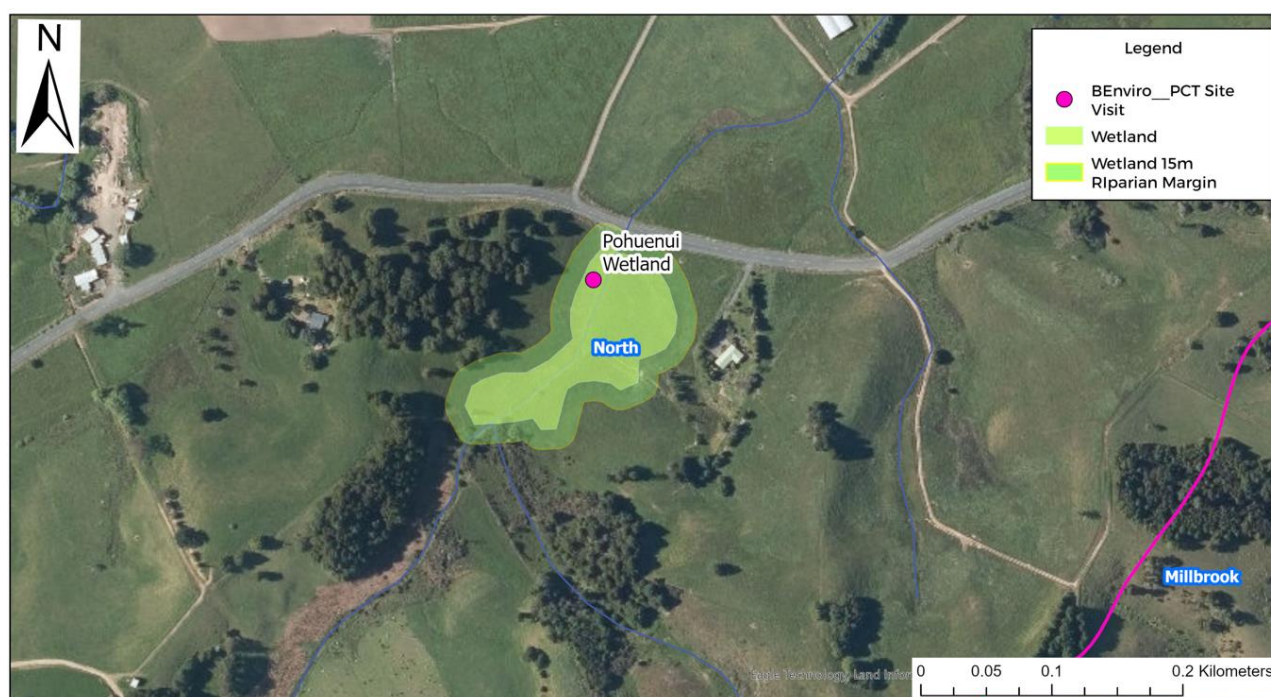
ACTION PLAN: POHUENUI WETLAND

Pohuenui Wetland Map demonstrates a wetland within the North Catchment. Date: 16/08/2024 Compiled by: MB Reviewed by: NM BEnvironmental Limited All Rights Reserved www.benviro.co.nz

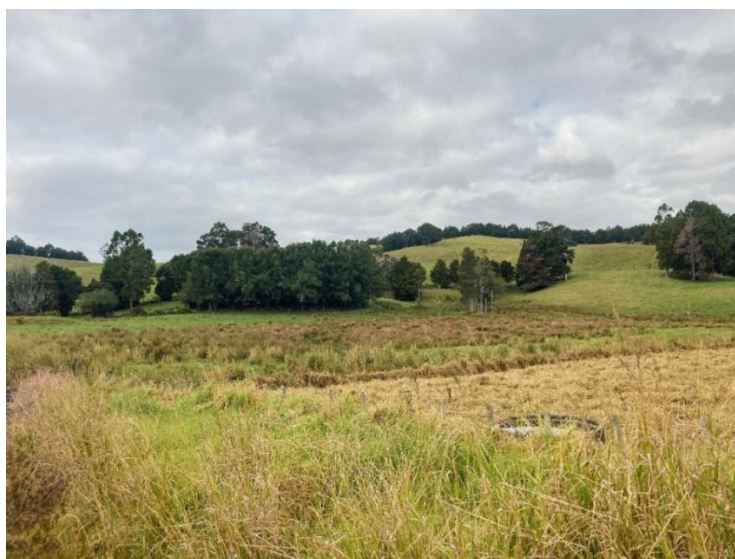
Address:	55-677 Helmsdale Road, Waipu, Northland, 0582
ID:	Pohuenui wetland
Catchment Name:	North
Main Issues Found in the Reach/Catchment:	Cattle access; Lack of riparian planting
Status of Work by Community Group(s)	Forecasted

Figure 10 shows a photo of the wetland that is proposed to be enhanced.

allow for lower nutrient levels being discharged to the watercourse downstream.
Enhancement Comments from Specialists:	<p>Instead of creating artificial holes through the wetland, which may resuspend sediment and may require consent, the specialists recommend PTC to include large logs through the wetlands. These logs can be placed in such a way as to reinstate a somewhat original flow path. It is important, however, to ensure that the logs are placed without creating a fish barrier. Lastly, the choice of logs should be opted to those that do not float easily and move with higher floods, otherwise, these can accumulate near the outlet of the wetland, adjacent to the road.</p> <p>In terms of plant species, the specialists recommend planting raupō (<i>Typha orientalis</i>) and sedges within the wetland, and kahikatea (<i>Dacrycarpus dacrydioides</i>) and swamp maire (<i>Syzygium maire</i>). Kahikatea (<i>Dacrycarpus dacrydioides</i>), Pukatea (<i>Laurelia novae-zealandiae</i>), Flax (<i>Phormium tenax</i>), Cabbage tree (<i>Cordyline australis</i>), Mānuka (<i>Leptospermum scoparium</i>), Kōwhai (<i>Sophora fulvida</i>), Purei (<i>Carex secta</i>), Toetoe (<i>Carex virgata</i>), Karamū (<i>Coprosma</i> sp.) round the riparian margins of the wetland.</p> <p>It may also be beneficial to use logs to create an island, which birds can use as a refuge. When undertaking the restoration, consider fencing the wetland from stock. This will prevent the resuspension of nutrients and sediments from being discharged downstream.</p>

Length of Riparian Downstream (m):	~190m
Success Measure Recommended by Specialist:	Improve riparian buffer and connectivity. Increase habitat diversity. Exclude stock by fencing.

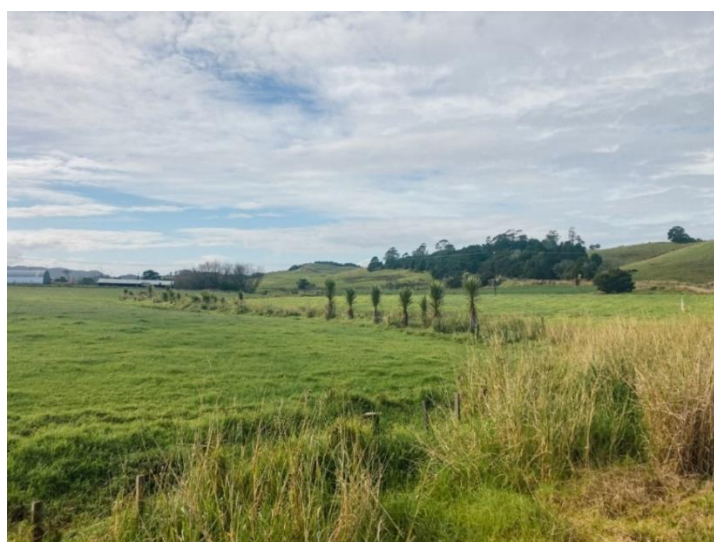
Figure 11 shows the watercourse, riparian planting downstream from the wetland, and road crossing.

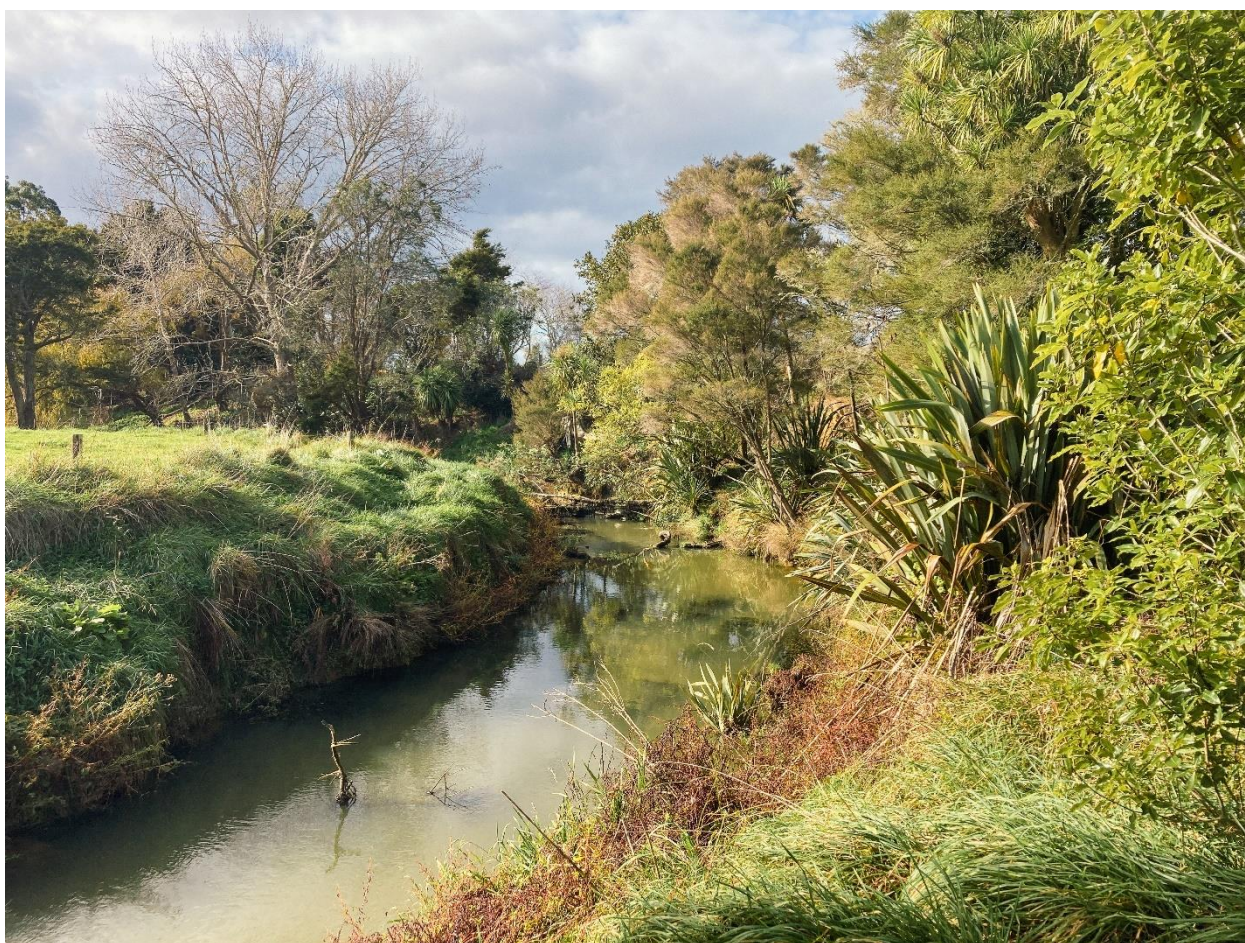
Address:	4212 State Highway 1, Waipu, Northland, 0582
ID:	Mid Ahuroa Ecological Corridor
Catchment Name:	Ahuroa
Main Issues Found in the Reach/Catchment:	Erosion, Flooding and Weed Invasion
Status of Work by Community Group(s)	Ongoing
Community Group Comments:	The landowner is experiencing significant flooding and erosion along the banks. He had attempted to

<p>plant a riparian margin, unfortunately the attempts were unsuccessful in some areas due to large flow events. The strength of the water flow caused trees, and other plants to be washed away. He is now interested in replanting riparian margins but is unsure which species would survive in this particular area.</p>
Current Biodiversity Value (Including Catchment Context)	<p>This section sits within the transitional zone of the permanent meandering Ahuroa River. This river has high sinuosity, and, in this section, is prone to erosion and flooding. This stretch is an important connection between the upper catchment and the sea. The dispersion potential for herpetofauna and birds is currently compromised due to the discontinuity of the riparian vegetation.</p>
Potential Biodiversity Value (Including Catchment Context)	<p>Given the importance of this region as an ecological corridor connecting the upper catchment to the ocean, there is potential for it to serve as a vital pathway for various species. By establishing a continuous riparian buffer in this area, not only can we facilitate the movement of wildlife, but we can also help safeguard the riverbanks from erosion. The creation an ecological corridor will undoubtedly contribute to the overall biodiversity, services and erosion resilience to this reach. From a terrestrial perspective, a continued green corridor can allow for the dispersion of vertebrates' species such as: birds, reptiles and frogs.</p> <p>Due to the pastoral nature of the neighbouring catchment area, implementing a wide and extensive riparian planting scheme will lead to improvements in aquatic organisms. This is primarily due to the enhanced shading effect and increased nutrient absorption.</p>

Figure 12 displays a photo facing downstream of the Ahuroa River.

Riparian Margin Area (m²):	~240,000m ² (8,000 m long x 15 m wide x 2 sides)
Length of Fencing and Riparian Margin (m):	8,000 m x 2 = 16,000 m
Success Measure Recommended by Specialist:	Improve riparian buffer and connectivity. Exclude stock by fencing.

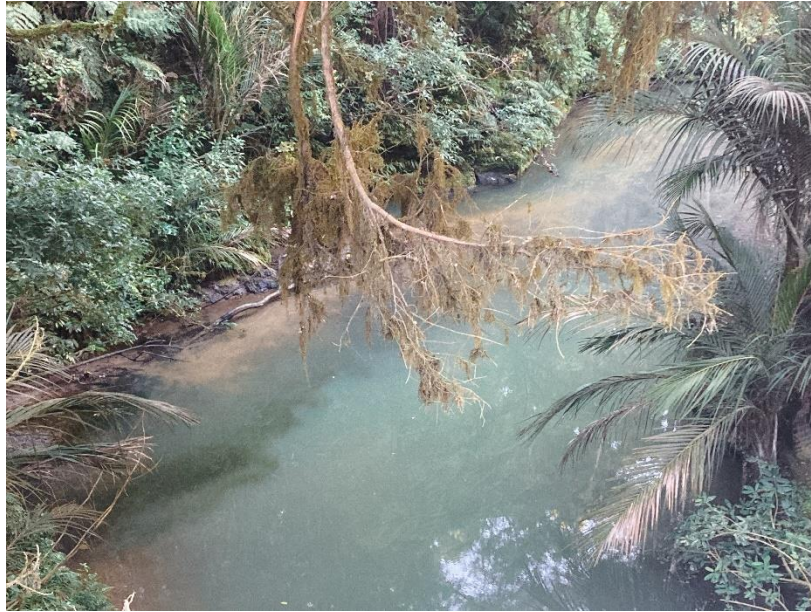
Figure 13 depicts the discharge from the upper catchment. Water coming from the left side of the photo comes from the Ahuroa River upper catchment, and from the right side of the photo comes from the Piroa Stream.

Success Measure Recommended by Specialist:	<p>Water quality- testing showing no effects from upstream activities. Effective pest management.</p>
