# **Assessing streambank erosion and riparian characteristics: comparison of field- and imagery-based methods**

June 2026

Simon S. Vale, Paul G. Peterson.

Contract Report registration number: 2627-0003

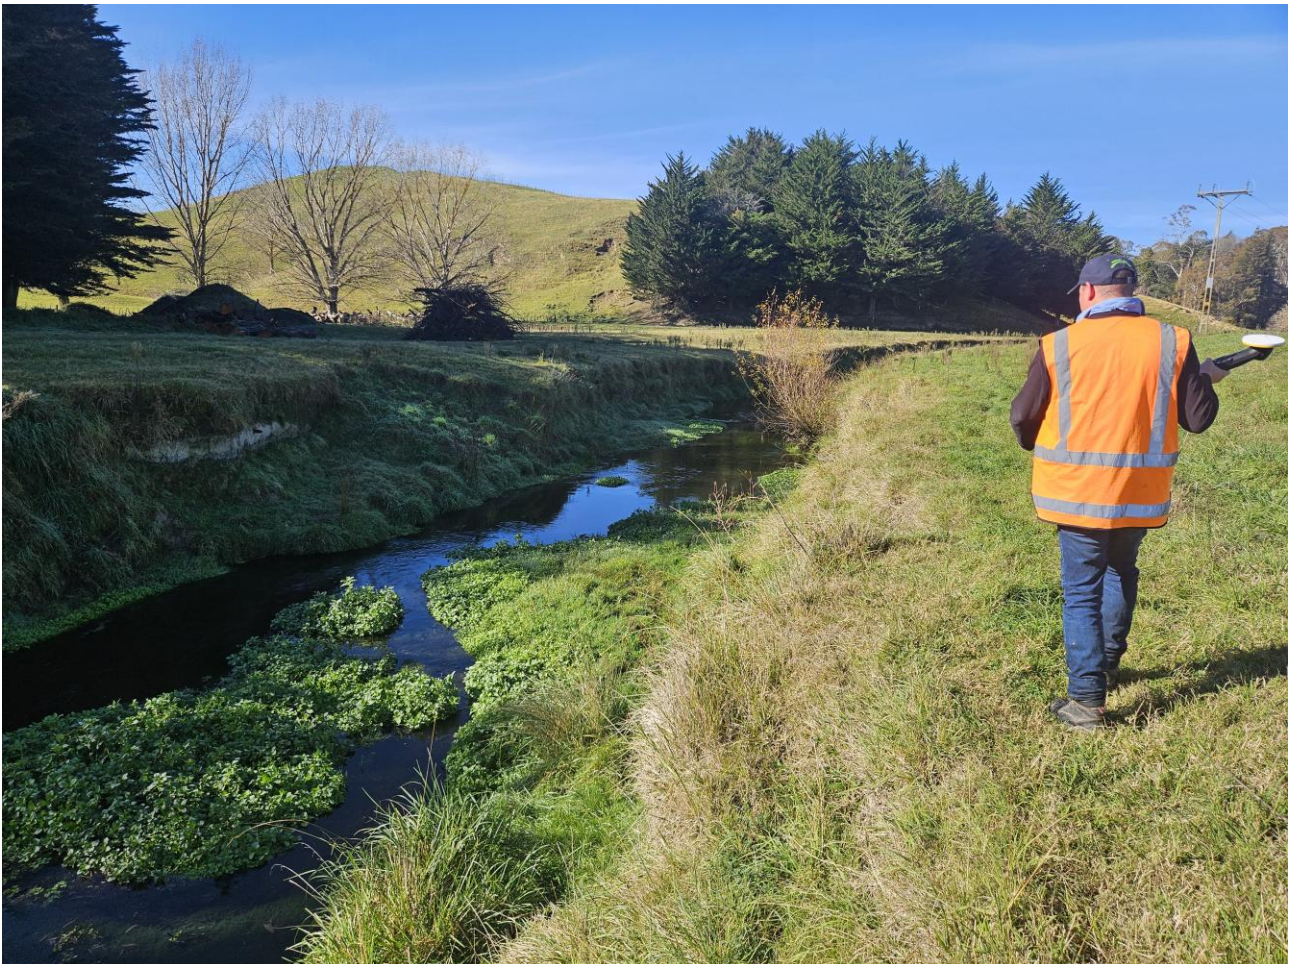
**Figure 3. Field assessment of streambank and riparian characteristics. Surveyors walked the stream reach recording georeferenced observations of streambank erosion, riparian vegetation, fencing, stock access, and other riparian characteristics.**

Each survey comprised an approximately 500 m stream reach. Starting at the upstream end of the reach, we traversed the riparian corridor on foot from upstream to downstream, generally remaining on one side of the stream, but changing sides where necessary to maintain access or improve visibility. We recorded general site information at the start of each reach, with representative point observations collected at the start, midpoint, and end (Table 1). Continuous streambank characteristics were recorded at the starting point and subsequently whenever a monitored characteristic changed on either the true left or true right bank (Figure 3). We recorded observations only where characteristics changed, enabling the reach to be subdivided into segments of relatively uniform condition while minimising unnecessary observations.

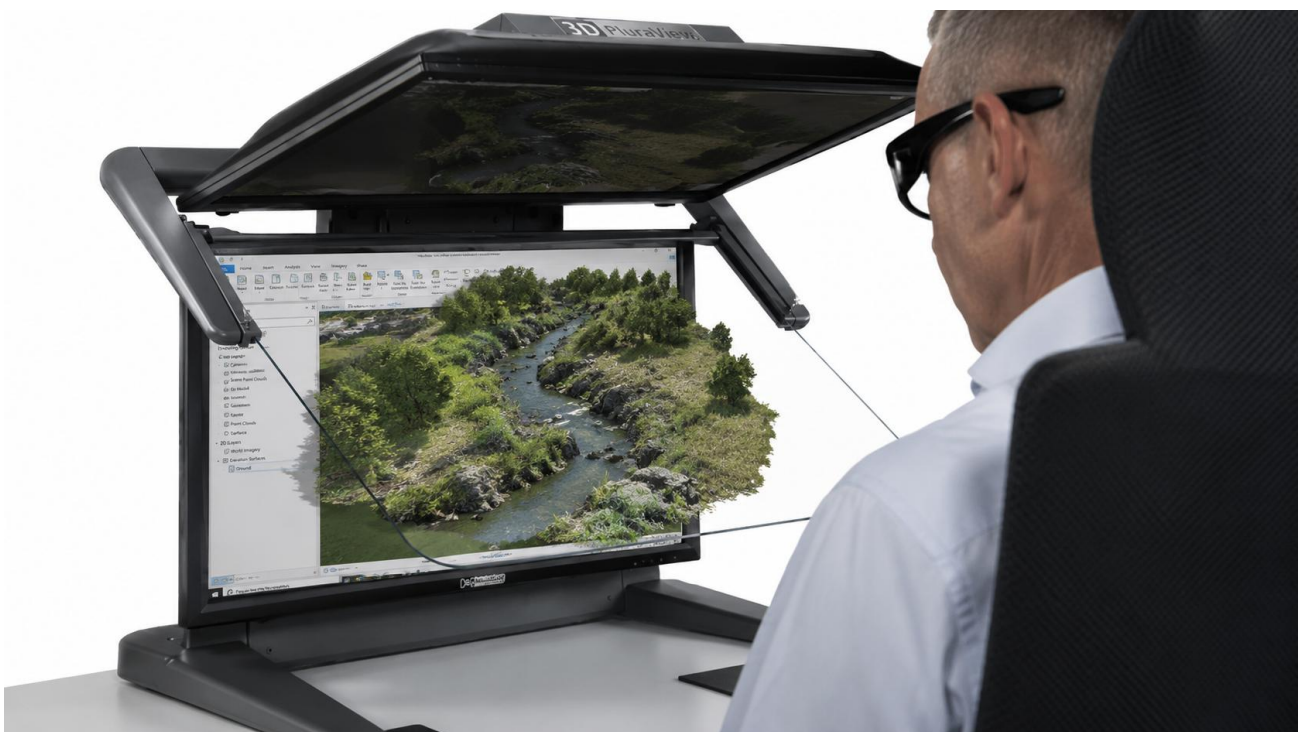
**Figure 5.** Example of the stereoscopic workstation used for desktop interpretation of overlapping aerial photographs. A dual-screen 3D PluraView display, dedicated graphics hardware, and active shutter glasses provided a three-dimensional view of the stream. (Source: adapted from <https://www.geospatialnext.org/workstation-for-gis-and-mapping/>)

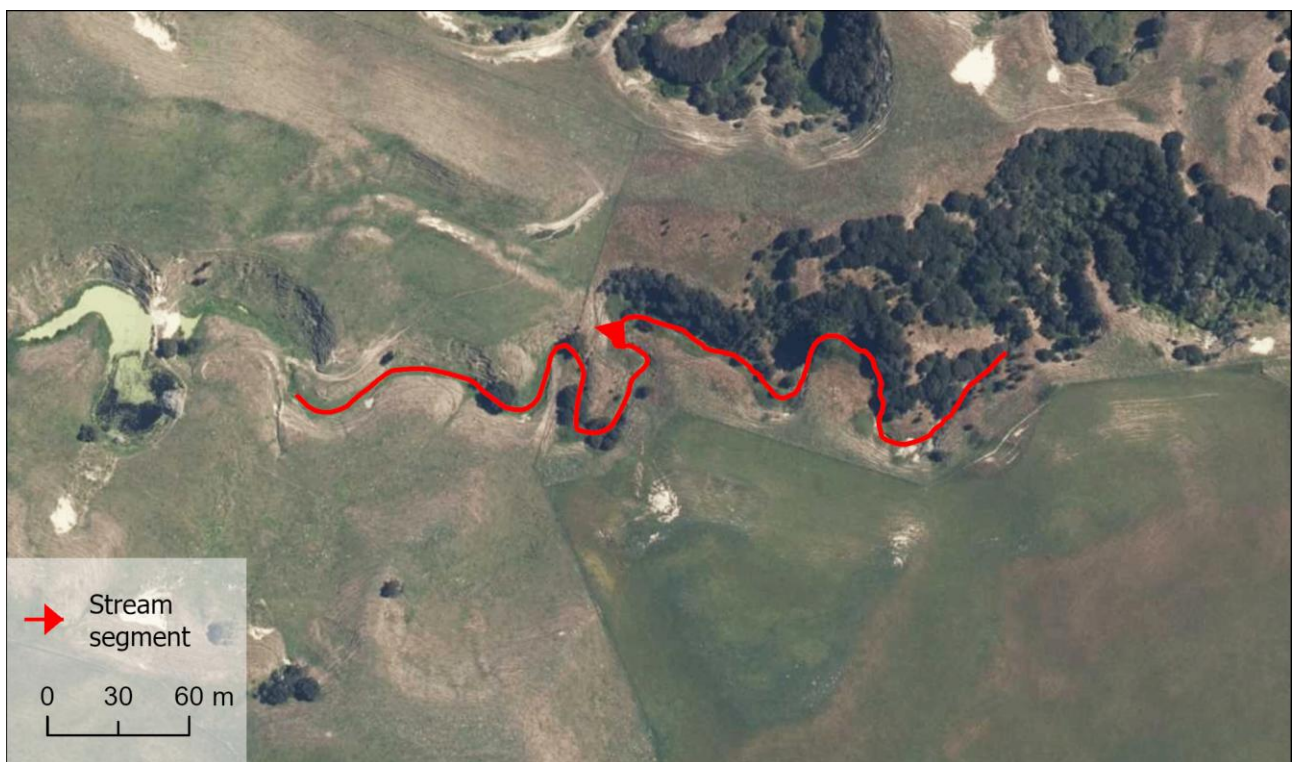
**Figure 6.** Example of the 25 cm standard resolution orthophotography used for desktop assessment of streambank and riparian characteristics. The red line indicates the surveyed stream reach used for the imagery assessment and the arrow shows the direction of flow.

We assessed each survey reach using the same stream extent of 500 m, segmentation approach, and classification framework (Table 1). Segments from the high-resolution assessment were retained as a starting point, and the assessor checked to see whether characteristics could still be seen in lower-resolution imagery. Where characteristics could not be interpreted with sufficient confidence they were recorded as unobserved (null) rather than inferred. Unlike the high-resolution assessments, interpretation relied solely on orthophotography because stereo imagery was not available. Following digitisation, the low-resolution imagery assessments underwent quality assurance, as was done with the high-resolution assessments.

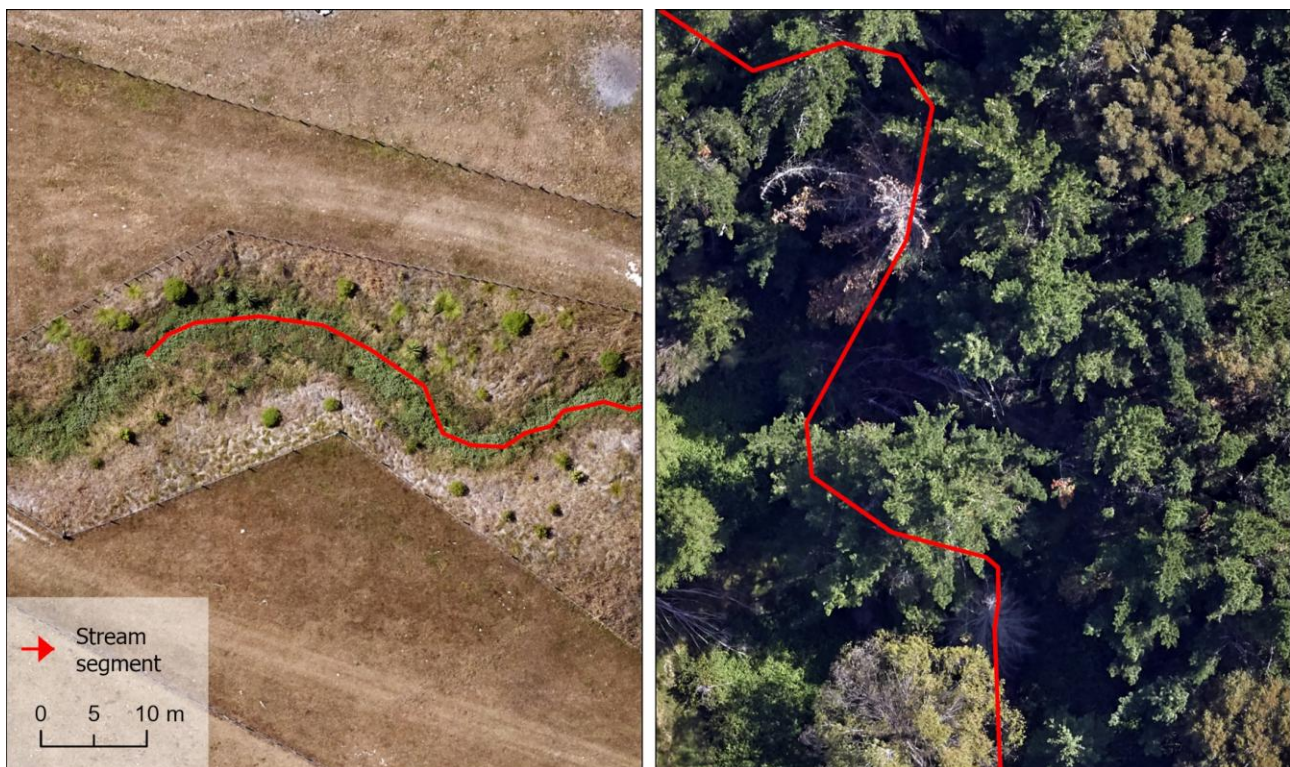
**Figure 22. Examples of stream reaches expected to exhibit high assessment repeatability. Clearly defined riparian margins, fences (left), and continuous woody vegetation (right) can be identified with minimal assessor interpretation.**

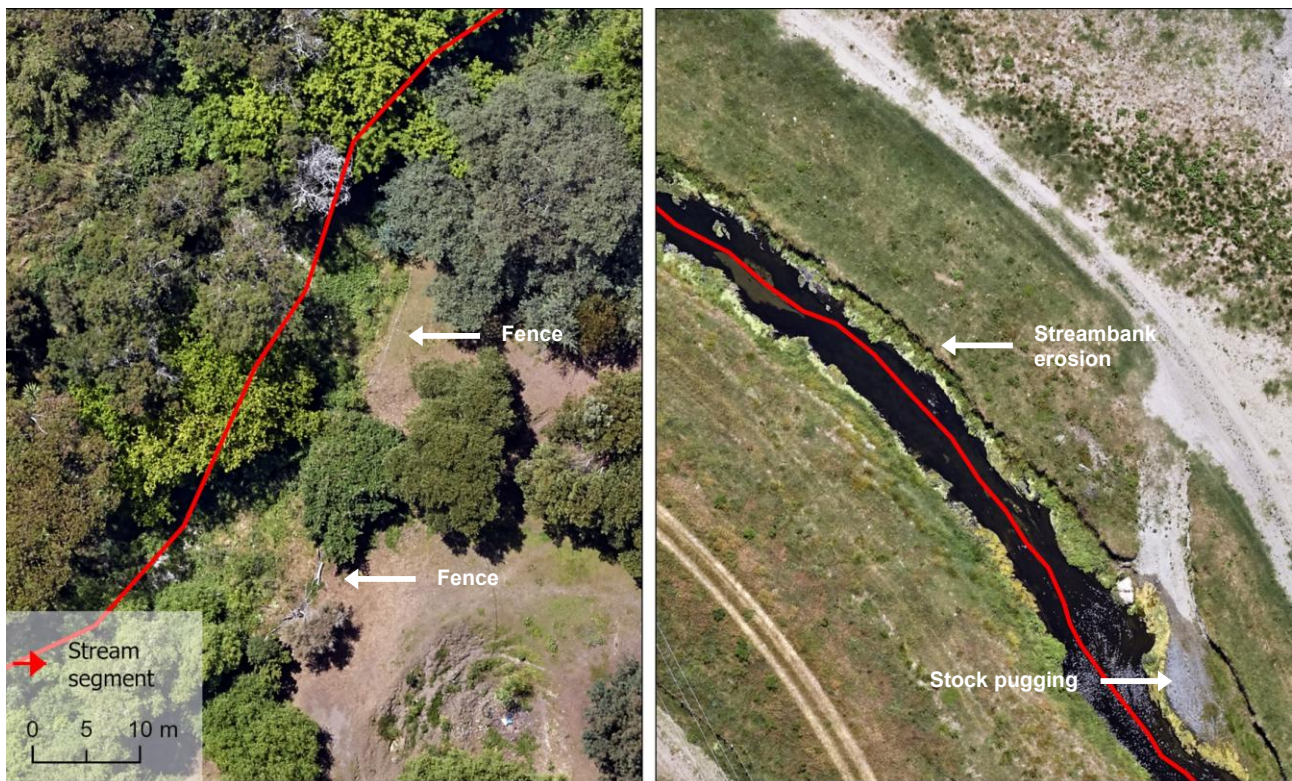
**Figure 23. Examples of stream reaches requiring greater assessor interpretation. The left image illustrates assessment of fence effectiveness where vegetation structure and riparian structure influence interpretation of stock exclusion. The right image shows streambank erosion and stock pugging, which are subtle, fine-scale characteristics that are more difficult to identify consistently from aerial imagery than from field observations.**

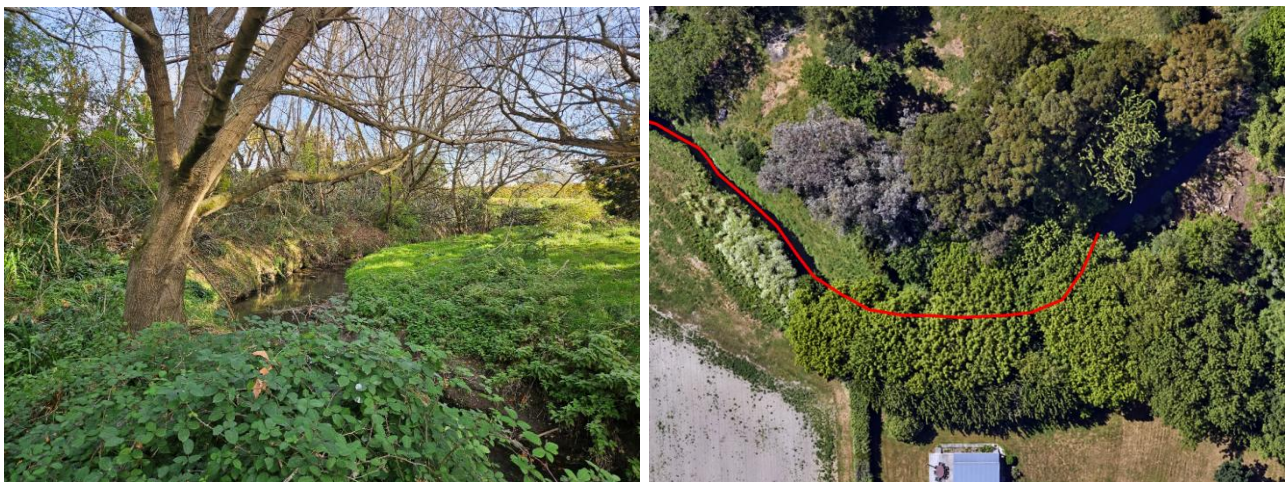
**Figure 24. Example of subjectivity in determining stream shading, partly influenced by seasonality of deciduous trees: even where complete canopy cover is clear from imagery (right), the field survey indicates some light is getting through so requires more judgement to determine if it would be complete or partial shading (left).**

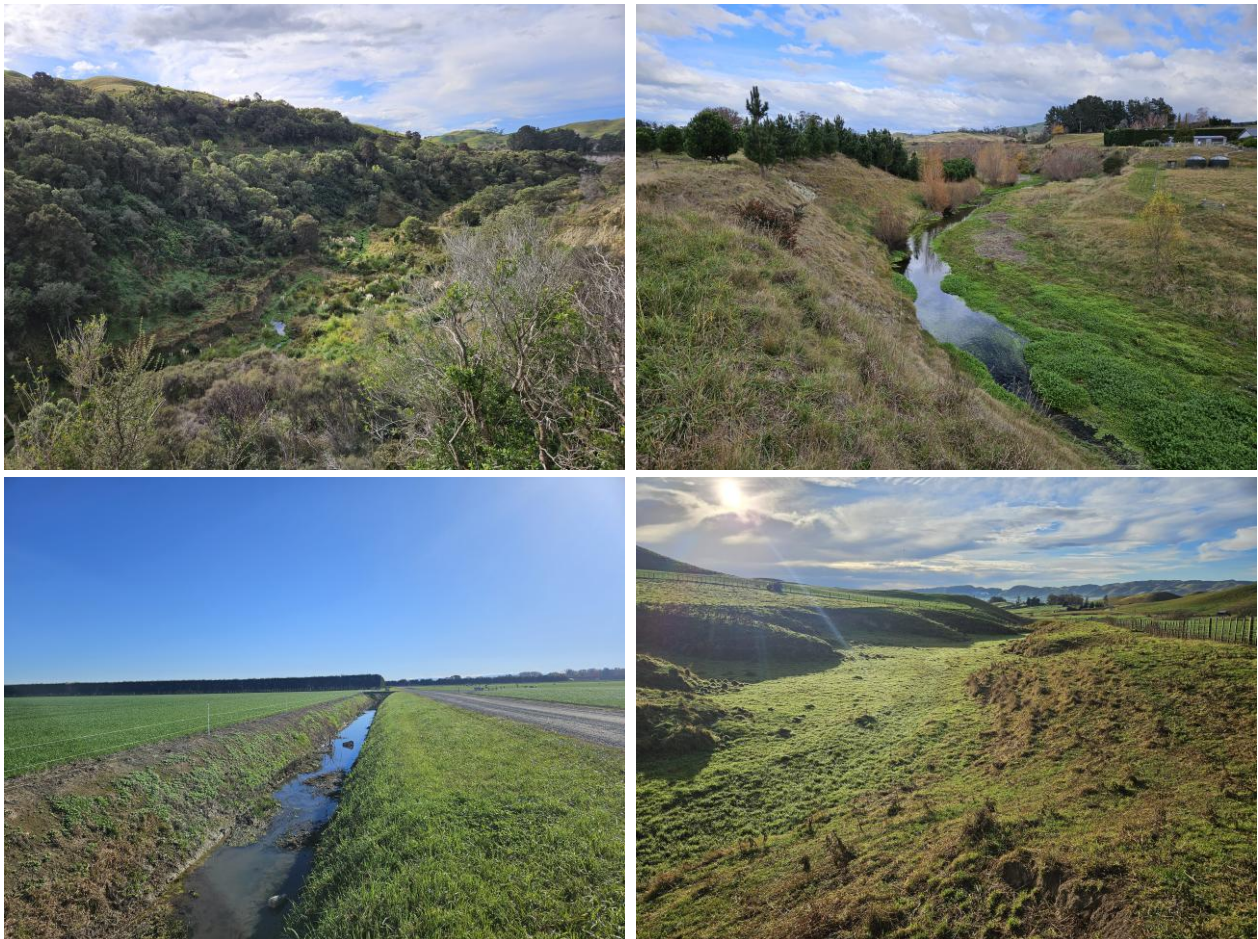
**Figure 25. Examples of channel settings that increase interpretation uncertainty. Complexity arising from diffuse floodplain margins, multiple bank surfaces, poorly defined channels, or extensive vegetation increases the importance of assessor judgement regardless of monitoring approach.**

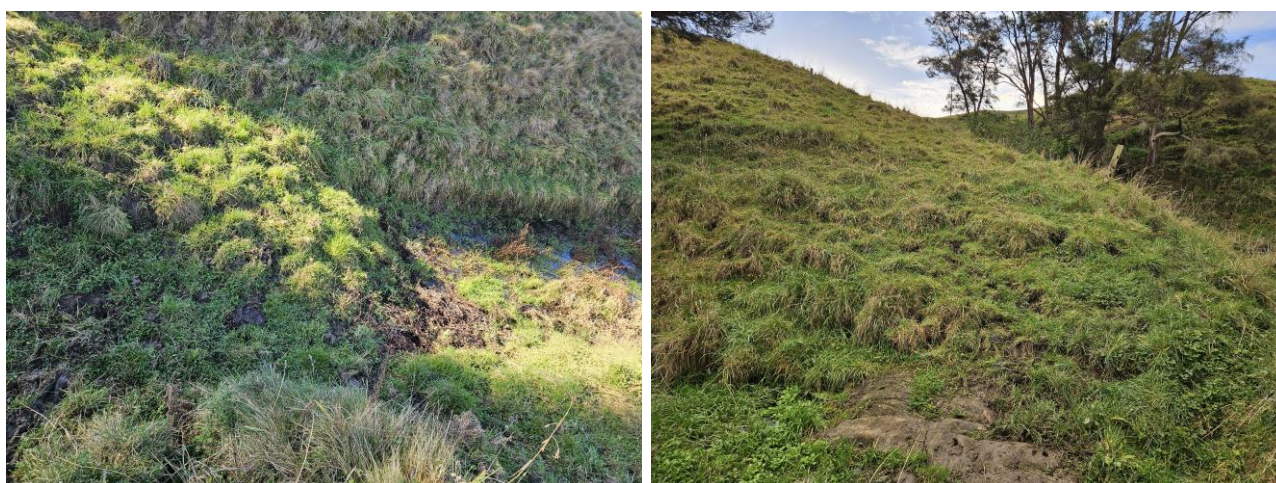
**Figure 26.** Examples of pugging observable during the field survey but difficult to identify from imagery, particularly standard-resolution imagery.

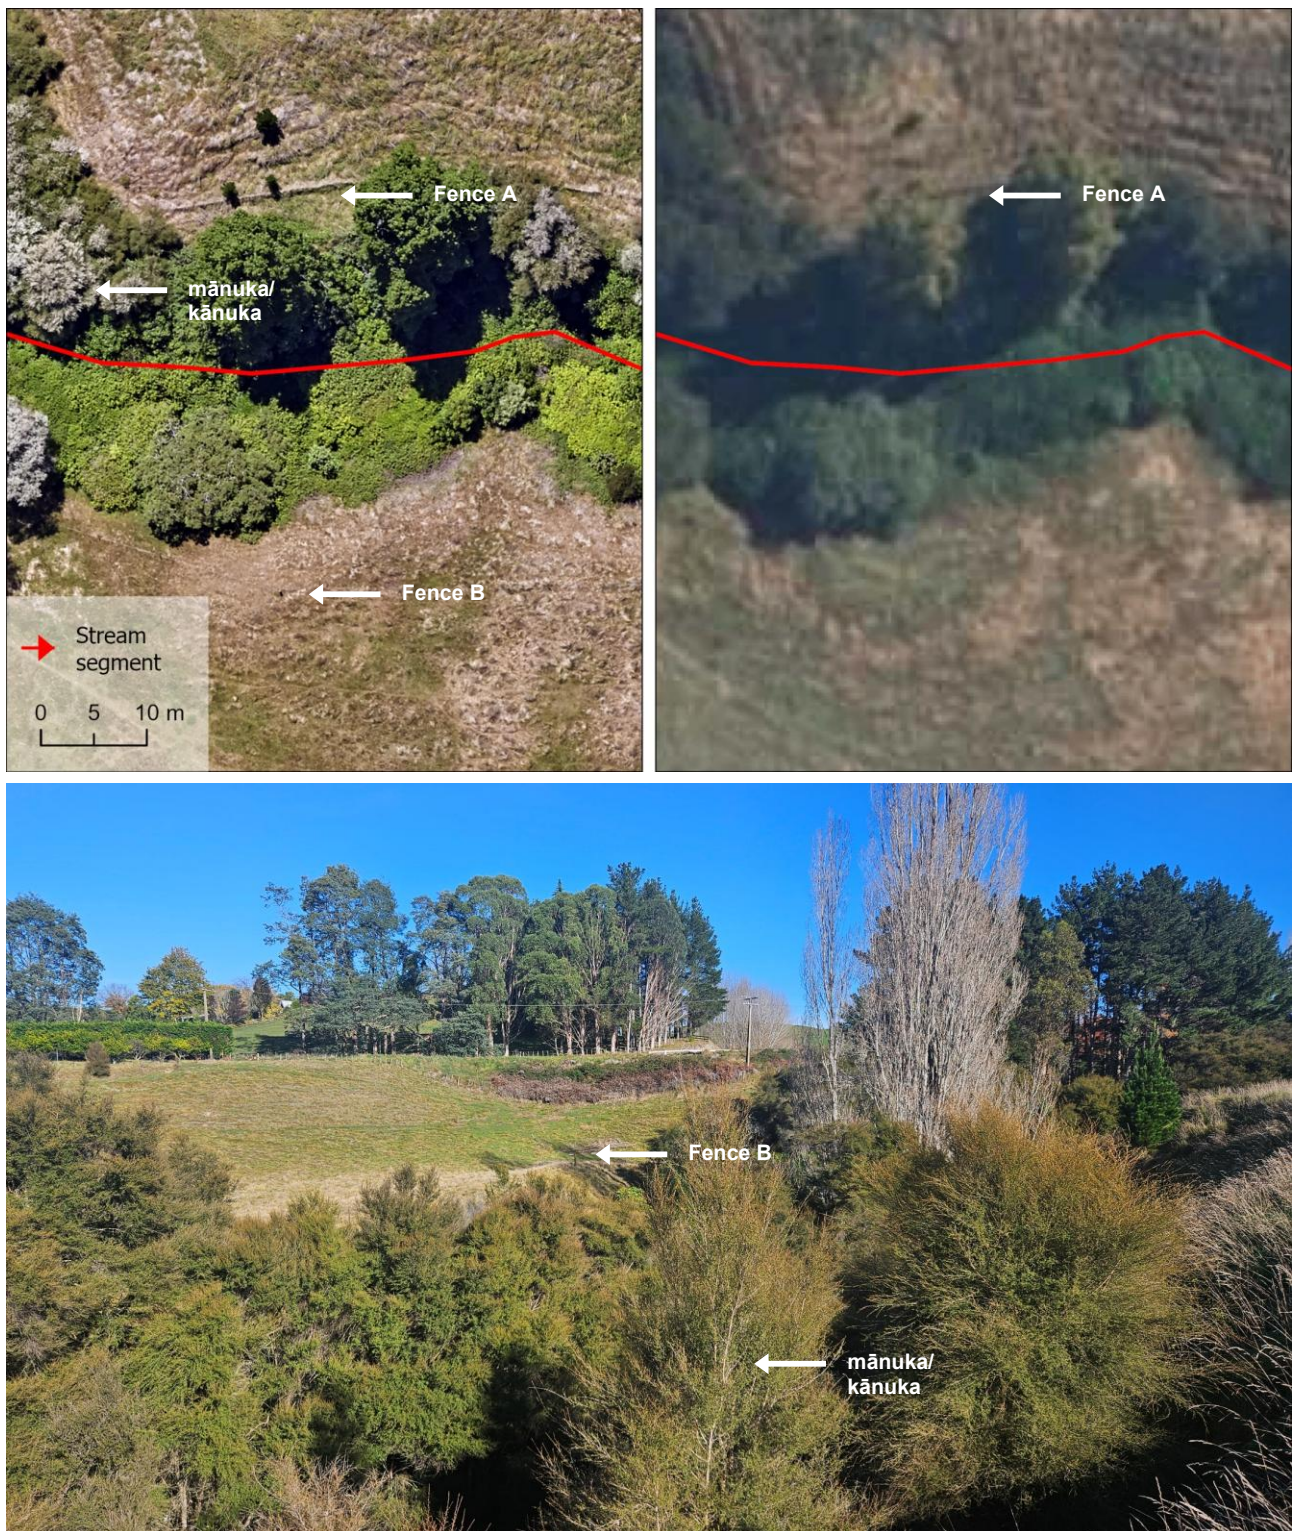
**Figure 27.** An example illustrating the influence of image resolution and survey perspective on riparian assessment. High-resolution imagery (top left) shows individual vegetation types (e.g. mānuka/kānuka, identifiable fences (Fence A and Fence B) as well as type, and narrow riparian features. In contrast, standard-resolution imagery (top right) provides only broad vegetation patterns and while Fence A is observable, Fence B is not. The field perspective (bottom) provides additional information on vegetation composition, and other characteristics that are less visible from an aerial perspective.

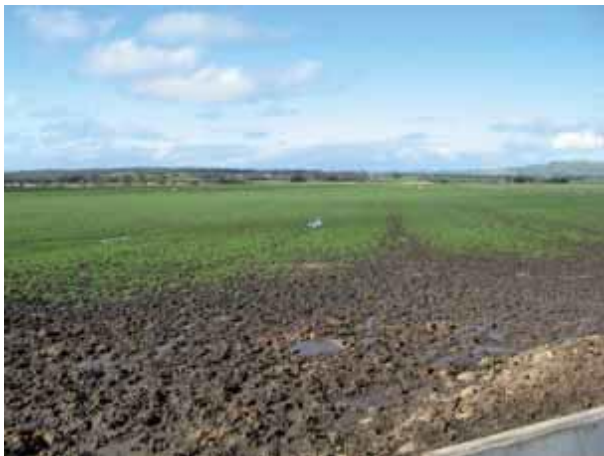
| Characteristic | Field | Description |
|---|---|---|
| | Pugging (>50%) | Soil trampled by livestock across more than 50% of the streambank area. |

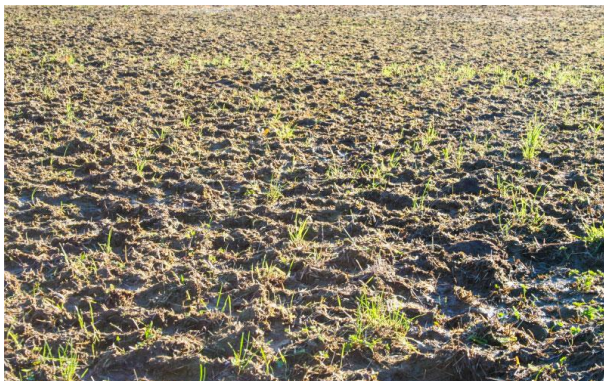
| Characteristic | Field | Description |
|---|---|---|
| | Pugging (<50%) | Soil trampled by livestock across less than 50% of the streambank area. |
