PFAS Detailed Site Investigation: Devonport Naval Base

New Zealand Defence Force

✦ December 2018

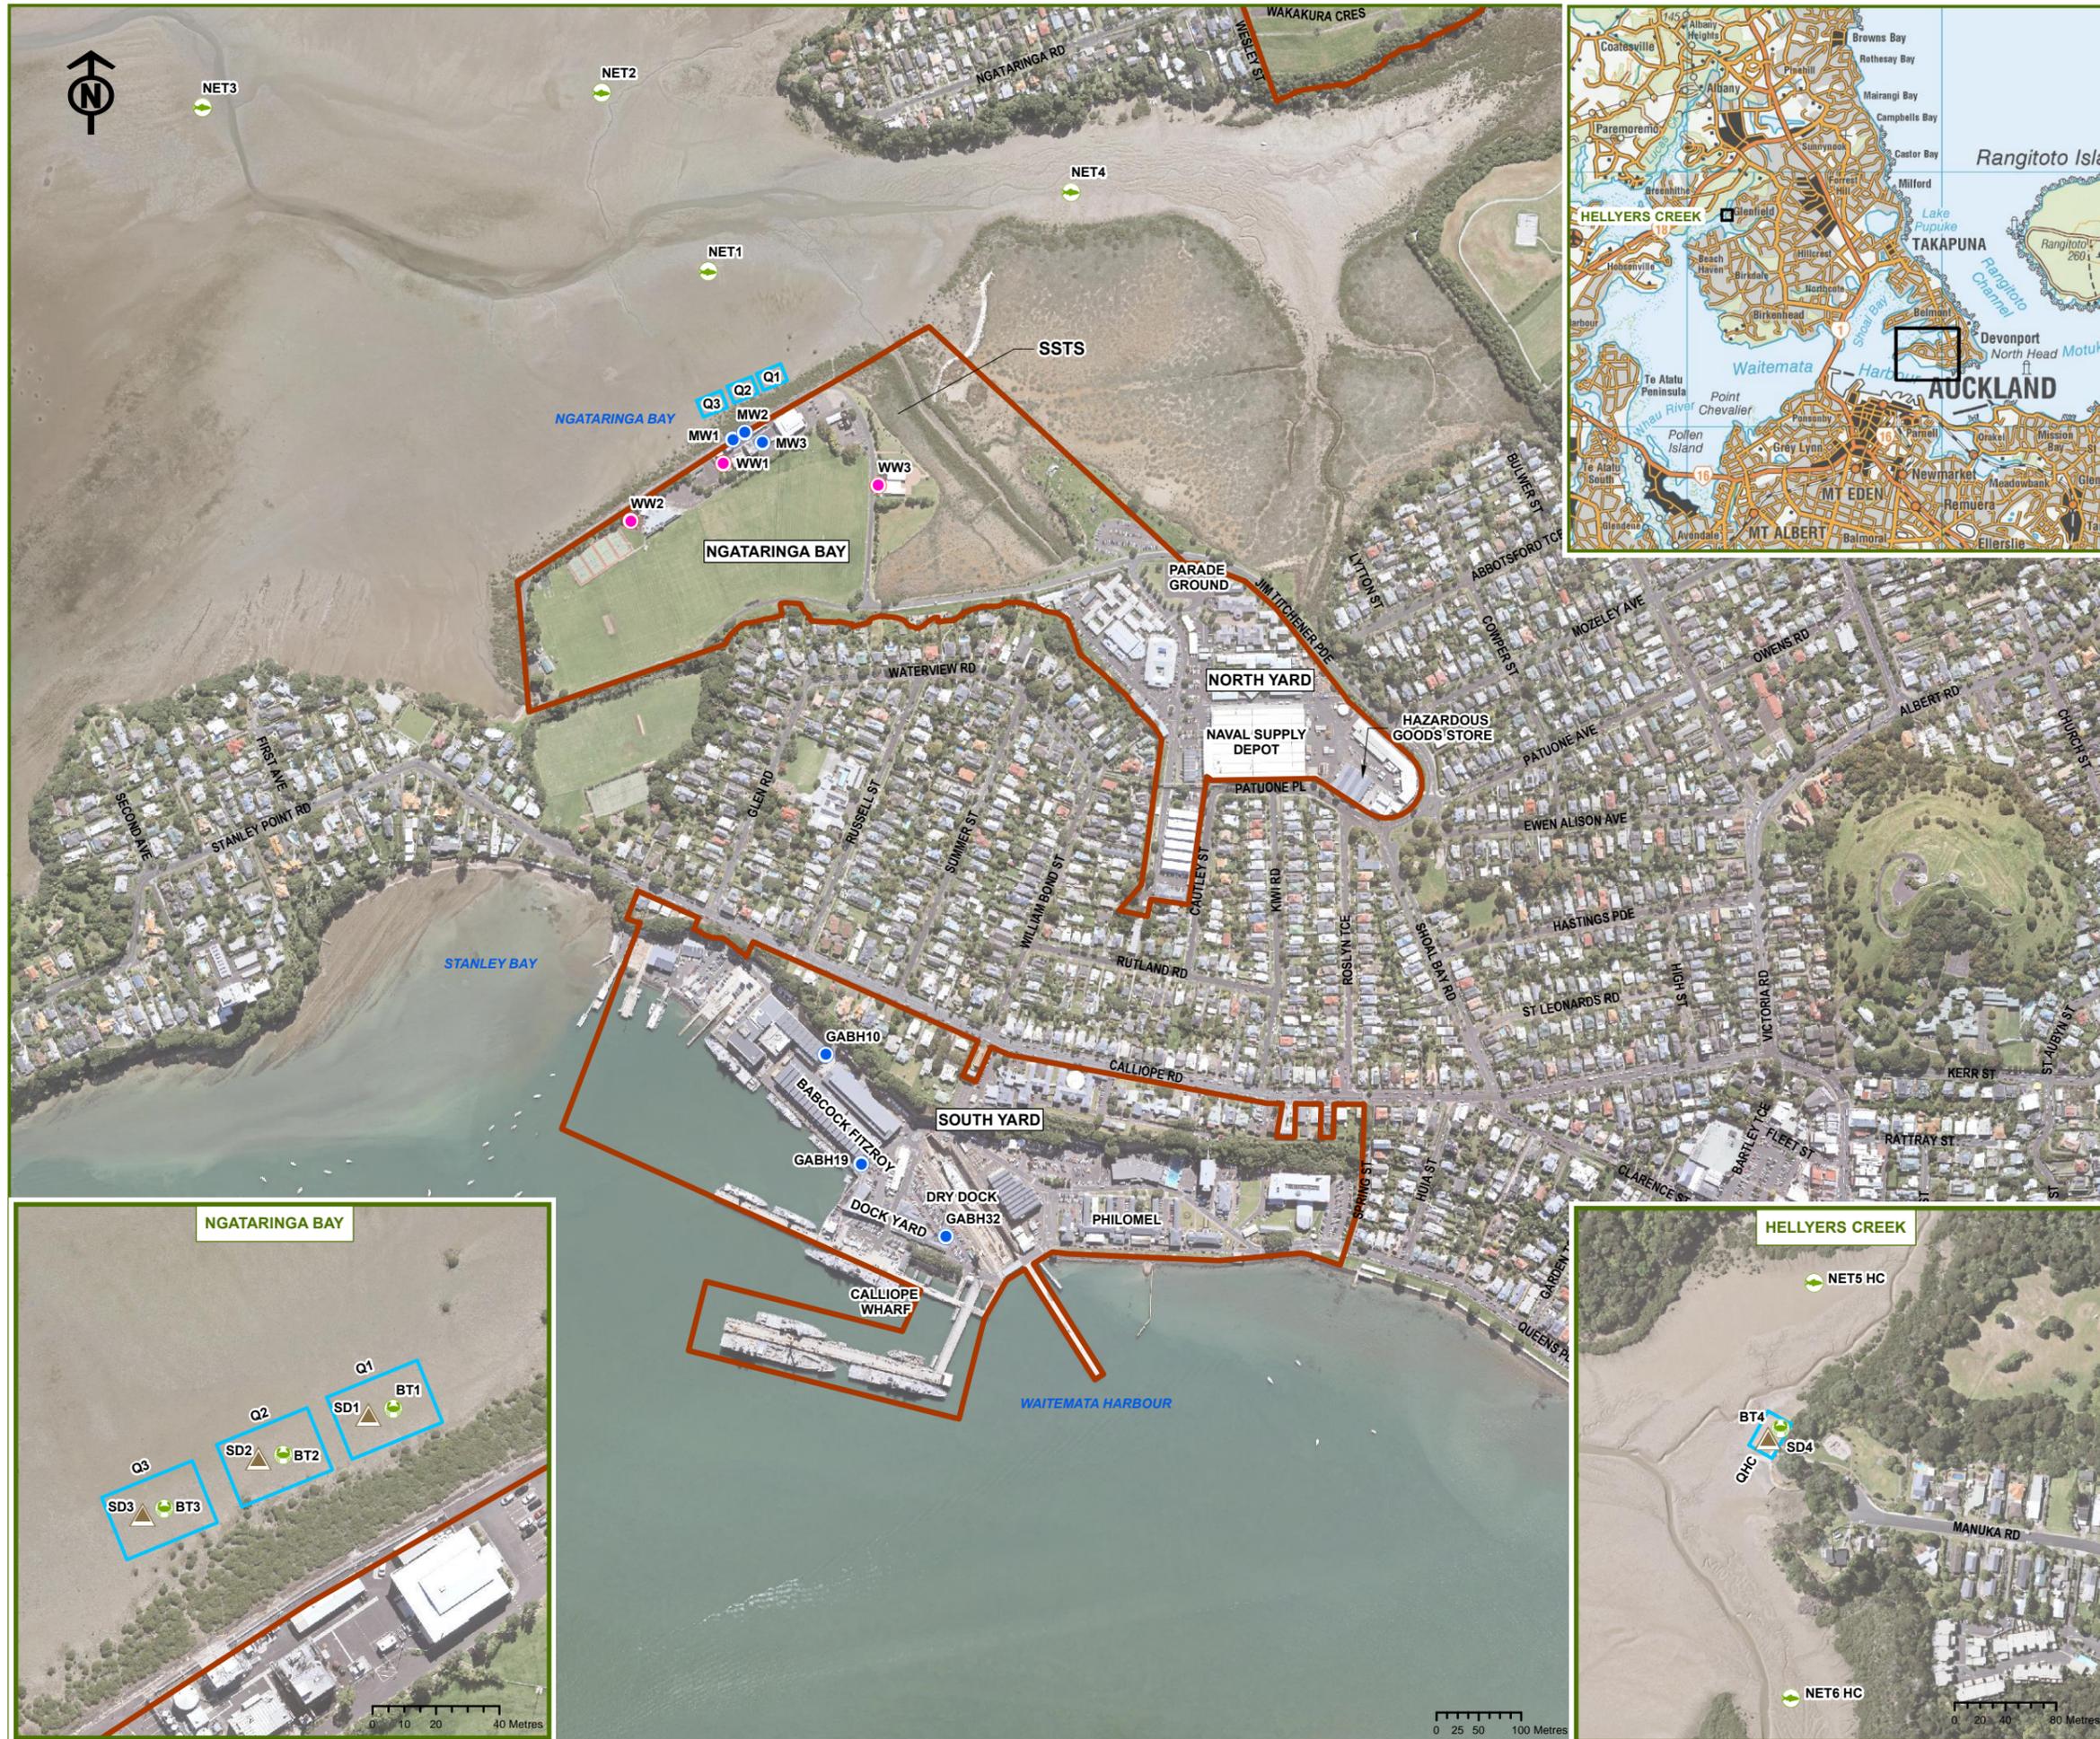
Pattle Delamore Partners Ltd (PDP) has been engaged by the New Zealand Defence Force (NZDF) to undertake a detailed site investigation (DSI) to investigate the potential for biota, sediment, groundwater and wastewater contamination relating to the historic use of products which contained per- and poly-fluoroalkyl substances (PFAS) at the Devonport Naval Base (DPT) in Devonport (the 'site'). The site is displayed on Figure 1.

Devonport Naval Base (Figure 1) is a large operating naval base located in Devonport in Auckland's Waitemata Harbour. The North Yard includes a number of offices for training and administration purposes, accommodation, a large supply depot and storage facilities. The South Yard includes the Calliope dry dock, Babcock workshops, wastewater treatment plant, bulk fuel storage facilities and along the eastern side: accommodation, dining facilities and offices. Most of the site is covered with impervious material comprising buildings or sealed areas. The Sea Safety Training Squadron (SSTS), sports complex and playing fields are located at Ngataranga Bay.

MW1 exhibited a slight hydrocarbon odour. No odour or visual contamination was observed in any other sample during the water and sediment sampling exercises. The sampling sheets and field notes are attached in Appendix C; refer to Figure 1 for locations.

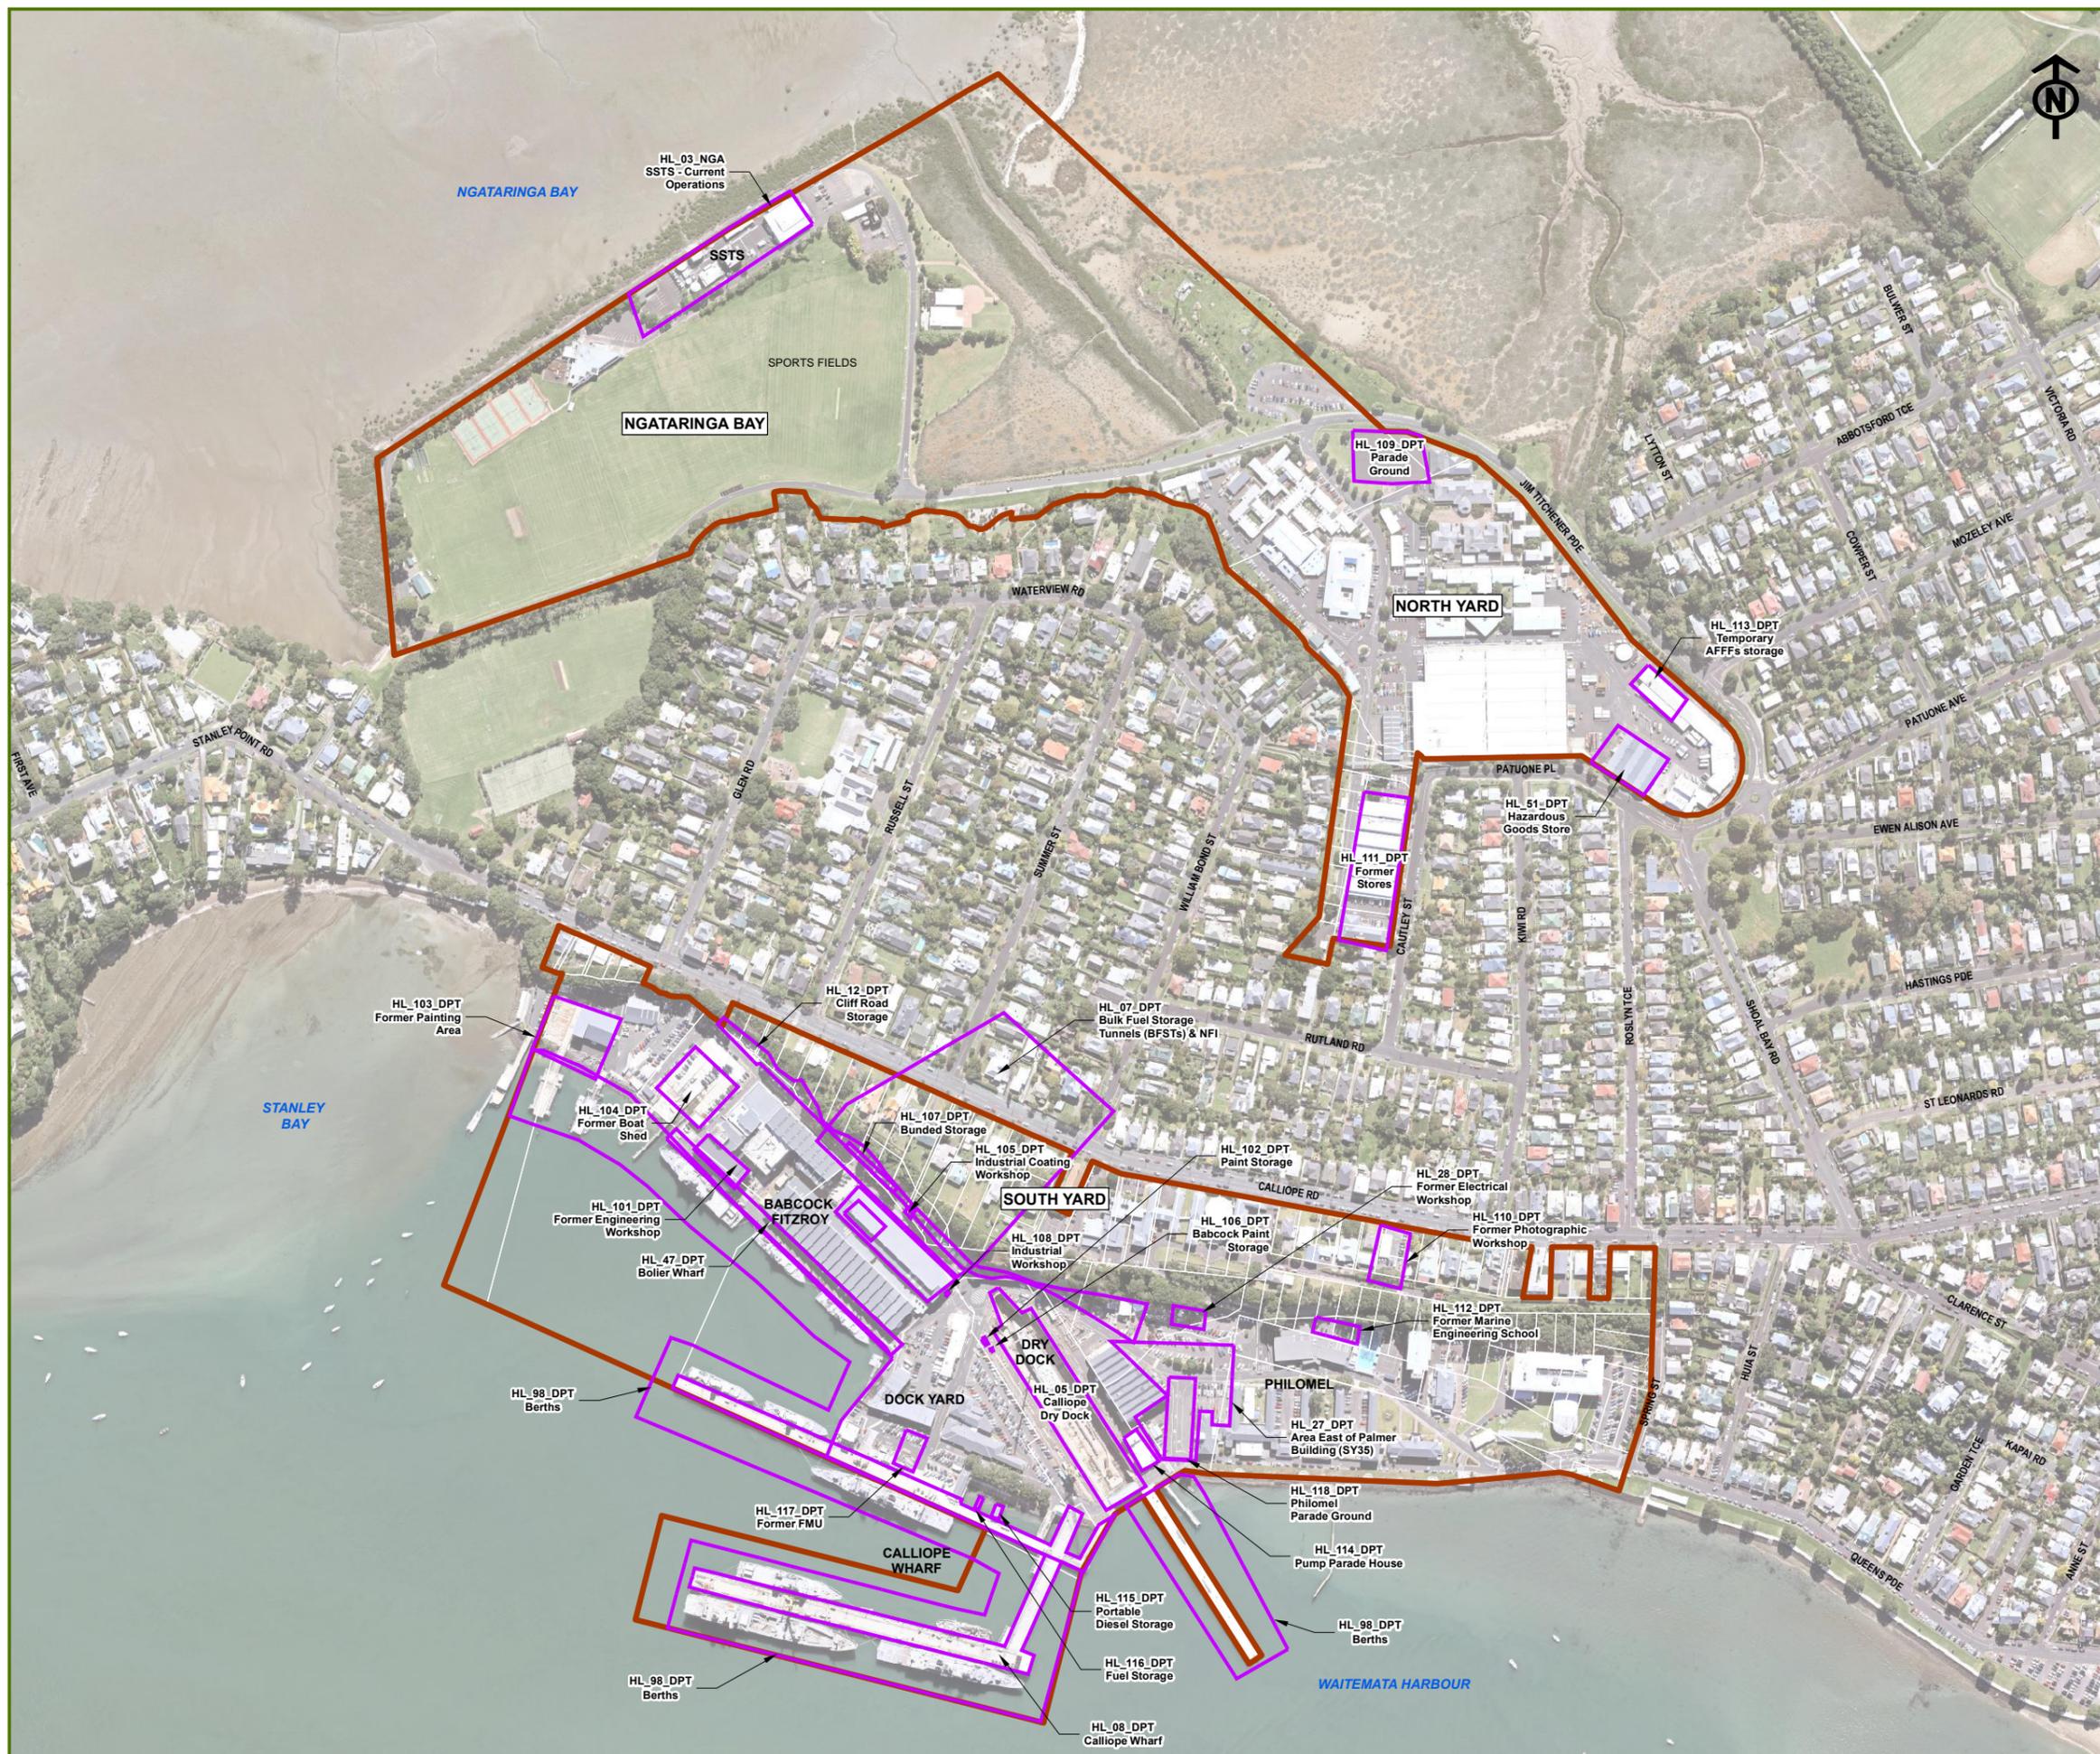
POTENTIAL PFAS SOURCE -
HAIL AREAS

NZDF maintains a Hazardous Activities and Industries List (HAIL) database. Each PFAS specific HAIL site identified through this DSI or prior investigations has been given a unique code in accordance with the *NZDF HAIL Investigation Report & GIS Specifications* (PDP, 2016), e.g. HL_03_NGA SSTS, these are shown on Figure 2.

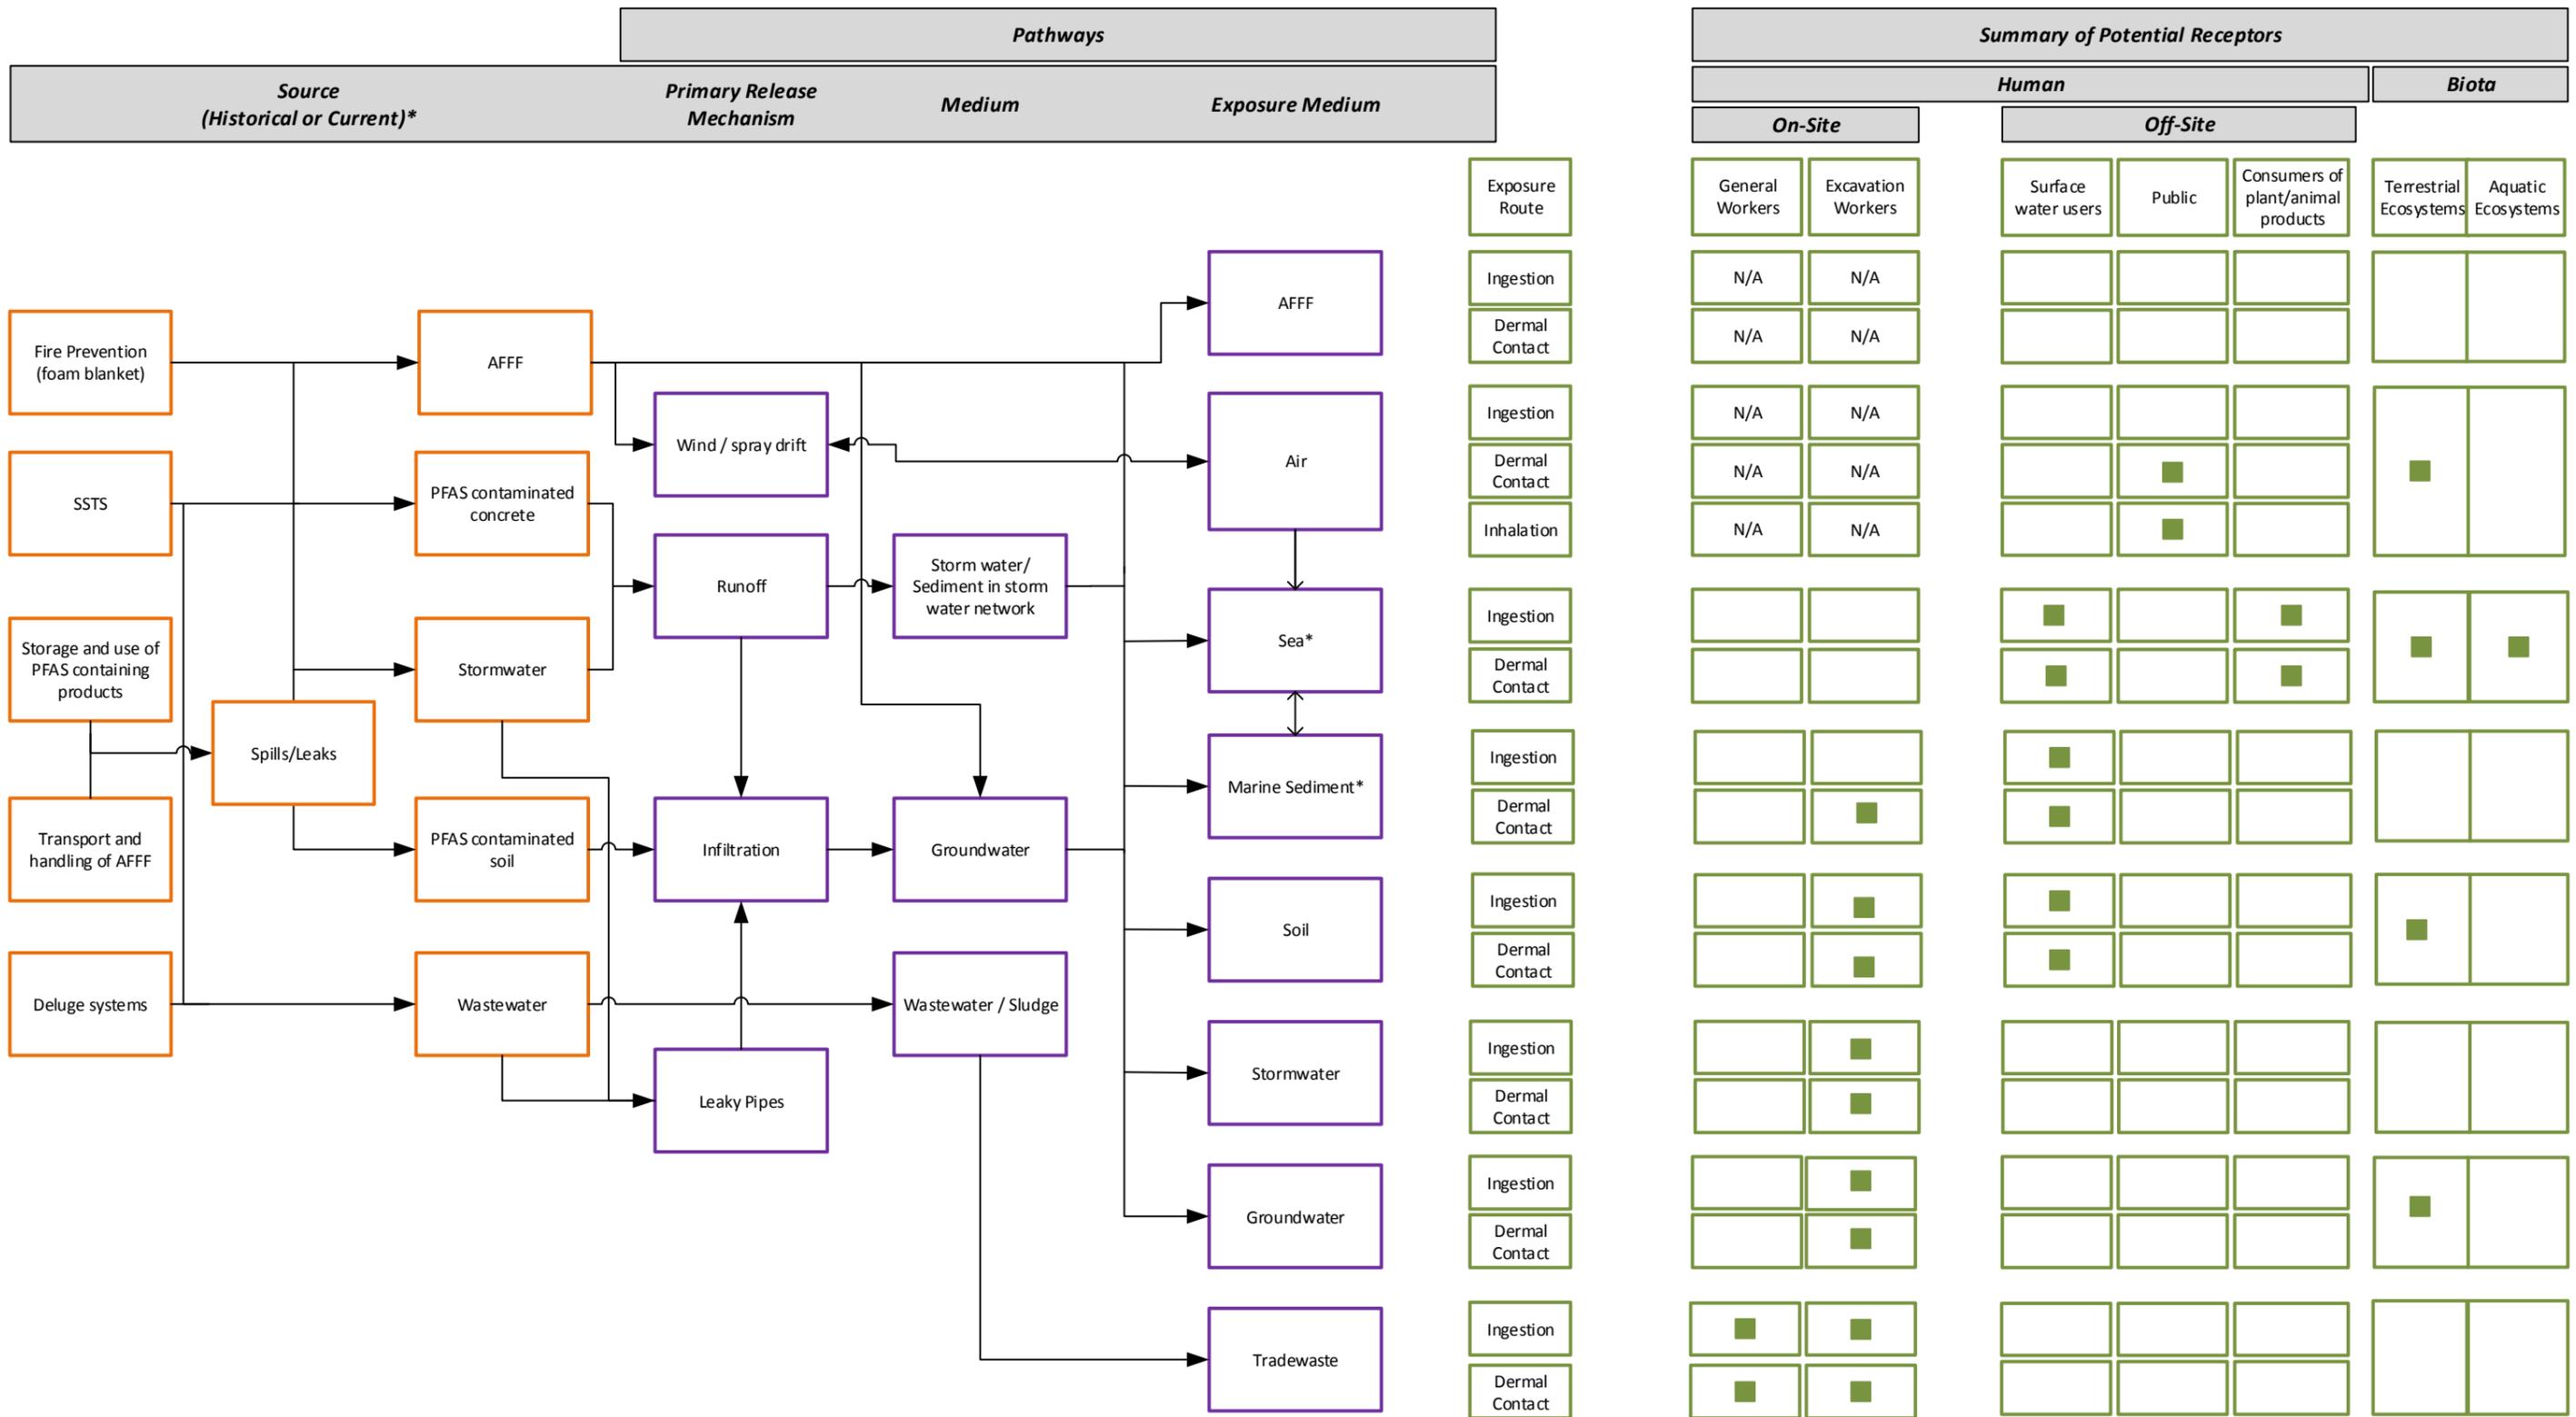
Conceptual Site Model – Devonport Naval Base

Key:
■ Potentially Complete Pathway
 Incomplete Pathway
N/A Addressed under the Health and Safety at Work Act, 2015

* There are other potential sources of PFAS to the Waitemata Harbour, these have not been considered in this CSM.

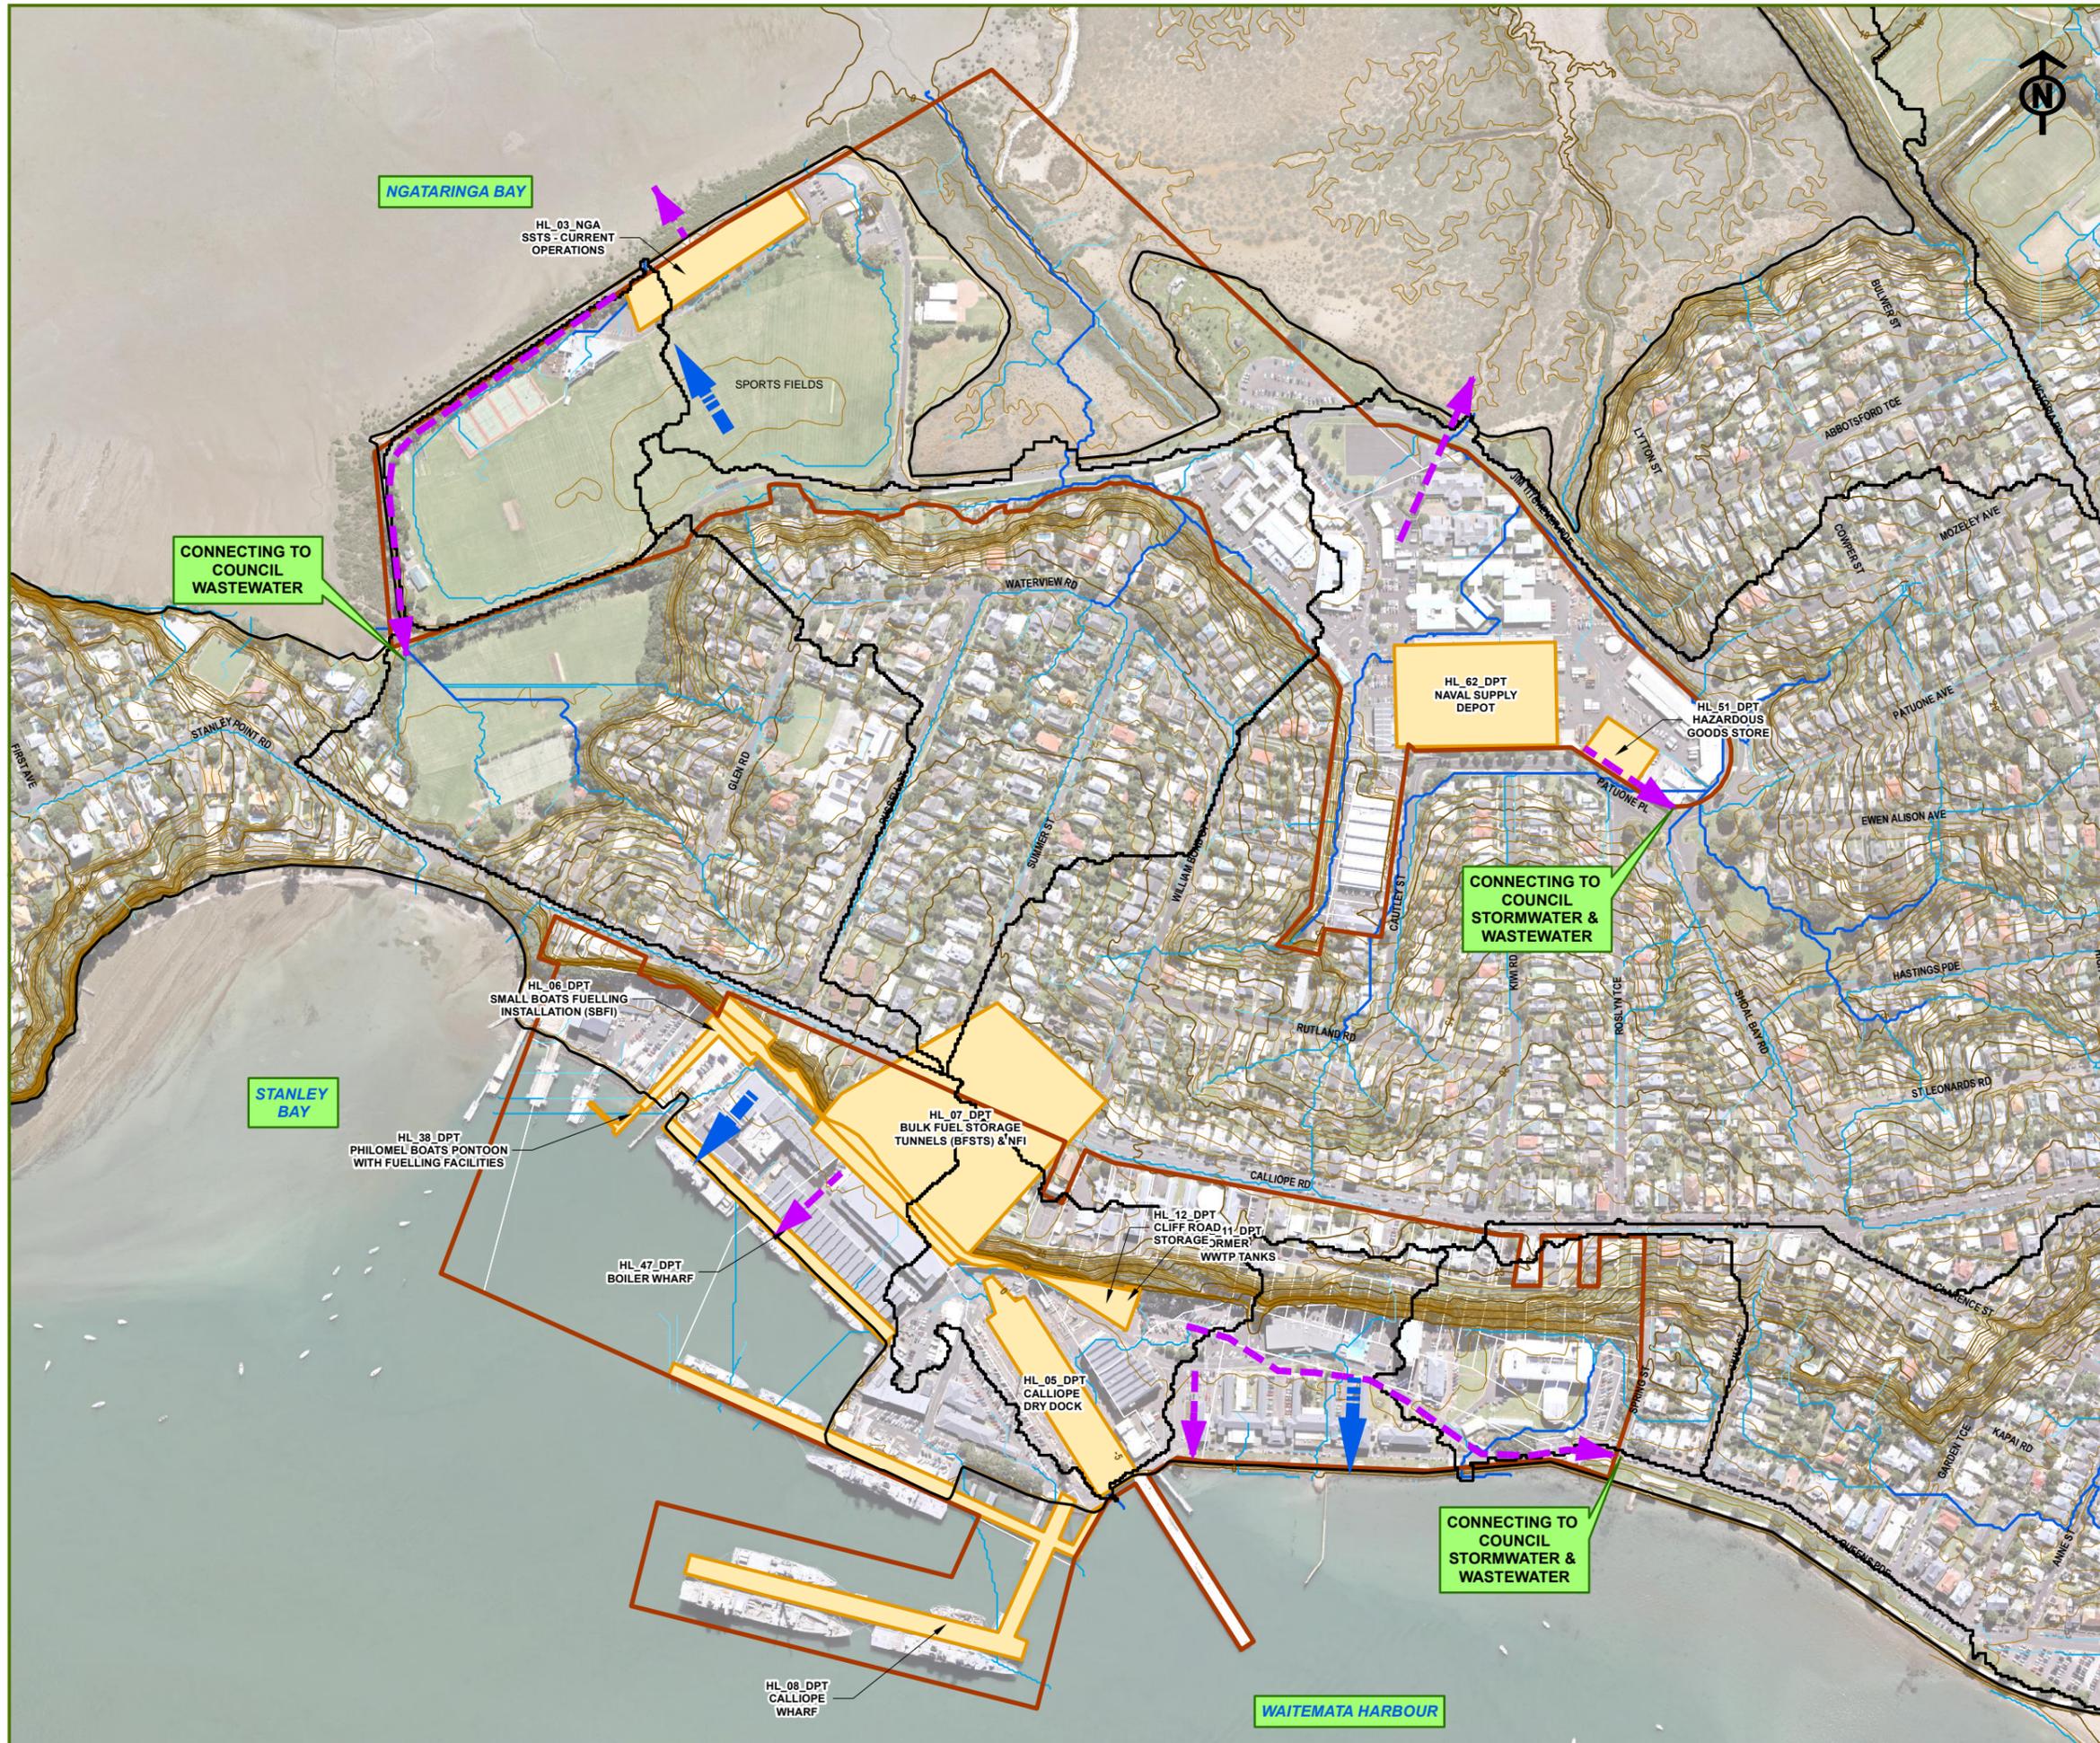
FIGURE TITLE:
CONCEPTUAL SITE MODEL - PLAN

At the SSTS and Ngataranga Bay Sports field, the groundwater flow direction is expected to be in a northeast to northwest direction towards Ngataranga Bay and the harbour. Groundwater flow direction at North Yard is expected to be in a general north direction towards Ngataranga Bay and the Waitemata Harbour. At South Yard, the groundwater flow direction is expected to be in a south to southwest direction towards Stanley Bay and the Waitemata Harbour.

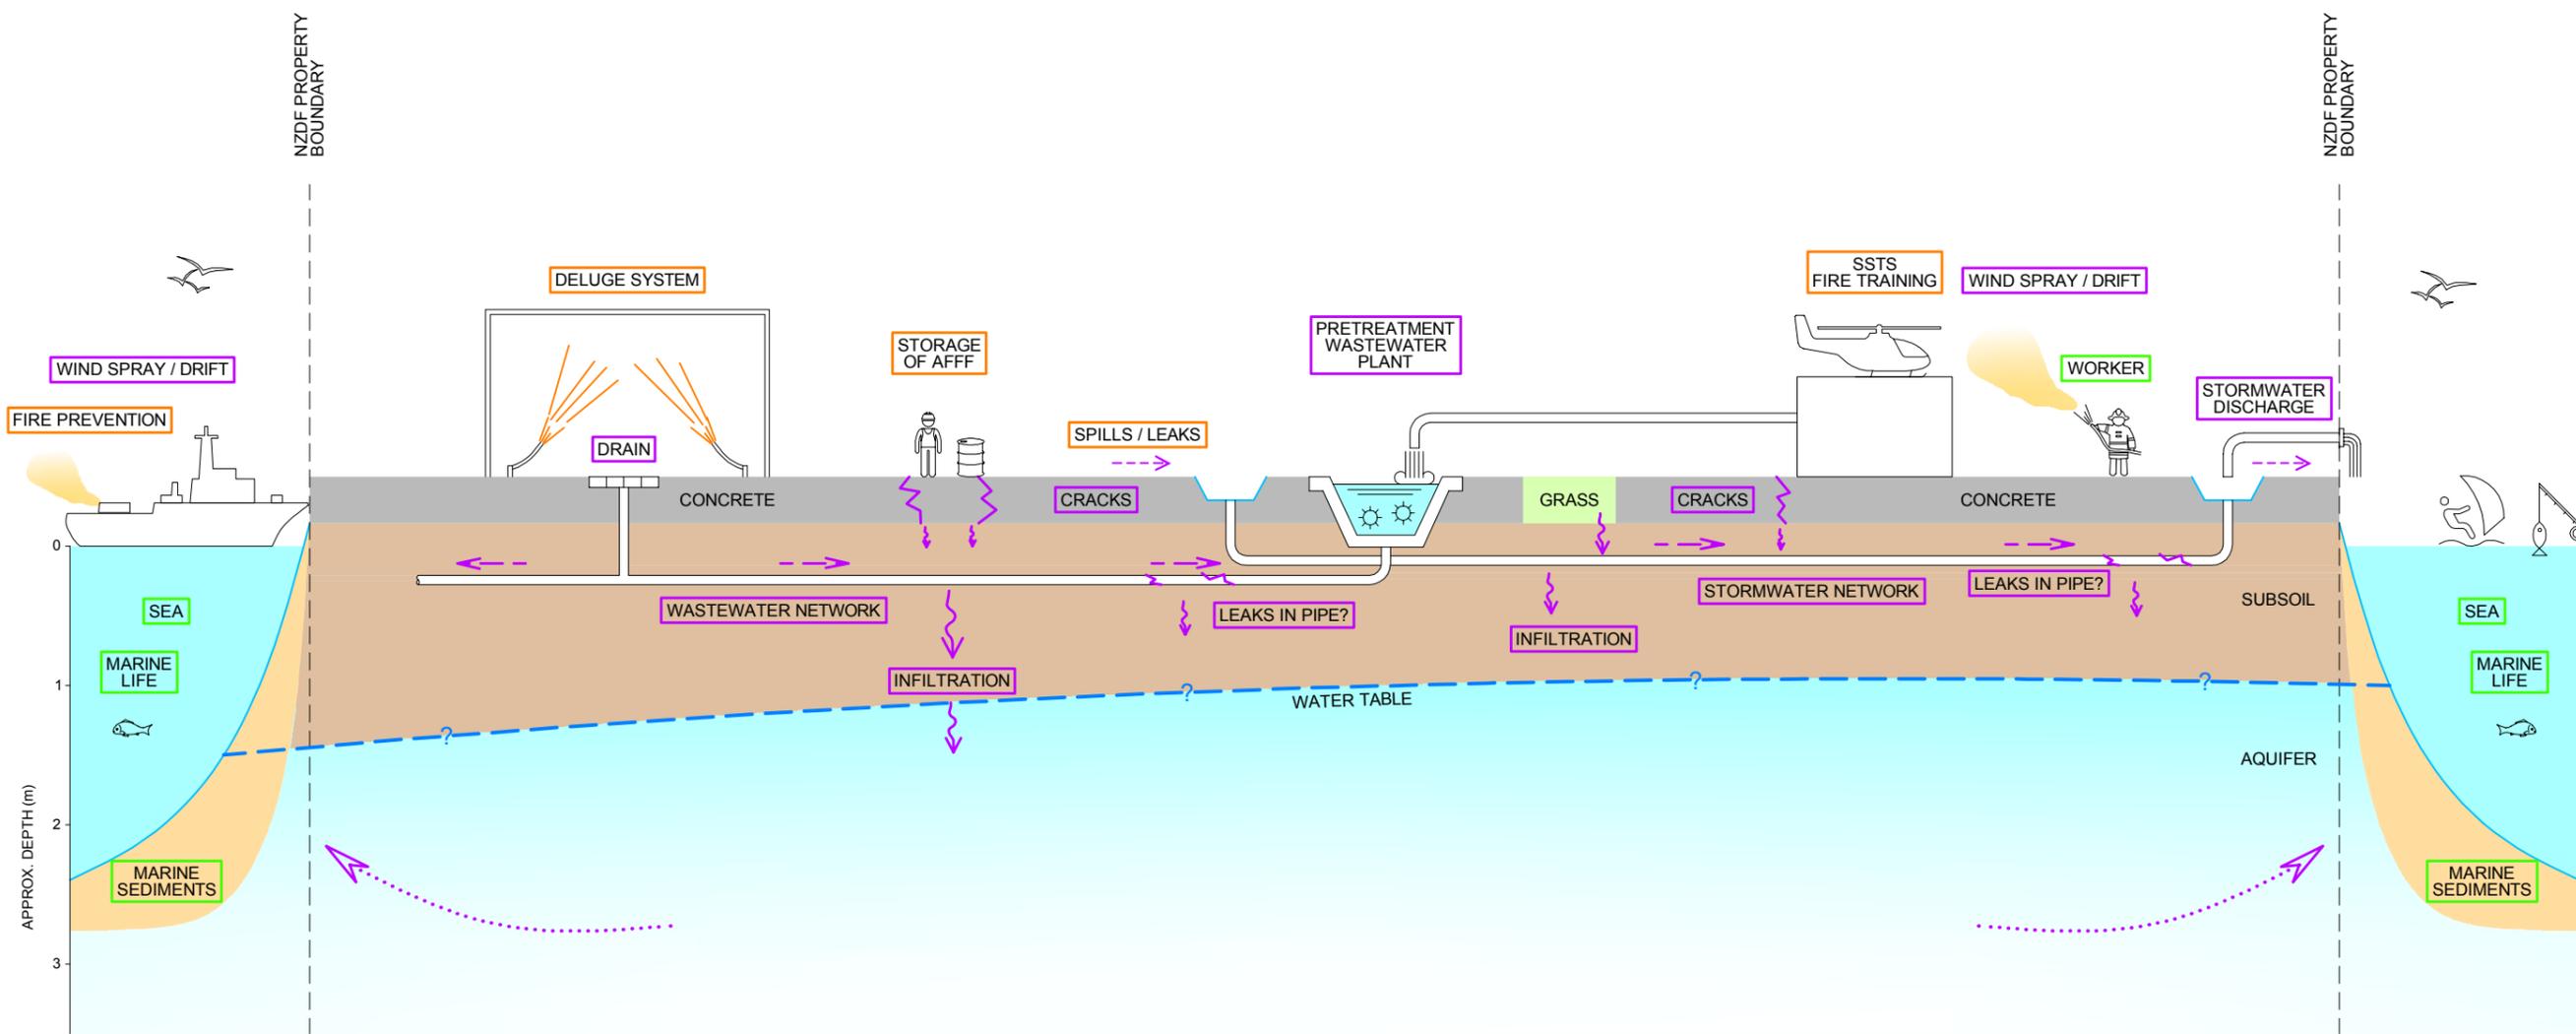
FIGURE 5: HMNZS DEVONPORT NAVAL BASE - PFAS
DSI CONCEPTUAL SITE MODEL - PROFILE

KEY	
[Orange Box]	SOURCE
[Purple Box]	PATHWAY
[Green Box]	RECEPTOR

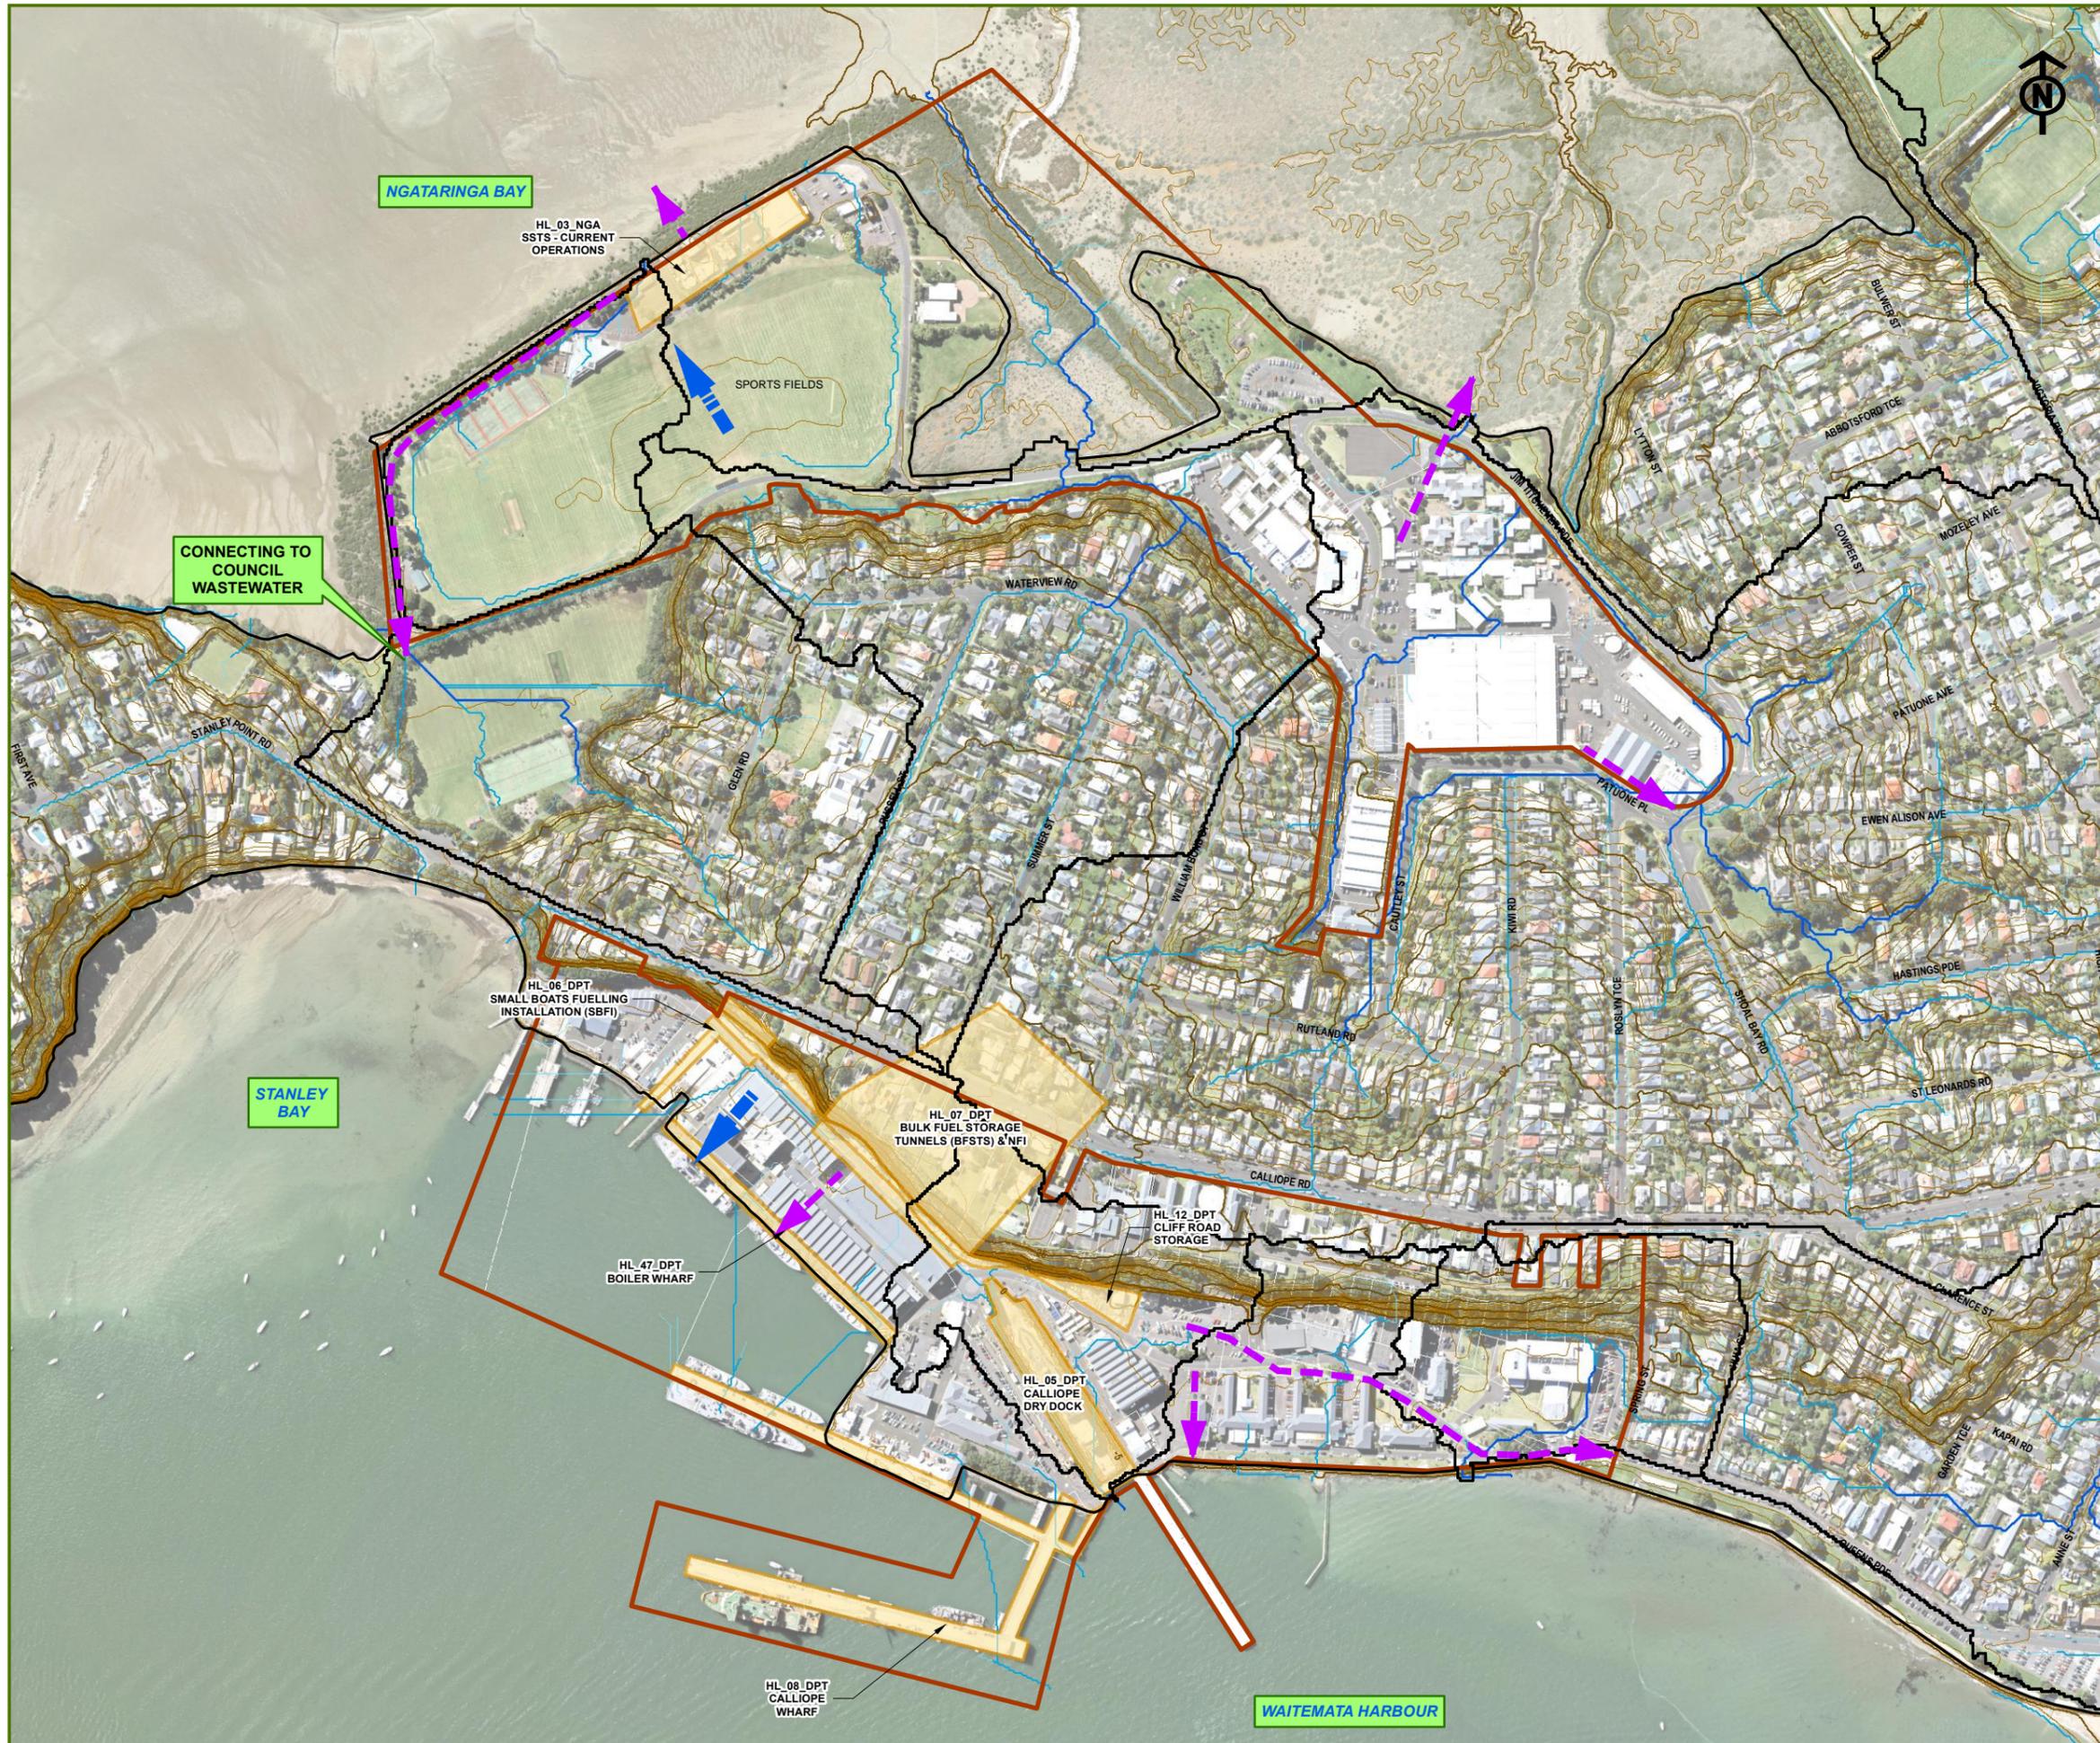
- KEY :**
- Pathway (Groundwater and Surfacewater)
 - Source
 - Receptor
 - Inferred Groundwater Flow Direction
- Auckland Council Overland Flow Paths:**
- 3ha and above
 - 4000m2 to 3ha
 - 2000m2 to 4000m2
 - Auckland Council River and Overland Flow Path Catchment
 - Base/Camp Boundary
