# Poolburn Gorge Willow Removal Plan – Freshwater Ecology Review & Mitigation Guidance

EOS Ecology Report No. BEC01-24006-01 | March 2024

Prepared for Ida Valley Catchment Group under the Access 2 Experts programme

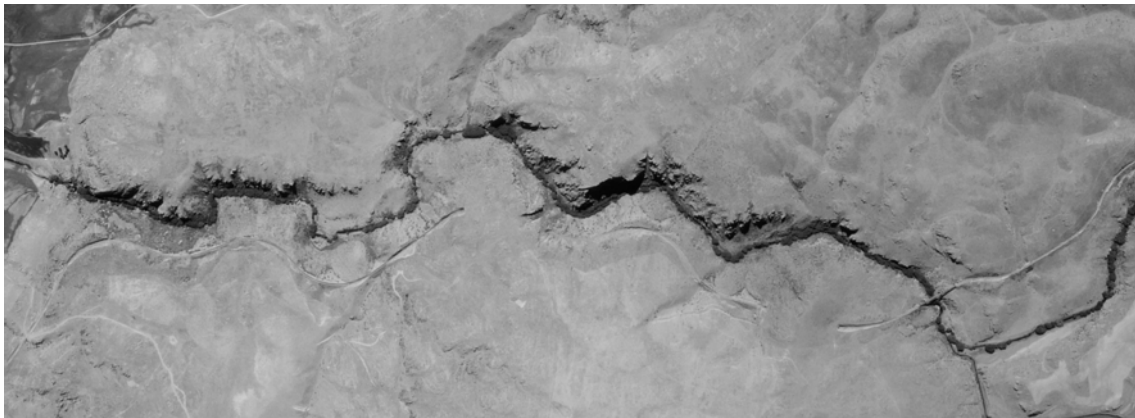
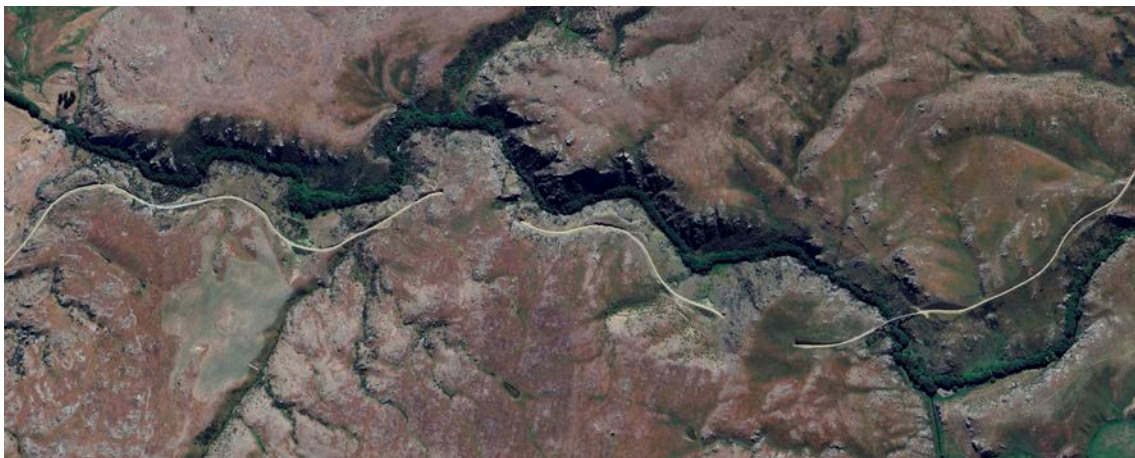
**Figure 2** Aerial views of Poolburn Gorge that track the spread of willows over time (photos have been rotated so are not showing north).

Based on historic aerial imagery from Retrolens (<https://retrolens.co.nz>) in 1959 the Poolburn Gorge appeared to be largely free of willows. By 1976 willows were well established through the gorge (Figure 2). All subsequent aerial images show abundant riparian willows. It is understood that some willow removal efforts previously took place in the Poolburn Gorge 20+ years ago, but no follow up control was undertaken, and the gorge continues to have abundant riparian willows growing from end to end.

1959: No large willows evident in the gorge.

1976: Willows have become well established throughout the gorge.

2023: Willows form a complete canopy closure throughout the gorge.

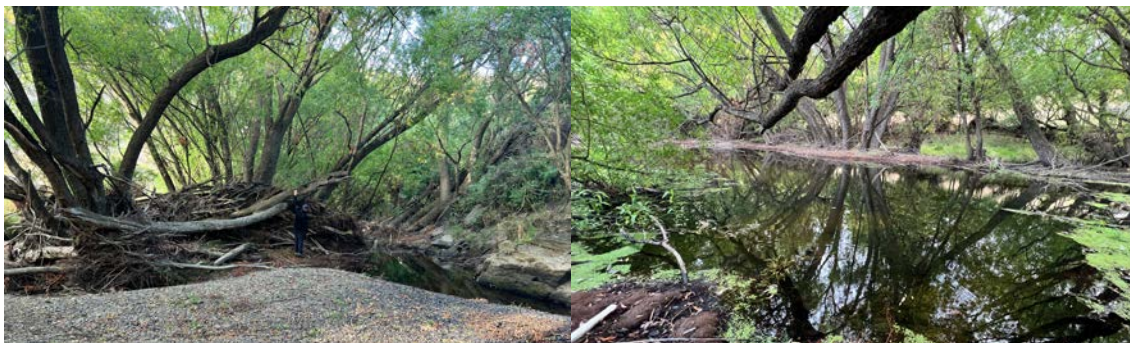
- » The sheer magnitude and size of the debris trapped against the willow trees and creating debris dams in the channel (some up to 2 m high) greatly increases the flood hazard, as they create debris dams that back up water flow during flood events, and could cause a flash flood if they failed (Figure 3A).

- » Willows are altering the natural morphology and stream habitats of the Ida Burn by creating pooled areas behind debris dams, some of which appear to be stagnating (Figure 3B).

A. Large debris dam with gravel deposit.

B. Large pooled area.

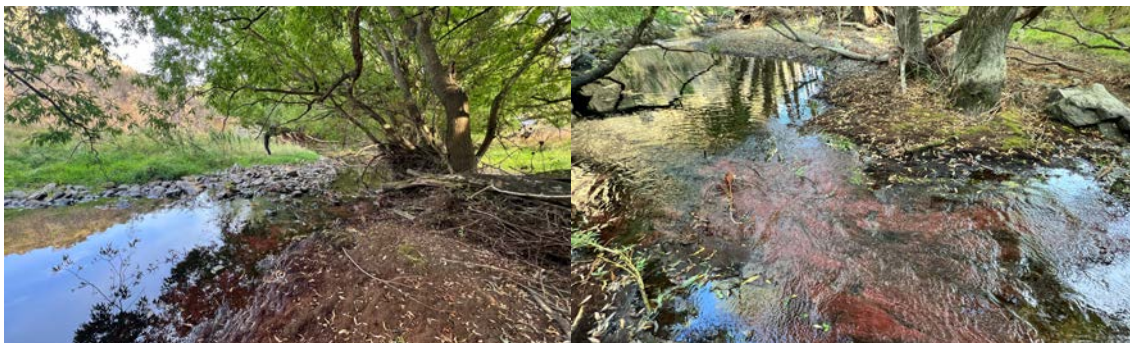
- » Willow growth has changed the substrate composition through increased deposition of fine sediments around debris jams, extensive willow roots effectively replacing the natural stony stream bed in places, and starving downstream habitats of gravels (Figure 3C, D, E, F).

C. Extensive willow roots completely covering natural, stony stream substrates

D. Willow roots completely covering bottom of wetted channel

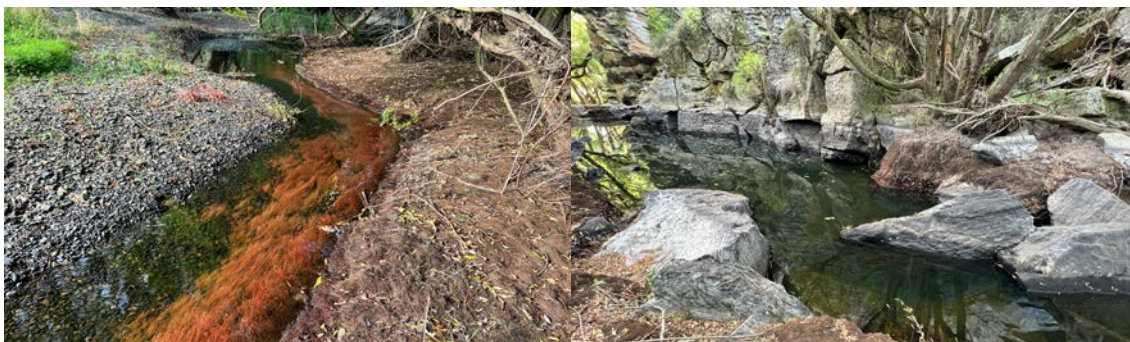
- » Willow growth is impeding the natural movements of river gravels through the system, by trapping material behind debris dams and extensive willow root growth effectively trapping loose gravels in place (Figure 3A, C, D, E, F). This is having the effect of starving the downstream reaches of river gravels, which is most likely the cause of the old weir at the downstream end of the gorge no longer having an effective seal around its rock structure, resulting in a subsurface discharge and thus creating a barrier to downstream fish passage as well as upstream movement (Figure 3G).

E. Extensive willow roots in the low flow channel.

F. Lower Gorge with deep pools starved of finer gravels due to upstream effects of willows.

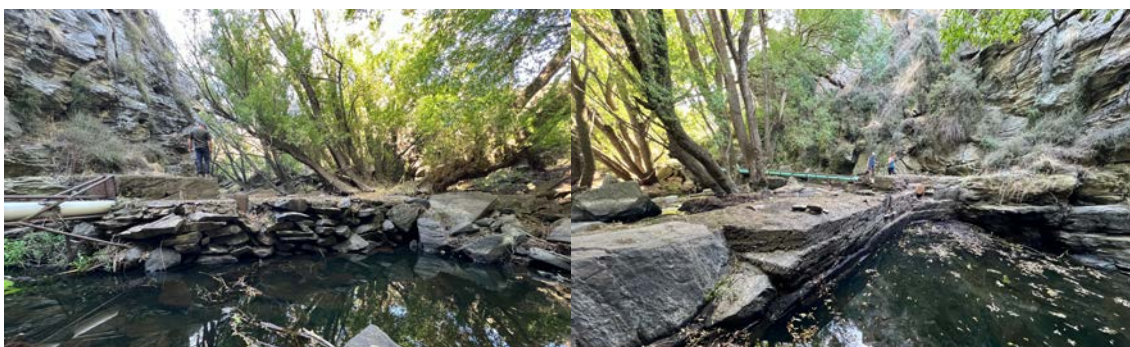
G. The downstream (left) and upstream (right) side of the Lower Gorge weir. With no finer gravels/sediment to seal the structure, water is flowing through it.

**Figure 3** Representative images of the Ida Burn in Poolburn Gorge taken by EOS Ecology during 27 February 2024 site visit.

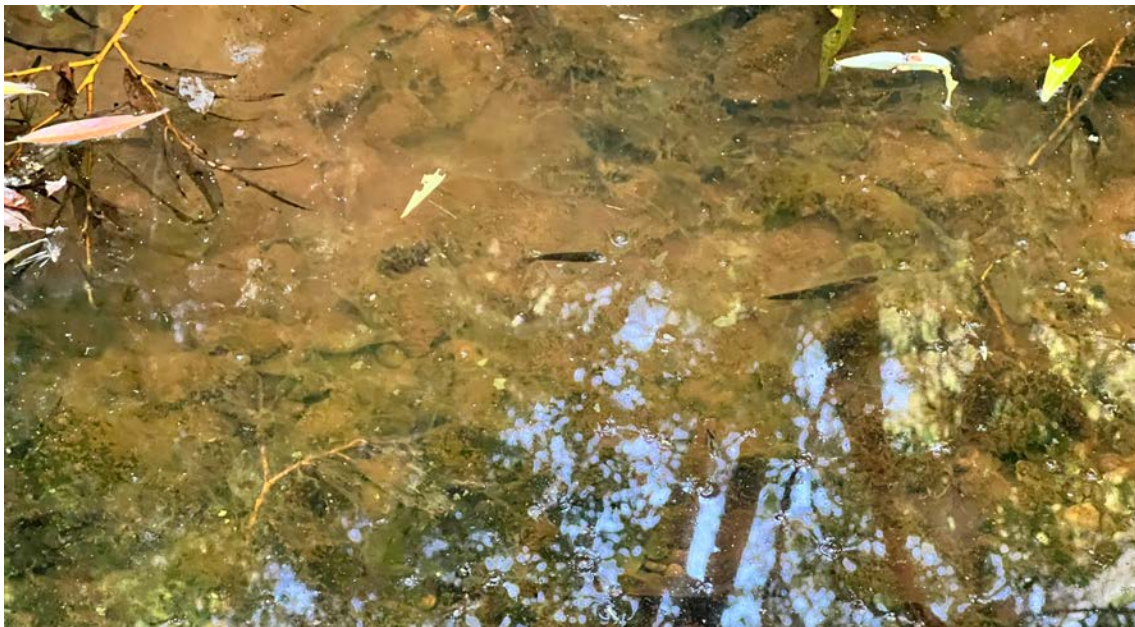
During the site visit on 27 February, a galaxiid was observed within a pool in the gorge (Figure 4). Given the known fish fauna of the area, it is most likely that this was a roundhead galaxias. Given the instream habitats observed in the gorge, which included some large pools, it is likely that longfin eel and possibly trout are also present. With respect to trout spawning, no suitable spawning habitat is likely to be present in the gorge based on the flow and substrate conditions observed during the site visit.

Figure 4 Small galaxiid fish observed in Poolburn Gorge on 27 February 2024.

- » Apart from the sighting of a small galaxiid fish in the gorge during the 27 February 2024 site visit (Figure 4), there is no information on the freshwater fauna of the Ida Burn as it flows through the Poolburn Gorge. We have provided some guidance to the Ida Valley Catchment Group as to where it would be best to collect water samples for eDNA analysis to help to gain some information on the aquatic biota through the gorge. Unfortunately it was not possible for the group to collect this information prior to the due date for this report.

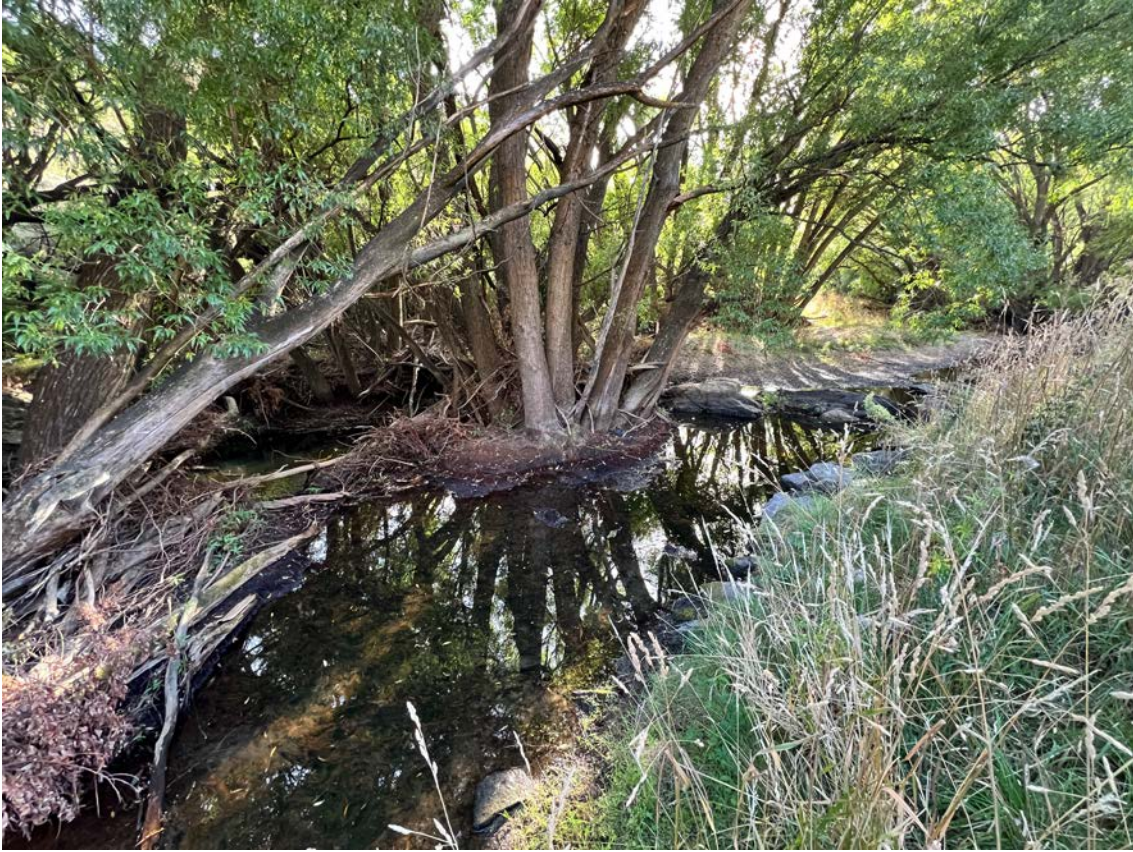
Figure 6 Willows growing in the channel as observed on 27 February 2024.

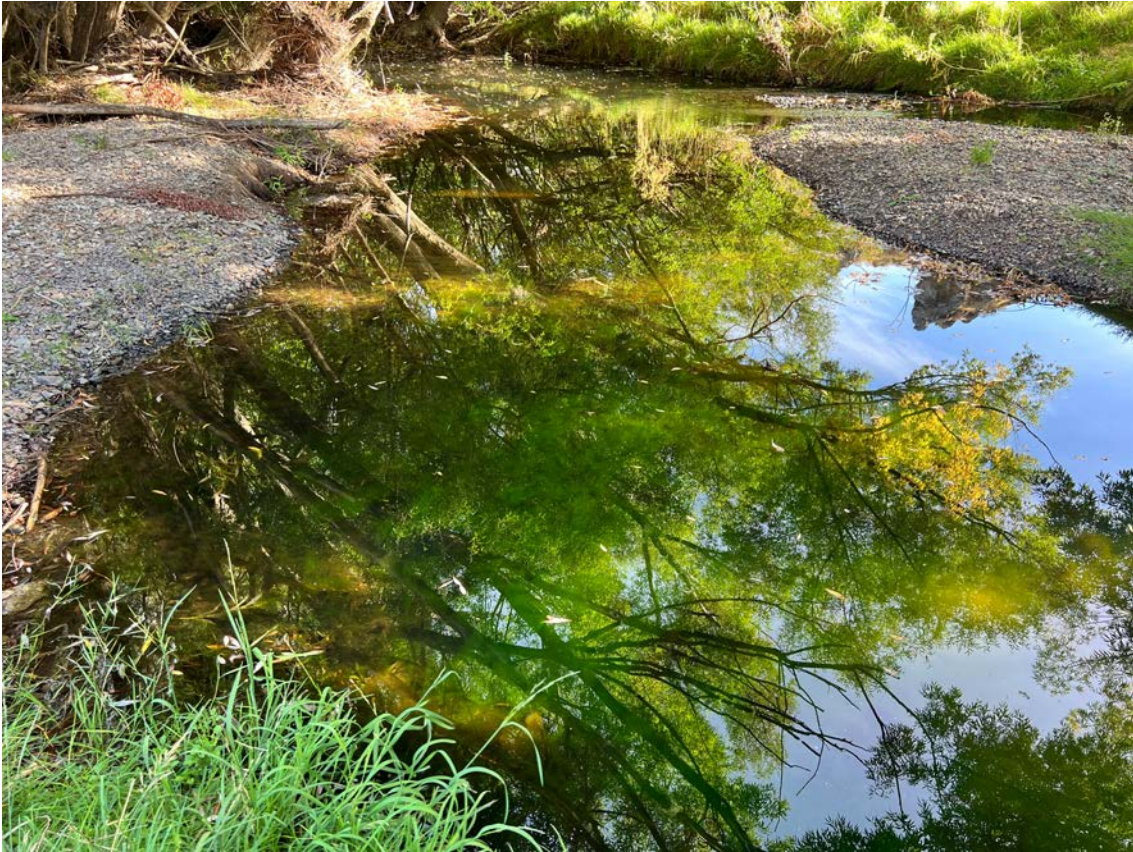
Extra sunlight reaching the stream channel may also result in increased biomass of algae and potentially macrophytes (aquatic plants) where they are present. It is noted that even with the willows there are some extensive growths of algae in places (Figure 7), and upstream in the open river sections there are algal blooms and macrophytes present. This suggests that there are sufficient nutrients in the water to support high algae and macrophyte growth and that with increased sun this may become a seasonal event, with algae flushed from the system during high flow events.

Figure 7 Extensive growth of filamentous green algae observed on 27 February 2024.

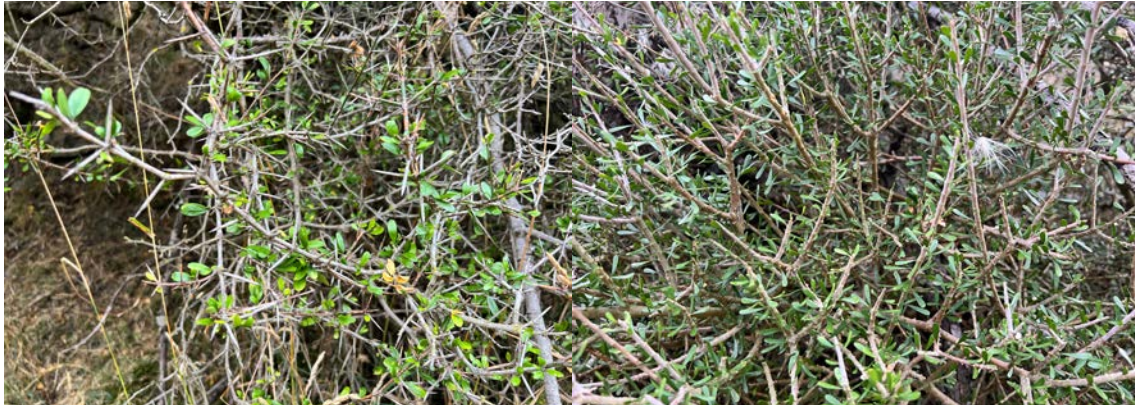
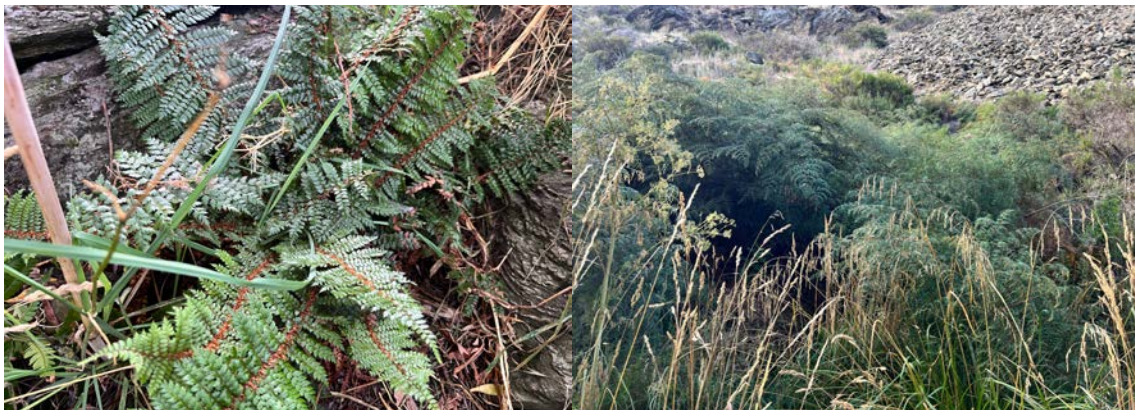
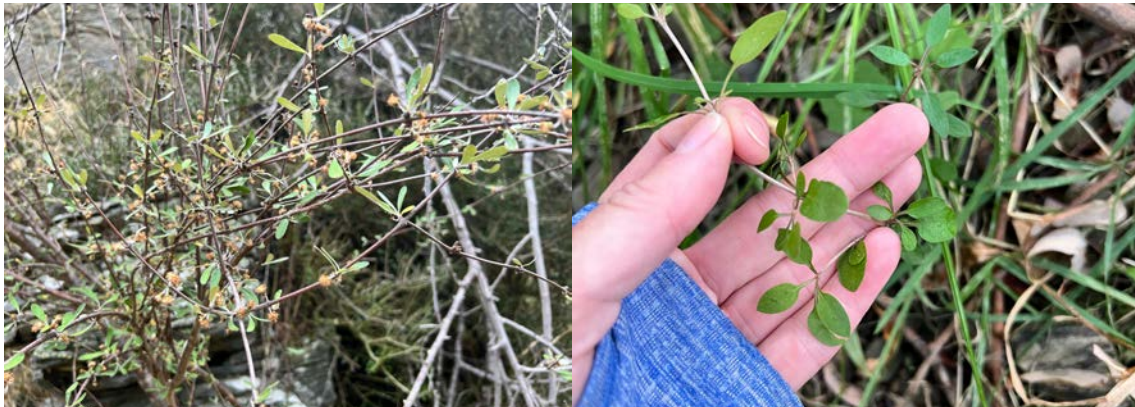
Matagouri (*Discaria toumatou*)Porcupine shrub (*Melicytus alpinus*)

Prickly shield fern (*Polystichum vestitum*)Austral bracken (*Pteridium esculentum*)

*Oleria odorata*Miki (*Coproasma propinqua*) seedlings

**Figure 8** Photos of some of the native plants that were observed in the Poolburn Gorge. Most of these were found along the sides of the gorge and thus likely be outside of the footprint of the willow removal. Some (including the miki seedlings) were seen along the riverbed and would likely be lost during the willow removal or subsequent gravel redistribution.

The additional light that will reach the gorge floor will likely allow terrestrial plants currently growing in the understory and gorge sides to further flourish. A number of native species were observed in the understory during the site visit including prickly shield fern (*Polystichum vestitum*), porcupine shrub (*Melicytus alpinus*), matagouri (*Discaria toumatou*), Austral bracken (*Pteridium esculentum*), *Oleria odorata*, miki (*Coprosma propinqua*), and some *Carex* species (Figure 8) Those plants that are in areas not disturbed by the willow removal or subsequent redistribution of the valley floor gravels, may well continue to grow and indeed thrive with the removal of the willows. However, some specimens such as the miki seedlings on the riverbed gravels will become inevitable collateral damage during the willow removal or subsequent gravel redistribution/migration. The Ida Valley Catchment Group intends to collect many of these seedlings prior to the removal works and grow them on in their Poolburn School tunnel house. We feel that this is a worthwhile thing to do, and will help to ensure the survival of some of those seedlings.

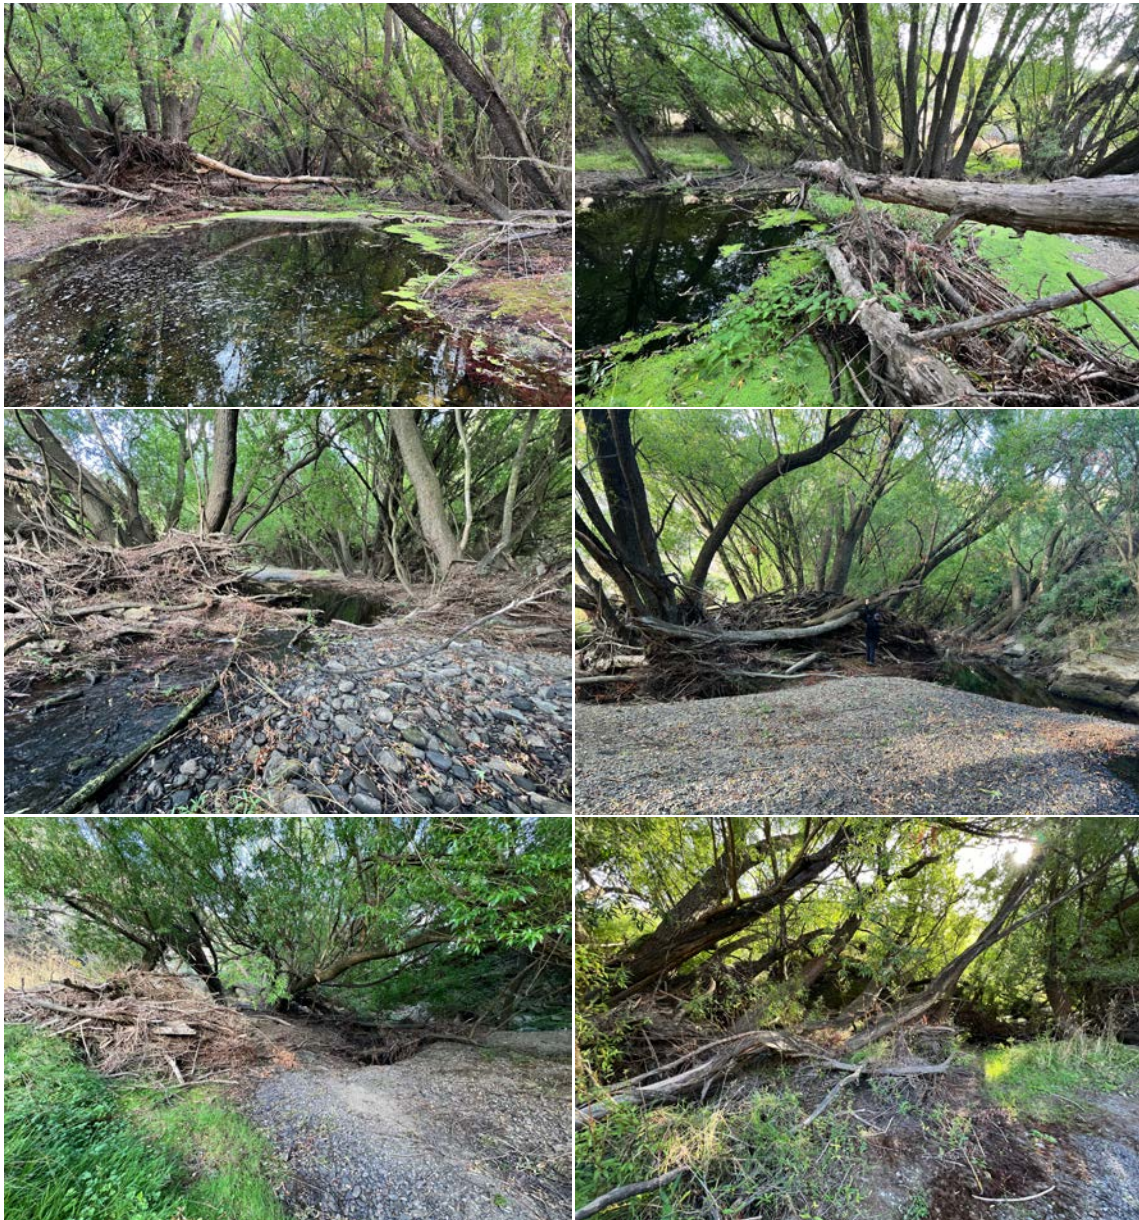
There is a significant amount of debris trapped against willows throughout the Poolburn Gorge (Figure 9). This woody material would need to be removed along with the willow logs, to avoid this material being redistributed downstream and causing damage during flood/fresh events.

Figure 9 Photos of debris caught against willows within Poolburn Gorge taken on the 27 February 2024. This material will need to be removed along with the willows.

- » There is a significant amount of woody debris trapped against willows throughout the Poolburn Gorge (Figure 9). This material would need to be removed along with the willow logs, to avoid this material being redistributed downstream during flood/fresh events that could cause damage.

- » Regular monitoring during the willow removal process to check for debris buildup after flood/fresh events and a programme to remove this material before such buildups become too substantial.

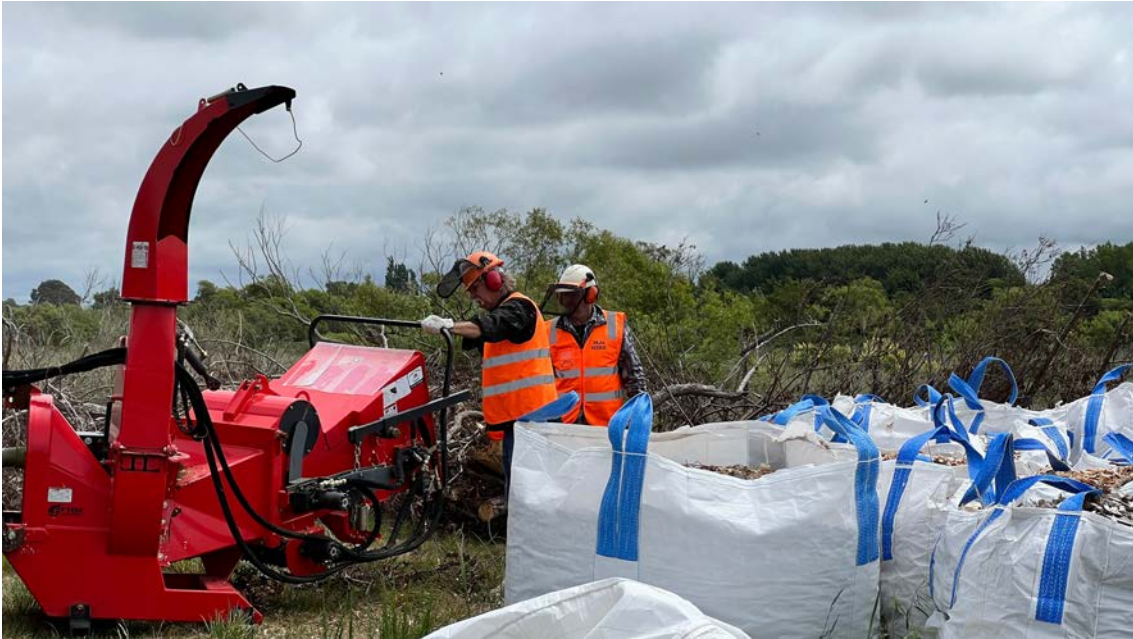
Figure 10 A wood chipper used by Mark Kruishoop to good effect in willow removal projects.

- » Look at whether it would be possible to bring in a wood chipper to chip some of the wood material (Figure 10) that can then be used either as a fundraising option for the project or used as planting mulch (in areas outside of the flood inundation zone).
