469 RIDGE ROAD DEVELOPMENT: FAST-TRACK APPLICATION – PRELIMINARY ECOLOGICAL ASSESSMENT

Land Use Capability classification assessment

469 Ridge Road, Pōkeno 2472

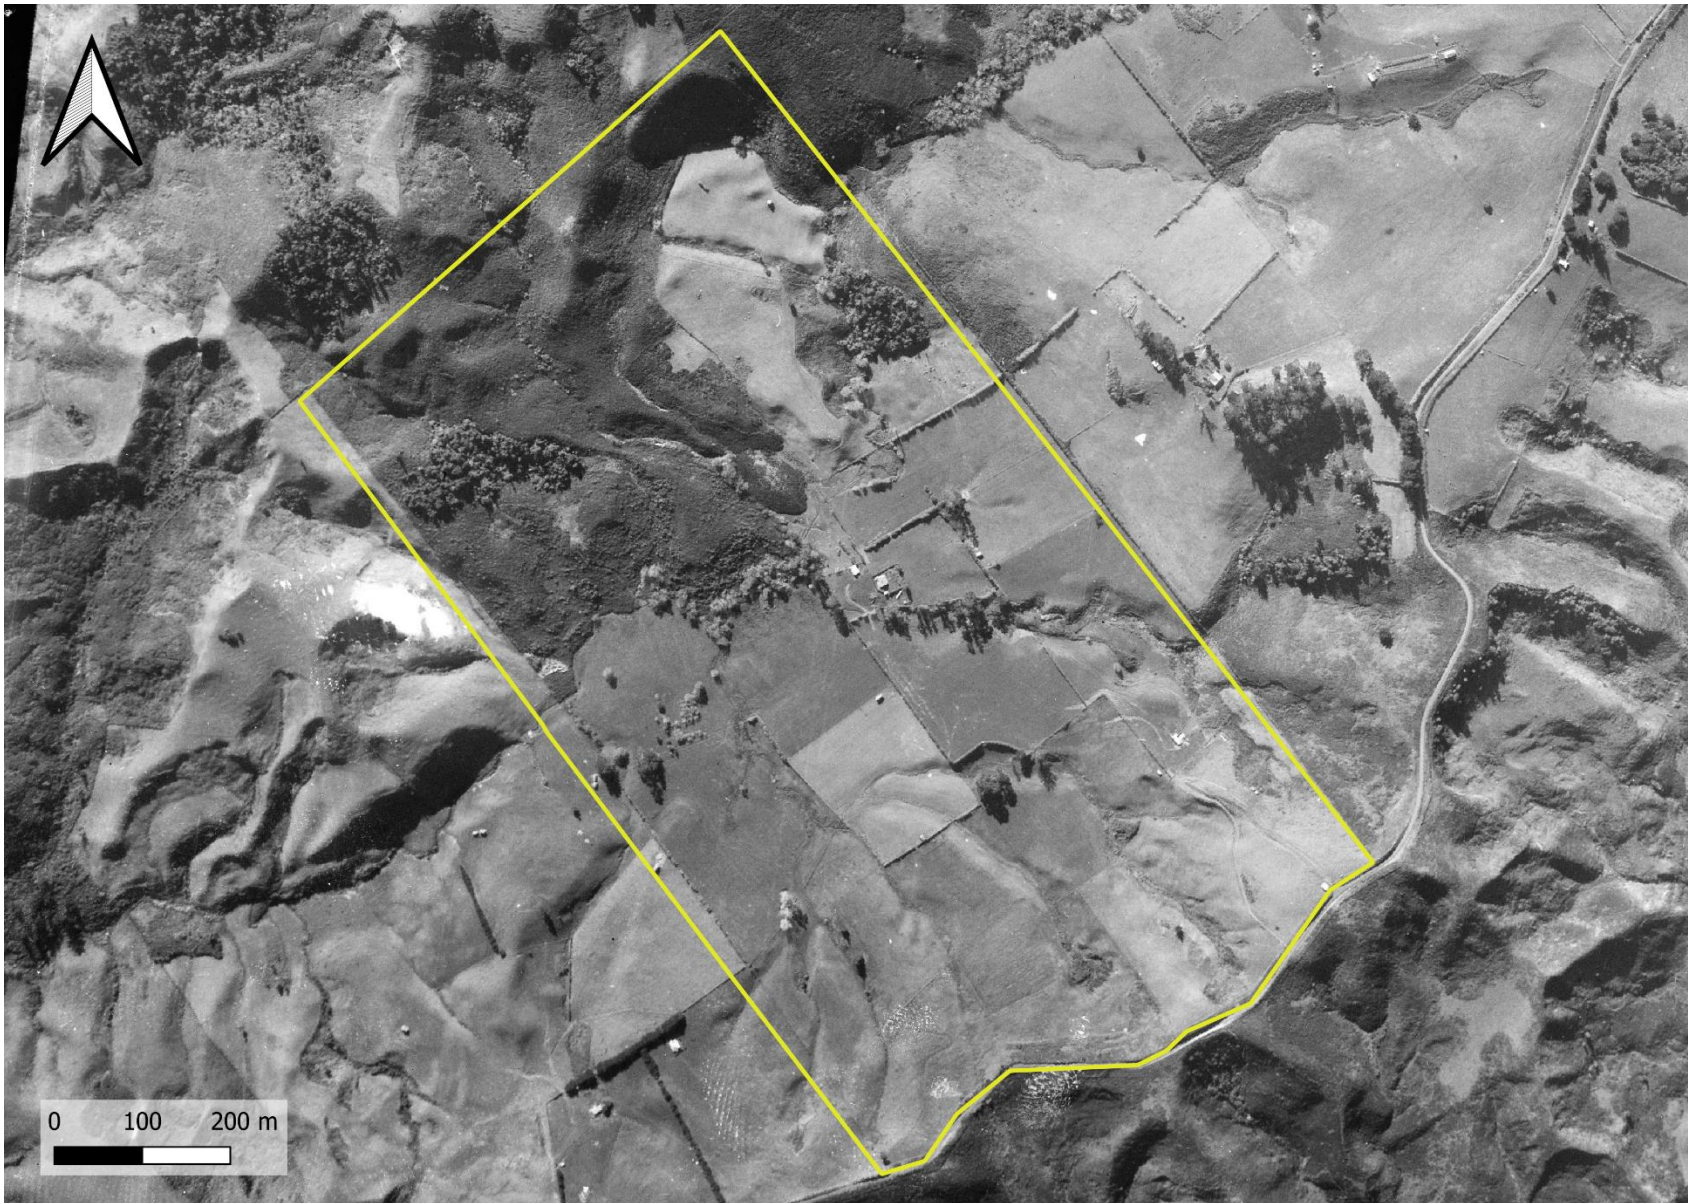
Figure 1. Historic aerial image of the site at 469 Ridge Road, Pokeno, dated 1942.

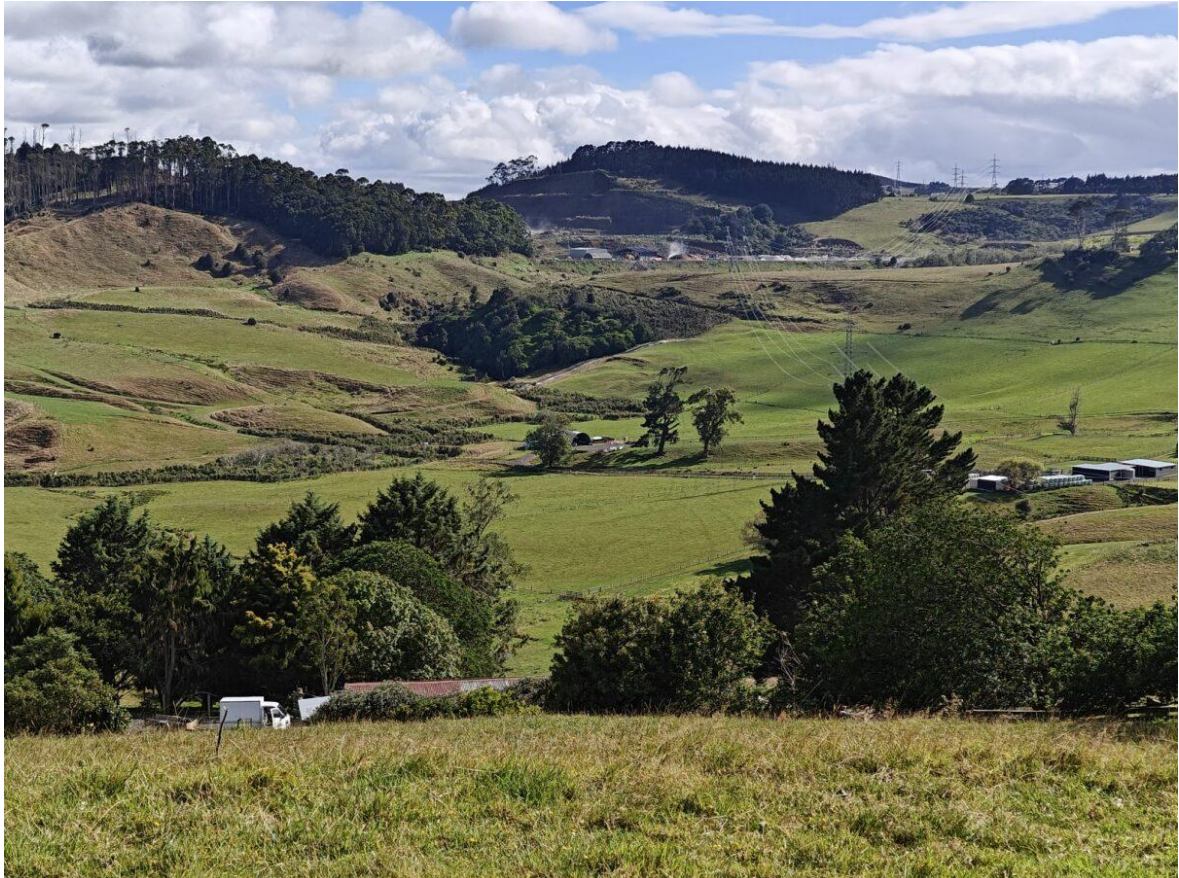
Figure 1. Assessment area, 469 Ridge Road, Pōkeno 2472.

An on-site Land Use Capability (LUC) classification assessment of 469 Ridge Road, Pōkeno 2472, totalling 76.1 ha (**Figure 1**), was undertaken in order to confirm the LUC units at property scale and to comply with rules of the Proposed Waikato District Plan (Decisions Version) and the Operative Waikato District Plan (ODP) in relation to the protection of high class soil, and identify the presence and distribution of highly productive land as defined by the National Policy Statement for Highly Productive Land 2022 (NPS-HPL).
