22 March 2011  
Project No. 42117001

Holcim (New Zealand) Limited  
PO Box 6040  
Upper Riccarton  
Christchurch 8442

**Subject: Private and Confidential**  
**469a Ridge Road, Bombay, Auckland - Preliminary Site Investigation**

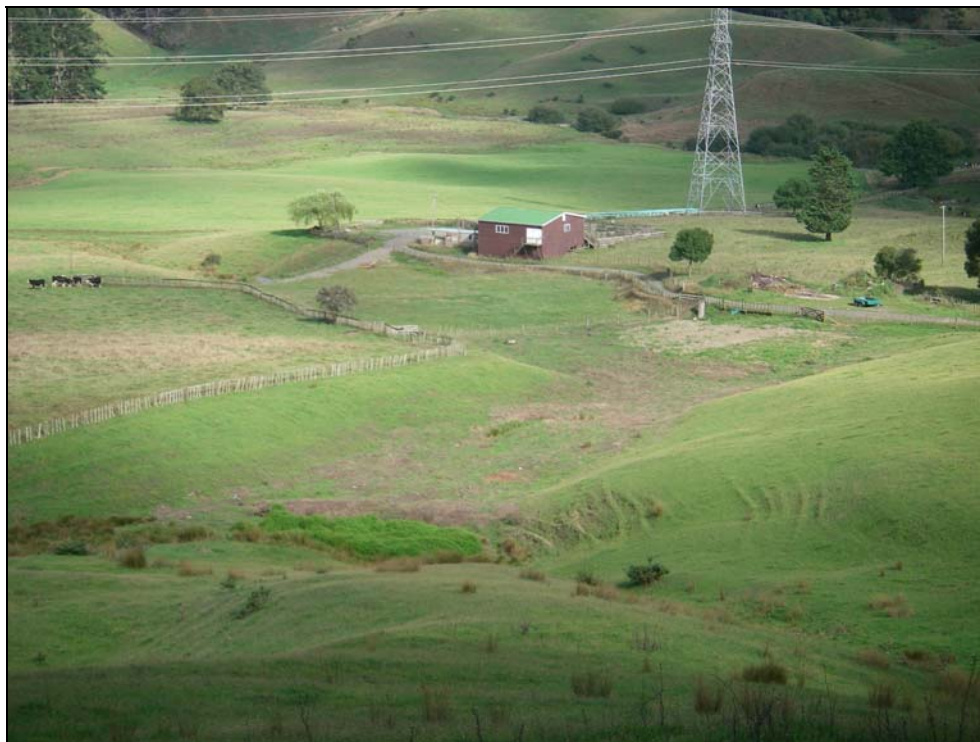
The following plates present visual observations made by the URS field staff member during the PS1 on 11 and 14 February 2011. As illustrated by Plate 1 the fill areas is visible at the ground surface and characterised by visible wood chips and poor grass coverage. Plates 2 and 3 represent the contents of typical test pits including large wood fragments and sawdust. Plates 4 and 5 illustrate the discoloration of standing water in the vicinity of both the northern and southern filling areas. A surface water sample was collected from one standing water area within the northern fill (SW1).

**Plate 1: View North Towards the Southern Fill Area**

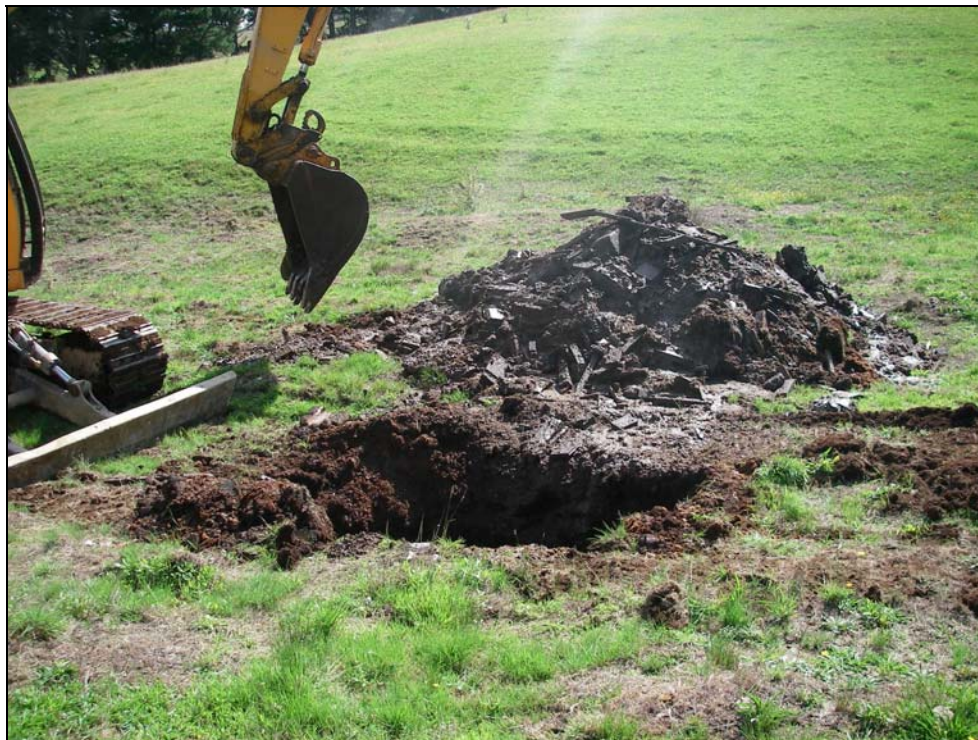
**Plate 2: Typical Contents of Test Pits – Wood Fragments**

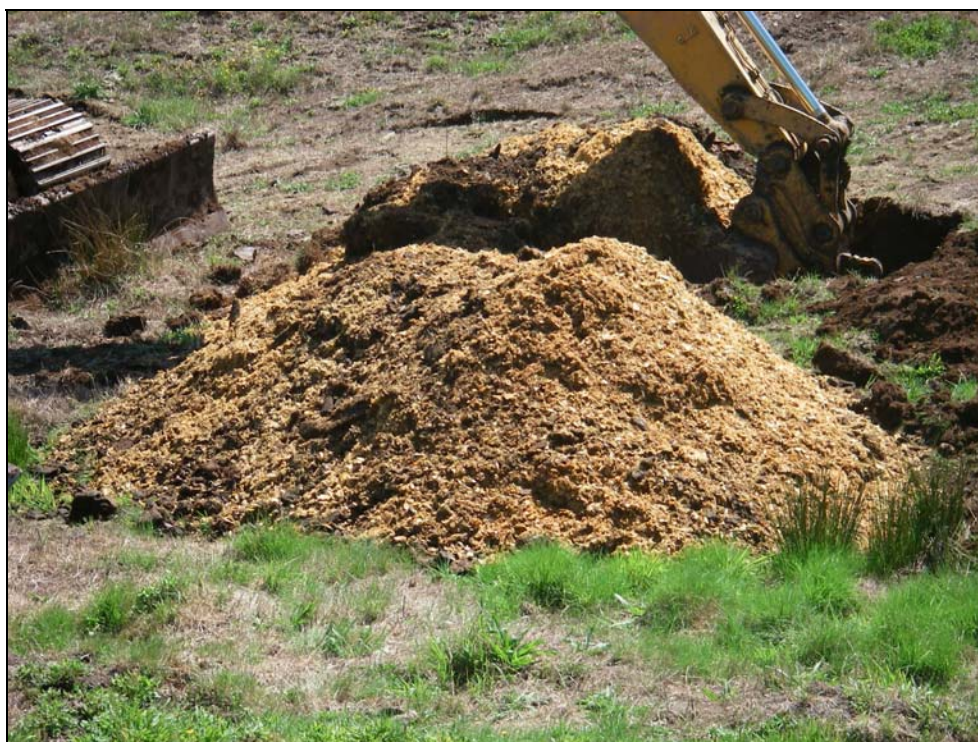
**Plate 3: Typical Contents of Test Pits – Sawdust**

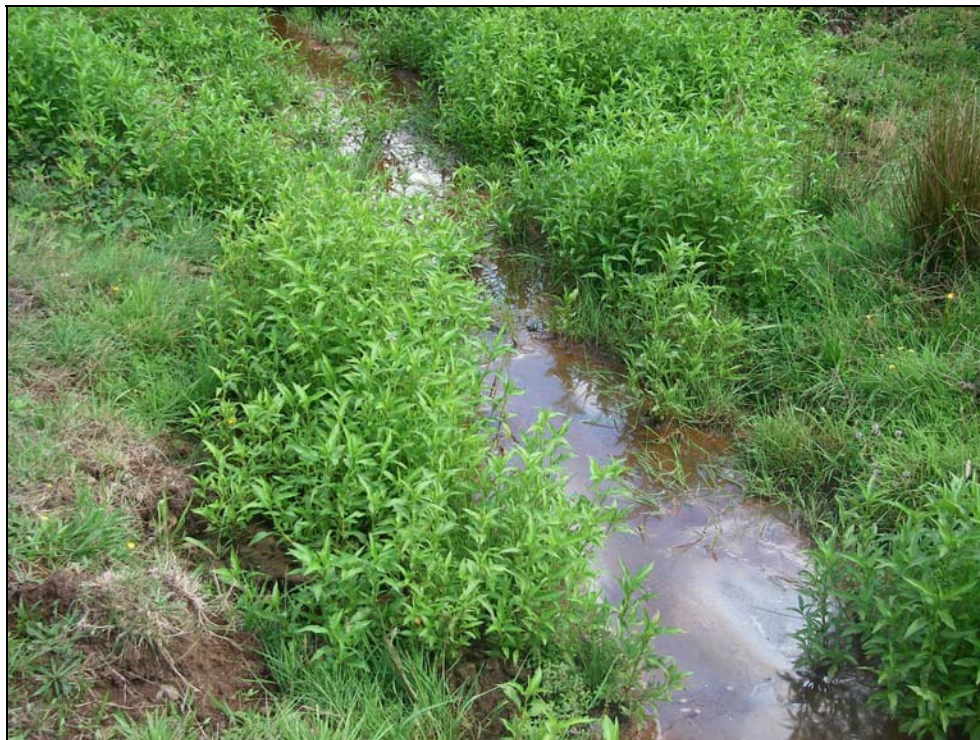
In addition, a single surface water sample (SW1) was collected for analysis. This sample was collected from standing water down-gradient of the northern fill area. Figure 2 illustrates the surface water sample location.

**Plate 4: Ponded Water Downgradient of the Northern Fill Area**

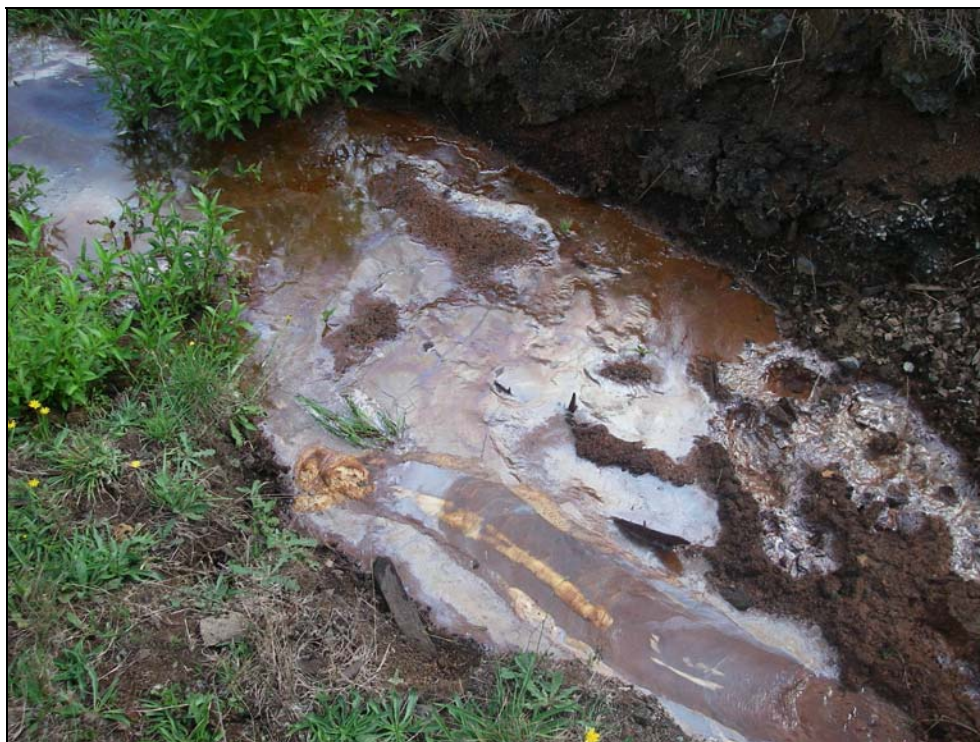
**Plate 5: Sample Location SW1**

Arsenic, copper, and chromium were measured at concentrations that exceeded ANZECC 2000 Guidelines for the protection of 95 % of freshwater species.

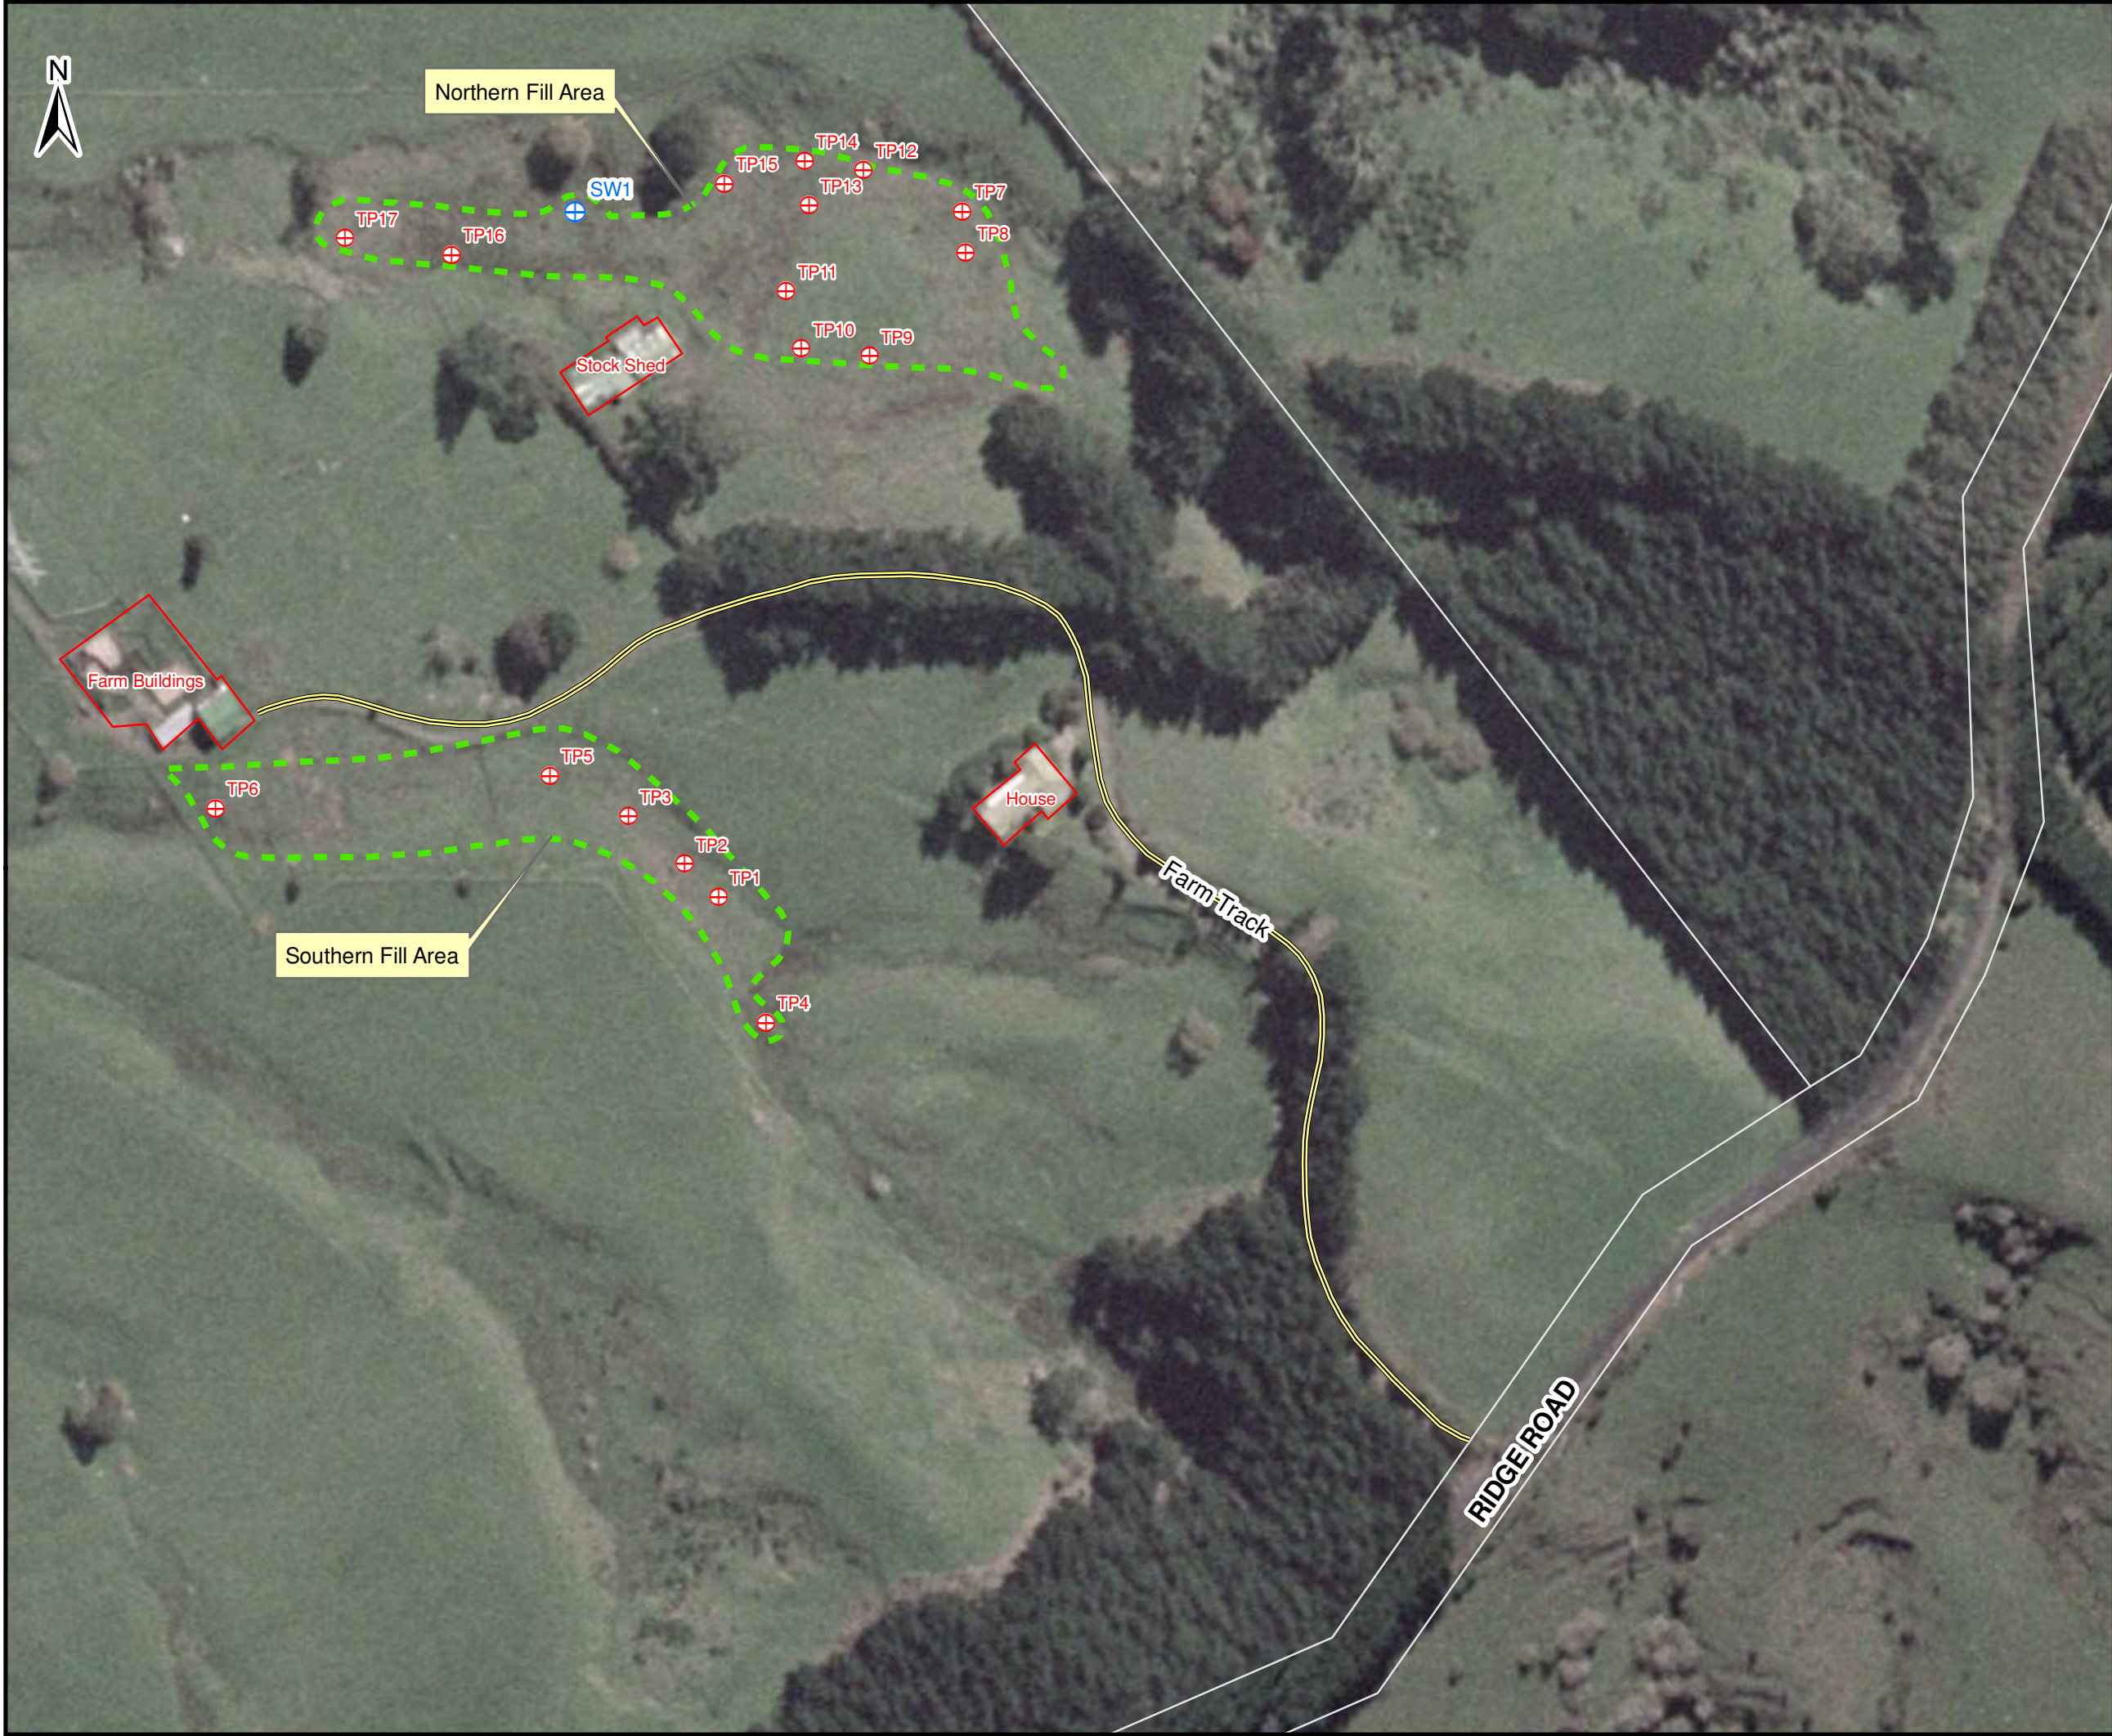
Drawing Number  
**Figure 2**

A URS field staff member oversaw the advancement of 15 test pits (sample locations TP1 to TP15) across the two historical disposal areas (hereinafter referred to as the Northern Fill Area and Southern Fill Area) on 11 and 14 February 2011. Figure 2 illustrates the test pit locations.

Title: 469a Ridge Road, Bombay  
Site Layout and Sample Location Plan
