**Omakiwi Cove Jetty - Coastal Ecological
Values Assessment
February 2023**

Document title:	Omakiwi Cove Jetty - Coastal Ecological Values Assessment
Prepared for:	Explore Ltd.
Version:	Final
Date:	11 April 2023
Document name:	64577 Omakiwi jetty assessment final v3.docx

Reference: Bioresearches (2023). Omakiwi Cove Jetty - Coastal Ecological Values Assessment. Report for Explore Ltd. Job No: 64577. pp 30

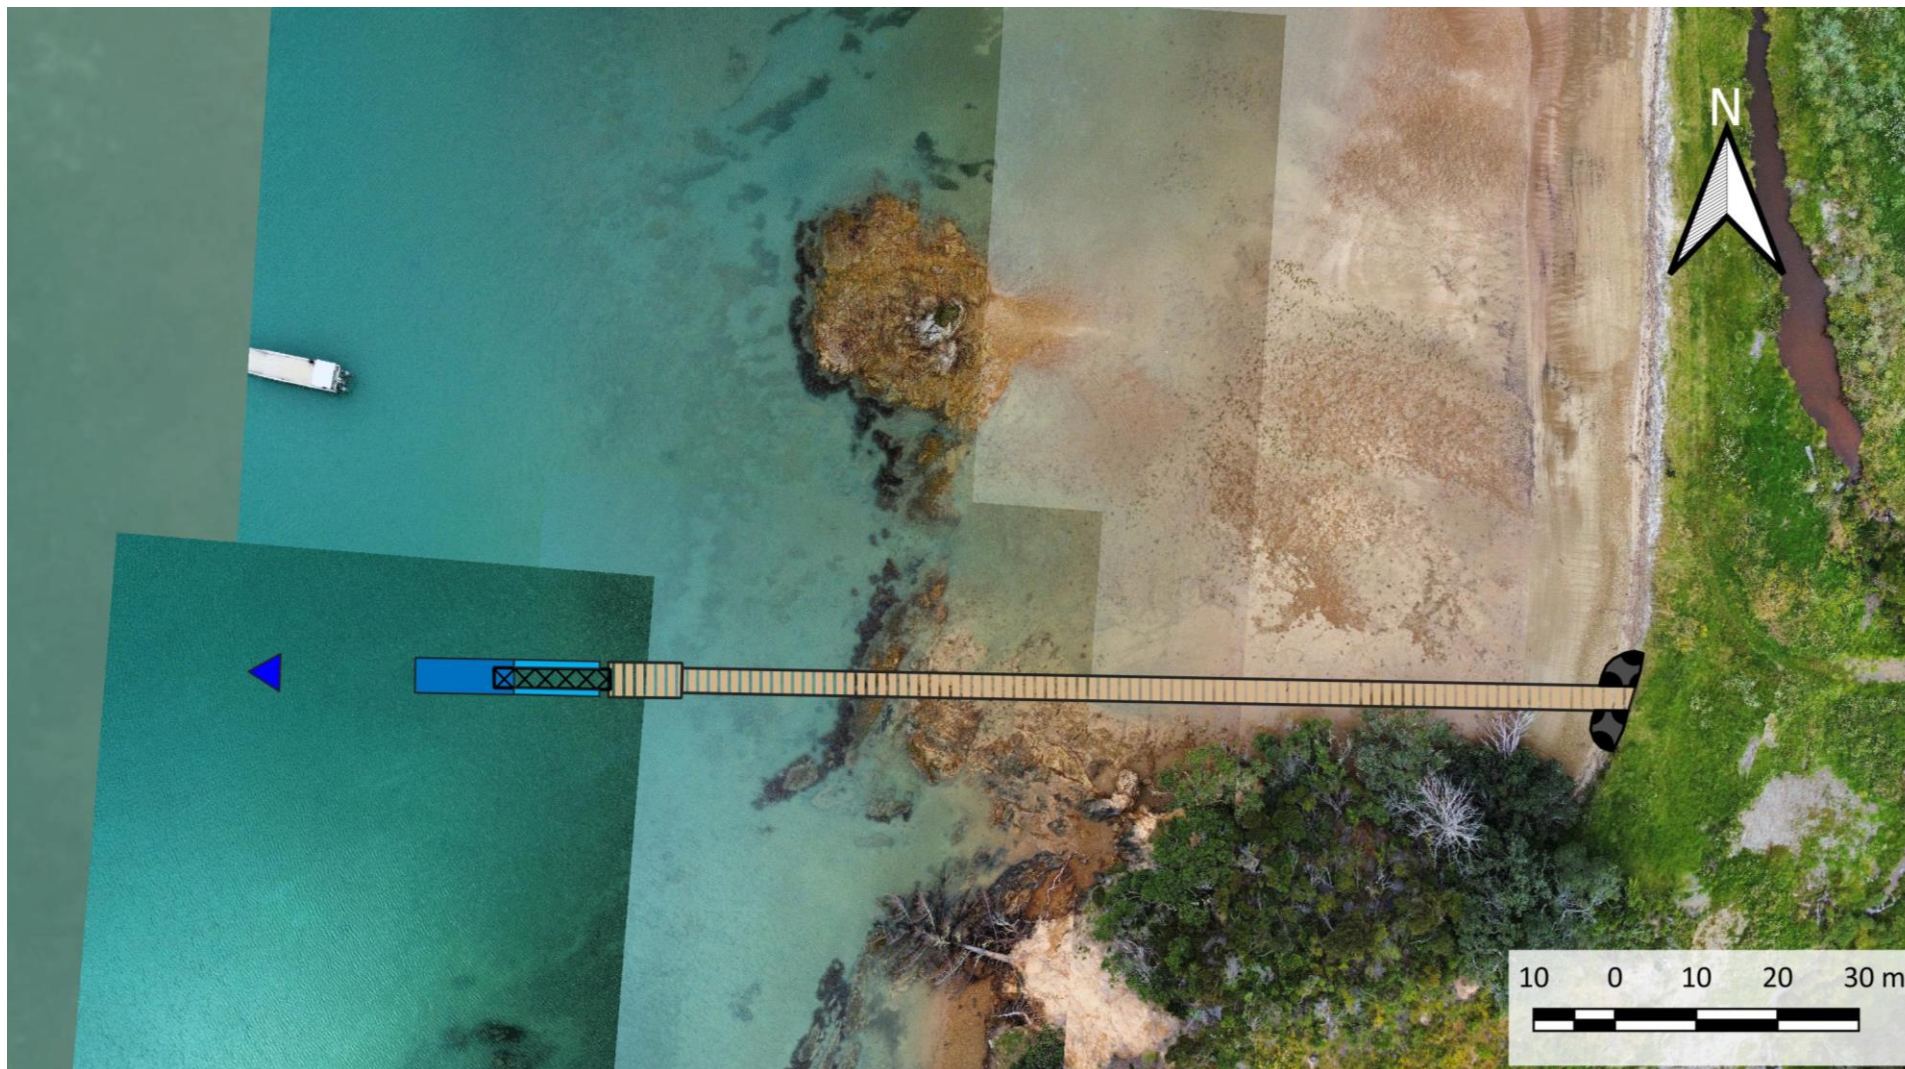
Figure 2. *Proposed Omakiwi jetty design (in orange), pontoon extension (in blue). Based on revised plans provided by Total Marine Services dated 14/10/2021. Background imagery georeferenced drone photographs taken 6 December 2022.*

The proposed project is the construction of a 150m long piled jetty from the grassed shore, ending with a 12m by 4m floating pontoon (Figure 2, Appendix 1). The pontoon would be held in place with piles and accessed by a 12m by 2.1m gangway. Due to the presence of seagrass in the bay Explore Limited intends manage the use of the pontoon by using vessels able to operate in the natural tidal depths.

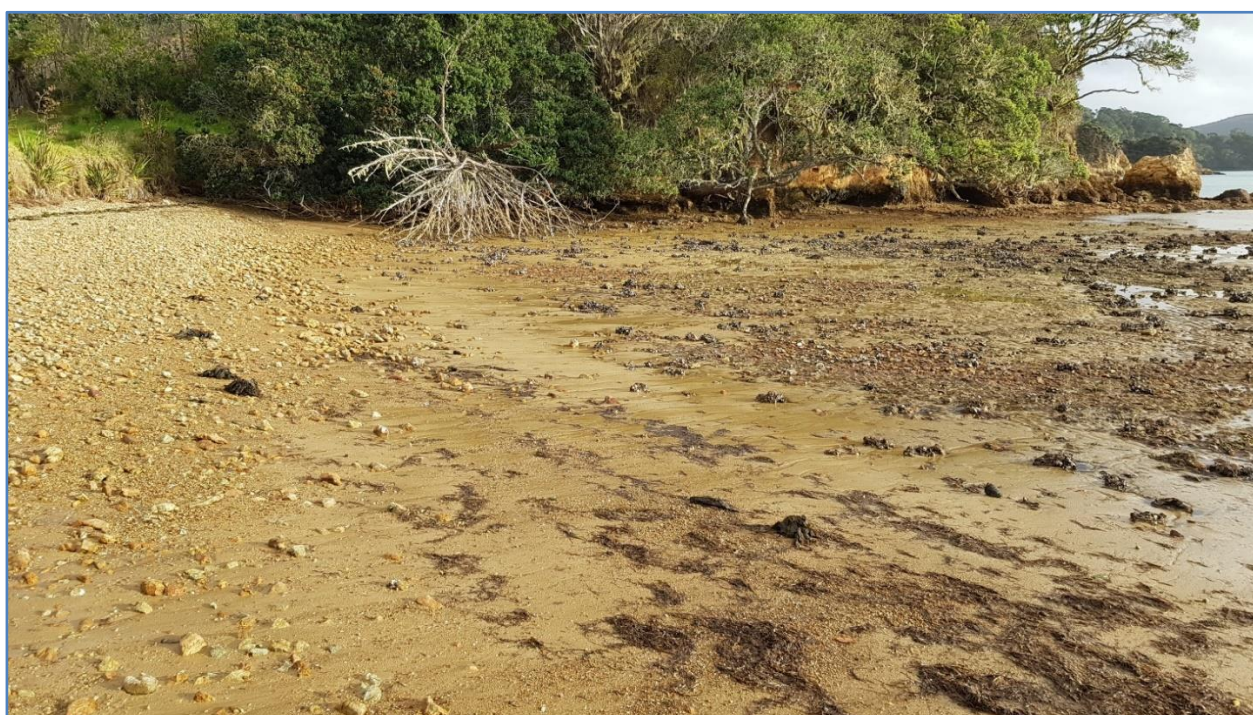
Figure 3. Upper and mid-intertidal zone at the southern end of Omakiwi Cove, view towards where the jetty is proposed.

The cobble beach was approximately 10m wide and sloped moderately steeply to a sandstone platform. To the north of the alignment the sandstone platform graded to sand, forming a sand and cobble beach. On the alignment isolated rocks or areas of harder substrate were present in elevated patches above the platform base. Most depressions in the platform were filled with fine sand (Figure 3 and Figure 4).

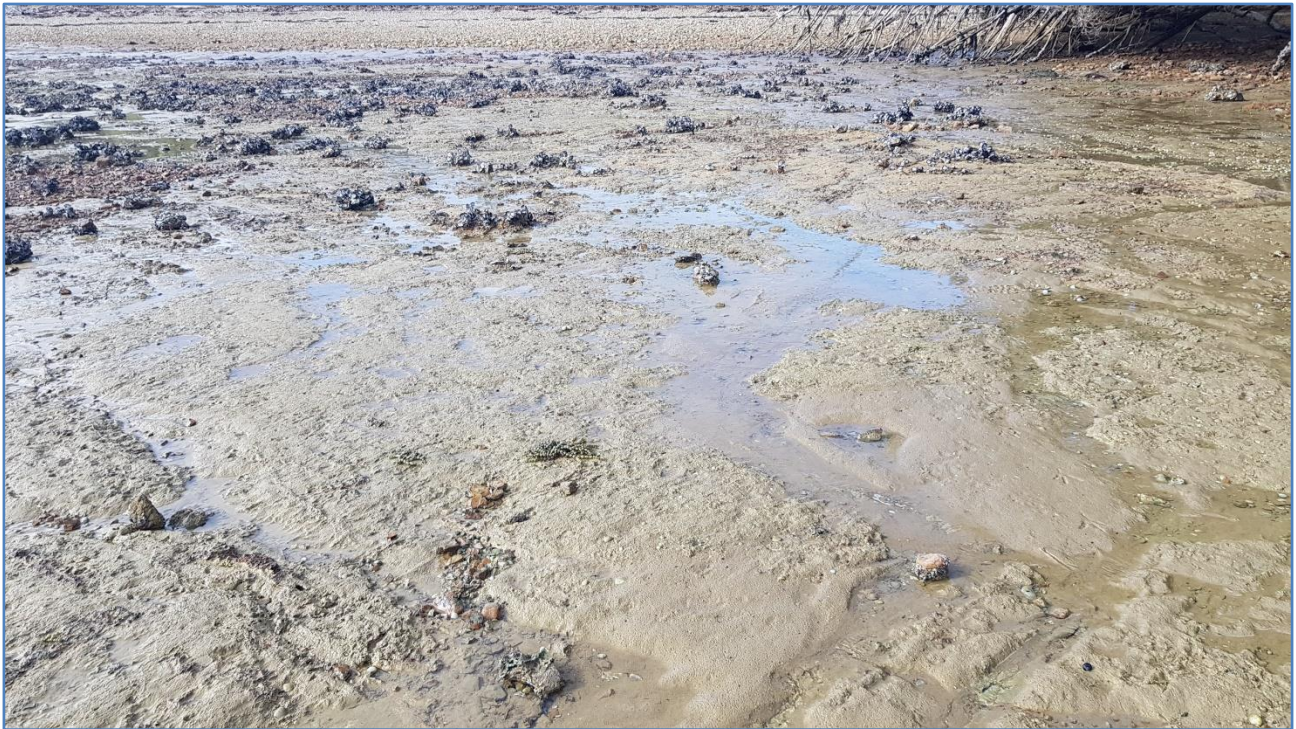
Figure 4. *Mid intertidal zone rocky platform, jetty alignment to the photo right*

Approximately 40m offshore, the rocky platform was overlaid with a thin layer of sand (less than 10mm deep), with rare rocks supporting oysters (Figure 4 and Figure 5).

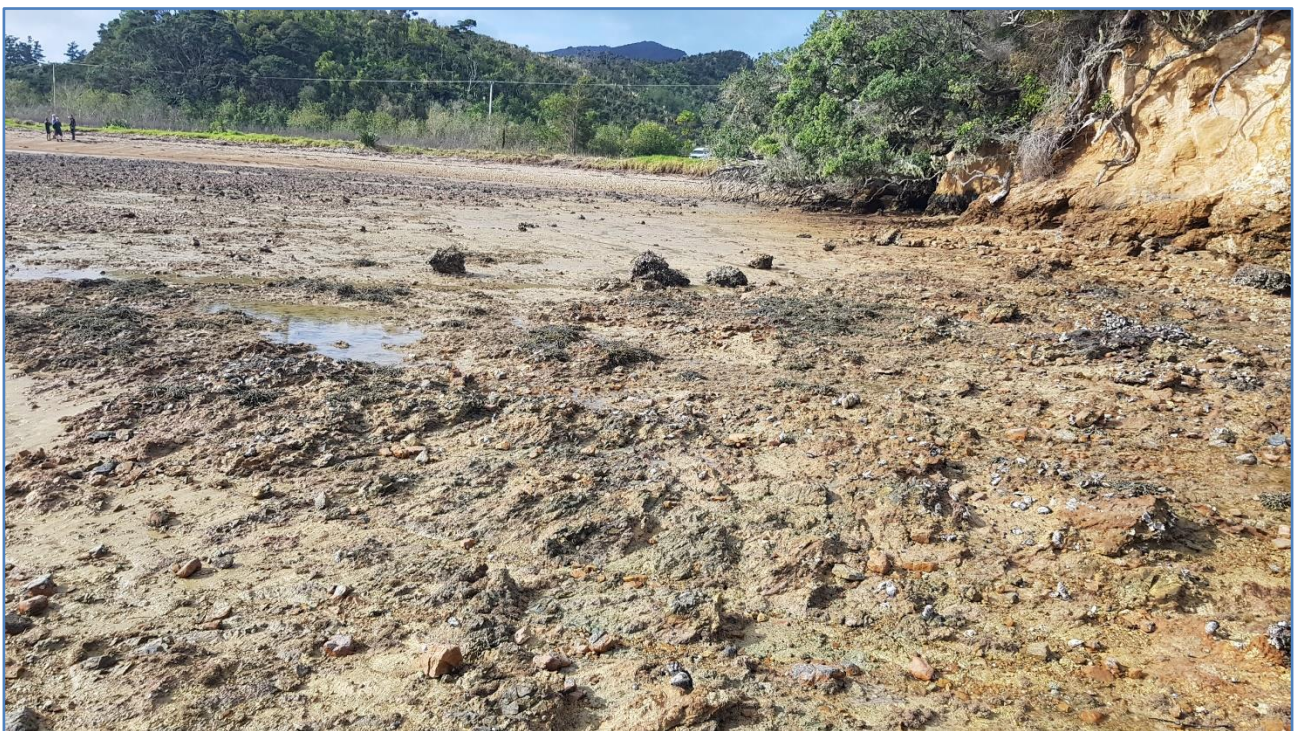
Figure 5. *Lower and mid intertidal zone on jetty alignment.*

The sandstone platform extended just over 80m before forming a shallow ridge and dropping into the muddy sand subtidal zone (Figure 5 to Figure 7). Approximately 30m north of the proposed jetty alignment a tall rocky knoll was present at the intertidal subtidal boundary.

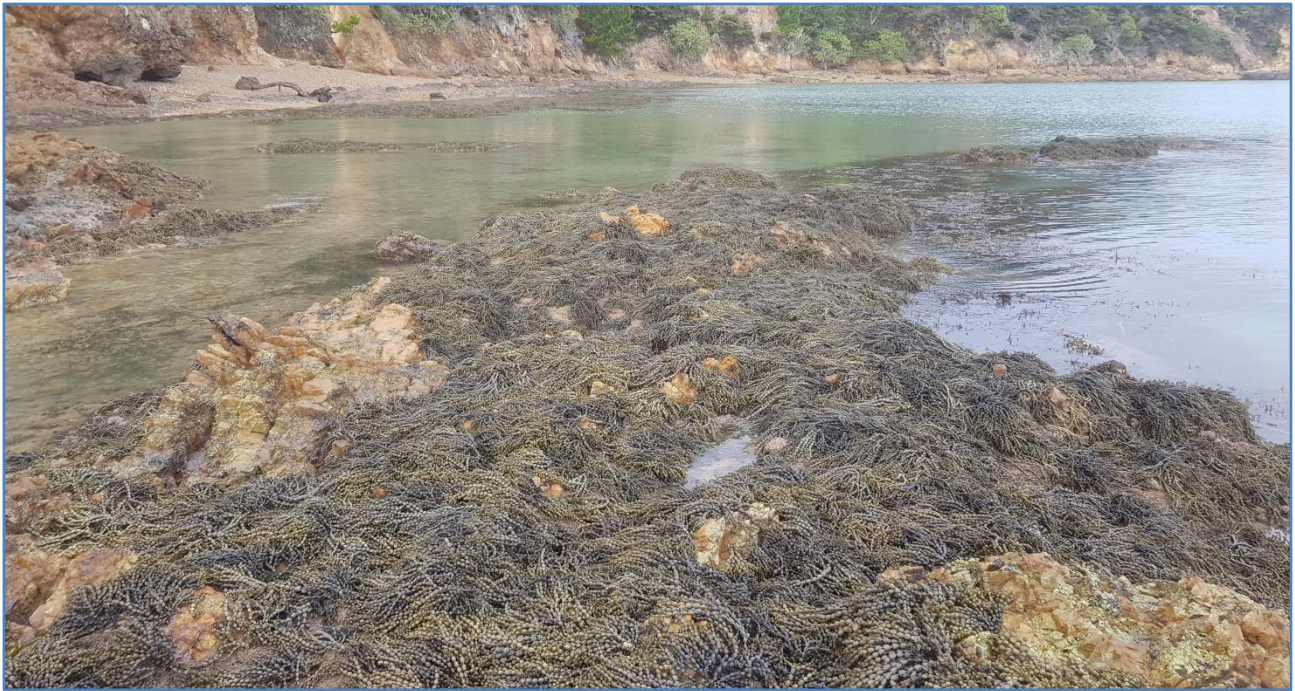
Figure 6. *Elevated reef at the edge of the lower intertidal zone, with a dense layer of Neptune's necklace*

At low tide level the intertidal rocky platform was dominated by a thick band of Neptune's necklace with cat's eye snails (168 per m², average size 15mm) and Corallina turf (*Corallina officinalis*). This zone graded down a short vertical step, supporting brown seaweed (*Carpophyllum flexuosum*) to the sandy shallow subtidal (Figure 6 and Figure 7).

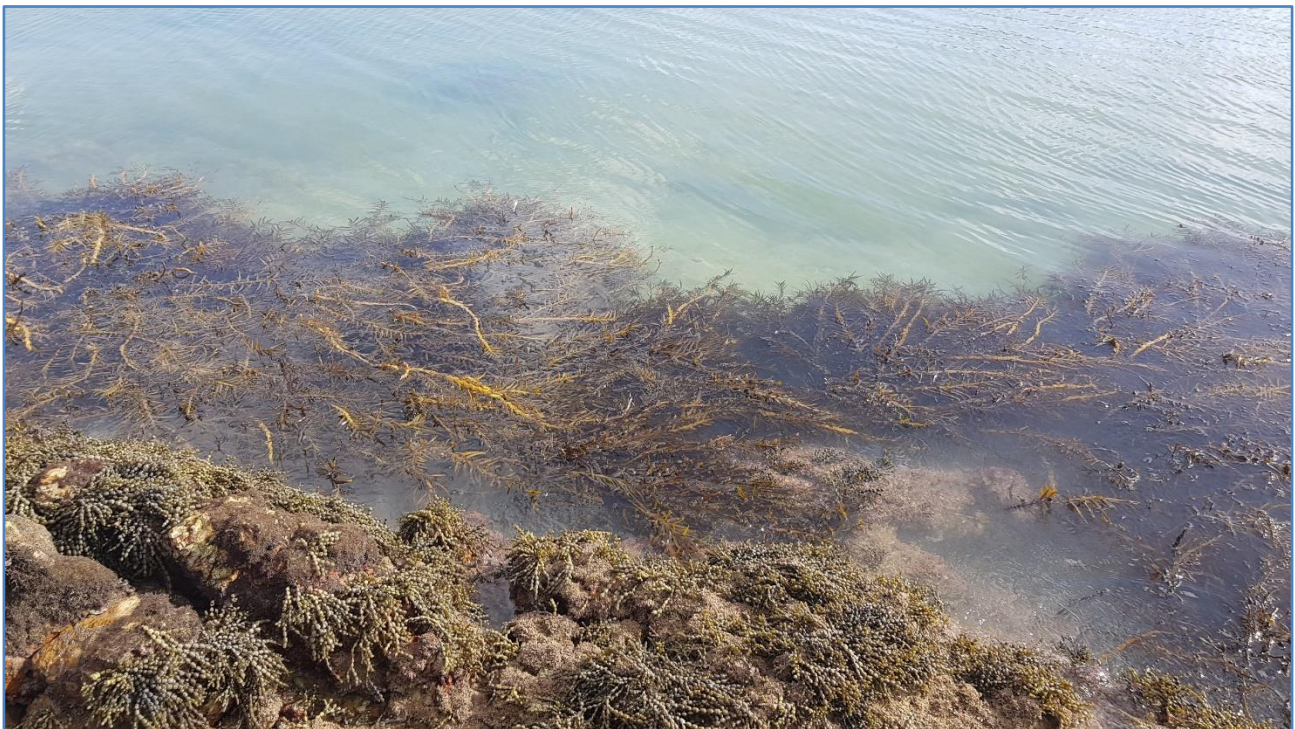
Figure 7. *Low tide drop off into sandy subtidal. Brown algae transition from Neptune's necklace to Carpophyllum.*

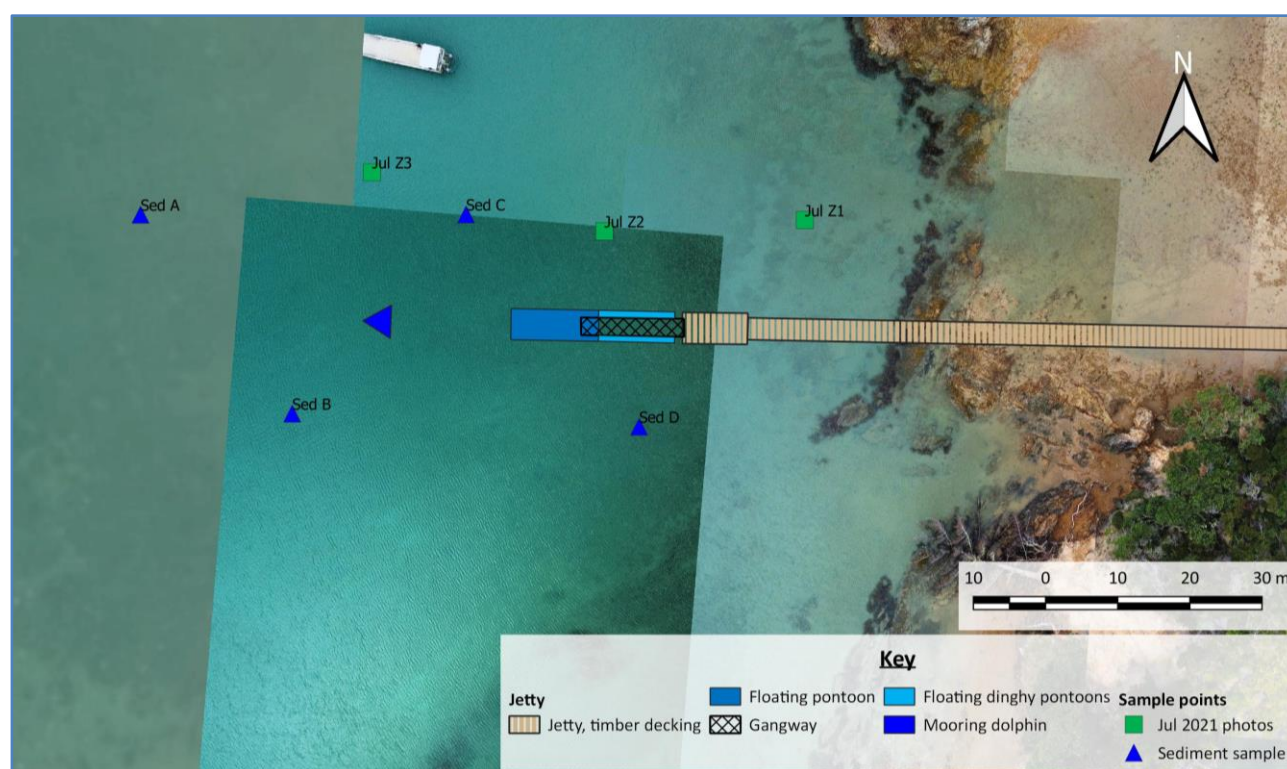
Figure 8. *Proposed Omakiwi pontoon and jetty design. Sample sites of seabed images Z1 to Z3, Sed C and Sed D, sediment quality and benthic biota (Sed A to Sed D). Based on revised plans provided by Total Marine Services dated 14/10/2021.*

The assessment, using photography from the GoPro cameras, was preliminary to provide information on the presence or absence of seagrass beds within the embayment, specifically along the jetty alignment the area around the pontoon (Figure 2). On 14 July 2021 sediment quality and benthic biota samples were collected from four sites (Sed A to Sed D) around the jetty (refer Figure 8).

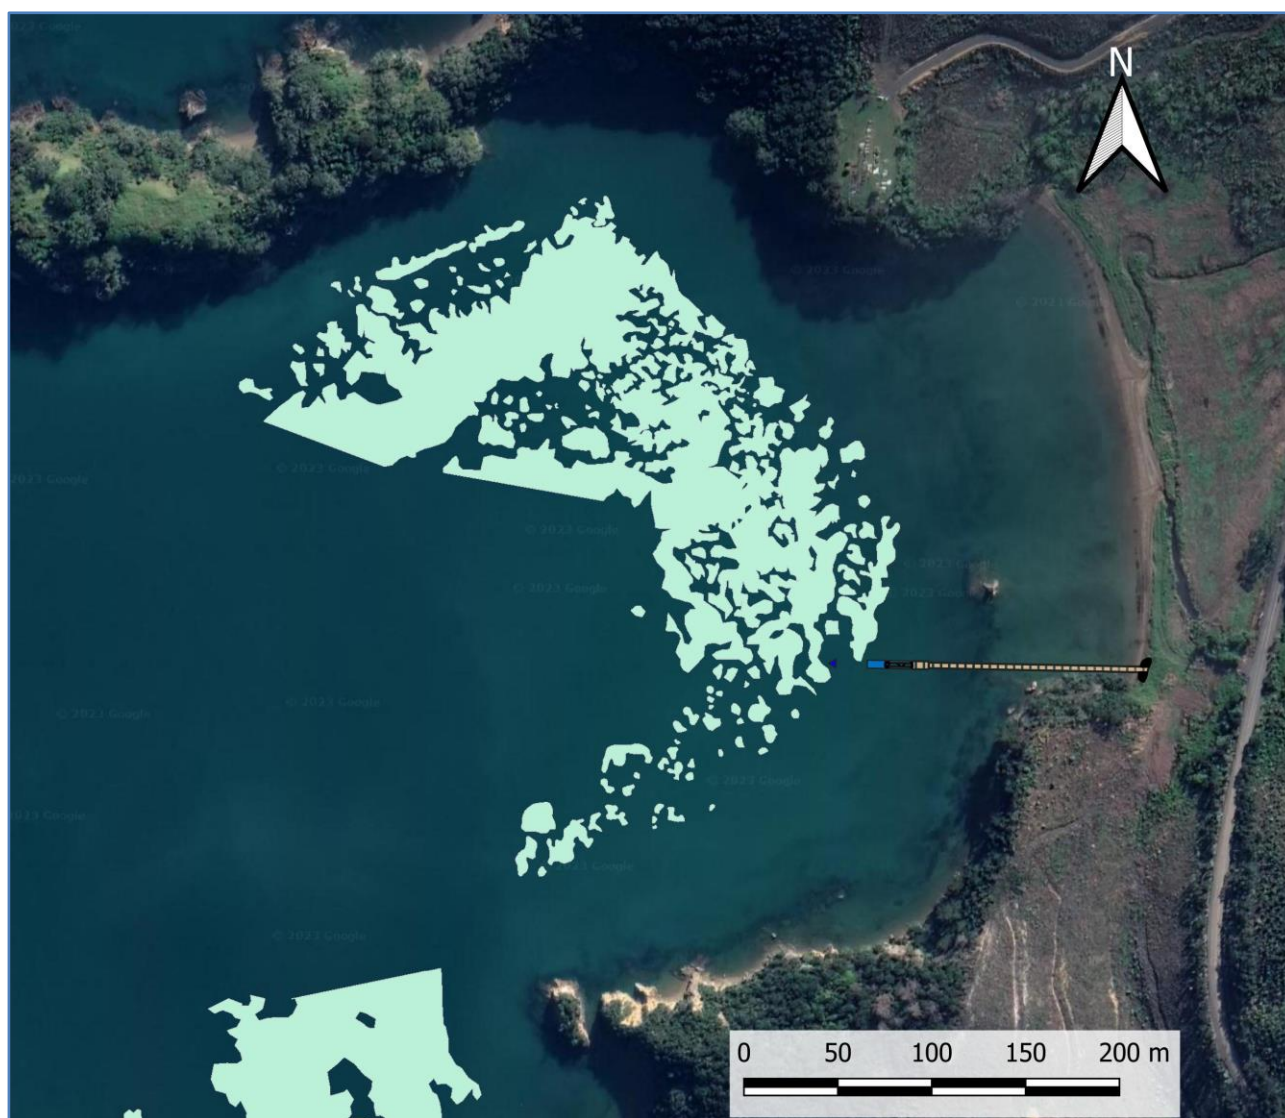
Figure 9. NRC modelled seagrass habitat from aerial photographs. Seagrass layer dated 2015 from the NRC map online tool.

present¹. This layer shows that seagrass beds are thought to have been present and may still be present in the subtidal zone of Omakiwi Cove (Figure 9). This modelled seagrass distribution map dated July 2015, was based on a number of aerial photographs spanning over 10 years. It is uncertain if the quality of the seagrass habitat has been ground-truthed as the NRC attribute tables were not available online.

While the NRC modelled seagrass habitat distribution shown in Figure 9 shows that the jetty and pontoon do not overlap with the presence of seagrass. Seabed photograph sites Z3 and Sed C correspond to areas identified by NRC as having seagrass present, however no significant seagrass was observed in the winter of 2021. It was considered possible that the *Zostera* bed could be semi seasonal, dying off in the low light levels of winter and proliferating in the warmer longer sun light hours of summer. To this end an in water visual inspection was conducted at low tide on 20 February 2022. The survey area was limited to that of the proposed pontoon and jetty areas as well as areas closely adjacent. The weather on the day was fine and sunny however the 2022/23 summer has been far from normal with higher than normal rainfall. In water visibility during the survey was only about 1m which was less than expected. Transects along the edges of the proposed pontoon footprint showed a muddy sandy seabed covered with a low (<20mm) thick layer of filamentous algae or diatom with very sparse blades of *Zostera* (Figure 13). *Zostera* was very slightly more abundant on the southern side (bottom picture) of the proposed pontoon. It is considered that the presence of the floating pontoon would have no detectable effect on the abundance of *Zostera*. Transects 5-10 m parallel to the proposed pontoon showed similar habitat.

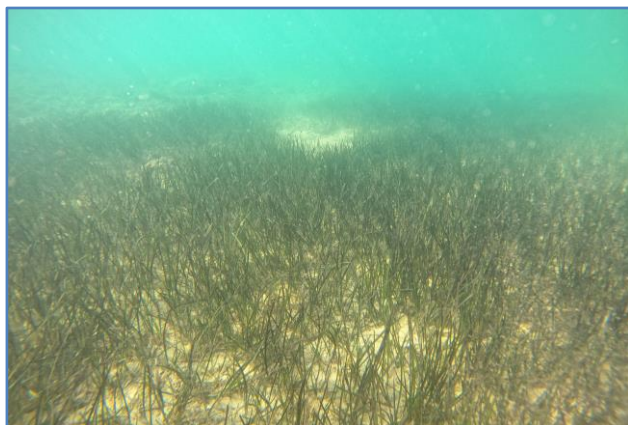
Figure 10. *Example of healthy Zostera meadows from Moturua Island (Bioresearches 2022)*

Seagrass meadows (Figure 10 and Figure 11) are vital coastal ecosystems providing important ecosystem services. For instance, they form nursery habitats for numerous fish species, contribute to the nutrient recycling, and stabilise sediments (Turner and Schwarz 2006).

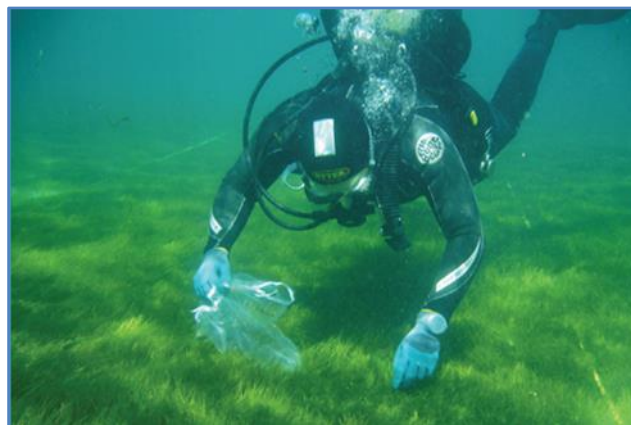
Figure 11. *Diver sampling a subtidal seagrass meadow (NIWA Seagrass Guide)*

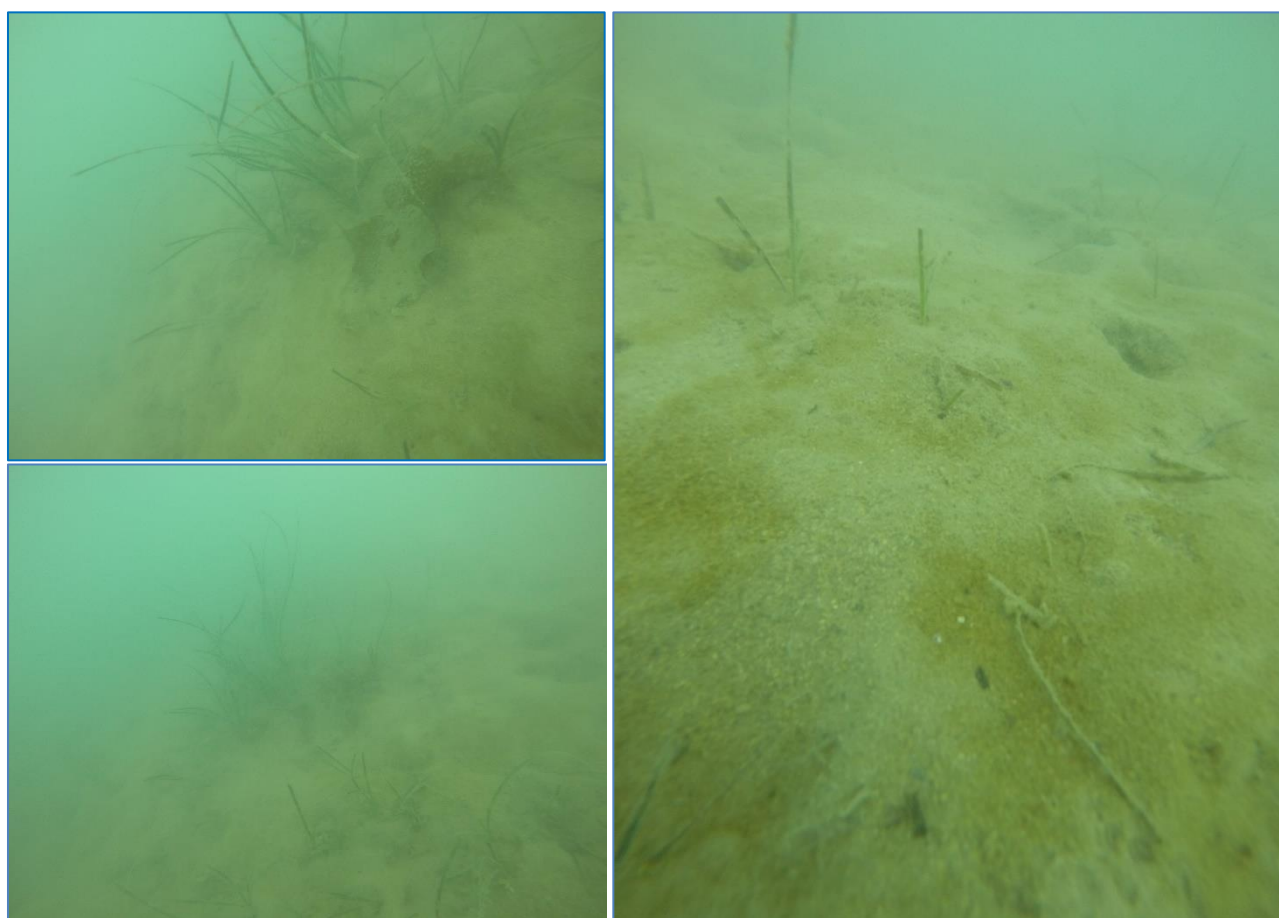
Figure 12 *Examples of drop camera images captured from the project foot print showing sparse Zostera.*

The visibility in June was very poor underwater, limiting the quality of the photos, however all seabed photos showed either no *Zostera* or a sparse distribution of *Zostera* plants on the seabed. Selected photos at each drop camera location presented in Appendix 3 and summarised in Figure 12.

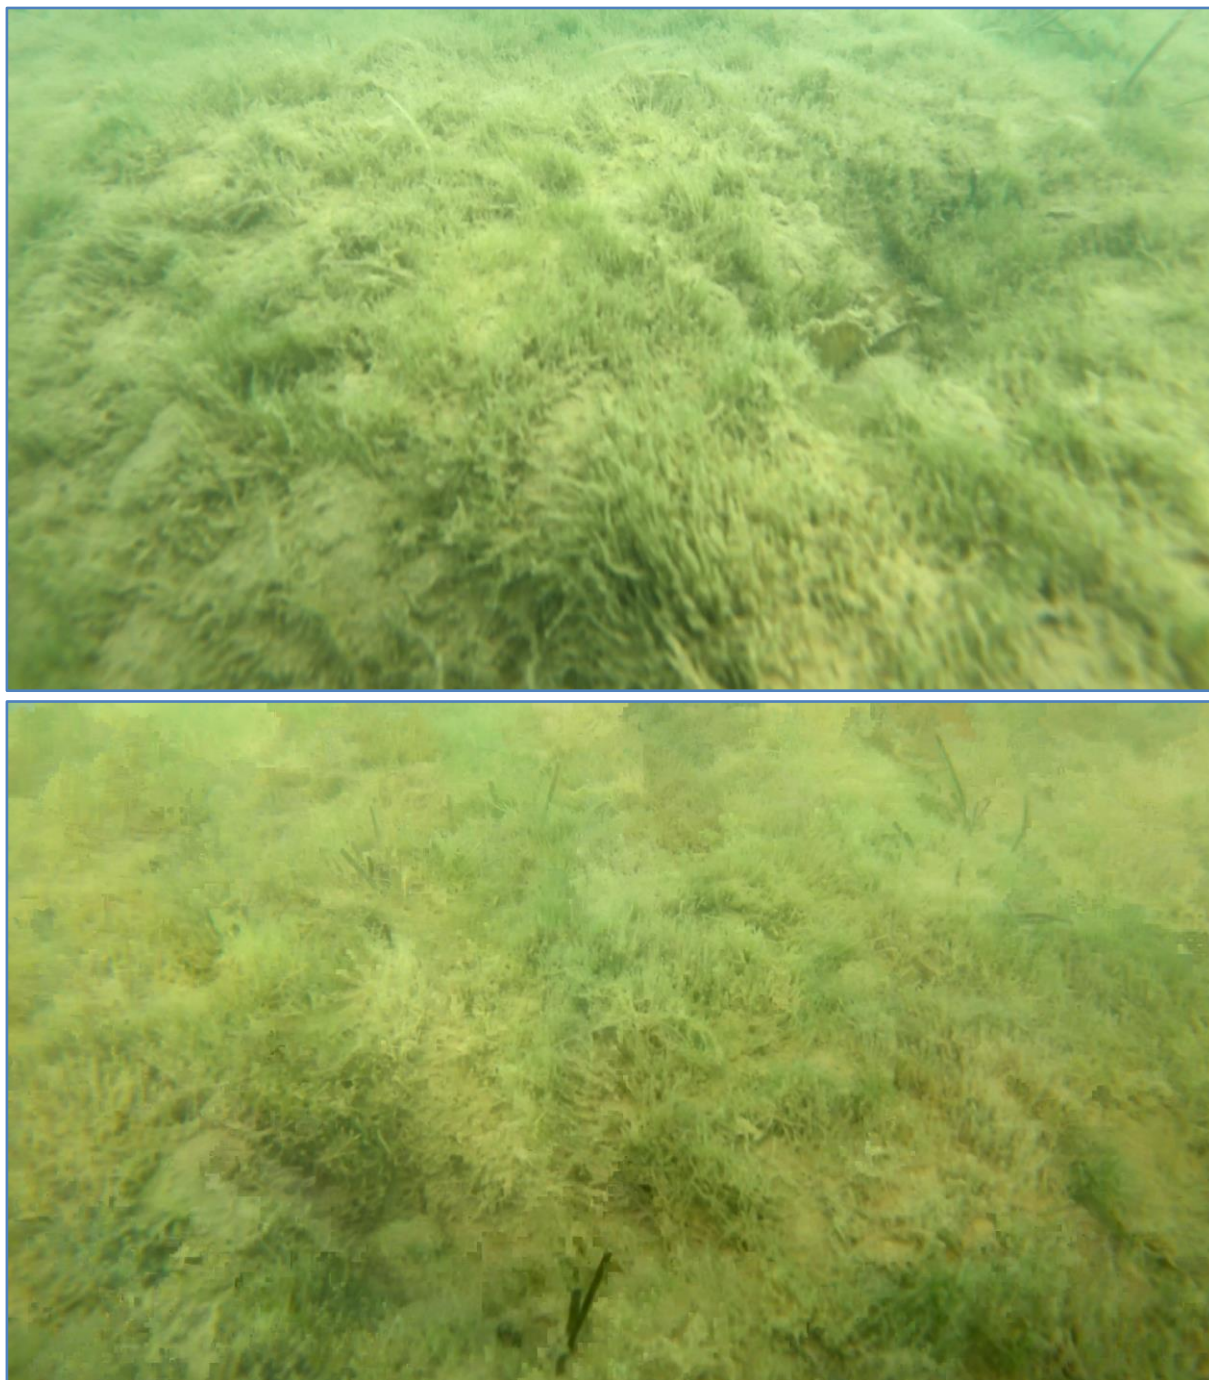
Figure 13 *Typical seabed habitat in the area of the proposed floating pontoon, 20 Feb. 2023.*

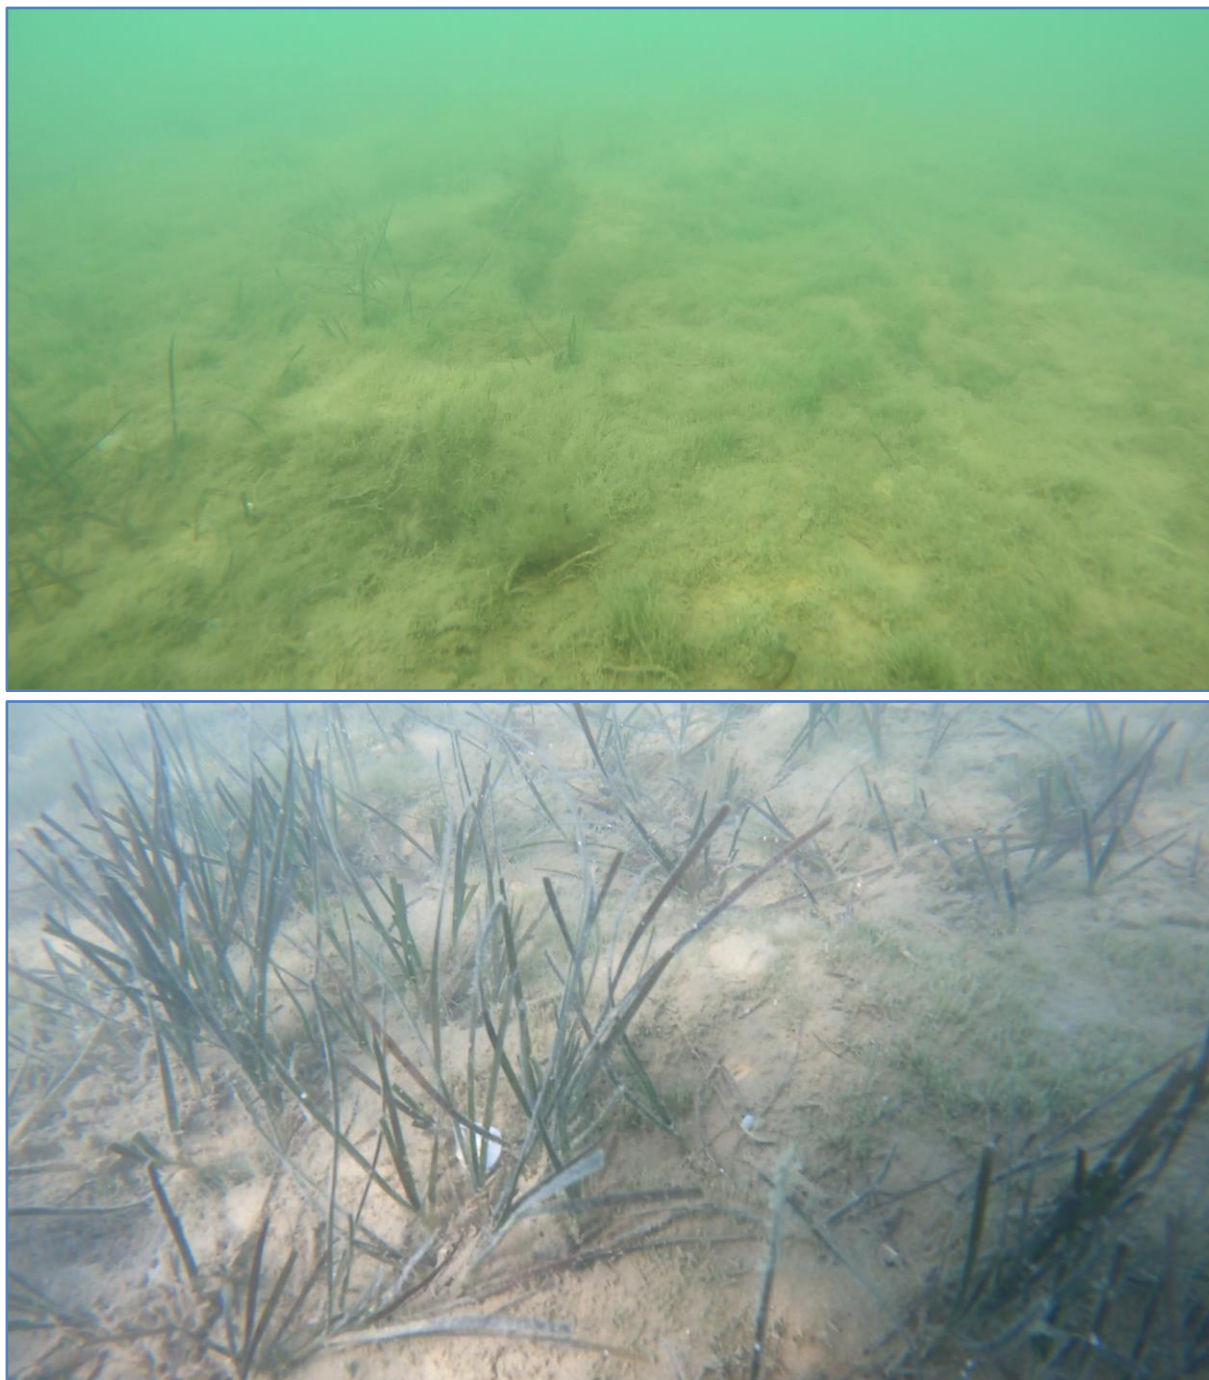
Figure 14 *Habitats along jetty transect, Top; 20m off rocks sparse Zostera, Bottom; 10m off rocks dense Zostera. 20 Feb. 2023.*

A video transect run along the alignment of the proposed jetty showed the seabed habitat grade from the muddy sandy filamentous algae habitat at the pontoon, to include more sparse low *Zostera* at about 20 m off the rock fringe (Figure 14 top), to a bed of denser longer leaved *Zostera* at about 10 m off the rock fringe (Figure 14 bottom), within the zone of larger boulders. Between the denser bed of *Zostera* and the rock reef fringe boulders were present some of which showed the presence of sponges (Figure 15 top) and the invasive sea squirt (*Eudistoma elongatum*) (Figure 15 bottom).

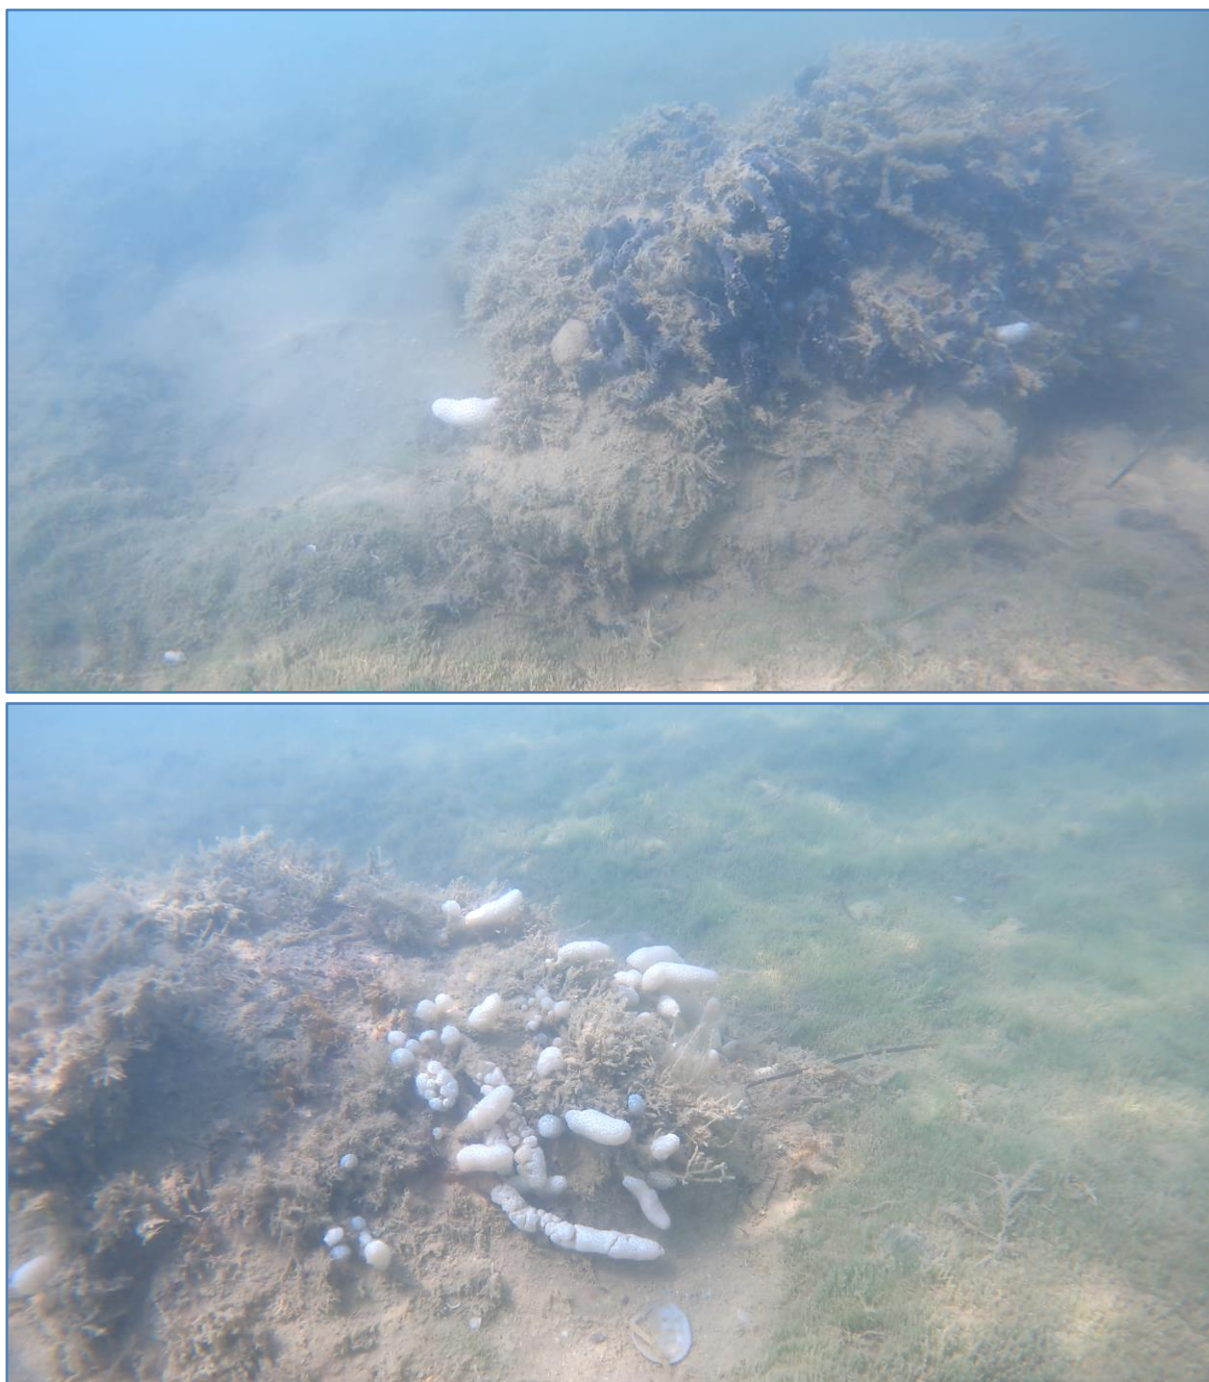
Figure 15 Habitats 5 m off rocks, Top; Sponges on boulders, Bottom; Invasive sea squirt. 20 Feb. 2023.

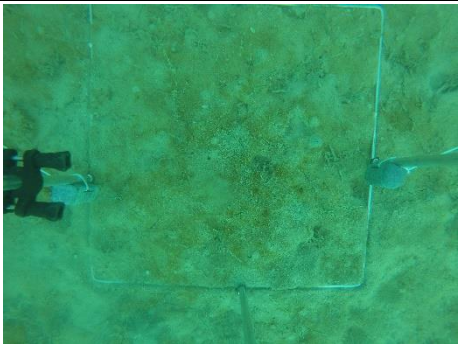
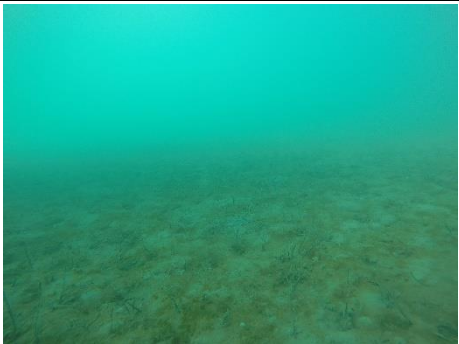
Location name	Seafloor photo	Side photo	Zostera presence and density
North of Pontoon (Z3) 14 July 2021

Sparse
North of Pontoon (Sed C) 14 July 2021

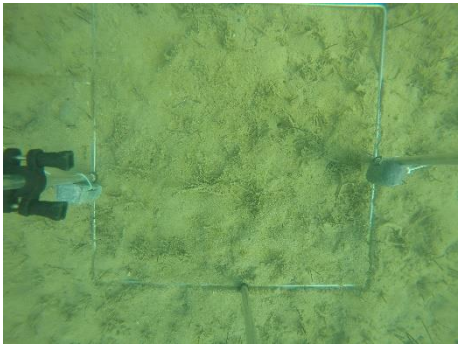
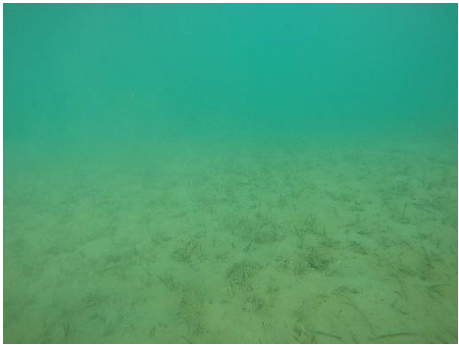
Sparse
North of Pontoon (Z2) 14 July 2021

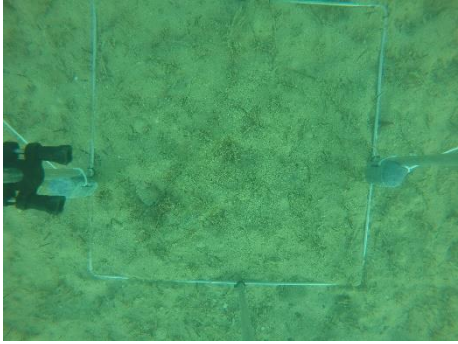
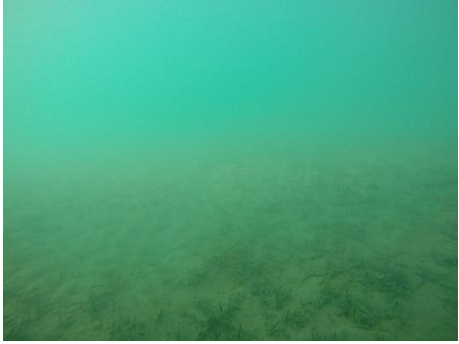
Sparse
South of Pontoon (Sed D) 14 July 2021

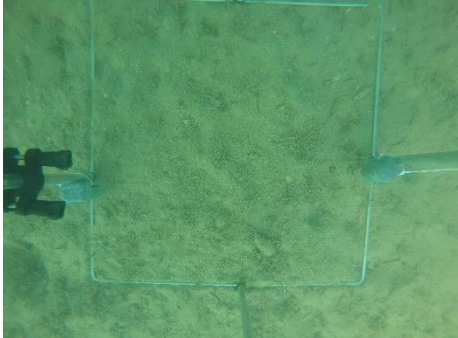
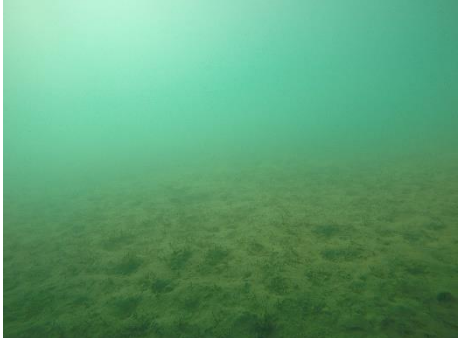
Sparse

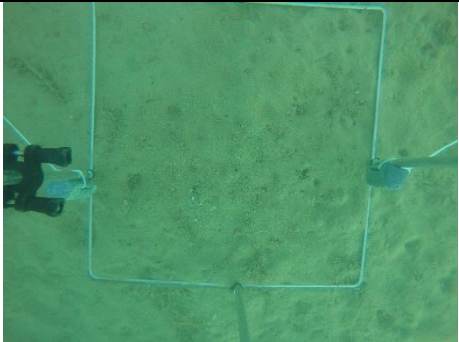
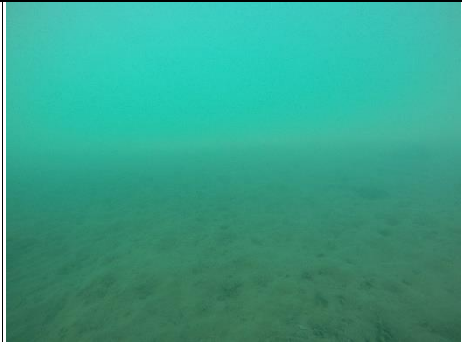
Location name	Seafloor photo	Side photo	Zostera presence and density
North of Jetty (Z1) 14 July 2021

None visible
