ORANGEFIELDS CIVIL INFRASTRUCTURE REPORT

482-484 Kerikeri Road

Project Reference: 25575

May 3, 2024

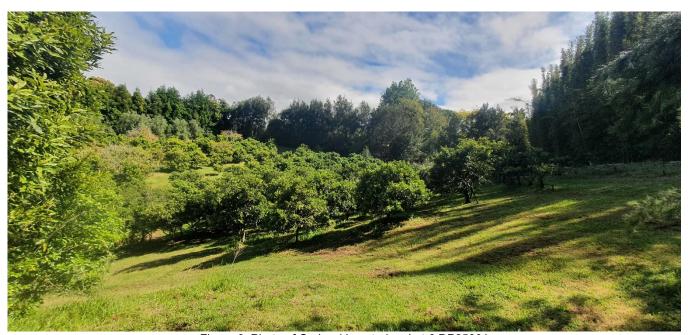
Figure 3: Photo of Orchard Located on Lot 6 DP25904

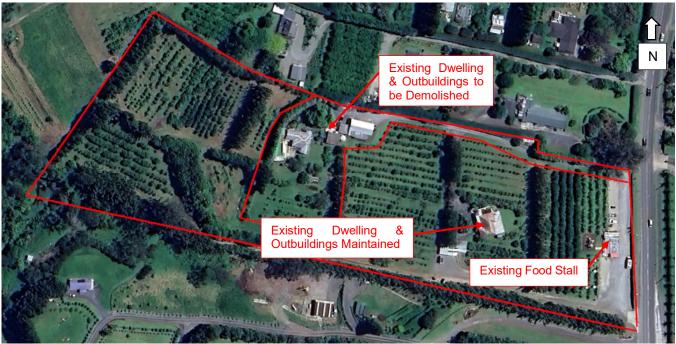
Figure 5: Existing Dwellings and Roadside Stall Shown (Image Sourced from Google Earth)

On the site there are two dwellings with outbuildings on the two respective lots and an existing roadside stall located on Lot 6 DP25904. It is proposed to maintain the dwelling on Lot 1 DP25904 and to demolish the existing dwelling and outbuildings on Lot 6 DP25904 and upgrade the roadside stall.

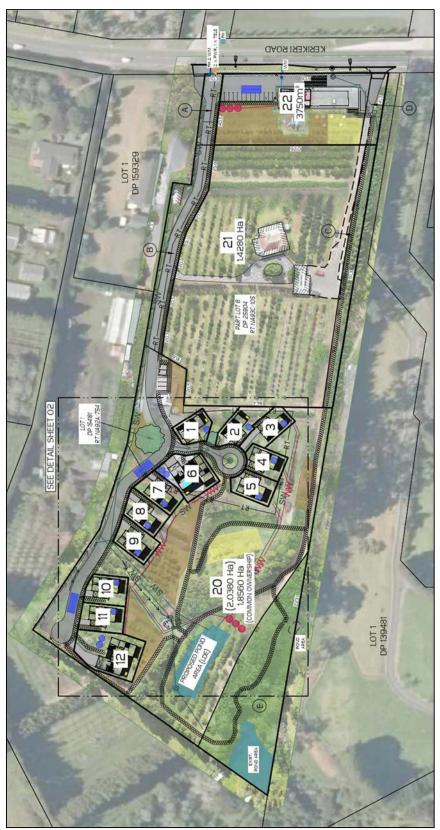
Figure 6: Proposed Scheme Plan

The proposed scheme plan is shown below in Figure 6 (also attached Appendix A).

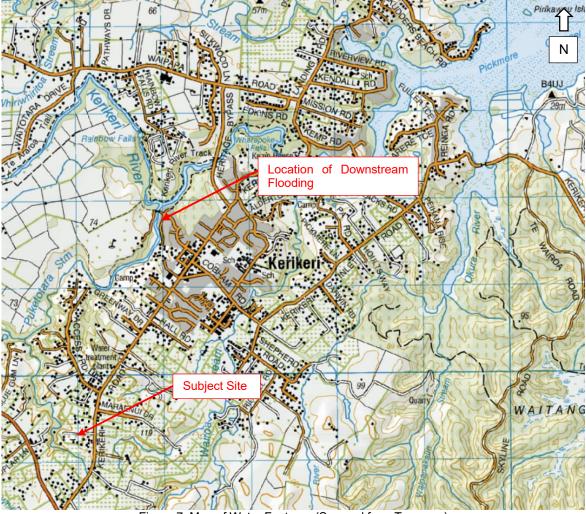
Figure 7: Map of Water Features (Sourced from Topomap)

An ephemeral stream is located along the western boundary of the site with an in-line pond located partially on the south-west border of the site.

This feeds into the Puketotoara Stream which then drains into the Kerikeri River. The catchment has substantial flooding indicated on the Northland Regional Council maps when considering the regionwide models for the 100-year climate change extent downstream of this site.

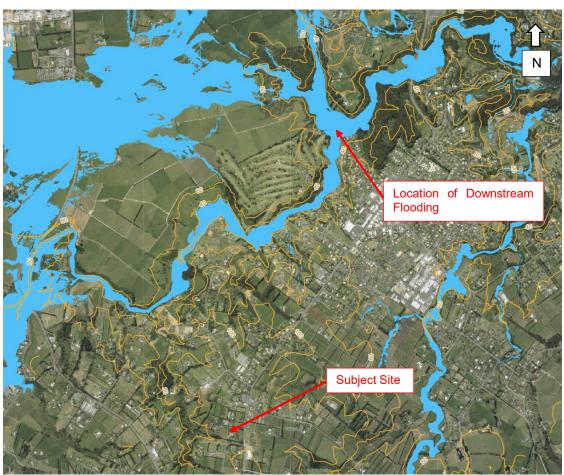
Figure 8: Flooding Map (Sourced for NRC Maps)

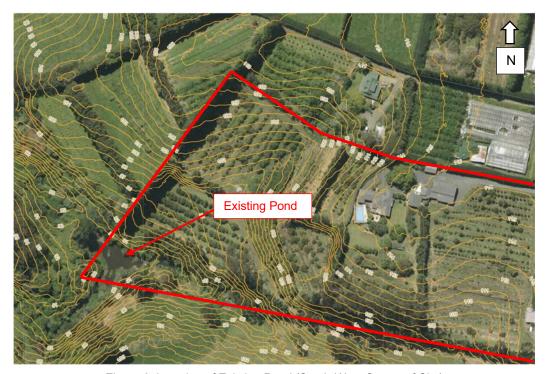
Figure 9: Location of Existing Pond (South-West Corner of Site)

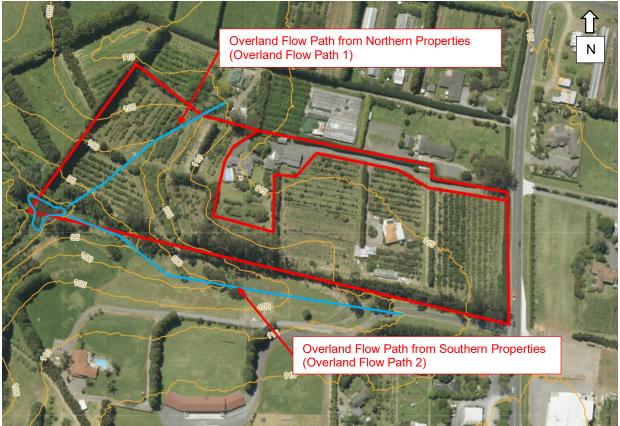
Figure 10: Overland Flow Path Through the Site

On the site itself there are two identified overland flow paths which enter the pond on the south-west corner of the site which are identified in Figure 10 below.

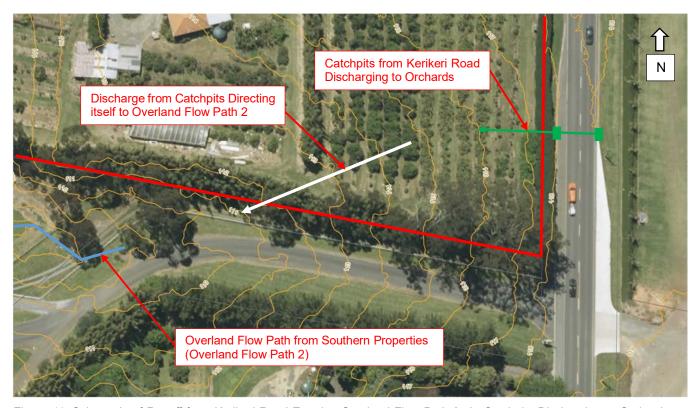
Figure 11: Schematic of Runoff from Kerikeri Road Entering Overland Flow Path 2 via Catchpits Discharging to Orchards on Proposed Lot 22

Runoff from Kerikeri Road enters this overland flow path via catchpits located on Kerikeri Road in front of proposed Lot 22. Currently the runoff from these catchpits discharges into the orchard on proposed Lot 22 via a bubble up, after which it flows across the surface towards the overland flow path as can be seen in Figure 11 below. The proposed design requires alteration to this system as it discharges upstream from a proposed effluent disposal field.

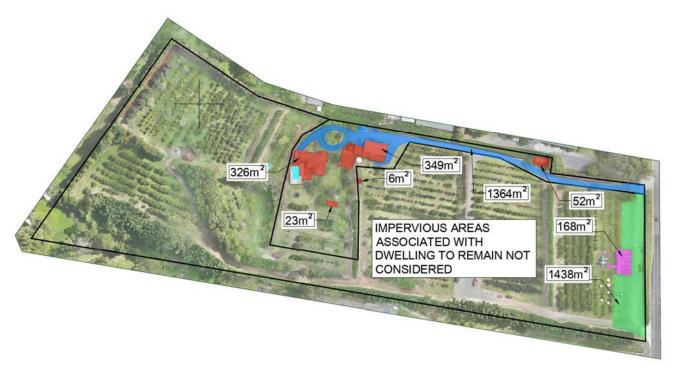
Figure 12: Map of Existing Impervious Areas Associated with Proposed Lots 20 & 22

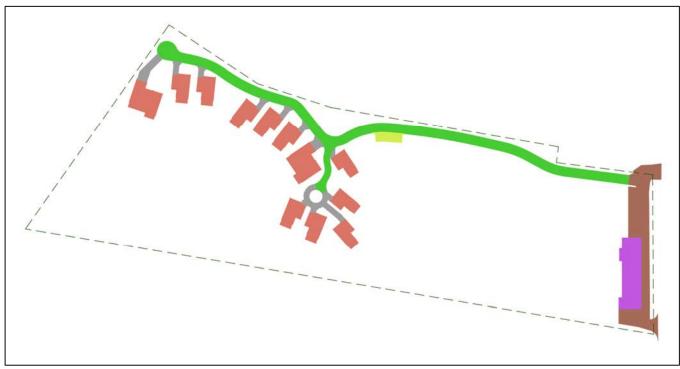
Figure 13: Map of Impervious Areas

The impervious areas associated with the proposed development are shown below in Table 2 and Figure 13 below.

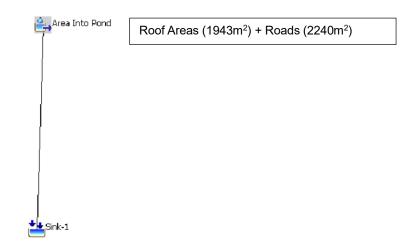
Figure 14: Water Quality Volume HEC-HMS Model Schematic

The model within HEC-HMS for calculation of water quality volume were set up as per Figure 14 below.

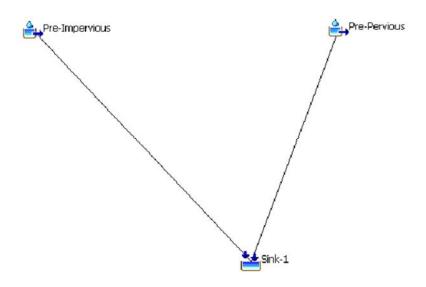
Figure 15: Predevelopment HEC-HMS Model Schematic

The model within HEC-HMS for predevelopment were set up as per Figure 15 below.

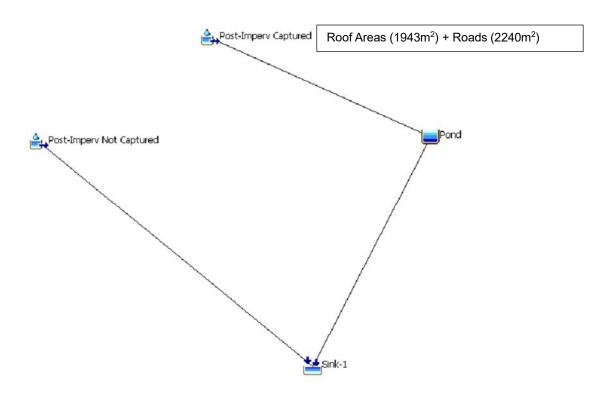
Figure 16: Post-development HEC-HMS Model Schematic

The model within HEC-HMS for post-development were set up as per Figure 16 below, with the captured areas offsetting the impervious areas where it is not practical to collect and divert them into the pond.

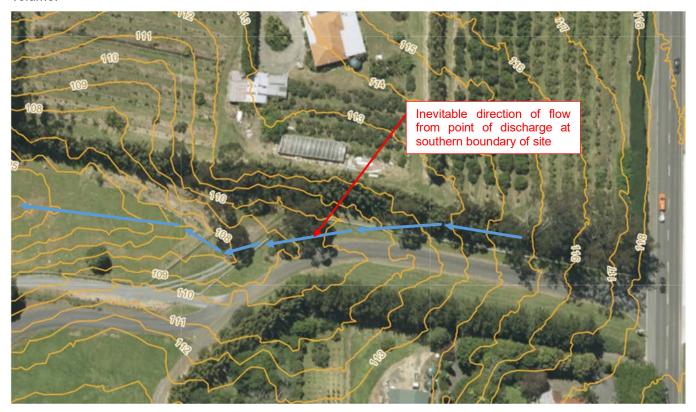
Figure 17: Topography from Point of Discharge on Southern Boundary

The topography along the southern boundary is such that no downstream flooding will occur as a result of the discharge and the intended design maintains the general flow regime in terms of direction, flow rates and flow volume.

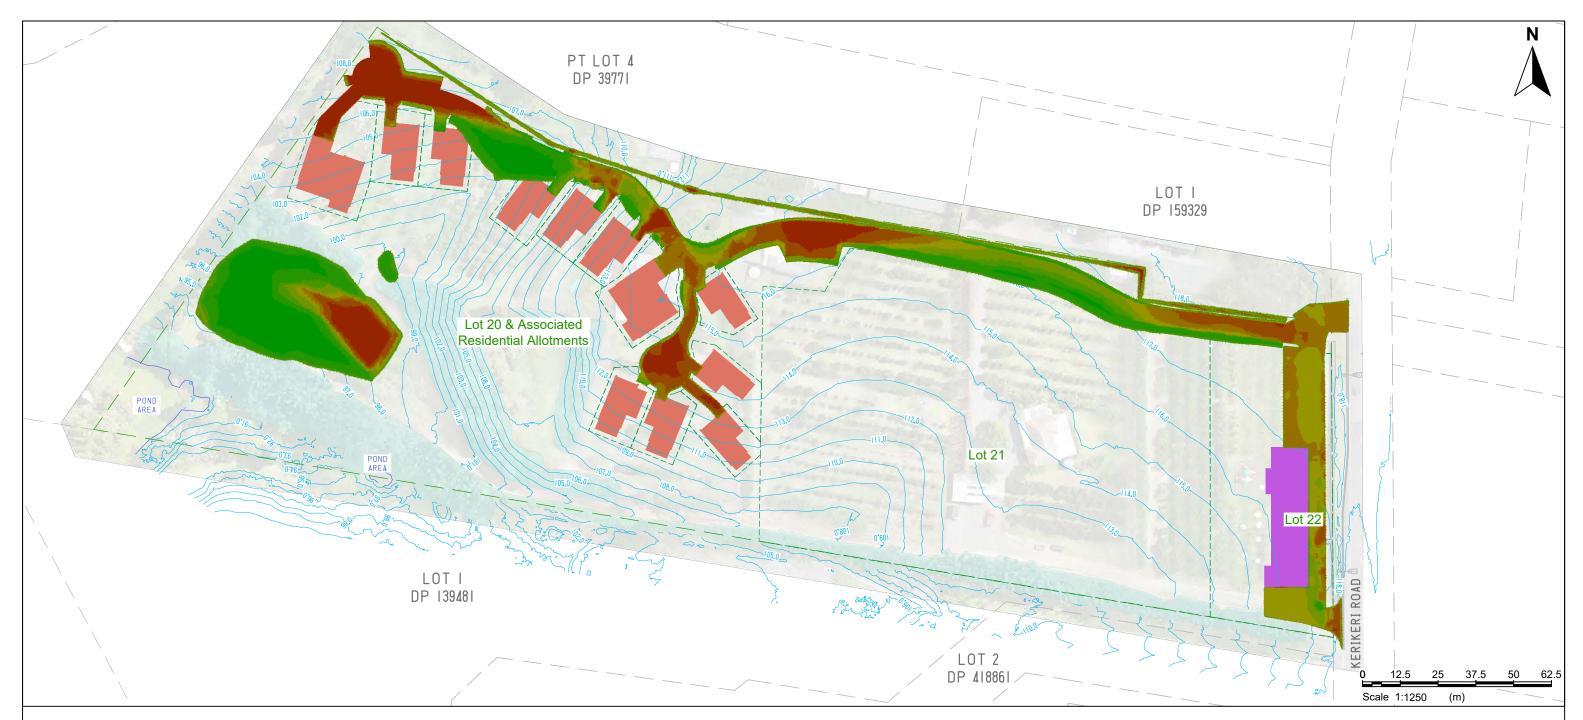
Surface Analysis: Depth Ranges								
NUMBER MINIMUM MAXIMUM DEPTH DEPTH								
-2.55	-0.64	1124						
-0.64	-0.42	919						
-0.42	-0.31	950						
4 -0.31		926						
-0.19	-0.02	841						
-0.02	0.13	620						
7 0.13		1183						
0.70	2.58	1061						
	MINIMUM DEPTH -2.55 -0.64 -0.42 -0.31 -0.19 -0.02 0.13	MINIMUM DEPTH -2.55	MINIMUM DEPTH MAXIMUM (m2) AREA (m2) -2.55 -0.64 1124 -0.64 -0.42 919 -0.42 -0.31 950 -0.31 -0.19 926 -0.19 -0.02 841 -0.02 0.13 620 0.13 0.70 1183

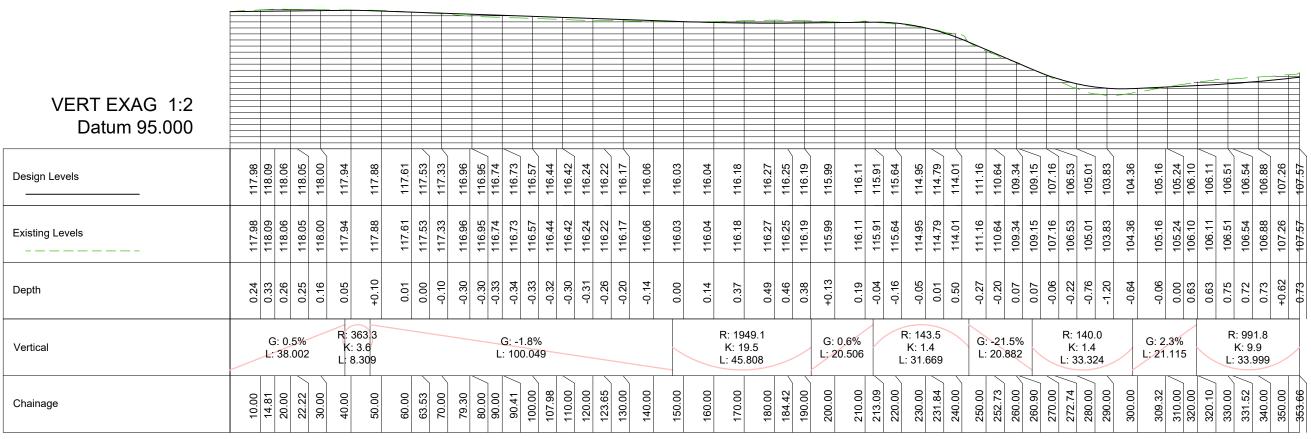
MAIN ACCESS LONG SECTION

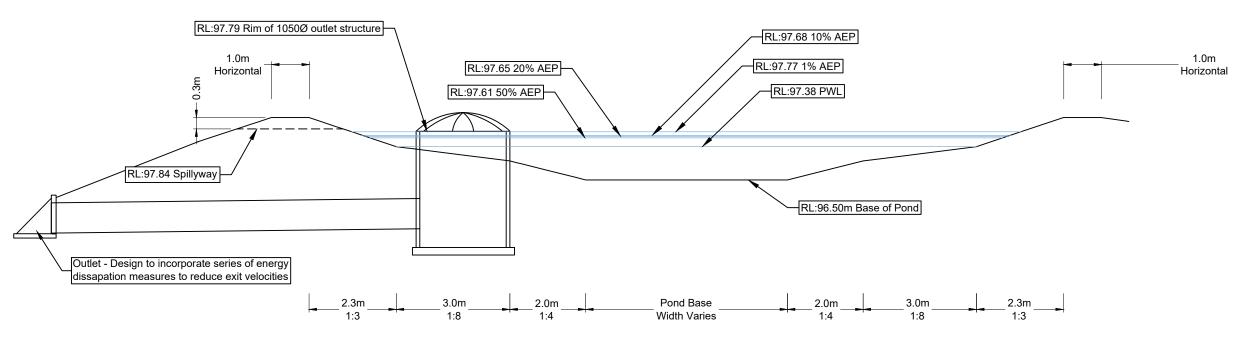
Pond Cross Section Scale 1:100

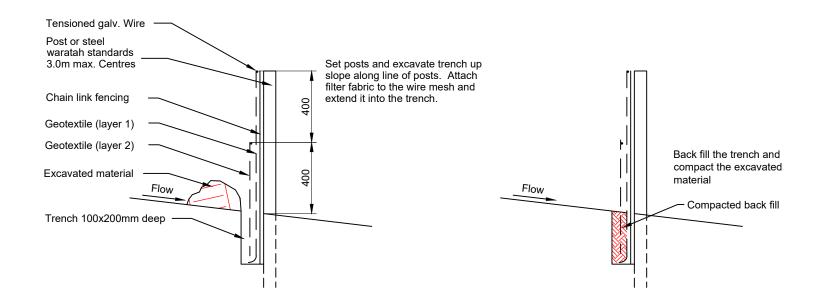
Super Silt Fence Construction

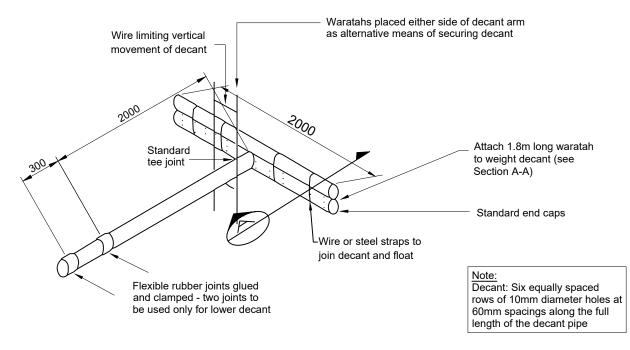
Decant System (up to 1.0ha)
