**DETAILED SITE INVESTIGATION (PSI/DSI)**

482-484 Kerikeri Road

A contamination detailed site investigation (DSI) has been conducted for the site located at 482-484 Kerikeri Road, Kerikeri

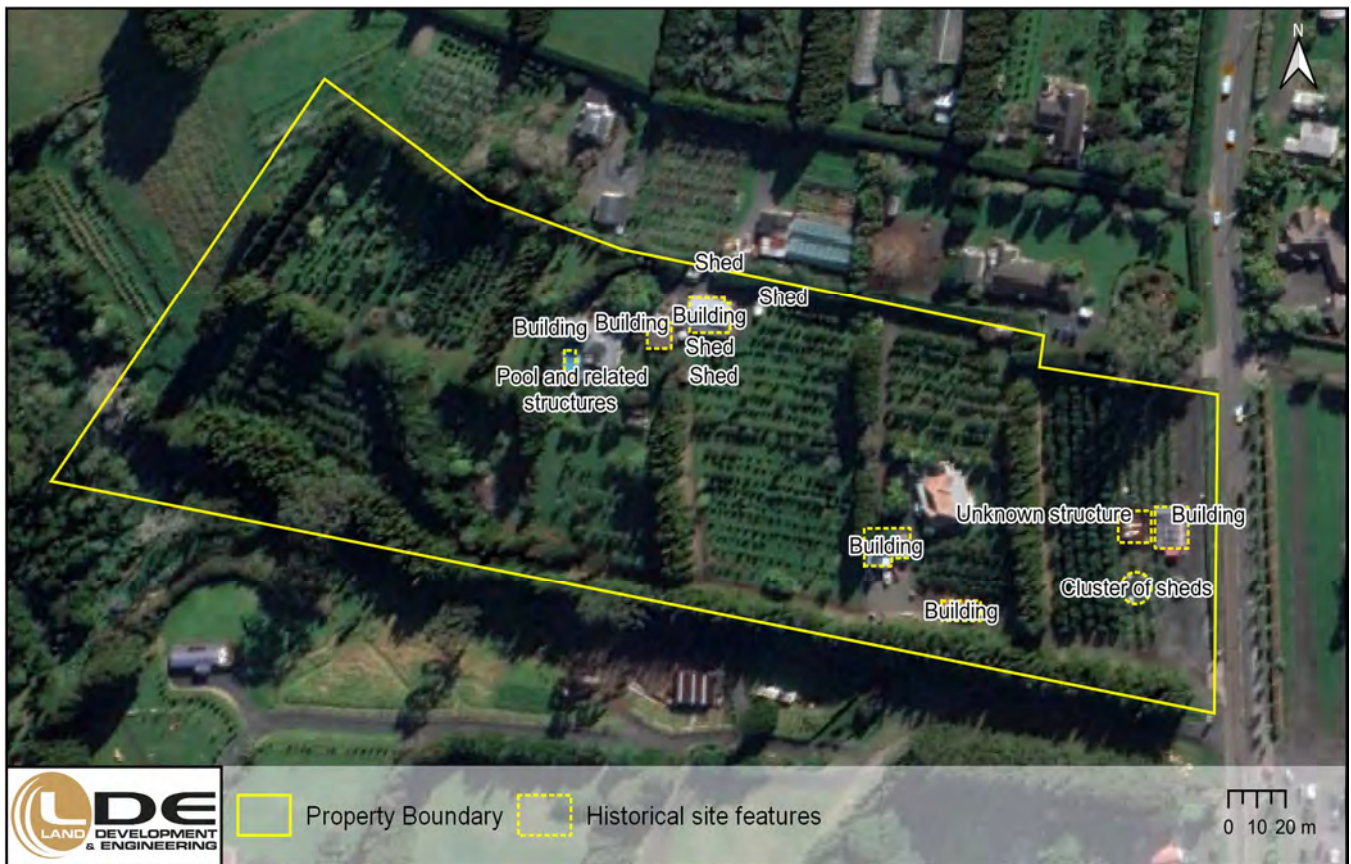
The site is predominantly vegetated with major and minor dwellings scattered throughout. The vegetation on site is made up of orchards consisting of fruit trees. There is also a playground and fruit shop along the eastern boundary of the site.

Figure 4. Annotated location map showing the current site layout. Source: LINZ Data service<sup>3</sup>.

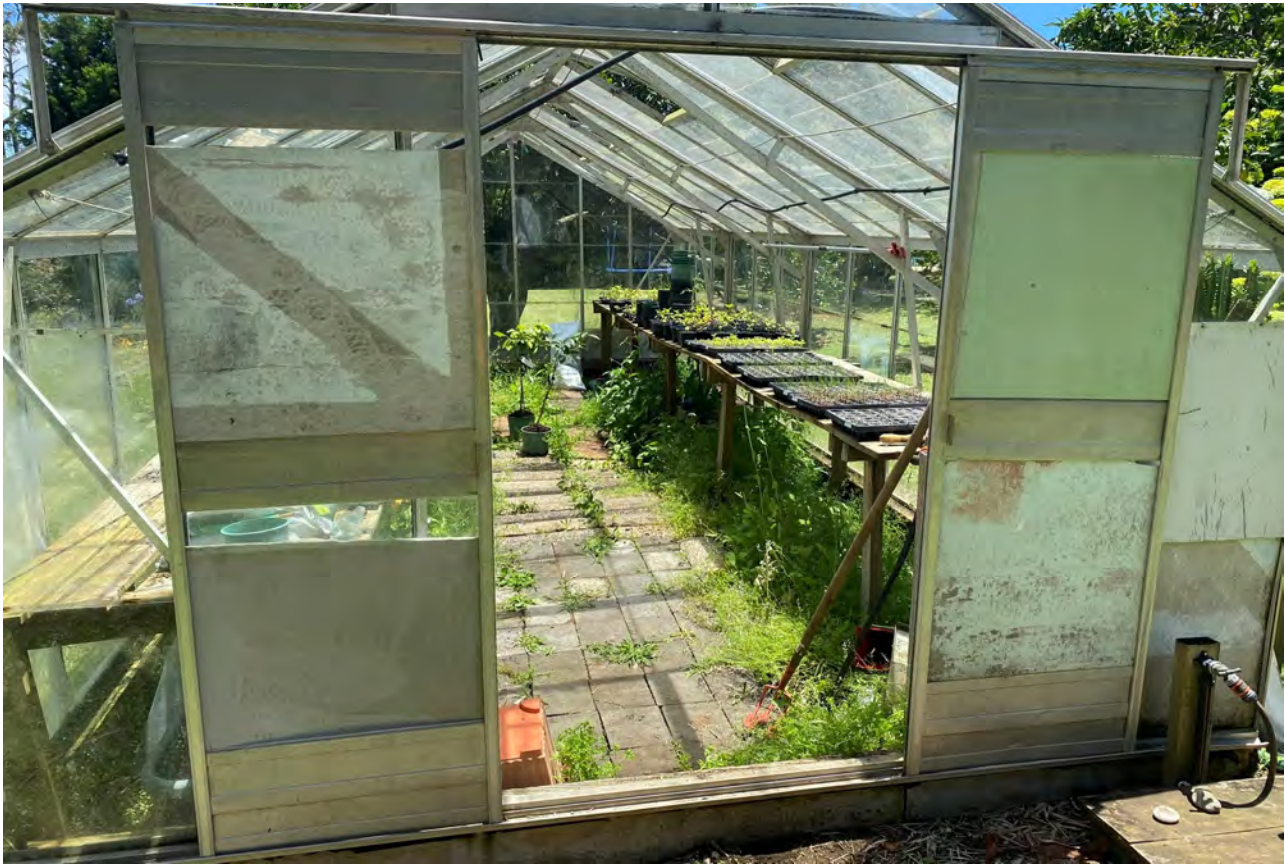
Site sampling was undertaken at the site on 7th December 2023. The site is generally flat with some undulation in the eastern portion of the site. During the sampling a glass house with deteriorated cladding was encountered, along with a burn pit, a stockpile with concrete debris and orcharding which was expected.

Figure 6. Glasshouse encountered on site.

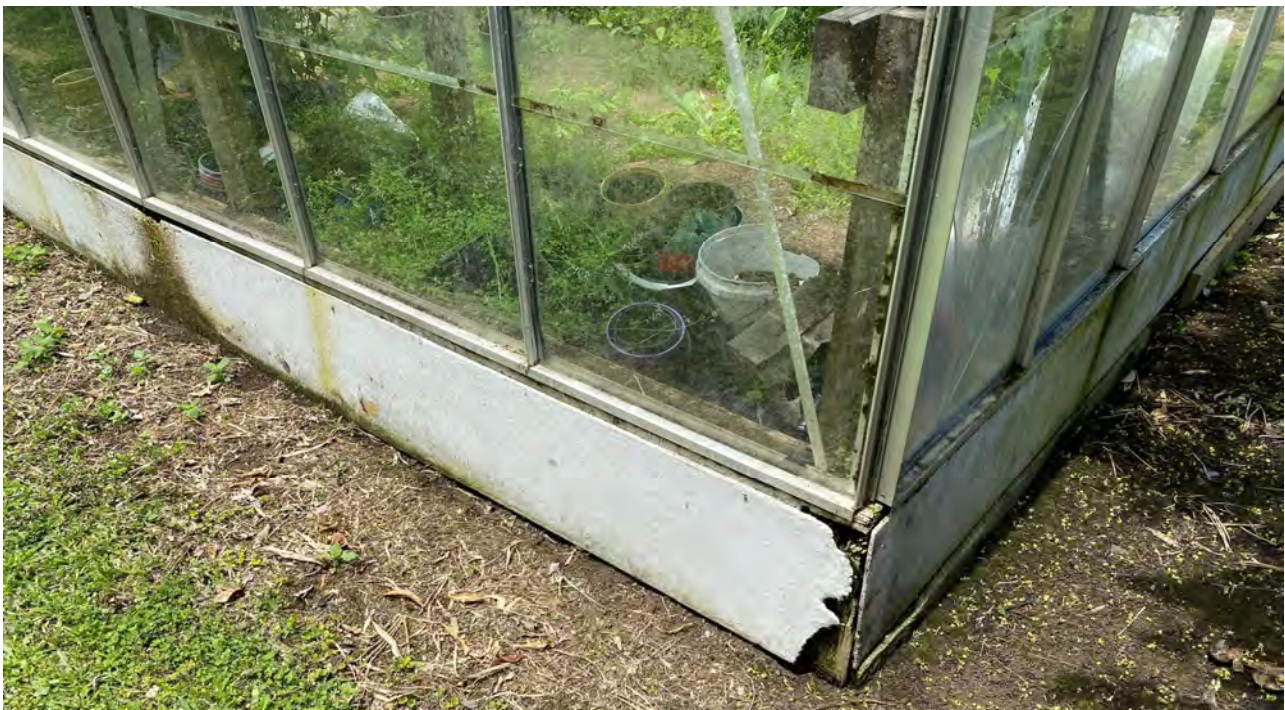
Figure 7. Deteriorated cladding of glasshouse.

| Test Pit / Borehole | Depth (mm) | Description | Analysis | Rational |
|---|---|---|---|---|
| GH-1 | 0 to 100 | Topsoil | Asbestos | ACM present and in a degraded condition on Greenhouse. |
| GH-FRAG | N/A | Building fragment | Asbestos | ACM present and in a degraded condition on Greenhouse. |

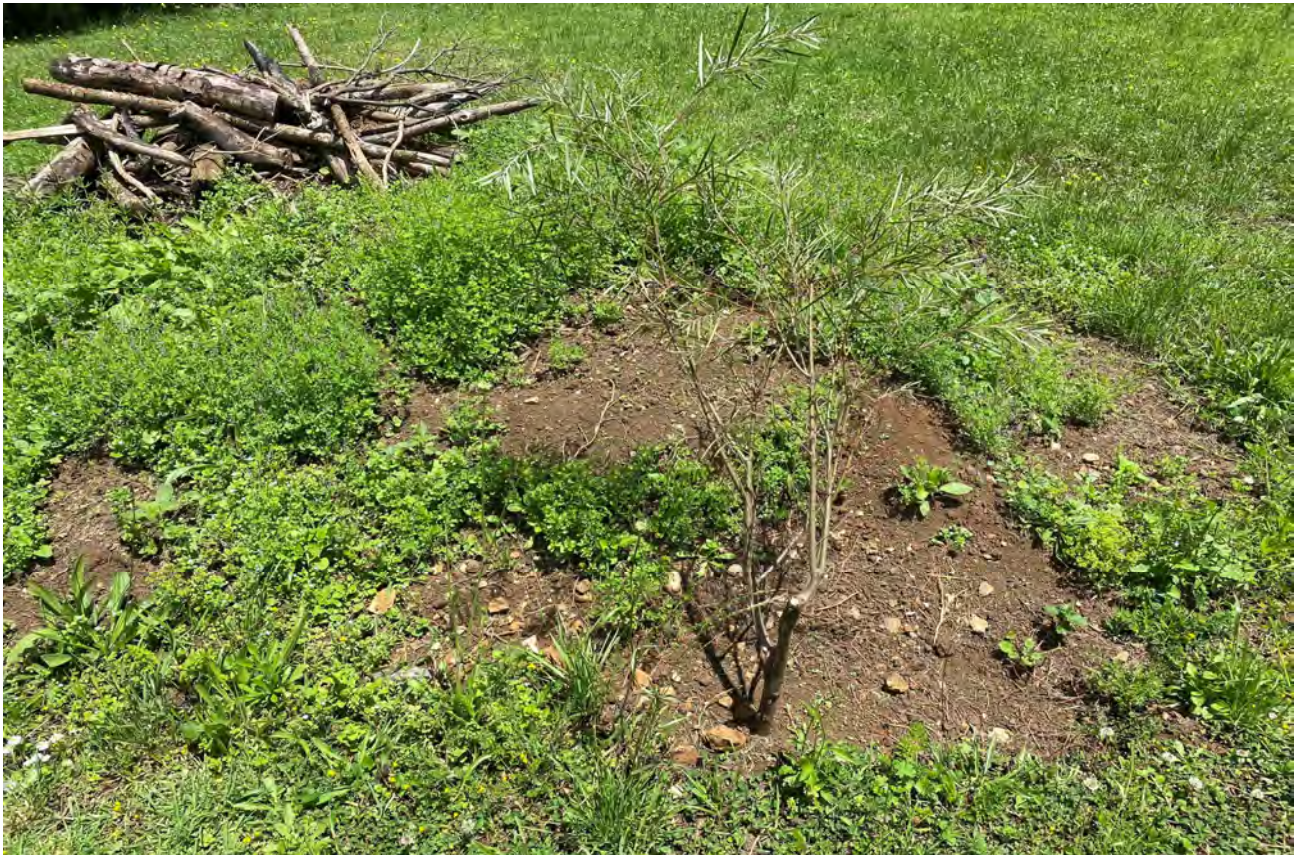
Figure 8. Stockpile with minor fragments of concrete.

| Test Pit / Borehole | Depth (mm) | Description | Analysis | Rational |
|---|---|---|---|---|
| S21 (Stockpile) | | Clayey silt with concrete | Heavy metals, OCPs | Orcharding |

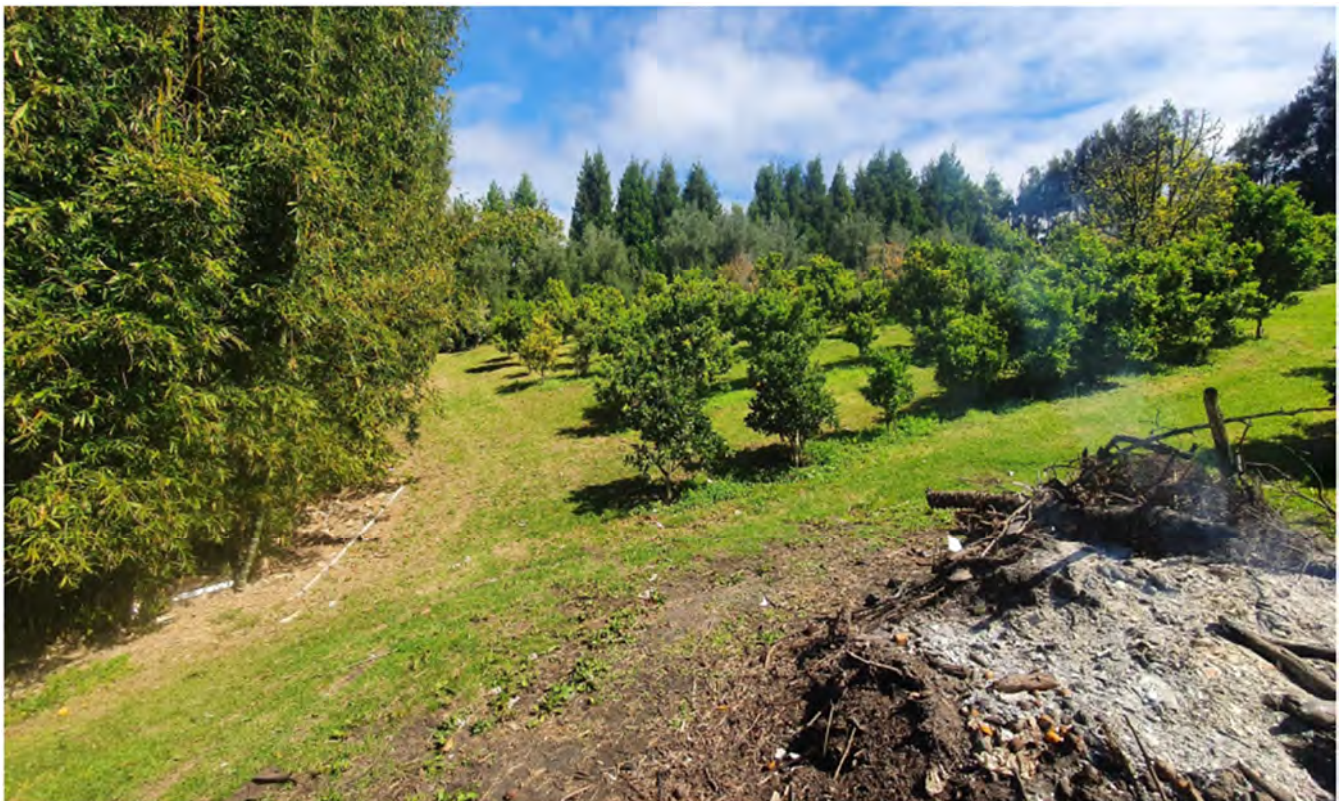
Figure 9. Burn pit encountered.

| Test Pit / Borehole | Depth (mm) | Description | Analysis | Rational |
|---|---|---|---|---|
| S18 (Burnpit) | | Burned fragments with charred topsoil | Heavy metals, OCPs | Burnpit |

Most of the highly elevated metals (B3, S33, S32 and S30) are associated with the halo of the existing building footprints. The exceptions are S18 which is a burn area, S27 which has elevated arsenic and copper (likely position of a former treated timber post) and S24 which may have been a temporary storage location for building materials due to the elevations of arsenic, cadmium, copper, lead and zinc.

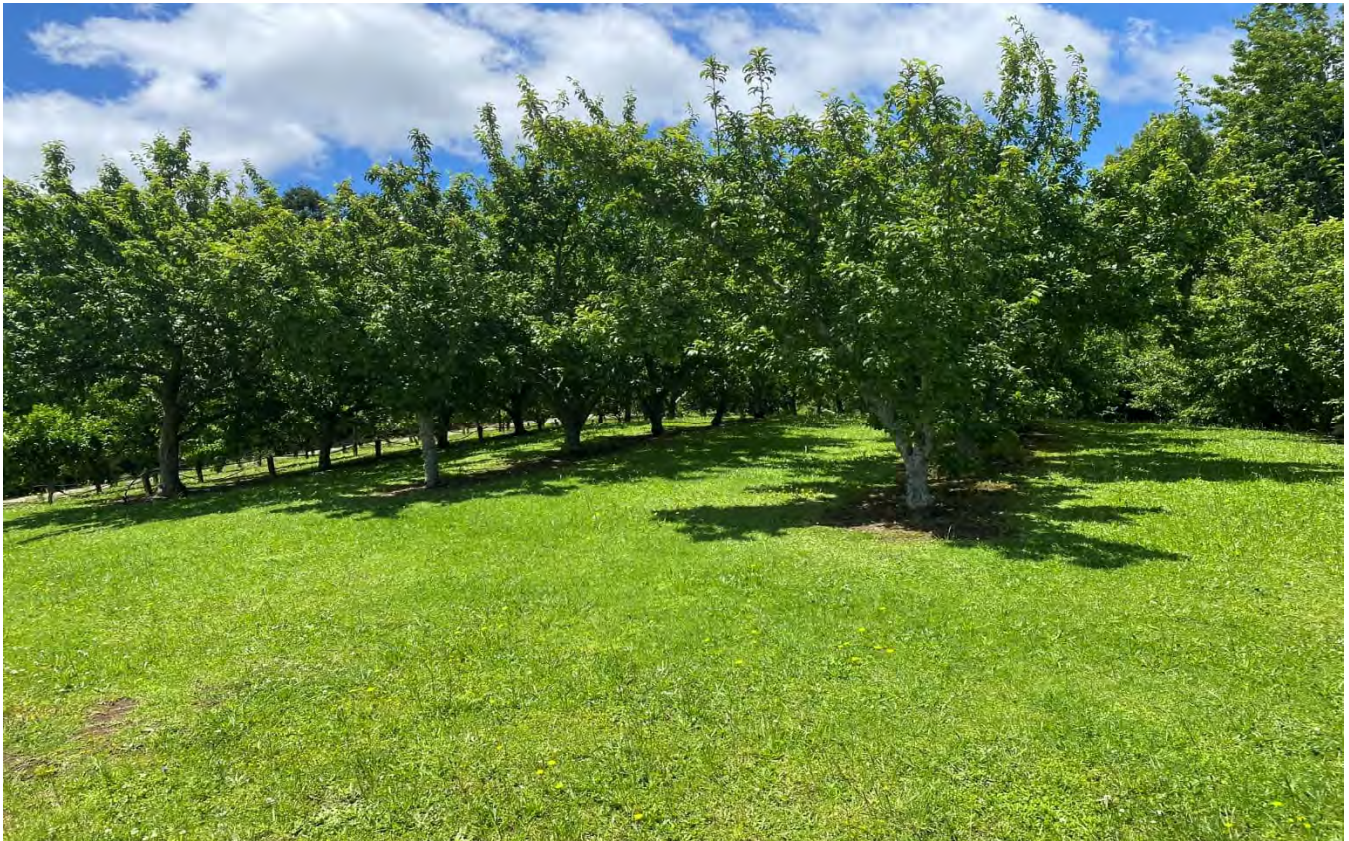
Figure 10. Homogenous orcharding on site.

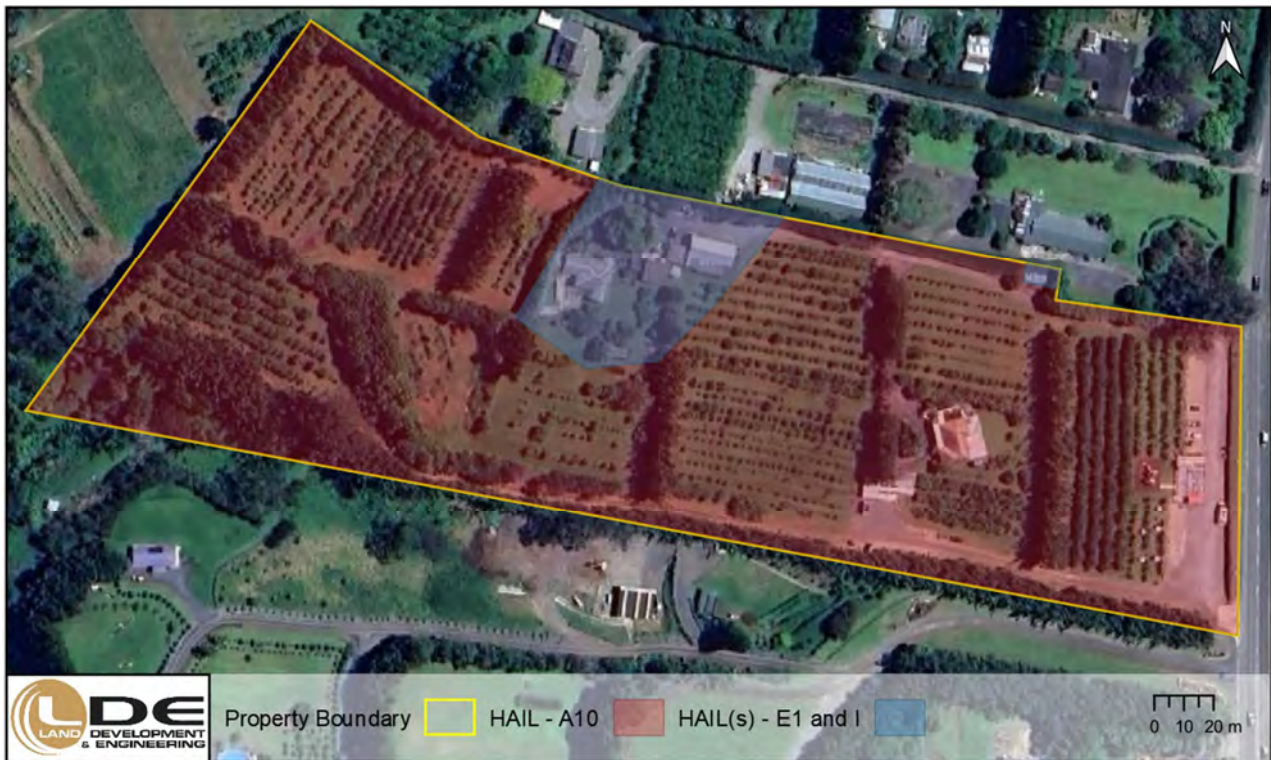
The preliminary site CSM is provided in Table 3 and Figure 11. A human health risk can only occur where there is a complete pathway between contaminant source and a receptor. Building floors and paved or sealed areas will largely or completely prevent contact with underlying soils and therefore, direct exposure pathways are or will be incomplete for such areas.

Figure 11. CSM plan showing areas of HAIL and potential areas of contamination.
