**PRELIMINARY SITE INVESTIGATION (PSI)**

482-484 Kerikeri Road

A contamination preliminary site investigation (PSI) has been conducted for the site located at 482 – 484 Kerikeri Road, Kerikeri. LDE understands that the site is to undergo soil disturbance and change in land-use that do not meet the permitted activity conditions (Regulation 8) of the National Environmental Standard for Assessing and Managing Contaminants in Soil to Protect Human Health (NESCSCS).

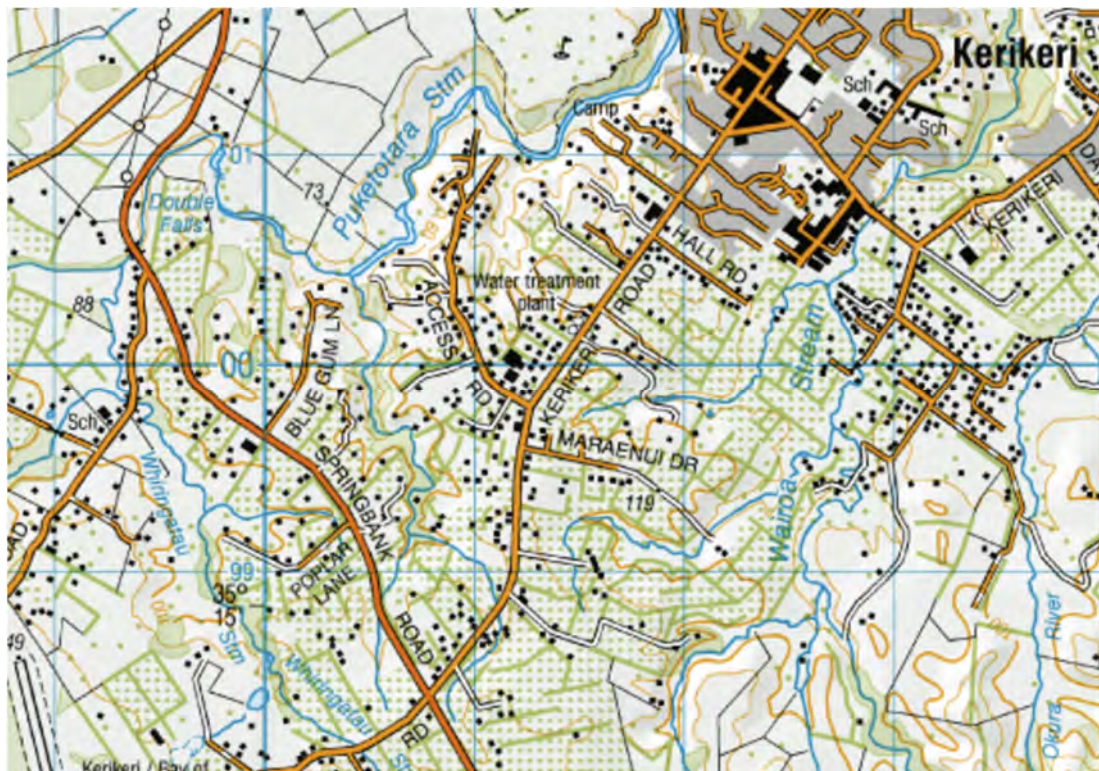
Figure 3. Topo map showing nearby waterbodies. Source LINZ / MapsPast<sup>5</sup>.

The Puketotara Stream is the nearest body of water from the property and is located approximately 1.1km southeast of the property at its closest point. An unnamed tributary of the Wairoa Stream is also located approximately 1.3 km west of the site.

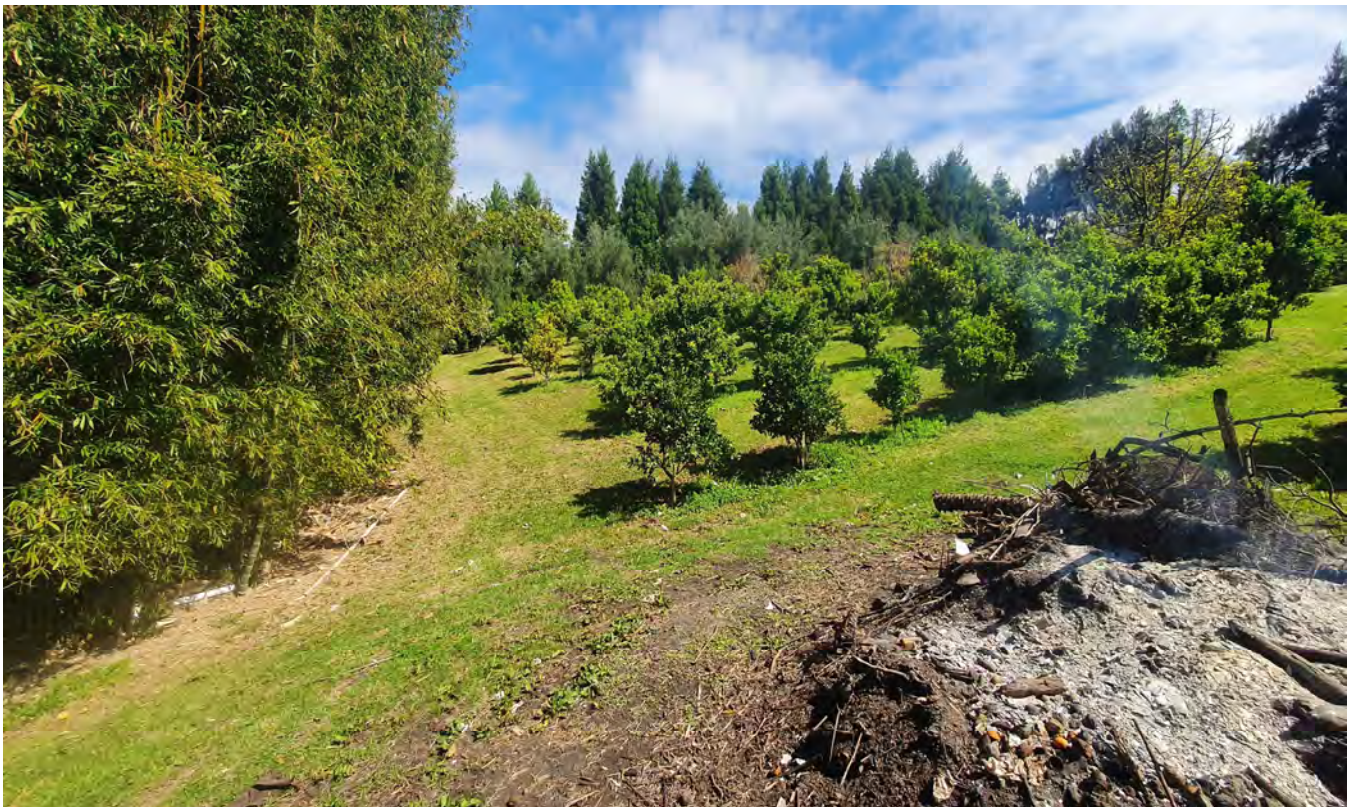
Figure 6. Photo showing orchard and burn area in the foreground.

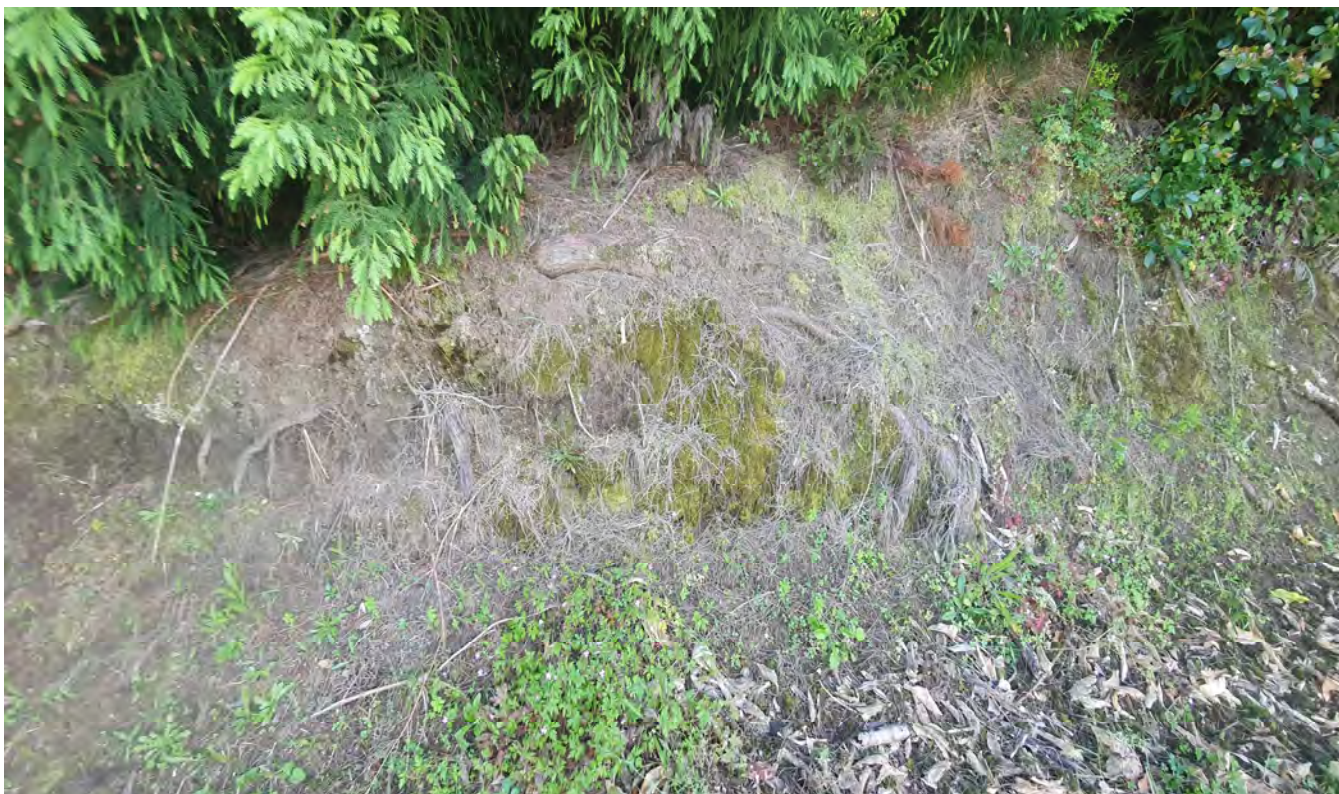
Figure 7. Possible stockpile on site.

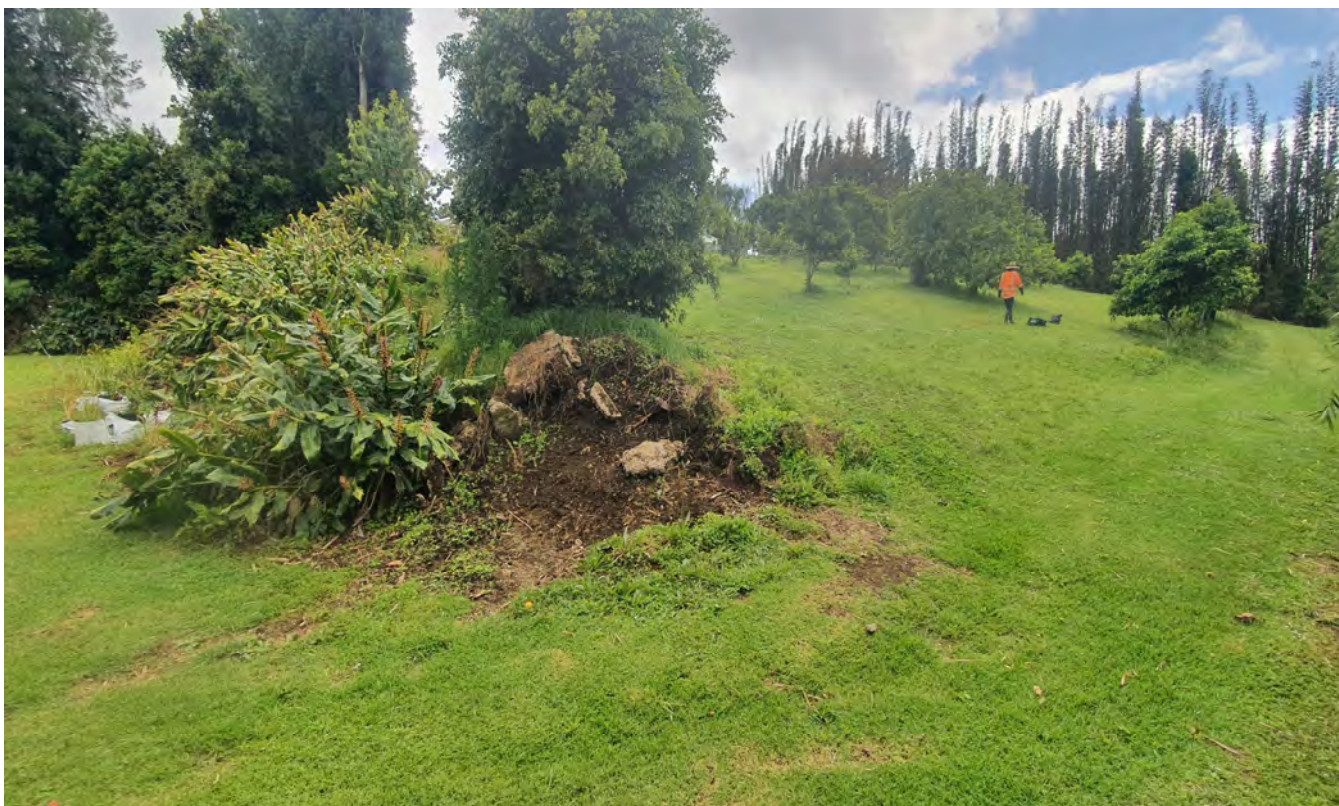
Figure 8. Photo showing stockpile with concrete debris.

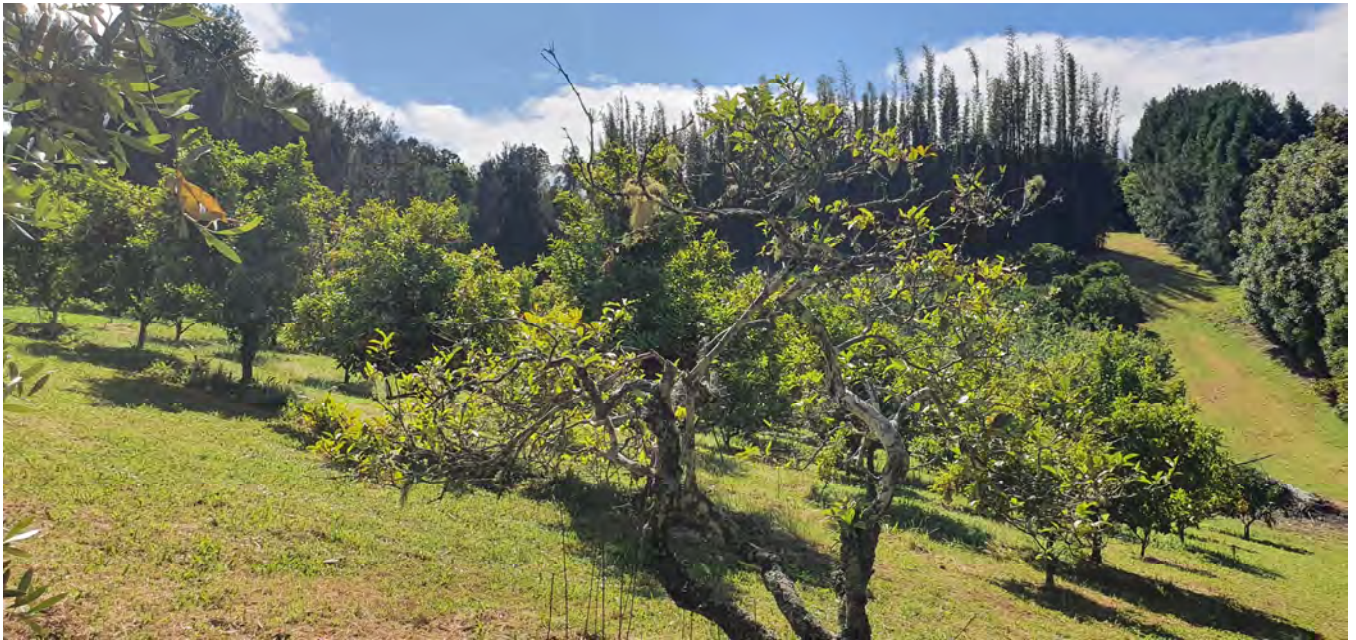
Figure 9. Photo showing orcharding.

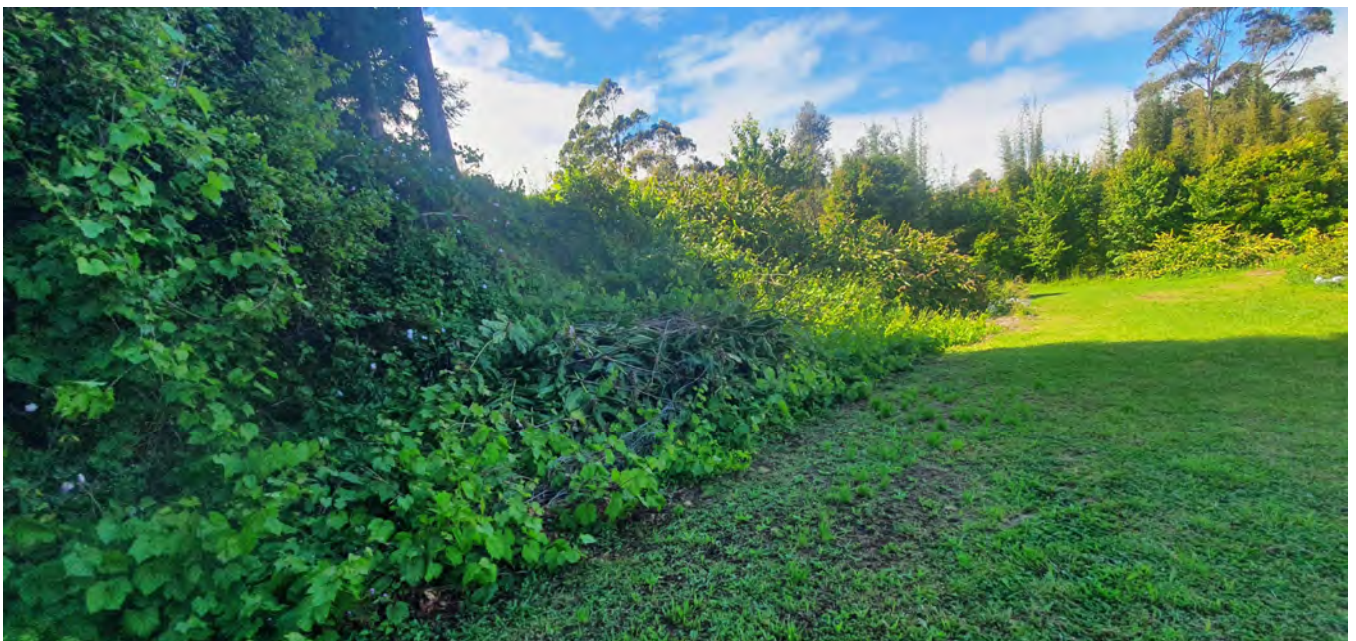
Figure 10. Vegetation and fruit trees.

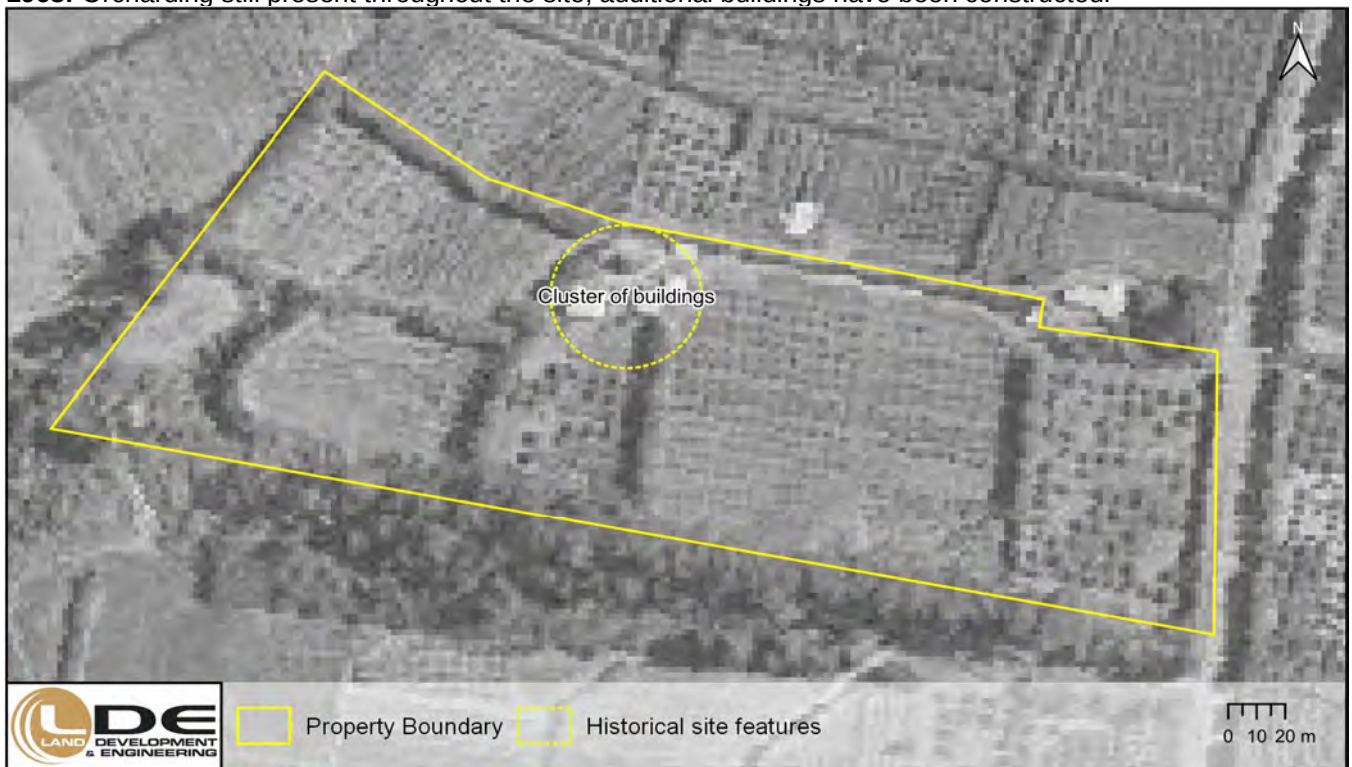
**1968:** Orcharding still present throughout the site, additional buildings have been constructed.

Figure 12. Aerial imagery 1968. Sourced from Retrolenz.nz and licensed by LINZ (annotated image). Approximate site boundary shown in yellow.

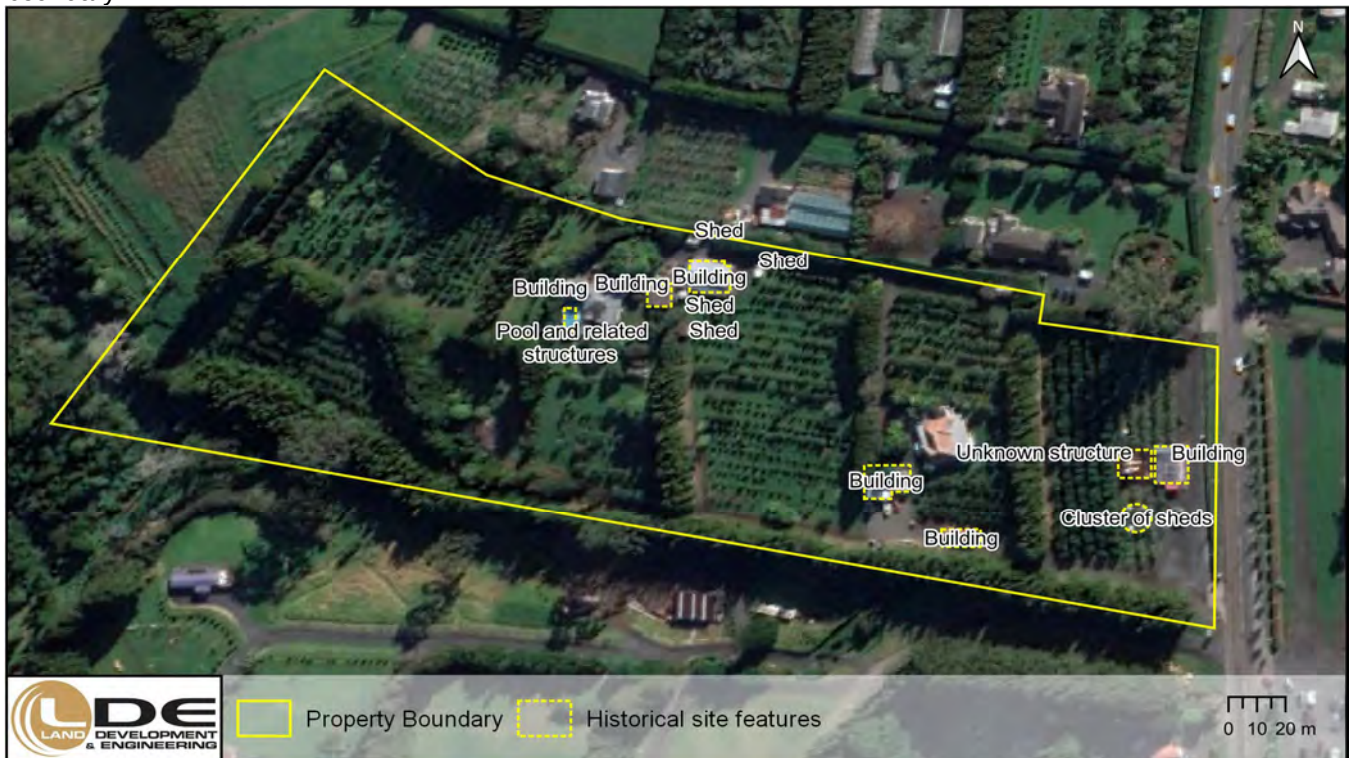
**2022:** Orcharding is still present, additional buildings and impervious areas have been constructed along the eastern boundary.

Figure 16. Aerial imagery 2022. Sourced from Retrolenz.nz and licensed by LINZ (annotated image). Approximate site boundary shown in yellow.

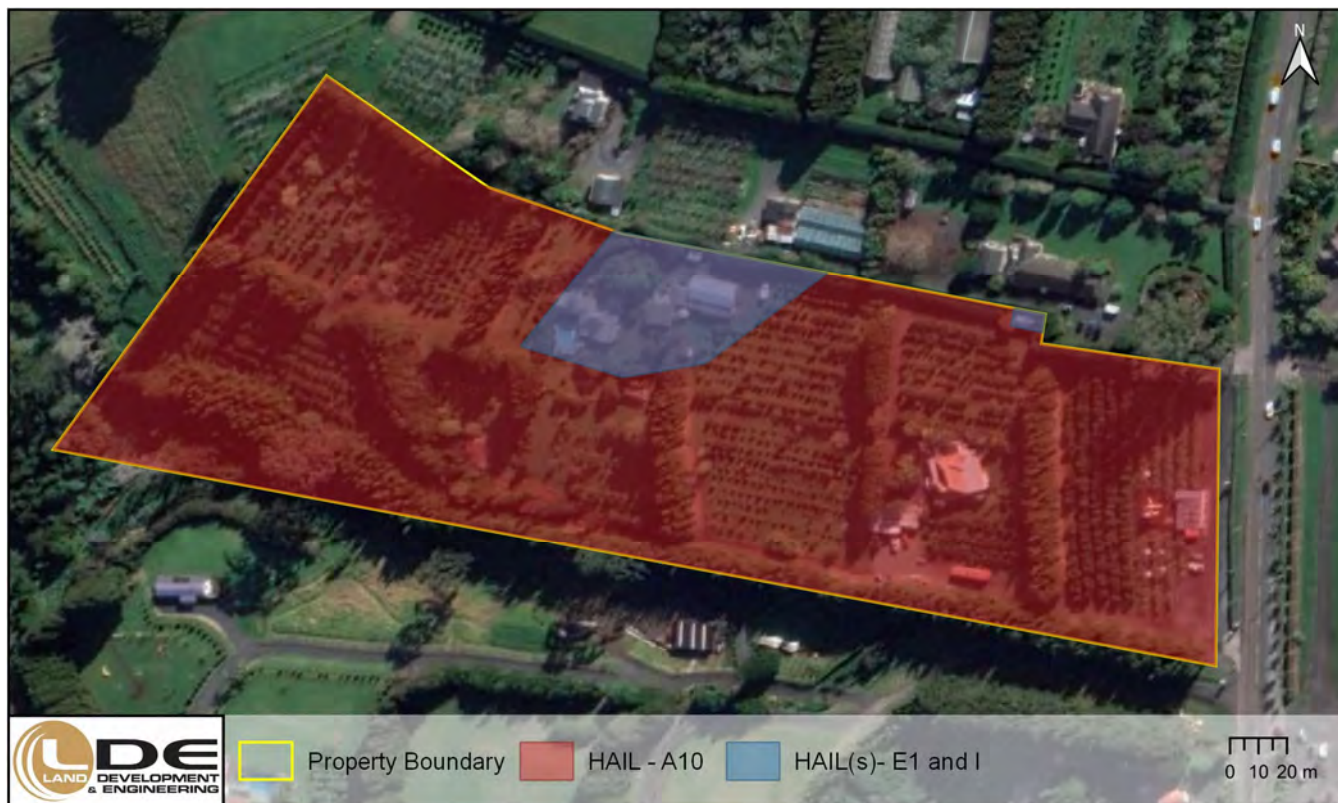
| HAIL, Potential Contaminants and Location | Receptors | Potential Pathways |
|---|---|---|
| <b>A10 - Persistent pesticide use from likely orchard identified in the 1953 - 2023 dated aerial imagery.</b> | Construction workers | Ingestion, inhalation, dermal contact. |
| <b>E1 - Asbestos containing material (ACM) in the footprint of the existing building</b> | Construction workers | Inhalation of dust (containing asbestos fibers) |
| <b>I - Any other land that has been subject to the intentional or accidental release of a hazardous substance in sufficient quantity that it could be a risk to human health or the environment. Lead from paint.</b> | Construction workers | Ingestion, inhalation, dermal contact. |

Figure 17. CSM plan showing areas of HAIL and potential areas of contamination.

As per Regulation 6 (3) it is considered that it is more likely than not an activity or industry described in the HAIL has been undertaken on the piece of land (HAIL A10, HAIL E1 and I). The likelihood that the soil is contaminated and is a risk to human health as a result of activity or industry occurring is considered to be highly likely. As per Regulation 8(4)(b), LDE considers that it is not highly unlikely that there will be a risk to human health if the activity is done to the piece of land.
