## **Quirino Limited**

## GEOTECHNICAL SUITABILITY REPORT FOR PROPOSED RESIDENTIAL DEVELOPMENT

482-484 Kerikeri Road

**Project Reference: 25575**

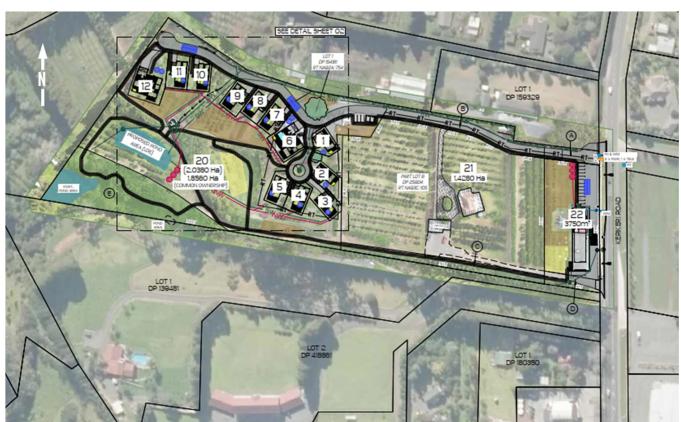
Figure 1 – Proposed scheme plan<sup>1</sup>.

The proposed development will include the subdivision of the property into 15 new allotments. Lot 22 will consist of the existing commercial property along Kerikeri Road, Lot 21 will consist of the existing dwelling and horticultural activity on Part Lot 6 DO 25904. Lots 1-12 are new allotments encompassing proposed new dwellings and Lot 20 is proposed to consist the remainder of the property surrounding Lots 1-12 which will be placed in common ownership. Below shows a map of the area that will be developed across Lot 1 DP 154181 (482) and Part Lot 6 DP 25904 (484A and 484B).<sup>2</sup> The total area is 4.38 hectares.

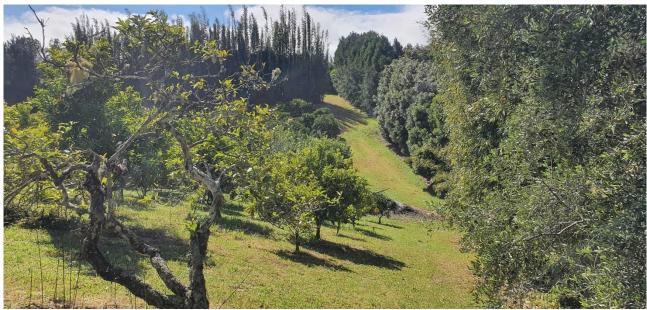
Figure 3 - Onsite image showing slopes on western side (looking east).

The eastern side of the property is relatively flat. From approximately 200m west of Kerikeri Road, the site begins to slope more steeply towards the west and south-west at approximately between 1V:3H and 1V:5H.

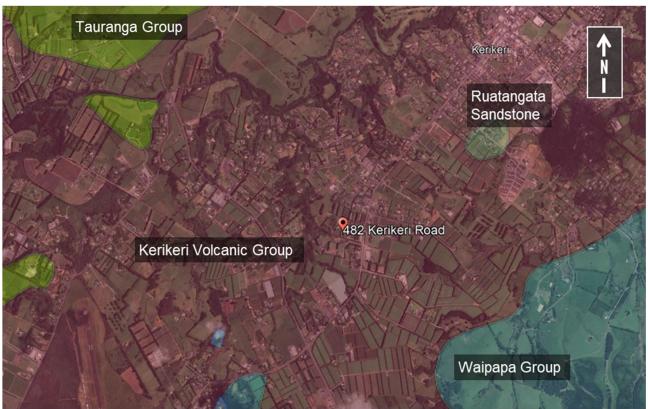
Figure 4 - Geological Map of site and surrounding area (GNS geological map over Google Earth).

The 1:250,000 geological map of the region<sup>4</sup> shows the site as being underlain by the Kerikeri Volcanic Group (Figure 4).

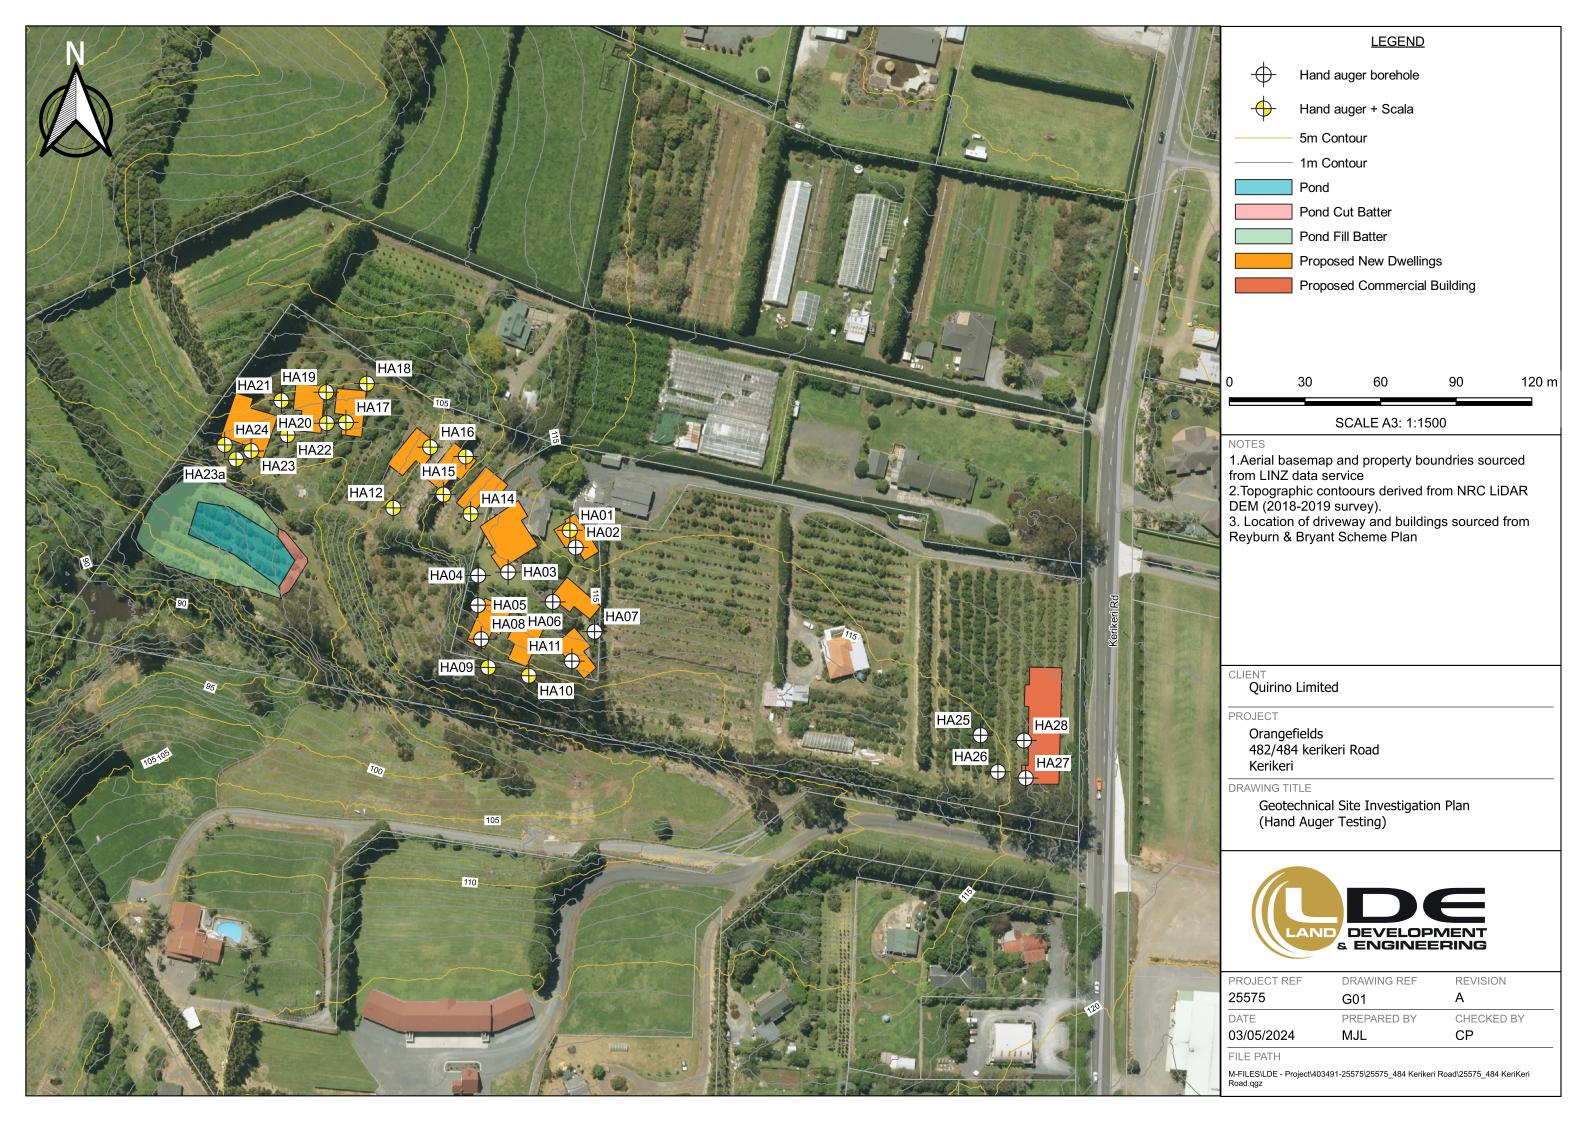
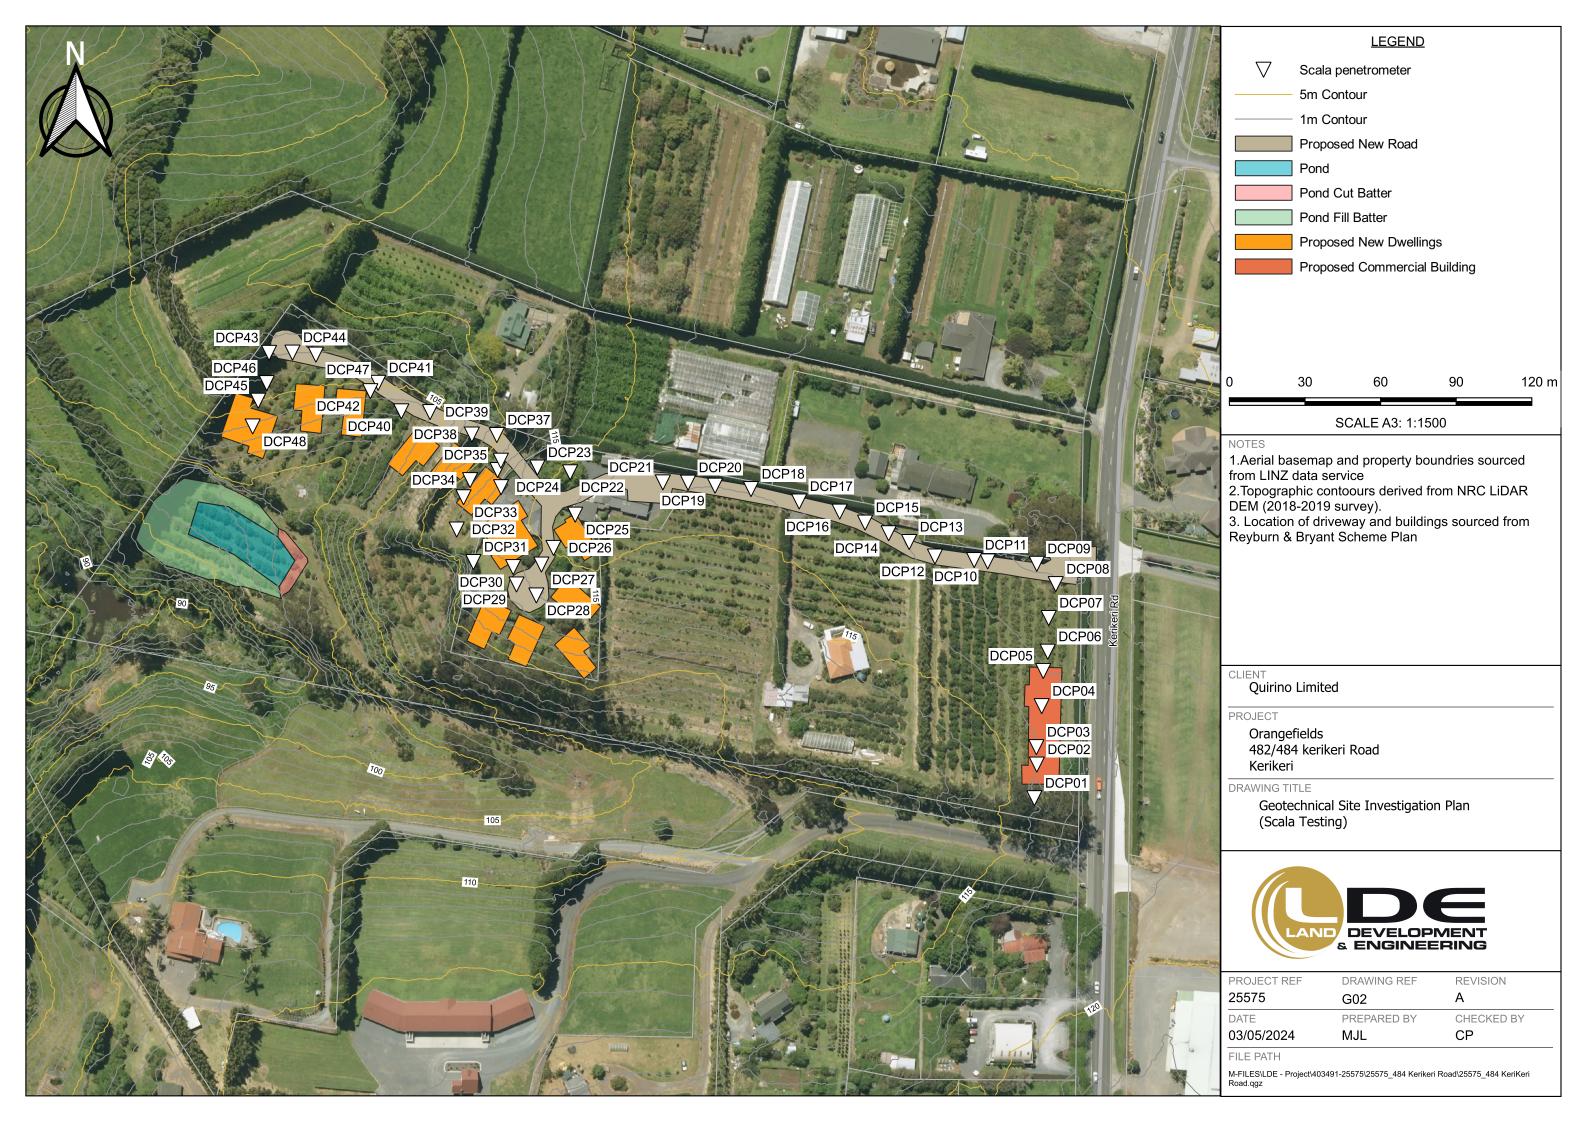
# APPENDIX B GEOTECHNICAL INVESTIGATION PLAN

Directly south-west of the existing pool on Lot 1 DP 154181 a cut bench (Terrace A) has been formed by excavating two batters, one running approximately east-west and one running approximately north-south. These batters have been formed at approximately 1V:1H and are between 2m to 5m in height. The flat area formed by these batters is between 20m to 30m in width with another man made slope of approximately 1V:2H and some 7m in height located to the south-west of Terrace A leading down to Terrace B (See Geotechnical Investigation Plan).

The locations of the subsurface investigations are on the Geotechnical Investigation Plan in Appendix B. Logs of the boreholes and penetrometer tests are presented in Appendix C.
