# DETAILED SITE INVESTIGATION

PENCARROW ESTATE,  
1491 STATE HIGHWAY 2, PONGAKAWA

Prepared For: Momentum Planning and Design Limited

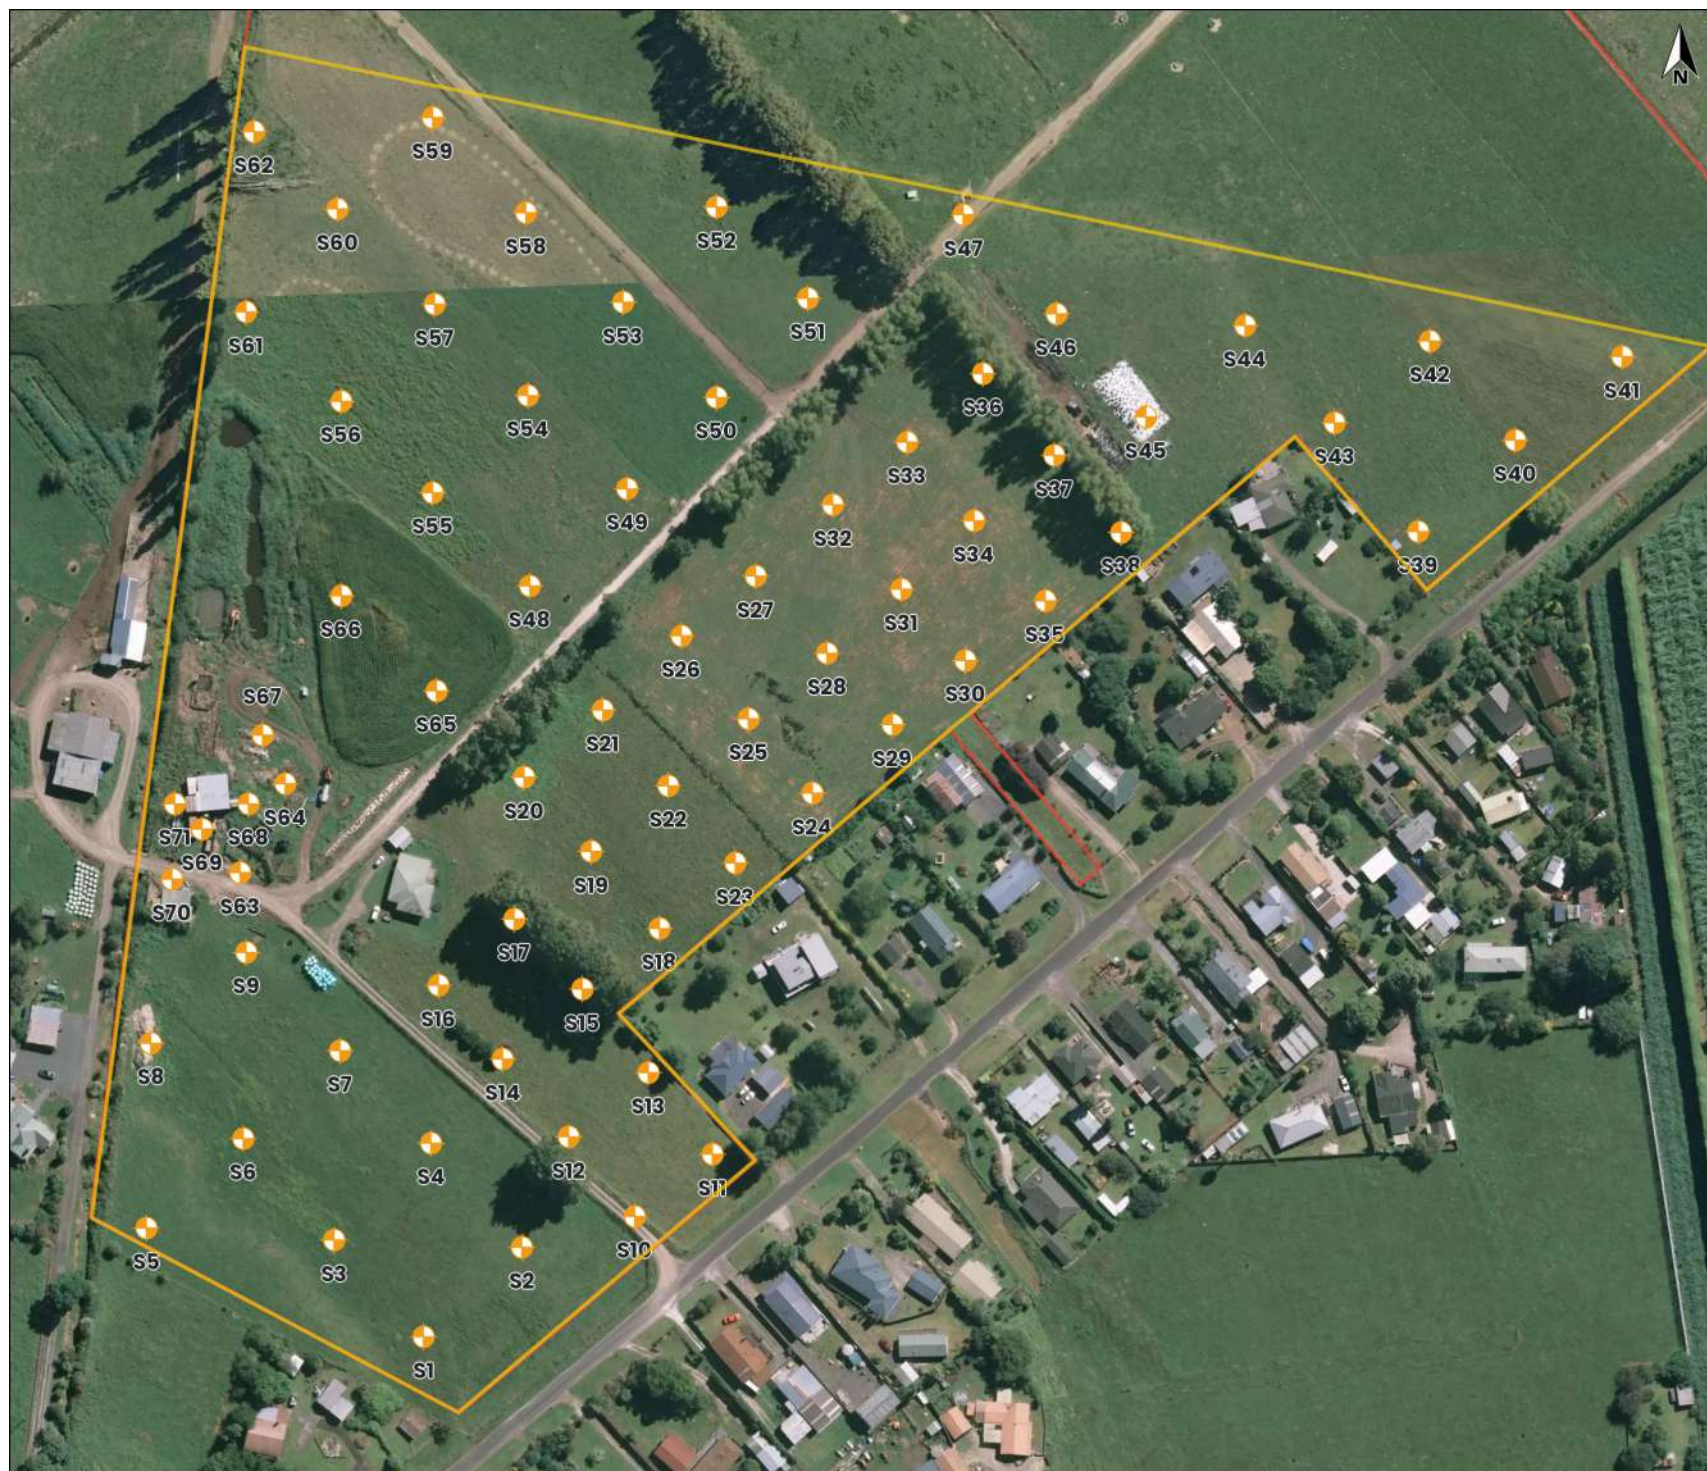
- Surface samples (0-0.1 m below ground level (bgl)) were collected from a total of 71 locations (refer Figure 2). The number of locations is in general accordance with Ministry for the Environment Contaminated Land Management Guidelines No. 5 (revised 2021).
- Soil sampling was undertaken using a stainless-steel hand auger. Soil samples were collected directly from the hand auger using disposable nitrile gloves and placed in a laboratory supplied glass jar for sample analytical purposes.
- Collection of quality control samples as per Section 7.6.
- Where re-useable sampling equipment was used, this equipment was decontaminated prior to collection of another sample.
- Soil samples were collected in the appropriate sample jars, stored and transported in chilled containers in accordance with IANZ laboratory requirements.
