**STATEMENT OF EVIDENCE OF ROBERT BOND ON BEHALF OF REMARKABLES
PARK LIMITED AND QUEENSTOWN PARK LIMITED**

(GEOTECHNICAL ENGINEERING – NATURAL HAZARDS)

STREAM 13 REZONING HEARINGS

Table 1. Queenstown Station Preliminary Geotechnical Hazard Appraisal

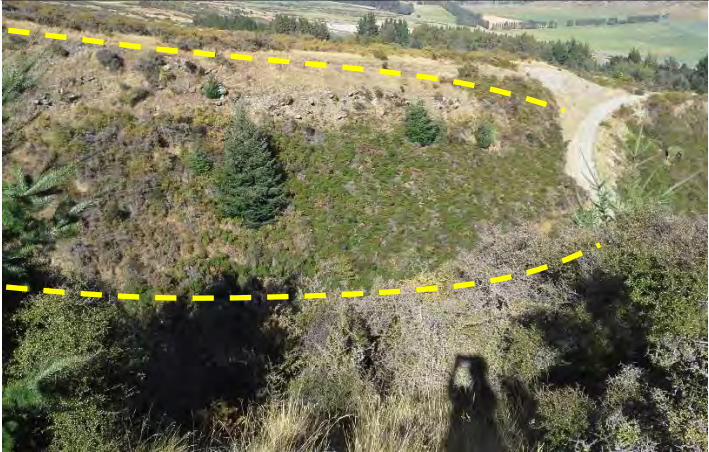
Development Site ID	Description of Site Topography and Planned Development	Geotechnical Hazards	Proposed Site Mitigation (if any)	Photographs
L1	<p>Living. Residential and Visitor Accommodation options.</p> <p>Site is flat on a ridgeline approximately 1.5km up the Remarkables Ski Field Road. 5-10m deep gully forms the southern boundary of development area. Site is currently vegetated with a mixture of tussock, grass and matagouri.</p>	<div>Scour</div> <div>Shallow landslide</div> <p>There is a 5-10m deep gully on southern boundary of development area. It is considered there is a low risk during storm events of minor scour, shallow landslide or slope erosion along this boundary. Minor slope failure scars on gully walls can be seen upstream of site.</p>	Development setback 5.0m from southern boundary.	<div>L1: Gully along southern boundary of site, shown by dotted yellow lines (30/3/2015).</div>

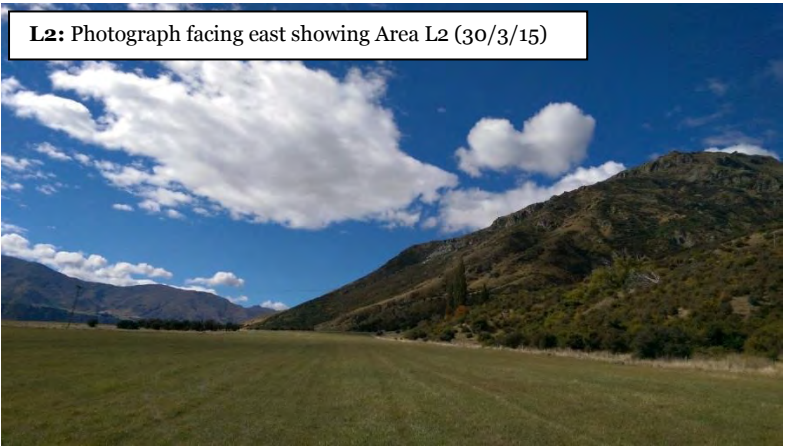
Development Site ID	Description of Site Topography and Planned Development	Geotechnical Hazards	Proposed Site Mitigation (if any)	Photographs
L2	<p>Living, Residential and Visitor Accommodation options.</p> <p>Site is located on top of a flat high alluvial terrace that is approximately 10m above the lower terrace (V2 development area) and approximately 15m above current bed level of the Rastus Burn. Rastus Burn is reasonably well channelized into its alluvial fan at this location. The southern boundary of the site is formed by the Remarkables Mountain Range, sloping towards the site at 25-30 degrees. Site is grassed and used for agricultural grazing/airport runway.</p>	<div>Rock fall –No risk to Low risk</div> <p>An erosional rockfall source area exists at the west end of the site approximately 500m upslope of development site L2. Assessed as no to low rockfall risk to site L2.</p> <p>It is considered most of the rock debris released from this area will run into the gully directly west of L2. There is also mature scrub (Matagouri, Poplar, assorted small trees) covering the slope between the source area and the development site which will act as protection to halt rock debris. Rock run out length from the source area appears to only be around 50m downslope. No rocks were observed in Area L2.</p> <div>Liquefaction</div> <div>Lateral Spreading</div> <p>The area is classified as possibly susceptible to liquefaction (Opus 2002) in the QLDC Natural Hazards Database.</p>	No mitigation measures considered necessary.	<div>L2: Photograph facing east showing Area L2 (30/3/15)</div>

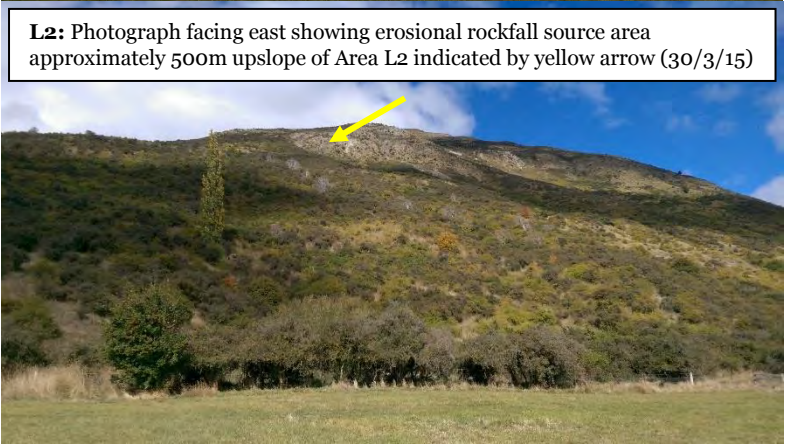
<div>L2: Photograph facing east showing erosional rockfall source area approximately 500m upslope of Area L2 indicated by yellow arrow (30/3/15)</div>

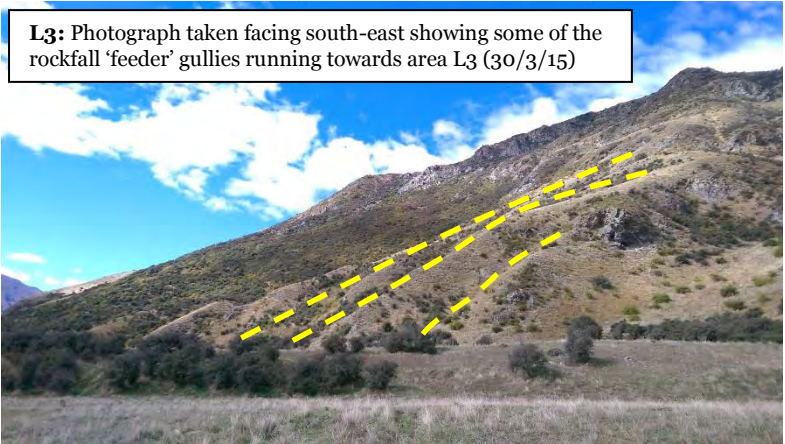
Development Site ID	Description of Site Topography and Planned Development	Geotechnical Hazards	Proposed Site Mitigation (if any)	Photographs
L3	<p>Living – rustic. Residential and Visitor Accommodation options.</p> <p>The topography of site is slightly undulating from ancient stream channel paths, with lower and upper (south eastern side of site) alluvial terraces with around 5m height difference. The southern boundary of the site is formed by the Remarkables Mountain Range, with slopes of 25 to 30 degrees.</p> <p>The site is approximately 10m above current bed level of the Rastus Burn. The Rastus Burn is reasonably well channelized into its alluvial fan at this location.</p> <p>Site is vegetated with grass and matagouri and used for agricultural grazing.</p>	<p>Rock fall – Low to Moderate</p> <p>The majority of this site can be classified as no to low rockfall risk.</p> <p>The south eastern corner of the site is considered to have a low to moderate rockfall risk due to the presence of rock bluffs above the site with adversely oriented rock joints. Several ‘feeder gullies’ lead to development area L3 and a large volume rock failure from one of the bluffs could potentially release rock with enough energy to reach area L3. These rock failures are considered to be a very rare event, likely occurring in a high magnitude seismic or storm event. No evidence of recent rockfall was found in area L3.</p> <p>Liquefaction Lateral Spreading</p> <p>The area is classified as possibly susceptible to liquefaction (Opus 2002) in the QLDC Natural Hazards Database.</p>	<p><i>In the area marked as Moderate Rockfall Risk on attached Map 1:</i></p> <p>Planting of large trees (non-invasive species similar size to pine) behind structures built within 100m of base of slope or directly below a ‘gully’ feature. Once structure locations are decided on they should also be assessed for rockfall risk by a suitably experienced geotechnical engineer.</p>	<p>L3: Photograph taken facing south-east showing some of the rockfall ‘feeder’ gullies running towards area L3 (30/3/15)</p>

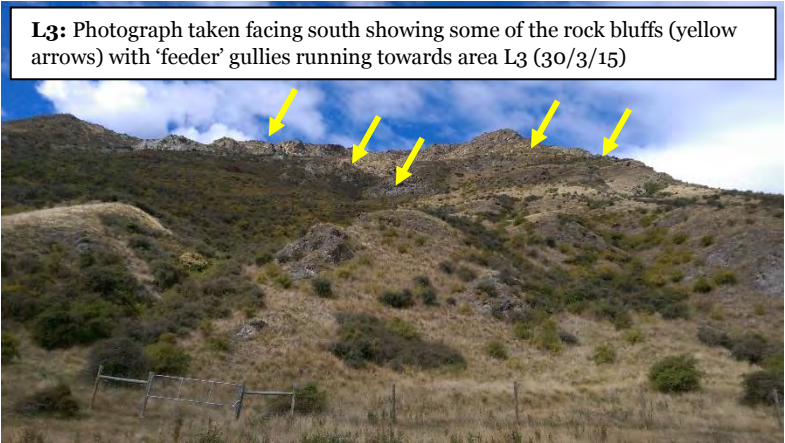
<p>L3: Photograph taken facing south showing some of the rock bluffs (yellow arrows) with ‘feeder’ gullies running towards area L3 (30/3/15)</p>

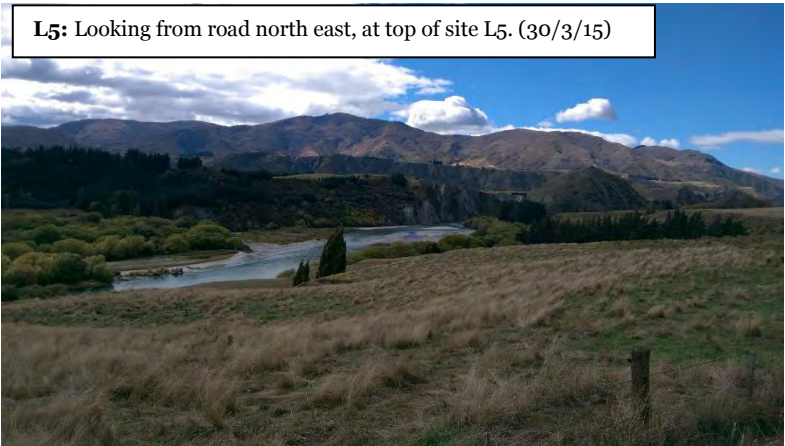
Development Site ID	Description of Site Topography and Planned Development	Geotechnical Hazards	Proposed Site Mitigation (if any)	Photographs
L5	<p>Living. Residential and Visitor Accommodation options.</p> <p>Undulating topography, likely a mix of colluvium or alluvium from the slope located directly south overlying an alluvial terrace of the Kawarau River. Approximately 10m above a lower alluvial terrace (V3 development site). Site is currently grassed and used for agricultural grazing.</p>	<div>Liquefaction</div> <div>Lateral Spreading</div> <p>The area is classified as possibly susceptible to liquefaction (Opus 2002) in the QLDC Natural Hazards Database.</p>	No mitigation measures considered necessary.	<div>L5: Looking from road north east, at top of site L5. (30/3/15)</div>

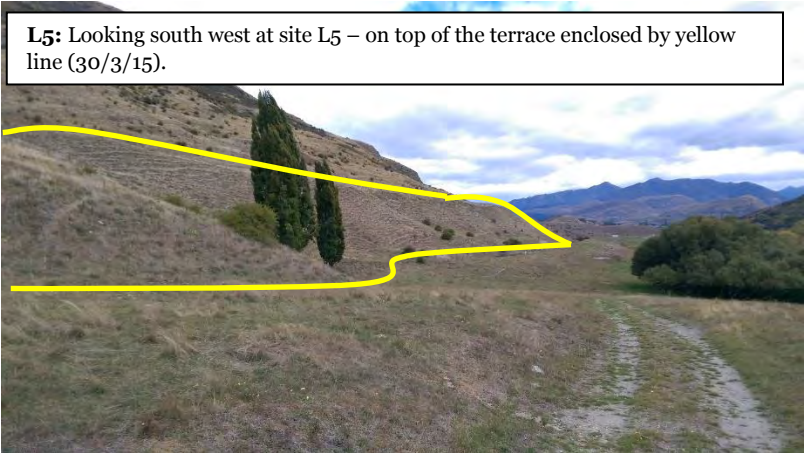
<div>L5: Looking south west at site L5 – on top of the terrace enclosed by yellow line (30/3/15).</div>

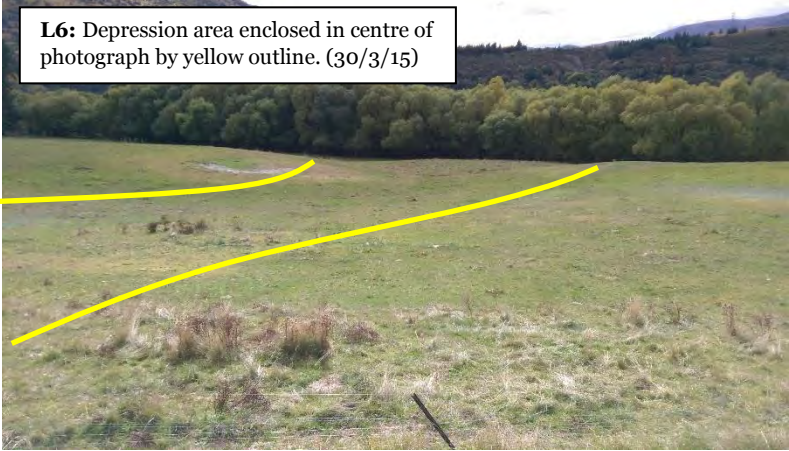
Development Site ID	Description of Site Topography and Planned Development	Geotechnical Hazards	Proposed Site Mitigation (if any)	Photographs
L6	<p>Living - Residential and Visitor Accommodation options.</p> <p>Site is located on a flat to slightly undulating alluvial terrace of the Kawarau River. A depression approximately mid-site, with a small gully leading to it from the south (across road). The site is currently grassed and used for agricultural purposes.</p>	<div>Flooding</div> <p>The depression in the centre of this site could indicate that water flows down the small feeder gully into the site during periods of rainfall – either ponding here or continuing onto the Kawarau River beyond.</p> <div>Liquefaction</div> <div>Lateral Spreading</div> <p>The area is classified as possibly susceptible to liquefaction (Opus 2002) in the QLDC Natural Hazards Database.</p>	<p>Observations of site during rainfall to determine amount of ponding and water flow. Either installation of drainage culverts to carry flow through site or perhaps formation of a landscaped pond at this location.</p>	<div><p>L6: Depression area enclosed in centre of photograph by yellow outline. (30/3/15)</p>

RR 4	L6	Flooding	LOW	Identified surface water erosion features on southern central part of site leading to depression on the area - possible swale feature	Possible formation of engineered swale drain through centre of site.
RR 4	L6	Possible Liquefaction Risk	LOW	Identified as Possibly Susceptible to liquefaction risk (ORC natural Hazards database) and QLDC natural hazards register. No shallow groundwater.	No Mitigation necessary
RR 5	L7	River Scour	LOW - MED	Evidence of river scour and erosional slopes adjacent to Owens Creek on eastern side of zone.	20m set back for development possibly consider additional planting to slow erosion of banks. Consider river training and bed load management to keep river channelised.
RR 5	L7	Possible Liquefaction Risk	LOW	Identified as Possibly Susceptible to liquefaction risk (ORC natural Hazards database) and QLDC natural hazards register. No shallow groundwater.	No Mitigation necessary

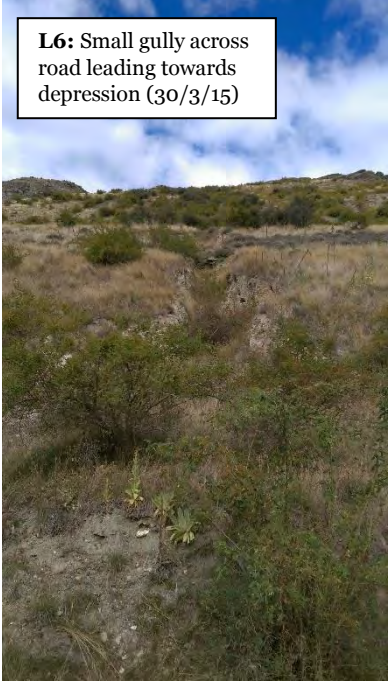
</div> <div><p>L6: Small gully across road leading towards depression (30/3/15)</p>

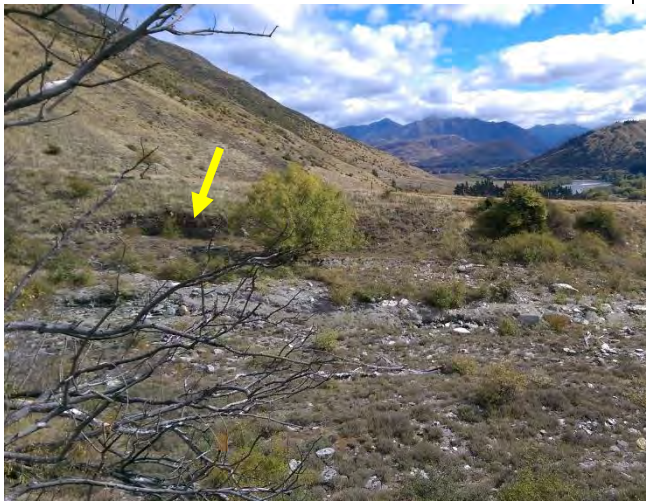
Development Site ID	Description of Site Topography and Planned Development	Geotechnical Hazards	Proposed Site Mitigation (if any)	Photographs
L7	<p>Living - Residential and Visitor Accommodation options.</p> <p>The L7 site comprises two alluvial terraces – an upper terrace approximately 5m (upper reaches) to 10 m above the current bed level of Owen Creek, and a lower terrace approximately 5.0m above the current bed level of Owen Creek. The southern boundary of the upper terrace is formed by the northern slope of the Remarkables Mountain Range (with a gradient of around 25-30 degrees).</p> <p>The L7 site is understood from the development plan provided by the client to not include the current dwelling location, which is at a lower level (approximately 2.0m to 3.0m above current bed level) and considered to have a higher risk of debris flows and flooding.</p>	<div>Scour</div> <p>A minor scour hazard exists along the eastern boundary of the L7 site from the Owen Creek. Although the flow in the Creek is normally small, the catchment area in the Remarkables Mountain Range is large indicating there is potential during a storm event for a rapid increase in flow. This flow will also likely carry rock and gravel due to the rock debris source areas currently visible upstream. The current height of the L7 terrace is considered likely to protect the site from the direct effects of debris flows or channel migration in all but the very extreme of events. However some scour of the banks is considered likely to occur annually, as shown in the photograph below (one recent scour site is indicated by yellow arrow).</p>

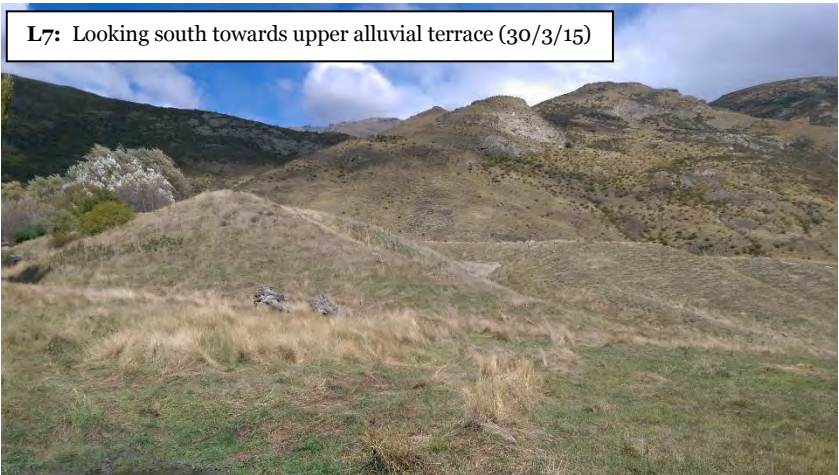
<p>There is not considered to be a rockfall risk at this site.</p> <div>Liquefaction</div> <div>Lateral Spreading</div> <p>The area is classified as possibly susceptible to liquefaction (Opus 2002) in the QLDC Natural Hazards Database.</p>	<p>Scour:</p> <ul style="list-style-type: none">20m setback for structures, Importance Level 2 -5 (NZS1170.0)Planting of tree species such as willows along the creek bank to help stabilise.River training measures such as channel excavation to channelize the stream and lower the bed level. Possible groyne placement upstream to direct flow away from L7 area.	<div>L7: Looking south towards upper alluvial terrace (30/3/15)</div>

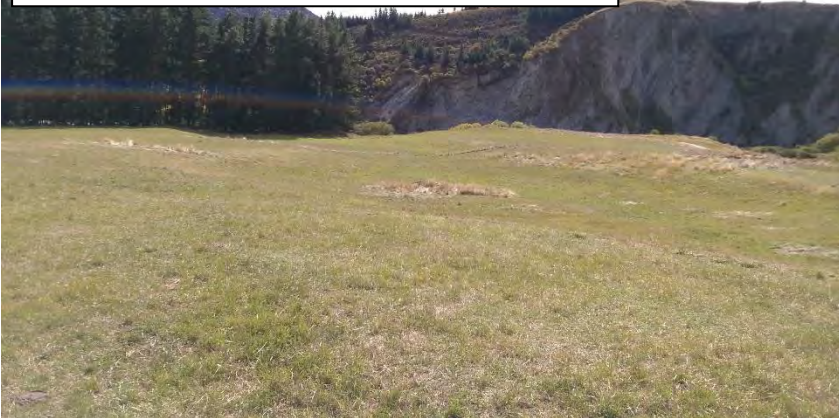
<div>L7: Looking north across lower alluvial terrace (30/3/15)</div>

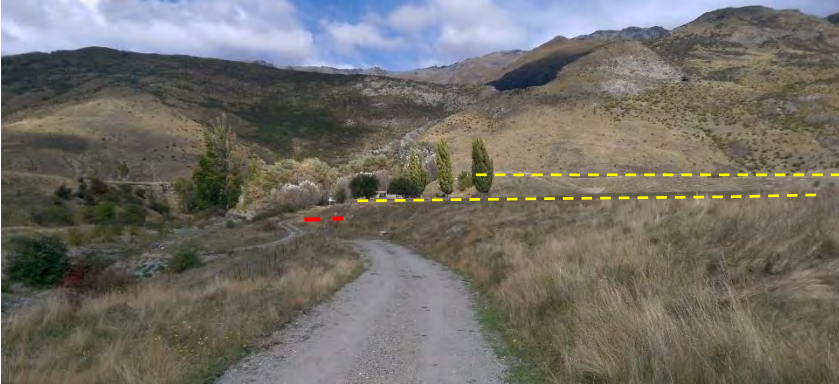
<div>L7: Looking south towards L7, with yellow dotted lines indicated the two terrace levels that form L7 and the red dotted line the level of the current dwelling (30/3/15)</div>

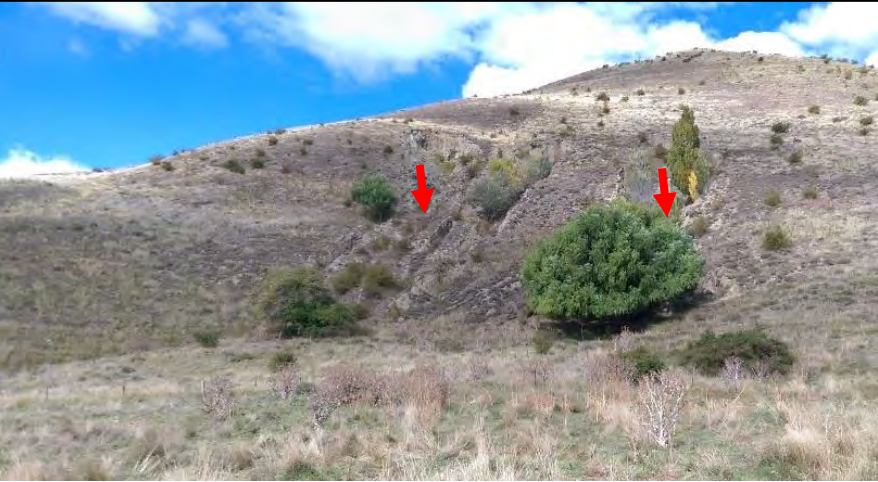
</div> <div><p>L9: South-western slope forming boundary of L9, showing the two erosional gullies – indicated by red arrows (30/3/15)</p>

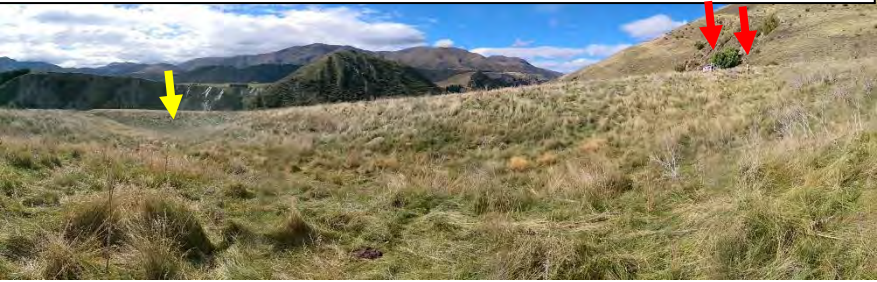
</div> <div><p>L9: Looking north east across L9 area, showing dam area in the distance (yellow arrow) and gullies (red arrows) (panoramic photograph - 30/3/15)</p>

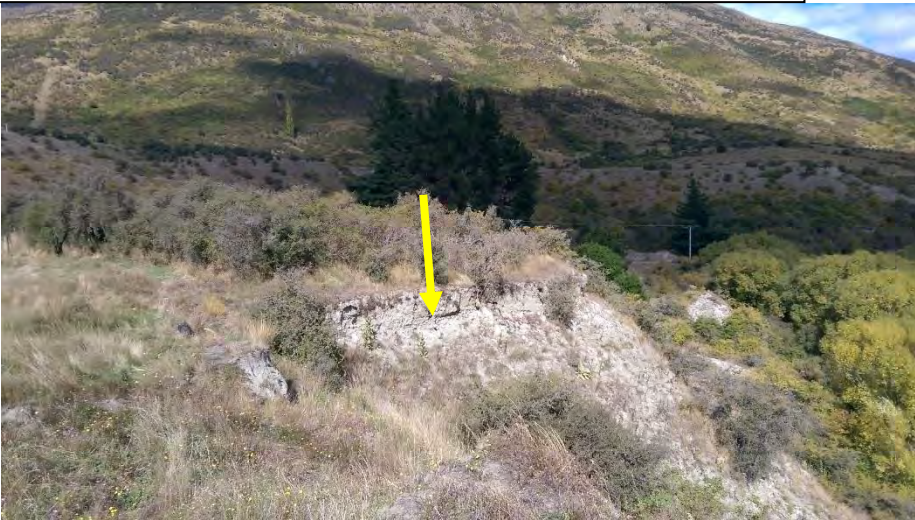
</div> <div>V2: Erosional slope failure at along the Kawarau River edge of area V2 (30/3/15)</div> <div>

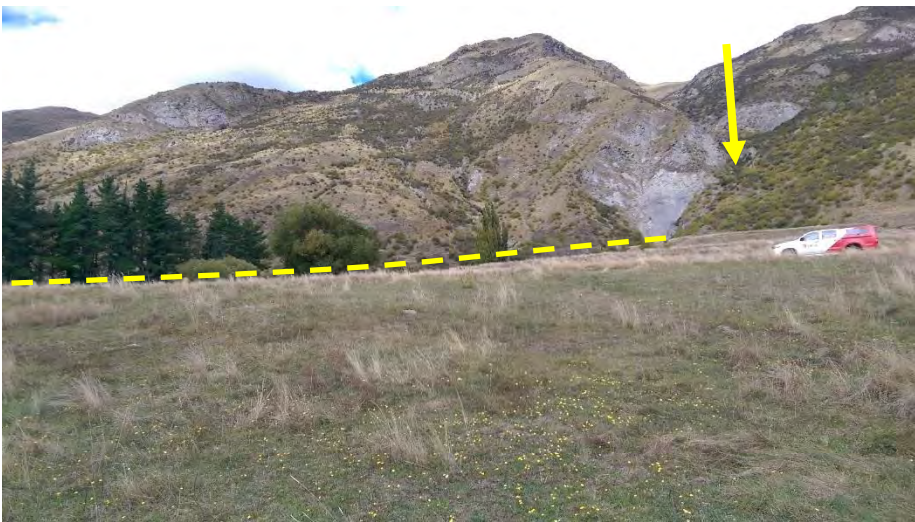
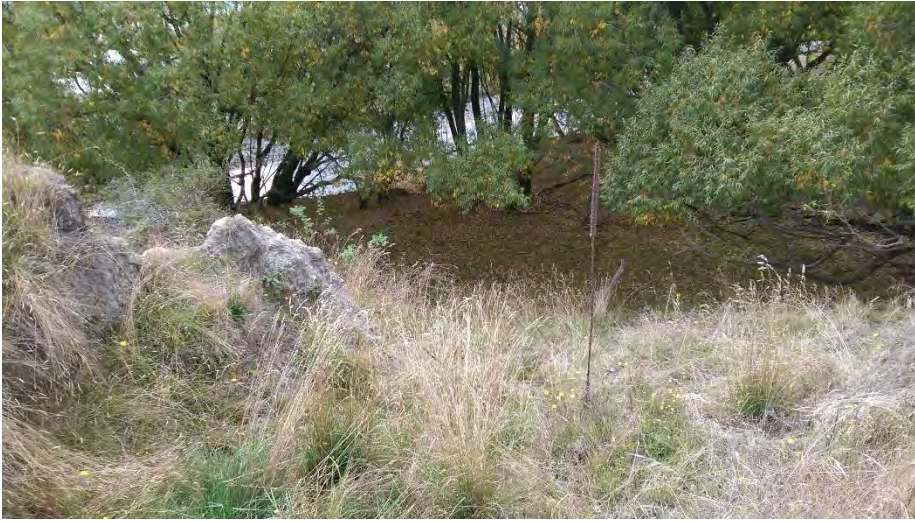
Development Site ID	Description of Site Topography and Planned Development	Geotechnical Hazards	Proposed Site Mitigation (if any)	Photographs
V3	<p>Commercial and accommodation facilities supporting people using the river trail. It also links a jetty to the river.</p> <p>The site is located on a lower alluvial terrace, approximately 3-5m above the Kawarau River flowing west to east and a small tributary (name unknown) flowing south to north.</p>	<div>Scour</div> <p>This site is around 5.0m above the average flow level of the Kawarau River and around 3.0m above a floodplain of the River. In times of high flow it is likely that this lower floodplain will flood and cause surficial failures and scour erosion along the edge of the V3 terrace. However at the time of inspection the edge of the terrace was reasonably well vegetated with only very minor signs of surficial erosion and no sign of any deeper seated slope failure.</p> <div>Liquefaction</div> <p>The area is classified as possibly susceptible to liquefaction (Opus 2002) in the QLDC Natural Hazards Database.</p>	<p>Scour</p> <ul style="list-style-type: none">- 20m setback for structures, Importance Level 2 -5 (NZS1170.0)	<div><p>V3: Looking northeast across site V3. The unnamed tributary runs from the gully indicated by the yellow arrow across the back of the photograph (approx. 3.0m below V3 terrace), shown by the yellow dotted line. (30/3/15).</p>

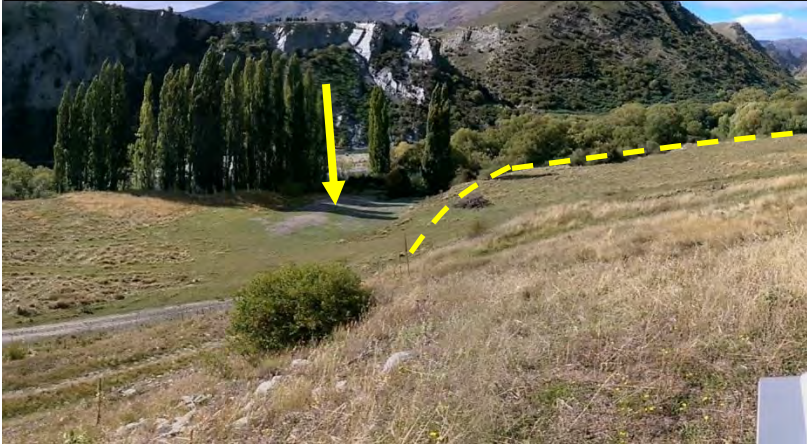
Development Site ID	Description of Site Topography and Planned Development	Geotechnical Hazards	Proposed Site Mitigation (if any)	Photographs
V4	<p>Commercial recreation activities, possibly including a café and restaurant to support the users of the river and trail. Jetty access.</p> <p>The site is generally flat and located on a lower alluvial terrace around 5-10m above the Kawarau River. There is a refuse tip (recently covered in) on its western boundary on a lower terrace. The station access road forms the southern boundary to the site.</p> <p>A disused woolshed is located just off the access road approximately mid-site.</p>	<p><i>Contaminated Land Assessment</i> - Unknown influence of the recent landfill area and woolshed on surrounding ground condition.</p> <div><div>Liquefaction</div><div>Lateral Spreading</div></div> <p>The area is classified as possibly susceptible to liquefaction (Opus 2002) in the QLDC Natural Hazards Database.</p>	<p>A Contaminated Land Assessment to be carried out in the area surrounding the woolshed and along the western edge of the terrace.</p> <p>20m setback for structures, Importance Level 2 -5 (NZS1170.0)</p>	<div><p>V4: Looking north across area V4, rubbish area shown by yellow arrow and northern and western extents of the V4 area indicated by yellow line. Access road can be seen on the left of the photograph. (30/3/15)</p>

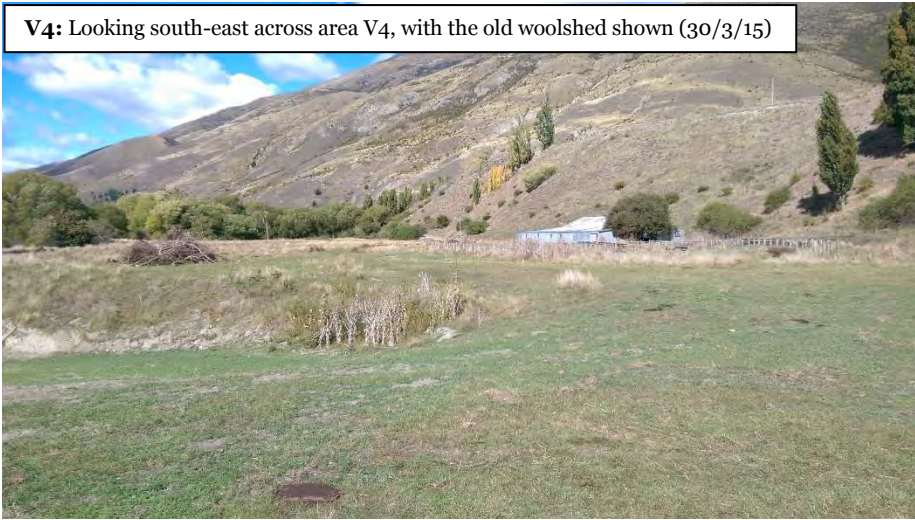
</div> <div><p>V4: Looking south-east across area V4, with the old woolshed shown (30/3/15)</p>

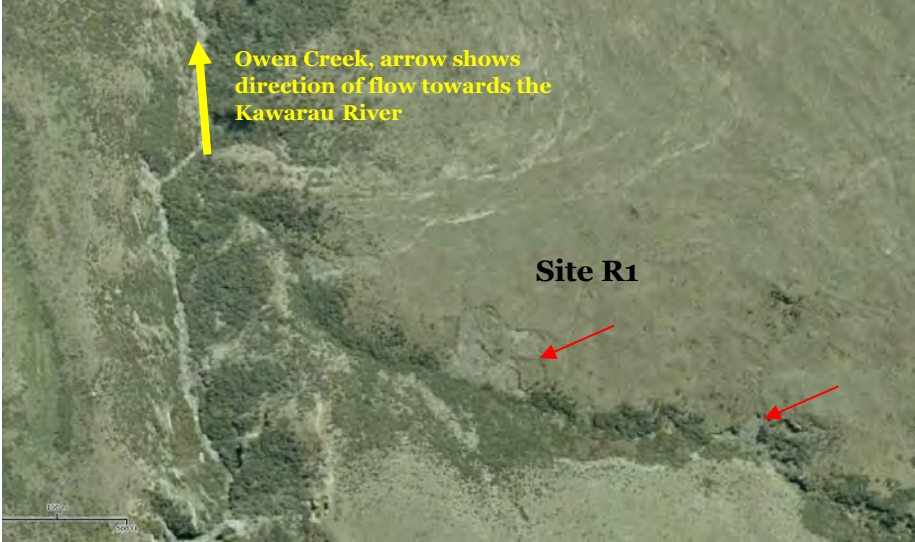
Development Site ID	Description of Site Topography and Planned Development	Geotechnical Hazards	Proposed Site Mitigation (if any)	Photographs
R1	<p>Low impact eco-tourism. Accessible only by helicopter.</p> <p>The site is located on a SW facing slope approximately 2.8km upstream of the confluence of Owen Creek with the Kawarau River.</p>	<p>Deep seated landslide</p> <p>SW facing slopes in Central Otago that approximately follow the direction of the regional foliation are prone to deep seated slide failure along this foliation. This is particularly prevalent when the toe of the slope is being actively downcut by a stream or river.</p> <p>From this preliminary overview analysis, it does appear that the R1 site could be prone to a deeper seated landslide failure. There are several slope failures on the same slope and the overall topography is generally hummocky which suggests ground movement. It may be possible to locate a resort building successfully at some point on this slope but it requires further detailed geotechnical investigation.</p>	<p>Further geotechnical investigation needed for situating of structures Importance Level 2-5 (NZS1170.0).</p>	<p>R1: Aerial photograph from QLDC GIS database showing the approximate location of Site R1. Existing slope failures are indicated by red arrows (7/4/15)</p>

<p>The photograph is an aerial view of a rugged, green landscape. A yellow arrow in the upper left points towards the center, labeled 'Owen Creek, arrow shows direction of flow towards the Kawarau River'. In the lower right, a black label 'Site R1' is positioned above two red arrows pointing to specific areas on the slope, which are identified as existing slope failures. The terrain appears to be a mix of grass and bare earth, with some rocky outcrops visible.</p>

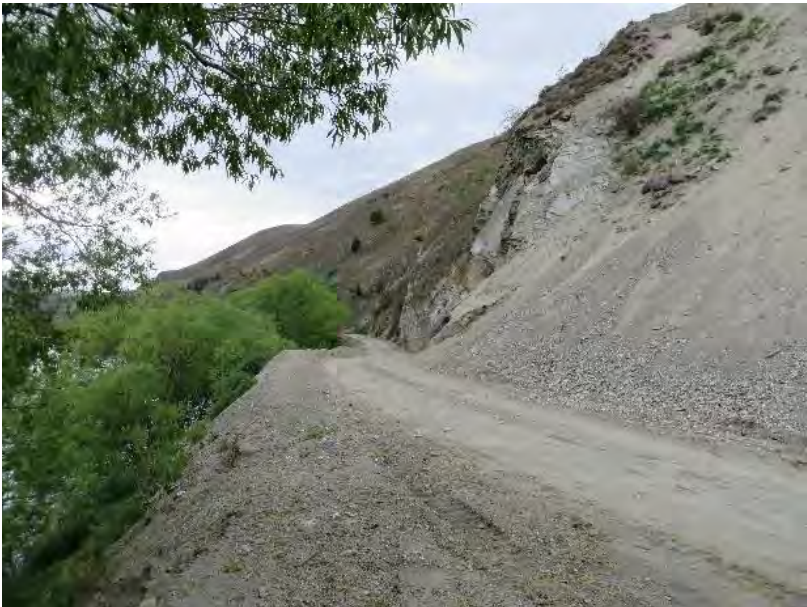
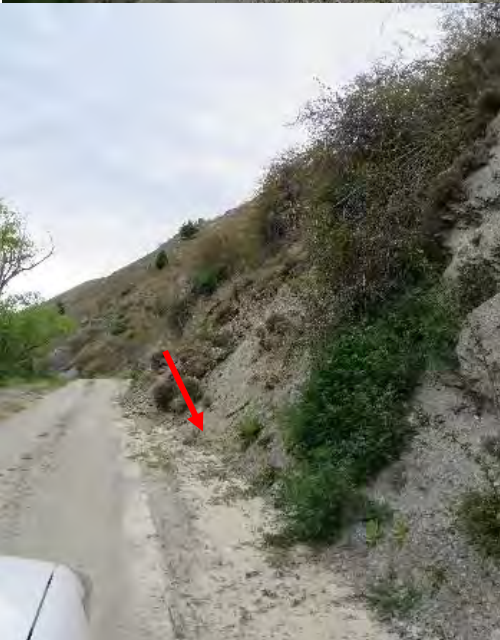
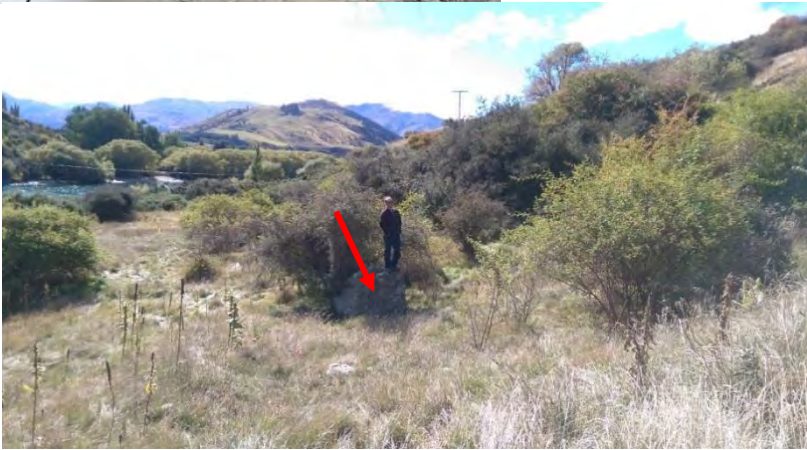
Development Site ID	Description of Site Topography and Planned Development	Geotechnical Hazards	Proposed Site Mitigation (if any)	Photographs
Access Road	Not specified in development plan – possible upgrading likely	<div><div>Rock fall</div><div>Scour</div><div>Flooding</div><div>Channel migration</div><div>Lateral Spreading</div><div>Shallow landslide</div><div>Debris Flow or Flood</div></div> <p>As it tracks east-west through the site approximately following the path of the Kawarau River the access road traverses a range of topography along the northern boundary of Queenstown Station, from being cut into slopes to running across alluvial river flats. It is important to the commercial success of the park that this road remains operational.</p> <p>The road is subject to several geotechnical hazards along its route.</p> <p>At times, the road has been cut into the base of the Remarkable Mountain Range, and this cutting has locally created steep 60 to 80 degree bluffs comprising predominantly colluvium and alluvium. The road is sometimes narrow and winds tightly between the Kawarau River and the large uphill slope. River scour from the Kawarau River has caused several washouts at both the Queenstown and Chard Farm end of the site.</p> <p>There are also small shallow landslips along the access road on the uphill side towards the Chard Farm end of The Park, and groundwater was observed emanating from the uphill slope at several locations. It is considered that the Queenstown Station can expect regular shallow land slips on this section of road during rain events and following freeze-thaw cycles, especially during the winter and spring months annually.</p> <p>Rock fall from the upper slopes rolling to road level is considered a very low risk based on the geology and observed existing rockfall debris, however could still be a rare occurrence.</p> <p>Flooding, debris flow and channel migration could affect the access road on both of the major alluvial fans (Owen Creek and Rastus Burn), as well as on several minor alluvial fans throughout the park.</p>	<p>The Queenstown Station access road will require proactive maintenance and clearance of shallow slips and debris flow as they occur. It will be important to maintain good drainage along the uphill drainage channel to prevent blockage and saturation of the uphill slope toe, which could destabilise the slope and cause shallow landslip.</p> <p>A driveover inspection of the access road immediately following rain events is advised.</p> <p>If scour erosion and failure is observed, Remarkables Park Limited could look at a programme of rock armouring and other road protection measures to protect against river scour damage (washouts) from the Kawarau River at the Chard Farm end of the site.</p> <p>Culverting, bridging and fords across either the Rastus Burn or Owen Creek will need to consider for the potential impact of debris flows.</p> <p>The only area of High Rockfall Risk is located immediately east of Chard Farm, which is outside the Queenstown Station property boundary however does affect the potential use of the Station and is included for that reason. It is recommended that QLDC and Remarkables Park Ltd work together to reduce the rockfall risk along this section of road, particularly if traffic volumes are to increase.</p>	<div>

</div> <div><p>Above: Washout /river scour location on road at Chard Farm end of the Station. The road has recently been reformed.</p><p>Left: Surficial slip encroaching into drainage channel and threatening road.</p><p>Below: Boulder from a rockfall event below the access road at the Queenstown end of the Station.</p></div>

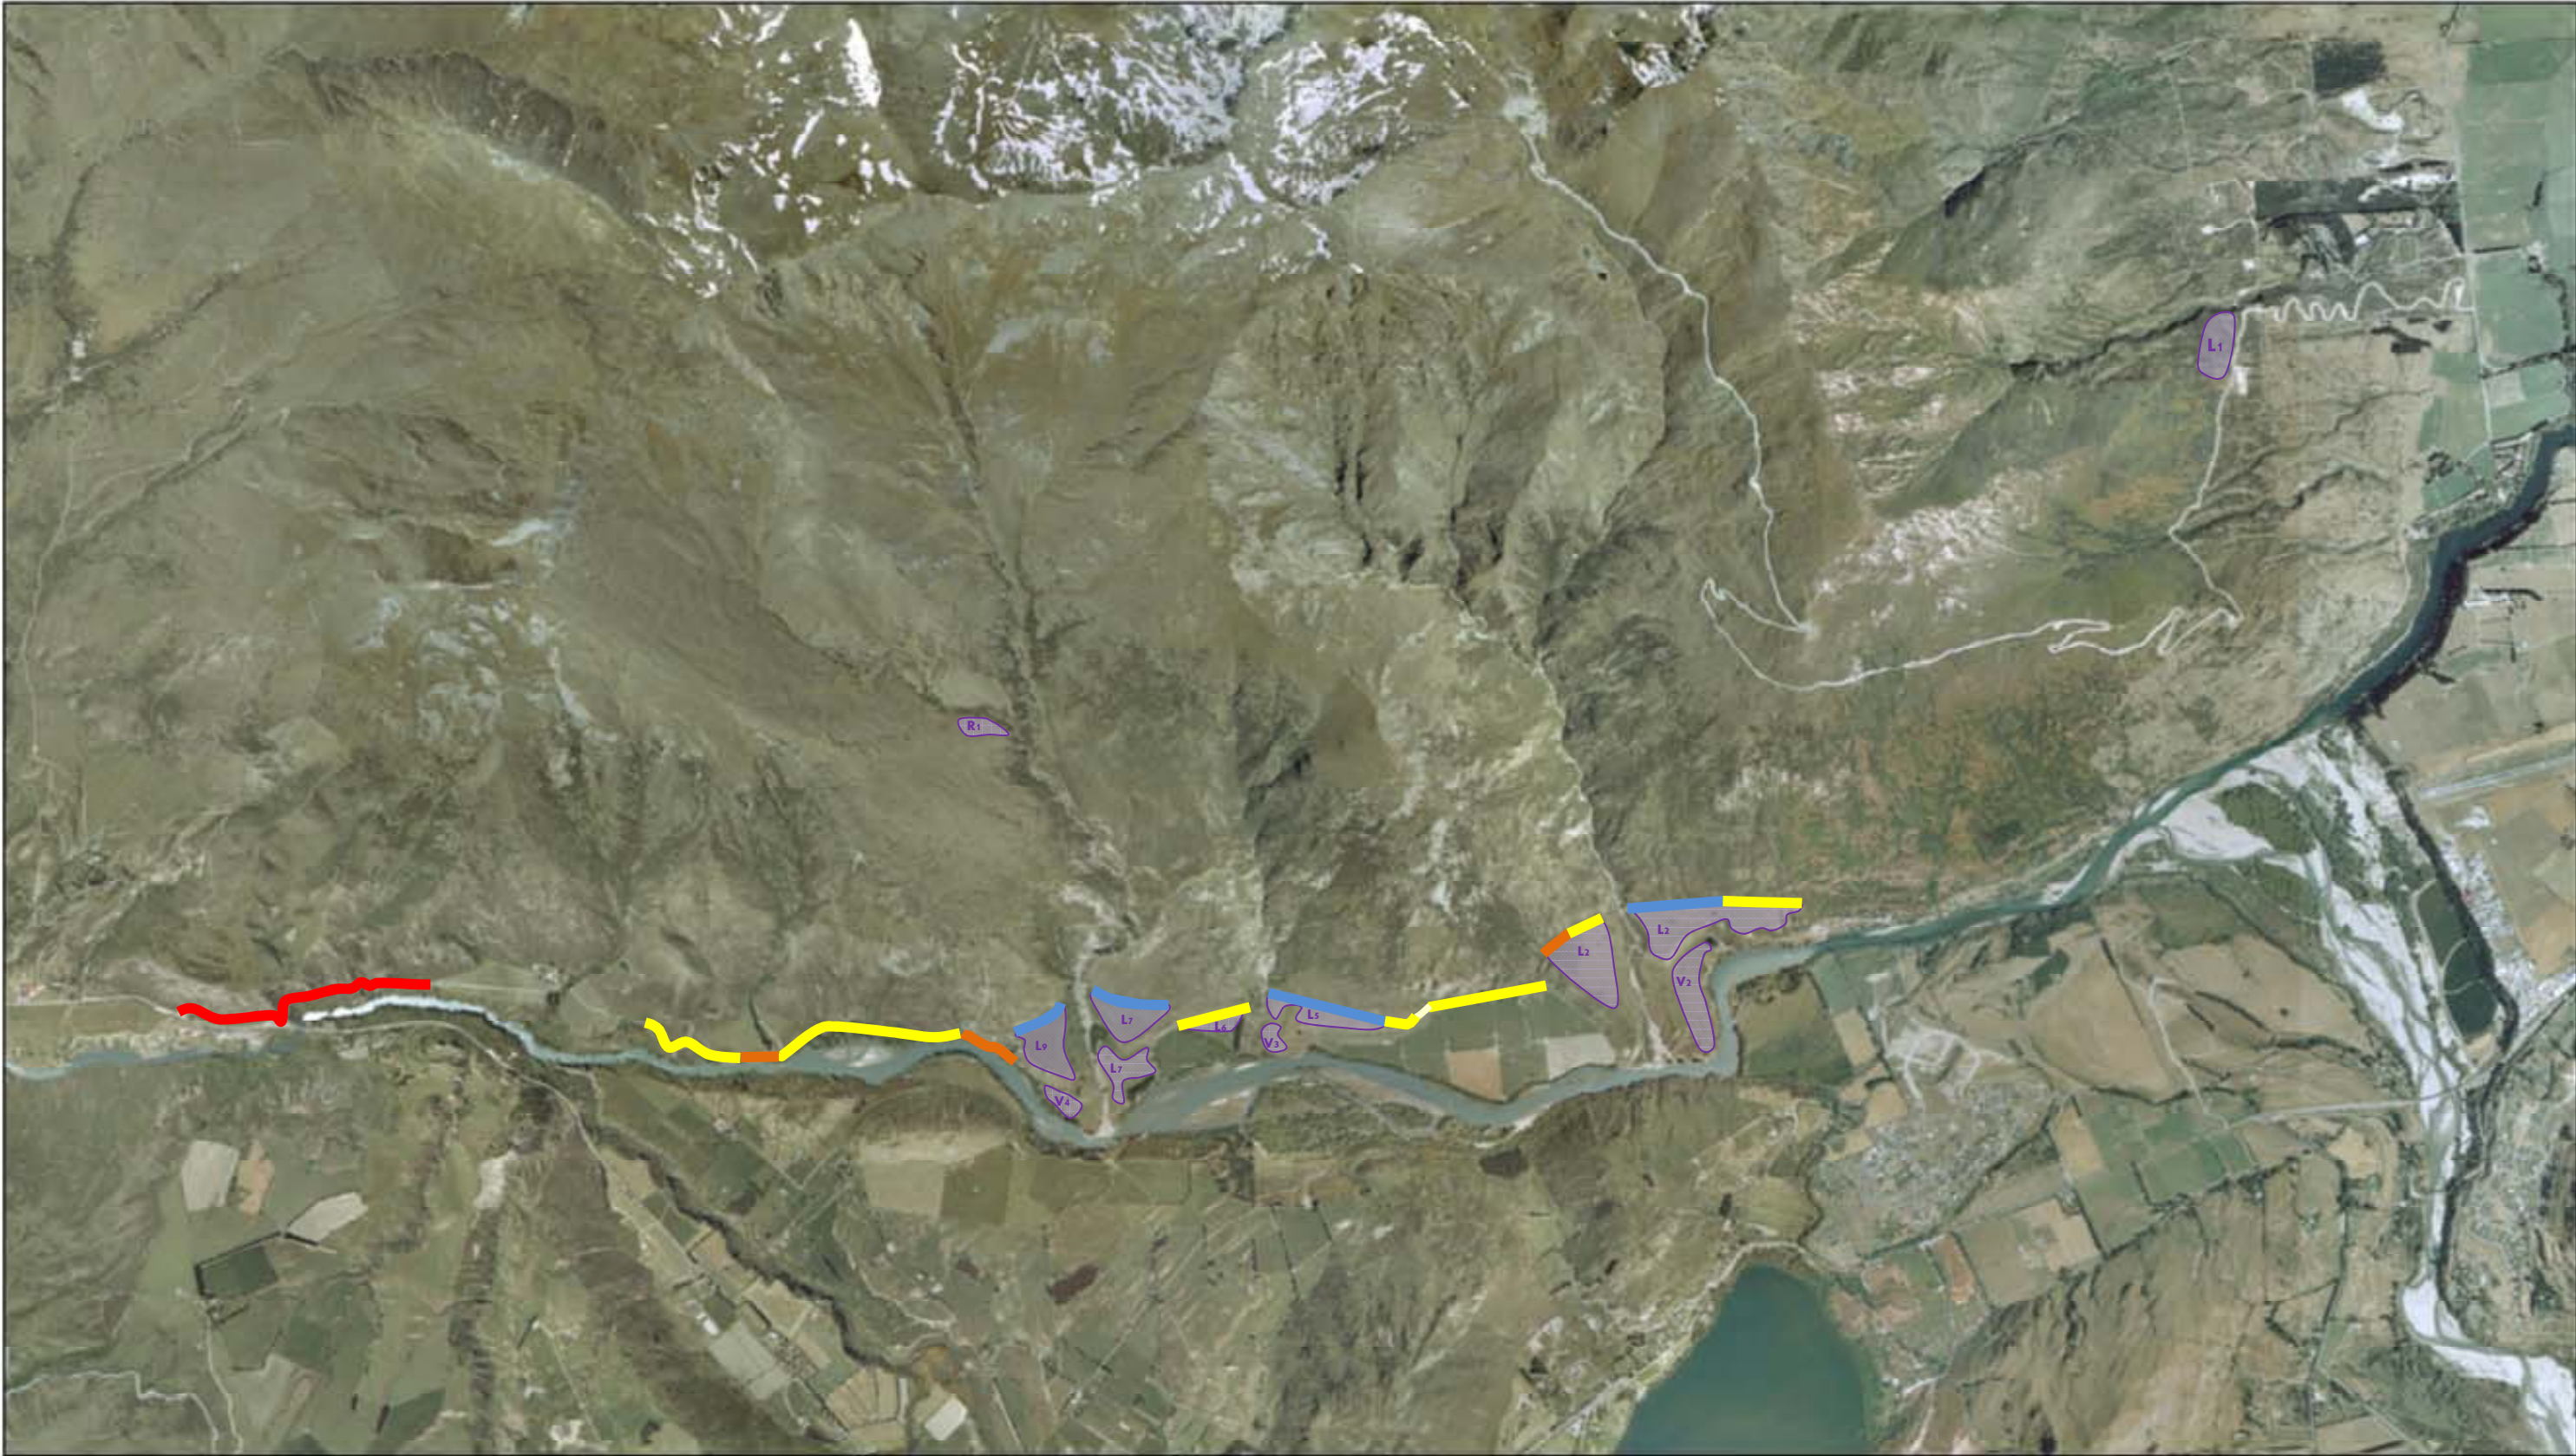
Map 1: Rockfall Hazard

LEGEND - ROCKFALL HAZARD

- No to very low rockfall risk
- Low rockfall risk
- Moderate rockfall risk
- High rockfall risk

- (a) **Rock fall** - Across the entire Site area various erosional rock fall sites were identified. The rock fall hazard rating that applied to the Site varied from None or Very Low to High. For the proposed activity areas however, the rock fall hazard risk was assessed as being None to Low;

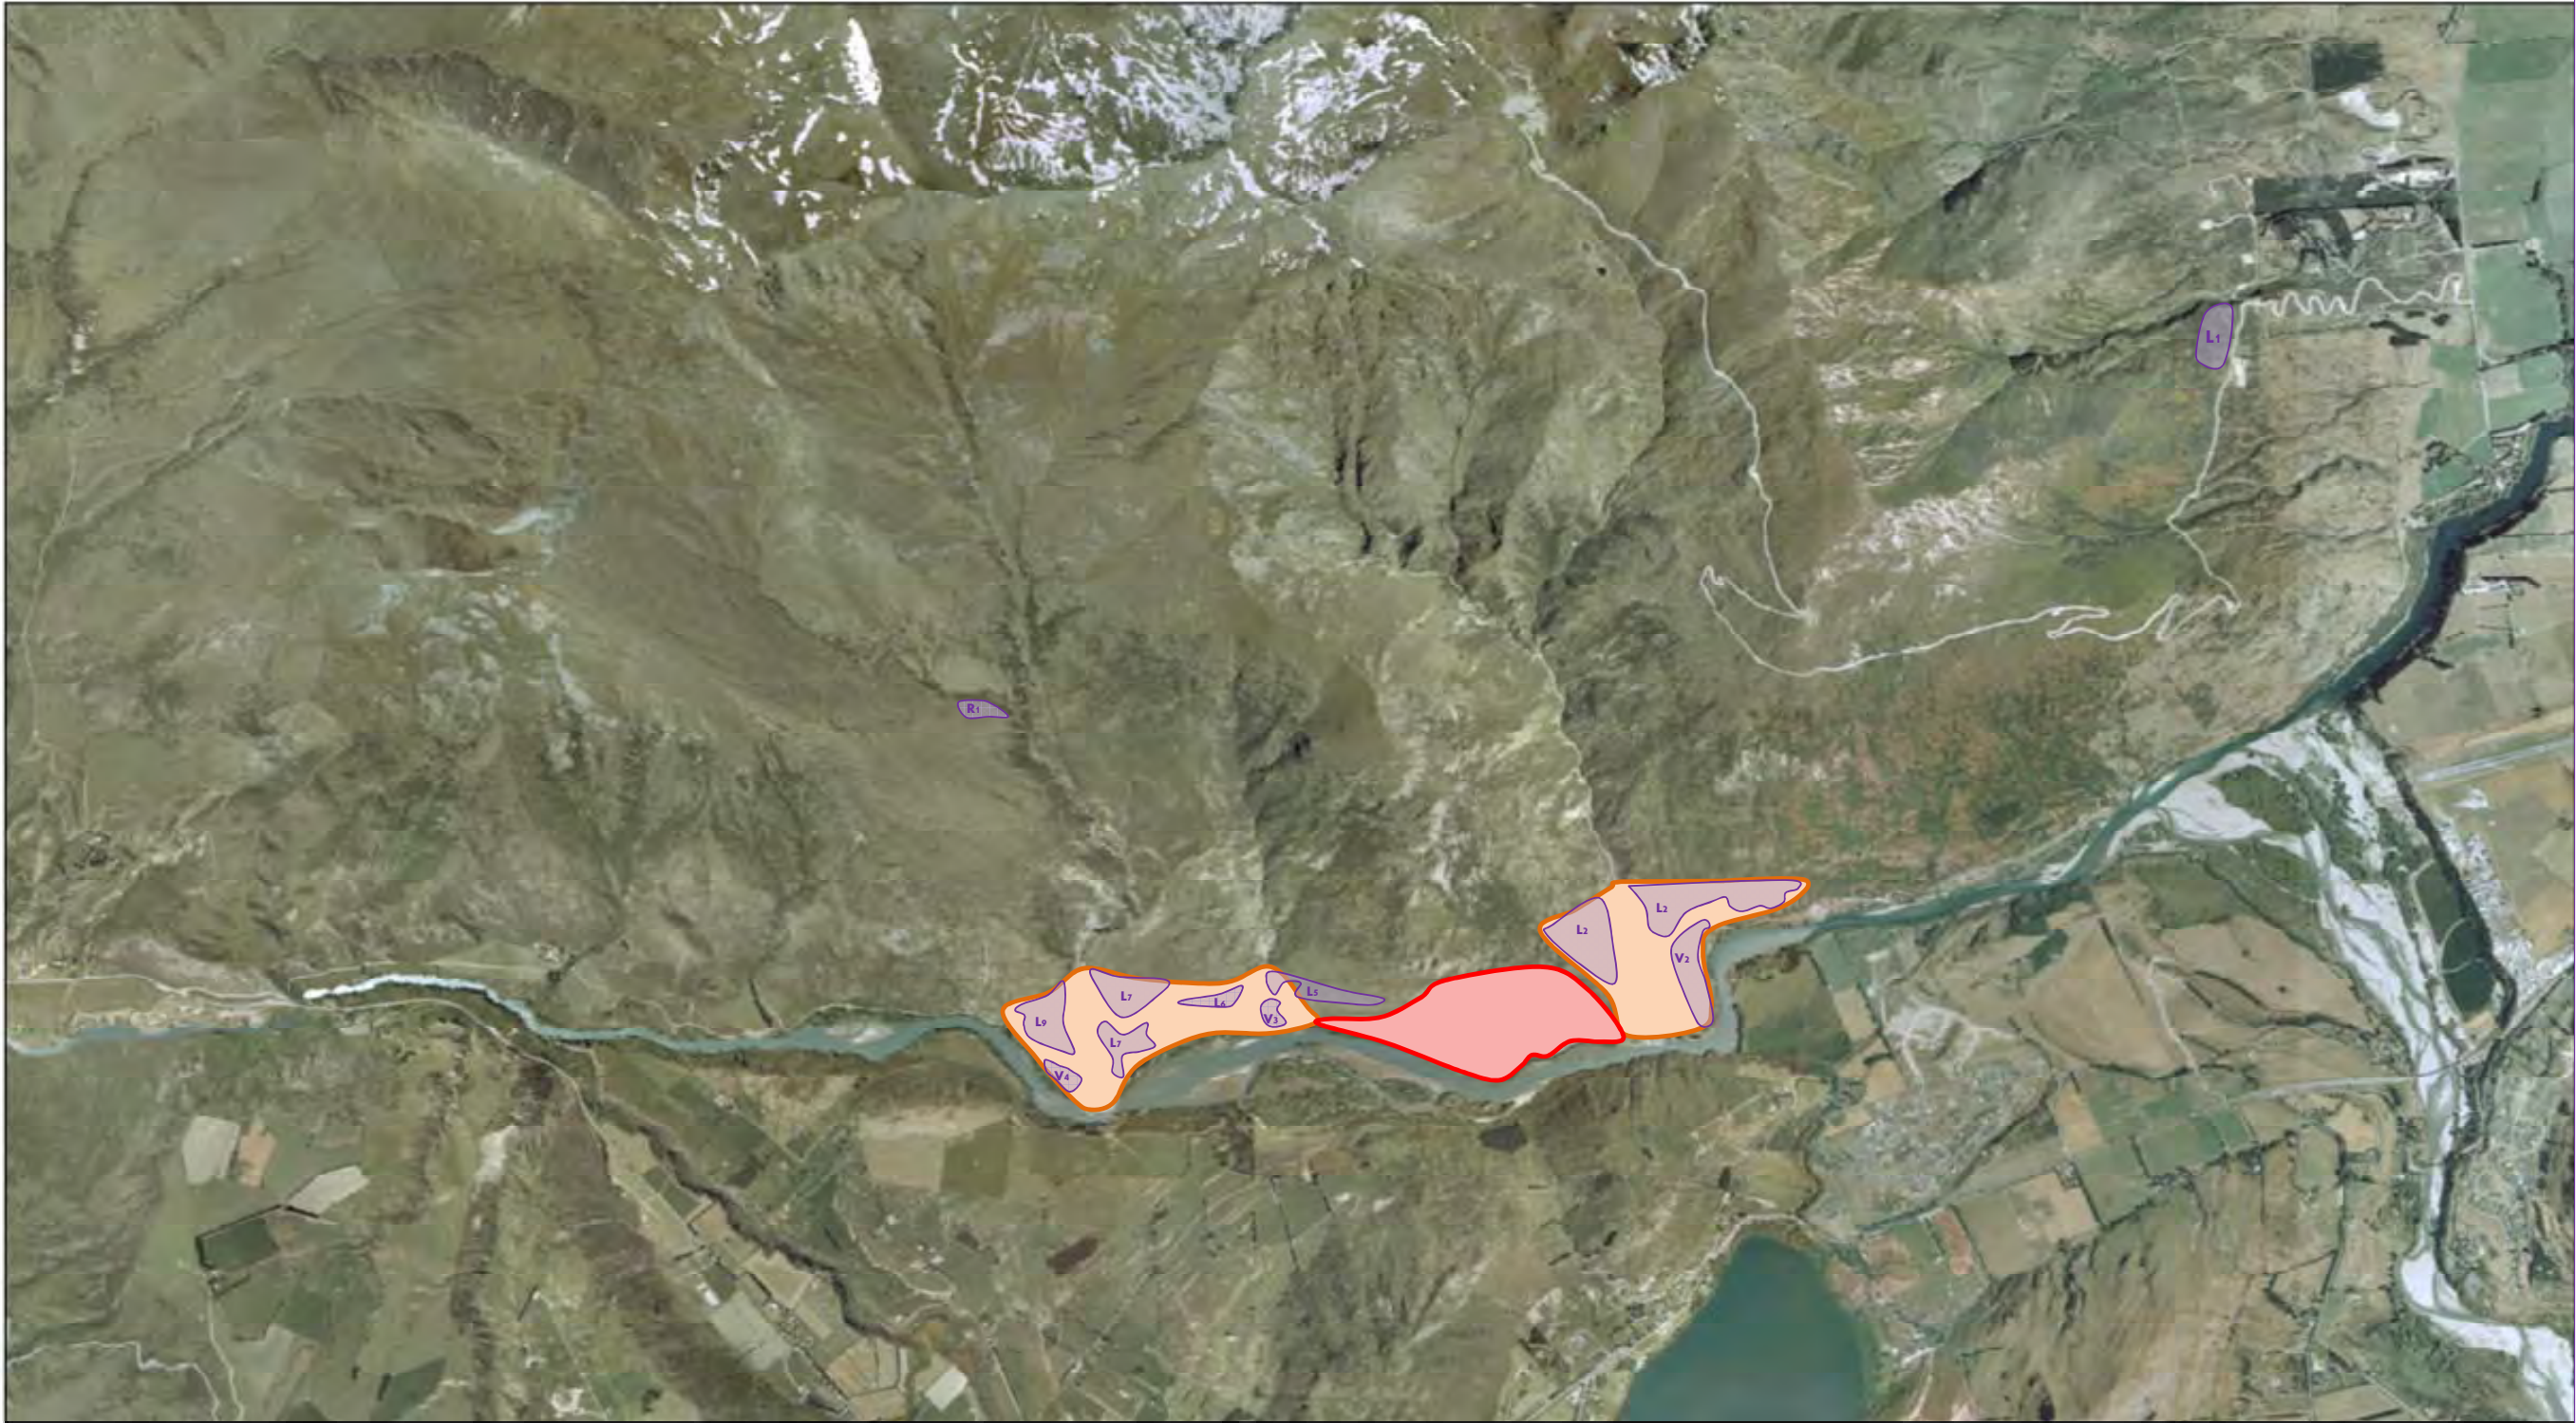
Map 6: Liquefaction & Lateral Spread Hazard
Drawn: Emily Stevens
Geotechnical Engineer, CPEng
Date: 31-Mar-15

Liquefaction Hazard - Possibly Susceptible (Opus, 2002)

- (g) **Liquefaction Potential** – As per the 2005 Opus Report the Site has been assessed in terms of liquefaction potential and assigned a soil Class A, B or C rating. The majority of the low lying areas of the Site in close proximity to the Kowarau River have been assigned as soil Class C, (Possibly Susceptible). The potential for liquefaction is governed by a number of factors including the presence of groundwater and grainsize of the deposited sediments. Liquefaction can result in slope failures, lateral spreading of river
