**STATEMENT OF EVIDENCE OF ROBERT BOND ON BEHALF OF REMARKABLES
PARK LIMITED AND QUEENSTOWN PARK LIMITED**

(GEOTECHNICAL ENGINEERING – NATURAL HAZARDS)

STREAM 13 REZONING HEARINGS

Table 1. Queenstown Station Preliminary Geotechnical Hazard Appraisal

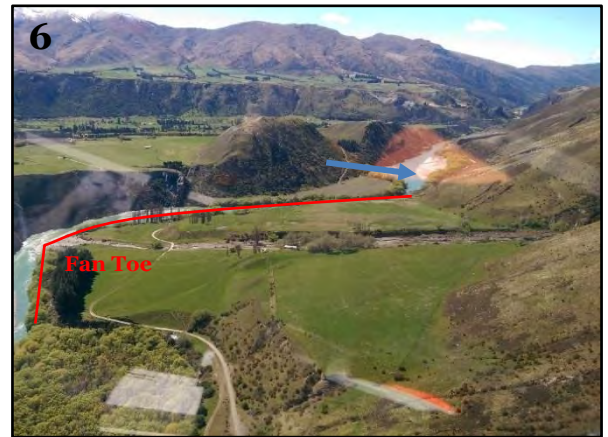
Photograph 4 (Top): Aerial photograph showing the Owen Creek fan characteristics. Approximate positions of proposed development sites are shown.

Photograph 5 (Bottom Left): Photograph taken on the Owen Creek fan where the access road crosses the current stream bed. Old alluvial fan terraces are shown by dotted yellow line.

The debris deposited by the flows onto this fan is smaller in size than on the Rastus Burn, up to a size of around 200mm. Aerial photographs indicate there could be a gorge followed by a sharp bend immediately upstream of the fan apex. The gorge may a) block some of the large debris from continuing in the flow or b) act to increase the water velocity, which rapidly decelerates when the flows hits the following sharp bend, causing rapid deposition of the larger fragments at this point upstream of the alluvial fan apex.

Regardless of the reason, it appears that debris flow carrying large boulders is not a major hazard on the Owen Creek alluvial fan. However, debris flow containing material less than 200mm, flooding inundation, scour and channel migration in the lower braided section are likely to still occur.

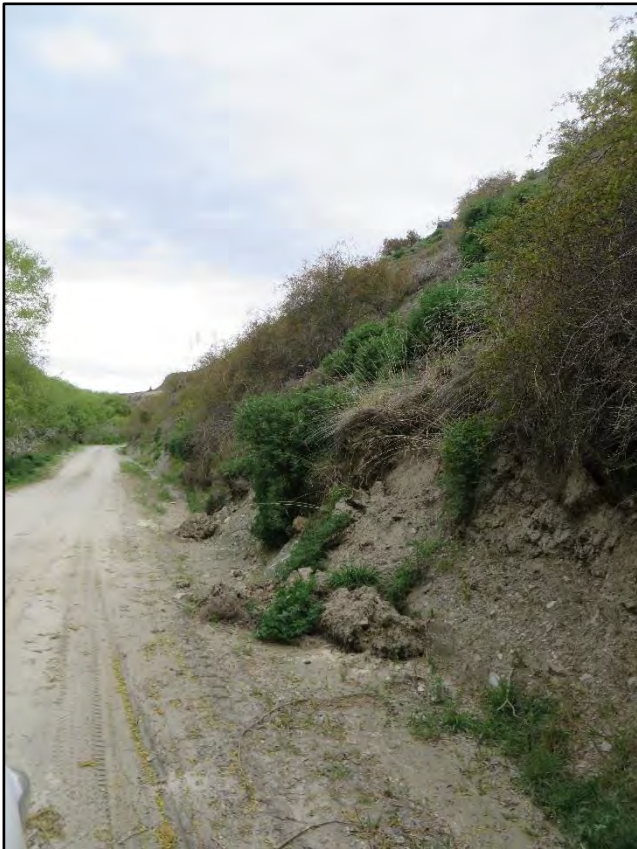
Photograph 9 (Left): Shallow landslide along access road (Chard Farm end of The Park)

This hazard refers to surficial slip failures in soil deposits, up to 5.0m³ in volume, such as those commonly observed in road cuttings throughout the Queenstown Station. These typically occur in loosely packed alluvium or colluvium (slope debris not carried by water). They are most often triggered by poor cut slope design (i.e. cutting at too steep angle into a slope without considering the friction/cohesion properties of the soil), effect of water, either surface water runoff or groundwater and poor drainage.
