# Rangiora Eastern Road Connections

Ecological Report  
Prepared for Waimakariri District Council

3 May 2021

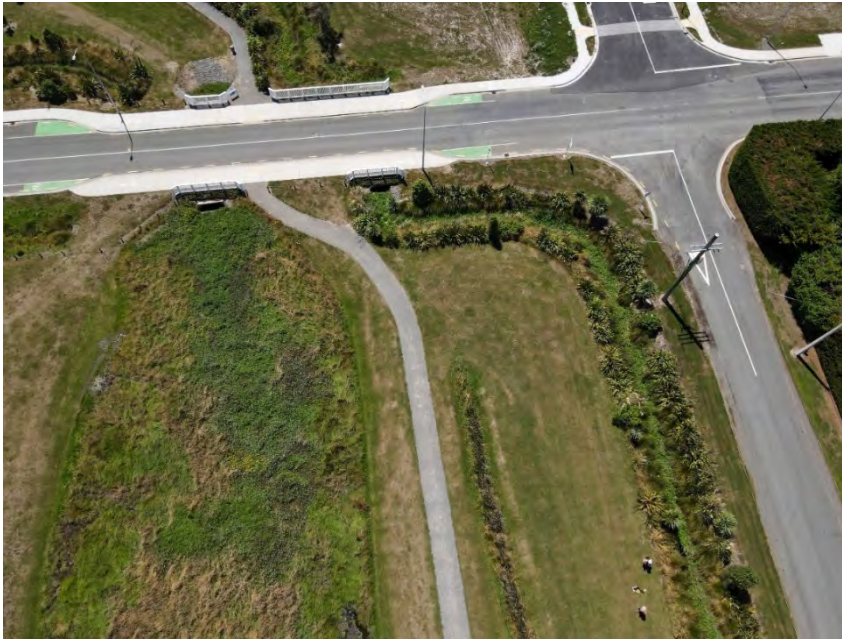
Kōura Creek supports a range of indigenous freshwater species including kēkēwai / freshwater crayfish (or kōura, *Paranephrops zealandicus*), tuna / longfin and shortfin eels (*Anguilla dieffenbachii* and *A. australis*) and kanakana / lamprey (*Geotria australis*) (McMurtrie 2008).

Figure 2. Kōura Creek flowing under Northbrook Road (top) and alongside Spark Lane (right). Photo taken looking upstream (north).

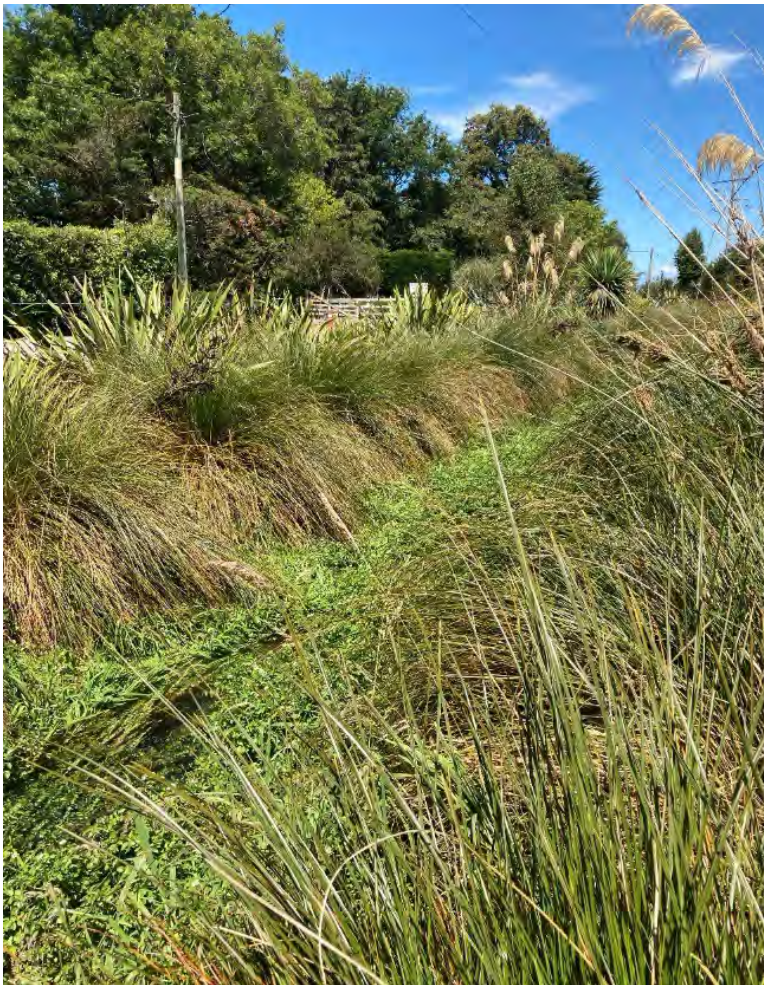
Figure 3. Kōura Creek with riparian plantings, such as harakeke, pūrei, tī kouka.

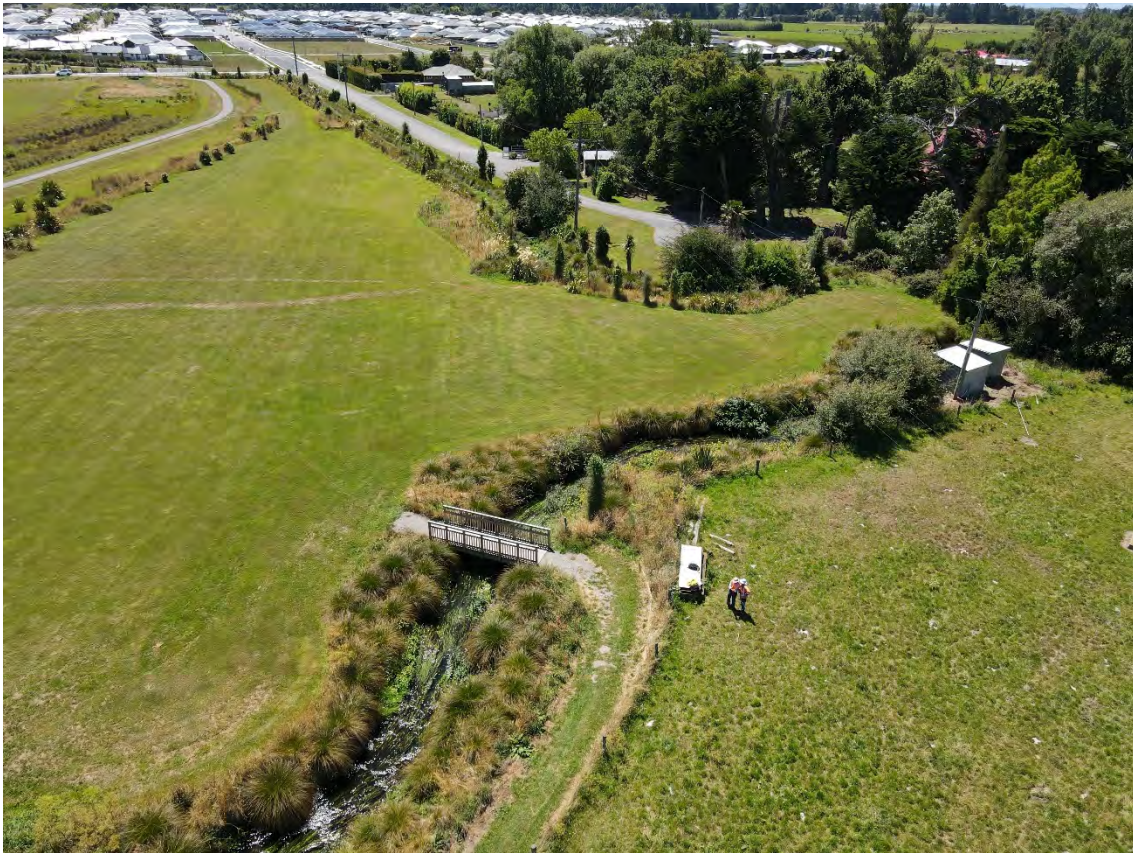
Nevertheless, a study by Aquatic Ecology Limited (AEL) in 2017, found a substantial number of brown trout redds (egg nests) in North Brook, as well as abundant kēkēwai and kanakana (AEL 2017). The NZFFD indicates other species are present in North Brook, including longfin eels and freshwater shrimp; and EOS Ecology (2005) also found upland bully (a non-migratory species) and common bully present in the brook.

Figure 4. North Brook near the confluence with Kōura Creek where the proposed RERC alignment crosses. Photo taken looking downstream (northeast).

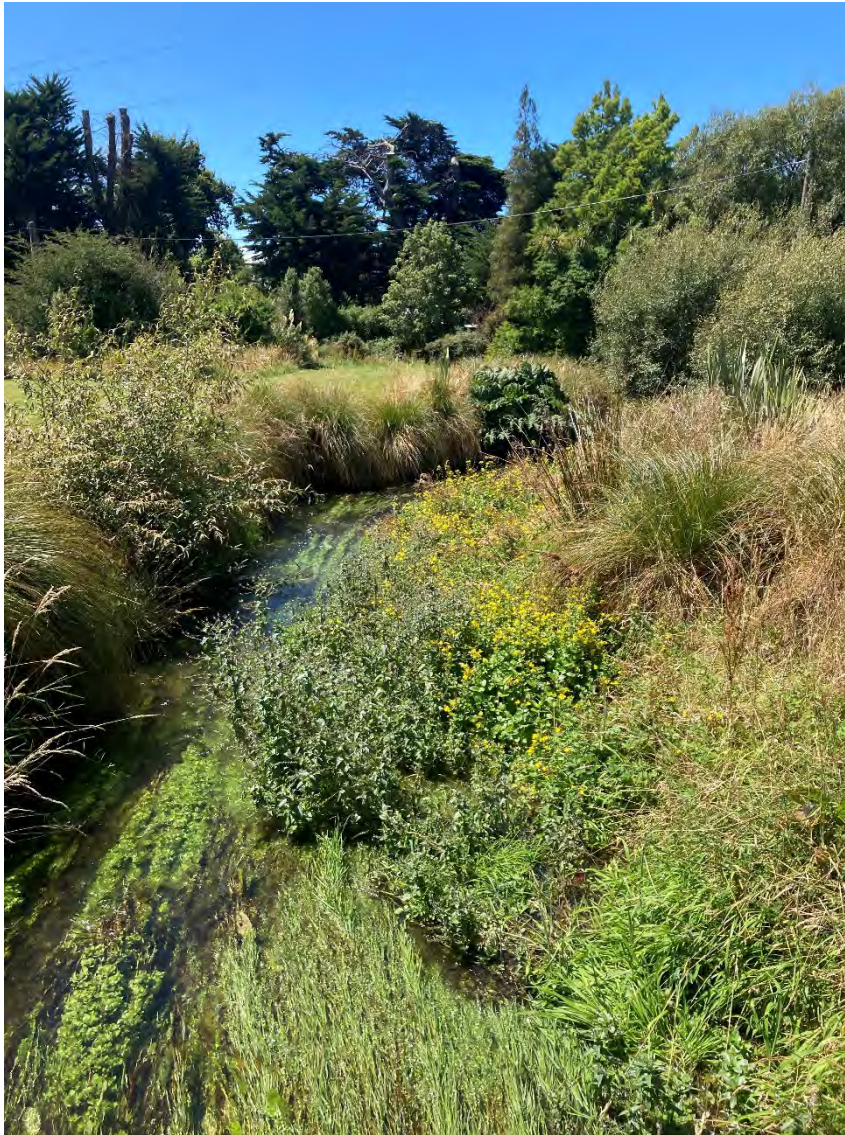
There is abundant cover of macrophytes (as shown in Figure 5), and the stream health is noted to be fair to poor (based on the Macroinvertebrate Community Index (MCI) measures from EOS Ecology 2005).

Figure 5. North Brook with deep, clear spring-fed water and abundant macrophytes (creeping bent, monkey musk, water speedwell, and cape pondweed).

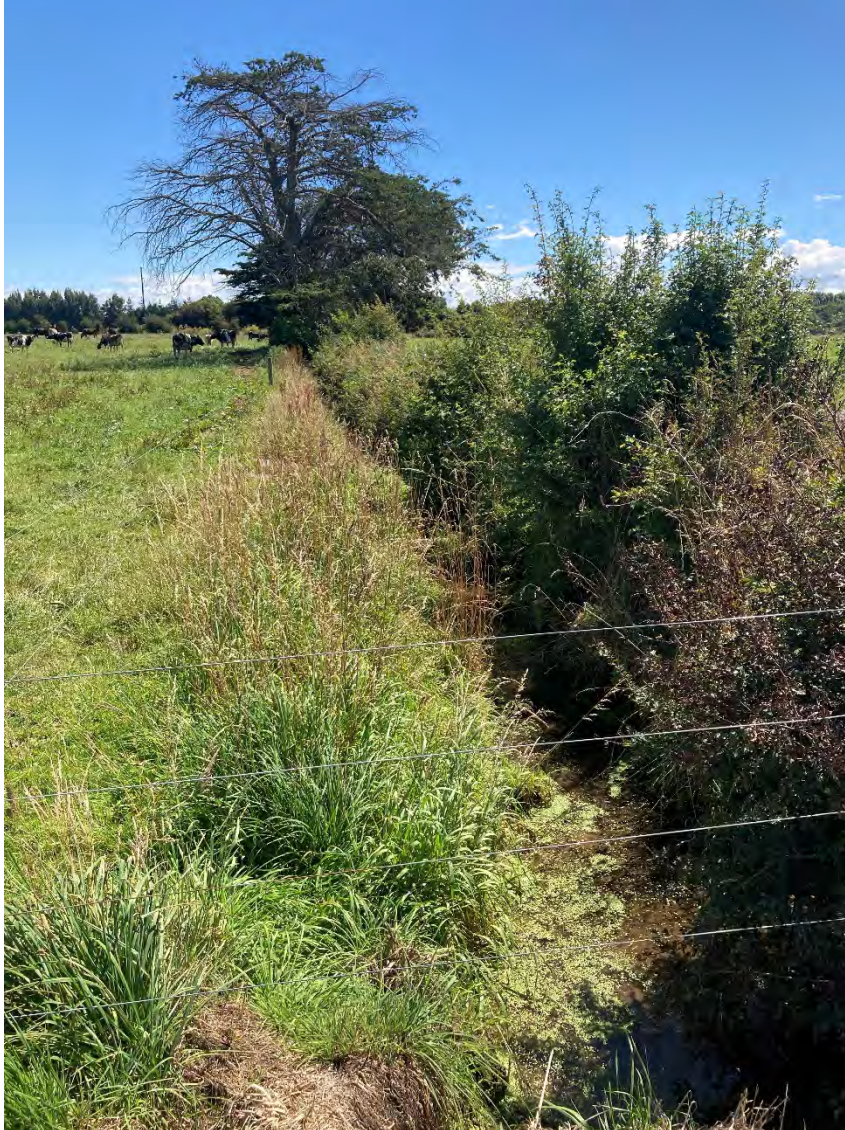
The channel is approx. 1.5 m and had c.10 cm of surface water present on the day of our site walkover.

The channel is straight and incised, with soft sediments dominating the bed; the waterway appears to be regularly maintained for drainage purposes (Figure 6). The vegetation is predominantly rank pasture grasses with some exotic shrubs, which together provide a reasonable amount of shade to the waterway. Given there is surface water present and due to its proximity to and connection with North Brook, it's possible that this waterway provides habitat for more tolerant fish and macroinvertebrate species, including shortfin eels.

Figure 6. Farm drain (photo taken c.80 m downstream of the proposed RERC alignment where surface water was present).

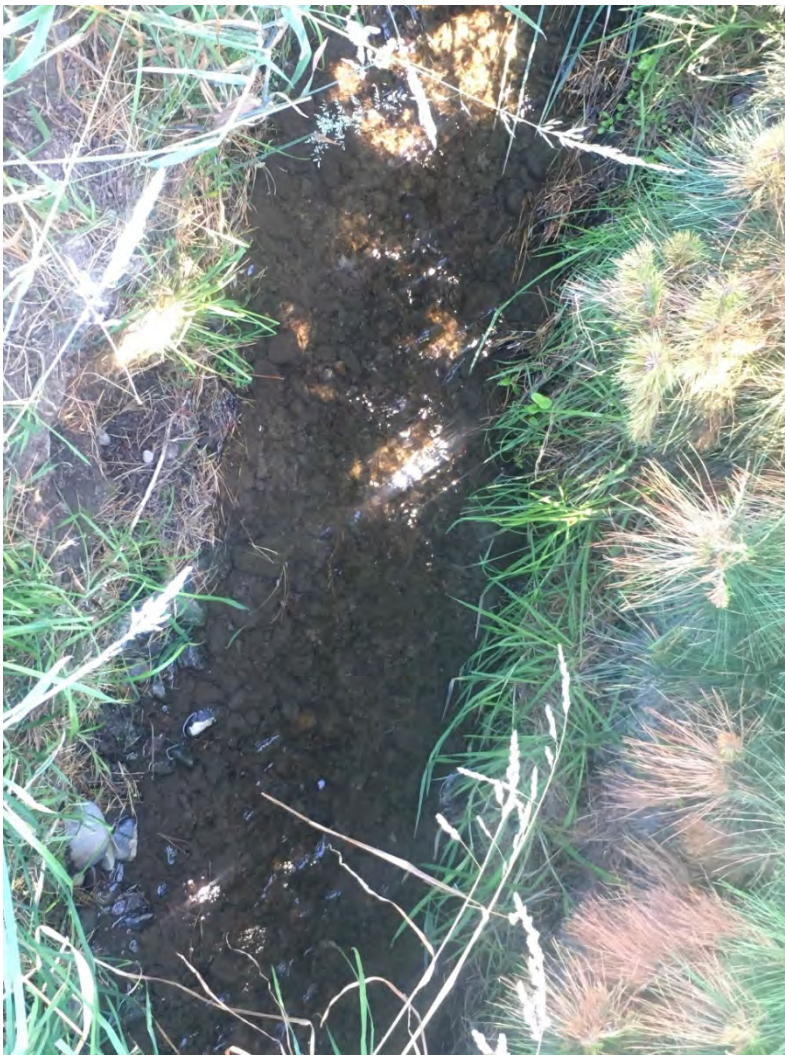
The vegetation is predominantly rank pasture grasses with a shelter belt on the northern bank at the RERC crossing location, which provides high shading to the stream.

Given the perennial and reasonable flows, presence of cobbles and gravels, and the proximity to and connection with North Brook, this waterway is likely to support a reasonably representative assemblage of macroinvertebrate and fish species, including eels and bullies.

Figure 7. Roadside waterway tributary of North Brook, on the north side of Boys Road.

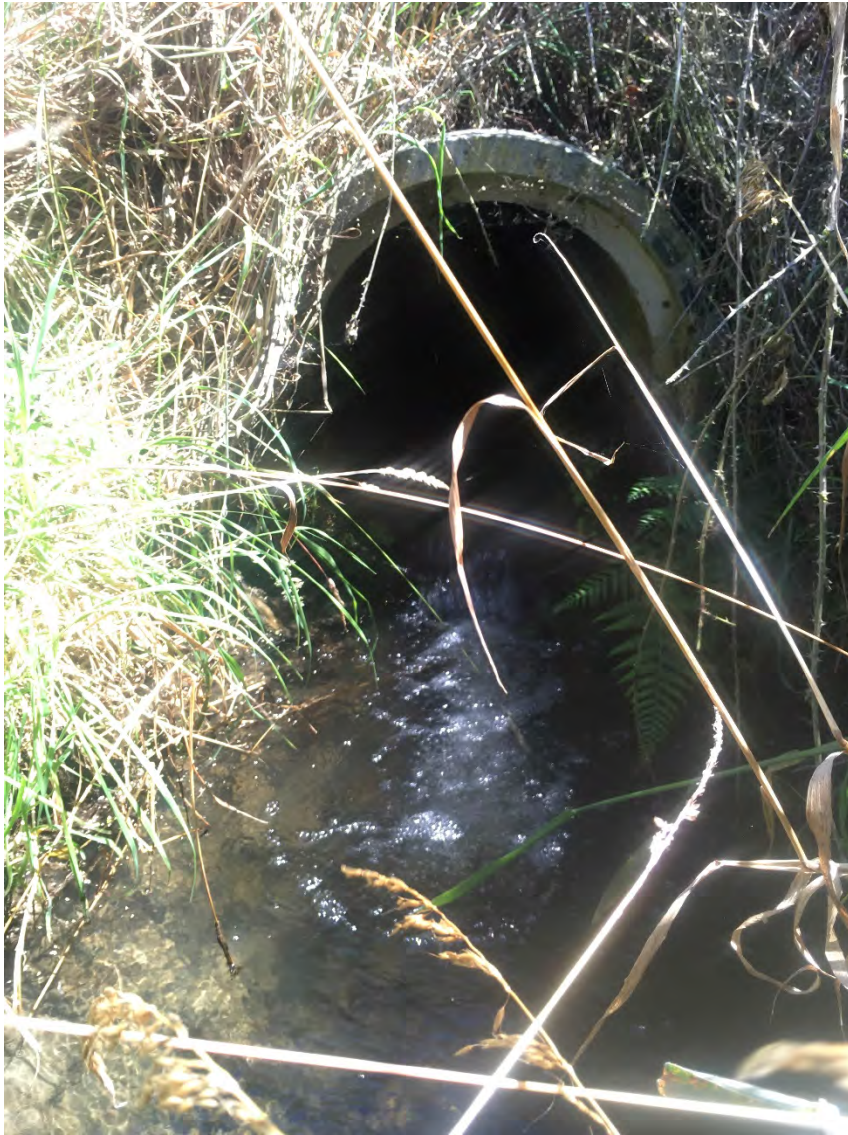
Figure 8. Perched culvert in the roadside waterway and tributary of North Brook.

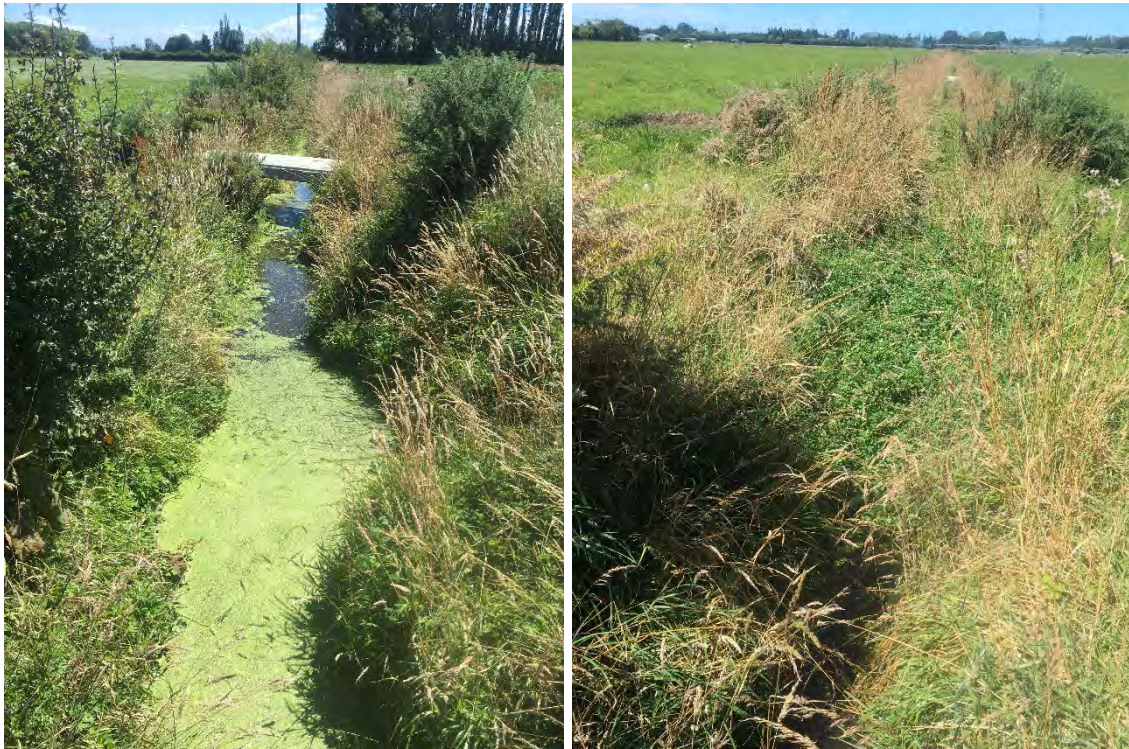
The channels of both waterways are straight and incised, with soft sediments dominating the bed; the waterways appear to be regularly maintained for drainage purposes. The vegetation is predominantly rank pasture grasses with some exotic shrubs, but these provide little shade to the waterways. However, as with the other farm waterways, given the presence of surface water and the proximity and connectedness to North Brook, these waterways may provide habitat for more tolerant fish and macroinvertebrate species, including shortfin eels.

Figure 9. Waterway at Crossing 5: a tributary of North Brook (left: looking upstream; right: looking downstream). Abundant duckweed and dense, emergent creeping bent, watercress and monkey musk indicate high nutrient loads and slow flow.

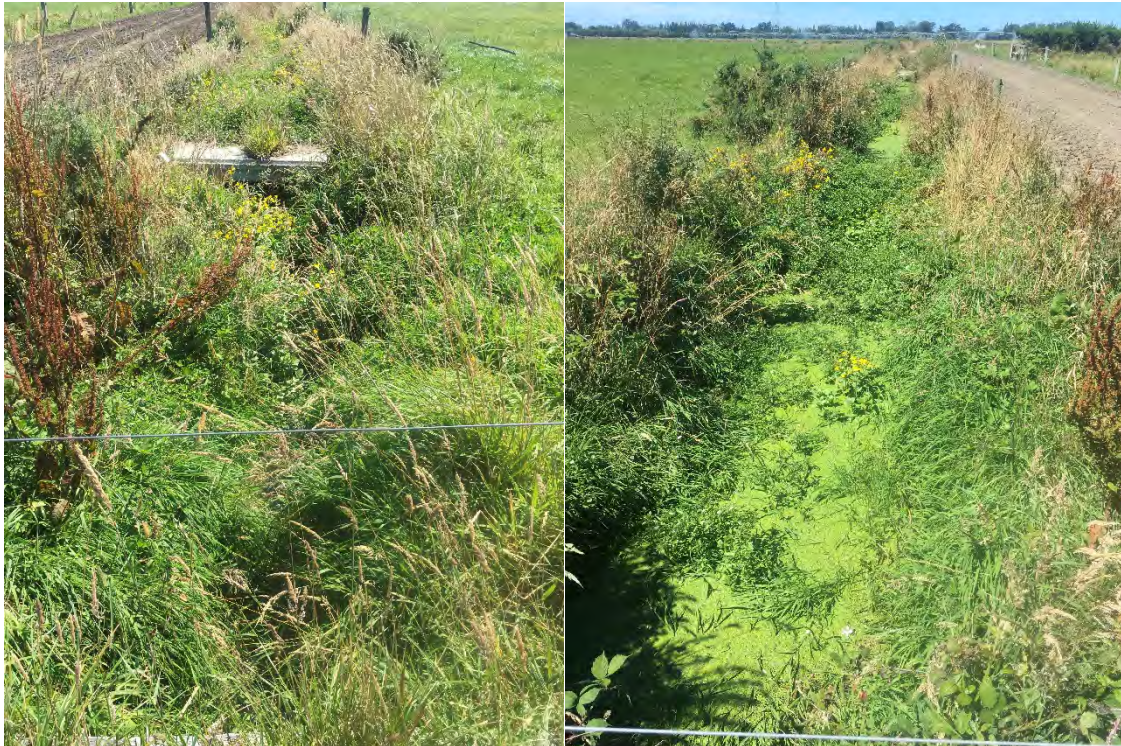
The waterway at Crossing 6 (Figure 10) is approx. 2 m wide and also had c. 20 cm of surface water present on the day of our site walkover.

Figure 10. Waterway at Crossing 6: a tributary of North Brook (left: looking upstream; right: looking downstream). A similar waterway to that at Crossing 5.

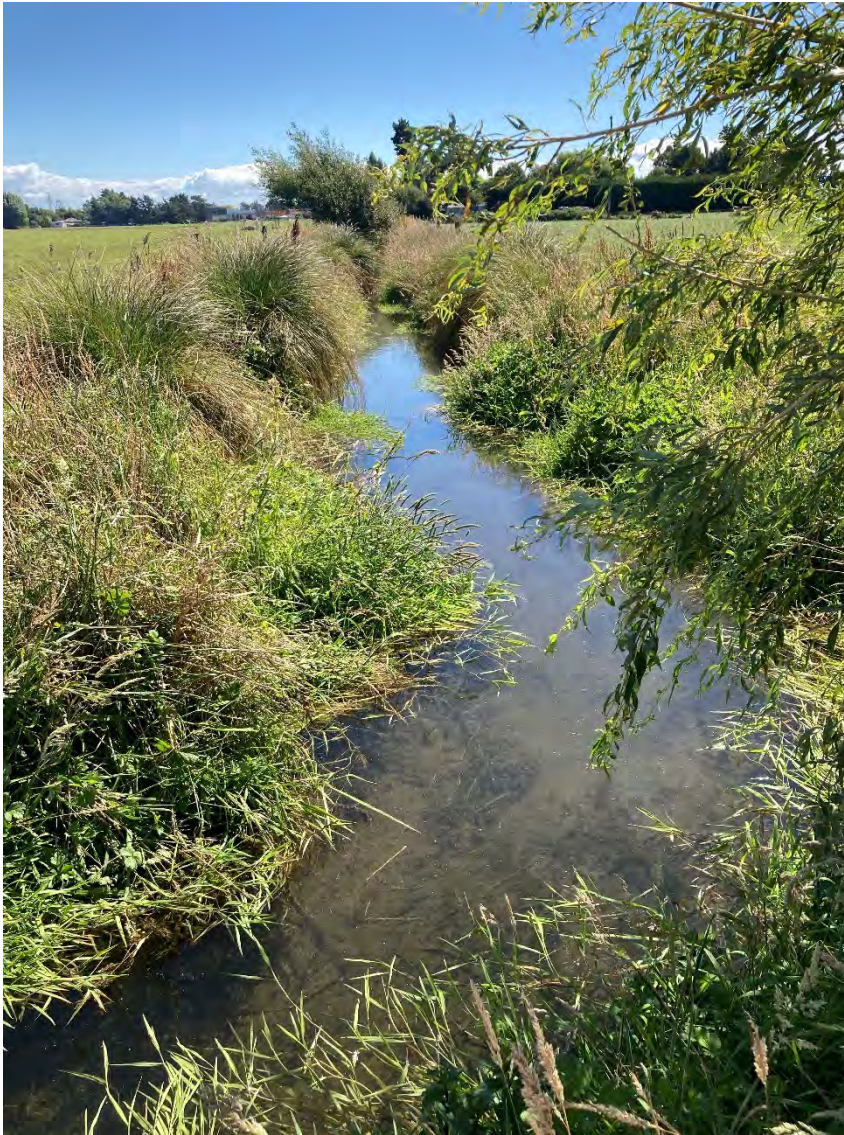
Middle Brook is a spring-fed waterway, sometimes known as South Brook Tributary. Previous studies have found that the waterway generally has a cobble-dominated bed (EOS Ecology 2005). The riparian vegetation, immediately adjacent to the waterway, is a mixture of planted pūrei, scattered willow trees, and rank exotic grasses. The vegetated riparian buffer is narrow, with only c.1 m width of plantings.

Figure 11. Middle Brook (looking upstream). A deeper, slow-flowing pool is impounded by a vehicle crossing point and water intake structure.

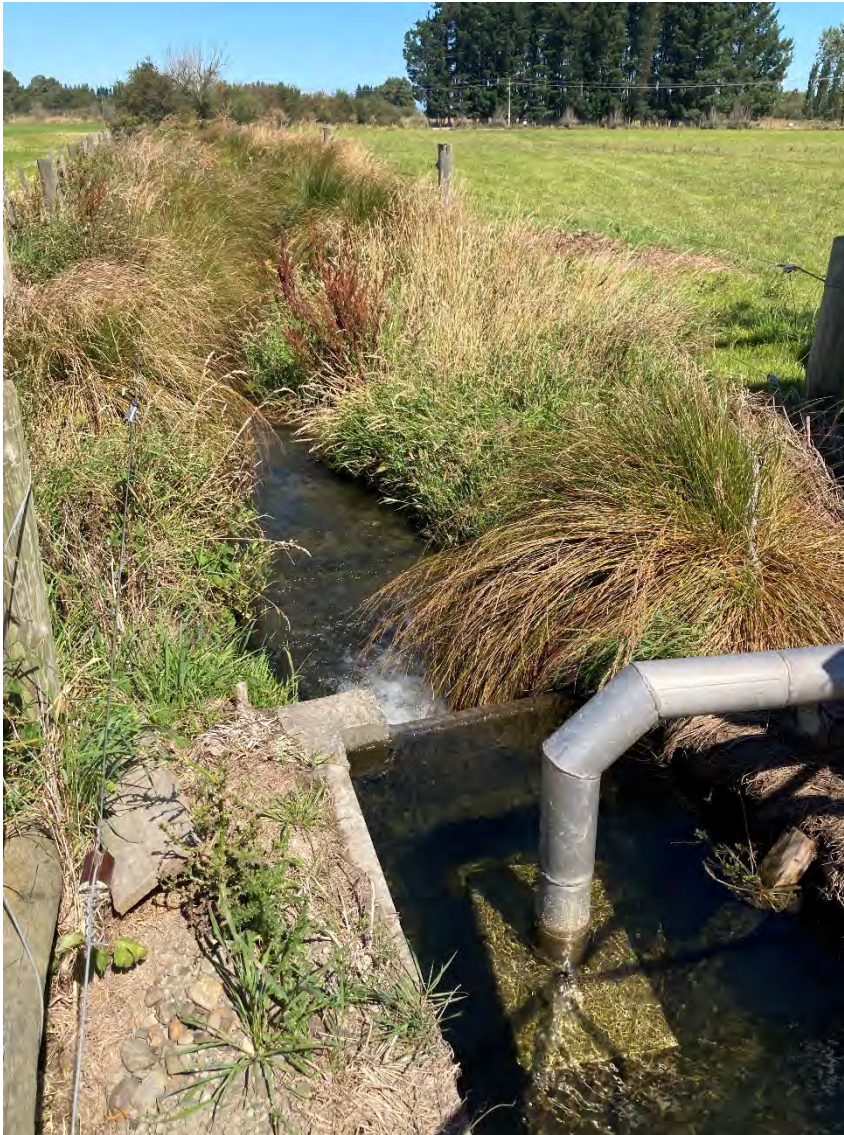
There is an irrigation intake and pumphouse located generally within the proposed crossing location (Figure 12). The irrigation intake consists of a concrete weir that impounds the flow to allow sufficient depth for a pump to take water. This is likely to impede passage of most, if not all, freshwater fish species that migrate and move along Middle Brook.

Figure 12. Middle Brook (looking downstream). An irrigation intake is located immediately upstream of a c.40 cm weir that likely prevents upstream and downstream fish passage.

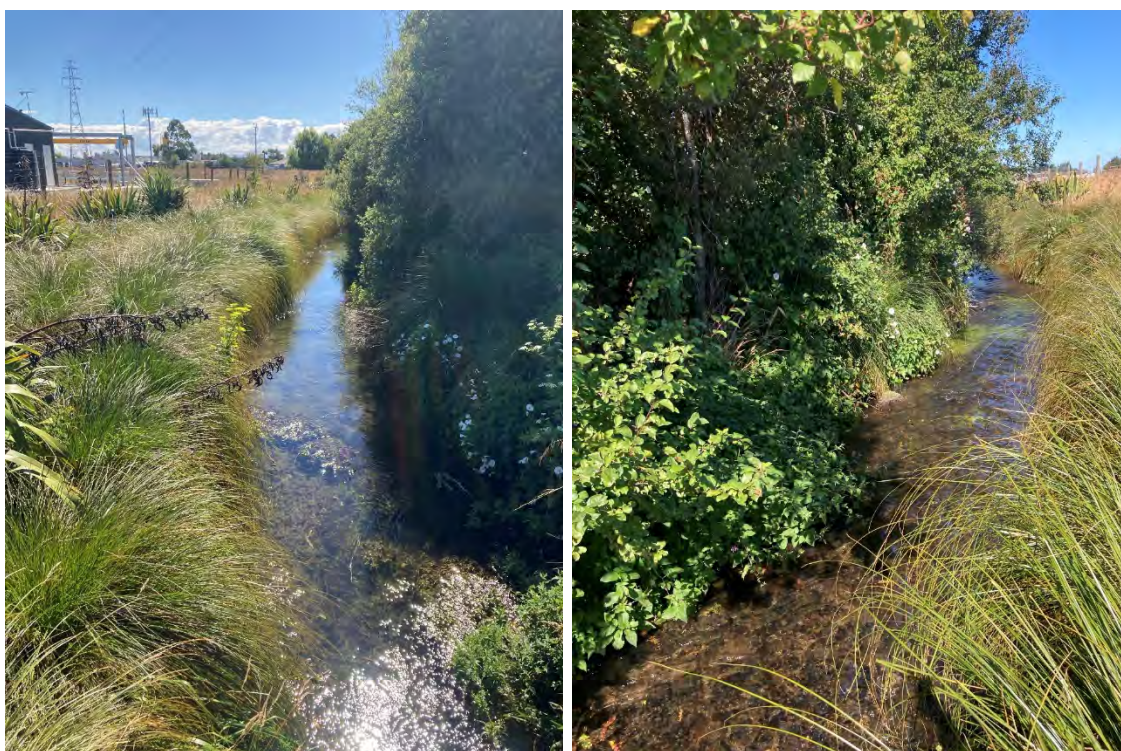
The riparian margins are planted with pūrei (predominantly on the south or true right side) with kōhūhū trees (*Pittosporum tenuifolium*) on the north or true left side (Figure 13). The kōhūhū are particularly important for providing substantial shade and leaf litter inputs to the stream; essential components of the freshwater ecosystem for good stream health.

The stream health is noted to be good to poor (based on the Macroinvertebrate Community Index (MCI) measures from EOS Ecology 2005). As with North and Middle Brooks, South Brook has been found to have trout redds throughout, owing to the cobble-bottom bed. The waterway also supports kēkēwai, and longfin and shortfin eels, upland and common bullies, and brown trout. The WDC Wastewater Treatment Plant (WWTP) staff noted they often feed large longfin eels under the bridge within the site. A large (>1 m long) longfin eel was visible during the day, presumably habituated to vibrations from humans and being fed. The bridge and stable undercut banks likely provide good habitat for these large eel/s.

Figure 13. South Brook (left: looking upstream; right looking downstream) at the proposed RERC crossing point, within the Rangiora Wastewater Treatment Plant.

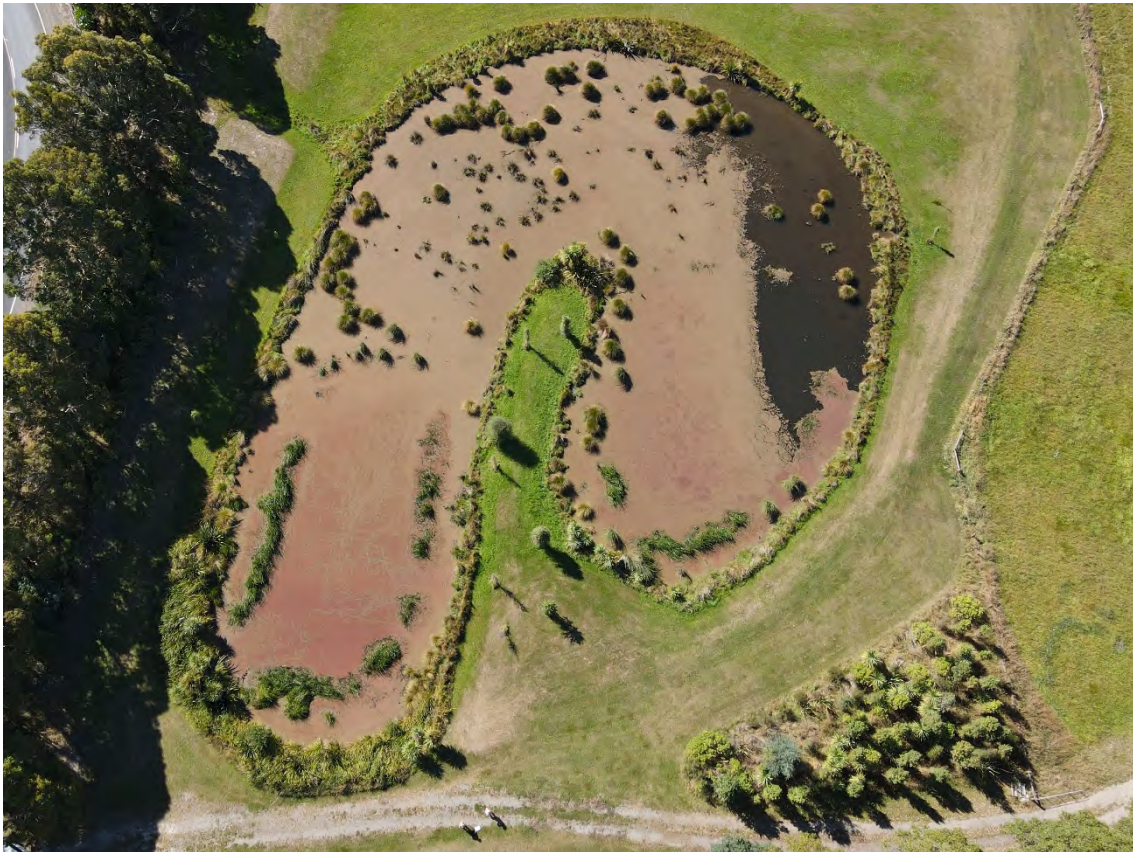
This waterbody is a constructed wetland with mature plantings of pūrei, *Juncus* spp. rushes, and tī kōuka. The native floating red fern (*Azolla*) is also abundant, which can be seen in the aerial image (Figure 14 and Figure 15). This constructed wetland provides important habitat for waterfowl and while it is not connected to adjacent waterways via surface water, there is an apparent input via a swale to the north. The wetland habitat appears to be suitable for freshwater fish species such as shortfin eels, although as this is a migratory species the presence of this fish would require connection to other waterways at some point.

Figure 14. Constructed wetland at south end of proposed RERC alignment.

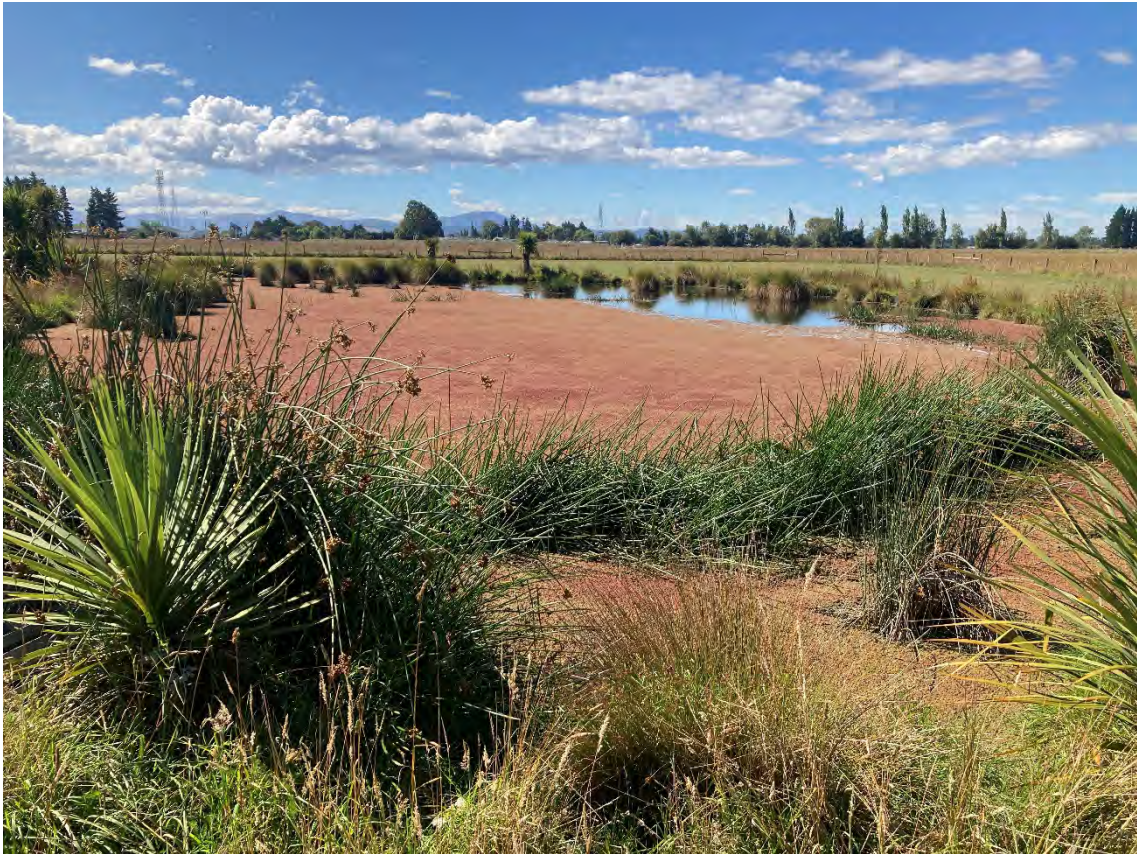
Figure 15. Constructed wetland at south end of proposed RERC alignment.
