Tasman Bay Village

Ecological Effects Assessment

Stormwater Report

Harakeke Ltd Development Cultural Impact Assessment

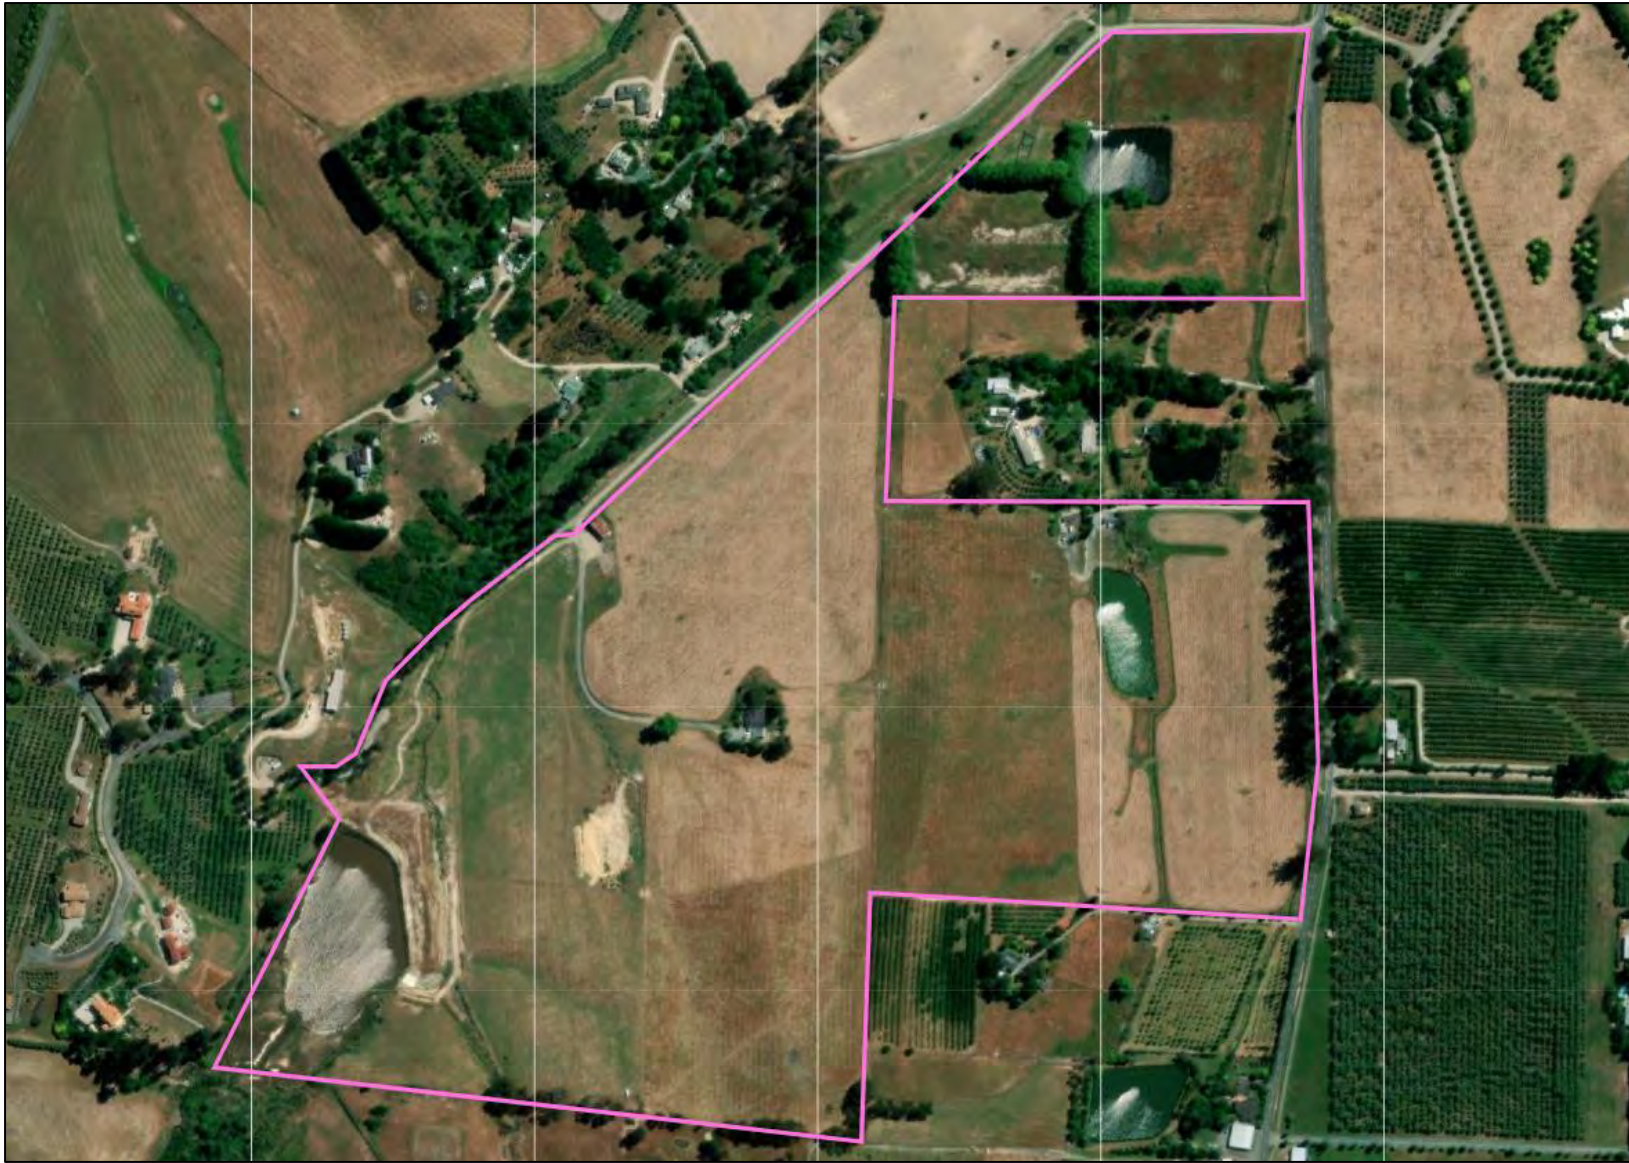
Figure 2. Aerial image of the site (pink border) showing the lack of woody vegetation, and dominance of pasture.

The site has been heavily modified from its pre-human condition. All original vegetation has been removed through logging and farming activities. The current land use of the site and surrounding areas is agriculture and horticulture (**Figure 2**).

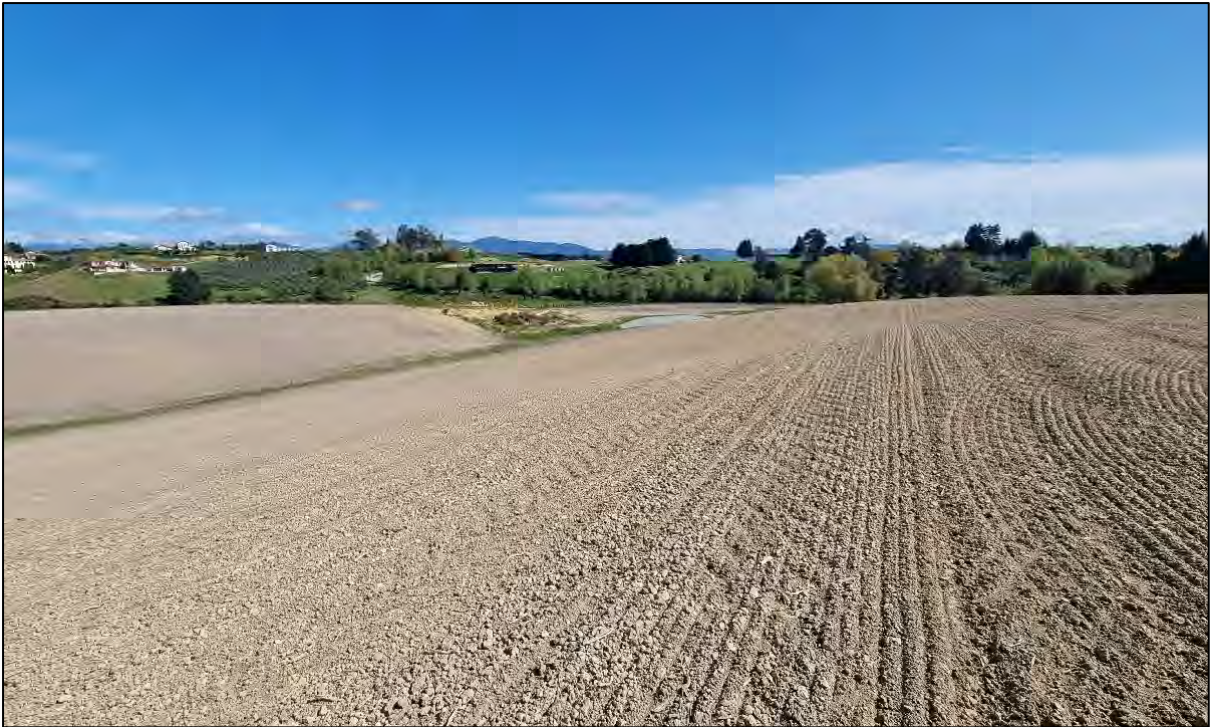
Plate 1. Most of the site was bare earth during the site survey on 11 October 2022.

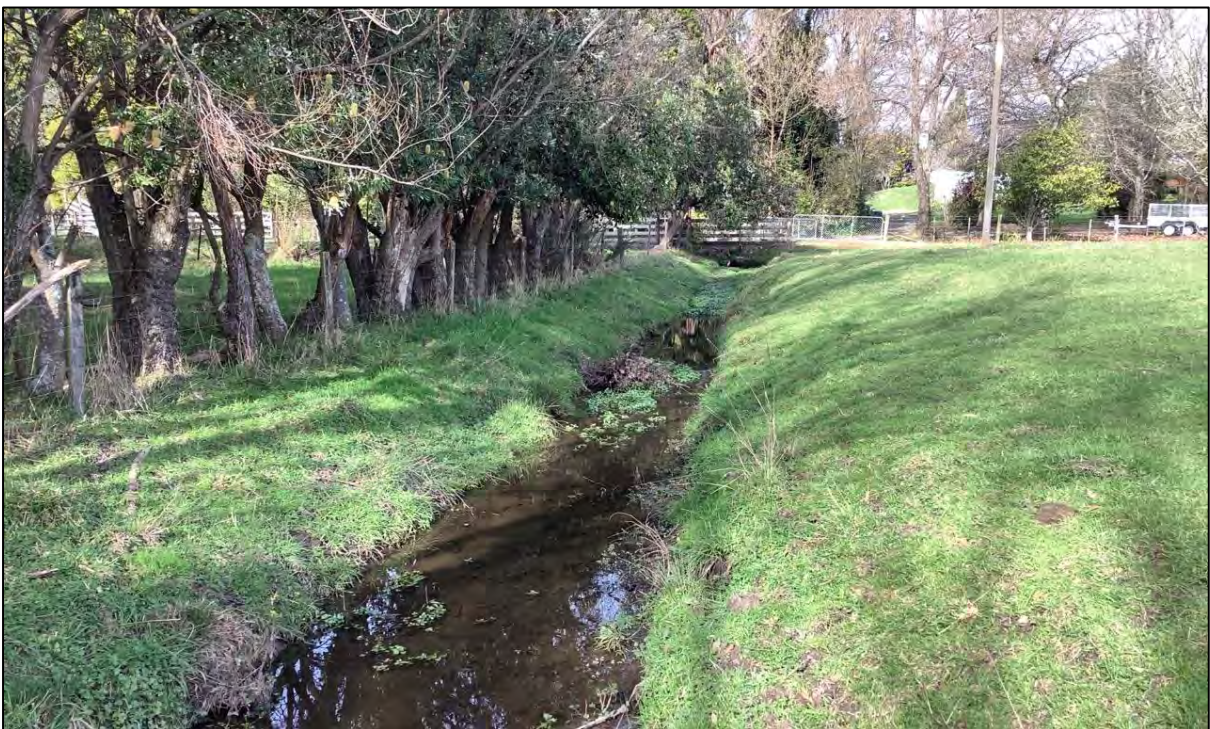
Plate 2. Hedgerow of coastal banksia alongside an artificial watercourse.

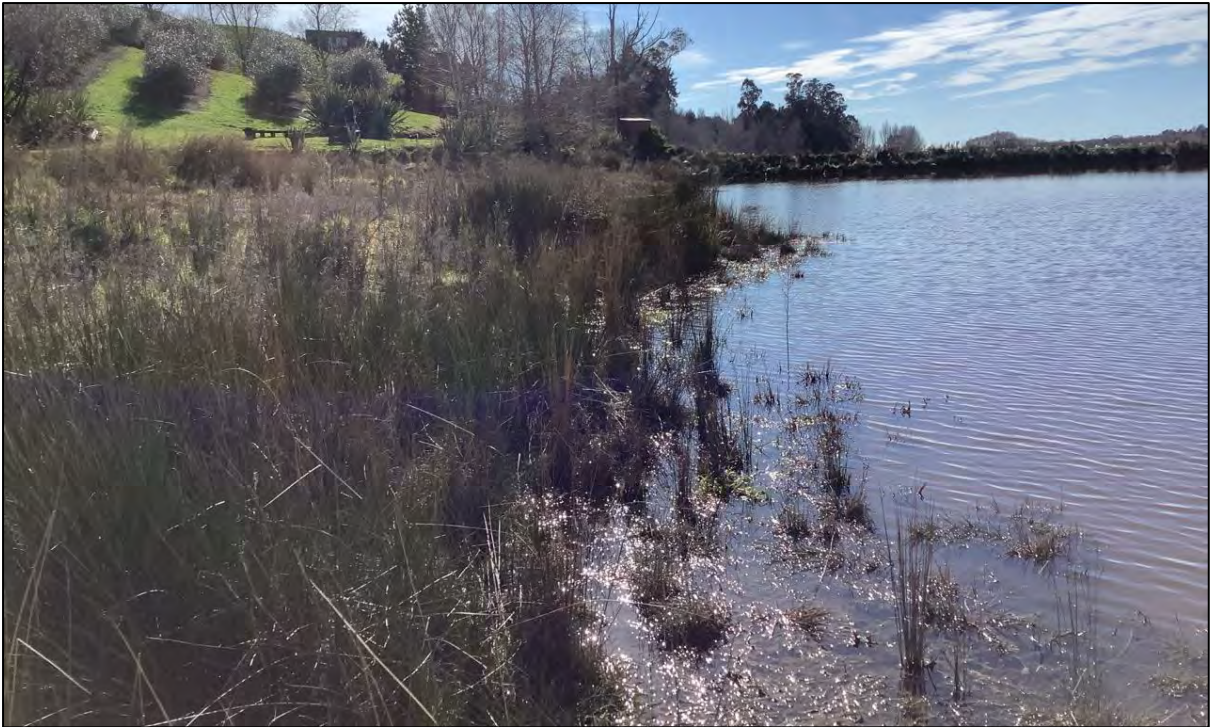
Plate 3. Wetland vegetation alongside the south-western pond that developed following a drop in pond water level. This area offers habitat for waterfowl.

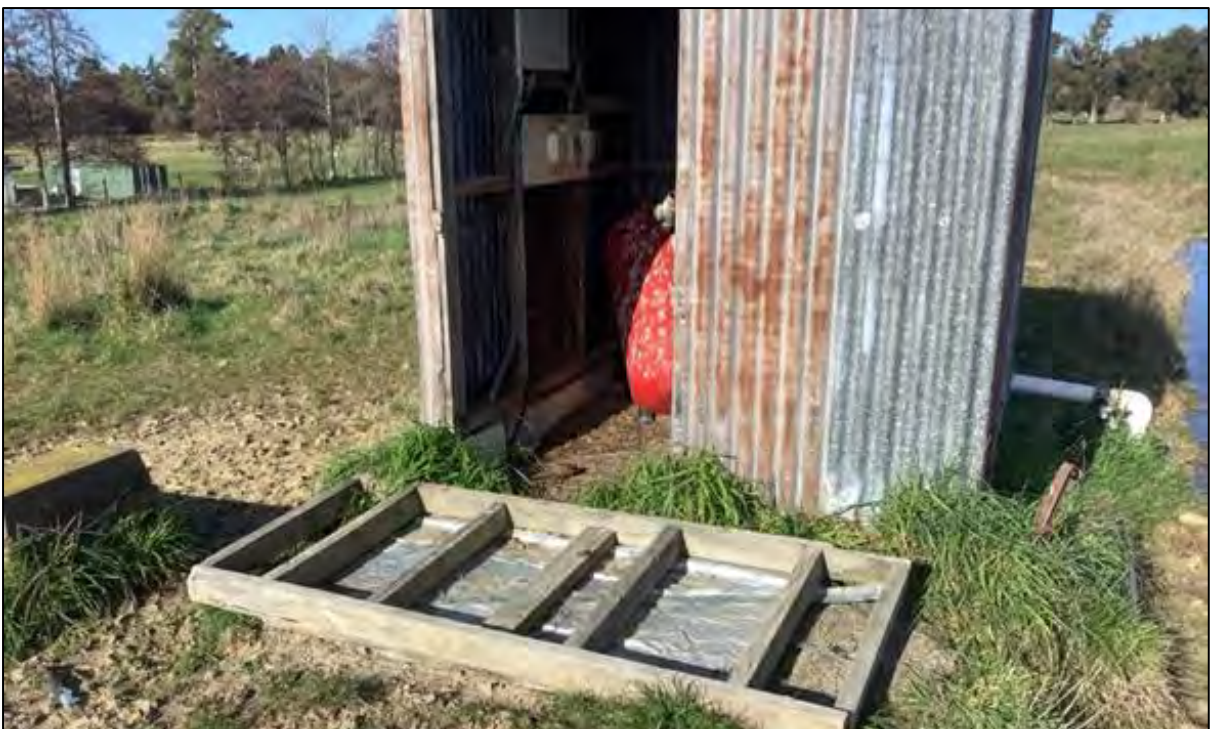
Plate 4. Pump shed where two northern grass skinks were detected.

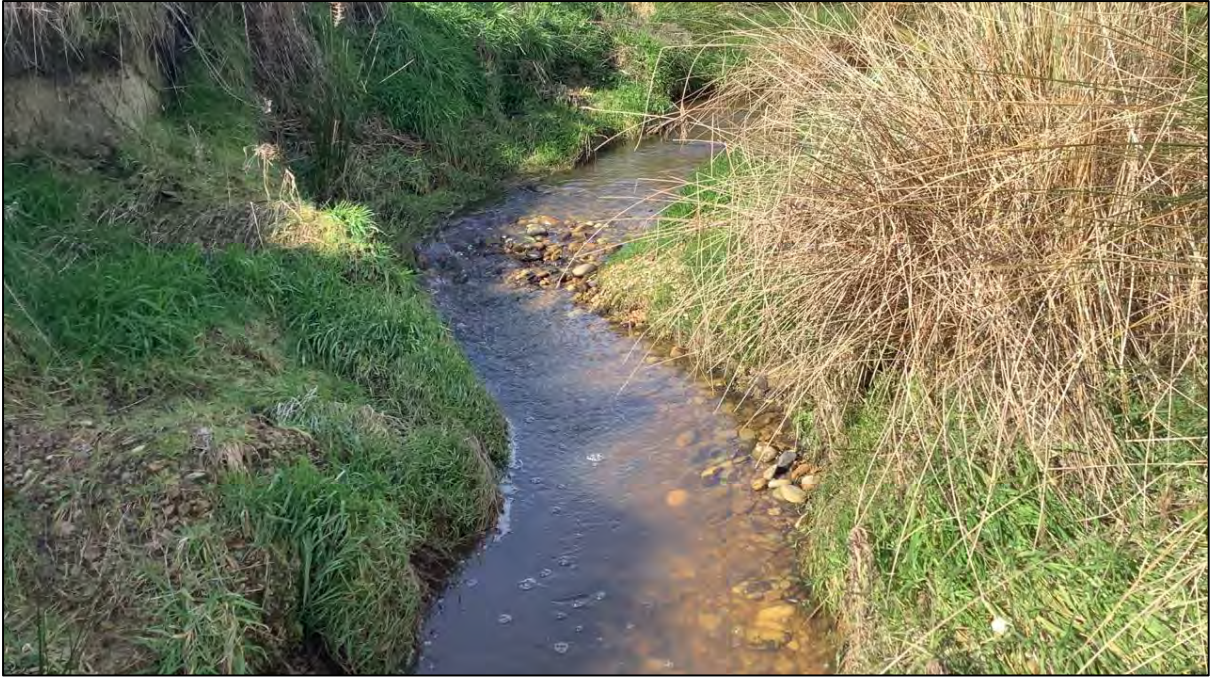
Plate 5. Stream R1.

Some reaches of stream and modified watercourse offer good fish habitat with undercut banks, variable substrate and moderate shading, though most reaches are straightened and incised with poor connectivity to the flood plain. The seven ponds offer good habitat for shortfin eels.

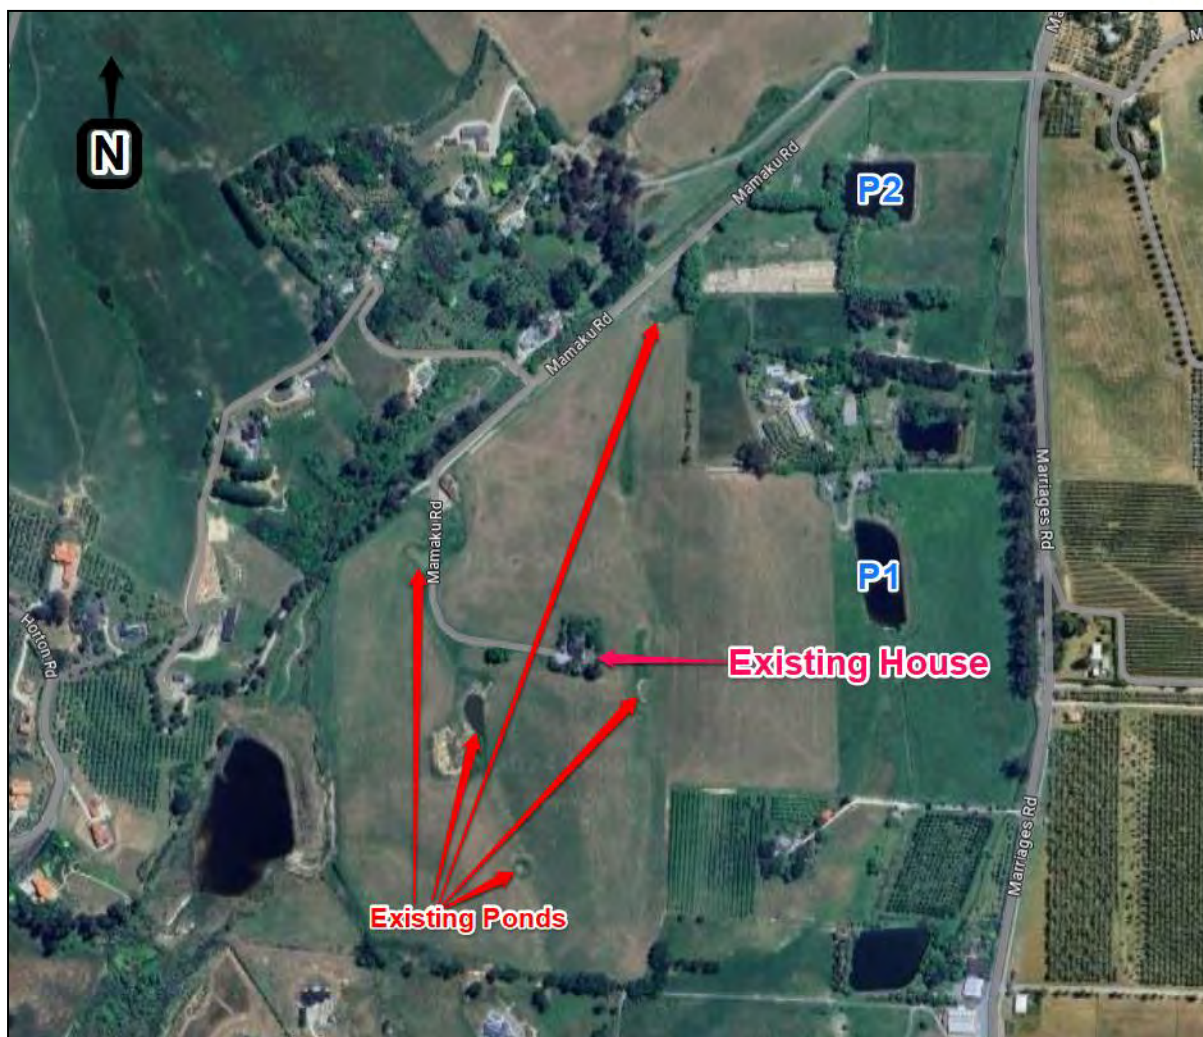
Figure 2: Markup of Google Satellite screenshot showing existing ponds and structure at the site.

The proposed works include the repurposing of two larger existing ponds, referred to as P1 & P2 herein, for stormwater detention. Several smaller ponds are also located throughout the site as shown in Figure 2 below.

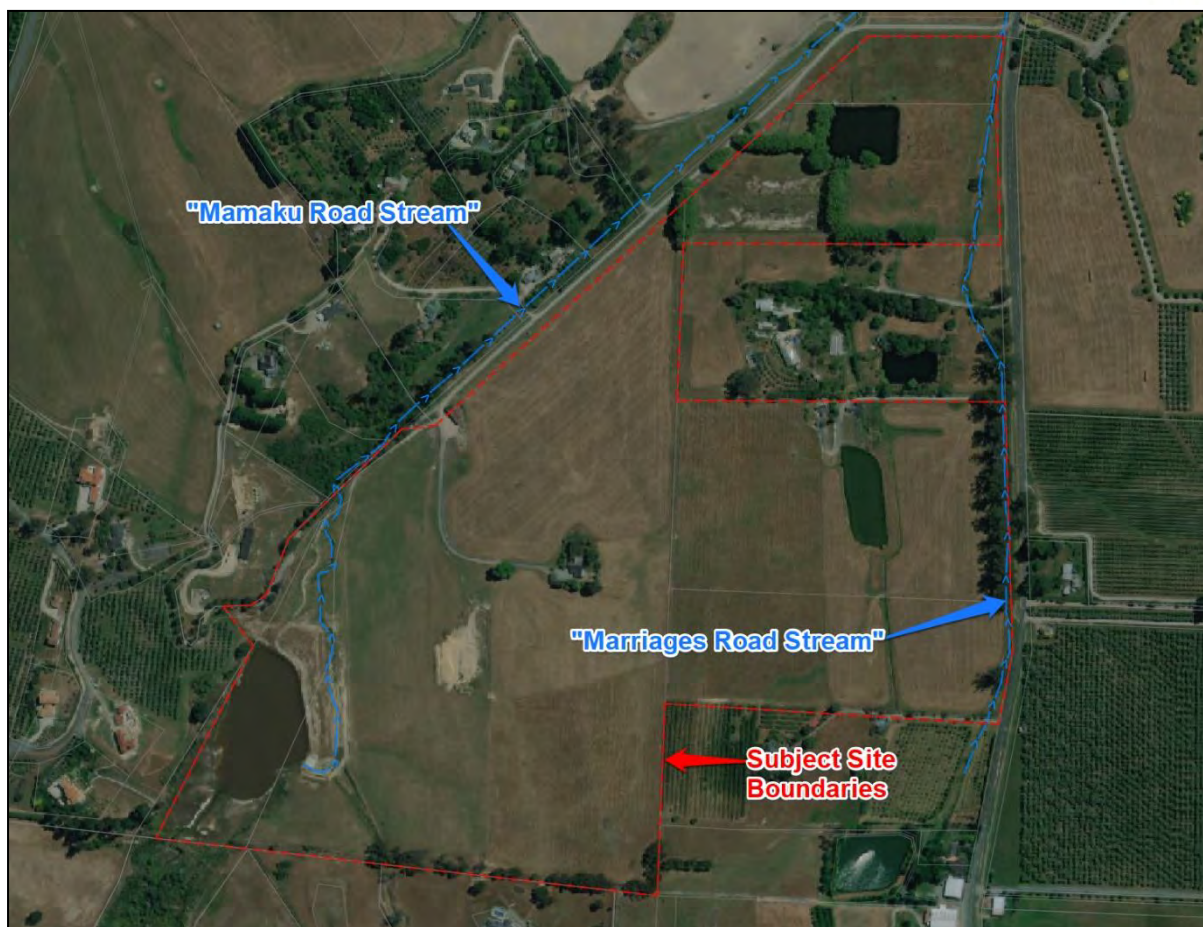
Figure 6: Diagram of "Mamaku Road Stream" & "Marriages Road Stream" alignments.

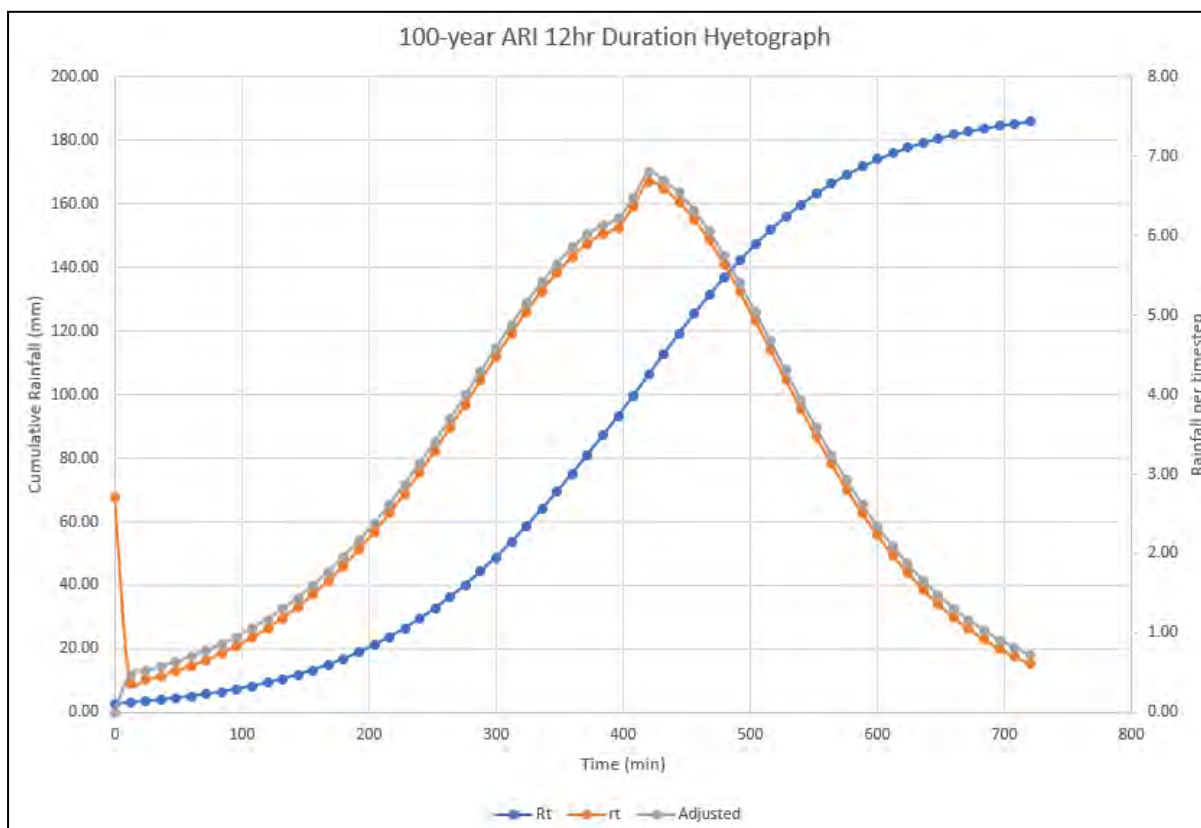
Figure 7: 100-year ARI 12hr Duration HIRDS North of SI Hyetograph.

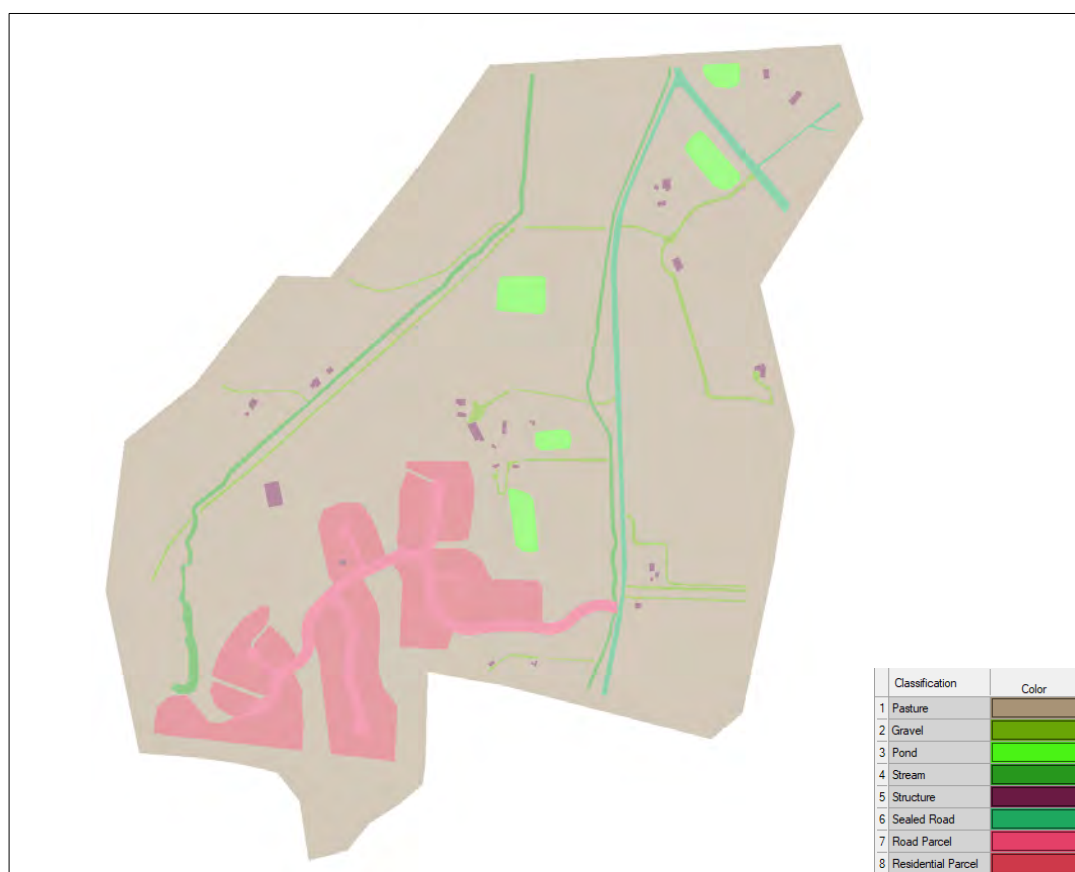
Figure 9: HEC-RAS model Post-Development Land Cover layer.

Surface	Manning's N
Pasture	0.03
Gravel Roding	0.025
Pond	0.035
Structures	0.3
Sealed Road	0.016
Proposed Road Parcel	0.02
Proposed Residential Parcel	0.08

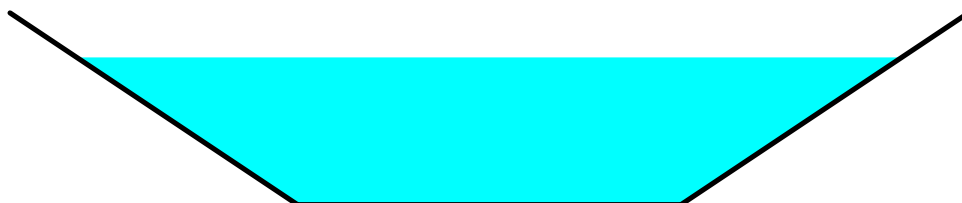
Reach 33R: Cat1 / Cat2 Channels

Peak Storage= 6.1 m³ @ 7.35 hrs
 Average Depth at Peak Storage= 0.38 m
 Bank-Full Depth= 0.50 m Flow Area= 0.88 m², Capacity= 949.11 L/s

1.00 m x 0.50 m deep channel, n= 0.030
 Side Slope Z-value= 1.5 m/m Top Width= 2.50 m
 Length= 10.00 m Slope= 0.0050 m/m
 Inlet Invert= 0.000 m, Outlet Invert= -0.050 m

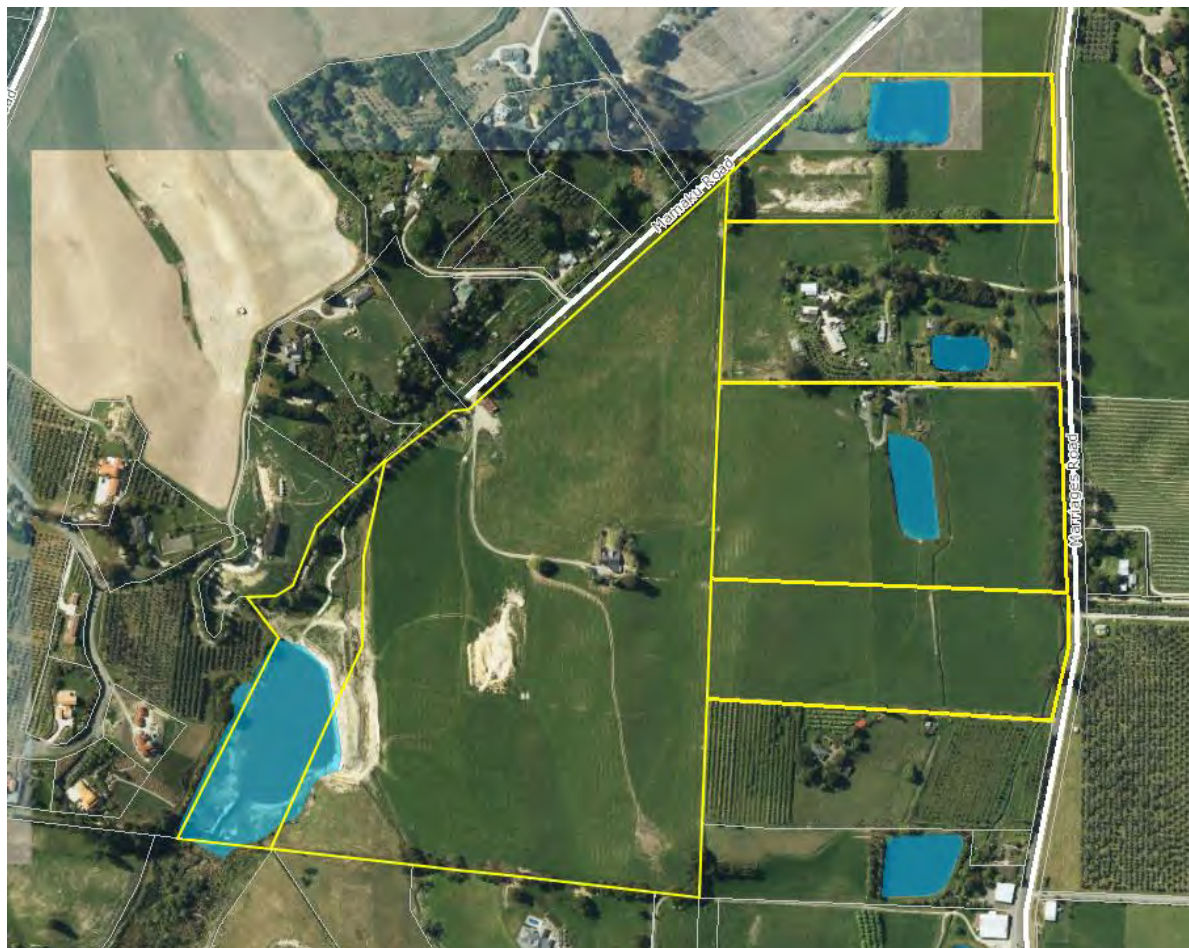
Figure 1.1: Proposed development site (existing site boundaries shown in yellow).

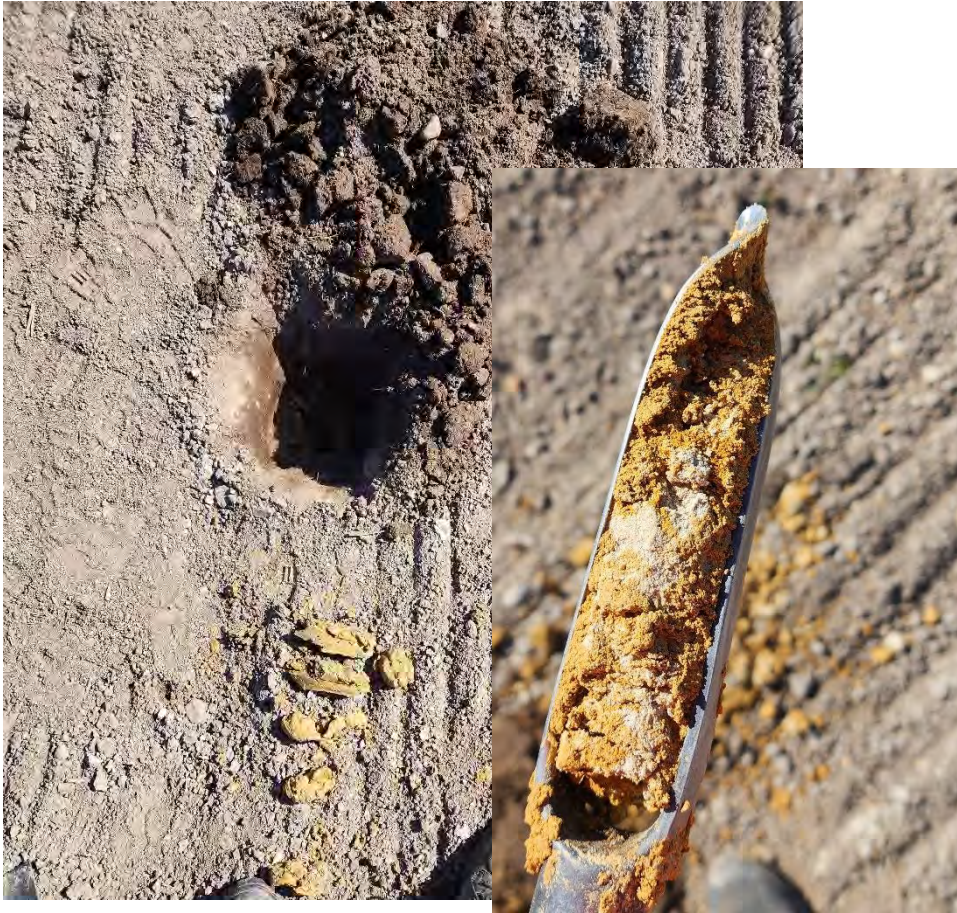
Figure 4.1: Soil Conditions BH1

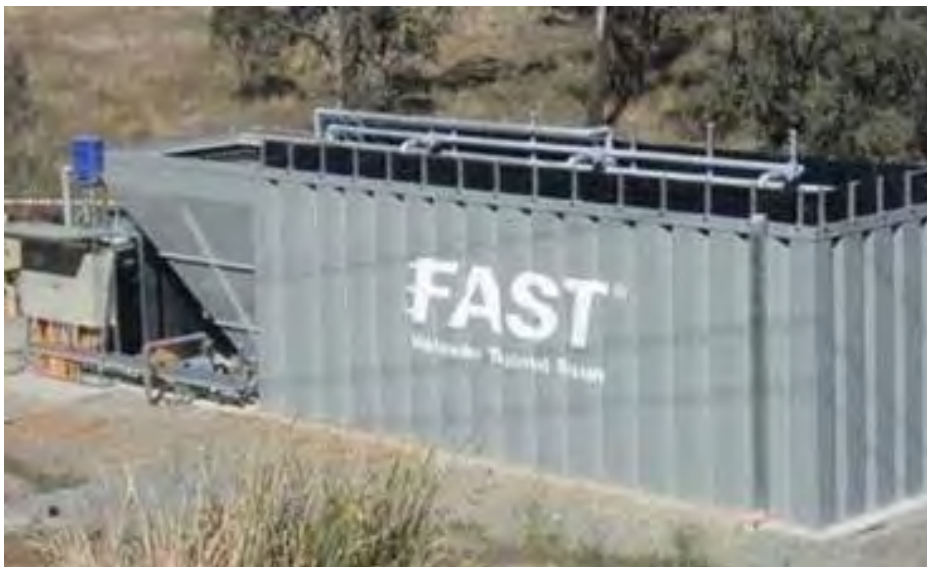
Figure 5.1: Smith and Loveless FAST Plant

- A single dedicated plant to treat the proposed design capacity. This is typically a containerised unit such as a Smith and Loveless “Fixed Activated Sludge Treatment” (FAST) plant, shown in Figure 5.1 below. OR
- A modular onsite wastewater plant consisting of several modules installed in parallel to provide the required treatment capacity such as the Innoflow AX100 modules shown in Figure 5.2 below. These are typically installed below ground.

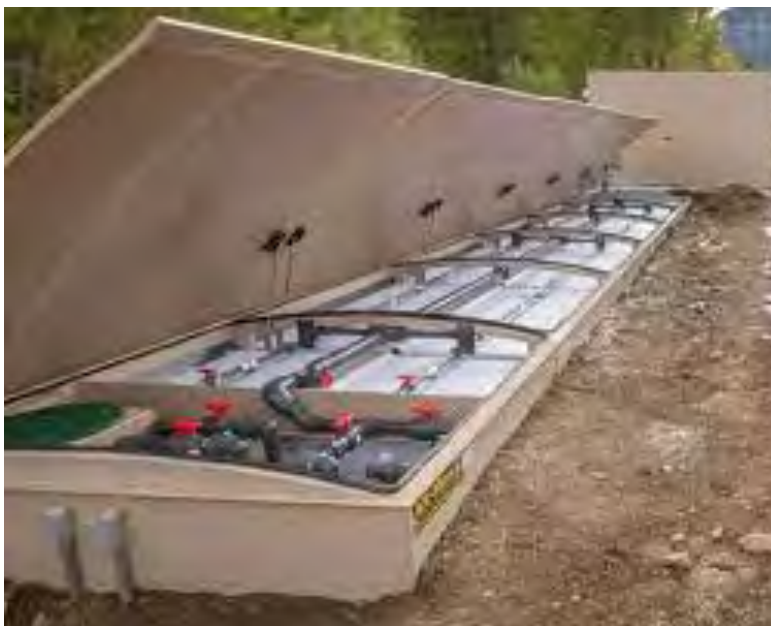
Figure 5.2: Innoflow AX100 Modules

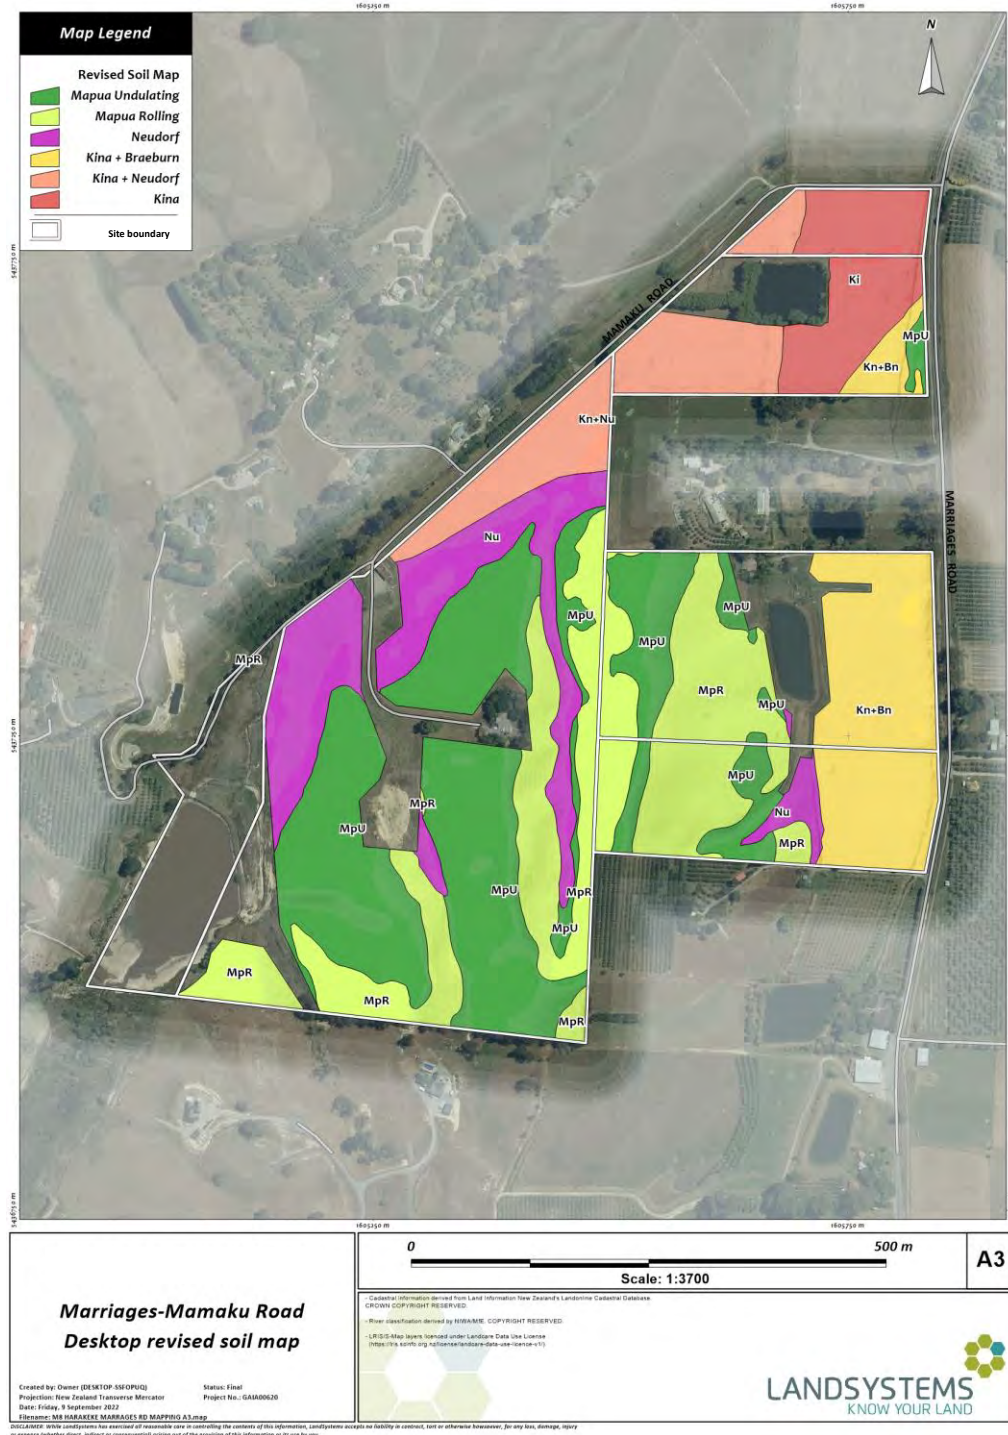
Figure 3. Desktop revised soil map units for the Marriages-Mamaku Road site.

The revised soil map for the Marriages-Mamaku Road site is shown in **Figure 3**.

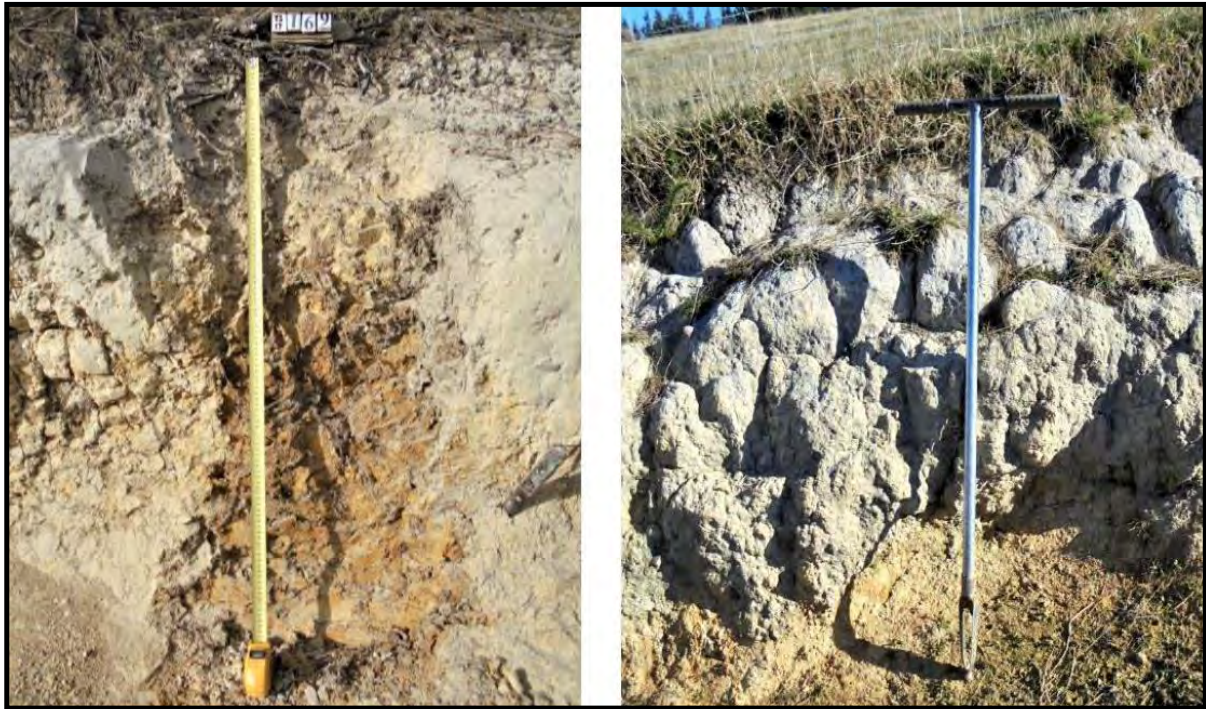
Figure 4. Example soil profiles of the Mapua soils (from Campbell, 2018).

The properties of the Mapua soils vary across the landscape. Topsoil thickness ranges between 9 cm to 25 cm due to erosion and over-thickening from down slope sediment movement. The intensity of mottling also varies across the landscape, mainly relating to topographic

differences, however, this only occasionally results in a change in the soil drainage class. The depth to underlying weathered Moutere Gravels varies between 40 cm and 110 cm, with the effective rooting depth varying by the same range. Indicative soil profiles for the Mapua soils are provided in **Figure 4**.

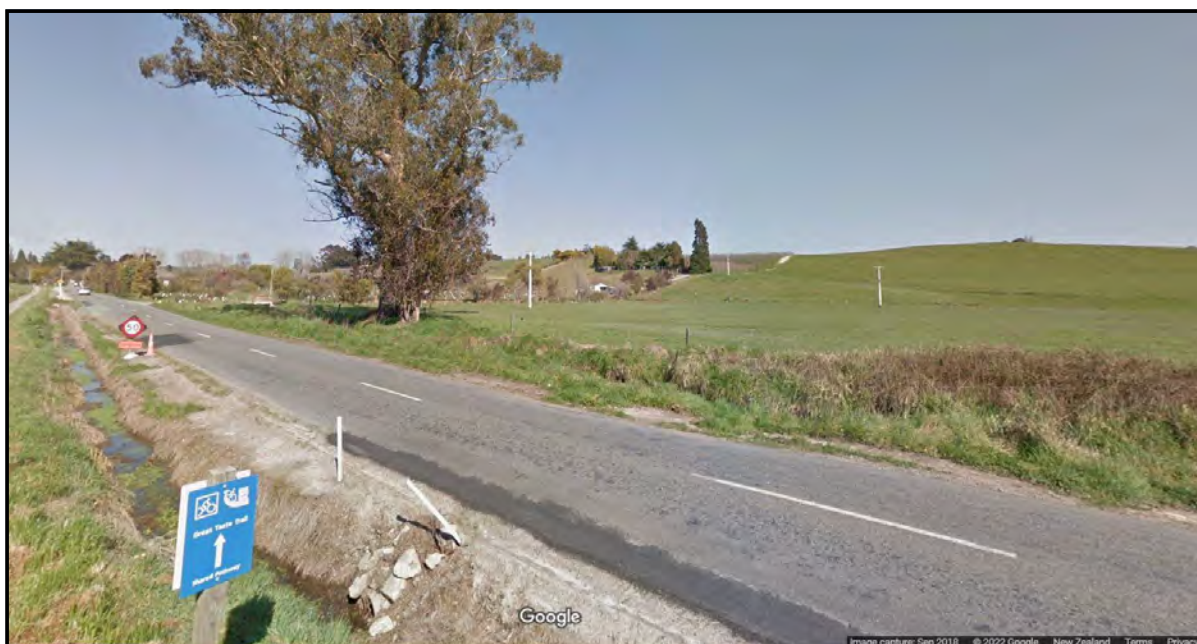
Figure 6. A view of the Kina and Braeburn soil map unit on the Marriages-Mamaku Road site with flat to gently undulating topography shows the high winter water table and pale subsoil colours indicative of the poor drainage (image from Google Maps street view).

Braeburn soils were not identified by Campbell (2014). Although mapped in association with Kina soils by Campbell (2018) and shown in Figure 3, they are a sub-dominant soil within the soil map unit. Given their occurrence with the poorly drained Kina soils, they are most likely to be clay loam textured and have imperfect drainage. A view of the Kina and Braeburn soil map unit on the Marriages-Mamaku Road site (Marriages Road) with flat to gently undulating topography shows the high winter water table (August 2018) and pale subsoil colours indicative of the poor drainage (**Figure 6**).

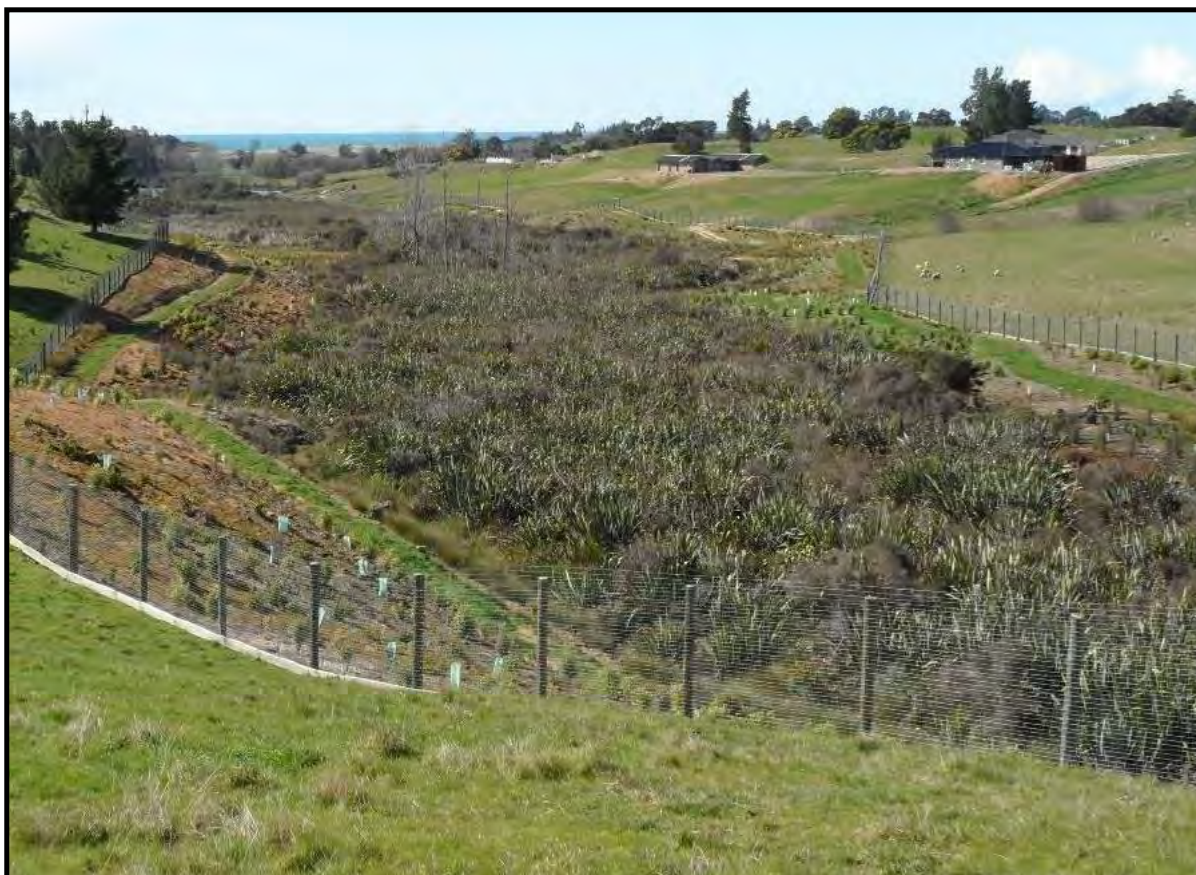
Figure 7. An indicative example of the topographic position of the poorly drained Kina soil on the valley floor (from Campbell, 2018).

These soils have formed on alluvium derived from weathering and erosion of Moutere Gravel materials and the Mapua soils. The Kina soils on the Marriages-Mamaku Road site occur on flat to slightly undulating land (slopes between 0° and 3°) and are poorly drained with a near surface water table evident in wetter months (Campbell (2014)). Below the topsoil, Braeburn X soils are characterised by predominantly white to grey subsoil colours resulting from prolonged reducing conditions. Reddish coloured mottles at variable depths and sometimes with dark brown concretions forming an indistinct iron pan may be present. The soils vary considerably with buried topsoils present and textural variation in places indicating additions of alluvium from flooding events. An indicative example of the topographic position of the poorly drained Kina soil on the valley floor is shown in **Figure 7**.

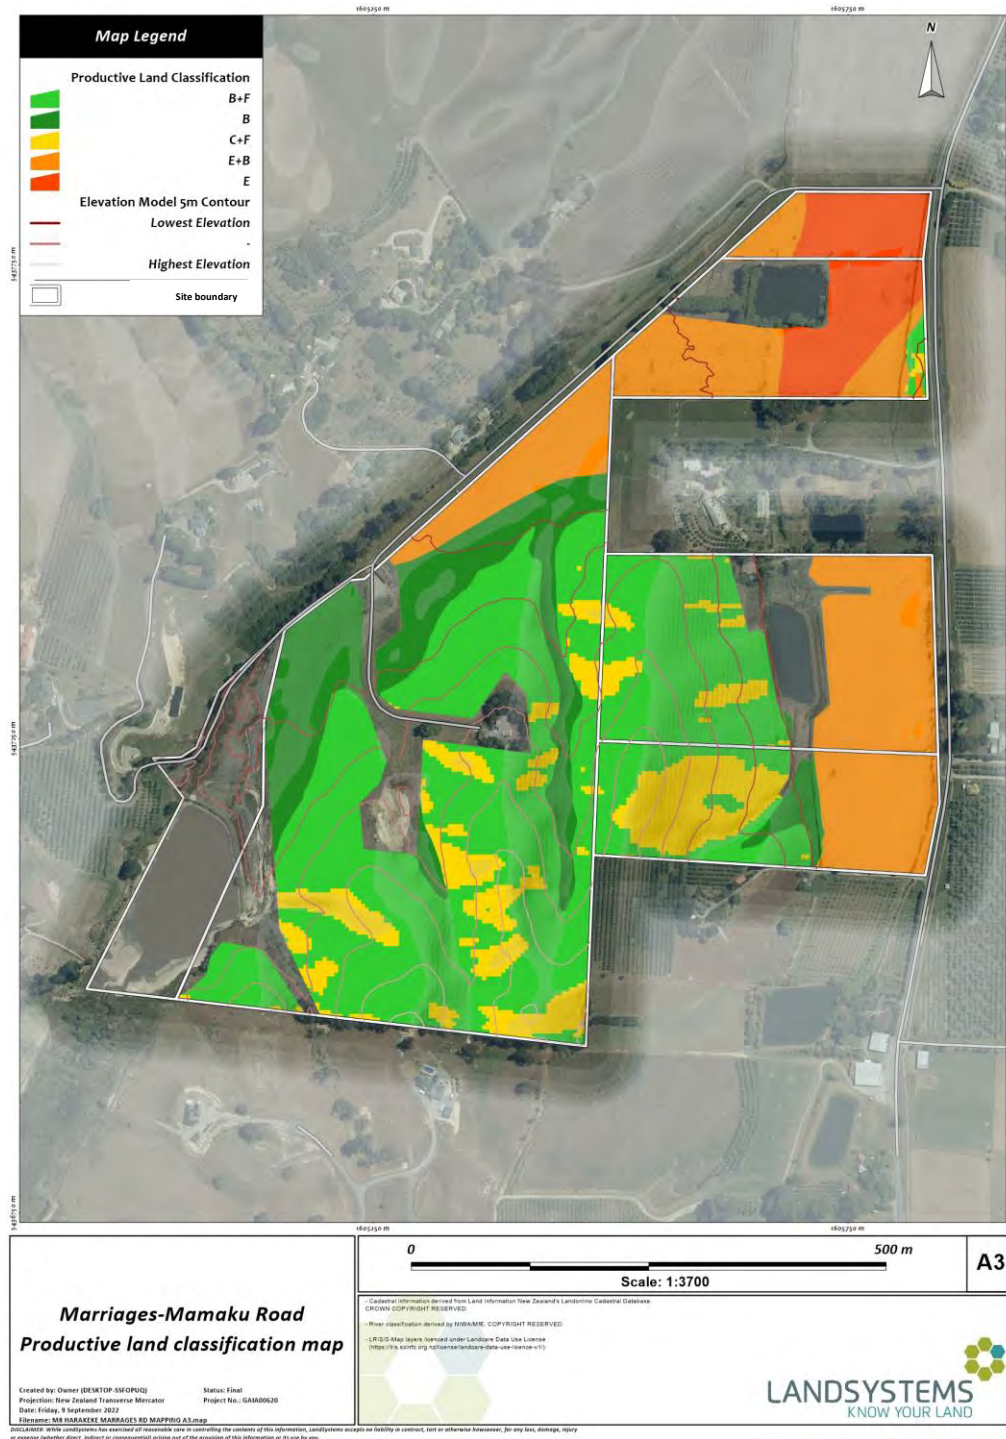
Figure 10. PLC classification classes for the Marriages-Mamaku Road site.

Kina + Neudorf (Kn+Nu)	≤15	Not applicable (gentle slope)	≥0.6	Poorly drained	E	E+B	Predominantly ≤3 degree slopes; dominant PLC class (E) noted first - Kina is the dominant soil in the map unit.
				Imperfectly drained	B		
Kina + Braeburn (Kn+Bn)	≤3	Not applicable (gentle slope)	≥0.6	Poorly drained	E	E+B	Dominant PLC class (E) noted first - Kina is the dominant soil in the map unit.
				Imperfectly to moderately well drained	B		
Kina (Kn)	≤3	Not applicable (gentle slope)	≥0.6	Poorly drained	E	E	Poor soil drainage.

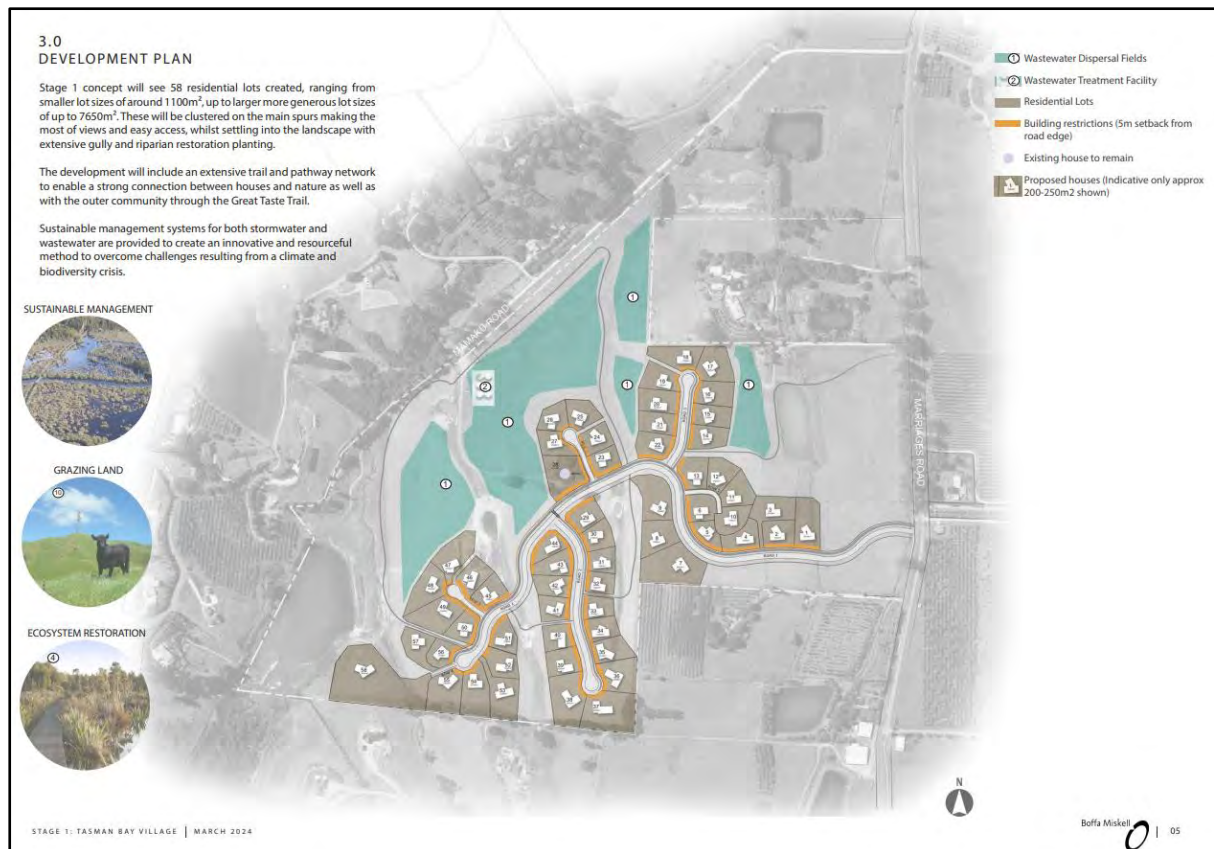
Figure 12. Proposed location of the wastewater areas on the Marriages-Mamaku Road site (wastewater areas shown in green).

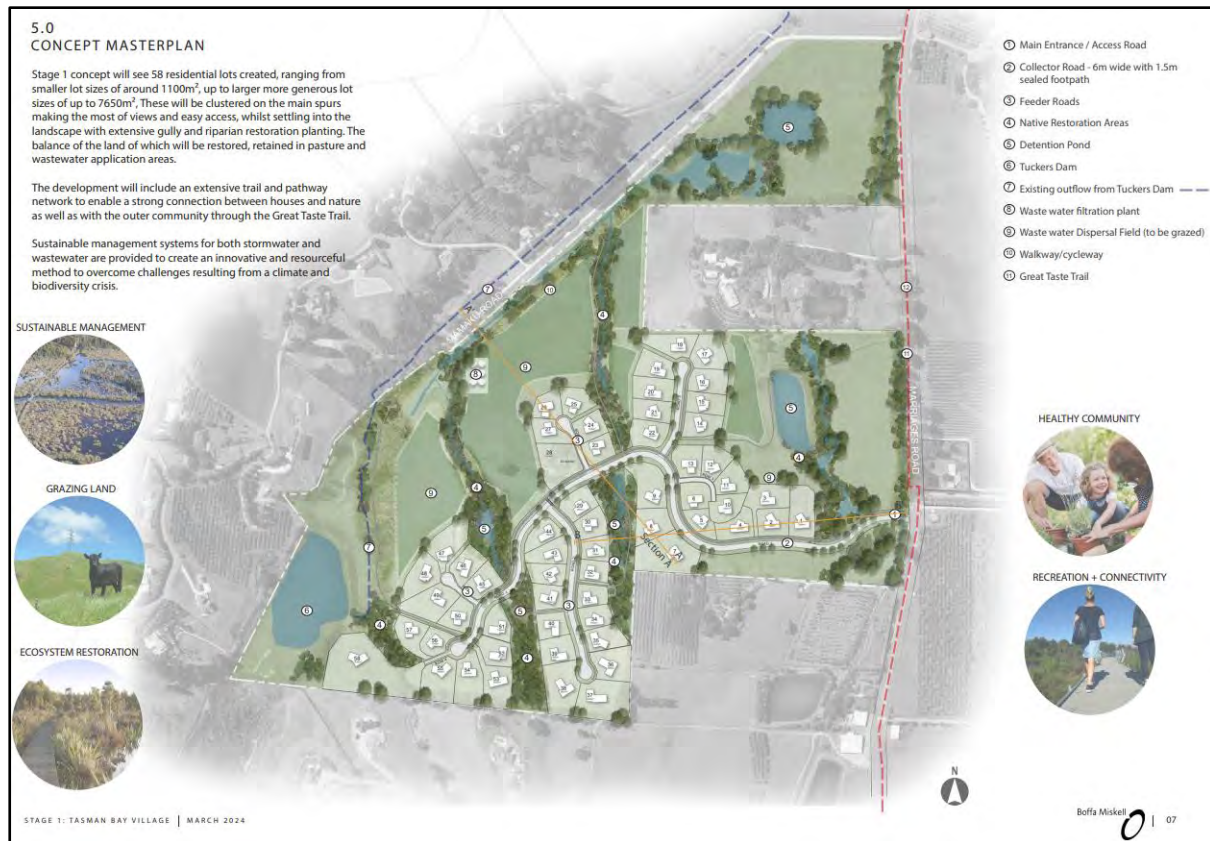
Figure 13. Concept masterplan for Stage 1: Tasman Bay Village showing enhanced riparian areas and a detention pond, Marriages-Mamaku Road site.
