Tasman Bay Village

Ecological Effects Assessment

Stormwater Report

Harakeke Ltd Development Cultural Impact Assessment

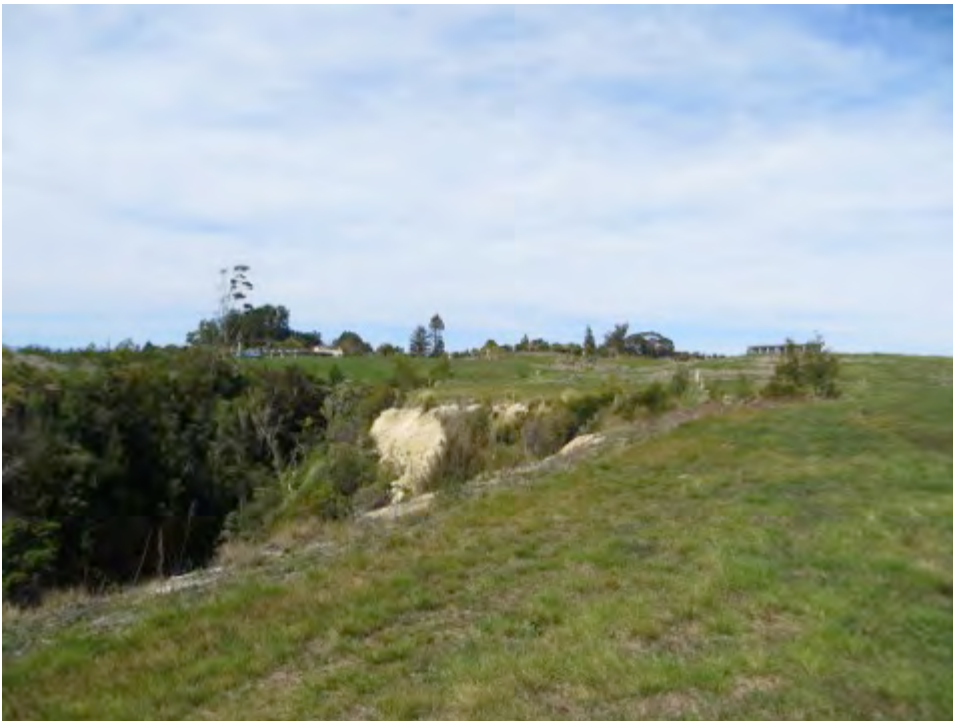
Figure 7: The edge of the Moutere Bluffs (looking south; taken from just north of Te Pa Pa).

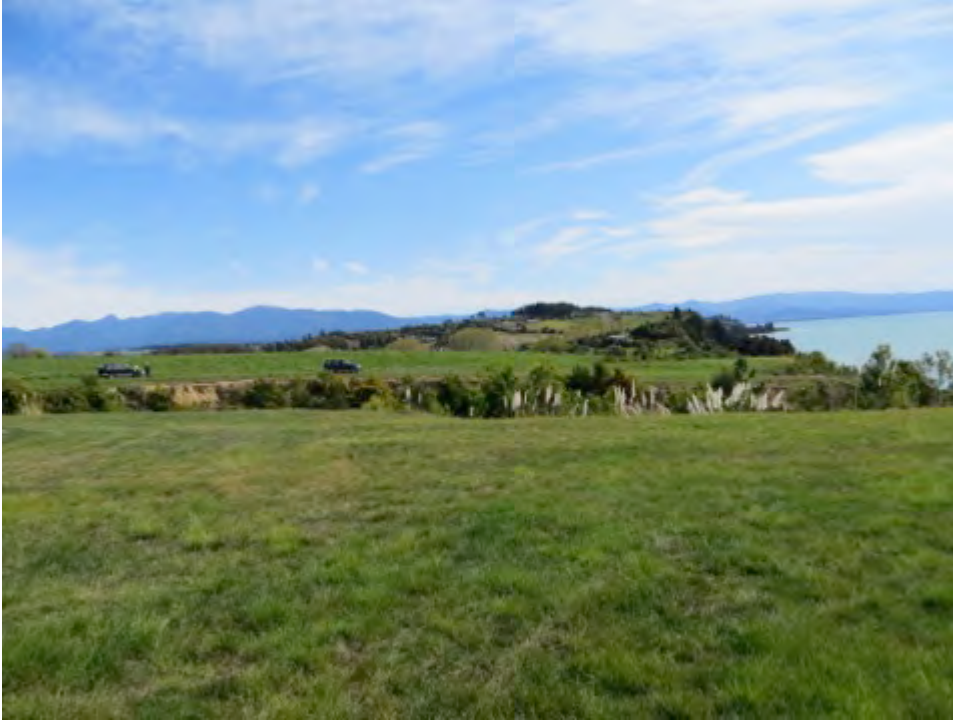
Figure 8: The edge of the Moutere Bluffs (looking north).

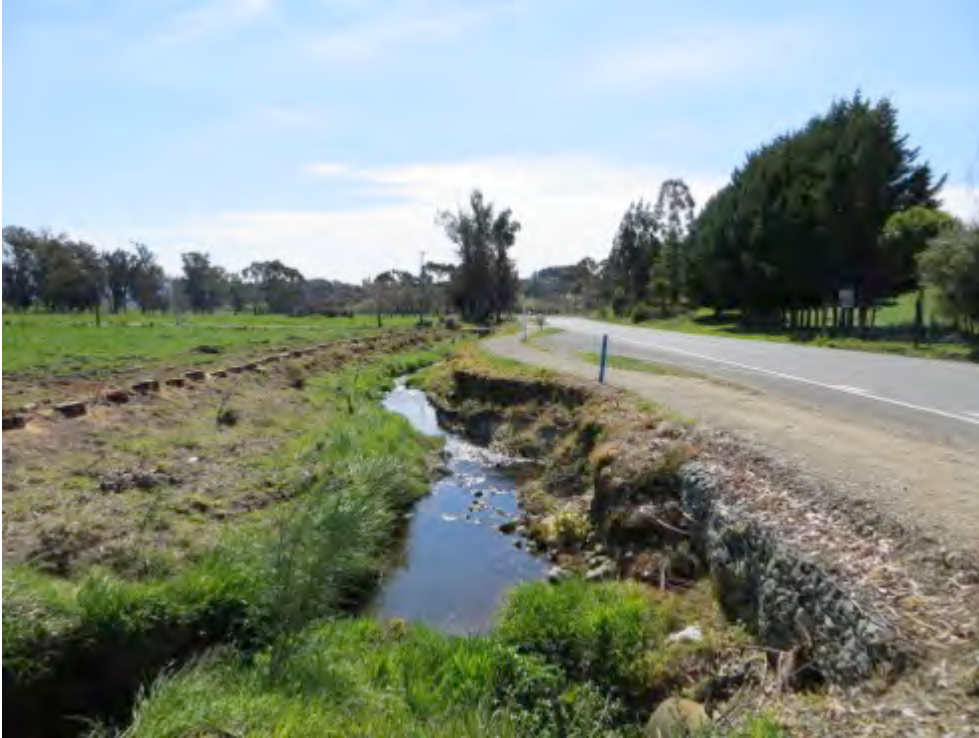
Figure 9: Aporo Stream next to Aporo Road (2014).

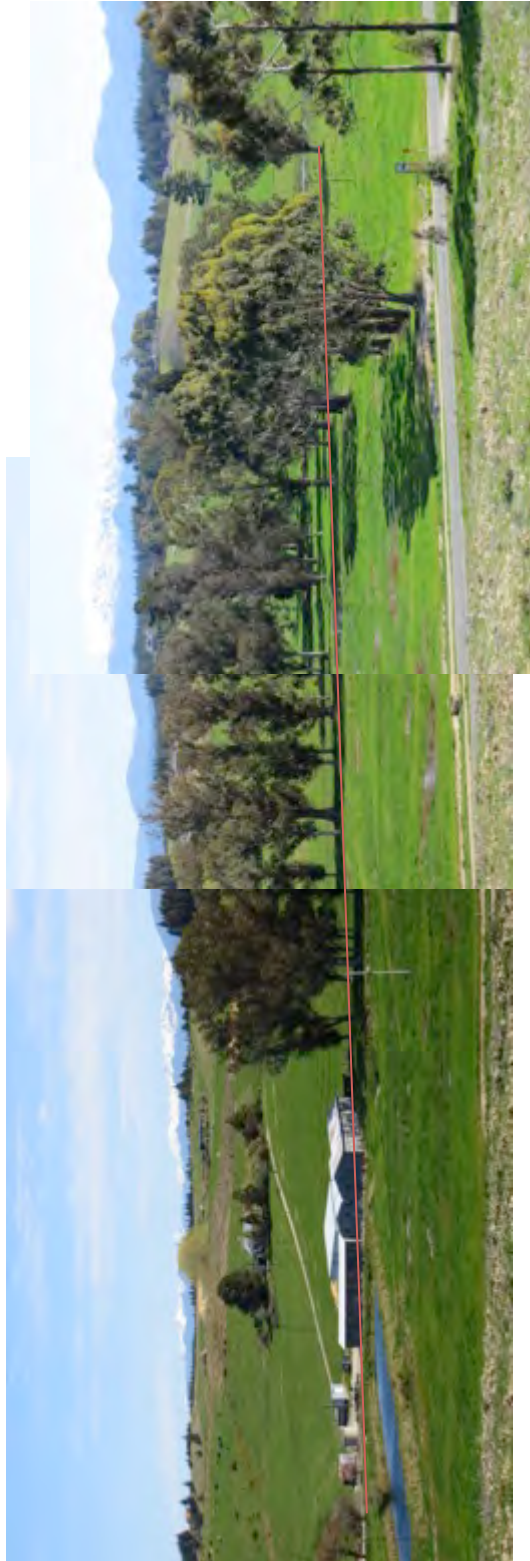
Figure 10: Panorama of the western part of the Harakeke 2015 Ltd property from the eastern side of Aporo Road. The first photographs show the earthworked land on the eastern side of the property in the foreground. The last section has the line of the historic drain crossing mid photograph from left to right (shown in red).

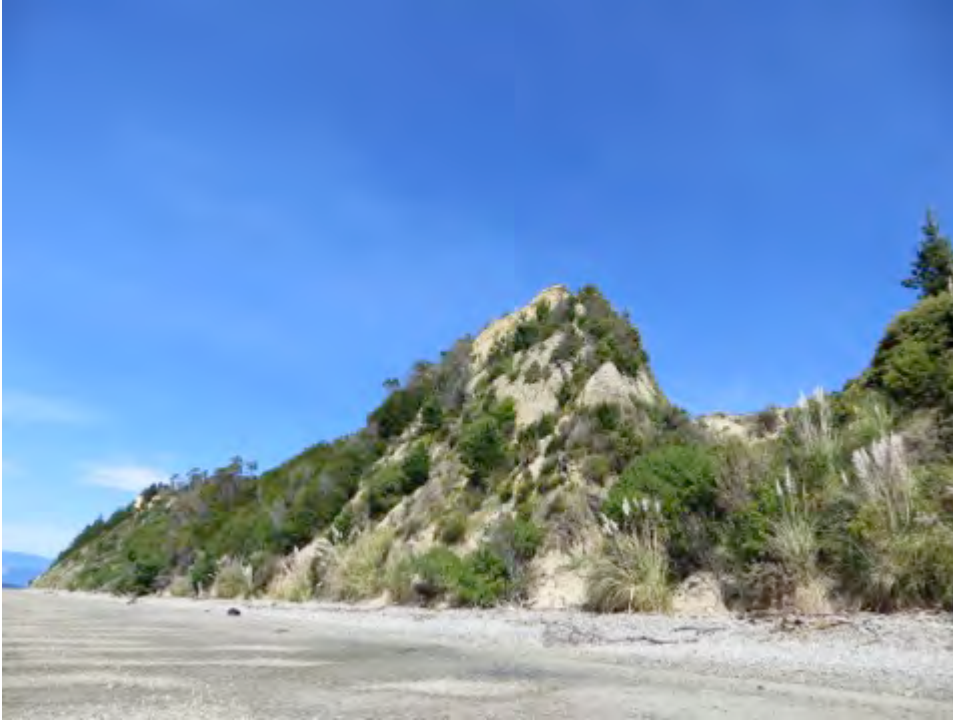
Figure 11: Te Pa Pa from the beach (2014).

Te Pa Pa was inspected. It is a beautifully preserved small, cliff top defence. Contrary to local gossip, the pa was not damaged during the 2002 removal of pines from within the defences nor by the recent Cherry Hills subdivision. The defensive ditch is still as recorded by Challis in the 1970s with some additional natural infilling and erosion. The internal features are no longer visible due to the ground cover but it is expected that they are also the same as recorded. There has been recent hand clearance of vegetation including the removal of wilding pines. Mr Dwyer confirmed that no machinery has been on the site. He is aware of that prohibition and has made it clear to his staff and contractors.

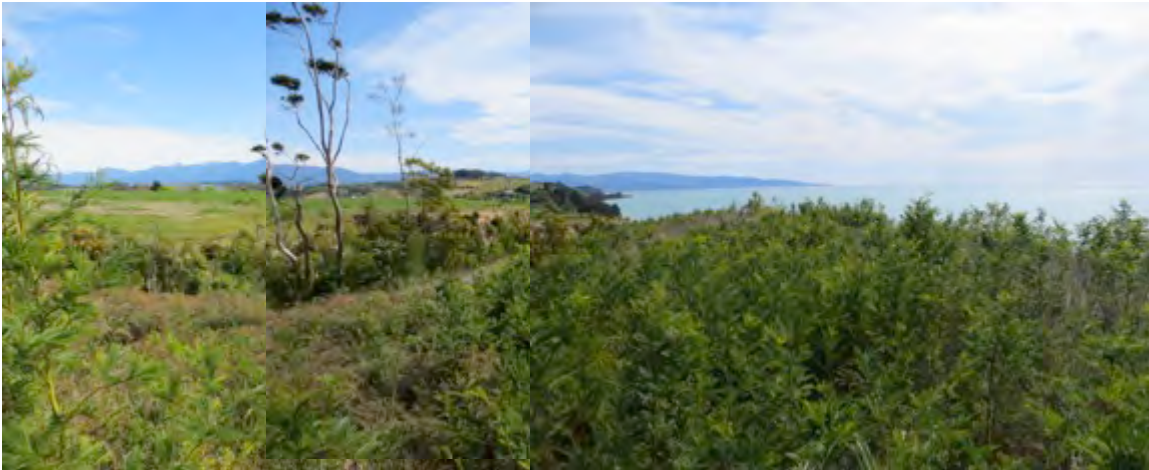
Figure 12: The interior of Te Pa Pa (2014).

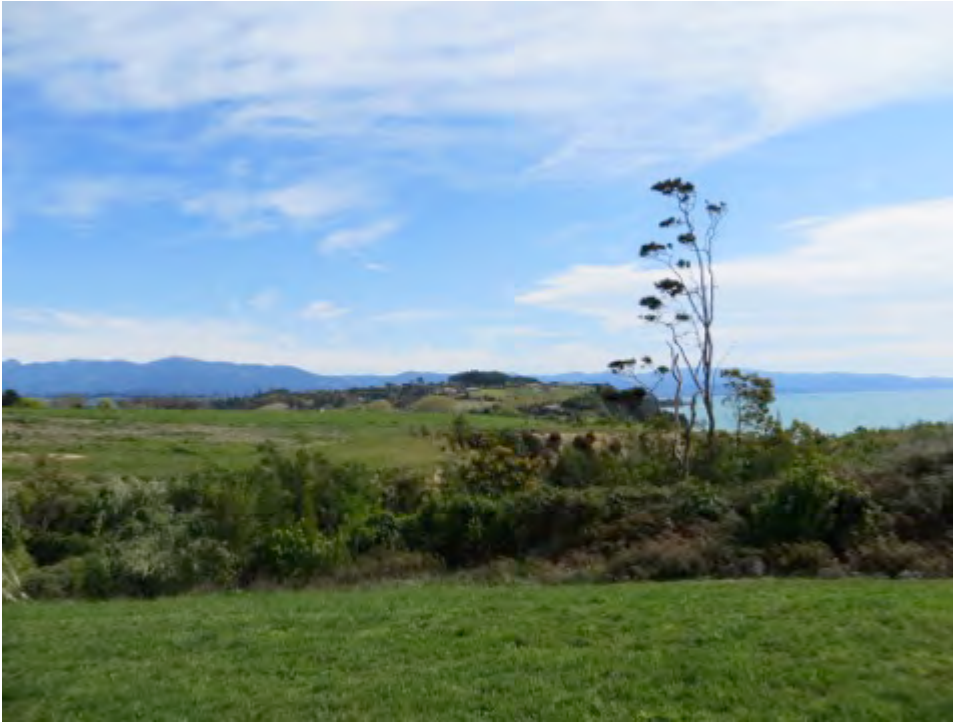
Figure 13: The ditch and bank from the southern side of the pa (2014).

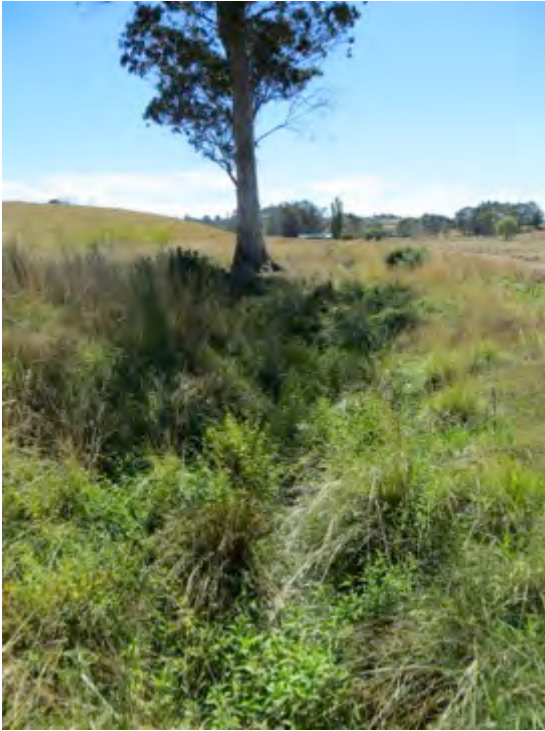
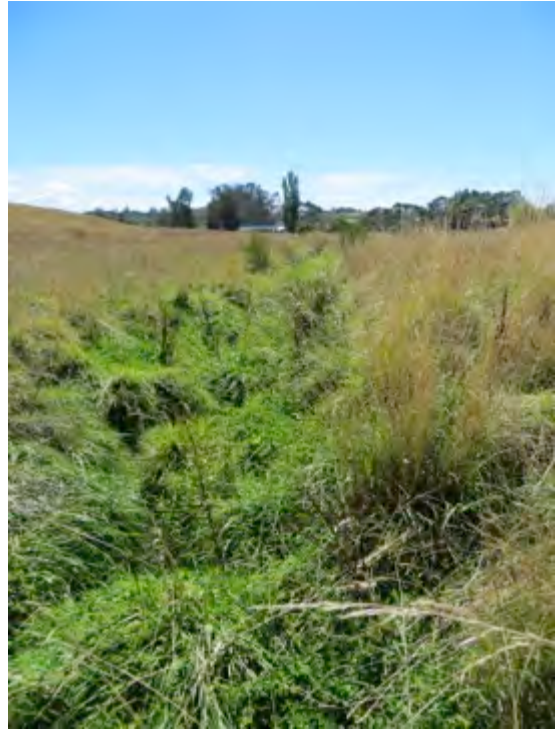
The historic drainage system that flows across the Harakeke 2015 Ltd property is still predominantly intact as a functional watercourse. The Mamaku Stream / Drain flows alongside Mamaku Road. A tributary diverts north following the route of the historic drain. The drain has a “U” shaped profile and is about 1 m wide at the base and 1.5 m to 2 m deep. It flows along the toe of the hill and to the east of the farm buildings. The historic plan shows the Mamaku Drain joining up with Aporo Stream before becoming one channel called the Arterial Drain. This area has been recently been re-contoured and root raked. The channels have been reconfigured and the area has no resemblance to the historic plan.

Figure 14: The drain to the north of Mamaku Road (looking north). March 2015.

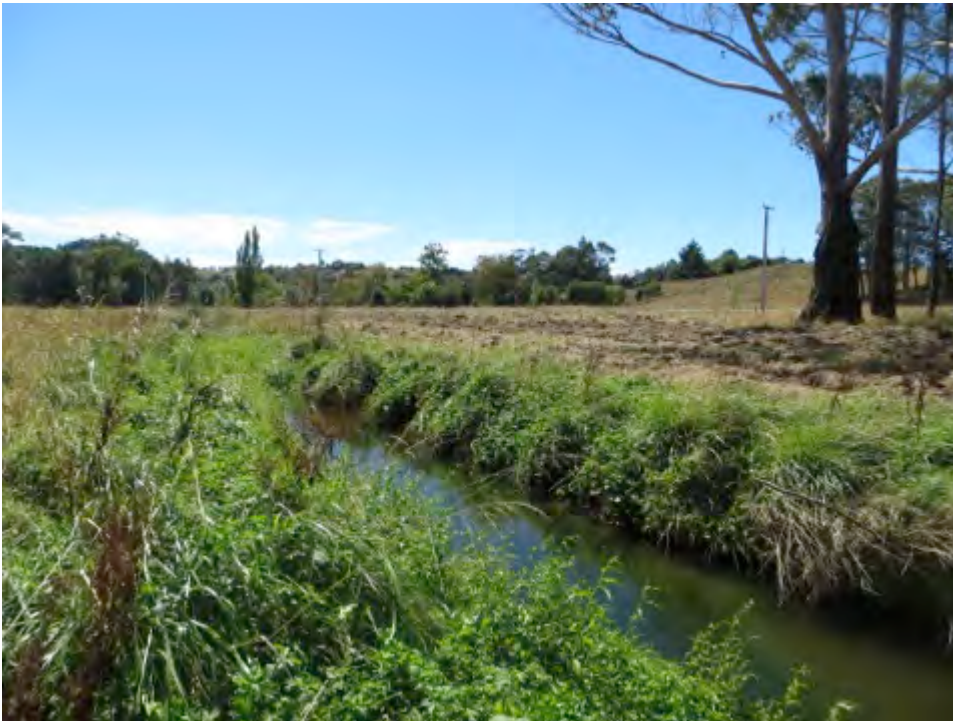
Figure 15: The Mamaku Drain north of the farm buildings and south of the confluence with Aporo Stream. March 2015.

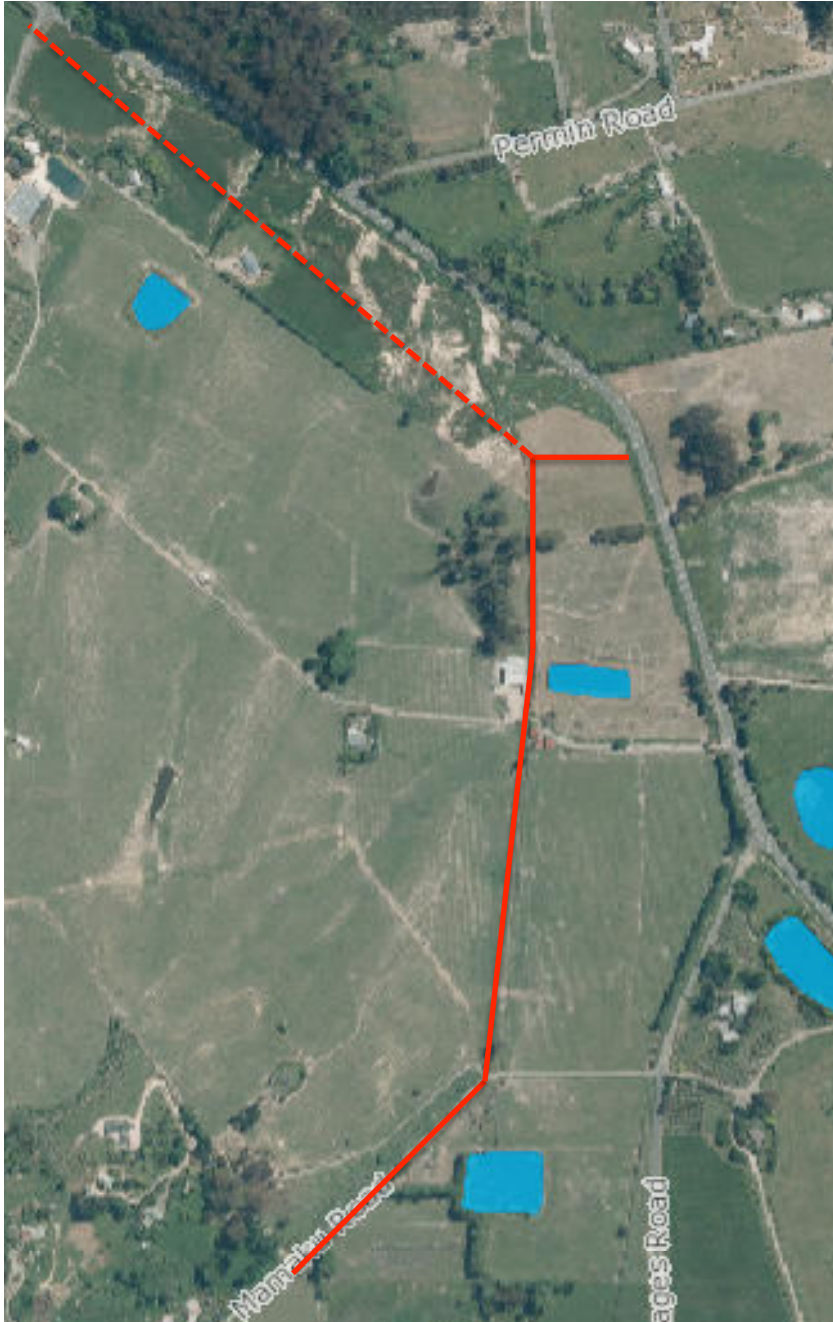
Figure 17: 2013 image with the approximate line of the historic drains superimposed. The solid line signifies drain is present (although in a modified form), and the dotted line is where the drain is missing.

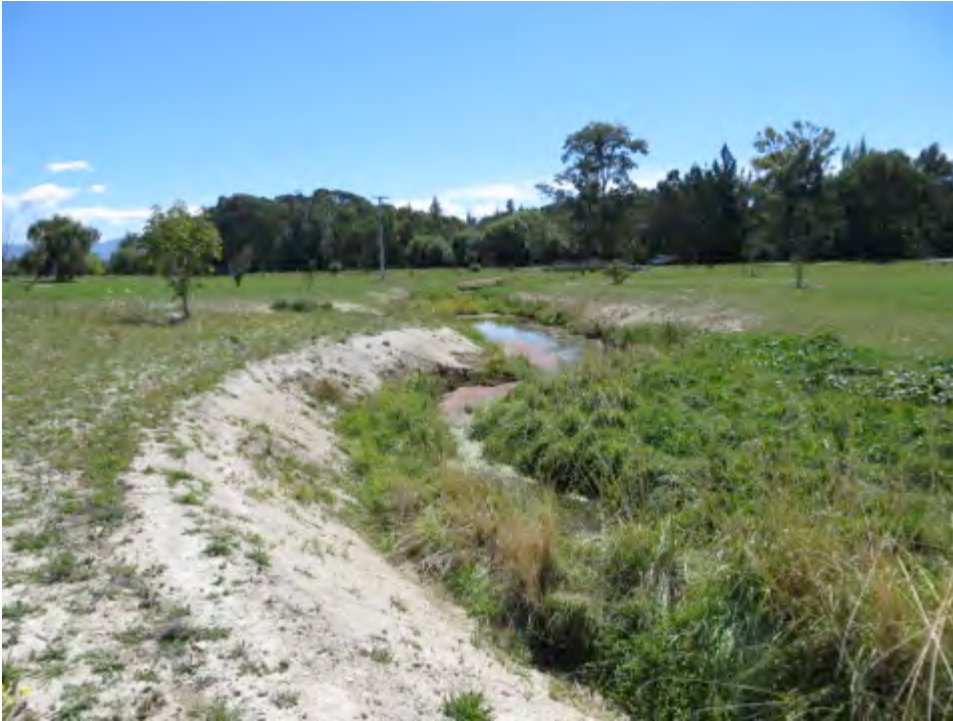
Figure 16: Aporo Stream in the area where the Arterial Drain used to flow.

The recently root raked and re-contoured area next to Aporo Stream was briefly walked through. The stream banks were checked (some areas were obscured by vegetation). No archaeological material was found.

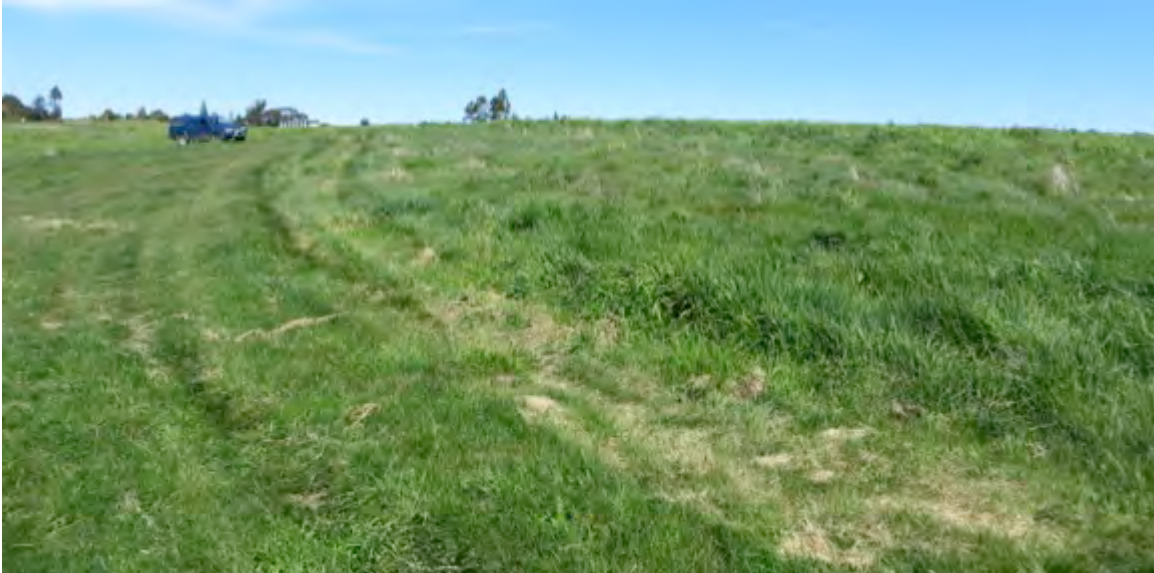
Figure 17: Damage from disking along the top of the Moutere Bluffs (2014).

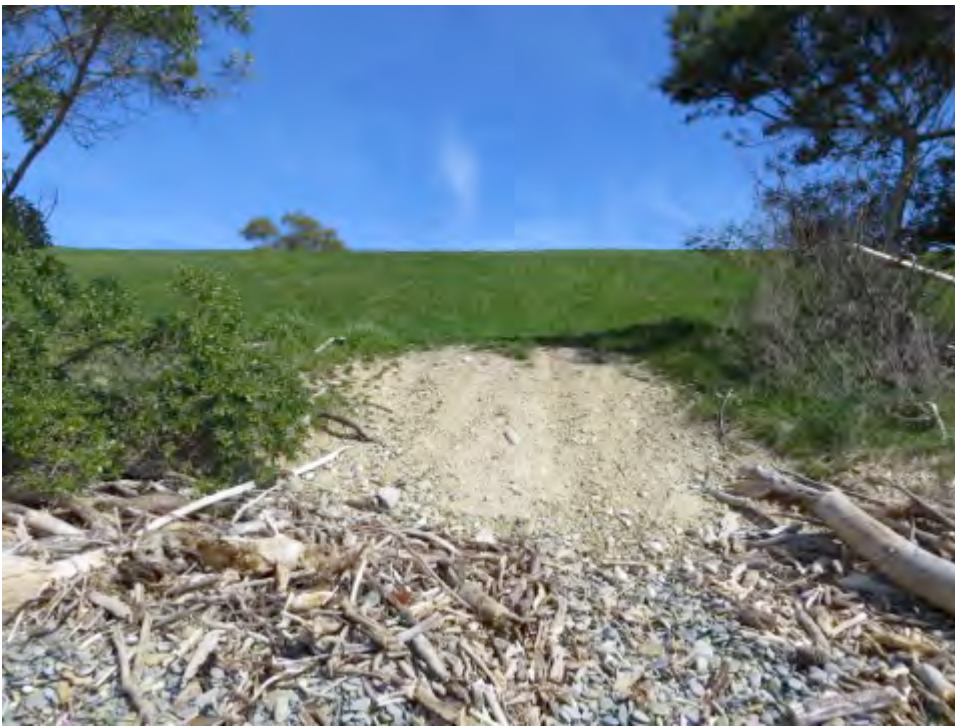
Figure 18: The area of Moutere Bluffs that have been lowered in ca.2002.

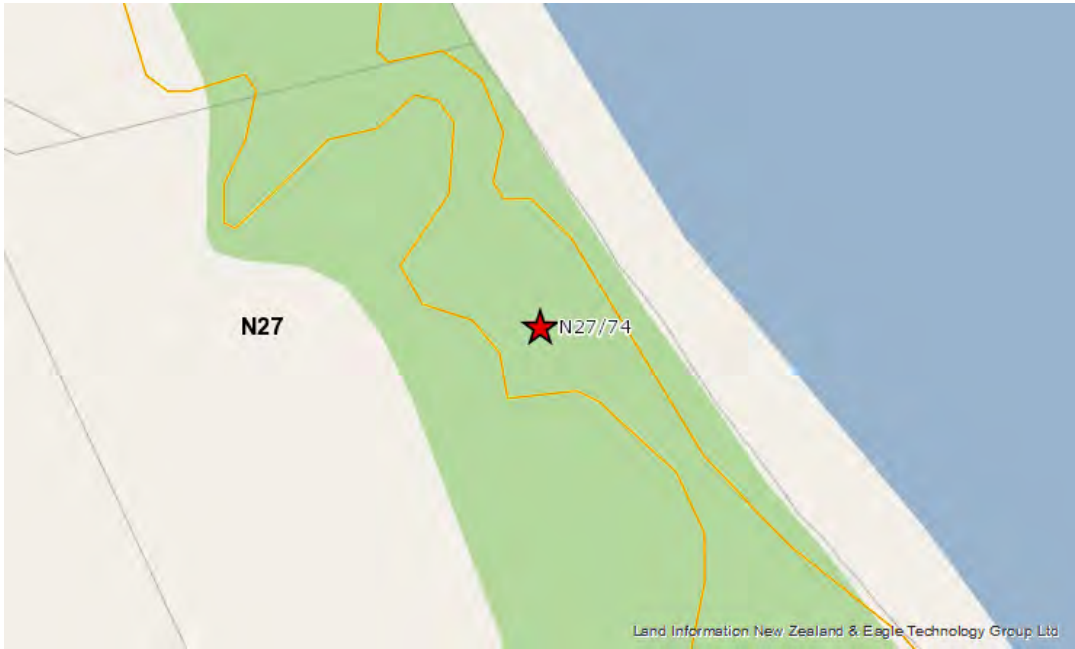
<p>Finding aids to the location of the site Situating on cliff edge between Permin Road and Mouere Bluff.</p>	
<p>Brief description Terraced promontory pa defended by a transverse ditch/bank.</p>	
<p>Recorded features Ditch - transverse, Terrace, Ditch - transverse, Pit, Terrace</p>	
<p>Other sites associated with this site</p>
