WHENUAPAI GREEN DEVELOPMENT

98-102 TOTARA ROAD, WHENUAPAI

GEOTECHNICAL INVESTIGATION REPORT

AKL2018-0085AF Rev 1

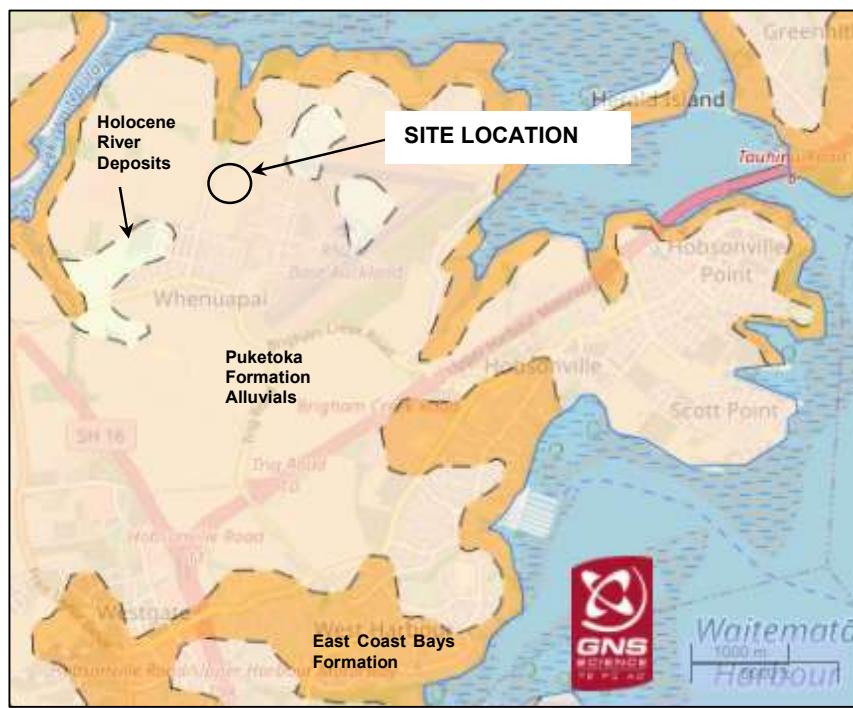
Figure 2: Regional Geology (GNS Science – Geology Web Map 1:250 000)

Published geological maps⁵ for the area depict the regional geology as comprising Late Pliocene to Mid Pleistocene alluvial deposits of the Puketoka Formation as illustrated in below.

These alluvial deposits predominantly consist of inorganic clays and silts with occasional inclusions of sand and gravel with muddy peat and lignite, rhyolitic pumice (including non-welded ignimbrite, tephra and alluvial pumice deposits) and massive micaceous sand beds. Below these upper soil layers, the deeper geological formation is reported to comprise, interbedded muddy sandstones and siltstones of the East Cast Bays Formation within the Waitemata Group.

The main geotechnical hazards likely to be encountered within Puketoka Formation are low bearing capacity and settlement of soft/organic soils.

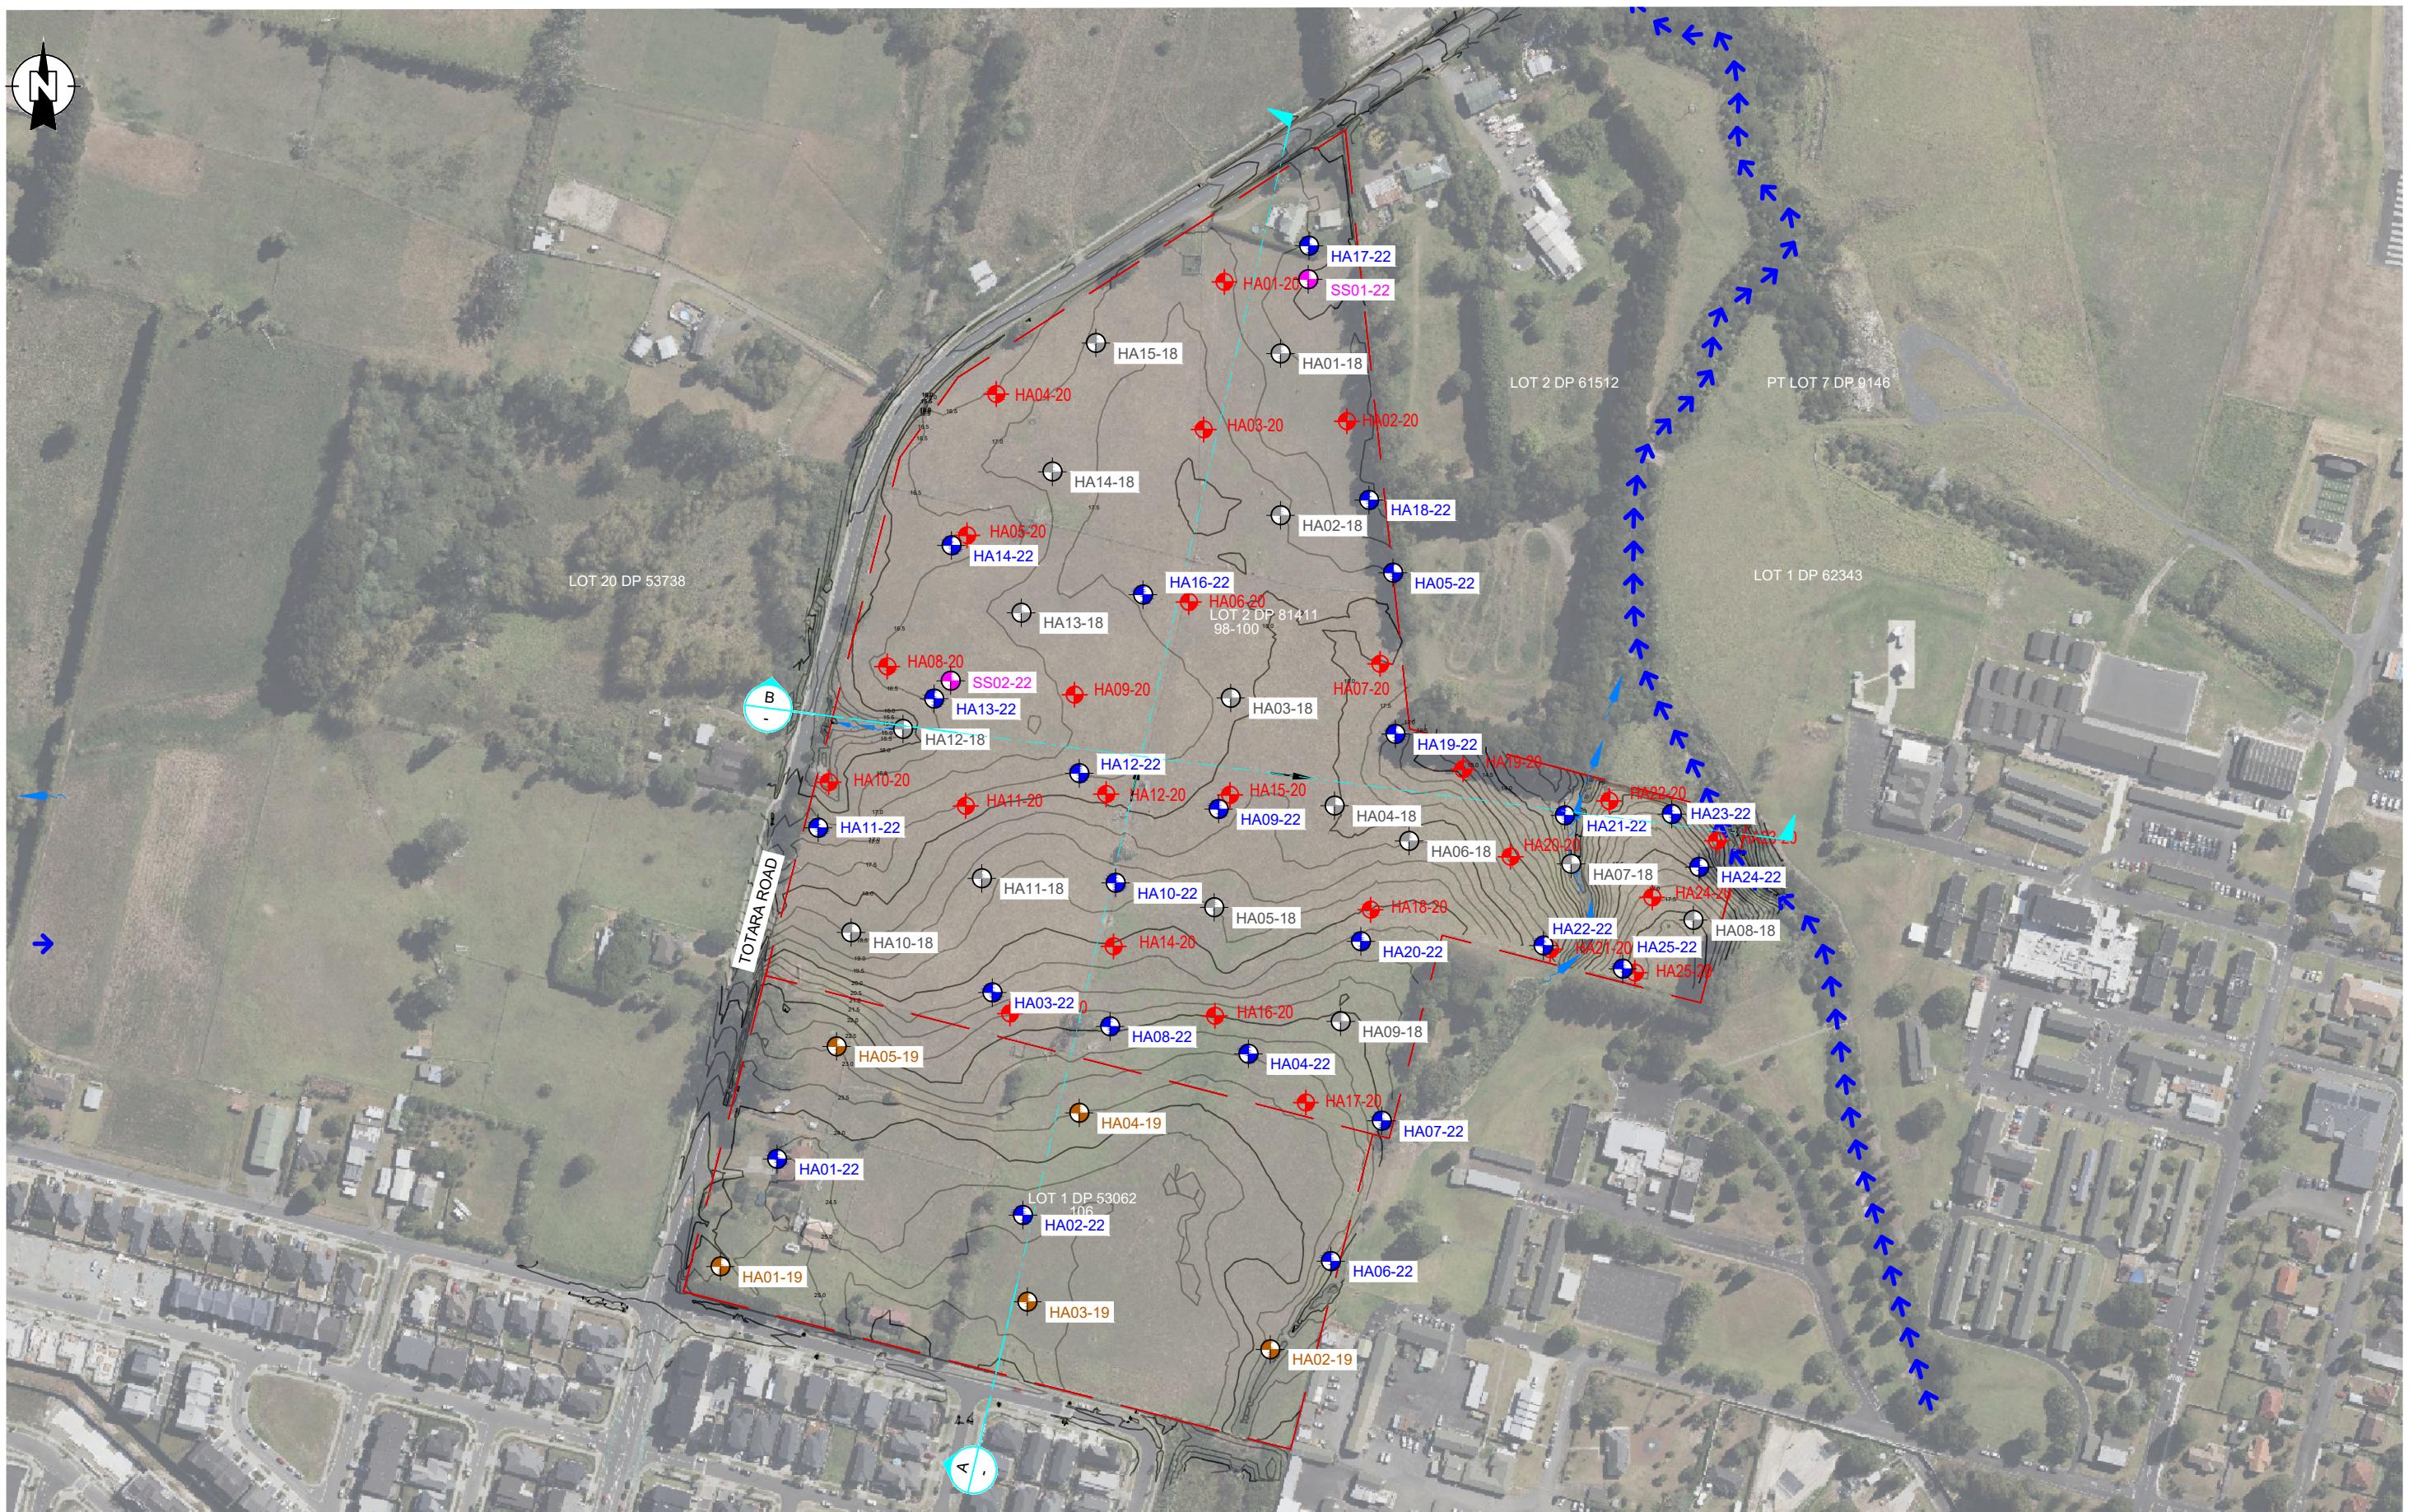
TITLE: **SITE INVESTIGATION PLAN**

- Undertook a walkover survey of the site to assess the general landform and site conditions;
- Twenty-five hand auger boreholes, denoted HA01-22 to HA25-22, were drilled using a 50mm diameter auger to target depths of between 4.0m and 5.0m below existing ground levels to visually observe the near surface soil profile and to facilitate in-situ permeability / vane shear strength testing. HA09-22, HA11-22, HA13-22, HA19-22, HA20-22, HA21-22, and HA25-22 were terminated between 1.5m and 3.7m depth due to refusal. Engineering logs of the hand auger boreholes, together with peak and remoulded vane shear strengths are presented in **Appendix C**.

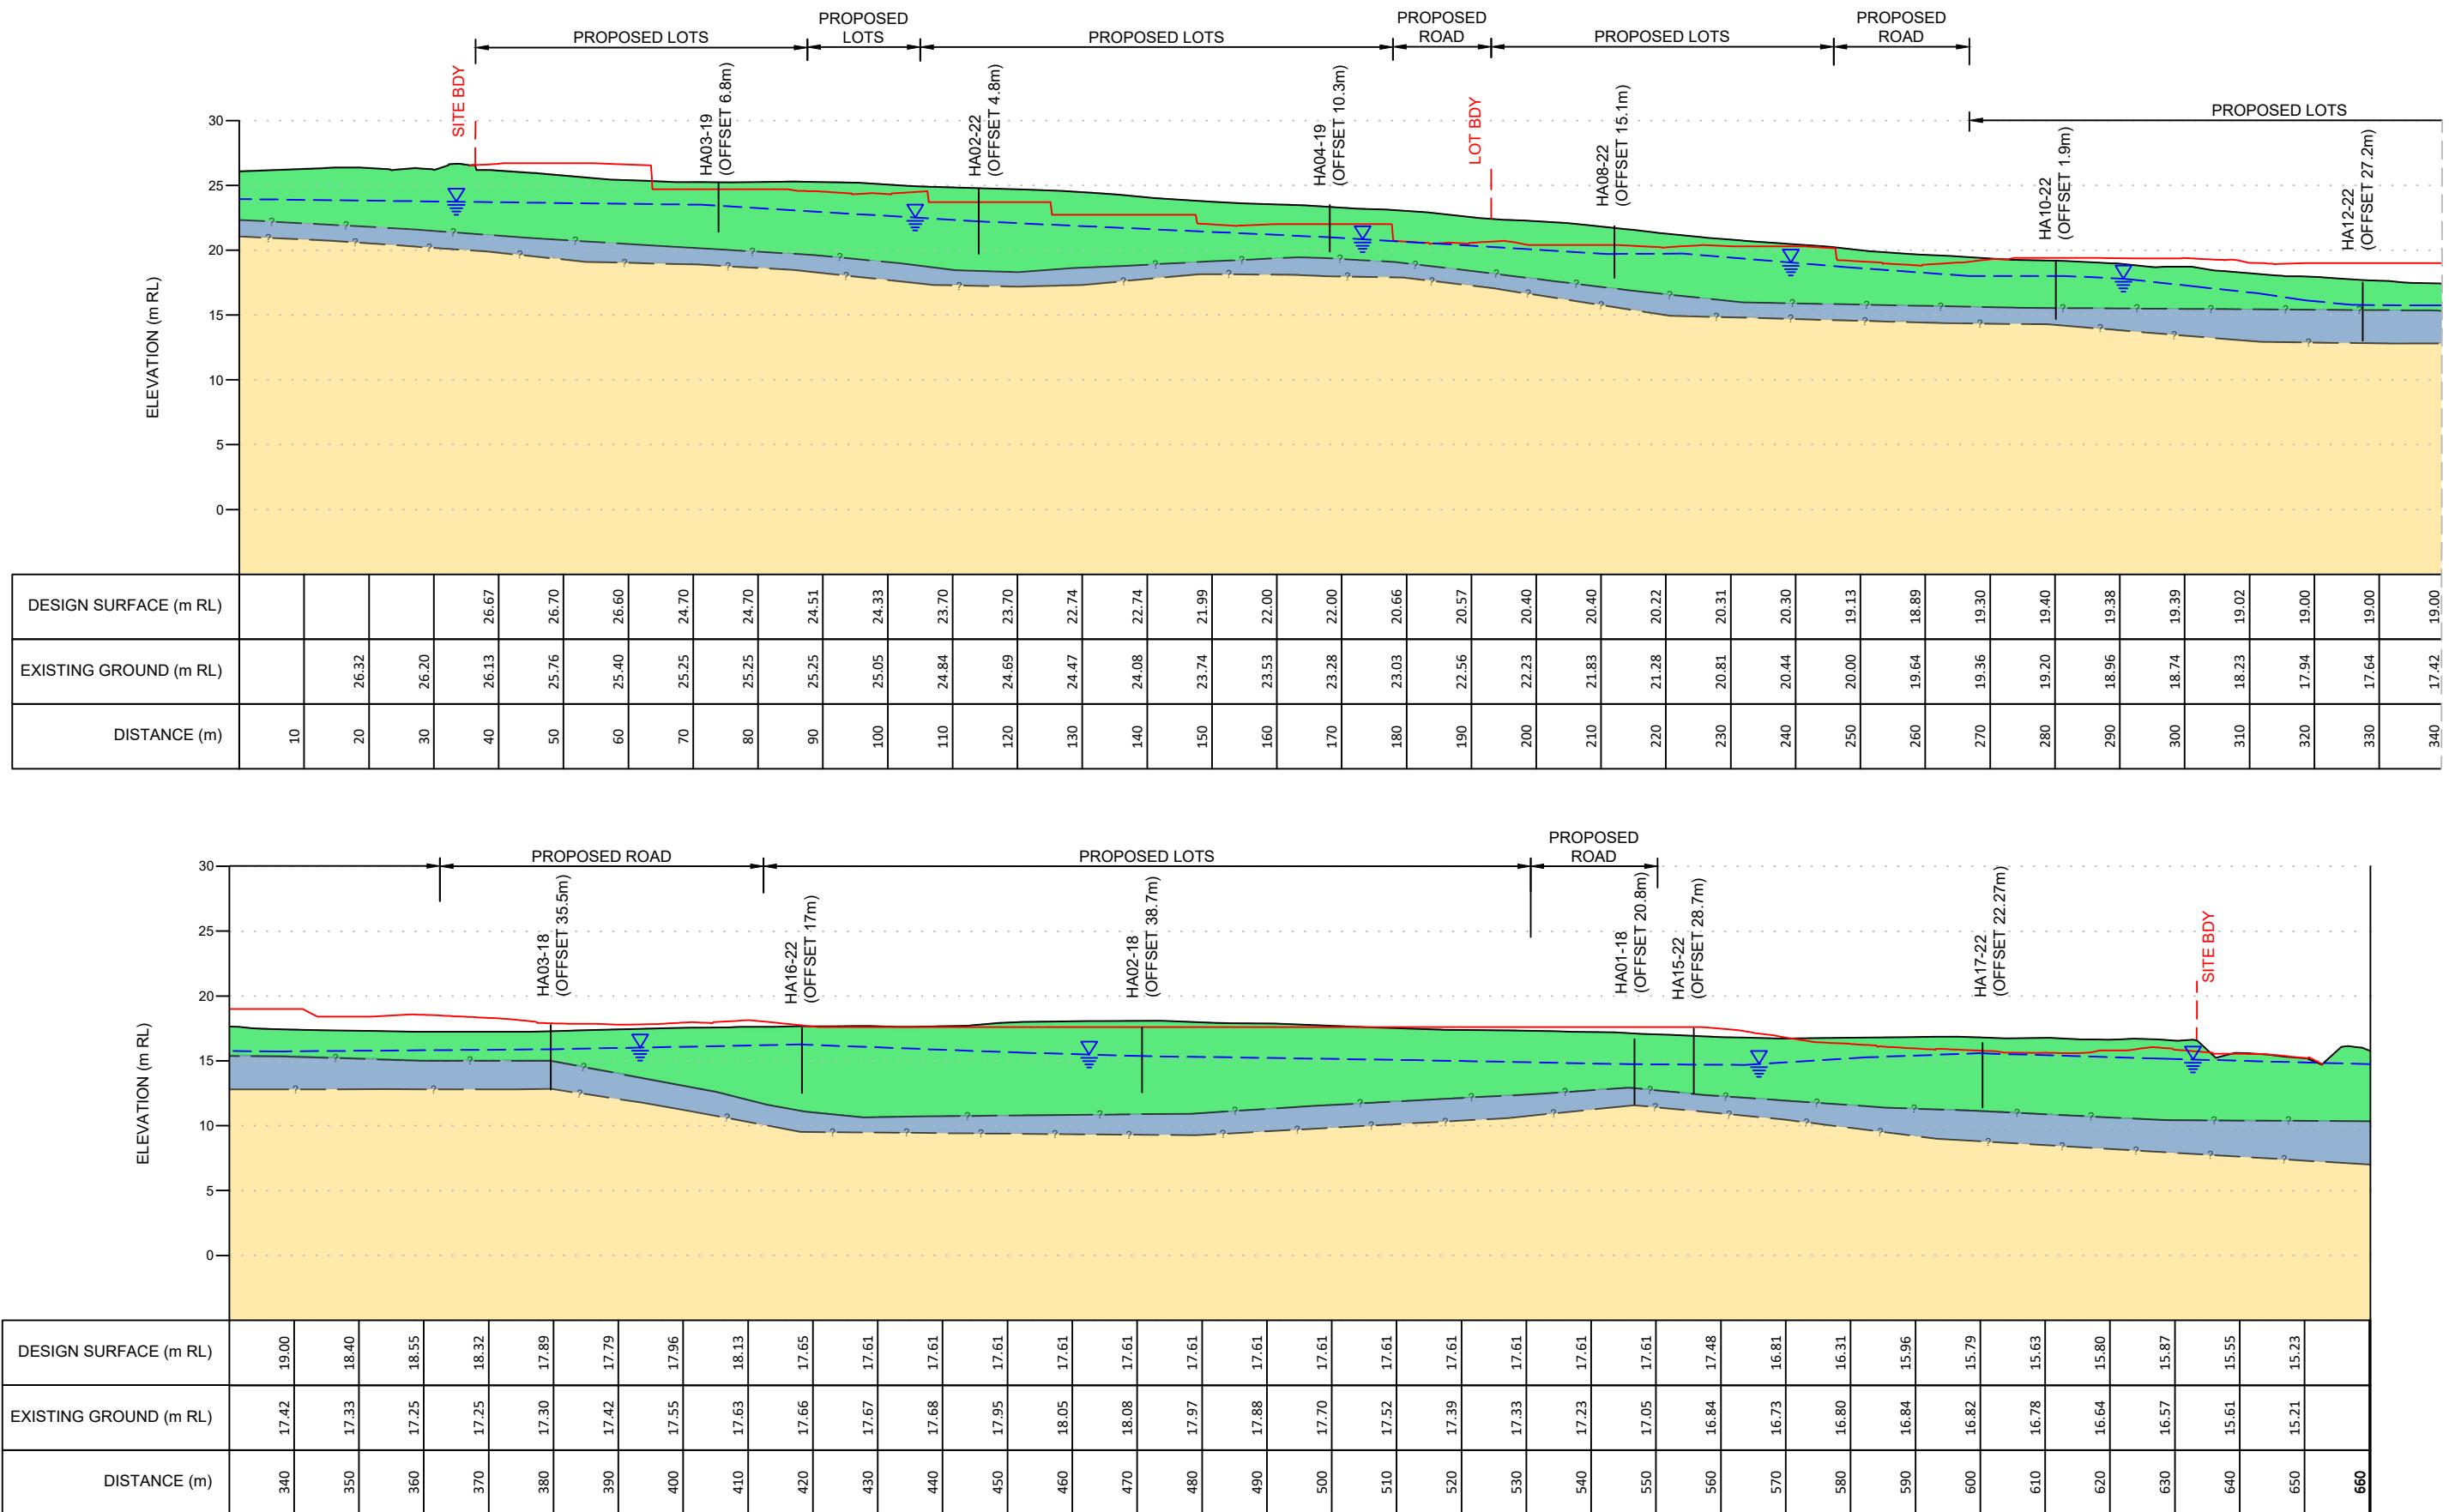
<p>CMW Geosciences</p>	CLIENT:	NEIL CONSTRUCTION LIMITED	DRAWN:	JS	PROJECT No: AKL2018-0085
	PROJECT:	98-100 TOTARA ROAD, WHENUAPAI	CHECKED:	HP	FIGURE: 03
			REVISION:	1	SCALE: H 1:1000 V 1:500
	TITLE:	GEOLOGICAL SECTION-A	DATE:	07/12/2022	SHEET: A3

The ground conditions encountered and inferred from the investigation were considered to be generally consistent with the published geology for the area and our previous site investigations. These can be generalised according to the following subsurface sequences.

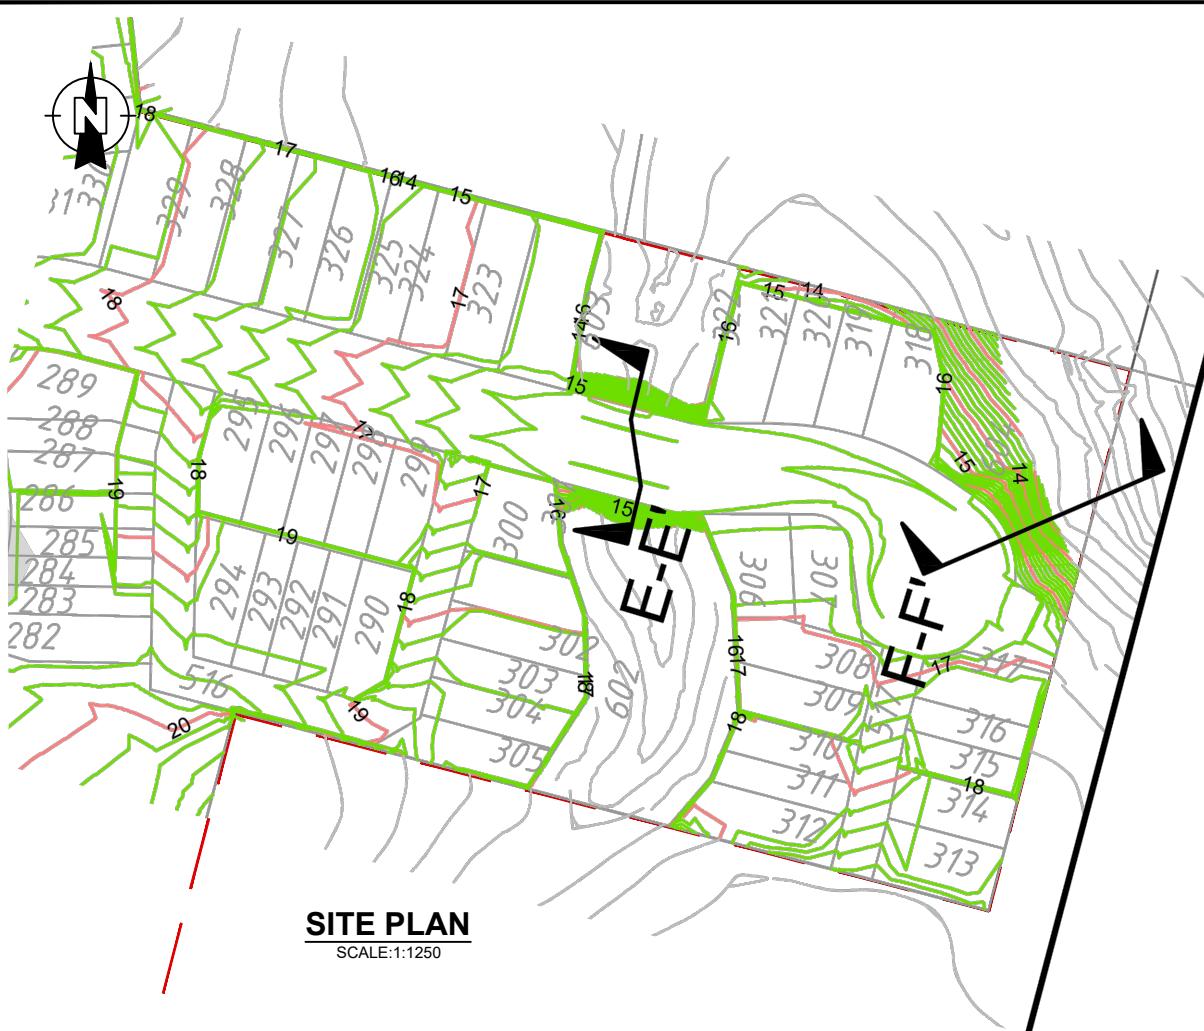
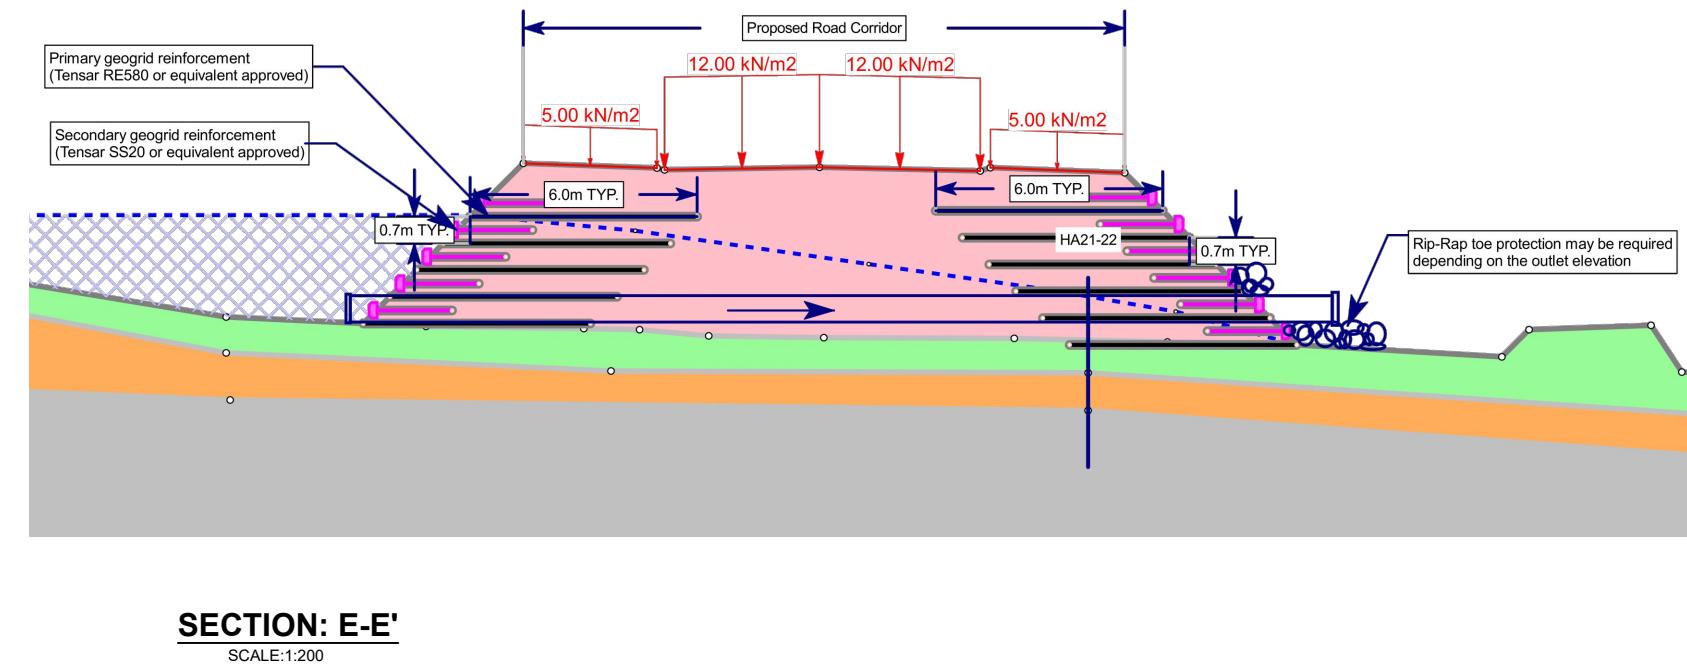
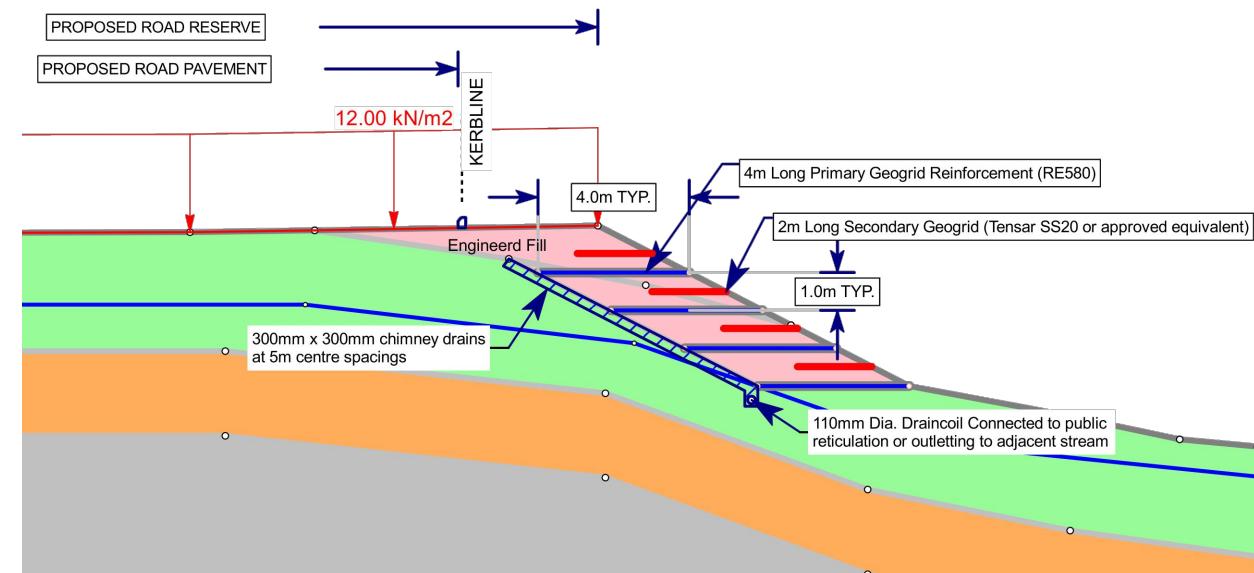
CLIENT: **NEIL CONSTRUCTION LIMITED**
PROJECT: **98-100 TOTARA ROAD, WHENUAPAI**
TITLE: **SLOPE REMEDIATION PLAN**

1. GEOGRID TO BE PLACED FLAT OR WITH 1% FALL TO REAR OF WALL, GRID SHOULD BE FREE OF WRINKLES AND LIGHTLY TENSIONED PRIOR TO AND DURING PLACEMENT OF FILL.

7. ONLY HAND OPERATED EQUIPMENT TO BE OPERATED WITHIN 1 METER OF THE FACE OF THE WALL.
8. THE PROPOSED FILL EMBANKMENT (SECTION E-E') SHALL BE FOUNDED ON A MINIMUM 500mm THICK LAYER OF COMPACTED HARDFILL RAFT TO ENHANCE TOE STABILITY. THE EDGE OF THE HARDFILL RAFT SHOULD EXTEND A MINIMUM OF 1m OUTSIDE THE FOOTPRINT OF THE EMBANKMENT.

9. FACING DETAIL FOR THE RE SLOPES SHOULD CONSIST OF PINNED GEOWEB (OR APPROVED EQUIVALENT FILLED WITH TOPSOIL).

- Similarly, slope stability analysis has also been undertaken for the existing (and proposed) steep slopes adjacent to the eastern site boundary and slope stability improvement works (e.g., Reinforced Earth Slopes) have been recommended to enhance stability.

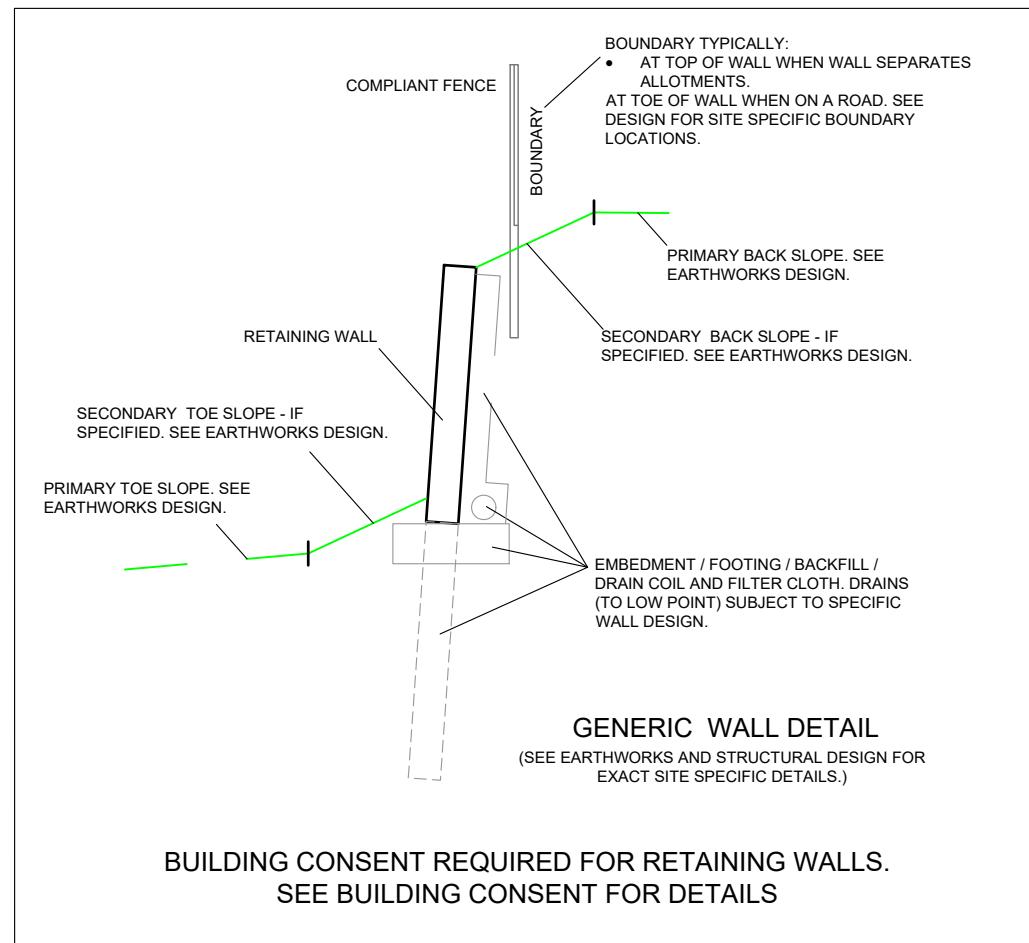
RETAINING WALL - EXAMPLE FINISH (ALLAN BLOCK - APPROX 1.5m HIGH)

1. RETAINING WALLS FACING ROAD RESERVE TO BE "ALLAN BLOCK" SEGMENTAL WALL.
2. ALL OTHER RETAINING WALLS TO BE STEEL POST AND TIMBER RAIL.
3. TOP AND BOTTOM OF WALL ARE FINISHED TOPSOIL LEVEL. TOPSOIL TO BE 150mm DEEP.
4. STEEL POST AND RAIL FENCE:
 - 4.1. FENCE FIXED TO WALL FACE IN COMPOSITE WALLS AND SLEEVED FOR BLOCK WALL.

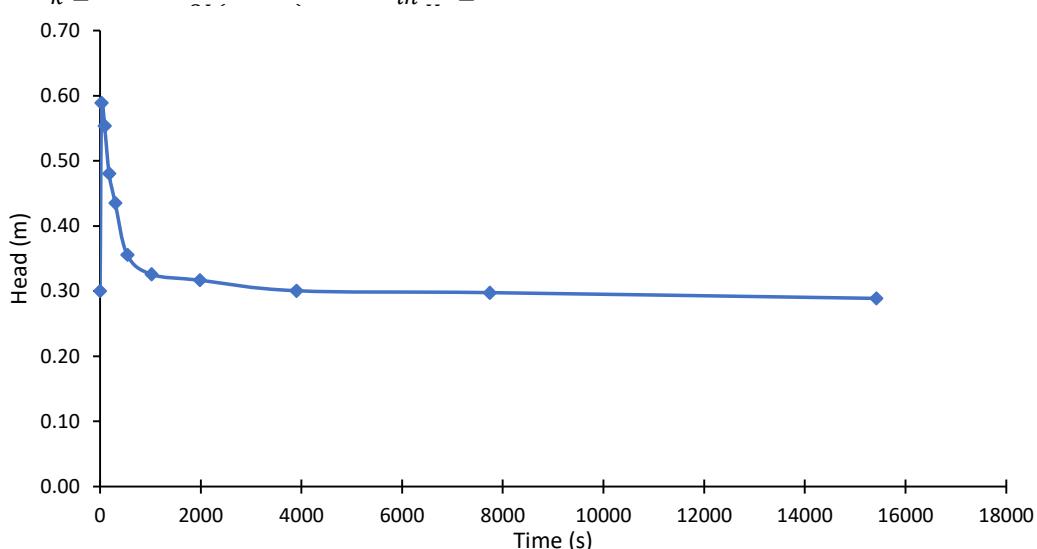
CMW Geosciences	CLIENT: Neil Construction Ltd	DESIGNER: PT																																																																								
	PROJECT: -	CHECKED: -																																																																								
	98-100 Totara Road																																																																									
	TITLE: Falling Head Permeability Test	REVISION: 4																																																																								
		DATE: 17/10/2022																																																																								
	PROJECT: AKL2018-0085																																																																									
Specifications - Open-Ended Tube		Ground Conditions																																																																								
Length L_1 :	1.5 m	GWL: 0.3 m BGL (Blank = Bottom of hole)																																																																								
Diameter:	100 mm	Permeability Anisotropy																																																																								
Non-Perm L_2 :	m	$m = \sqrt{k_h/k_v}$																																																																								
Above Gnd L_3 :	m	Bottom of Test Hole: 1.50 m BGL																																																																								
Hydraulic Conductivity (k) <i>Note: CMW considers the CIRIA 113 value the most appropriate method for most purposes, but also provides the analysis method as outlined by Hvorslev if desired.</i>																																																																										
CIRIA 113: Somerville (1986), <i>Control of groundwater for temporary works</i> , CIRIA Report 113, Appendix 4																																																																										
$k = \left(\log \frac{h_1}{h_2} - \log \frac{2h_1 + d}{2h_2 + d} \right) \cdot \frac{(h_1 + h_2)}{2(t_2 - t_1)} = -3.78E-05 \text{ ms}^{-1} : -3.27 \text{ m/day}$																																																																										
Hvorslev: Hvorslev (1951) <i>Time Lag and Soil Permeability in Ground-Water Observations</i> , Fig 18, p49																																																																										
$k = \frac{d^2 \ln \left(\frac{mL}{d} + \sqrt{\left(\frac{mL}{d} \right)^2 + 1} \right)}{\ln \frac{H_1}{H_2}} = -5.09E-06 \text{ ms}^{-1} : -0.44 \text{ m/day}$

<p>The graph plots Head (m) on the y-axis (0.00 to 0.70) against Time (s) on the x-axis (0 to 18000). The curve starts at approximately (0, 0.60) and drops sharply before leveling off around 0.30 m after about 4000 seconds.</p>		<div style="border: 1px solid black; padding: 5px; margin-bottom: 5px;"> STRATIGRAPHIC LOG </div> <div style="border: 1px solid black; padding: 5px; background-color: #e0e0e0; margin-bottom: 5px;">

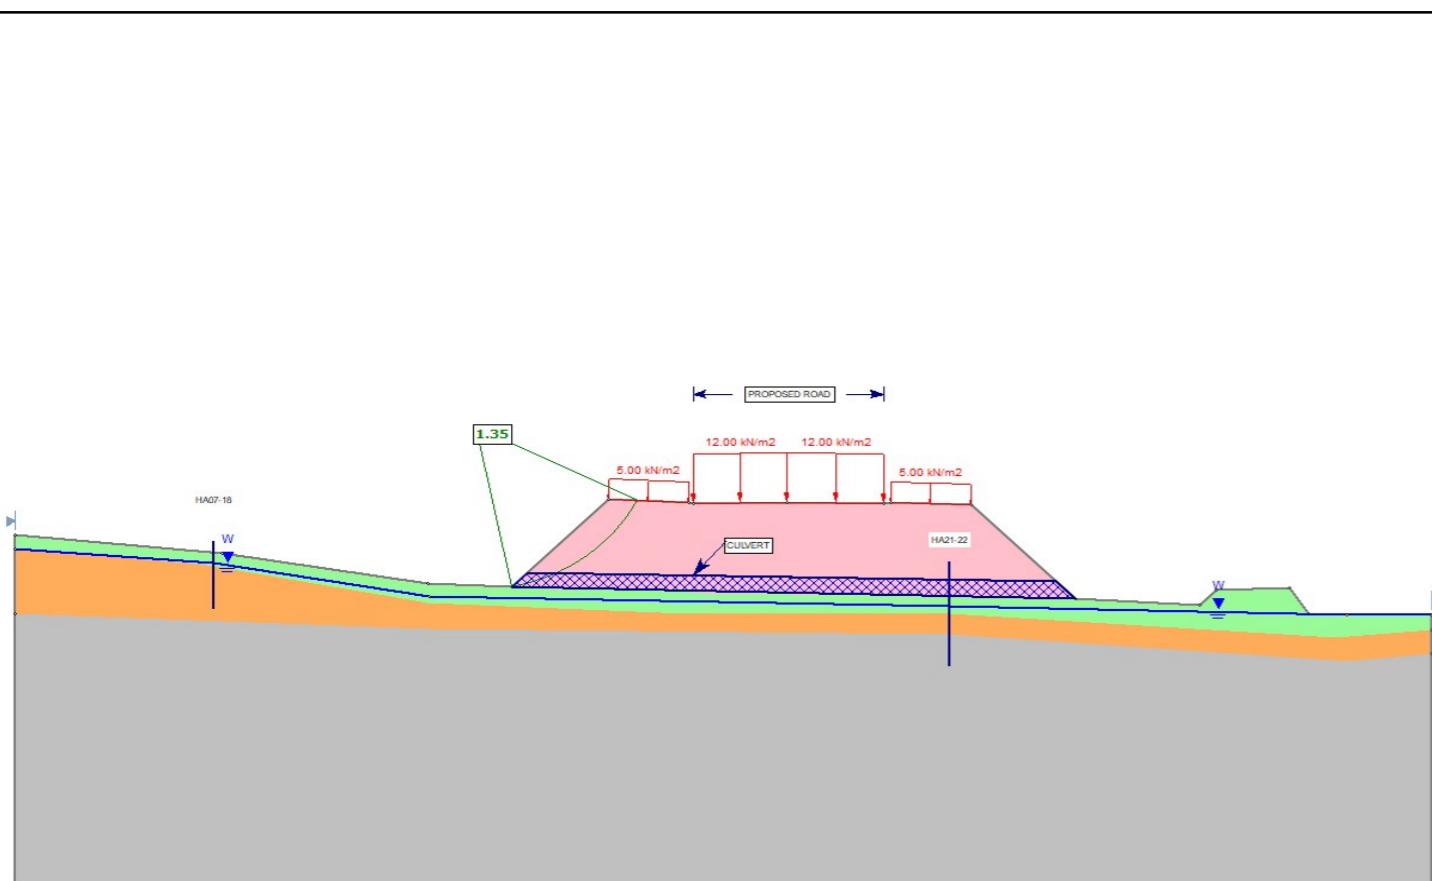
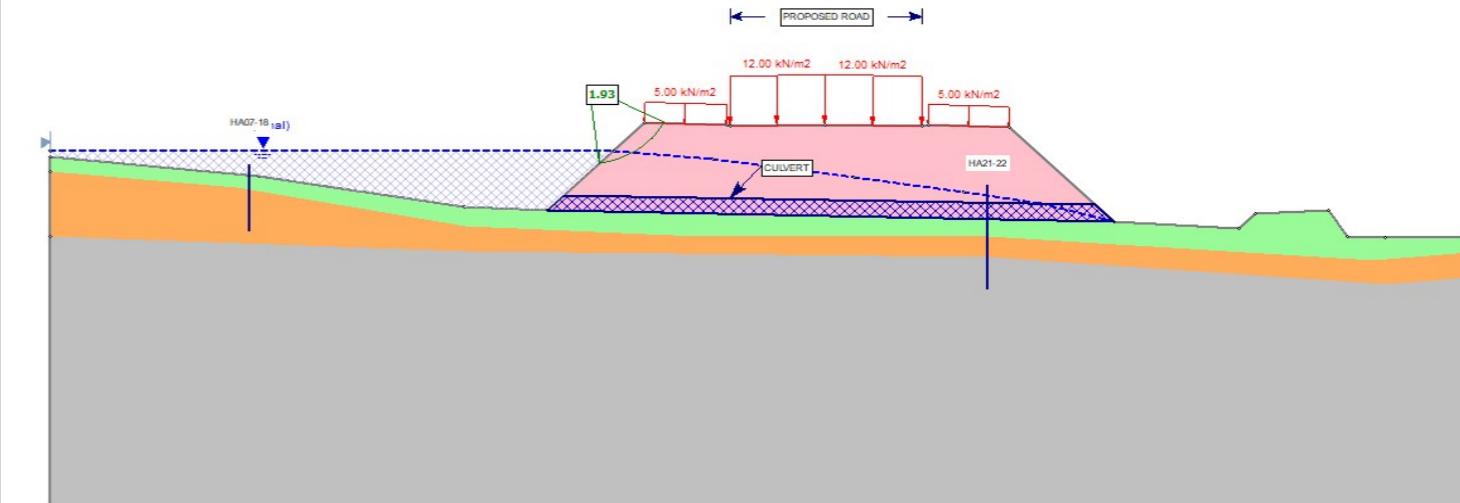
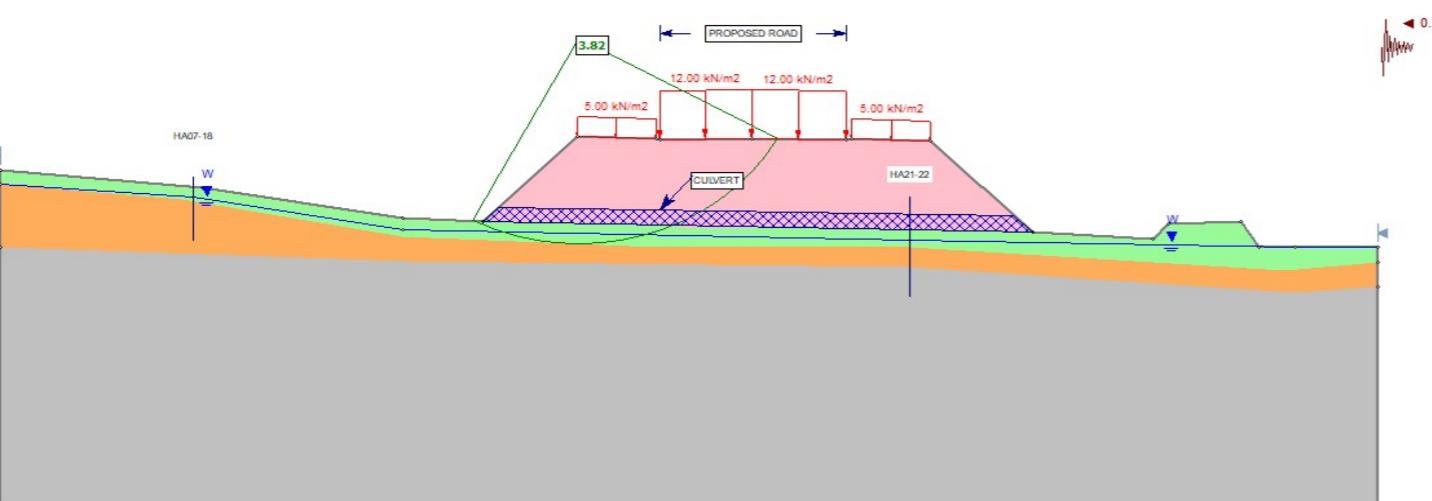
CMW Geosciences	Project	98-102 Totara Road, Whenuapai	Analysis	Circular	Project No.	AKL2018-0085
	Title	Section E-E' - Proposed	Date	29/11/2022	Drawing	STAB 01

Normal Groundwater Conditions

Transient Groundwater Conditions

Seismic Event

Material Name	Color	Unit Weight (kN/m ³)	Strength Type	Cohesion (kPa)	Phi (deg)	Water Surface	Hu Type	Hu
PUKETOKA ALLUVIUM	Green	18	Mohr-Coulomb	3	28	Water Surface	Custom	1
ECBF RESIDUAL SOILS	Orange	18	Mohr-Coulomb	5	32	Water Surface	Custom	1
ECBF ROCK	Grey	20	Mohr-Coulomb	10	35	Water Surface	Custom	1
ENGINEERED FILL	Pink	18	Mohr-Coulomb	5	32	Water Surface	Custom	1

- **Section E-E':** A 4.5m high fill embankment is proposed to be formed across the gully located in the eastern portion of the site to provide vehicle access to the lots adjacent to the eastern boundary. This embankment will be formed with approximately 1V:1H batters and may be susceptible to slope instability under rapid drawdown conditions.
- **Section F-F':** The existing ground profile near the eastern boundary falls into the stream further east at approximately 1V:3H grade. Fill up to 1m high is proposed on the crest of these slopes (battered at 1V:2H grade) and will induce a surcharge load on the slopes.

Results show that for the proposed landform and ground model described above, inadequate slope stability factors of safety are achieved for normal and elevated groundwater cases and will require the implementation of specific remedial earthworks, as described in Section 7 below.

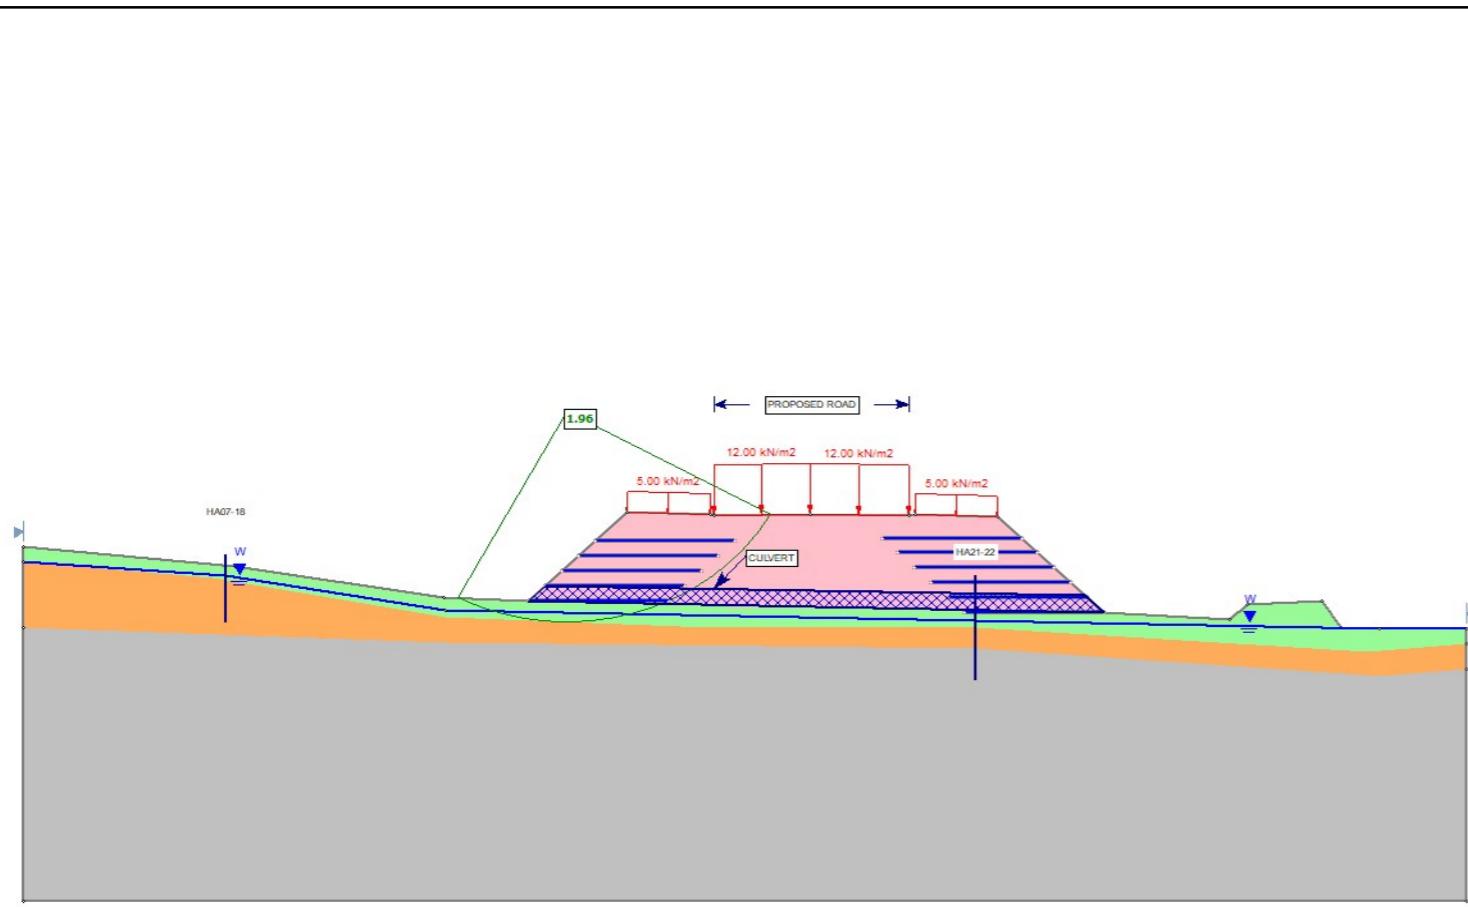
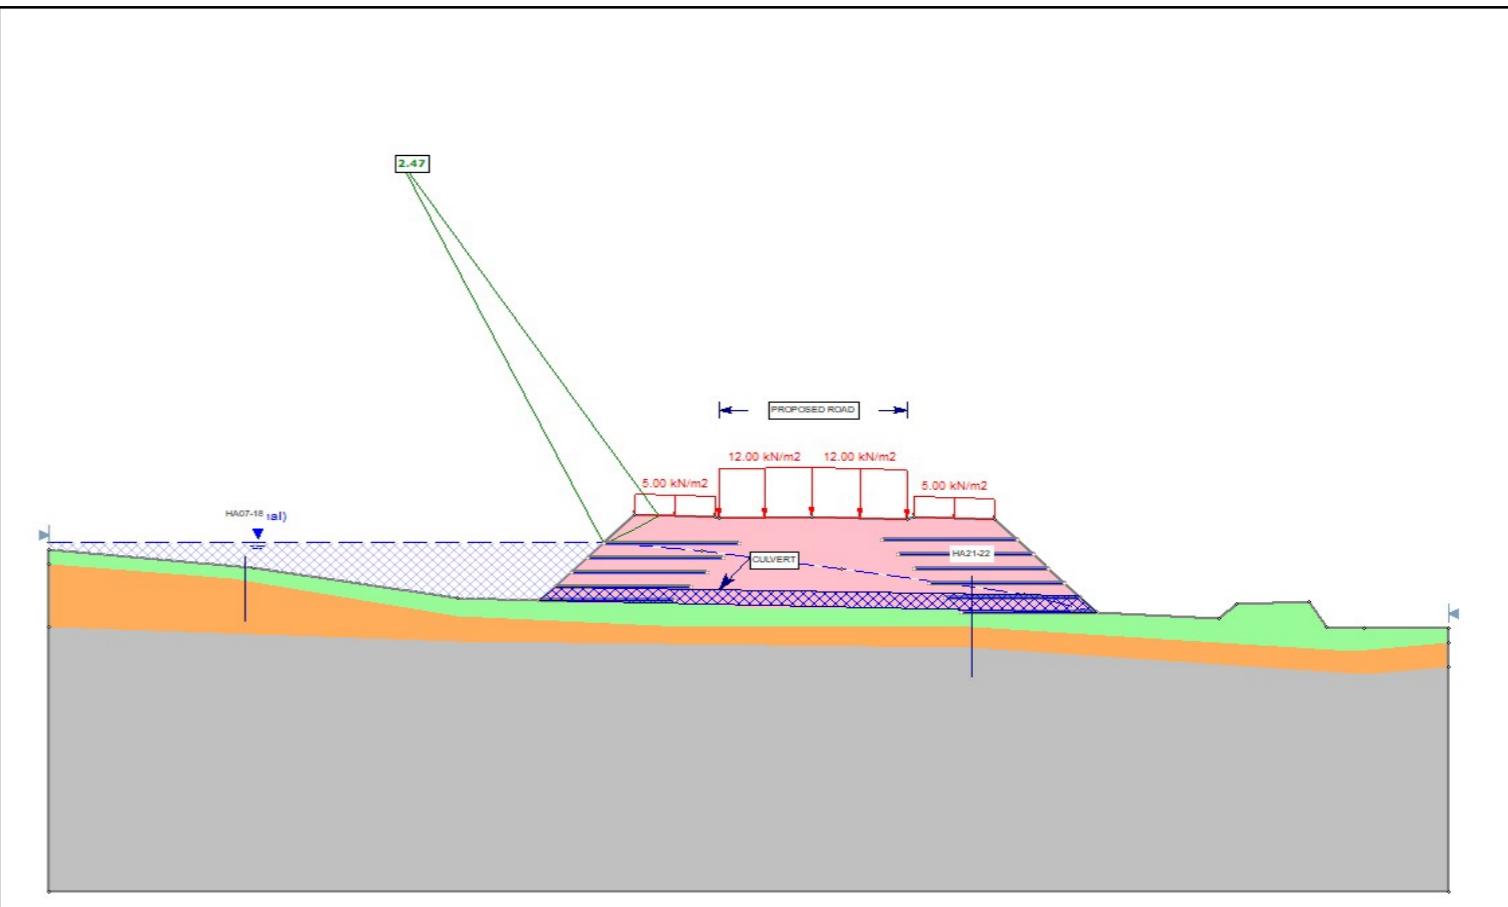
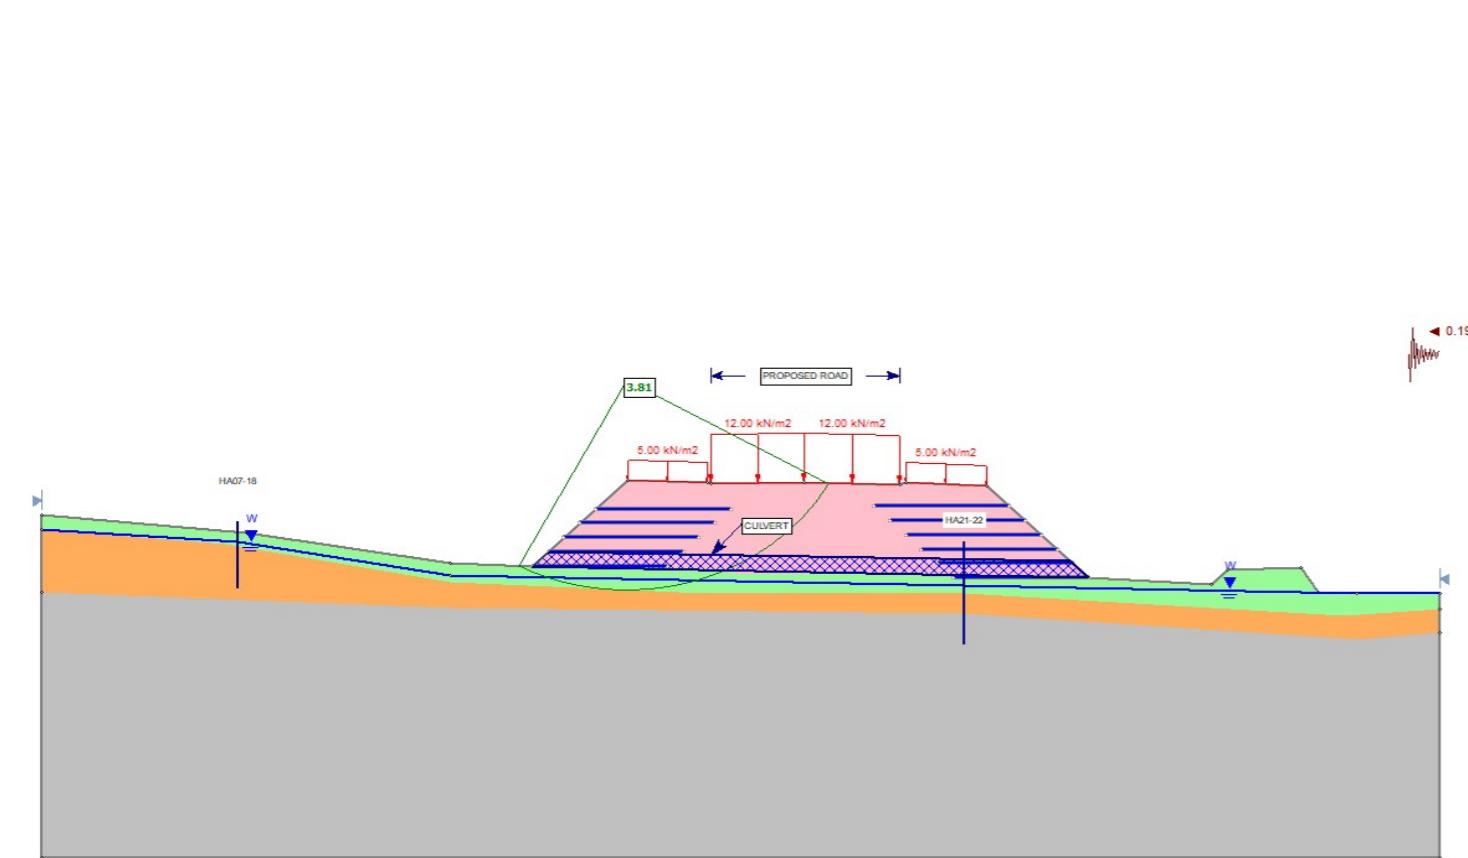
CMW Geosciences	Project 98-102 Totara Road, Whenuapai				Analysis Circular			Project No. AKL2018-0085	
	Title Section E-E' - Remediated				Date 29/11/2022			Drawing STAB 02

Normal Groundwater Conditions

Transient Groundwater Conditions

Seismic Event

Material Name	Color	Unit Weight (kN/m³)	Strength Type	Cohesion (kPa)	Phi (deg)	Water Surface	Hu Type	Hu
PUKETOKA ALLUVIUM	Green	18	Mohr-Coulomb	3	28	Water Surface	Custom	1
ECBF RESIDUAL SOILS	Orange	18	Mohr-Coulomb	5	32	Water Surface	Custom	1
ECBF ROCK	Grey	20	Mohr-Coulomb	10	35	Water Surface	Custom	1
ENGINEERED FILL	Pink	18	Mohr-Coulomb	5	32	Water Surface	Custom	1
