WHENUAPAI GREEN DEVELOPMENT

98-102 TOTARA ROAD, WHENUAPAI

GEOTECHNICAL INVESTIGATION REPORT

AKL2018-0085AF Rev 1

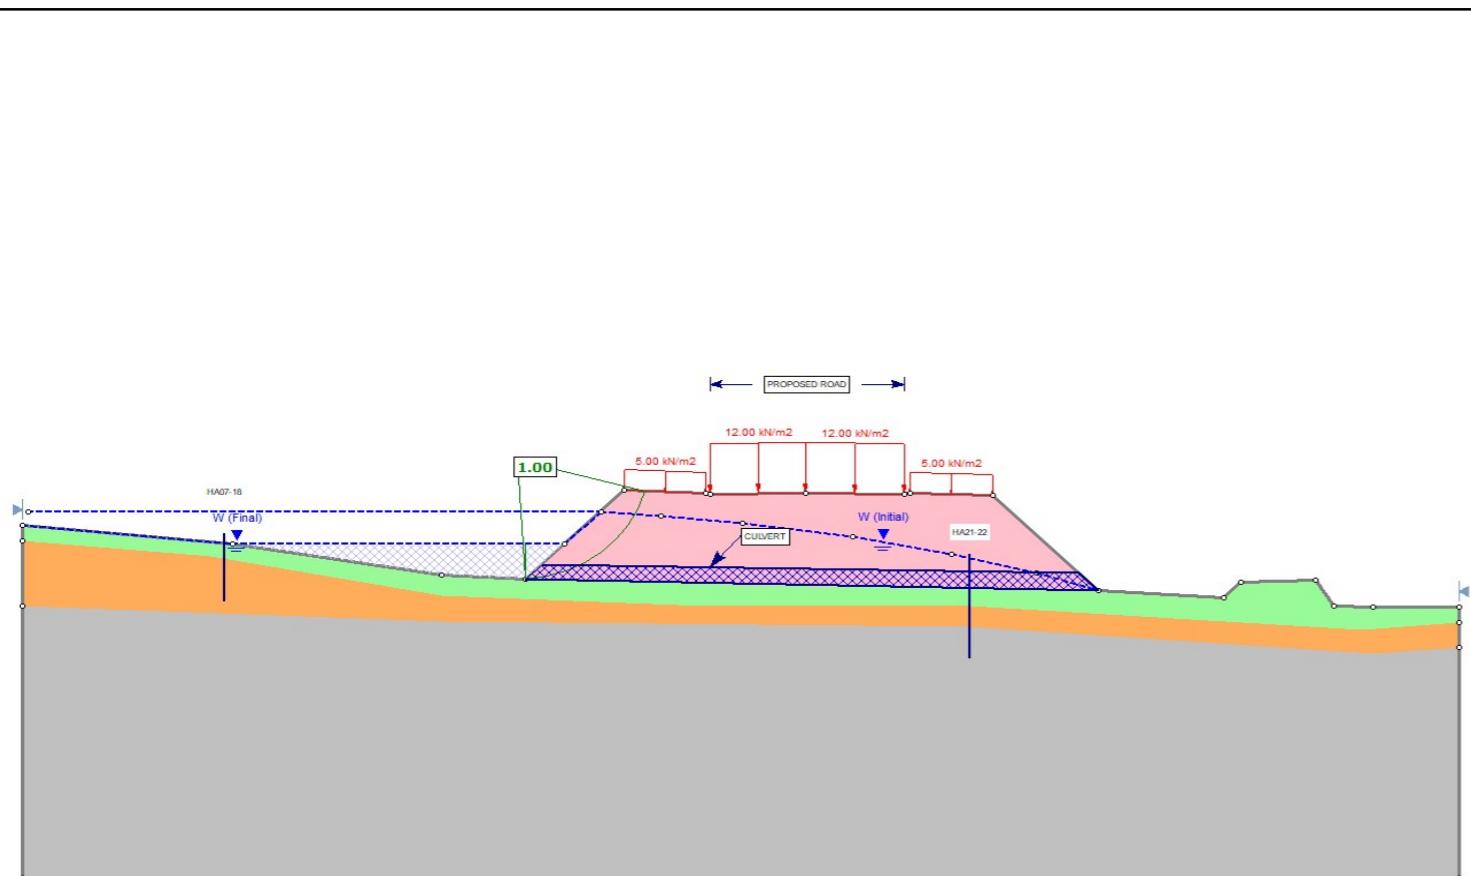
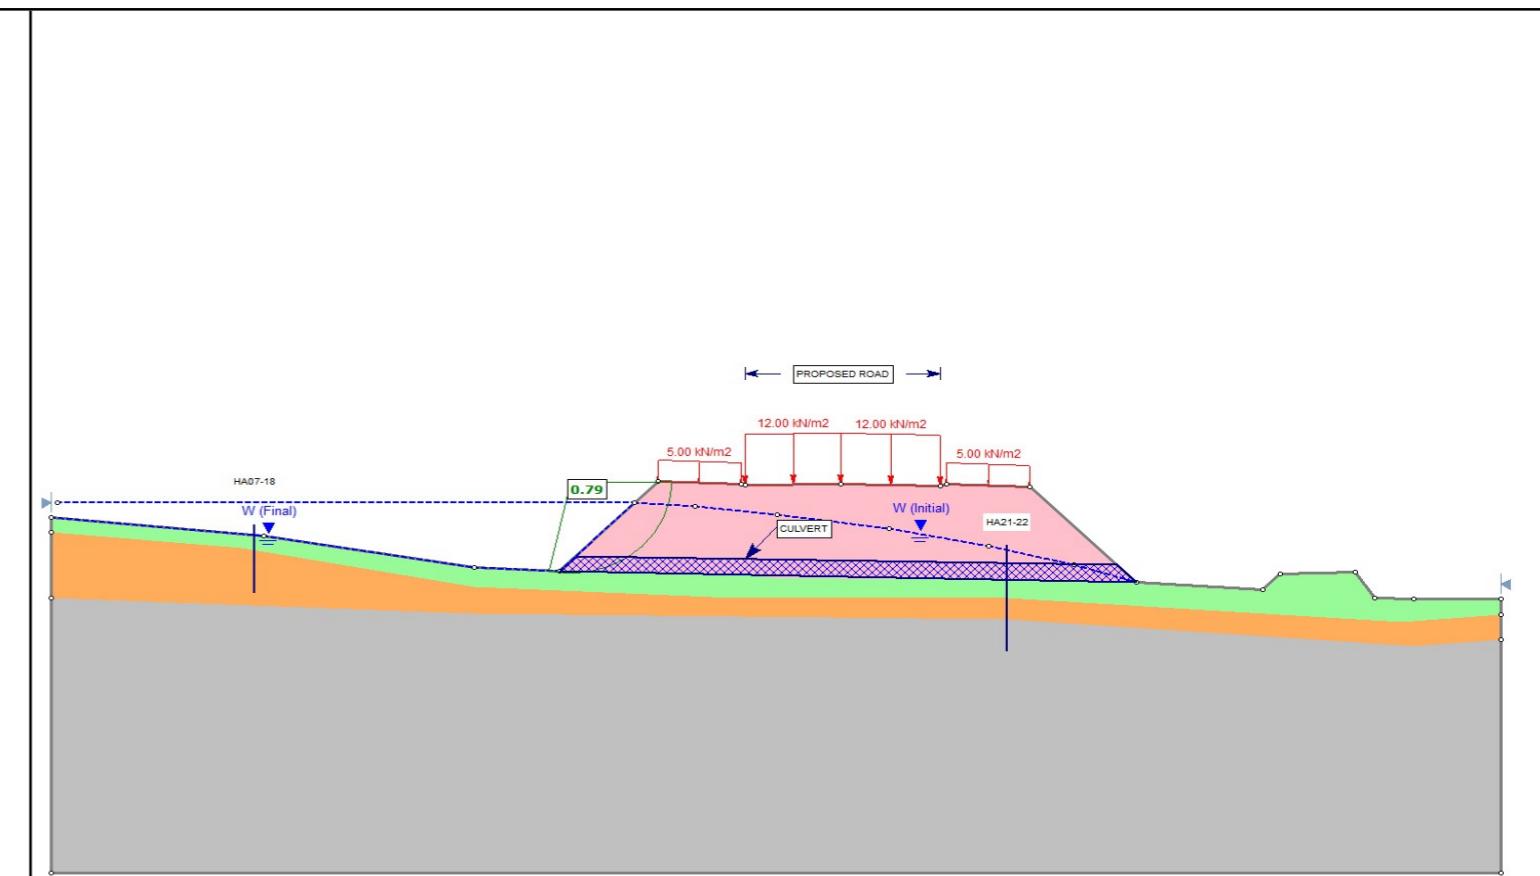
Project 98-102 Totara Road, Whenuapai	Analysis Circular	Project No. AKL2018-0085
	Title Section E-E' - Proposed (RD)	Date 29/11/2022	Drawing STAB 01

Rapid Drawdown - Partial

Rapid Drawdown - Full

Material Name	Color	Unit Weight (kN/m ³)	Strength Type	Cohesion (kPa)	Phi (deg)	Rapid Drawdown (RD) Undrained Strength	RD Cr (kPa)	RD PhiR (deg)	Water Surface	Hu Type	Hu
PUKETOKA ALLUVIUM	[Green]	18	Mohr-Coulomb	3	28	Yes	0	0	Water Surface	Custom	1
ECBF RESIDUAL SOILS	[Orange]	18	Mohr-Coulomb	5	32	Yes	0	0	Water Surface	Custom	1
ECBF ROCK	[Grey]	18	Mohr-Coulomb	10	35	Yes	0	0	Water Surface	Custom	1
ENGINEERED FILL	[Pink]	18	Mohr-Coulomb	5	32	Yes	0	0	Water Surface	Custom	1

In addition, the stability of the proposed fill embankment (Cross Section E-E') has also been assessed under the following drawdown conditions. Initial groundwater level for the rapid drawdown analysis is assumed to be located at approximately 1.2m below the crest of the fill embankment (e.g., elevated groundwater case).

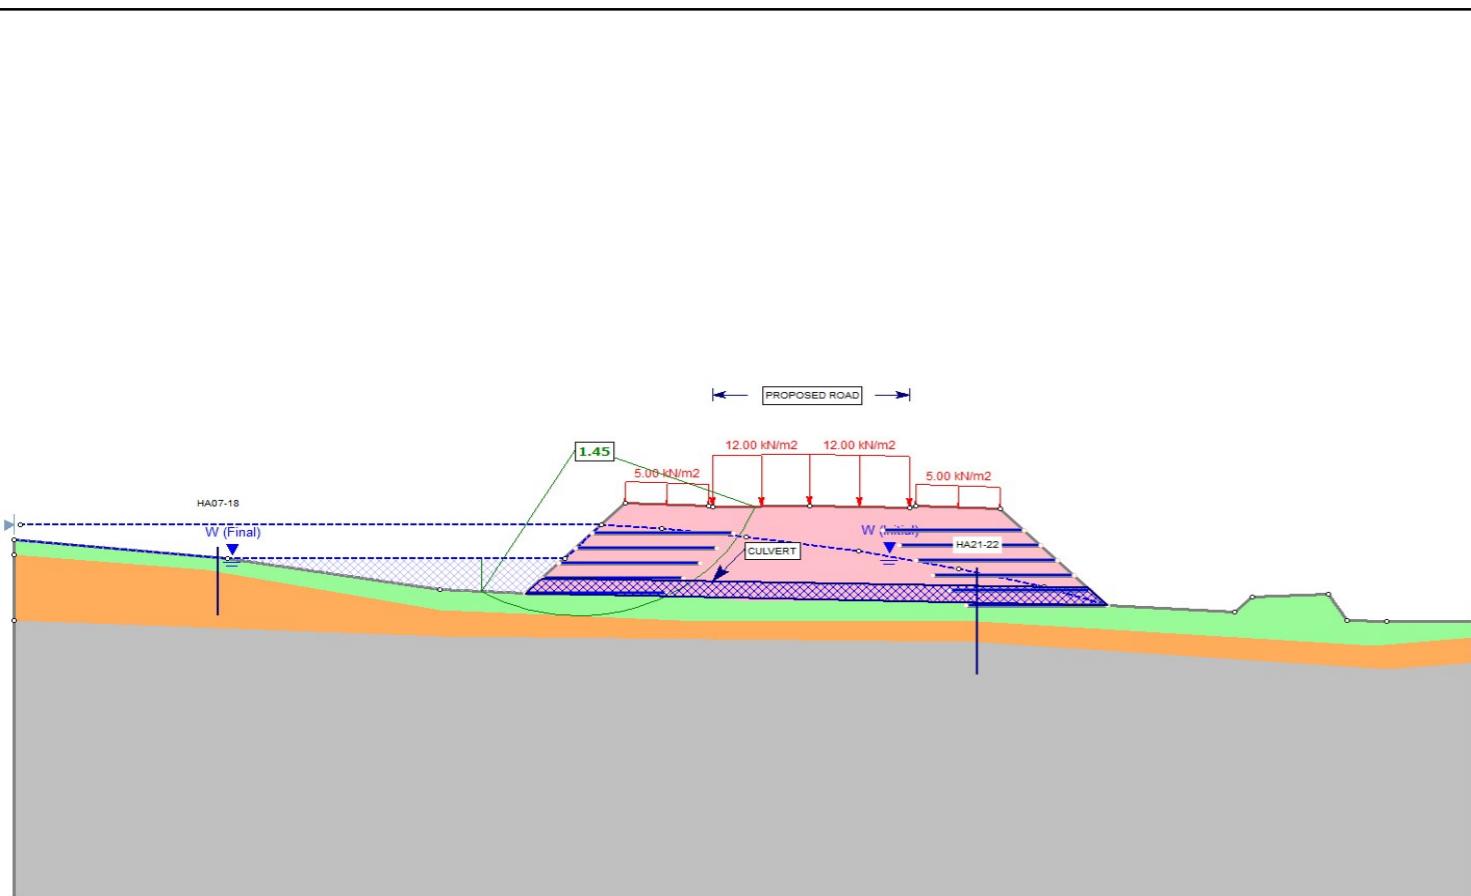
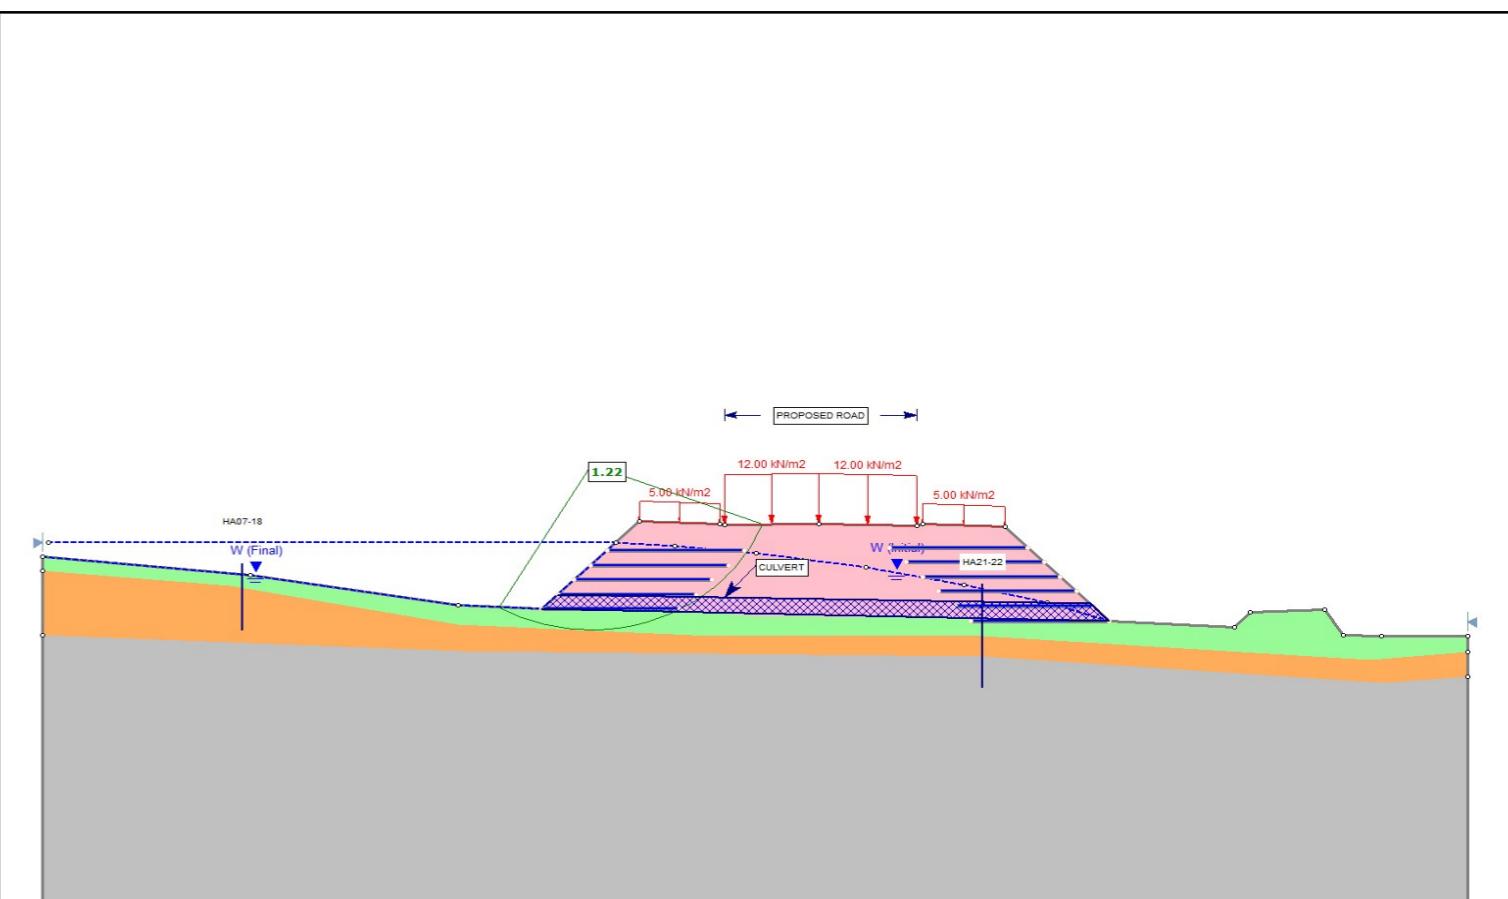
Project 98-102 Totara Road, Whenuapai				Analysis Circular			Project No. AKL2018-0085		
	Title	Section E-E' - Remediated (RD)				Date	29/11/2022			Drawing STAB 02

Rapid Drawdown - Partial

Rapid Drawdown - Full

Material Name	Color	Unit Weight (kN/m ³)	Strength Type	Cohesion (kPa)	Phi (deg)	Rapid Drawdown (RD) Undrained Strength	RD Cr (kPa)	RD PhiR (deg)	Water Surface	Hu Type	Hu
PUKETOKA ALLUVIUM	[Green]	18	Mohr-Coulomb	3	28	Yes	0	0	Water Surface	Custom	1
ECBF RESIDUAL SOILS	[Orange]	18	Mohr-Coulomb	5	32	Yes	0	0	Water Surface	Custom	1
ECBF ROCK	[Grey]	18	Mohr-Coulomb	10	35	Yes	0	0	Water Surface	Custom	1
ENGINEERED FILL	[Pink]	18	Mohr-Coulomb	5	32	Yes	0	0	Water Surface	Custom	1

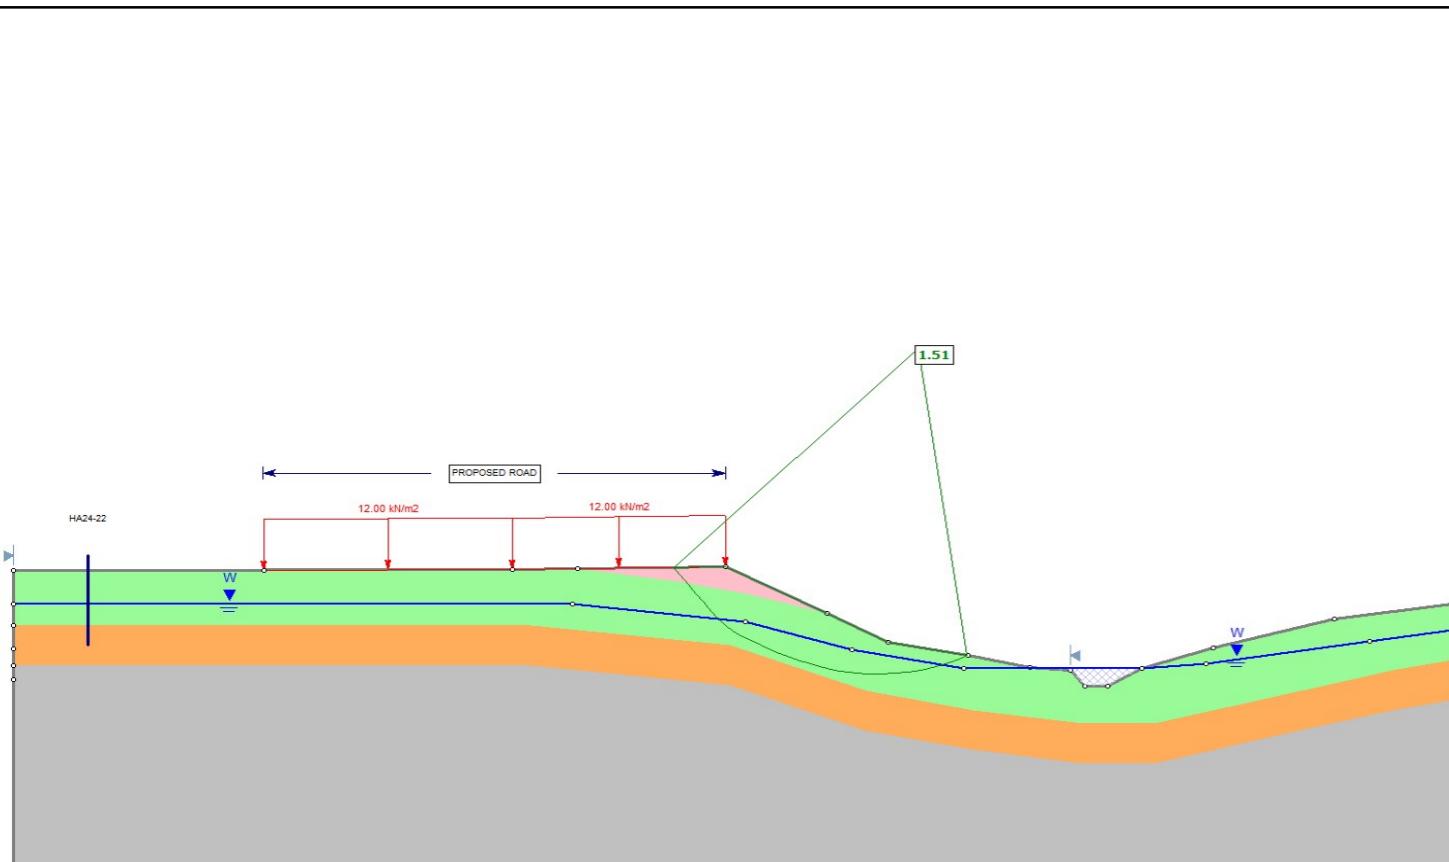
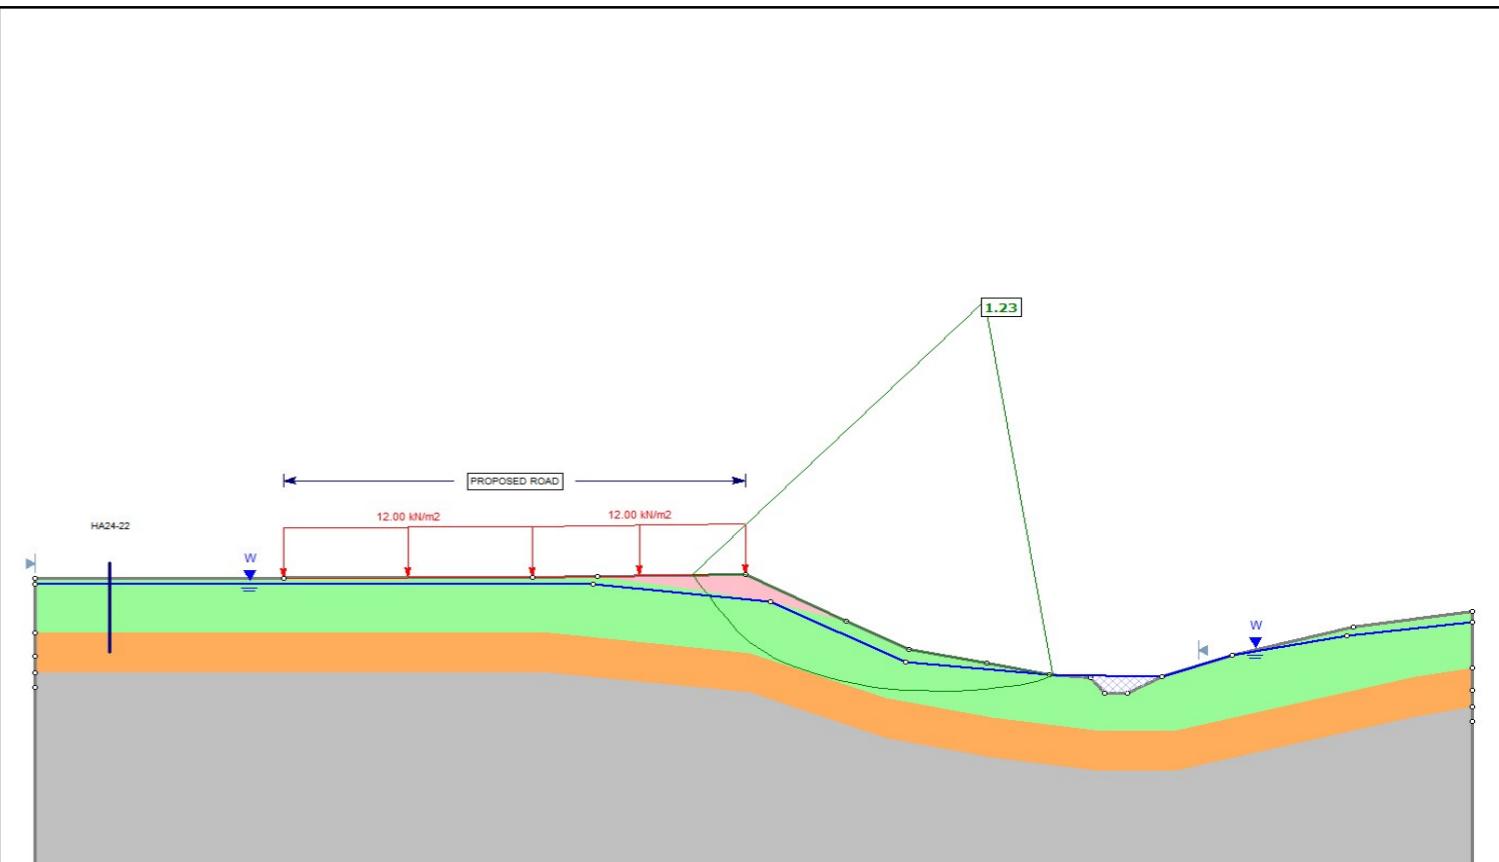
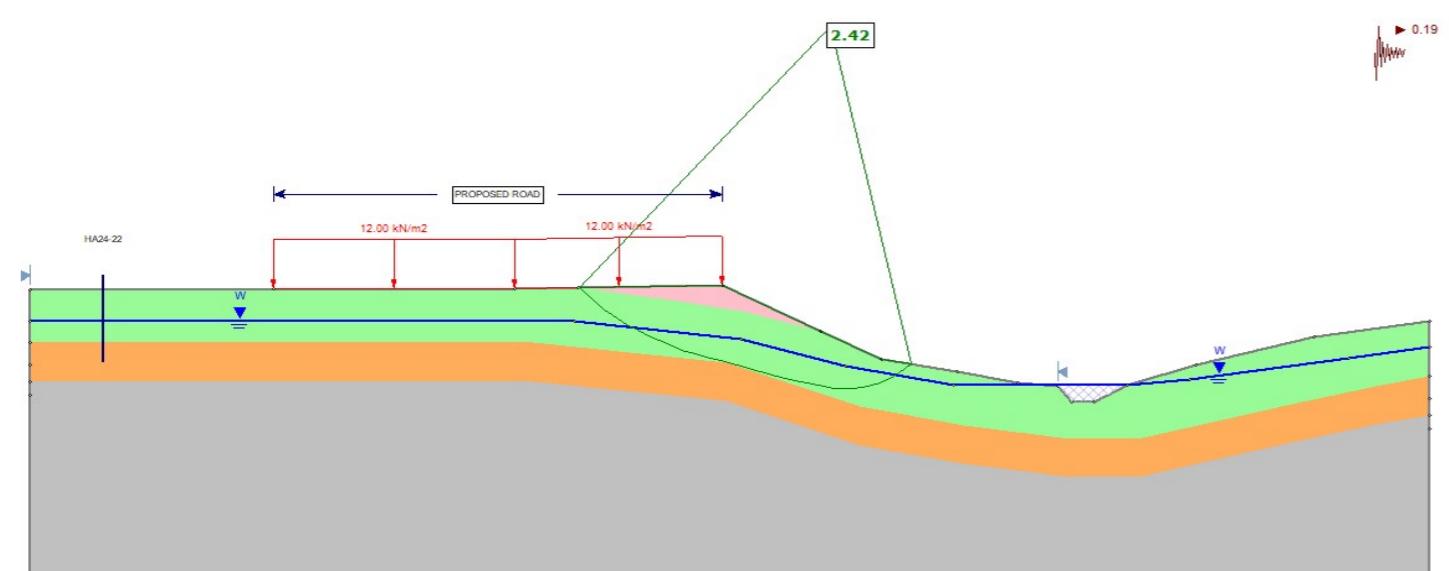
CMW Geosciences	Project 98-102 Totara Road, Whenuapai	Analysis Non-Circular (Cuckoo)	Project No. AKL2018-0085
	Title Section F-F' - Proposed	Date 29/11/2022	Drawing STAB 01

Normal Groundwater Conditions

Transient Groundwater Conditions

Seismic Event

Material Name	Color	Unit Weight (kN/m ³)	Strength Type	Cohesion (kPa)	Phi (deg)	Water Surface	Hu Type	Hu
PUKETOKA ALLUVIUM	Green	18	Mohr-Coulomb	3	28	Water Surface	Custom	1
ECBF RESIDUAL SOILS	Orange	18	Mohr-Coulomb	5	32	Water Surface	Custom	1
ECBF ROCK	Grey	20	Mohr-Coulomb	10	35	Water Surface	Custom	1
ENGINEERED FILL	Pink	18	Mohr-Coulomb	5	32	Water Surface	Custom	1
