KA Woolshed Limited Partnership

PATERSON BLOCK, WOOLSHED RD, JACKS POINT, QUEENSTOWN PRELIMINARY SITE INVESTIGATION

7 MARCH 2023

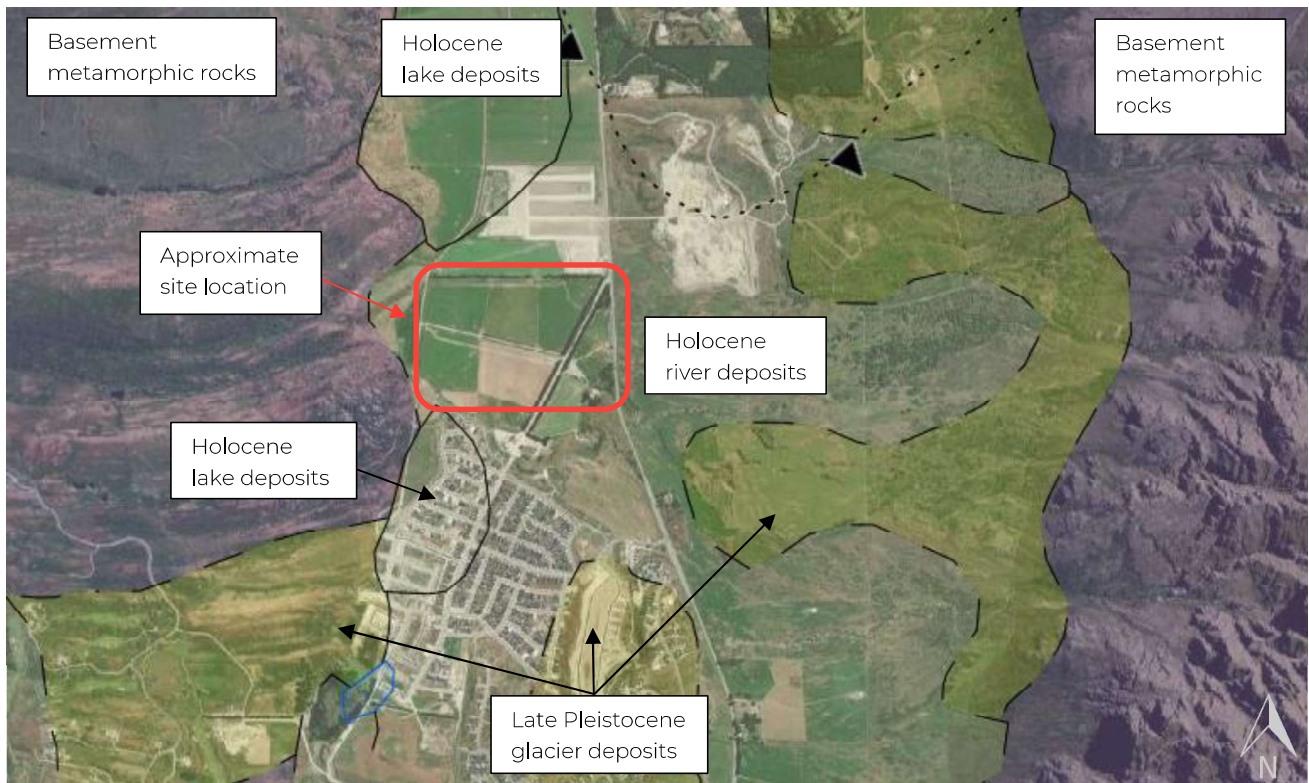
Figure 2: Geology of the site area

The geology of the site is shown on the 1:250,000 scale GNS Geology Web Map extract (accessed January 2023) as shown in Figure 2.

This map indicates the site to be underlain by Holocene river deposits. The deposits generally comprise loose, commonly angular, boulders, gravel, sand, and silt forming alluvial fans; grades into scree (upslope) & valley alluvium.

The geology east and west of the site comprises Late Pleistocene glacier deposits and Basement metamorphic rocks.

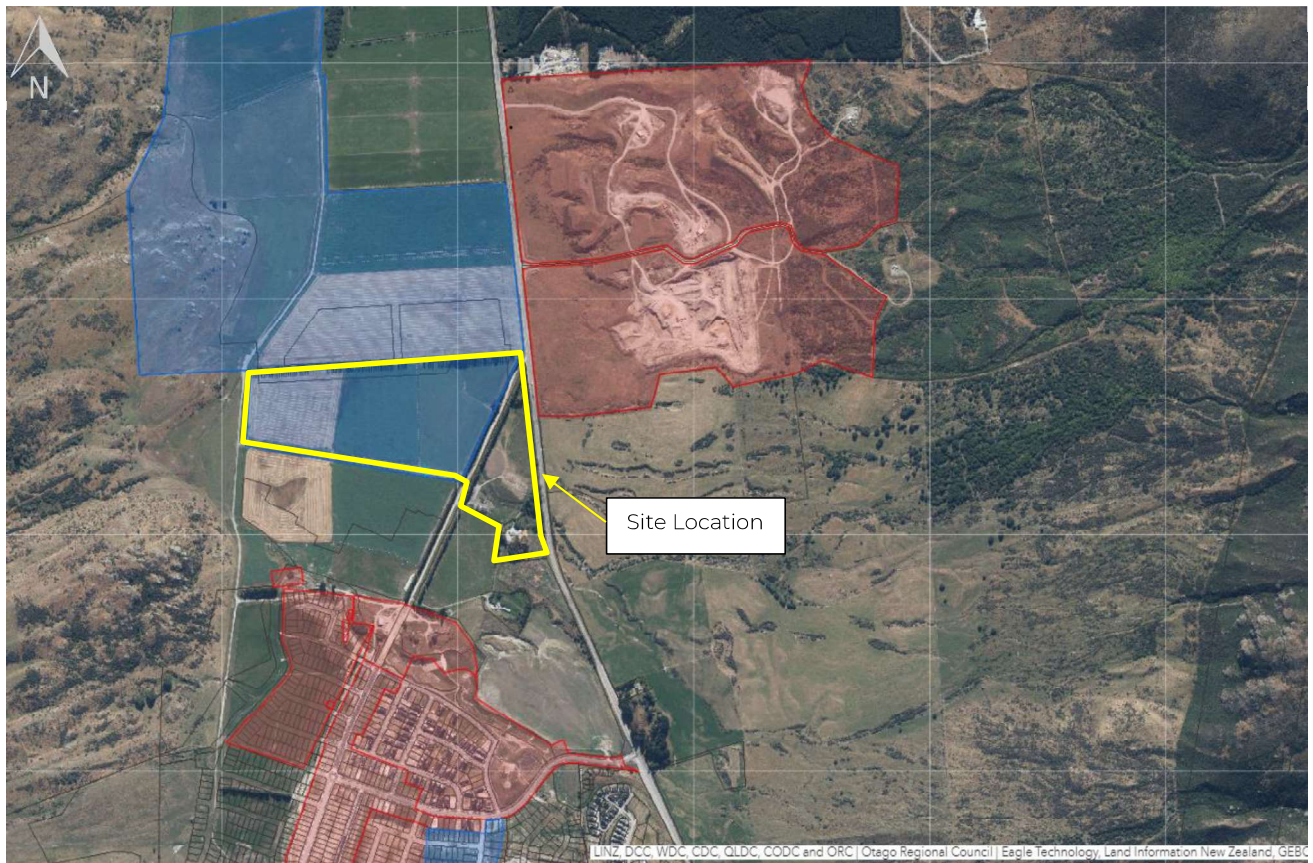
Figure 3: Extract from ORC Land Use Register showing an overview of HAIL sites surrounding the site, with blue and red shading indicating respectively a verified non-HAIL site and a verified HAIL site.

Several properties located within a 1km radius of the site are listed on the ORC Land Use Register as HAIL sites. A summary is shown in Table 5 below with an overview in Figure 3.

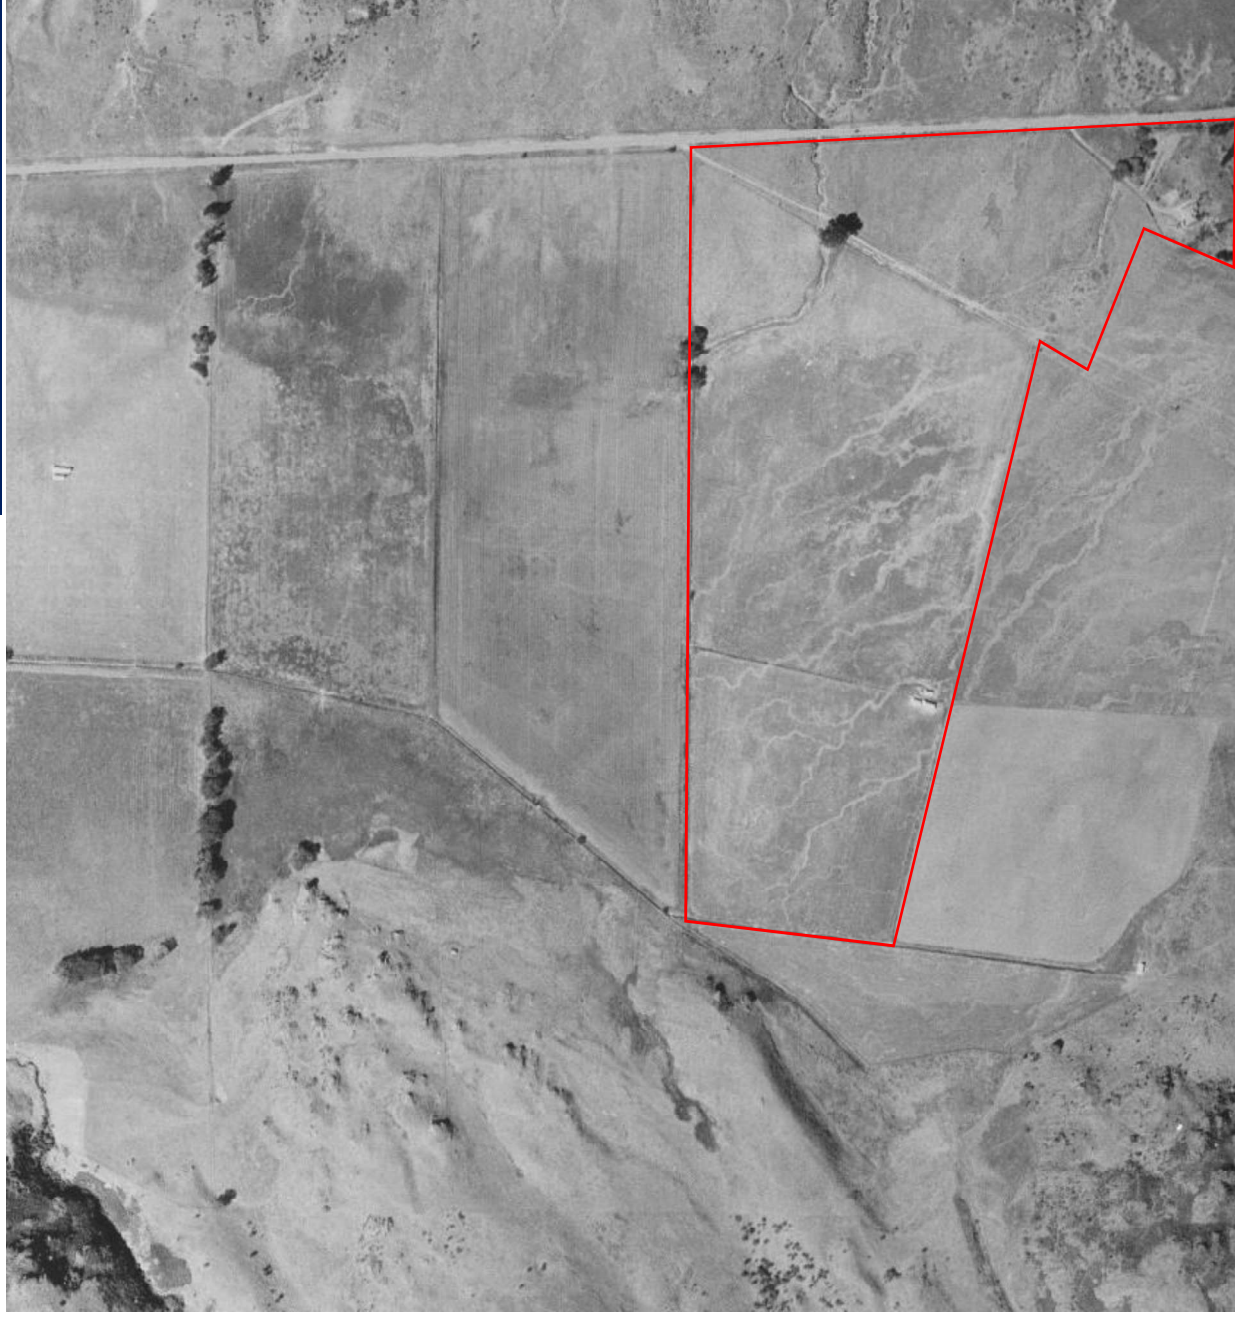
YEAR	OBSERVATIONS
1956 Retrolens	The site comprises vacant pastoral land. The eastern boundary aligns the main road with a gravel road dividing the site in two parts. Signs of general surface water flow are noted in a northwesterly direction and a creek is seen in the northeastern corner of the site. A shed can be seen near the centre of the site and a dwelling is located in the southeastern corner.
1959 Retrolens	No notable changes are seen on the site.
1964 Retrolens	Only part of the site is shown on the aerial. The creek in the northeastern corner originates east at the Remarkables Mountain Range. Several trees are planted in the vicinity of the dwelling.
1976 Retrolens	The sheds in the centre of the site have been removed. No discerning changes are noted to the site.
1978 Maps Past	Topographic map of the site and surrounding area showing the site at approximately 1100 feet amsl. State Highway 6 is shown along the eastern boundary of the site and Woolshed Rd is an established road through the site.

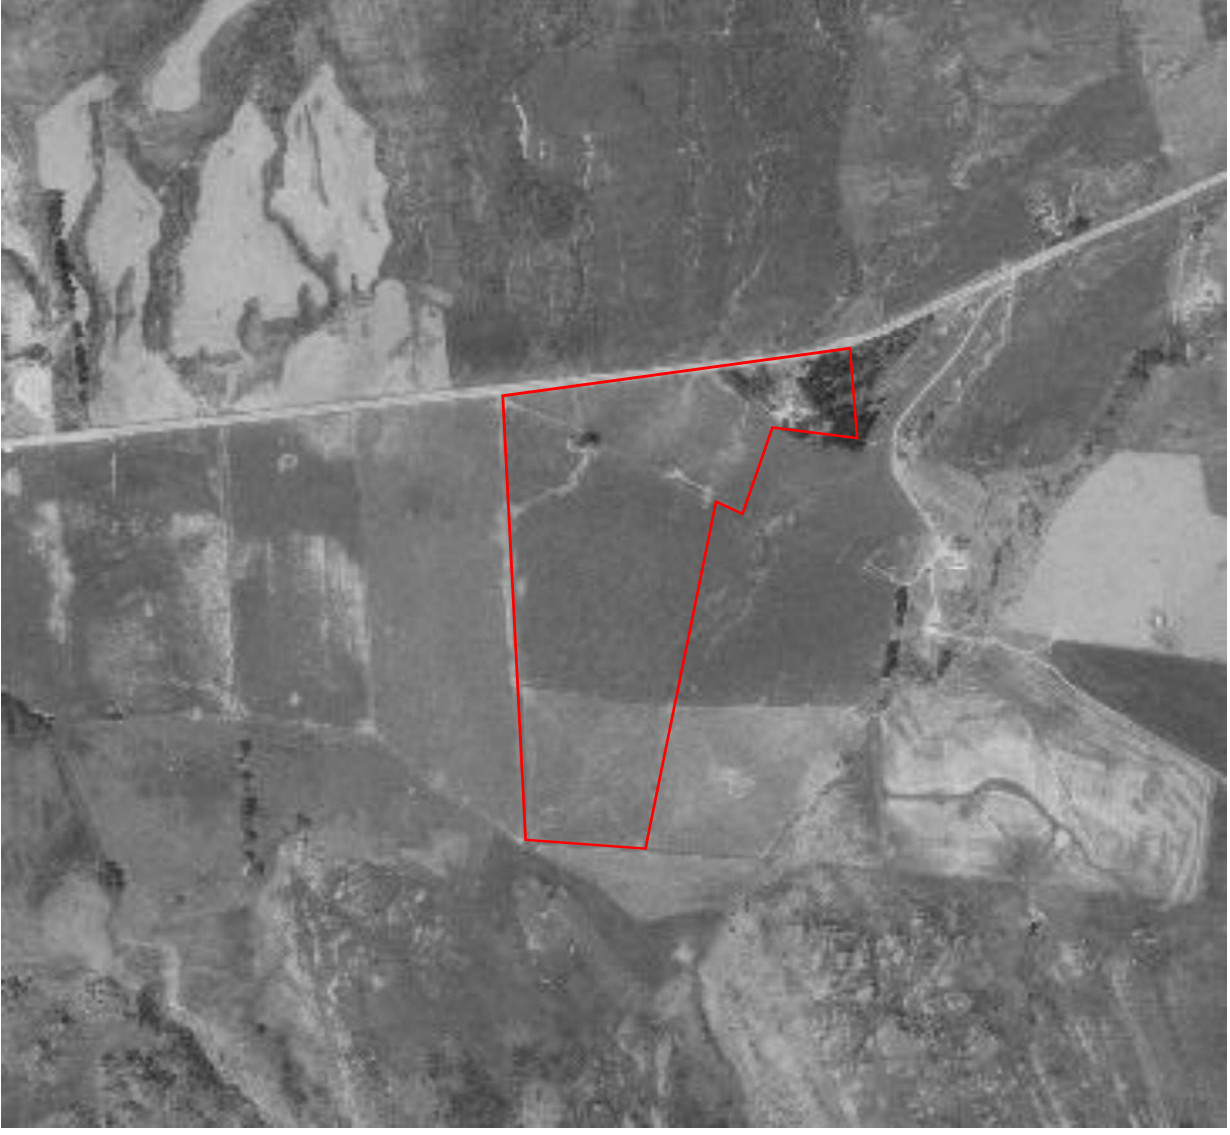
1983 - 1984 Retrolens	No notable changes are seen on the site or to the surrounding area.
