Project Number #22235.000.001

Geotechnical Investigation Report

*Patterson Block, Woolshed Road,
Queenstown*

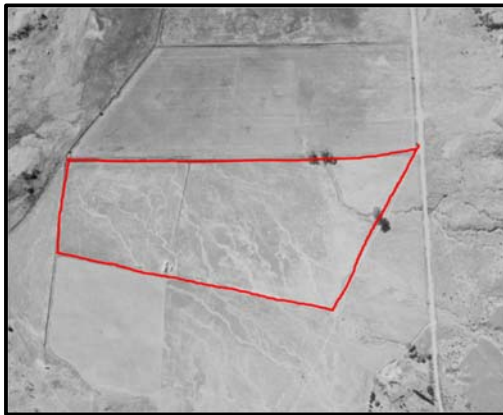
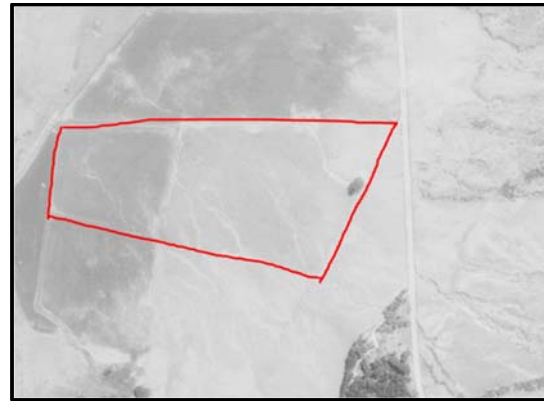
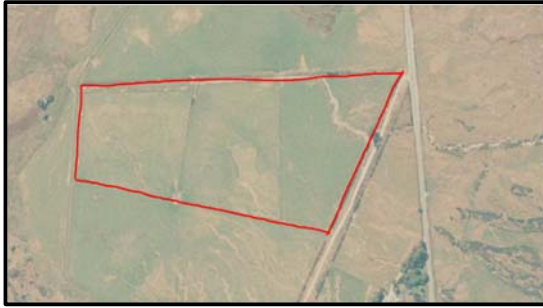
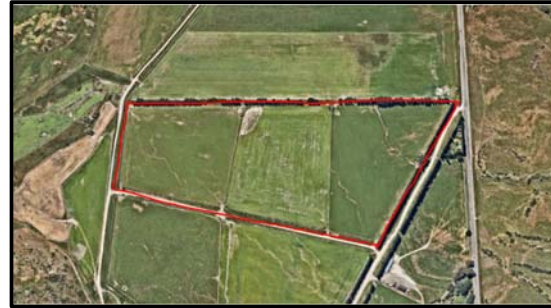
Figure 4: Historic Aerial Photographs of the Site

Photo 1: Image of the site in 1956 (Source: Retrolens)

Photo 2: Image of the site in 1976 (Source: Retrolens)

Photo 3: Image of the site in 2001 (Source: Retrolens)

Photo 4: Image of the site in 2020 (Source: Retrolens)

Images from 1956 until present day suggest the site has remained an undeveloped greenfield site, used for farming purposes. There are no distinct geomorphological changes that can be observed from historic photographs, other than suggestions of migration of overland flow paths over time.

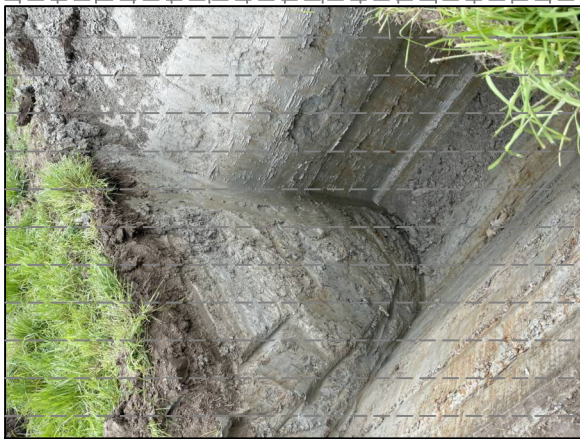
Groundwater inflow encountered at 1.9 m bgl
TS - Topsoil

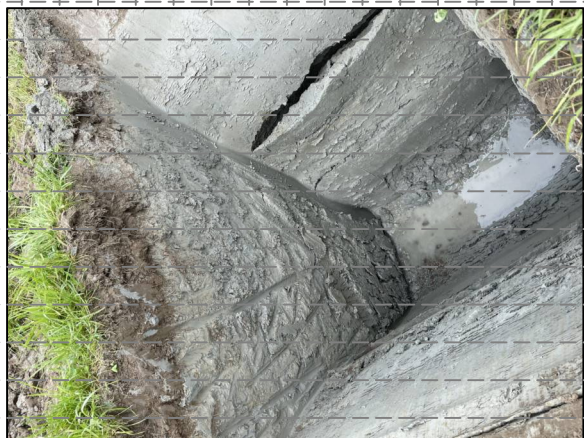
Groundwater inflow encountered at 1.9 m bgl
TS - Topsoil

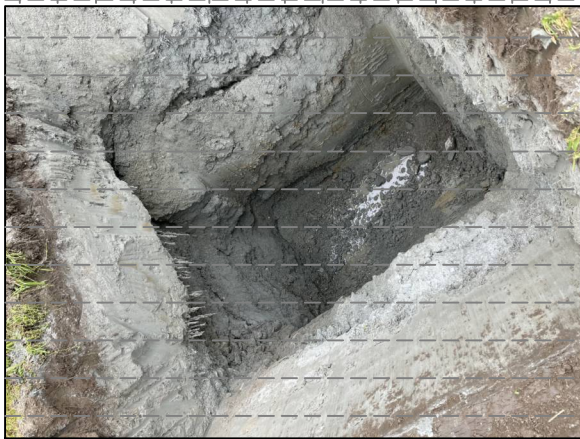
Groundwater inflow encountered at 2.1 m bgl
TS - Topsoil

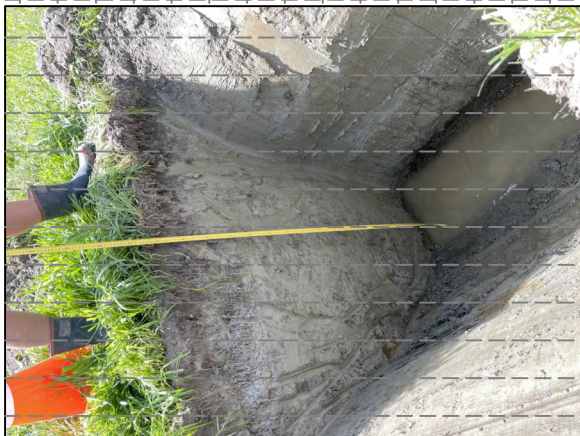
Groundwater inflow encountered at 1.9 m bgl
TS - Topsoil

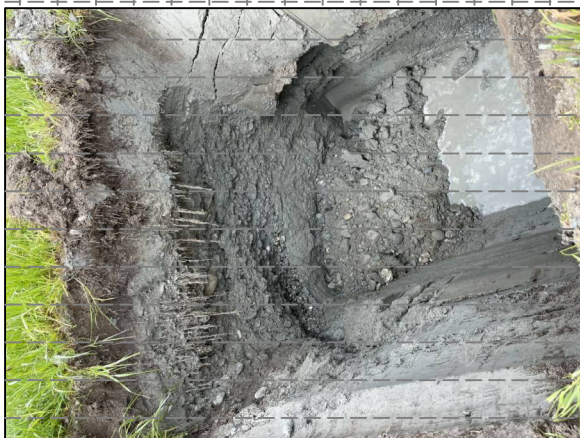
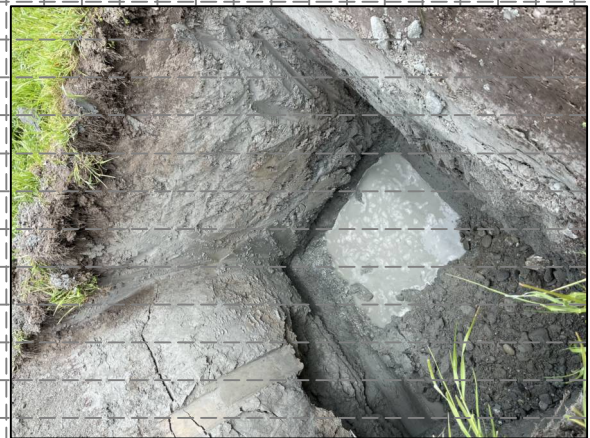
Groundwater inflow encountered at 1.2 m bgl; TS - Topsoil
The geological profile observed is indicative of the western wall of the TP. Variability in the geology of the pit walls was observed, with the outwash material 1

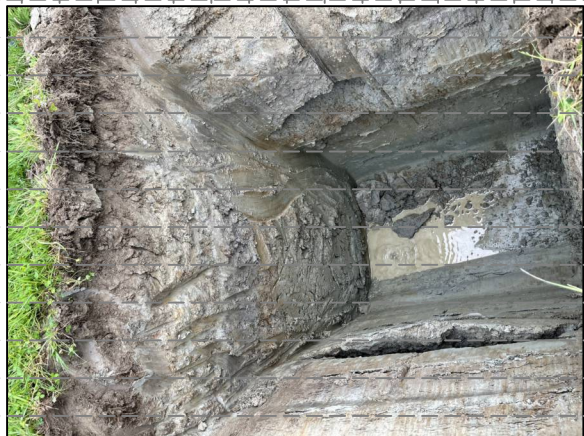
Groundwater inflow encountered at 2.1 m bgl
TS - Topsoil
