Sunfield Developments Limited

PRELIMINARY GEOTECHNICAL ASSESSMENT REPORT

Sunfields Landholding, Ardmore

Project Reference: J01627 December 8, 2023

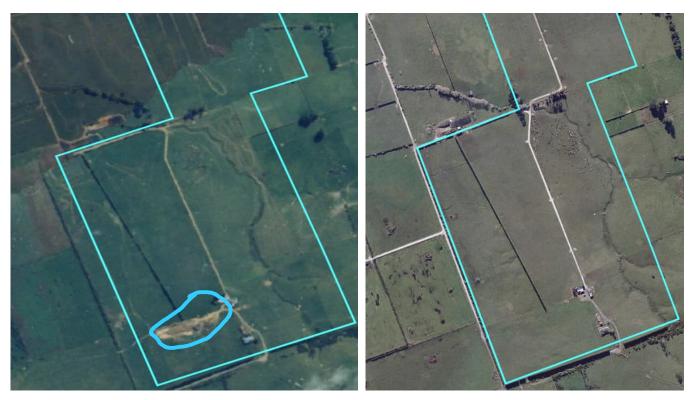
<u>Inset A</u>. Left: Photograph dated 1959, retrieved from Auckland Council GIS database. Area of earthworks circled in blue. Right: Photograph dated 2001.

Our interpretation of available historic photographs on Auckland Council's online GIS database, Google Earth images and historic images from Retrolens.nz generally found only minor land modification on the study area over the period 1940 to 2017, however, an area of localised earthworks is identified on or prior to 1959 within the south-western portion of 508 Old Wairoa Road. The next available aerial photograph in 2001 shows the area to be grassed and in the same condition as of the time of preparing this report. This area is discussed in further detail in Section 6.2. Historic aerial photographs dated 1959 and 2001 are inset below.

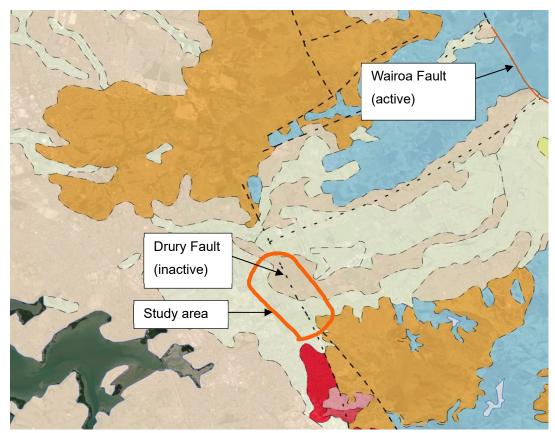
<u>Inset B</u>: Published Geology (Institute of Geological and Nuclear Sciences. QMap geology. KMZ file. Available from https://services.arcgisonline.co.nz).

Beyond the site to the south are deposits (Basalt and Ash / Tuff soils) of the South Auckland Volcanic Field (i.e. pink and red shadings on Inset B). The inactive Drury Fault runs through the site in a north-south fashion. Additionally, the Wairoa Fault (reportedly active, but last event unknown) is located approximately 10km to the east of the study area beneath the Hunua ranges. The position of these geological units and faults are summarised in Inset B below, and also in more detail in Figures 2.11 and 2.12 (Appendix 2).

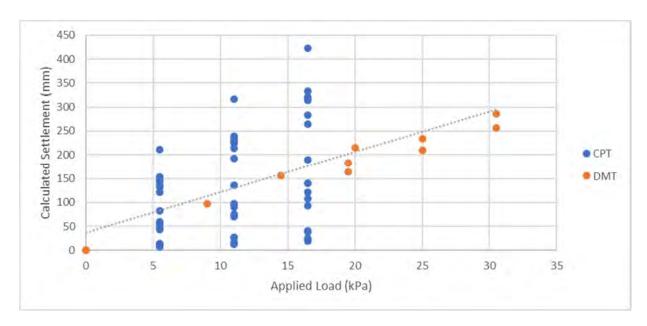
Inset C: Applied Load vs Calculated Settlement for all Zone 1 assessments.

The insets below show a summary of the expected settlements calculated for both Zones. It should be noted that there is a reasonable disparity between CPT and DMT settlement estimations. DMT methods are widely regarded as a more accurate in-situ test for estimating settlements due to the direct measurement of the soil constraint modulus (M). Notwithstanding, trial preloading as alluded to later in this section will help assess actual response of the ground to surcharge application, as opposed to reliance on widely varying theoretical estimations.

Based on these preliminary analyses, the settlements are assessed to generally be acceptable for NZS3604-type buildings up to three-storeys constructed in Zone 2 areas, however, within Zone 1, all assessed tests were found to be in excess of this requirement as is expected in 'Peat'.

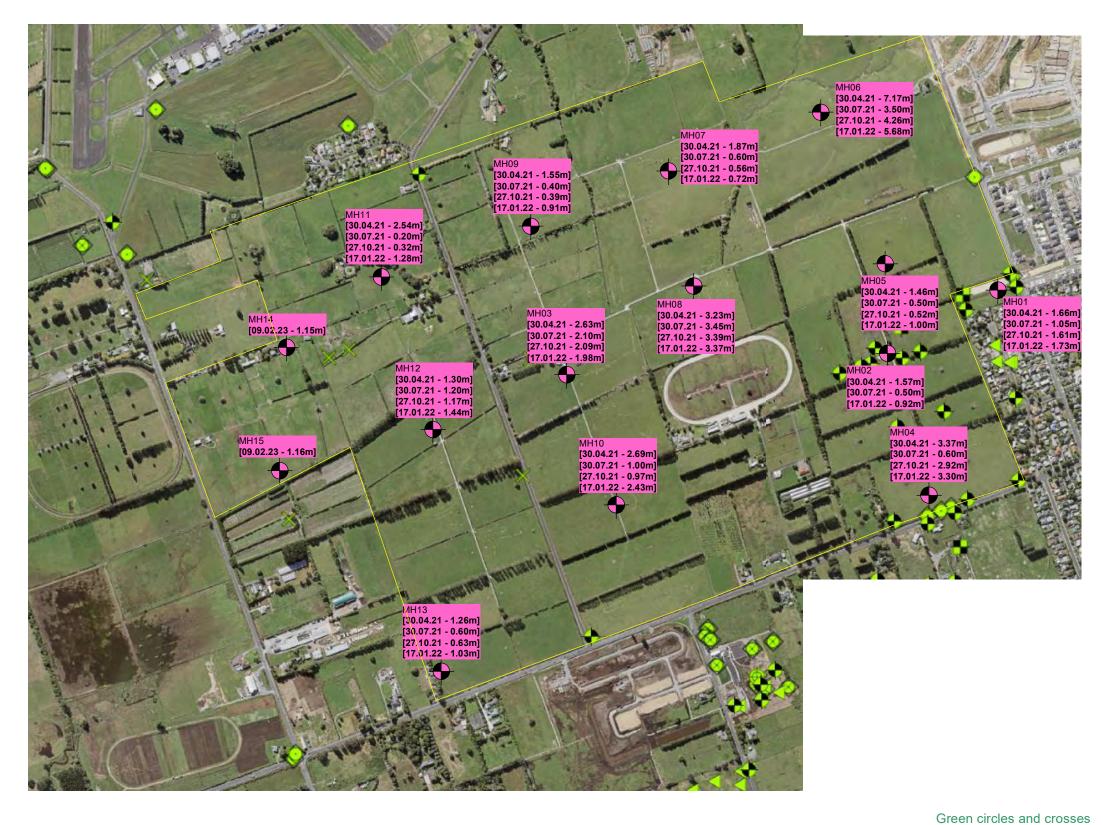
77	client:	SUNFIELD DEVELOPM	ENTS LIMITE	ED					
	project:								
	SUNFIELDS, ARDMORE								
	title:	STUDY AREA GEOL	OGY PLAN						
	project no:	J01627	figure no:	2.1

SOURCE: NZGS Database, existing tests as green circles or crosses

These materials comprise inorganic and organic stained silty CLAY and clayey SILT of firm to hard shear strength, although generally stiff. The inferred locations of these materials are indicated on Figure 2.1 which are generally

These materials comprise inorganic or organic stained silty CLAY and clayey SILT, with some variable beds of organic silty CLAY or organic clayey SILT. The materials were generally stiff to hard, and their locations on site are shown in Figure 2.1 to be in the central northern portions of the study area, generally extended to depths of between 6m to 12m below existing ground levels.

Two percolation tests (P01 and P02) were undertaken in the locations indicated on appended Figure 2.1. Tests were undertaken in accordance with TR 2013/040, Appendix A, Annexure C, Worksheet W1 – Falling Head Percolation Test (i.e. autumn conditions). Percolation rates are as indicated on the table below:
