***DETAILED SITE INVESTIGATION***  
***55 COSGRAVE ROAD &***  
***55A COSGRAVE ROAD***  
***ARDMORE***  
***AUCKLAND***

Reference: FES 1443.008 December 2023 (R4)

Project Name Detailed Site Investigation  
55 Cosgrave Road & 55A Cosgrave Road, Ardmore

Winton Land Limited - 55 Cosgrave Road, Ardmore

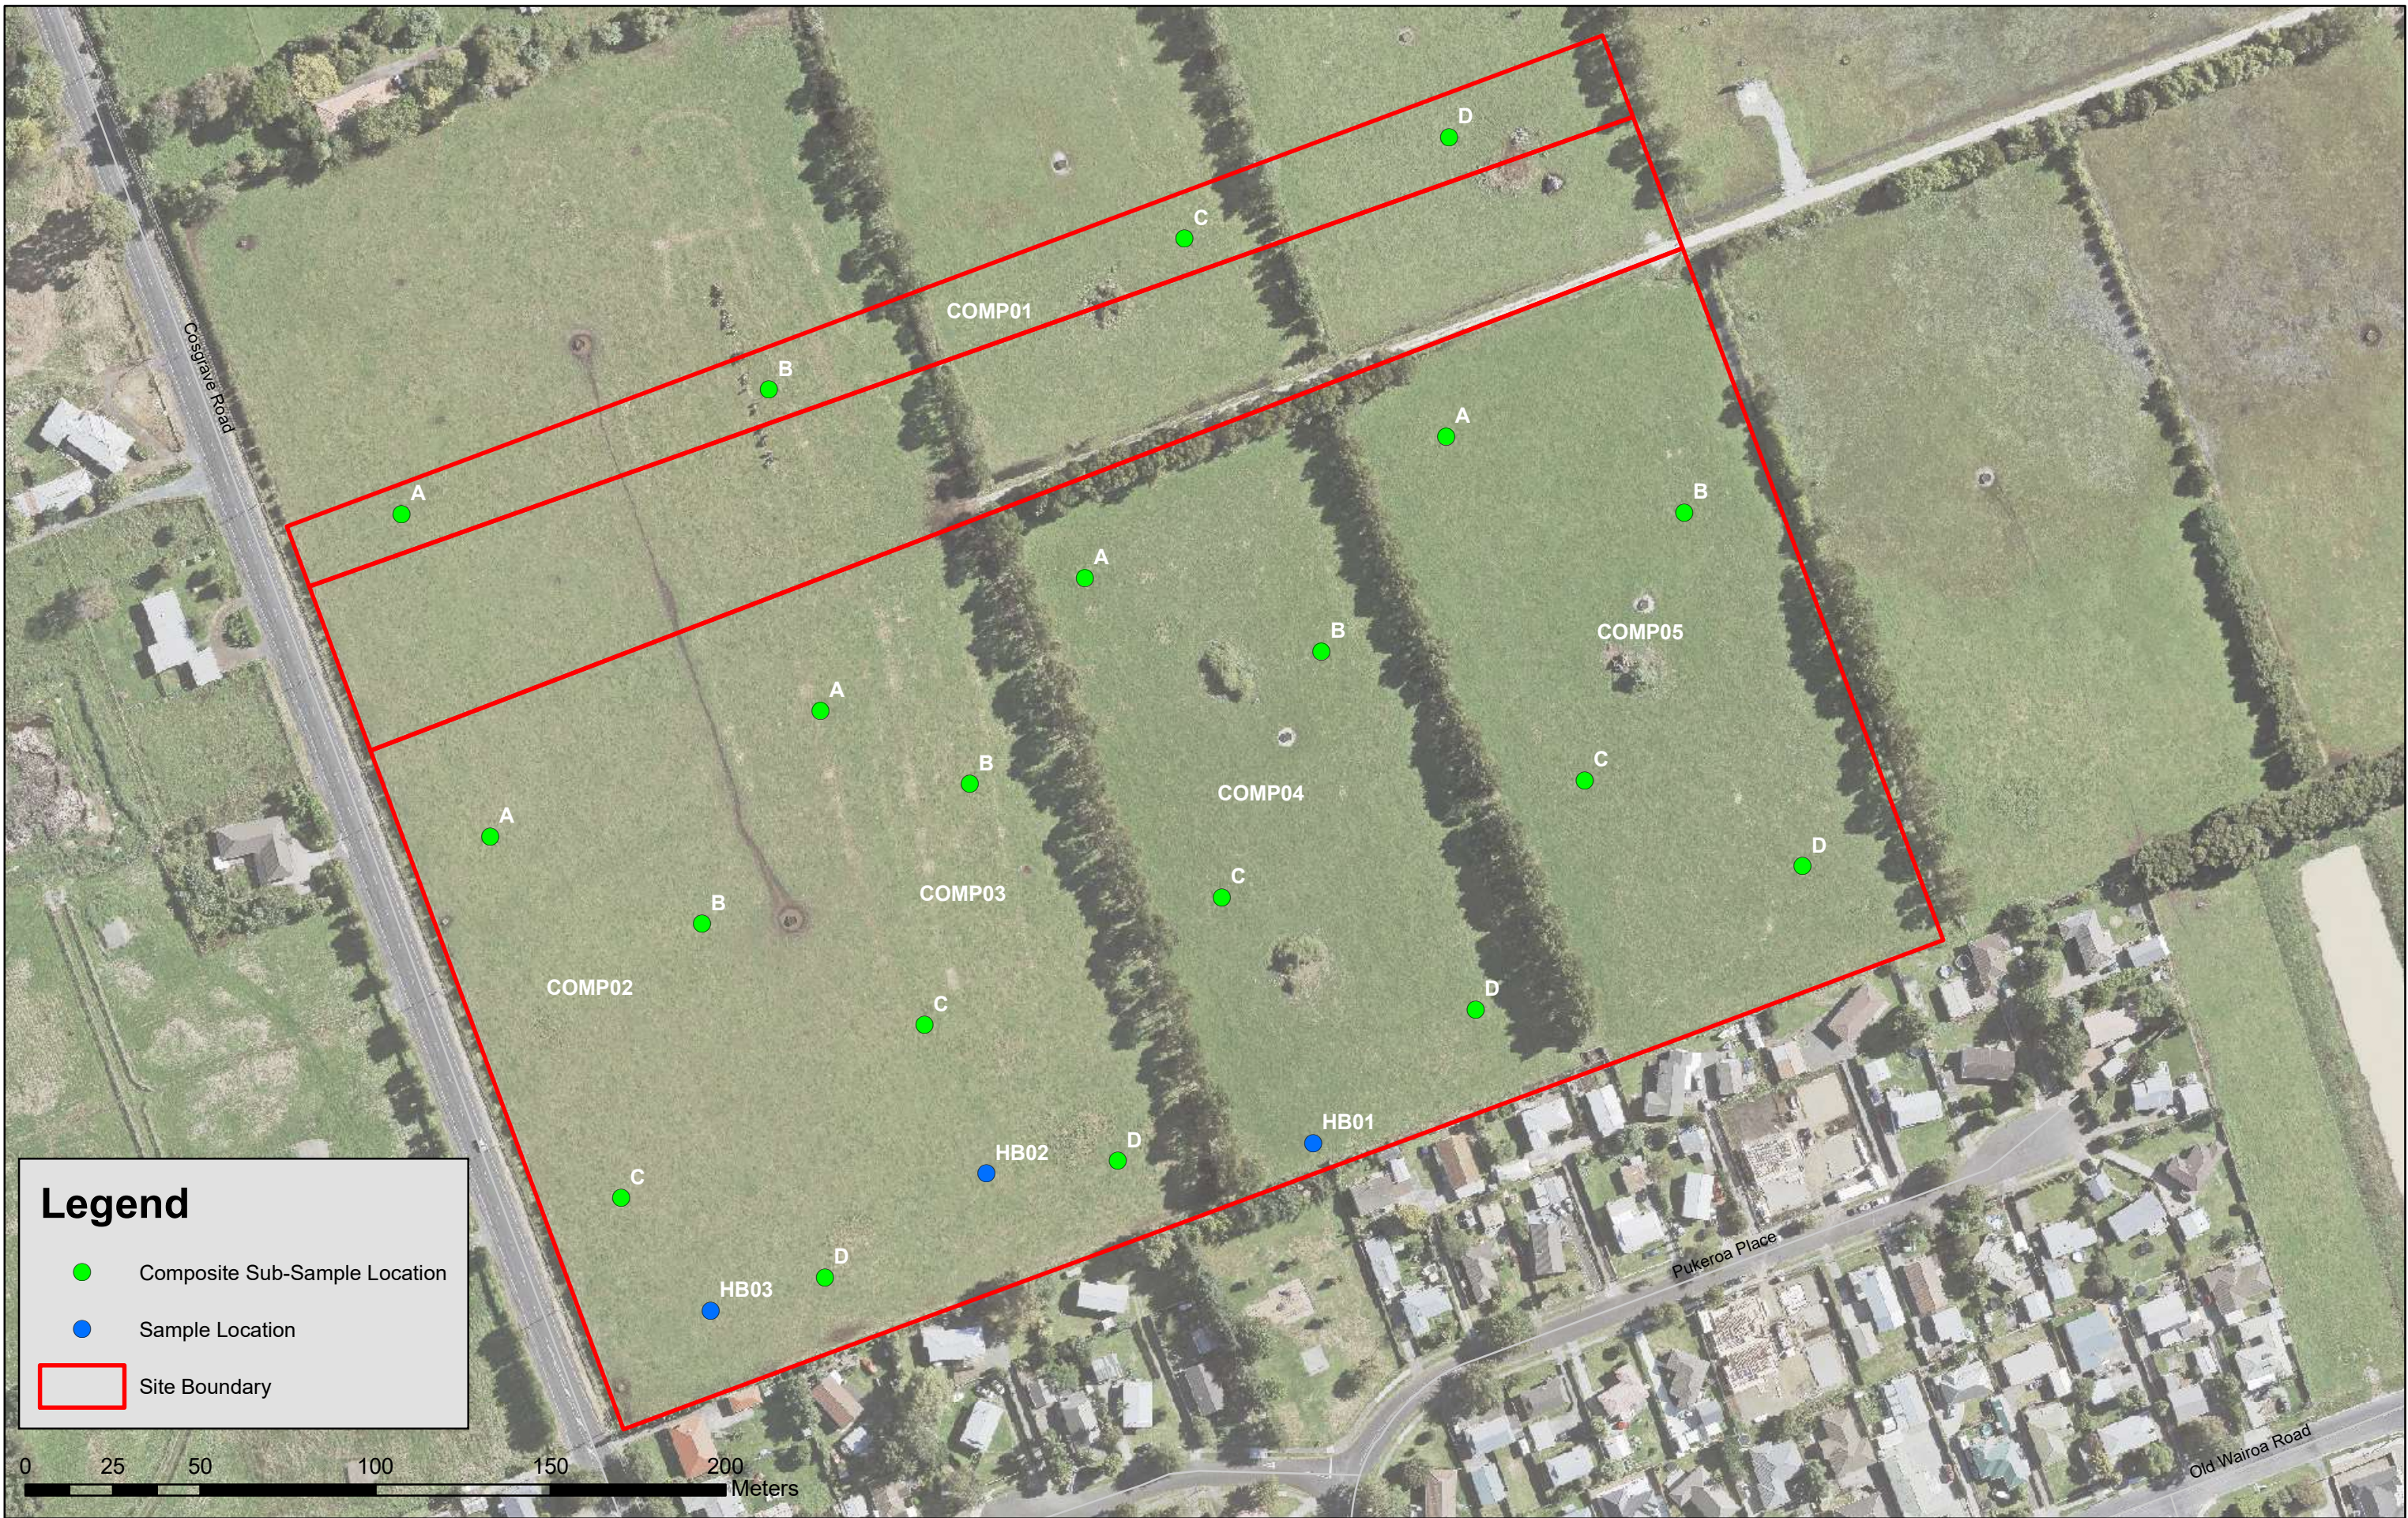
**Figure 1 -Site Location Plan**  
**Figure 2 - Sample Location Plan**

<p>Focus Environmental Services Limited PO Box 11455 Ellerslie Auckland 1542</p> <p>Ph: +64 9 579 4155 www.focusenvironmental.co.nz</p>	<p><b>Winton Land Limited</b> 55 &amp; 55A Cosgrave Road Sunfield Urban Development Area Papakura Auckland</p>	<p><b>Figure 2: Sample Location Plan</b> Detailed Site Investigation</p>

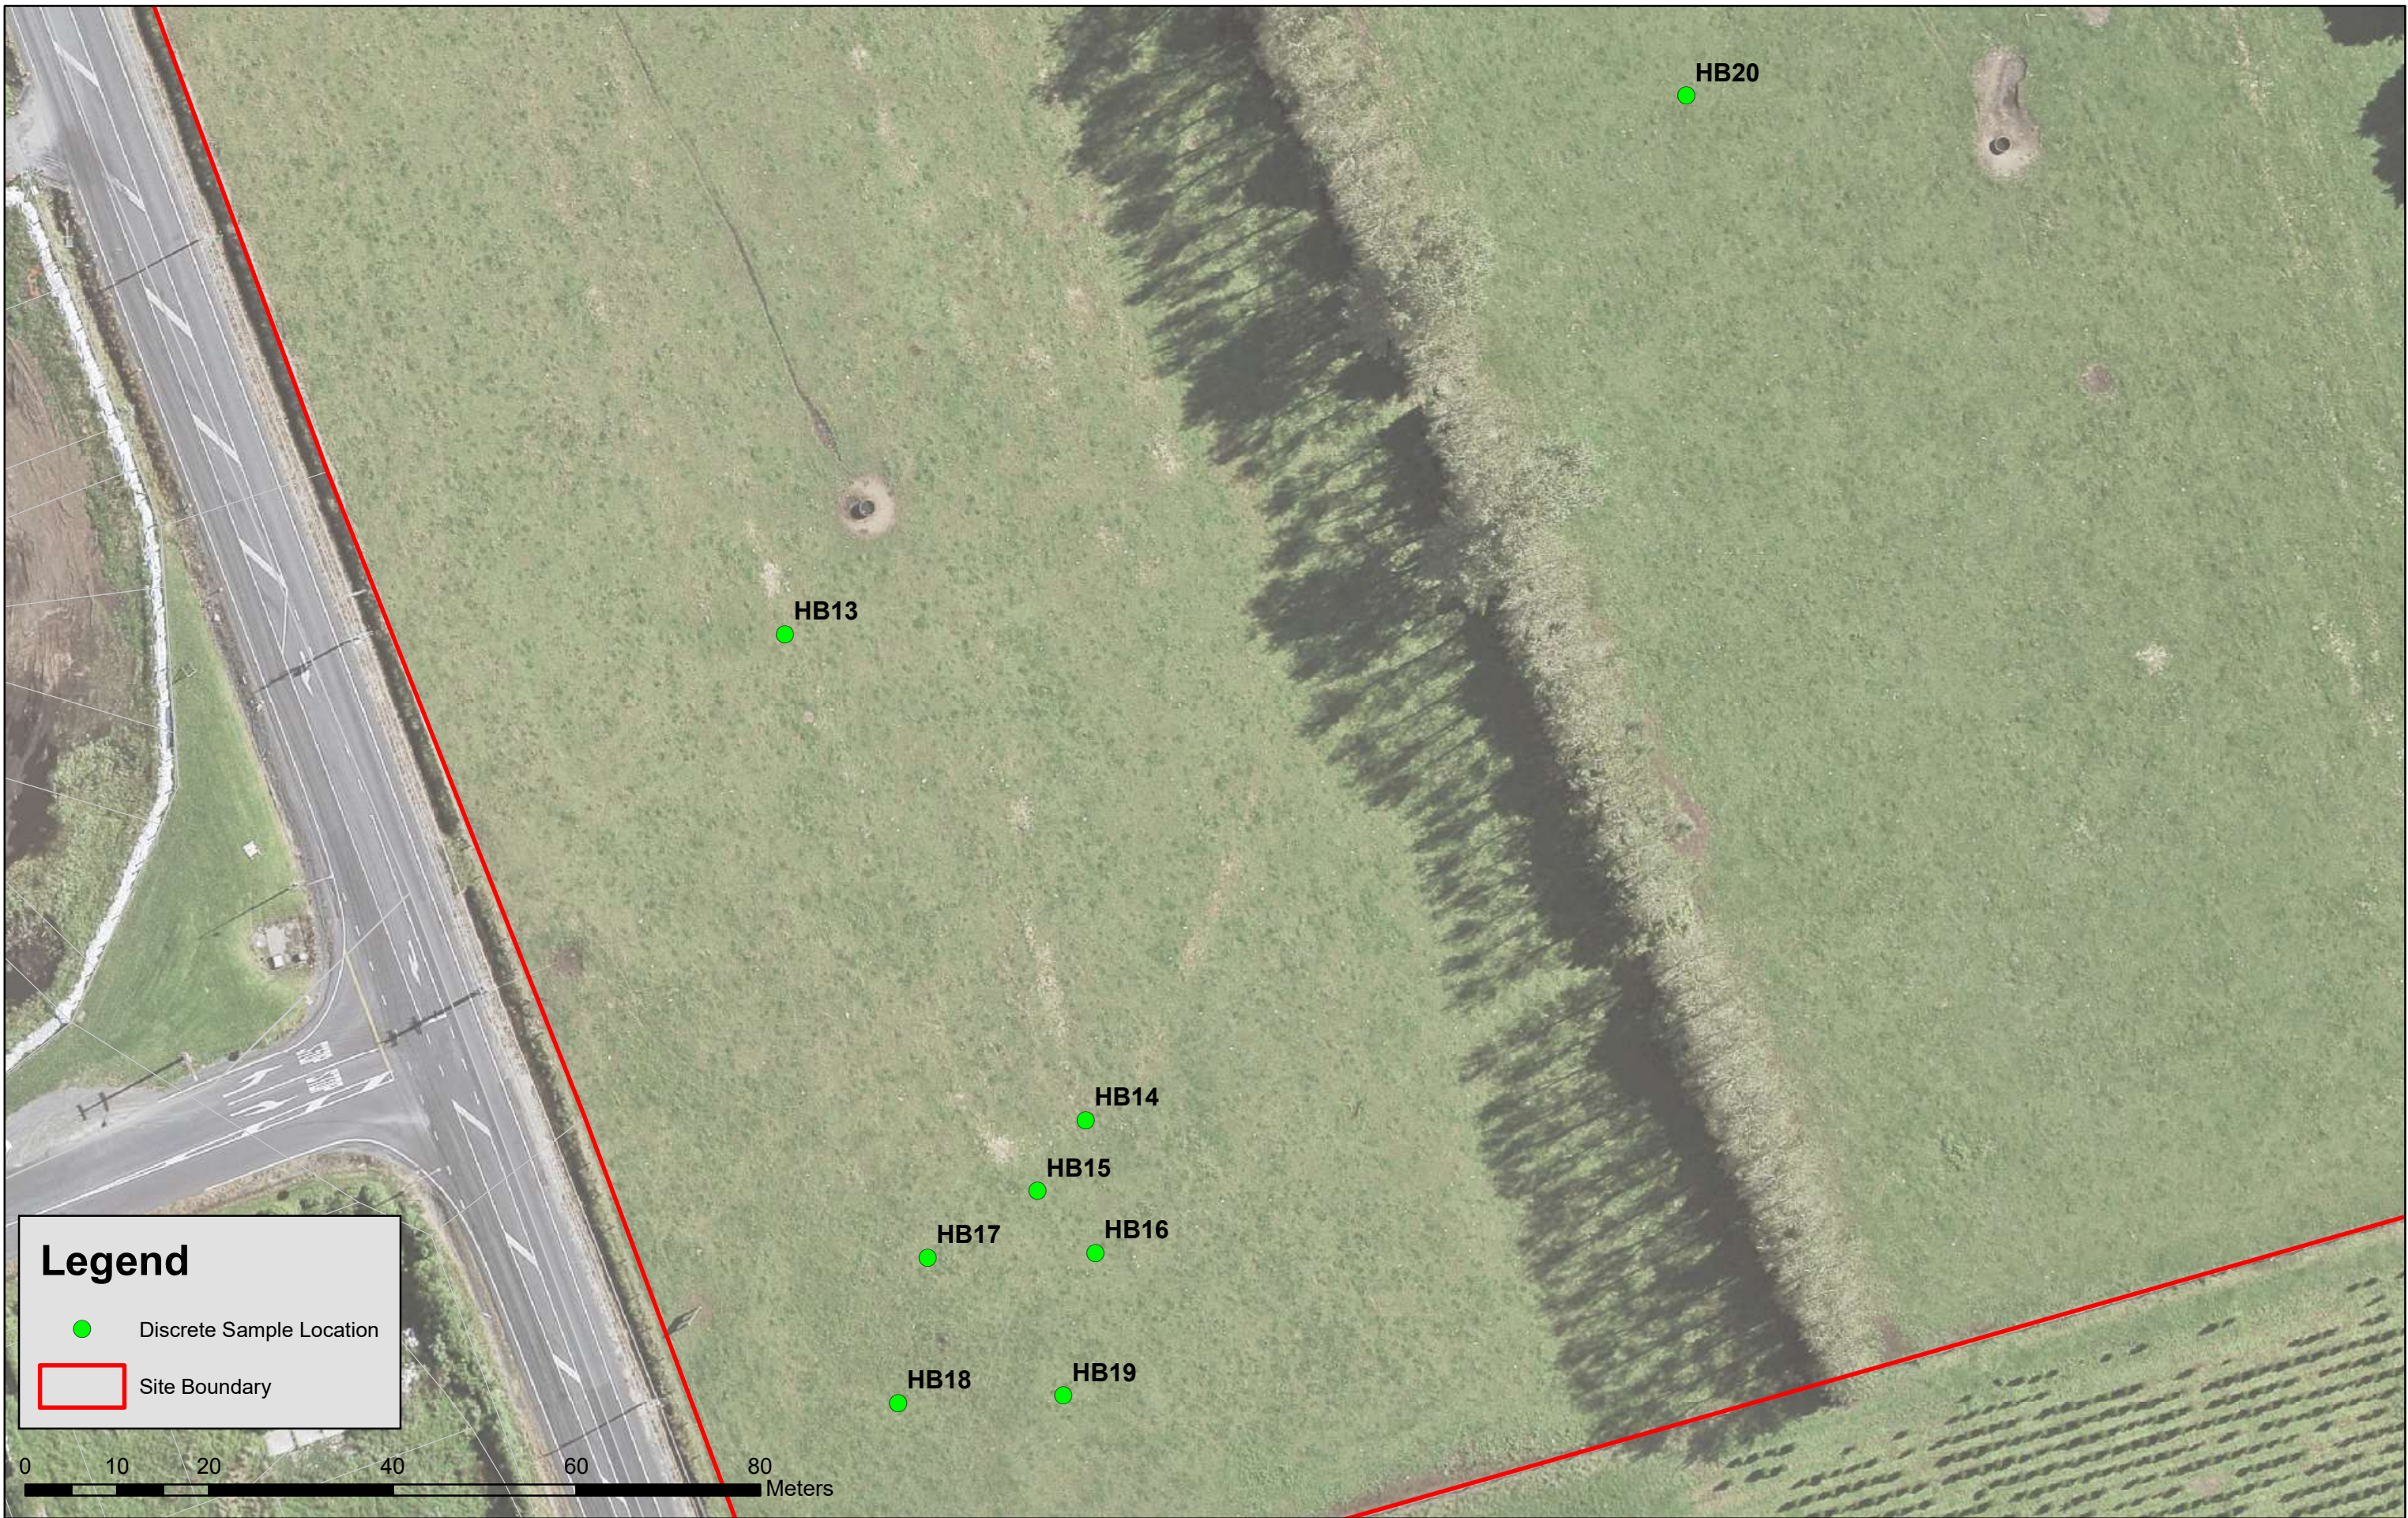
Drawing Number: 1443.009.02-1
				Drawn By: MT
				Checked By: DO'R
				Date: 20/12/2023

<p>Focus Environmental Services Limited PO Box 11455 Ellerslie Auckland 1542</p> <p>Ph: +64 9 579 4155 www.focusenvironmental.co.nz</p>	<p><b>Winton Land Limited</b> 80 Hamlin Road Sunfield Urban Development Area Papakura Auckland</p>	<p><b>Figure 2-1: Sample Location Plan</b></p> <p>DSI, RAP &amp; AEE</p>

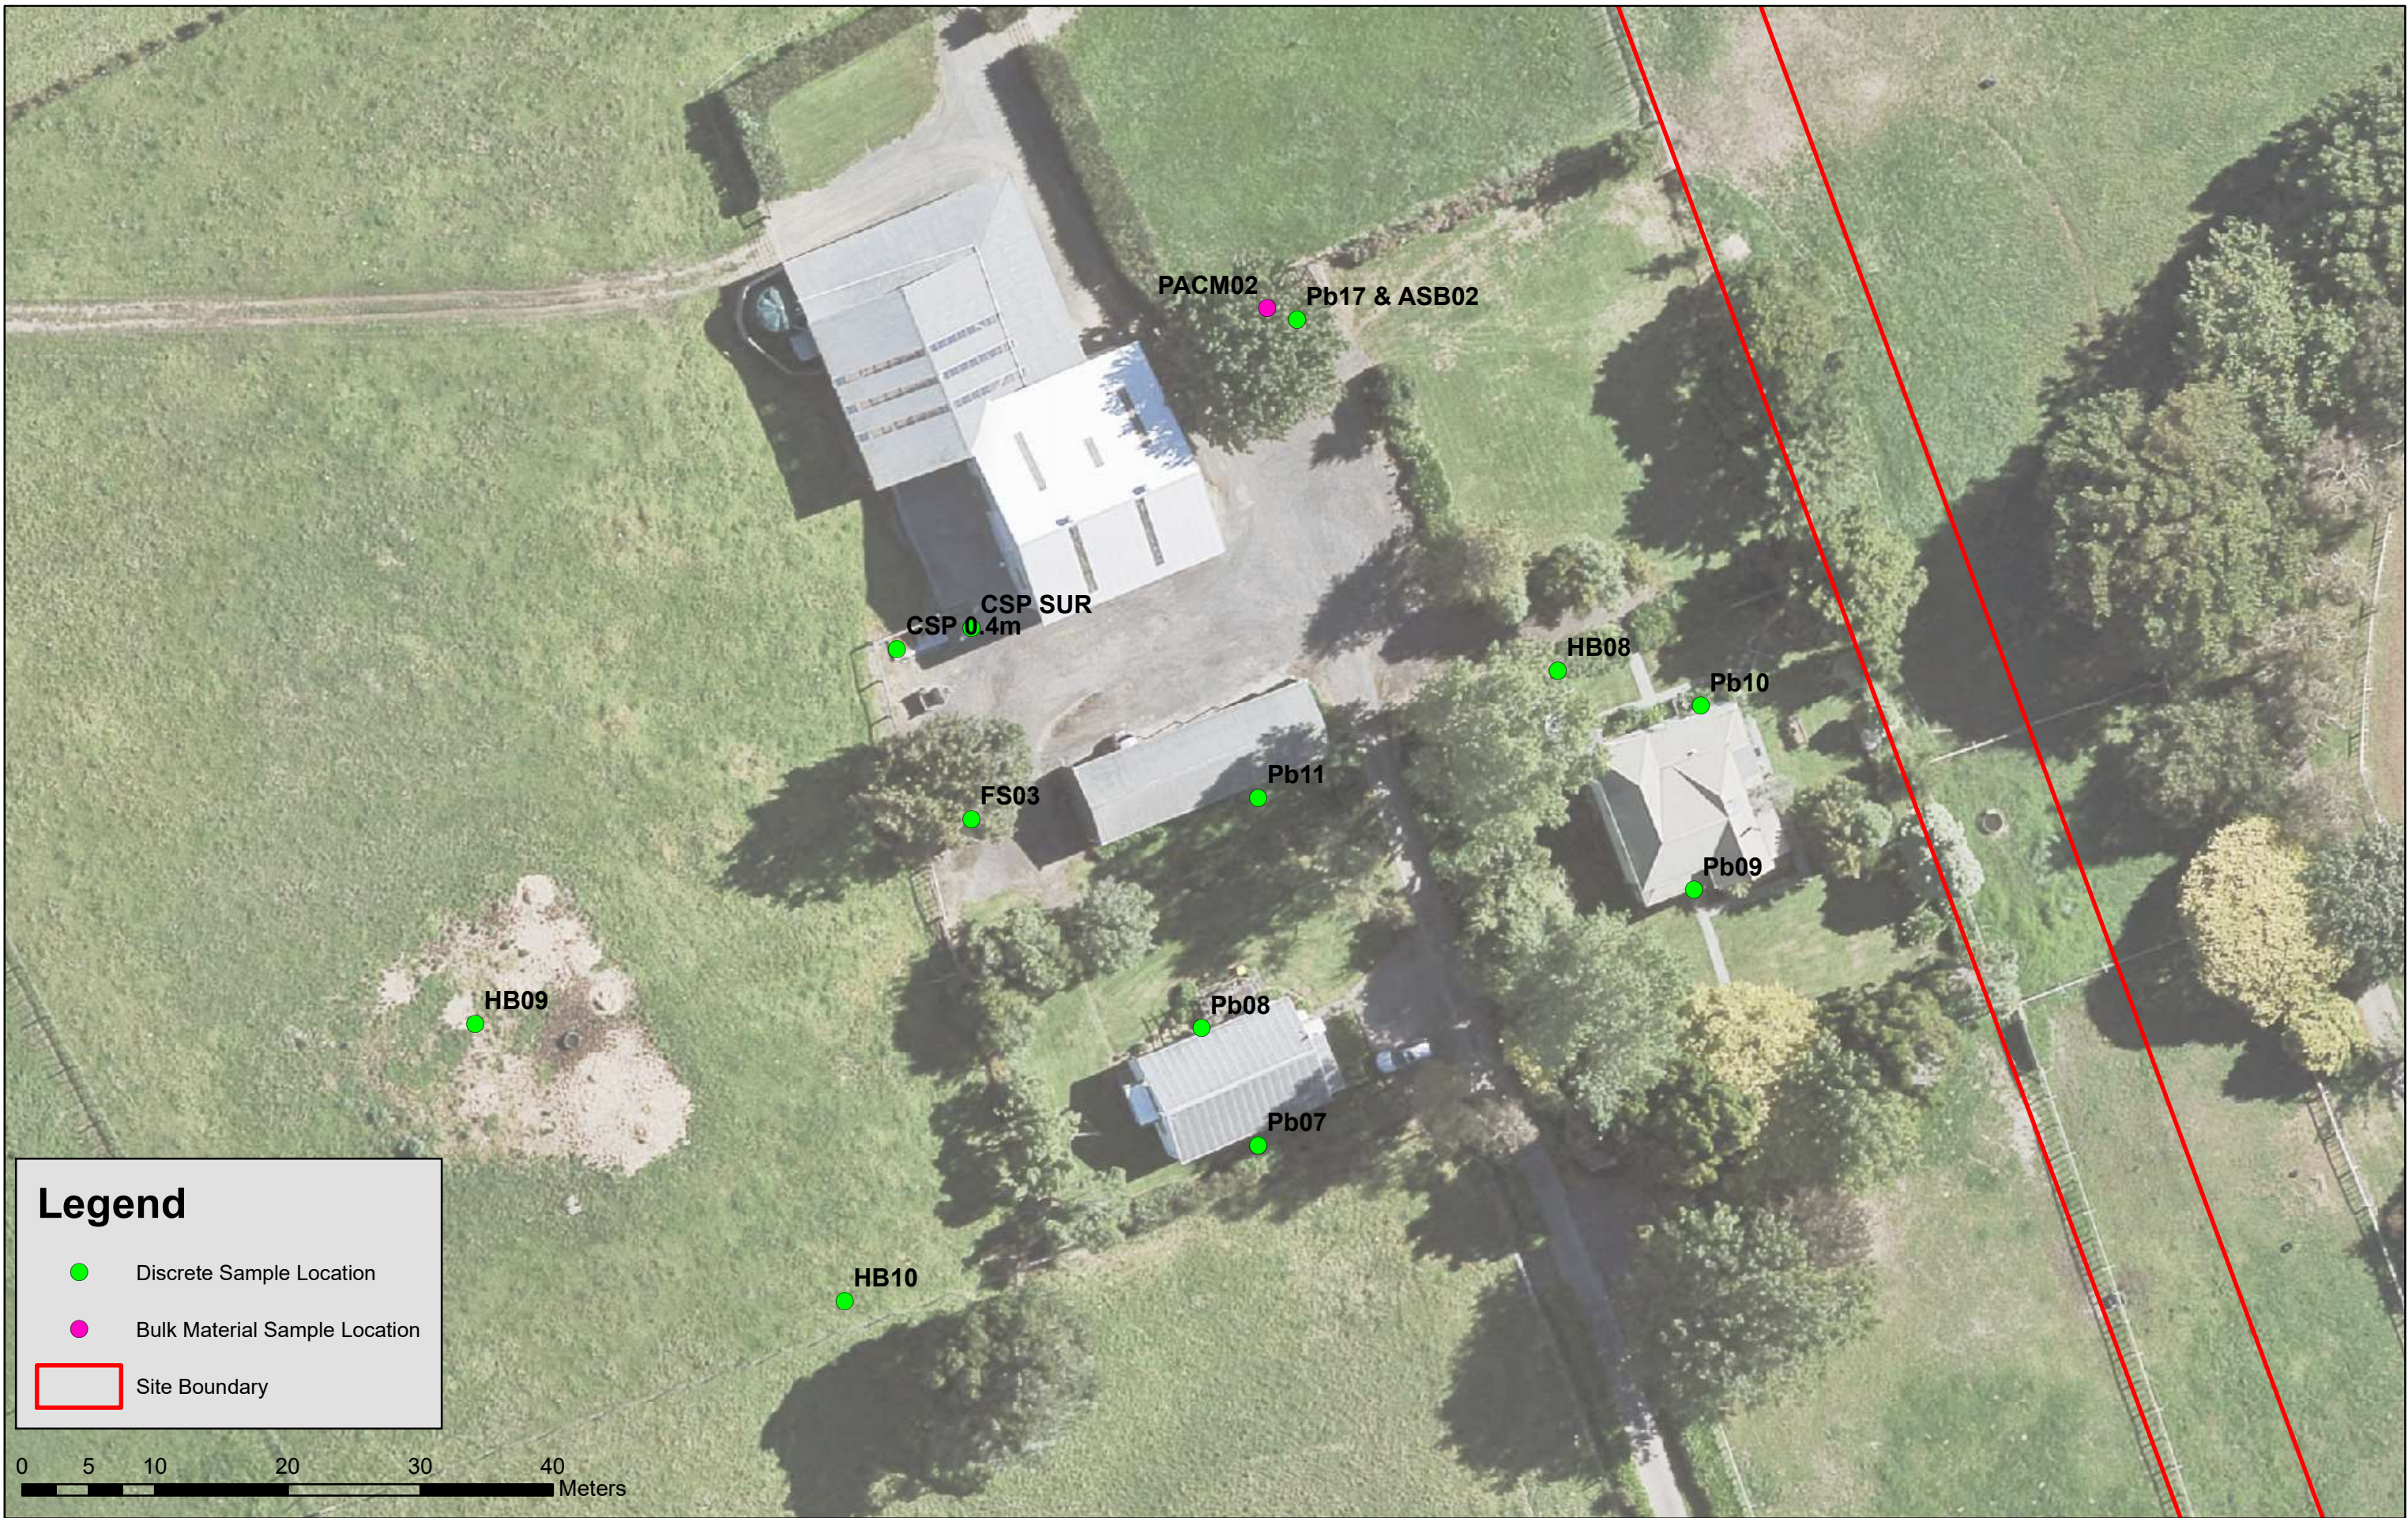
<div>1443.009 (R1)</div>	Drawing Number: 1443.009.02-4
				Drawn By: MT
				Checked By: DO'R
				Date: 20/12/2023

<div>Focus Environmental Services Limited PO Box 11455 Ellerslie Auckland 1542  Ph: +64 9 579 4155 www.focusenvironmental.co.nz</div>	<div>Winton Land Limited 80 Hamlin Road Sunfield Urban Development Area Papakura Auckland</div>	<div>Figure 2-4: Sample Location Plan</div> <div>DSI, RAP &amp; AEE</div>

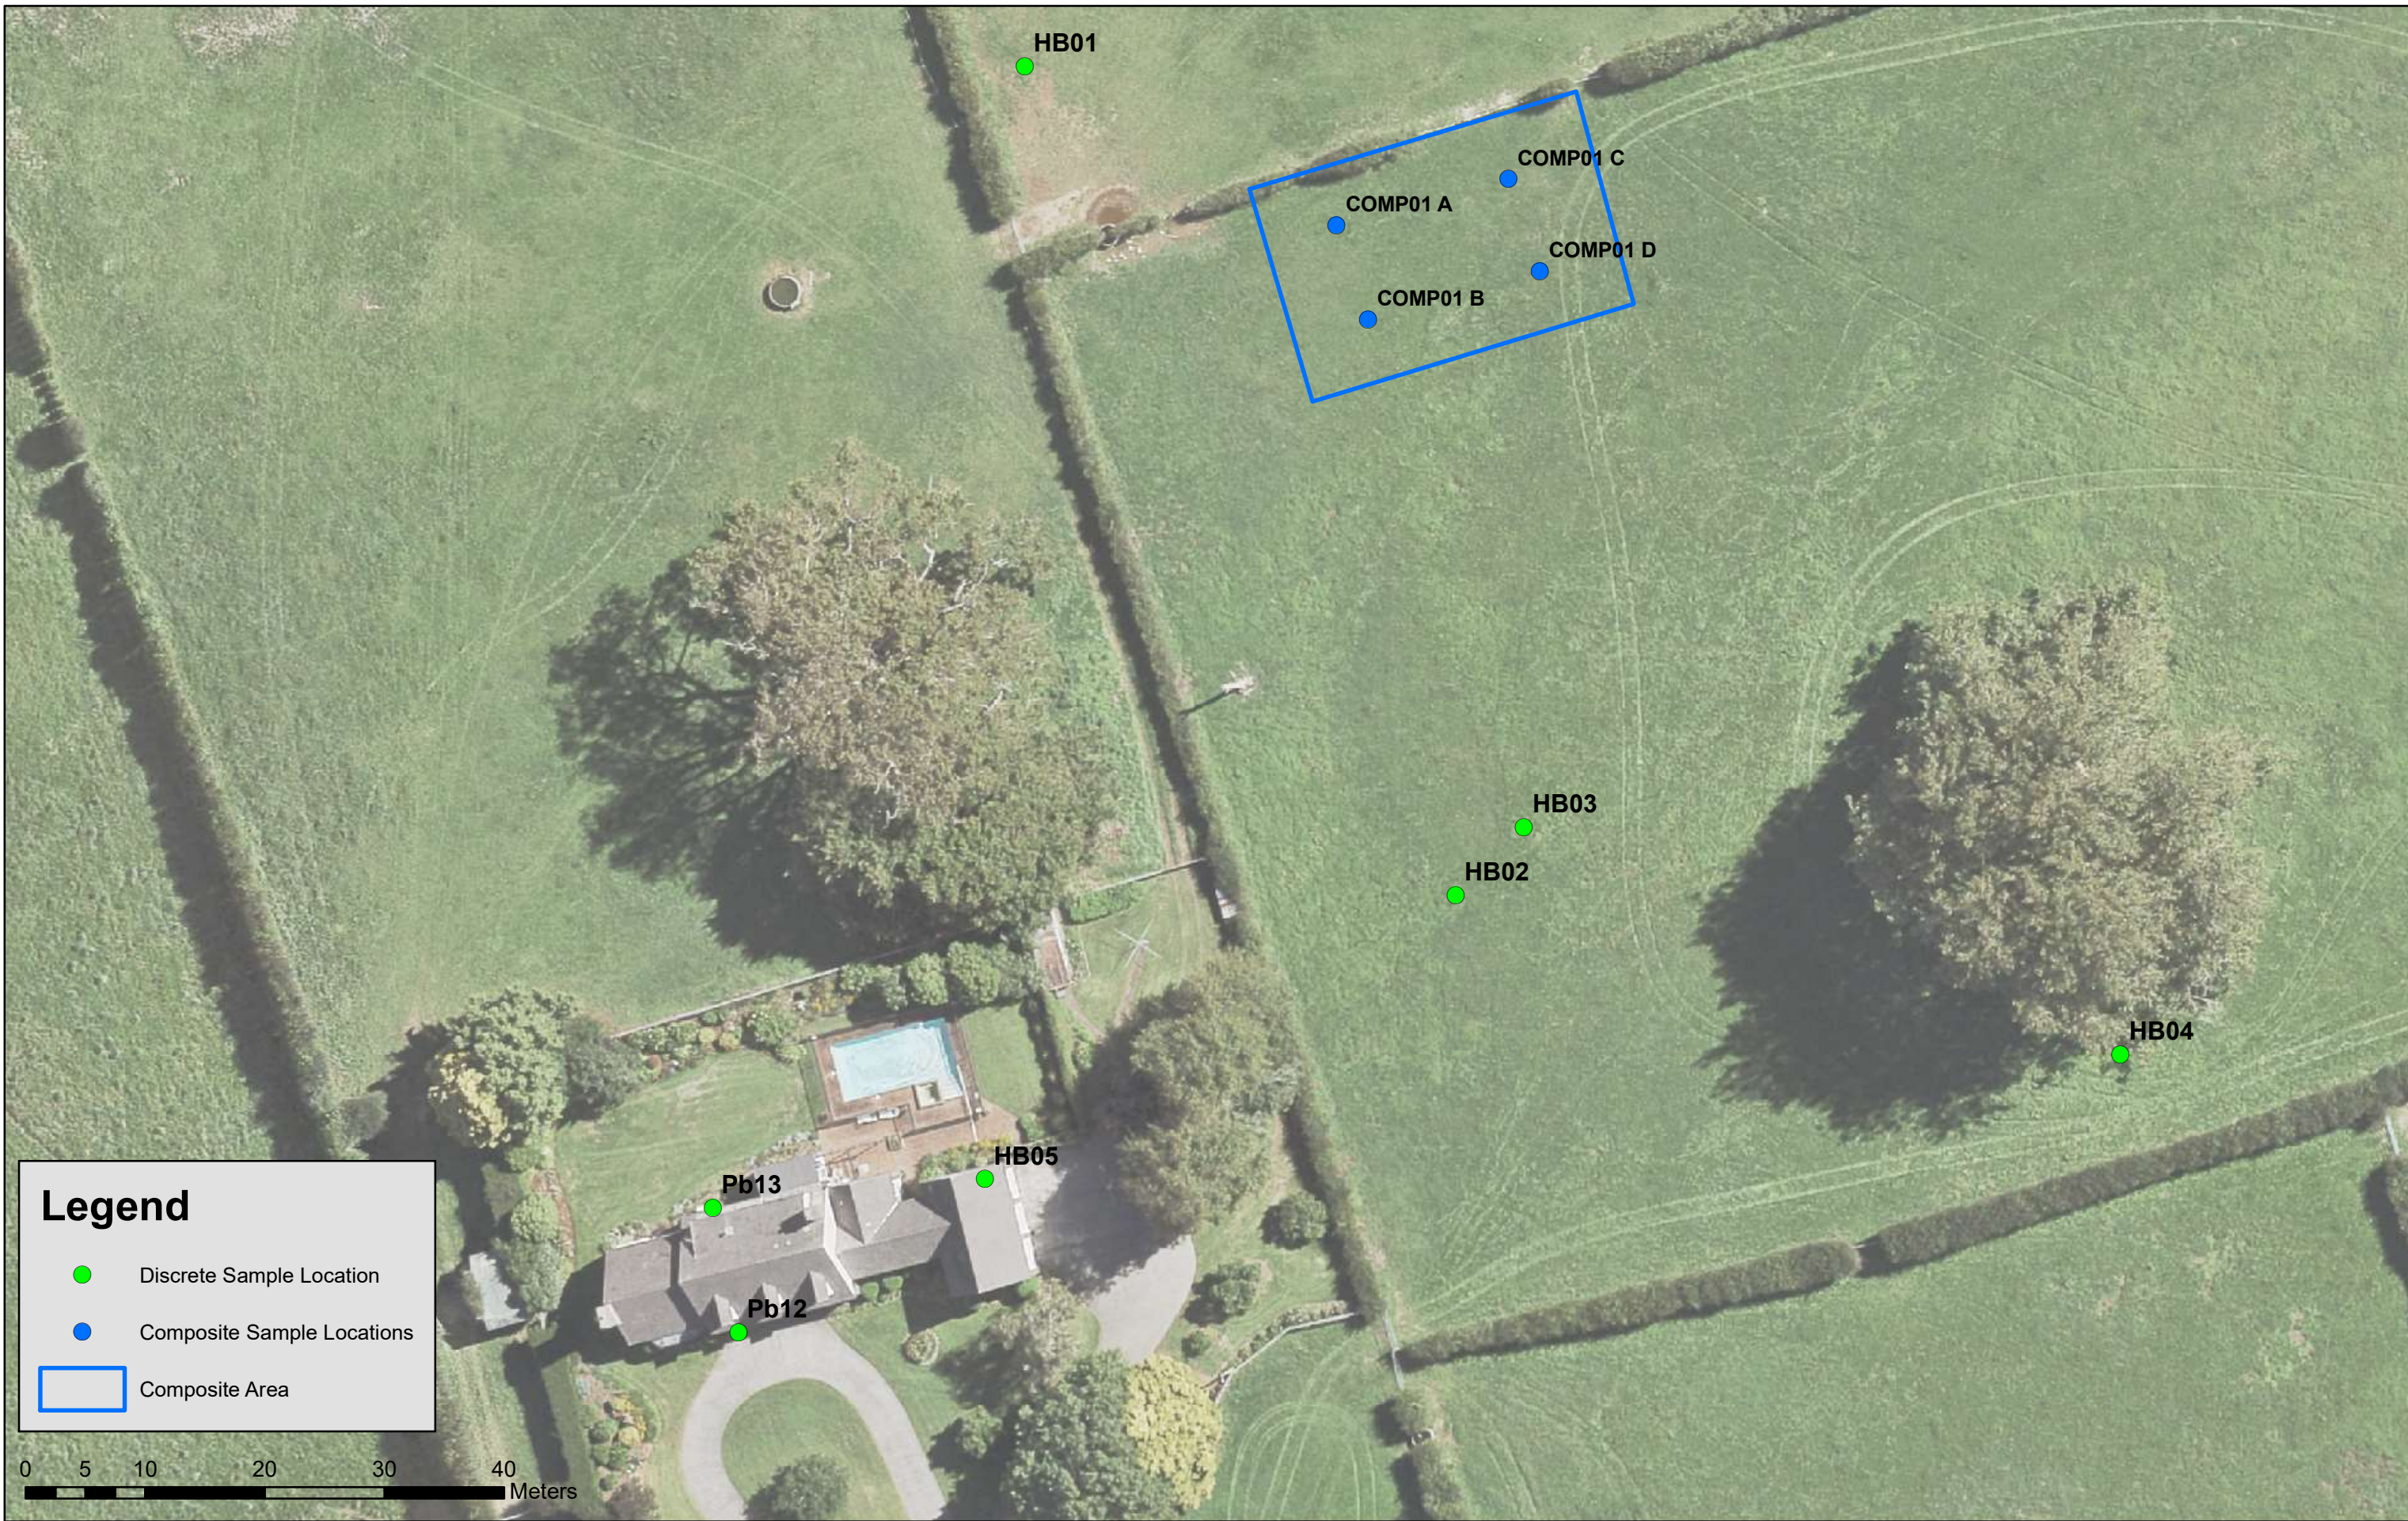
<div>Focus Environmental Services Limited PO Box 11455 Ellerslie Auckland 1542  Ph: +64 9 579 4155 www.focusenvironmental.co.nz</div>	<div>Winton Land Limited</div> <div>80 Hamlin Road Sunfield Urban Development Area Papakura Auckland</div>	<div>Figure 2-6: Sample Location Plan</div> <div>DSI, RAP &amp; AEE</div>

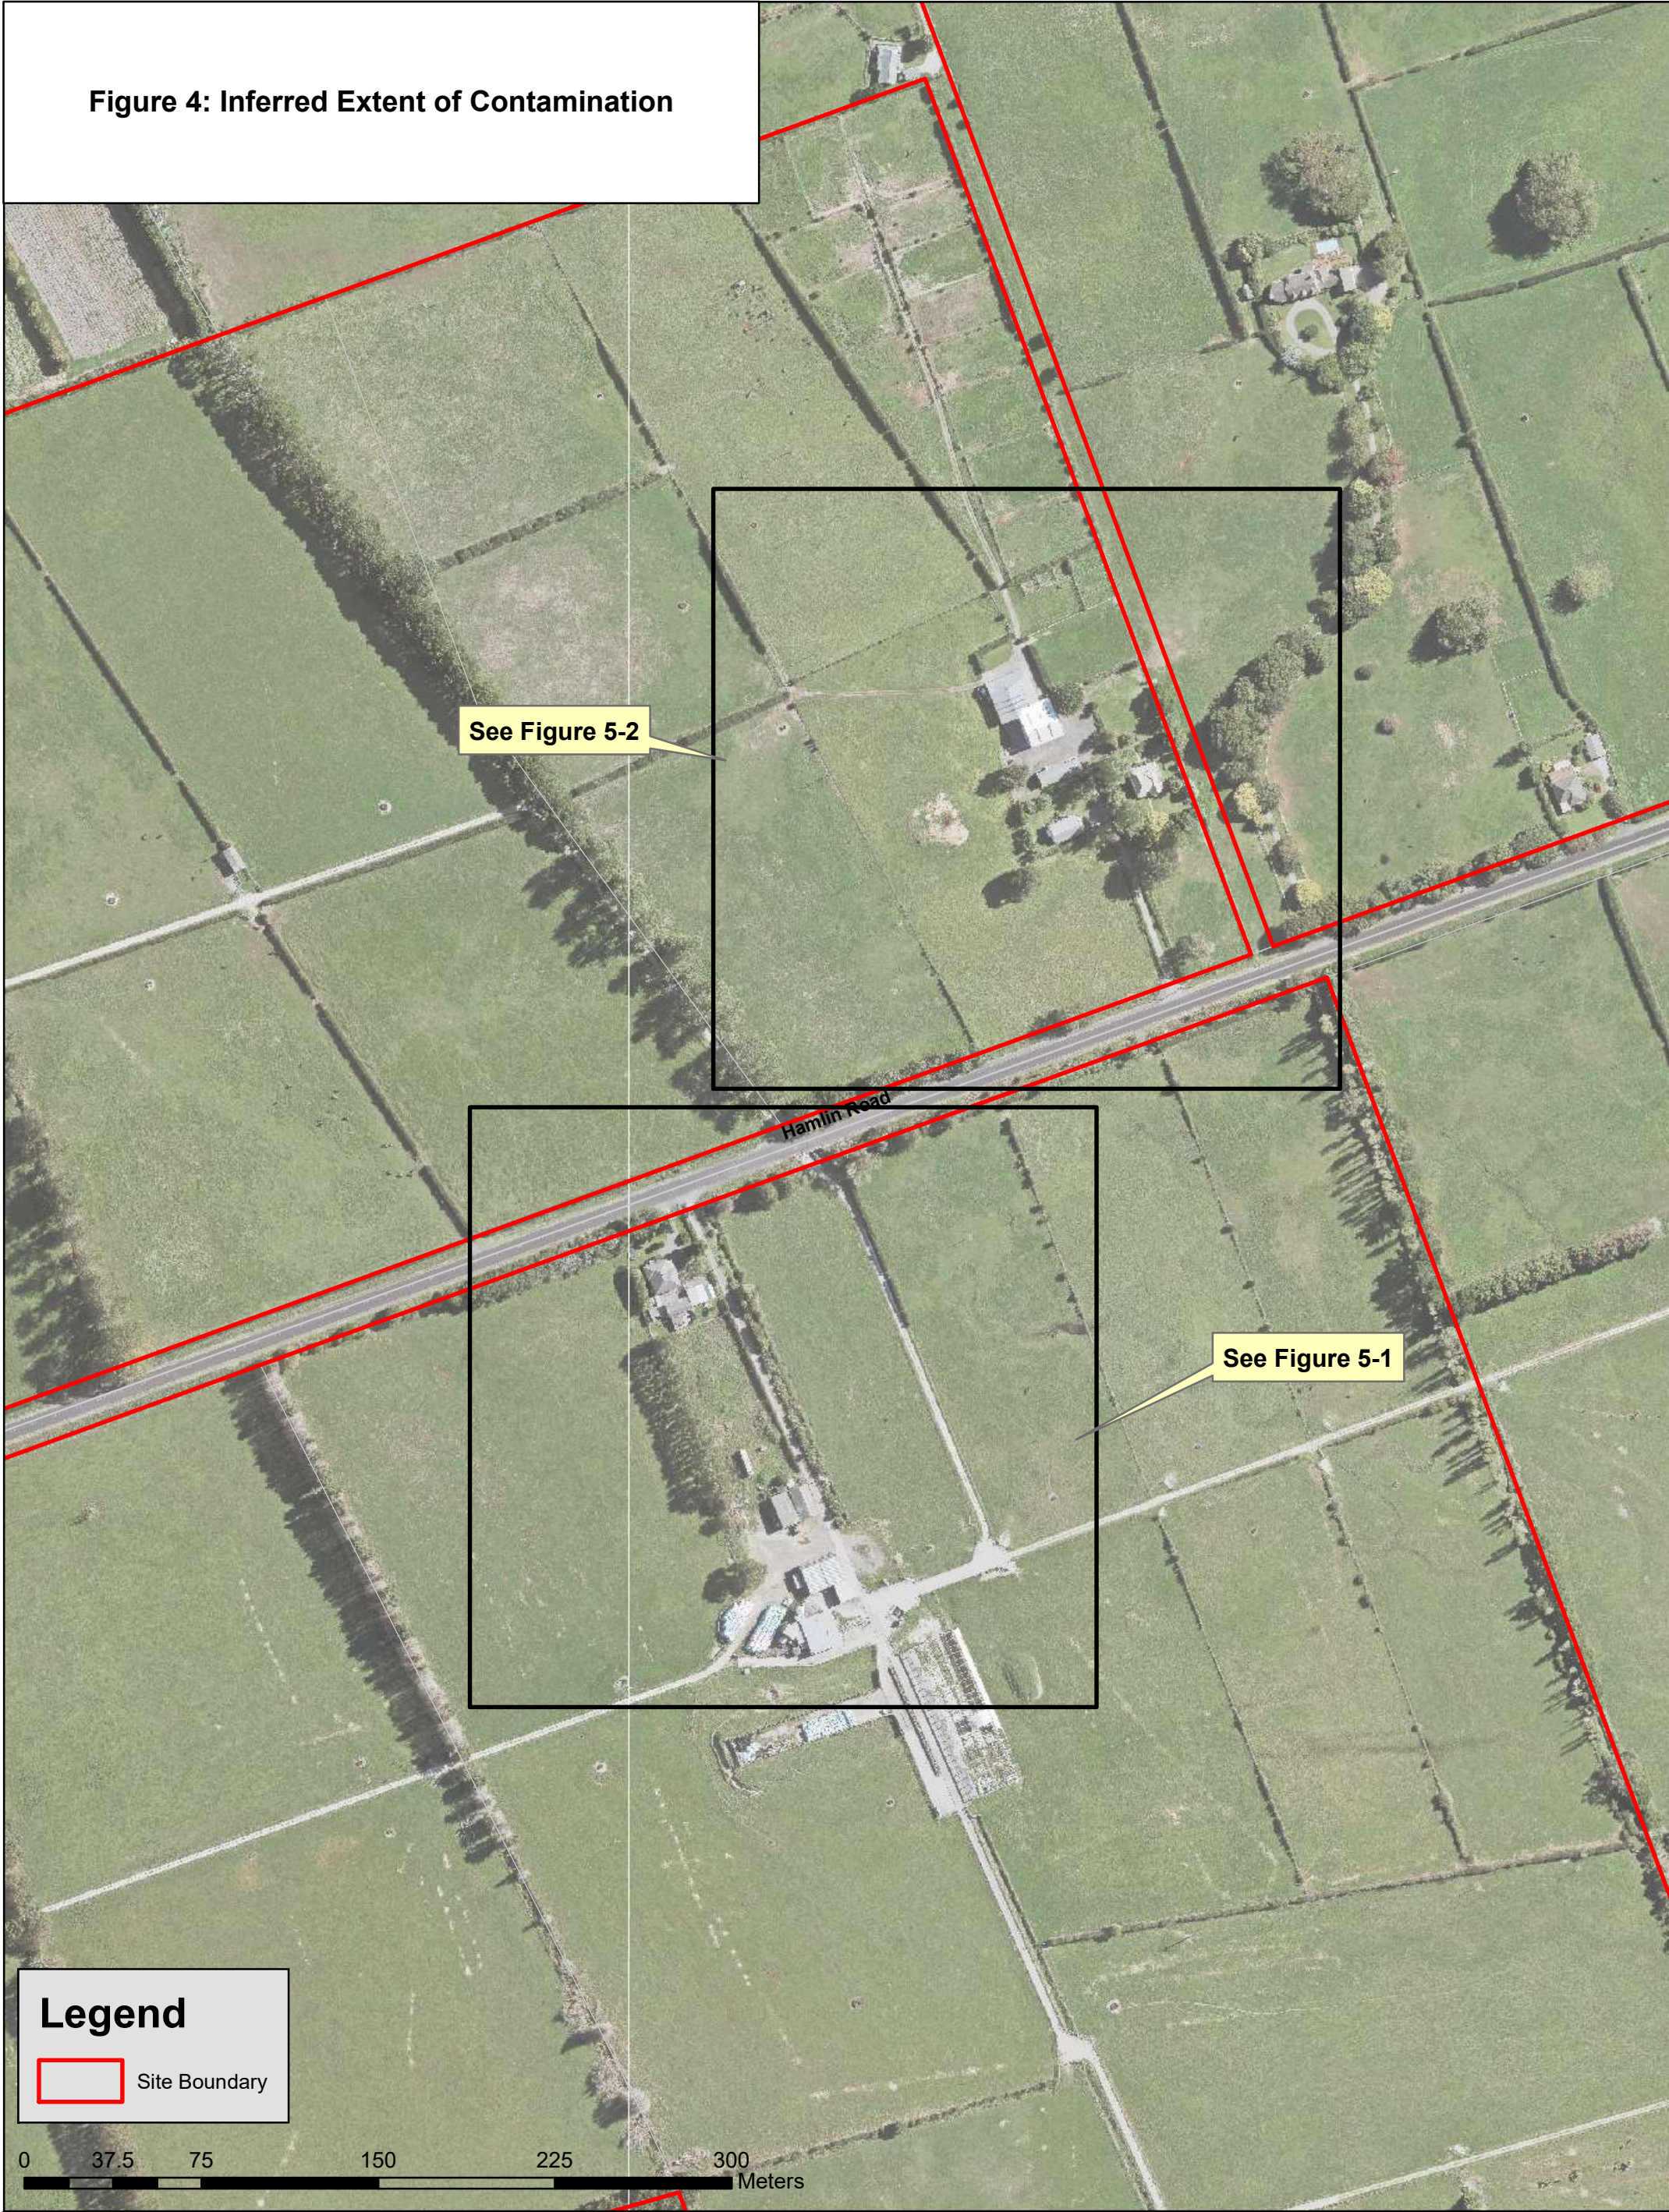
Figure 4: Inferred Extent of Contamination

The inferred extent of the contaminated soil at the site is presented in Figure 4, 4-1 & 4-2. This estimate is based on the sampling and results available following the site investigation and it should be noted that the volume may increase or decrease following inspection and validation sampling.

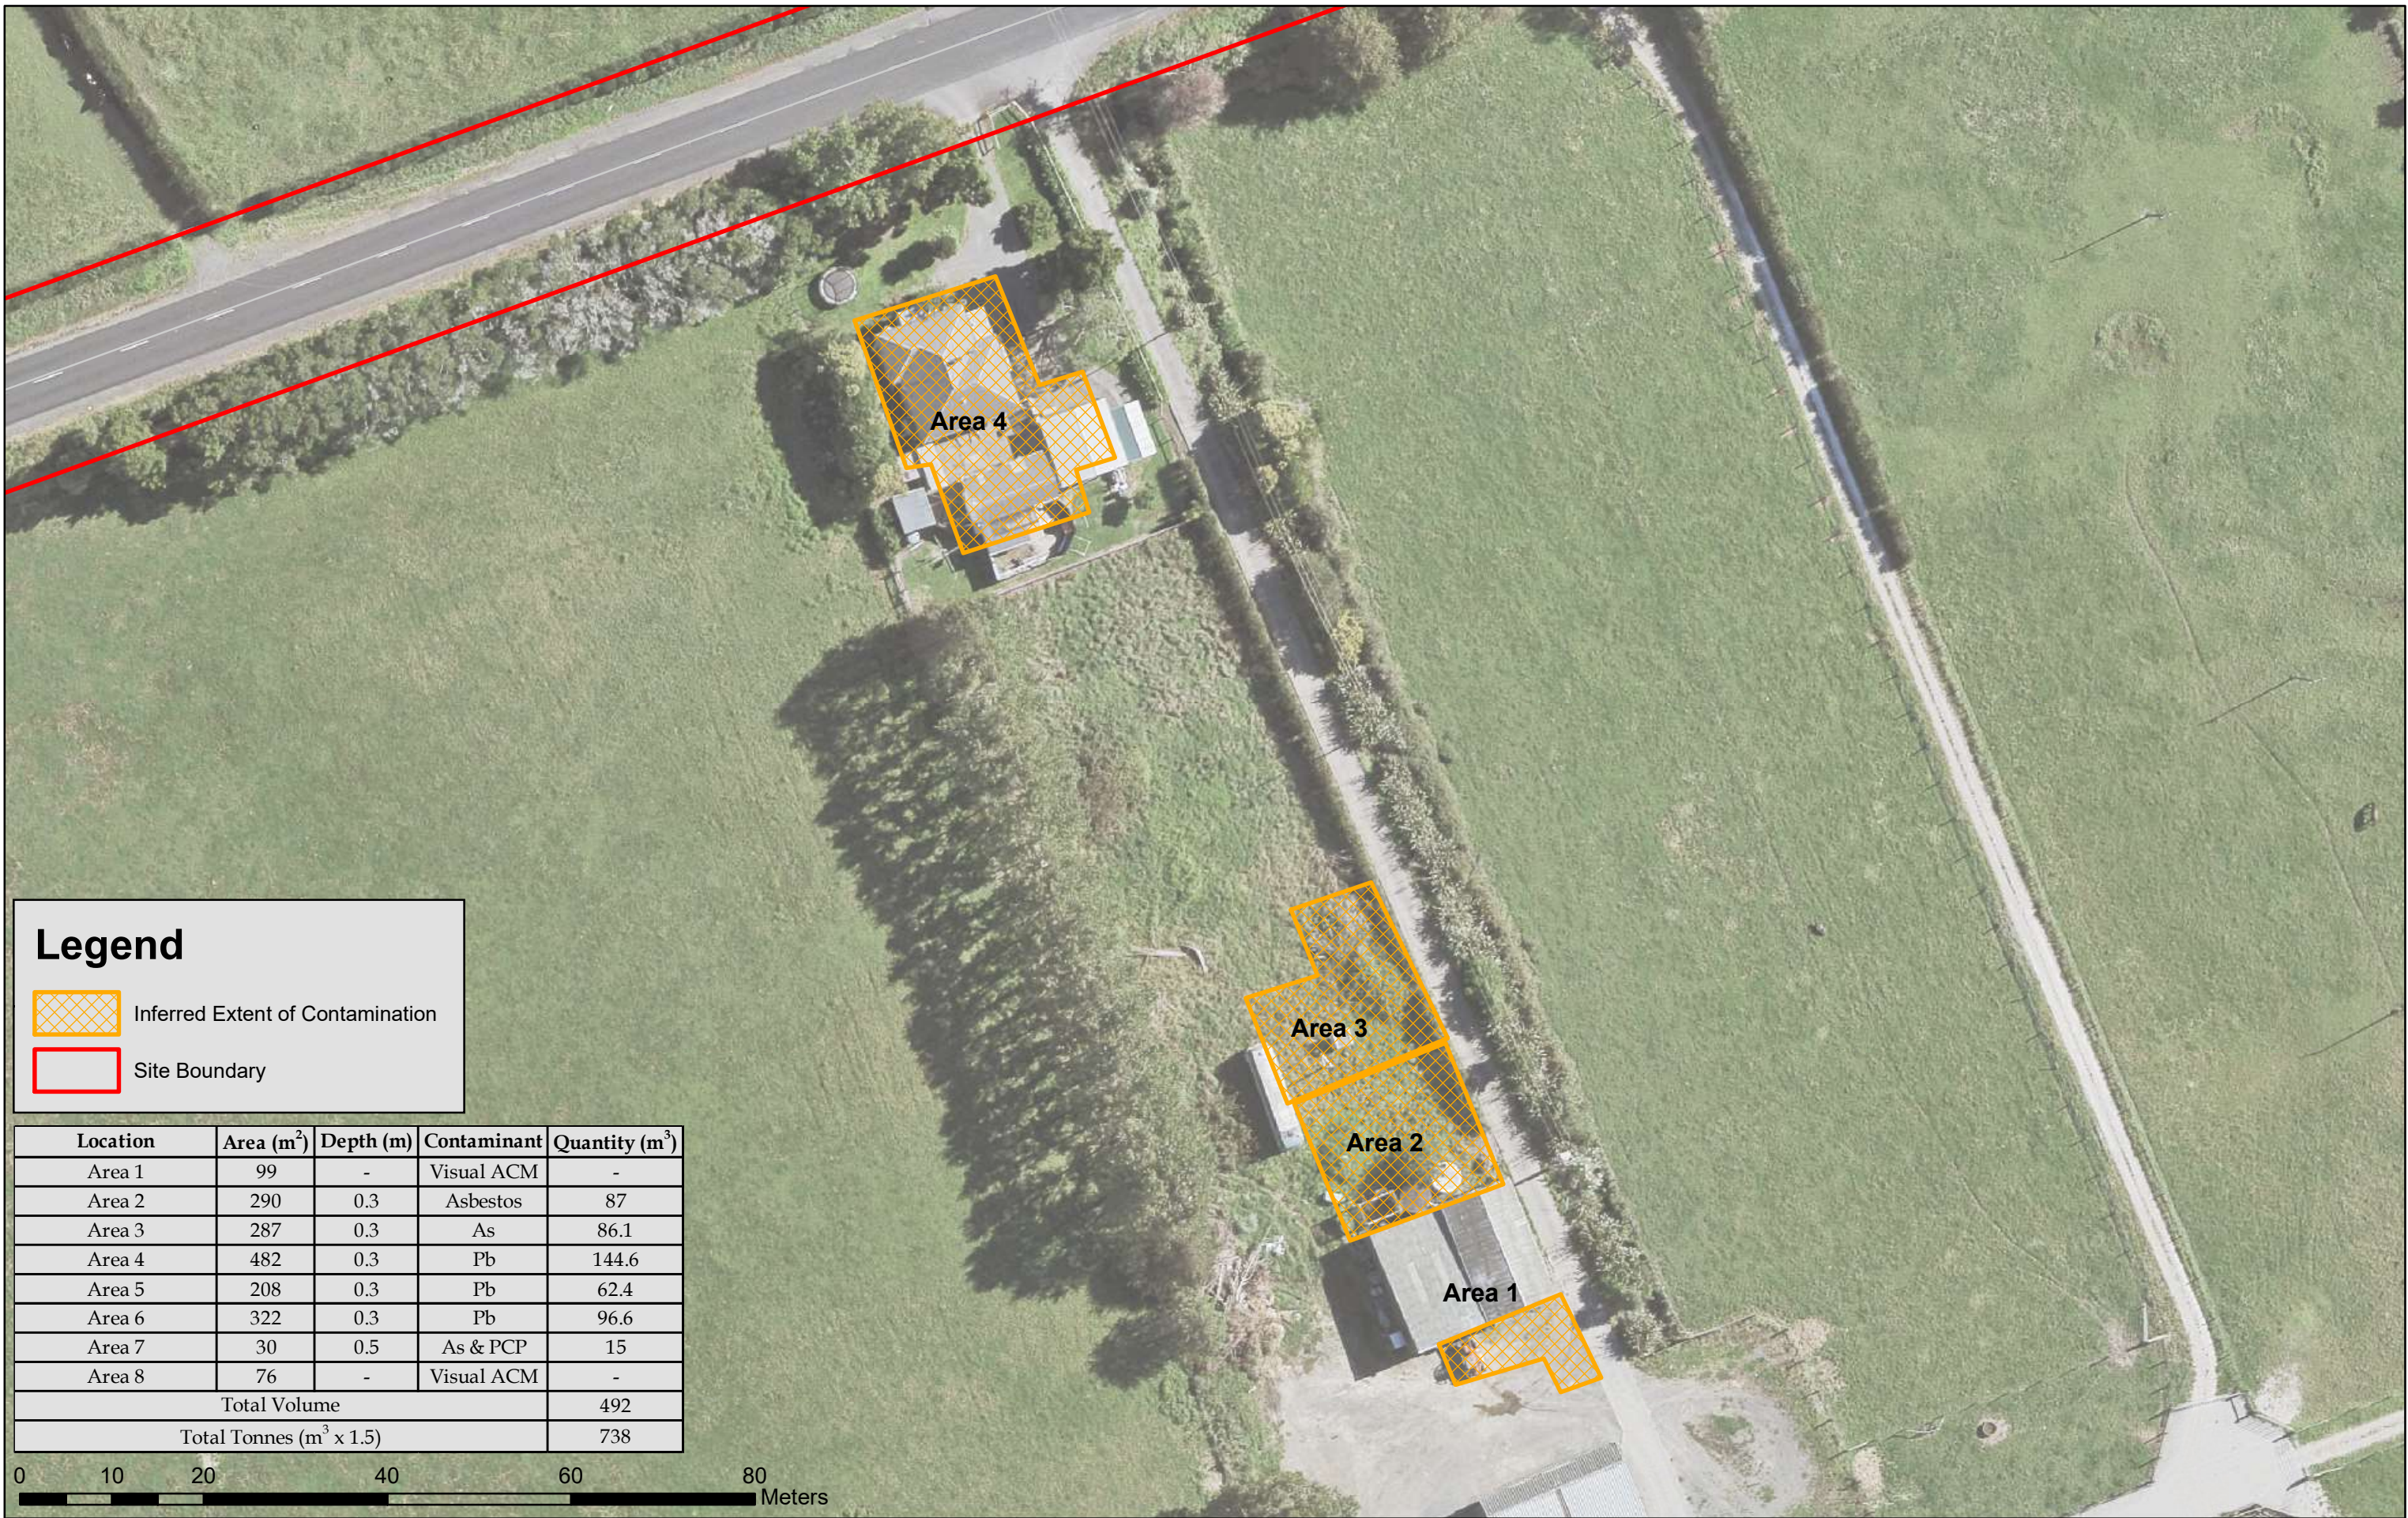
Location	Area (m <sup>2</sup> )	Depth (m)	Contaminant	Quantity (m <sup>3</sup> )
Area 1	99	-	Visual ACM	-
Area 2	290	0.3	Asbestos	87
Area 3	287	0.3	As	86.1
Area 4	482	0.3	Pb	144.6
Area 5	208	0.3	Pb	62.4
Area 6	322	0.3	Pb	96.6
Area 7	30	0.5	As & PCP	15
Area 8	76	-	Visual ACM	-
Total Volume				492
Total Tonnes (m <sup>3</sup> x 1.5)				738
