***DETAILED SITE INVESTIGATION***  
***55 COSGRAVE ROAD &***  
***55A COSGRAVE ROAD***  
***ARDMORE***  
***AUCKLAND***

Reference: FES 1443.008 December 2023 (R4)

Project Name Detailed Site Investigation  
55 Cosgrave Road & 55A Cosgrave Road, Ardmore

Winton Land Limited - 55 Cosgrave Road, Ardmore

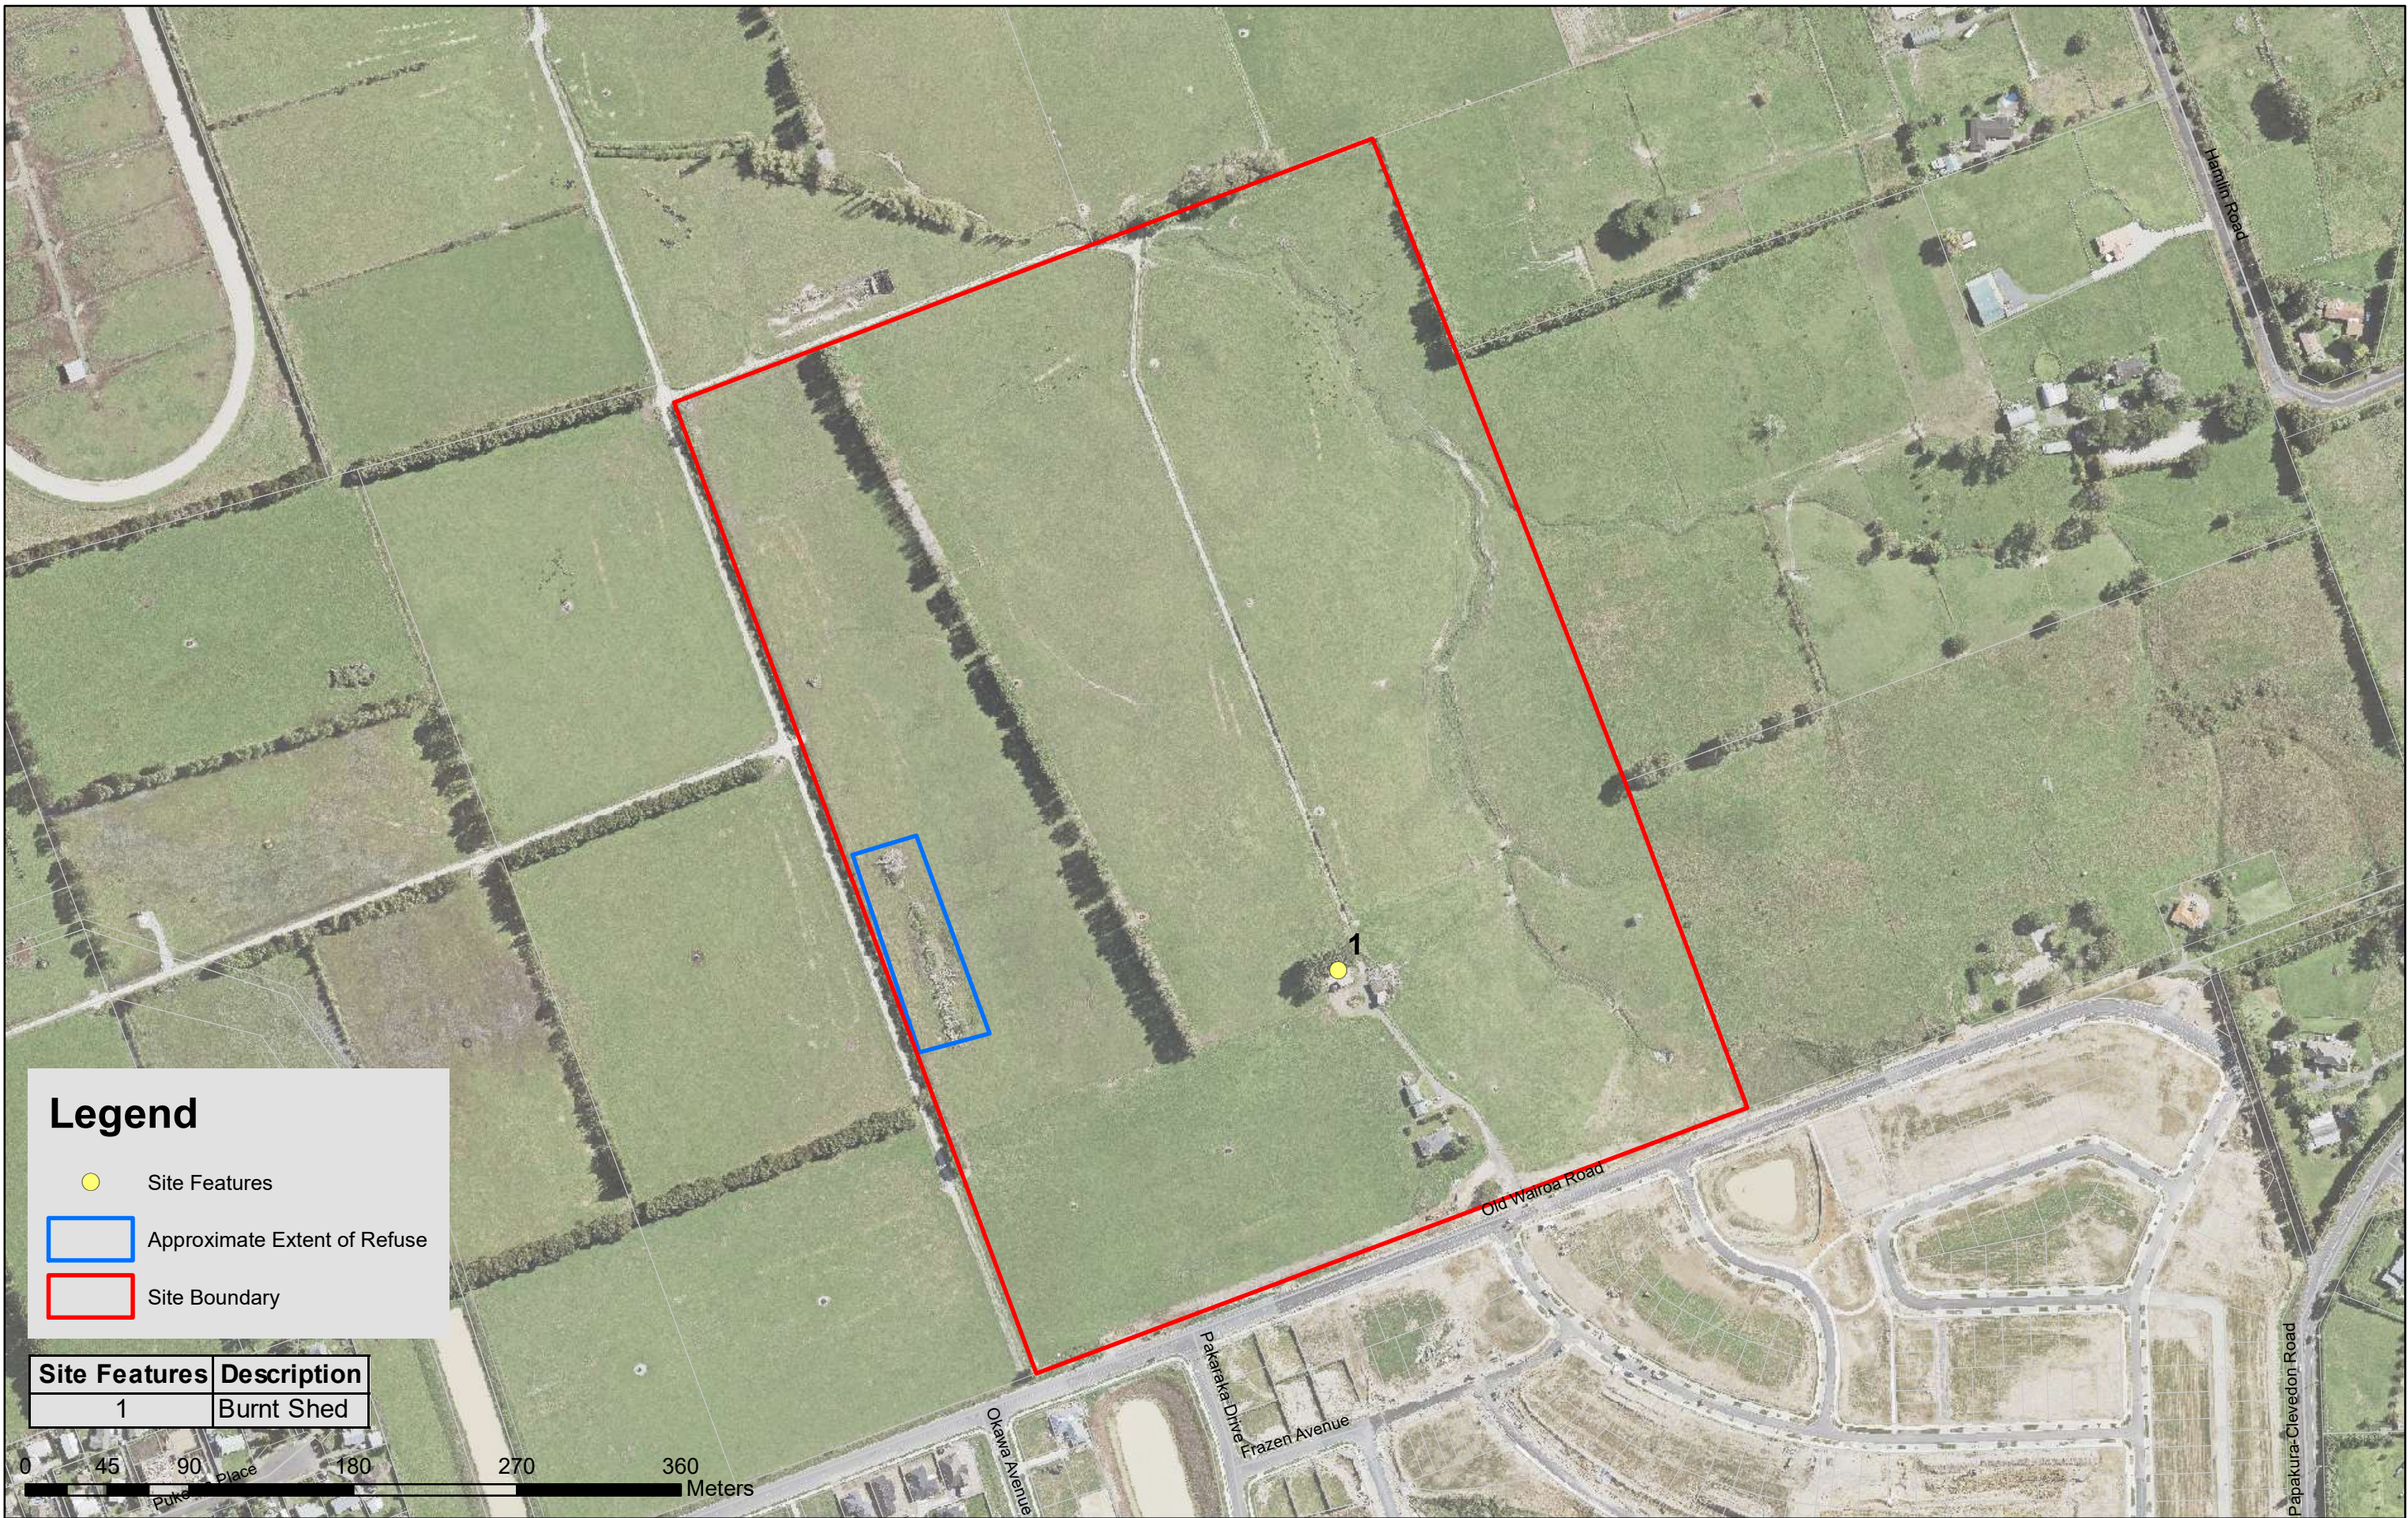
- Site Features
- Approximate Extent of Refuse
- Site Boundary

Site Features	Description
1	Burnt Shed

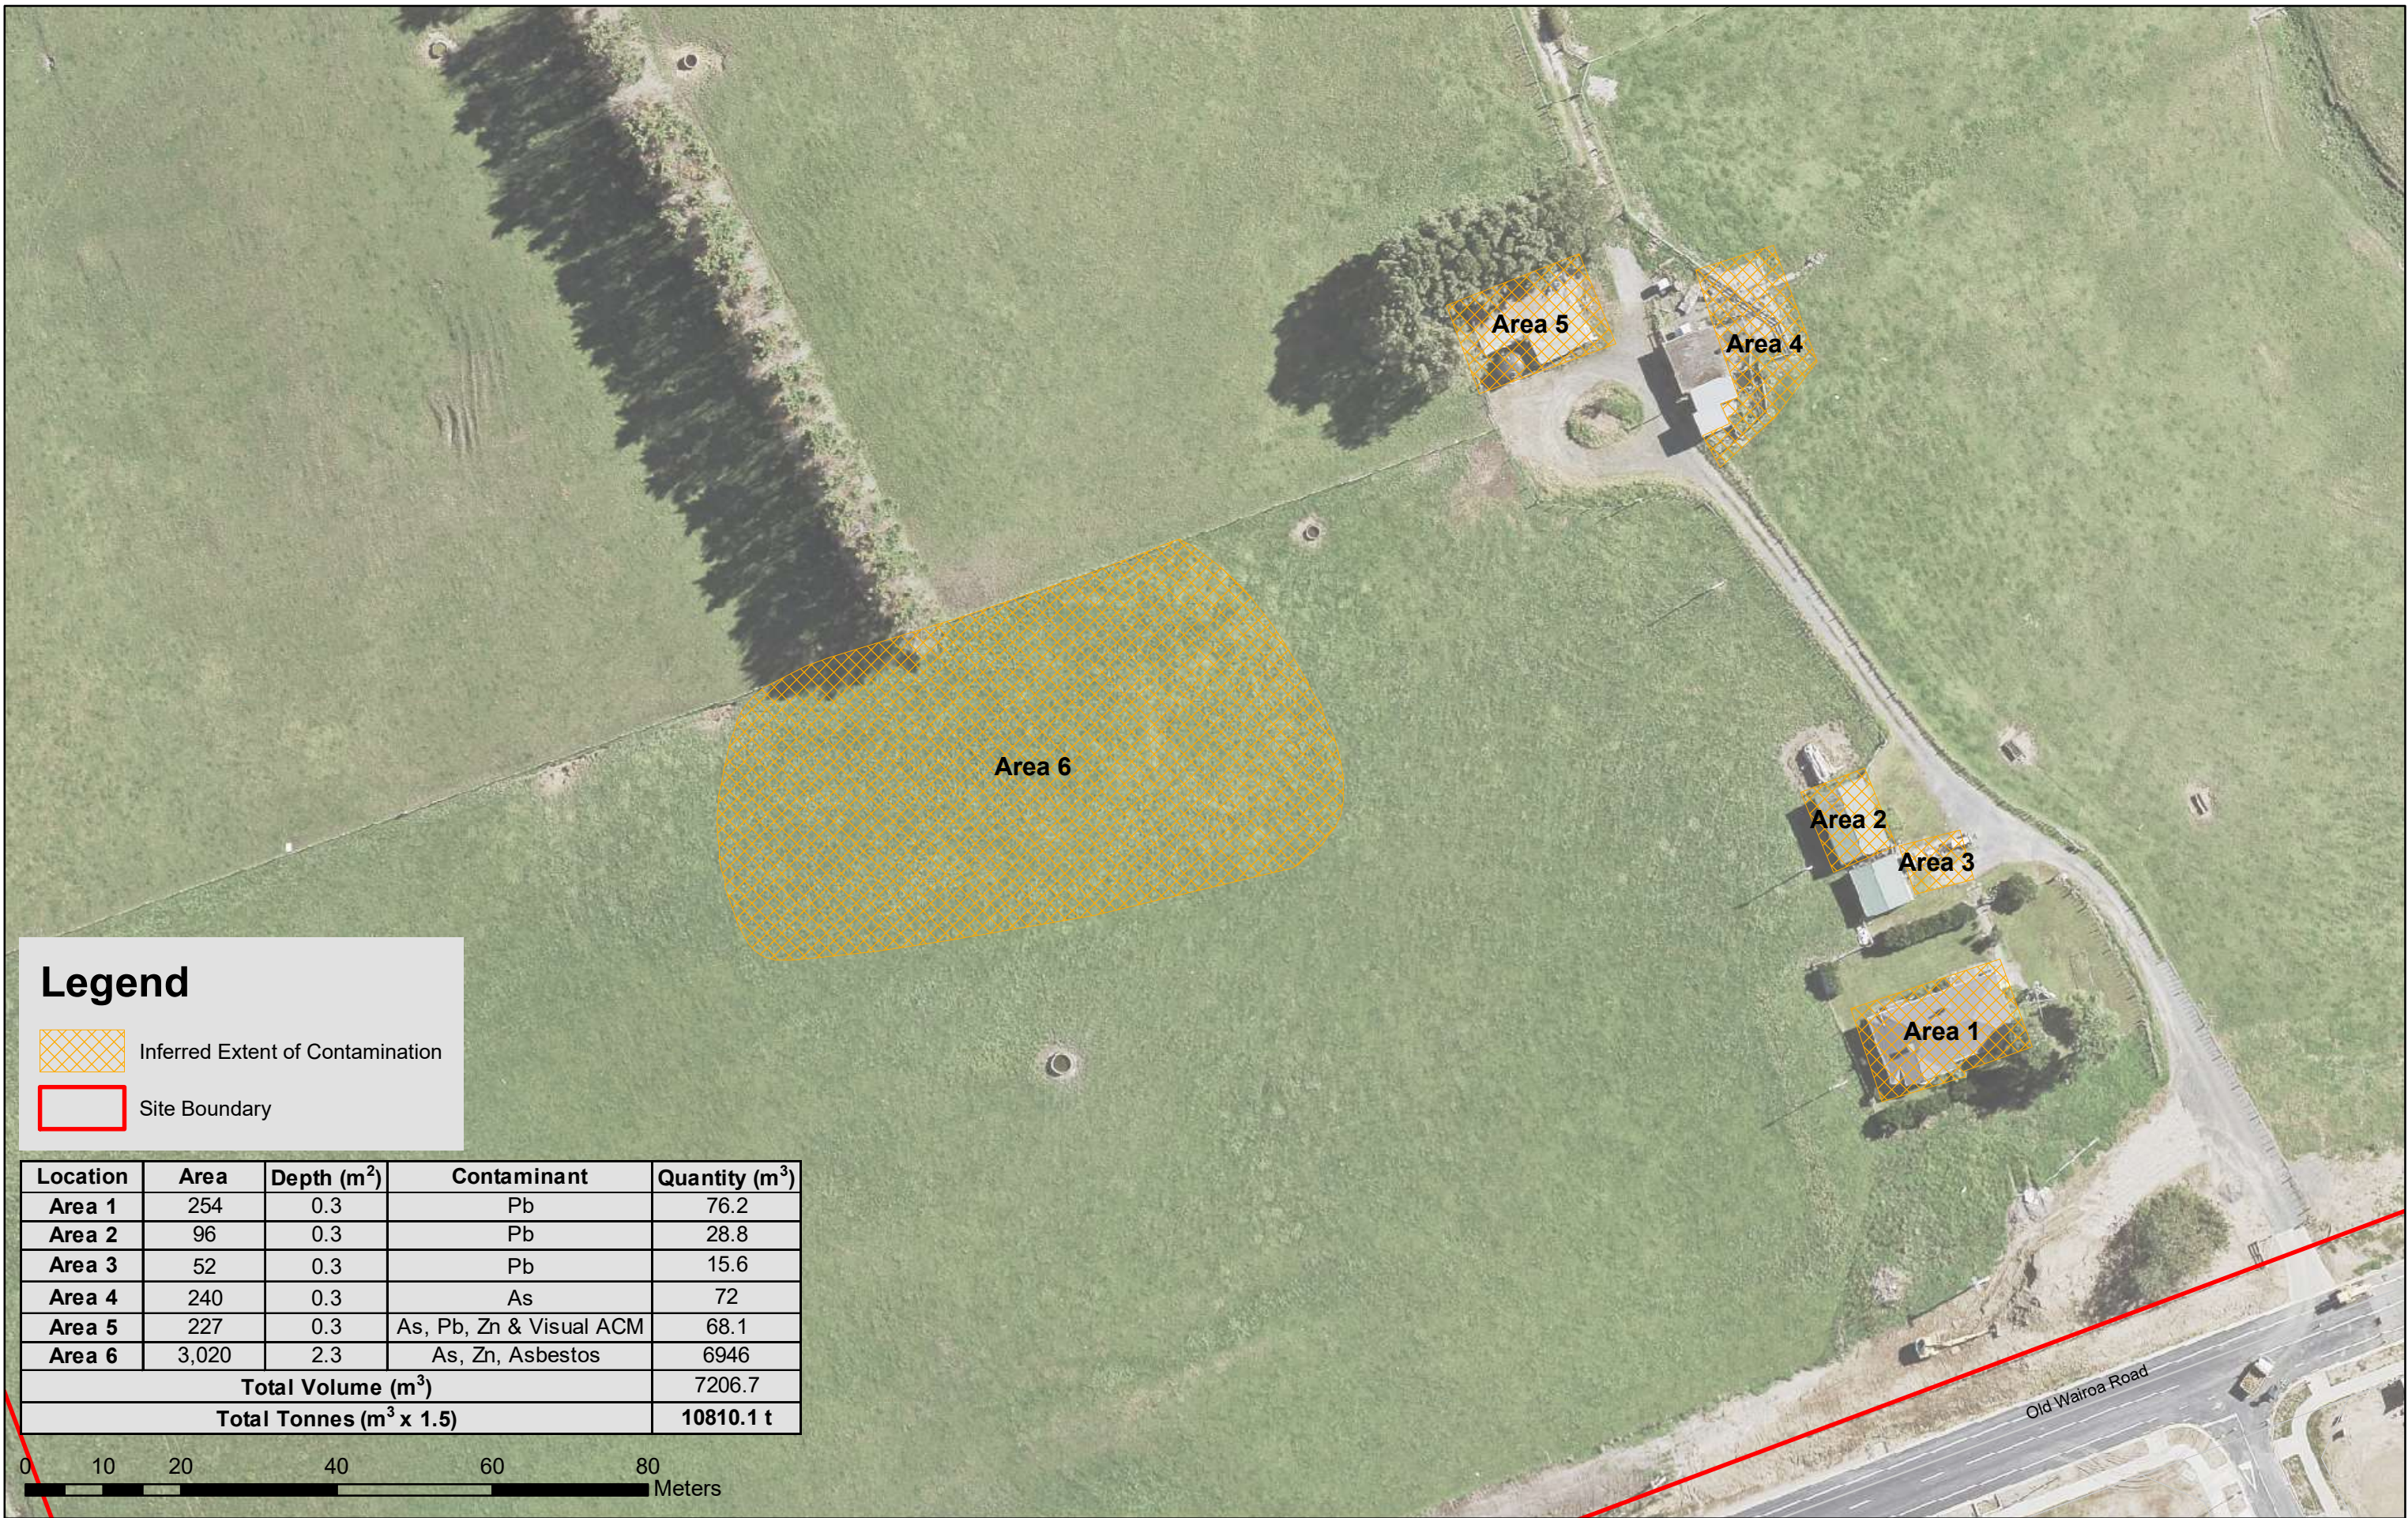
Location	Area	Depth (m <sup>2</sup> )	Contaminant	Quantity (m <sup>3</sup> )
Area 1	254	0.3	Pb	76.2
Area 2	96	0.3	Pb	28.8
Area 3	52	0.3	Pb	15.6
Area 4	240	0.3	As	72
Area 5	227	0.3	As, Pb, Zn & Visual ACM	68.1
Area 6	3,020	2.3	As, Zn, Asbestos	6946
Total Volume (m <sup>3</sup> )				7206.7
Total Tonnes (m <sup>3</sup> x 1.5)				10810.1 t

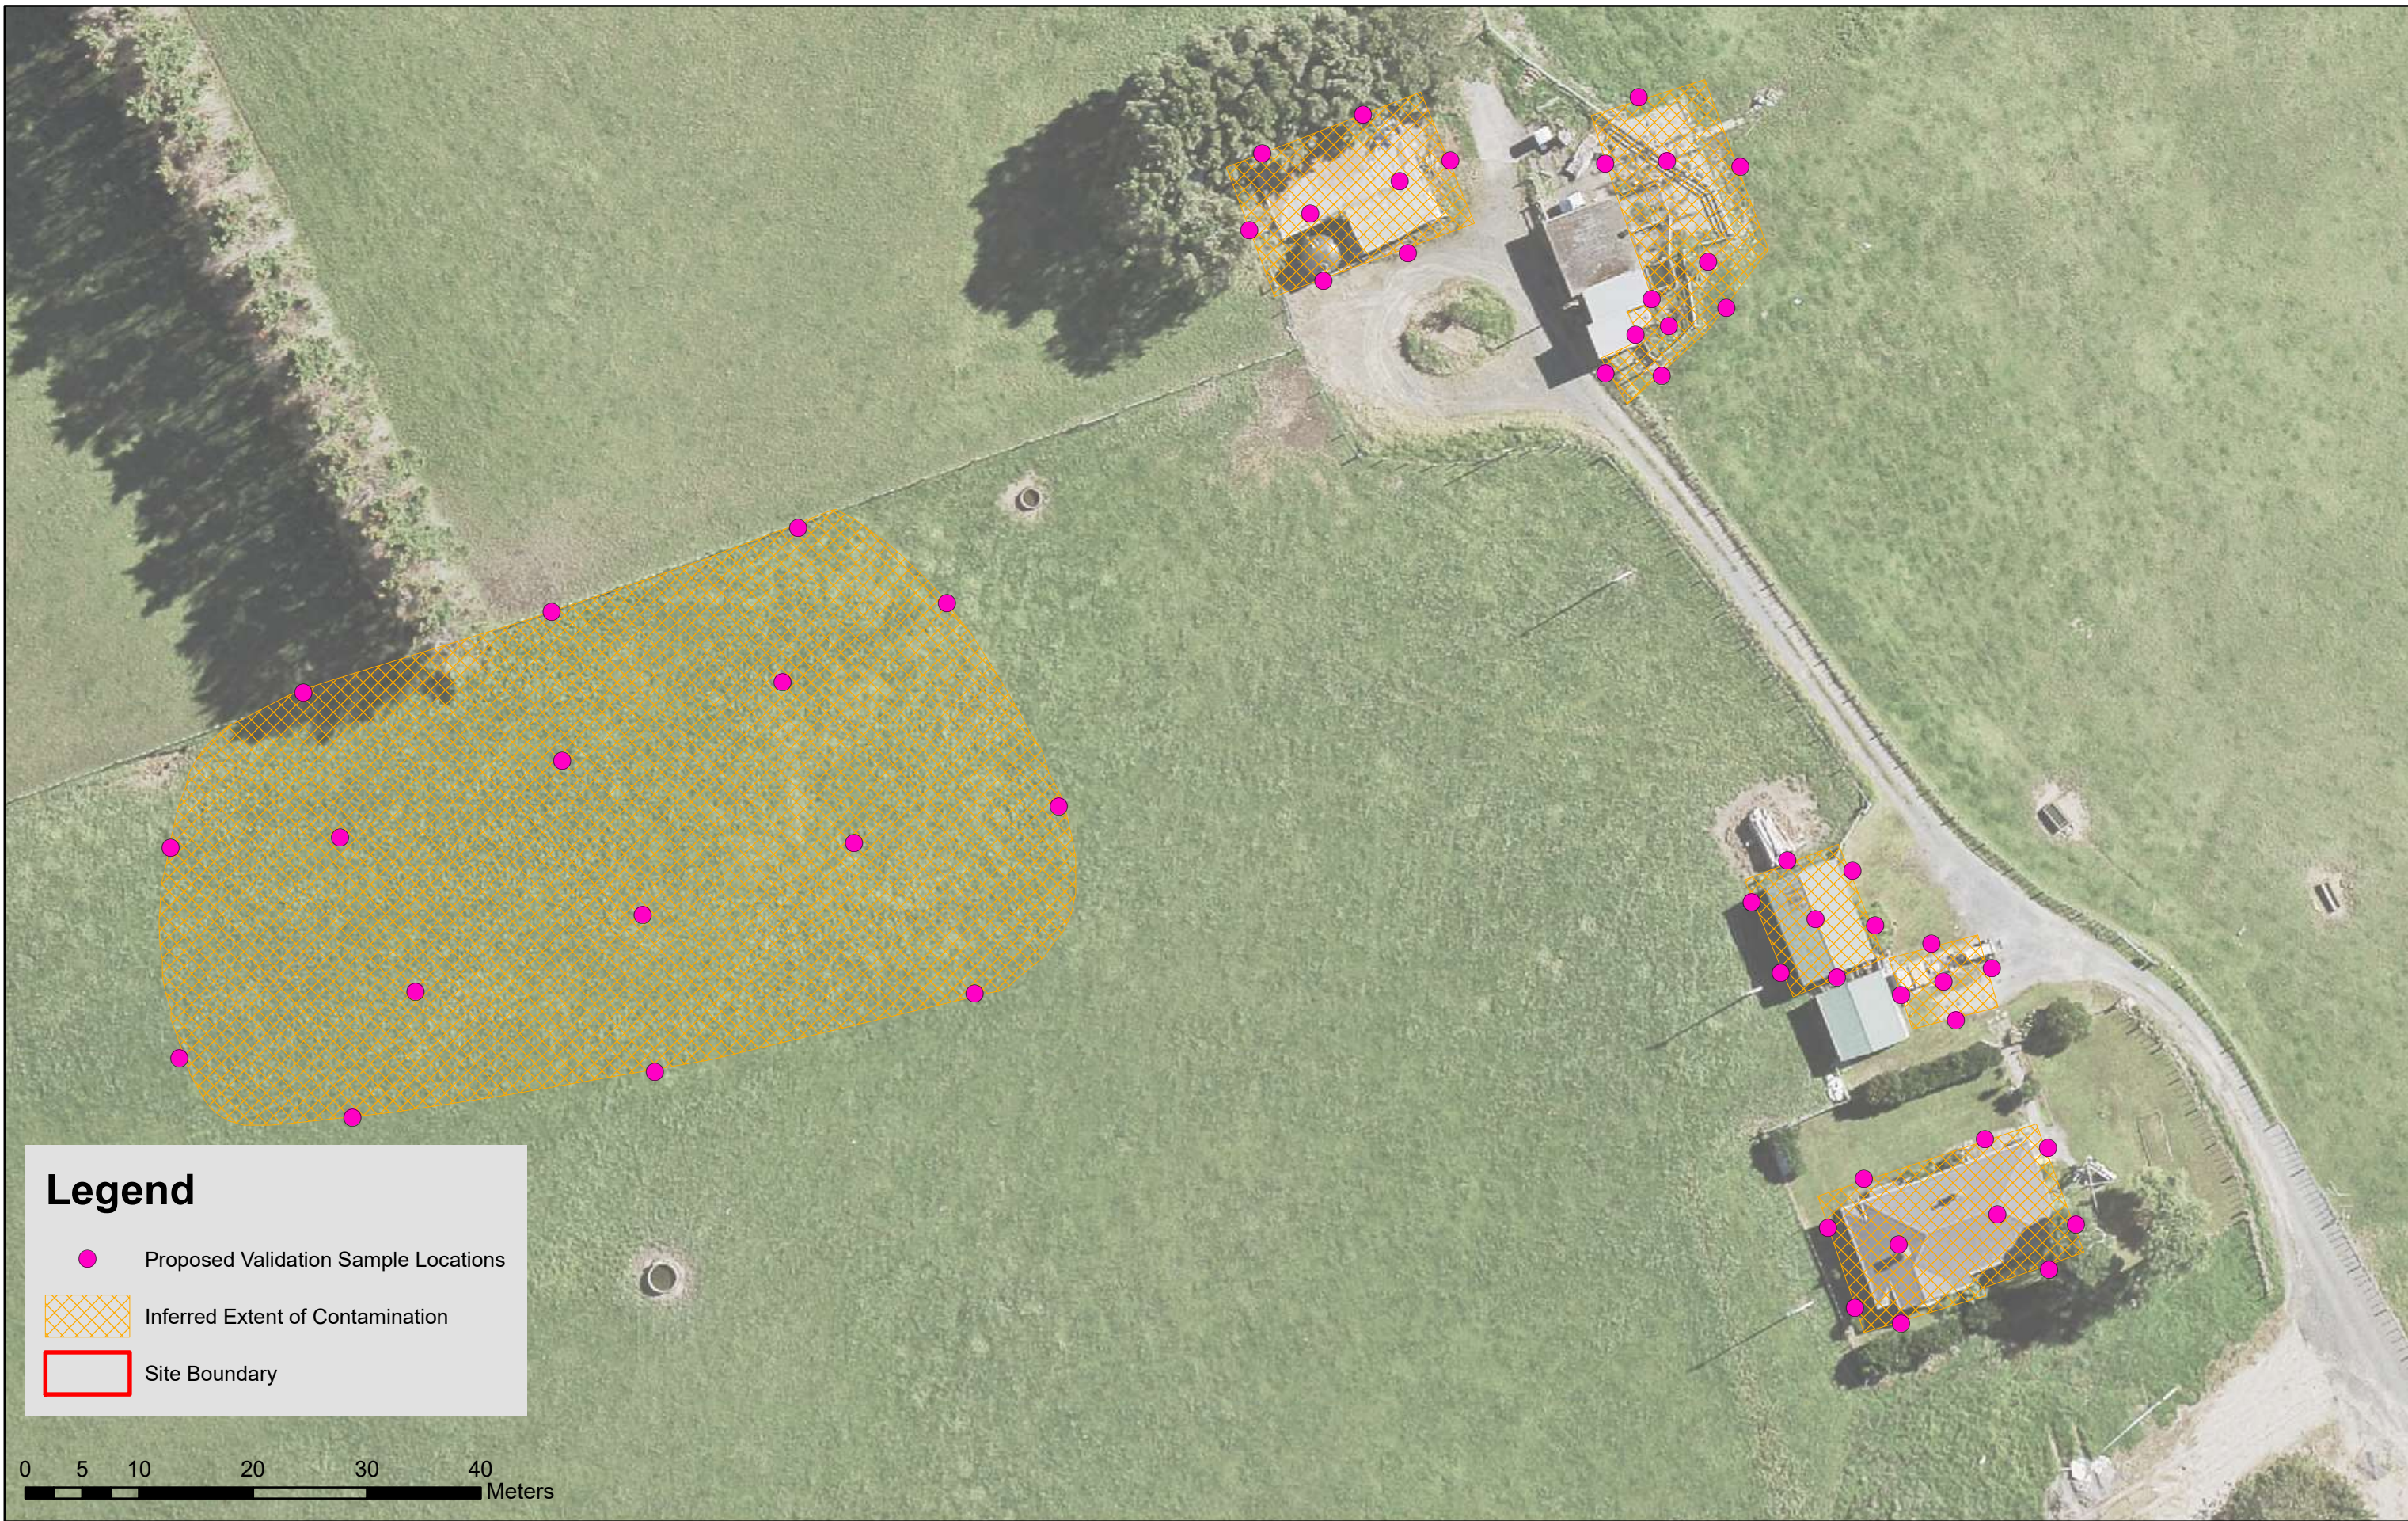
Drawing Number: 1443.010.05
Drawn By: MT
Checked By: DO'R
Date: 20/12/2023

**Legend**

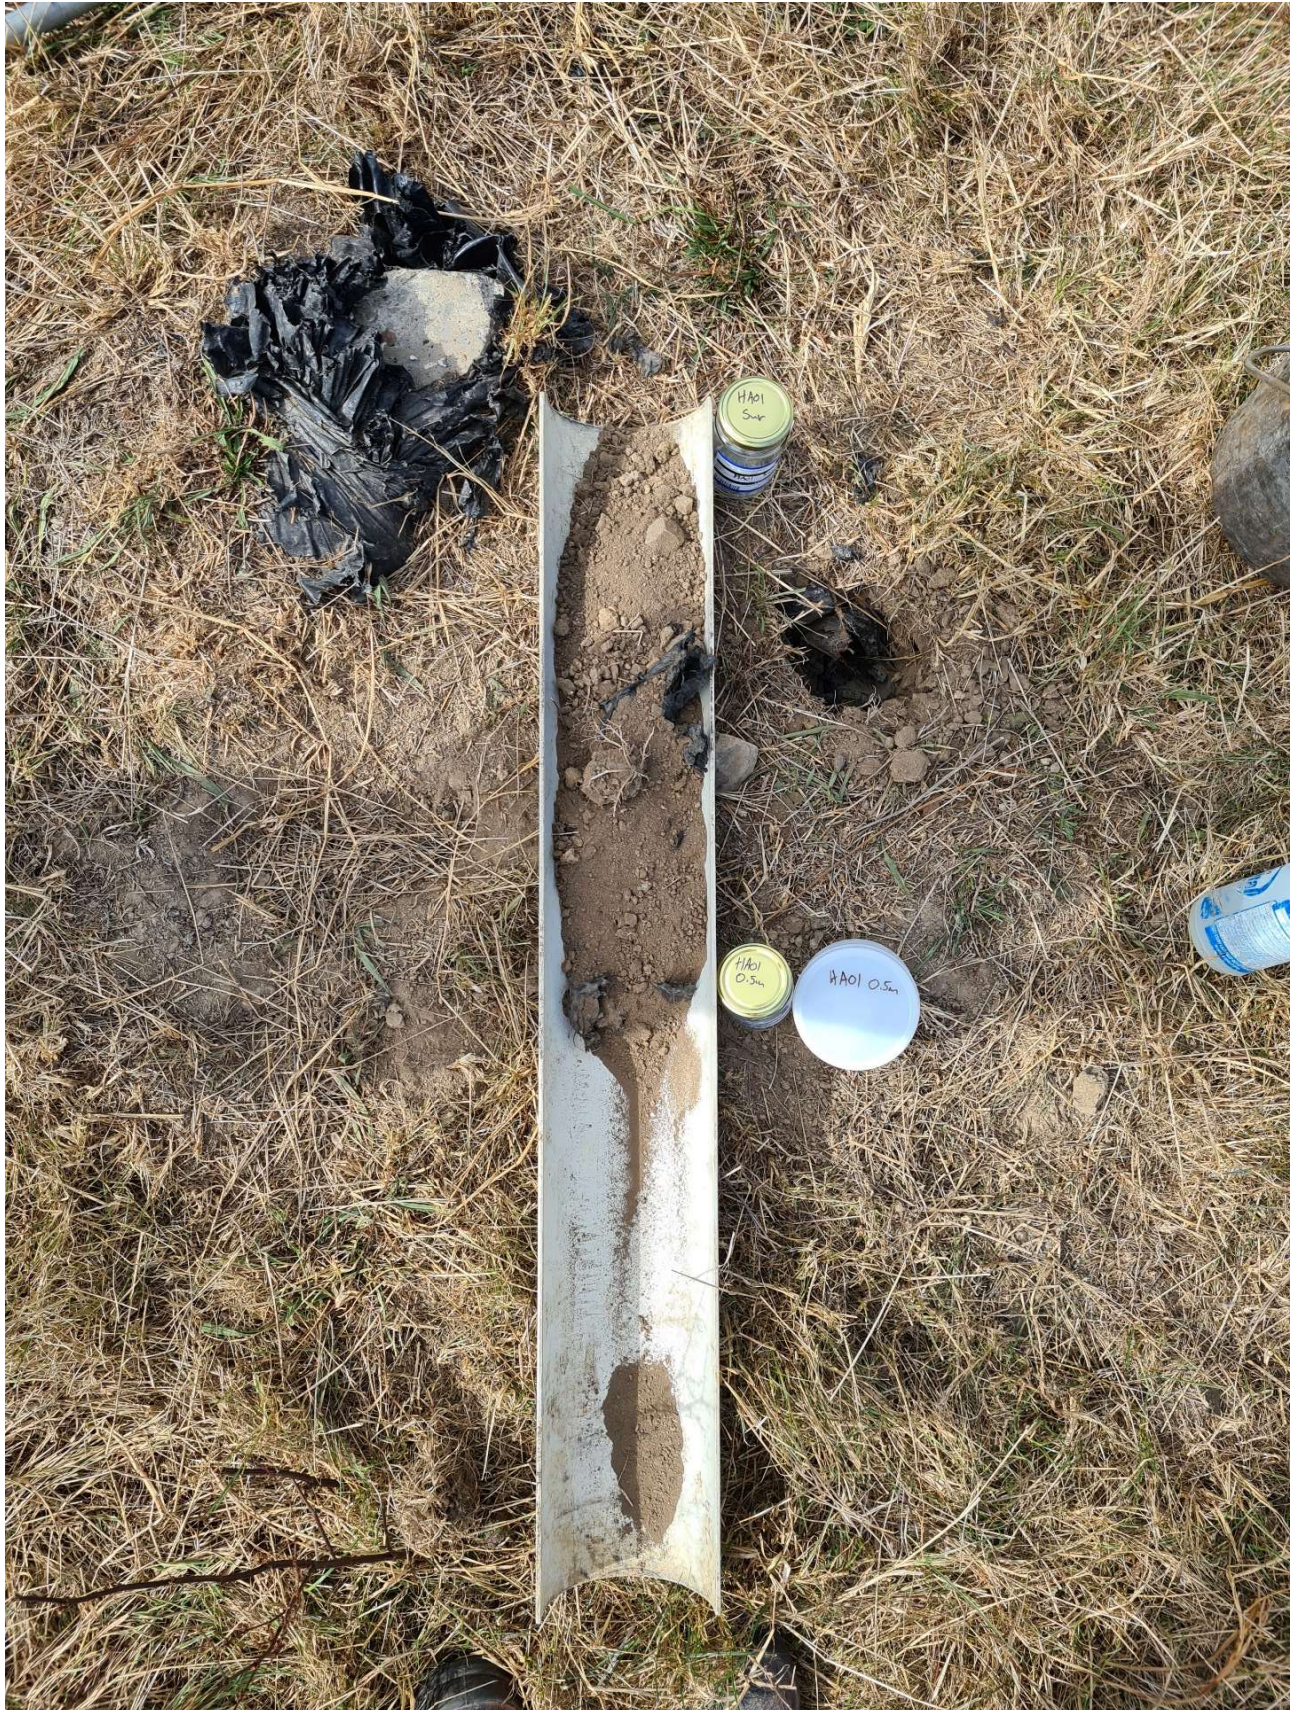
HA01

**COMMENTS** Refusal at 0.5m
