***DETAILED SITE INVESTIGATION
LOT 1 DP5548 COSGRAVE ROAD
ARDMORE
AUCKLAND***

Reference: FES 1443.011 December 2023 (R5)

Winton Land Limited – Lot 1 DP 55480, Cosgrave Road, Ardmore

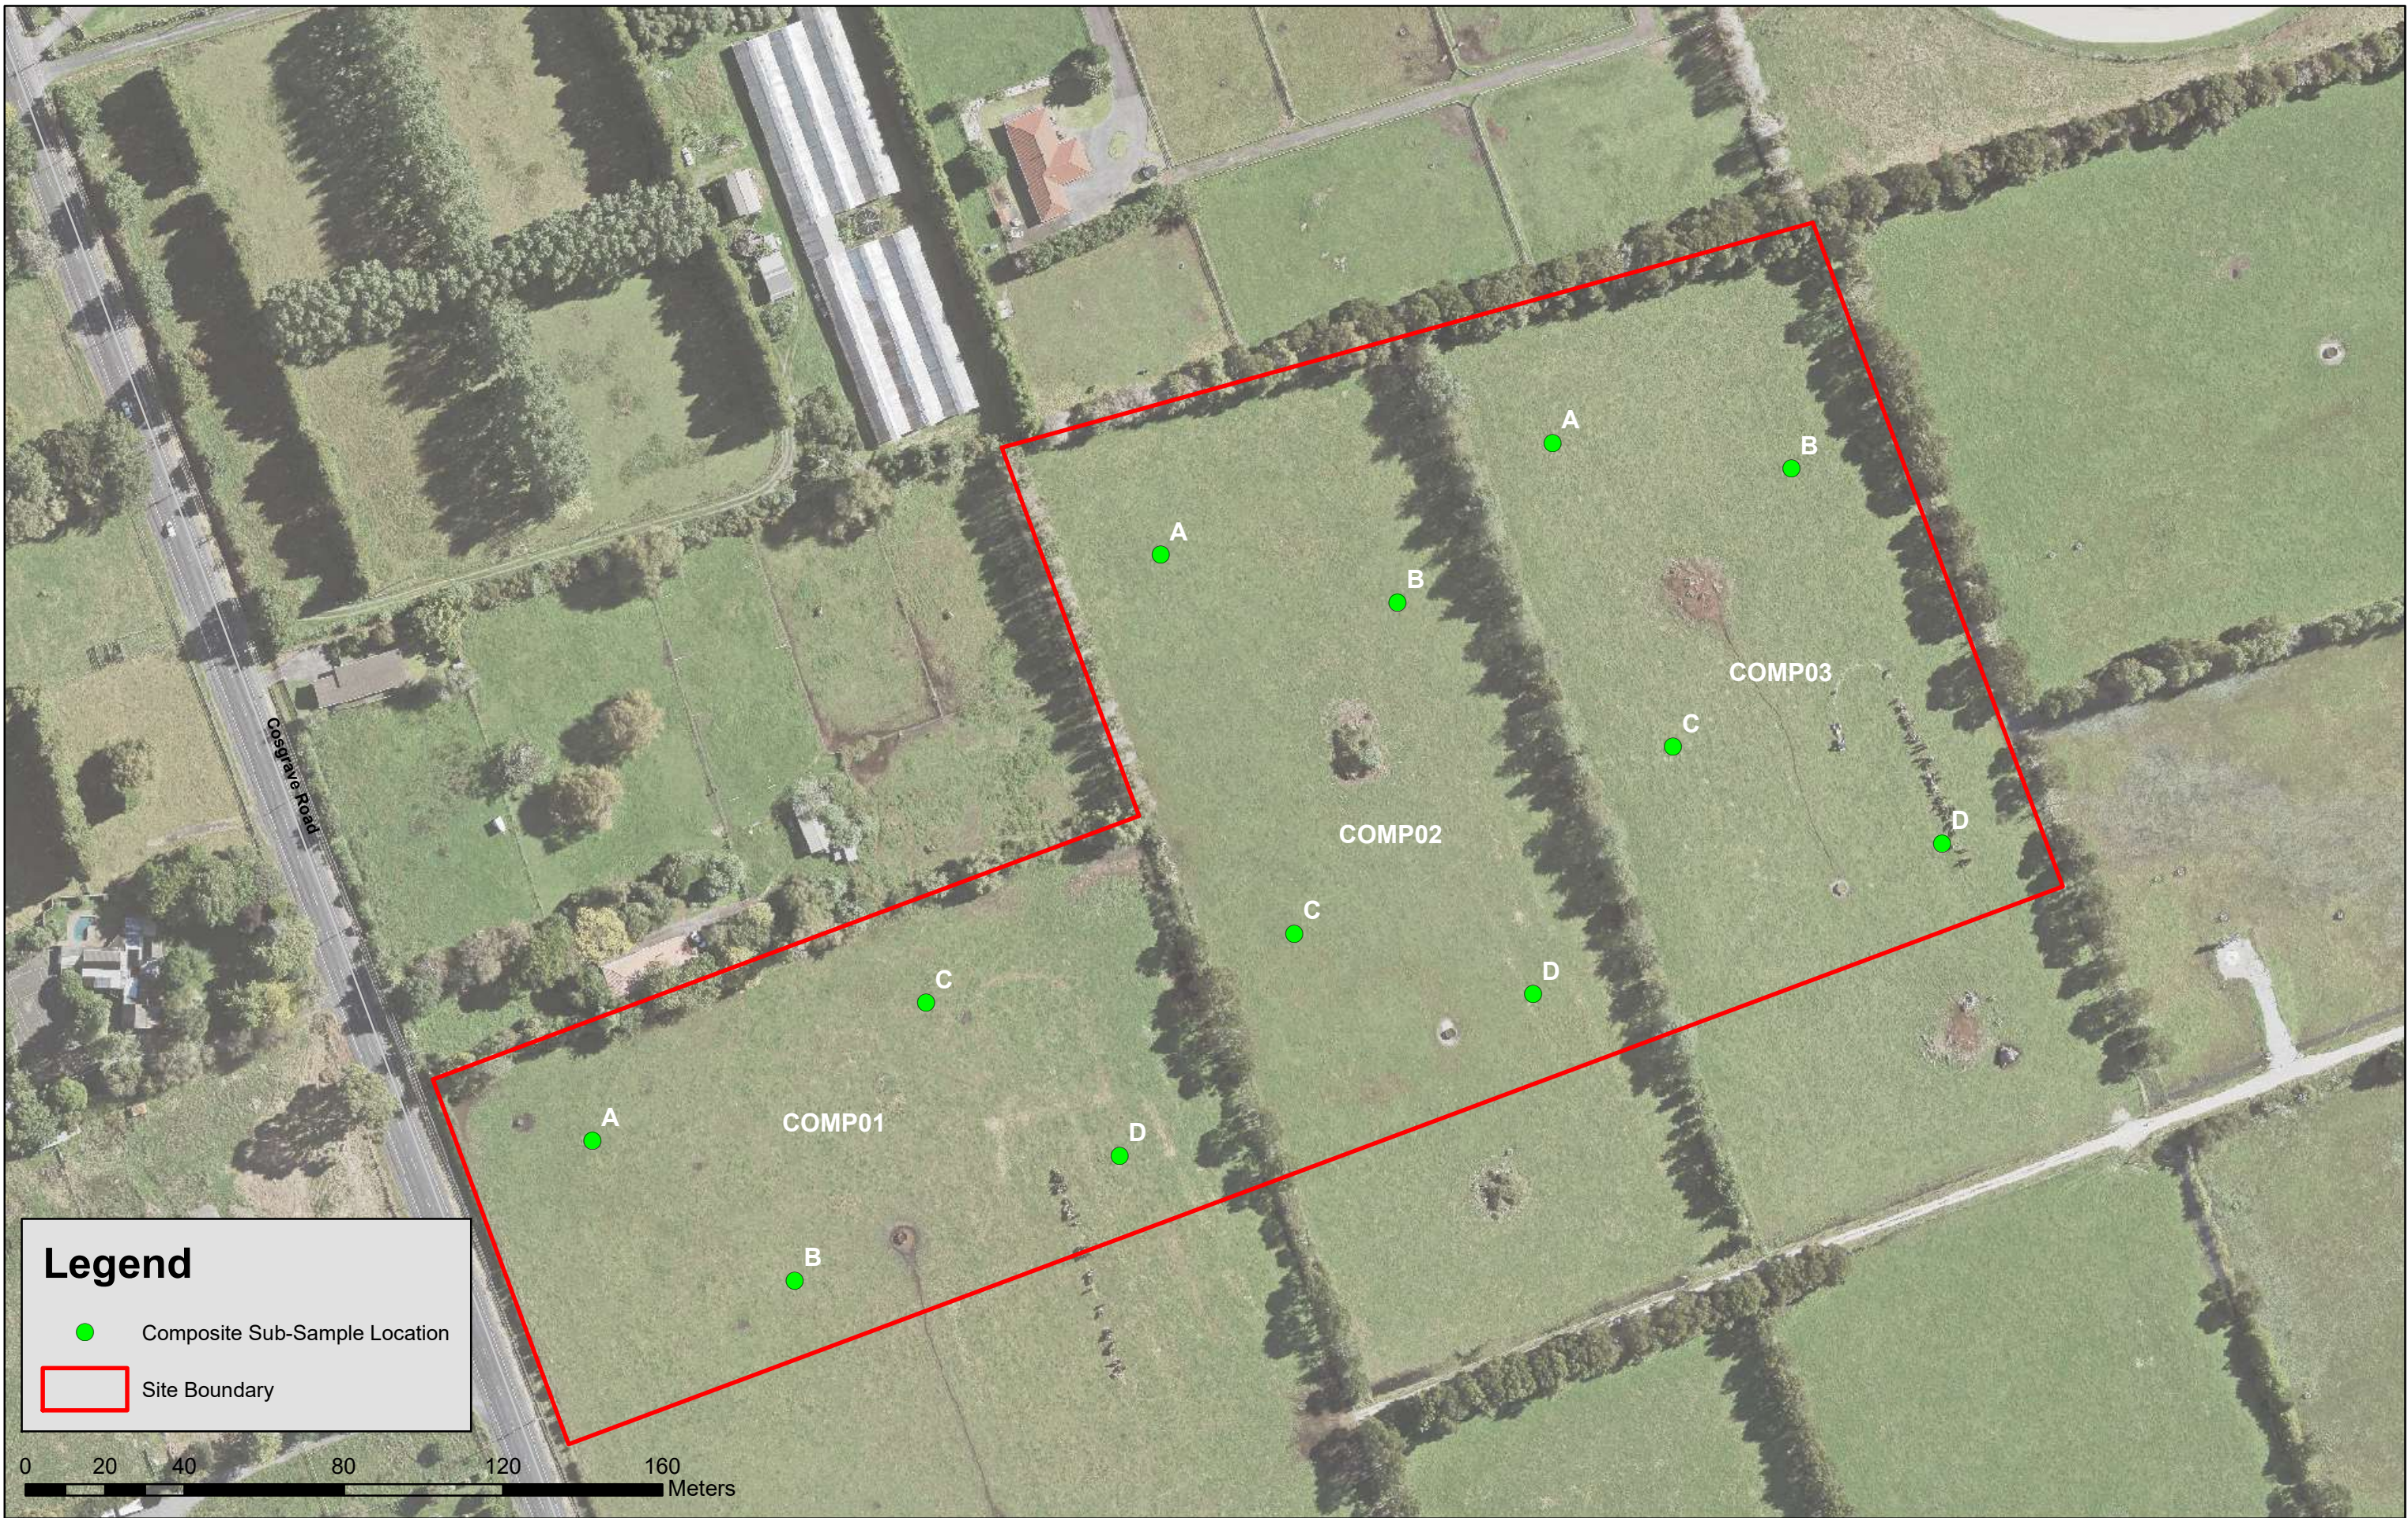
Figure 2 - Sample Location Plan

<p>Focus Environmental Services Limited PO Box 11455 Ellerslie Auckland 1542</p> <p>Ph: +64 9 579 4155 www.focusenvironmental.co.nz</p>	<p>Winton Land Limited Lot 1 DP 55480 Cosgrave Road Sunfield Urban Development Area Papakura Auckland</p>	<p>Figure 2: Sample Location Plan Detailed Site Investigation</p>

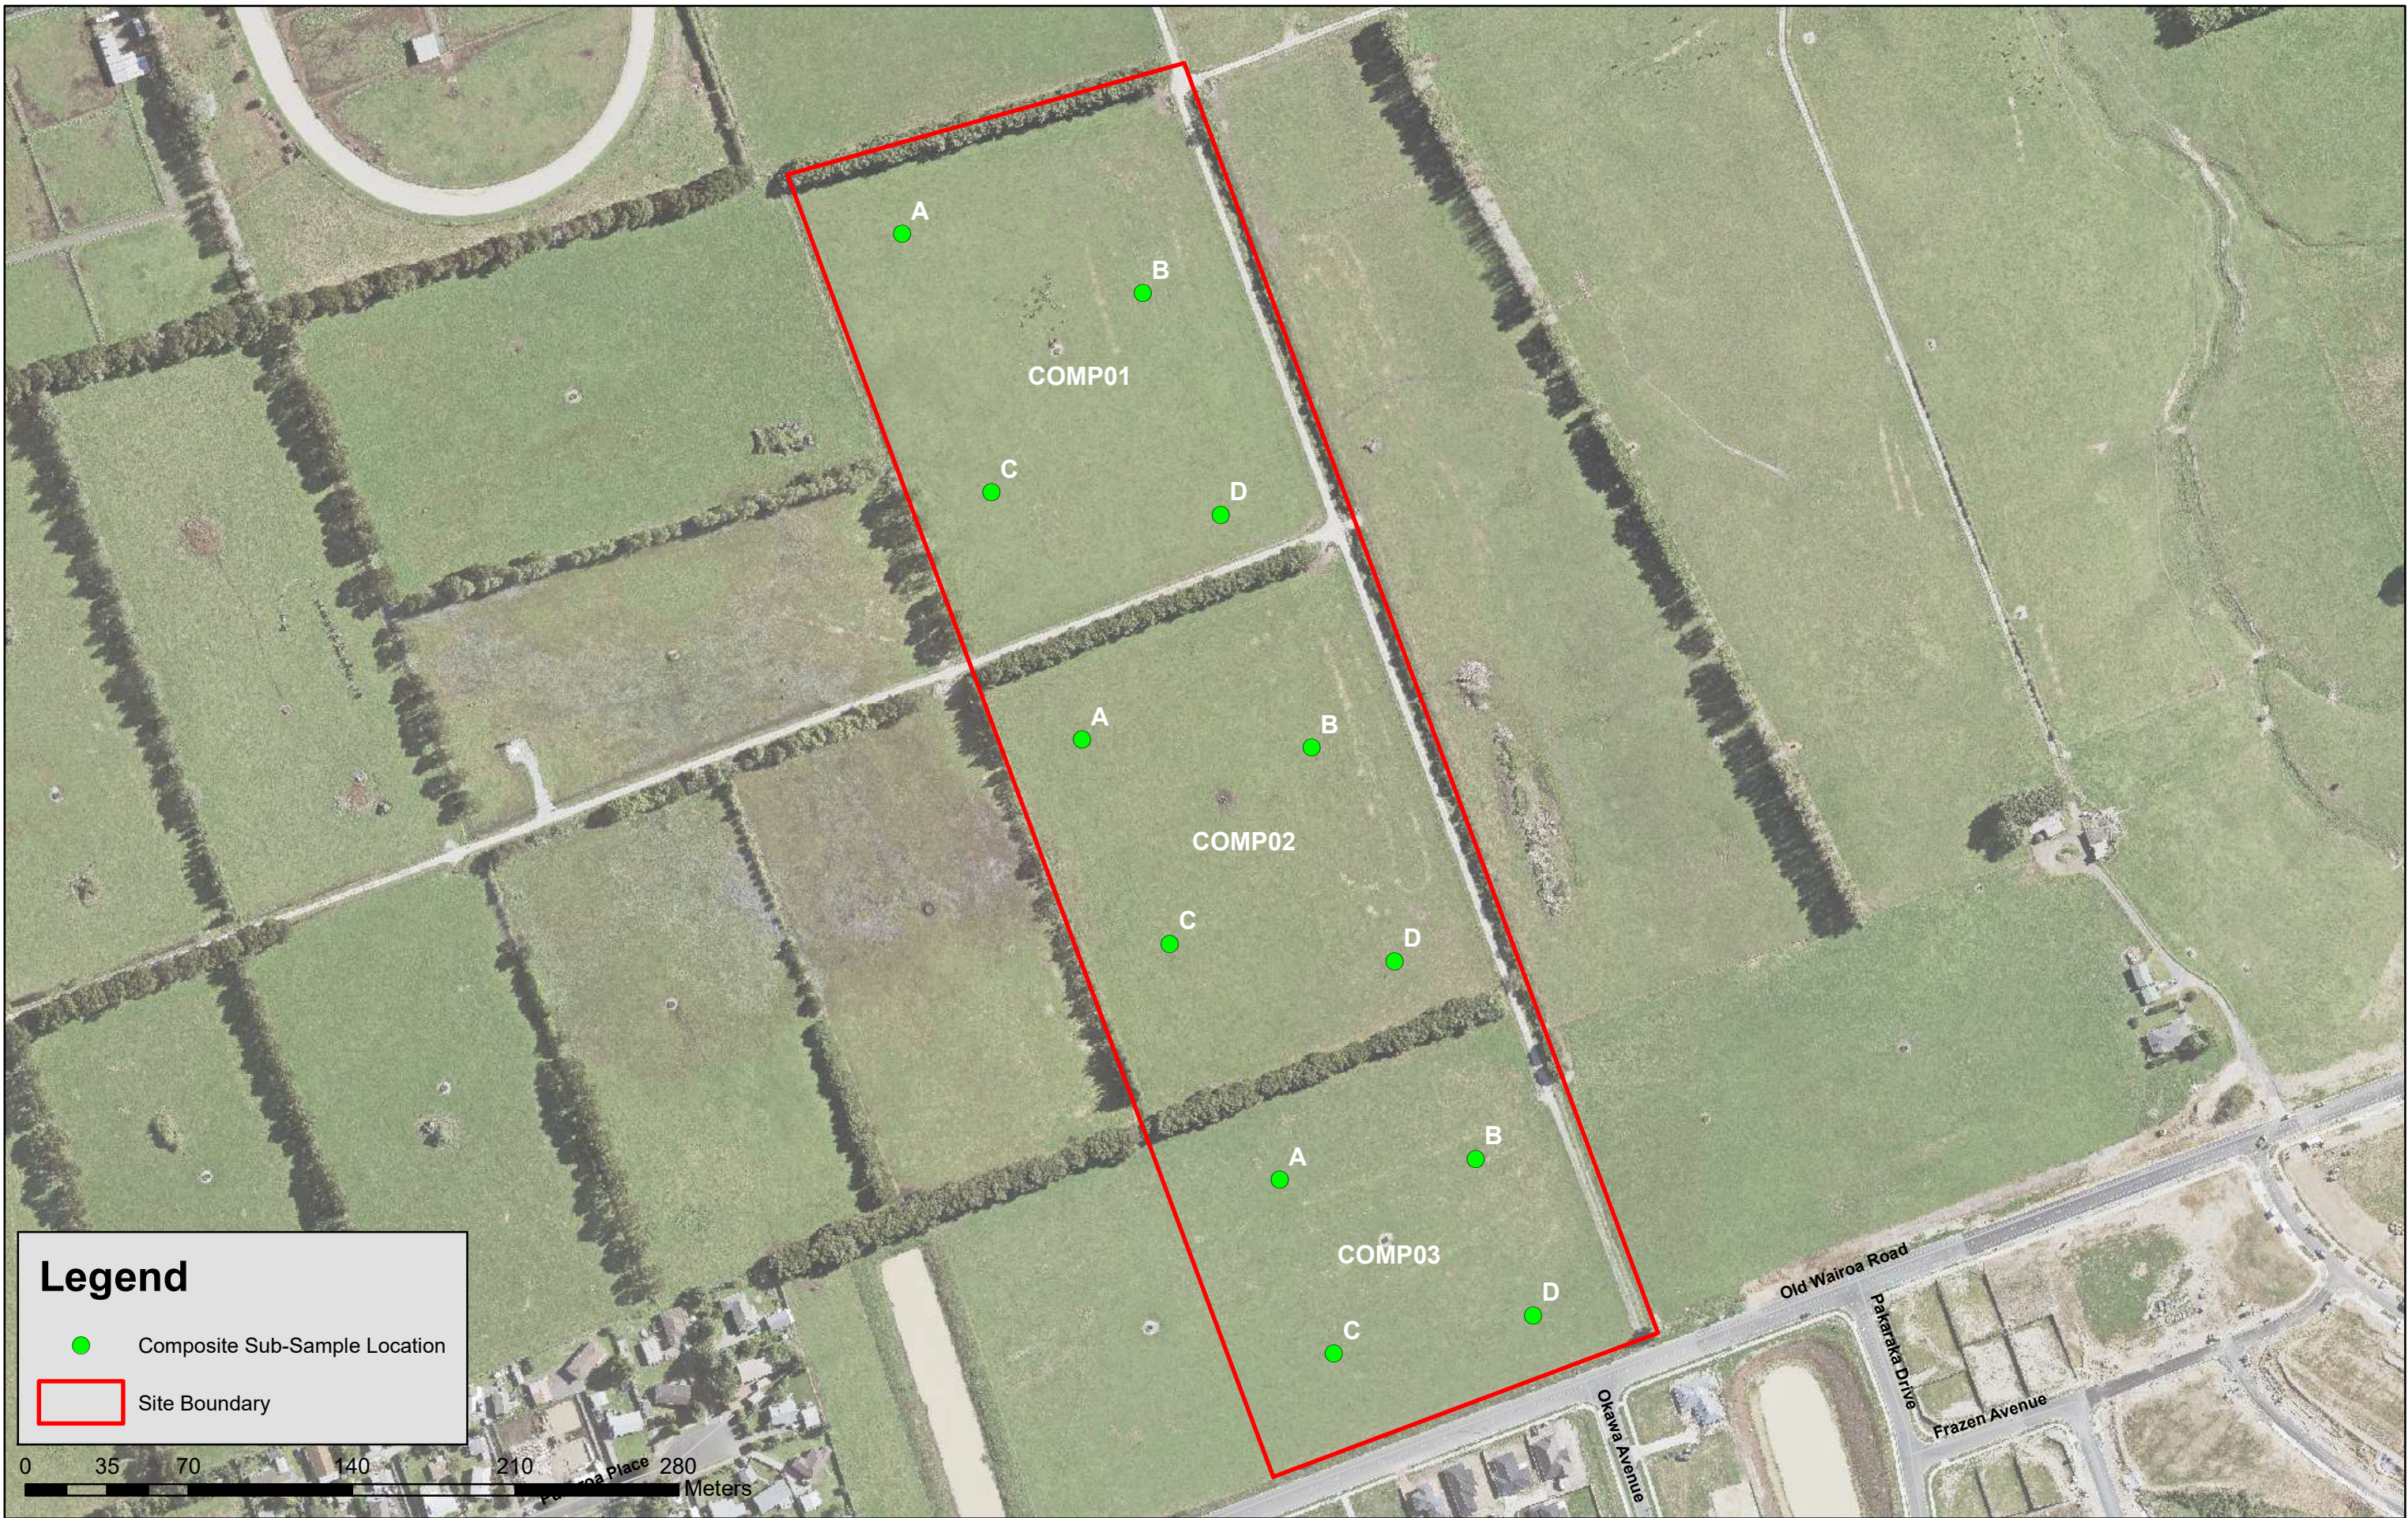
Drawing Number: 1443.012.03
				Drawn By: MT
			1443.012 R5	Checked By: DO'R
				Date: 19/12/2023

Composite Sub-Sample Location

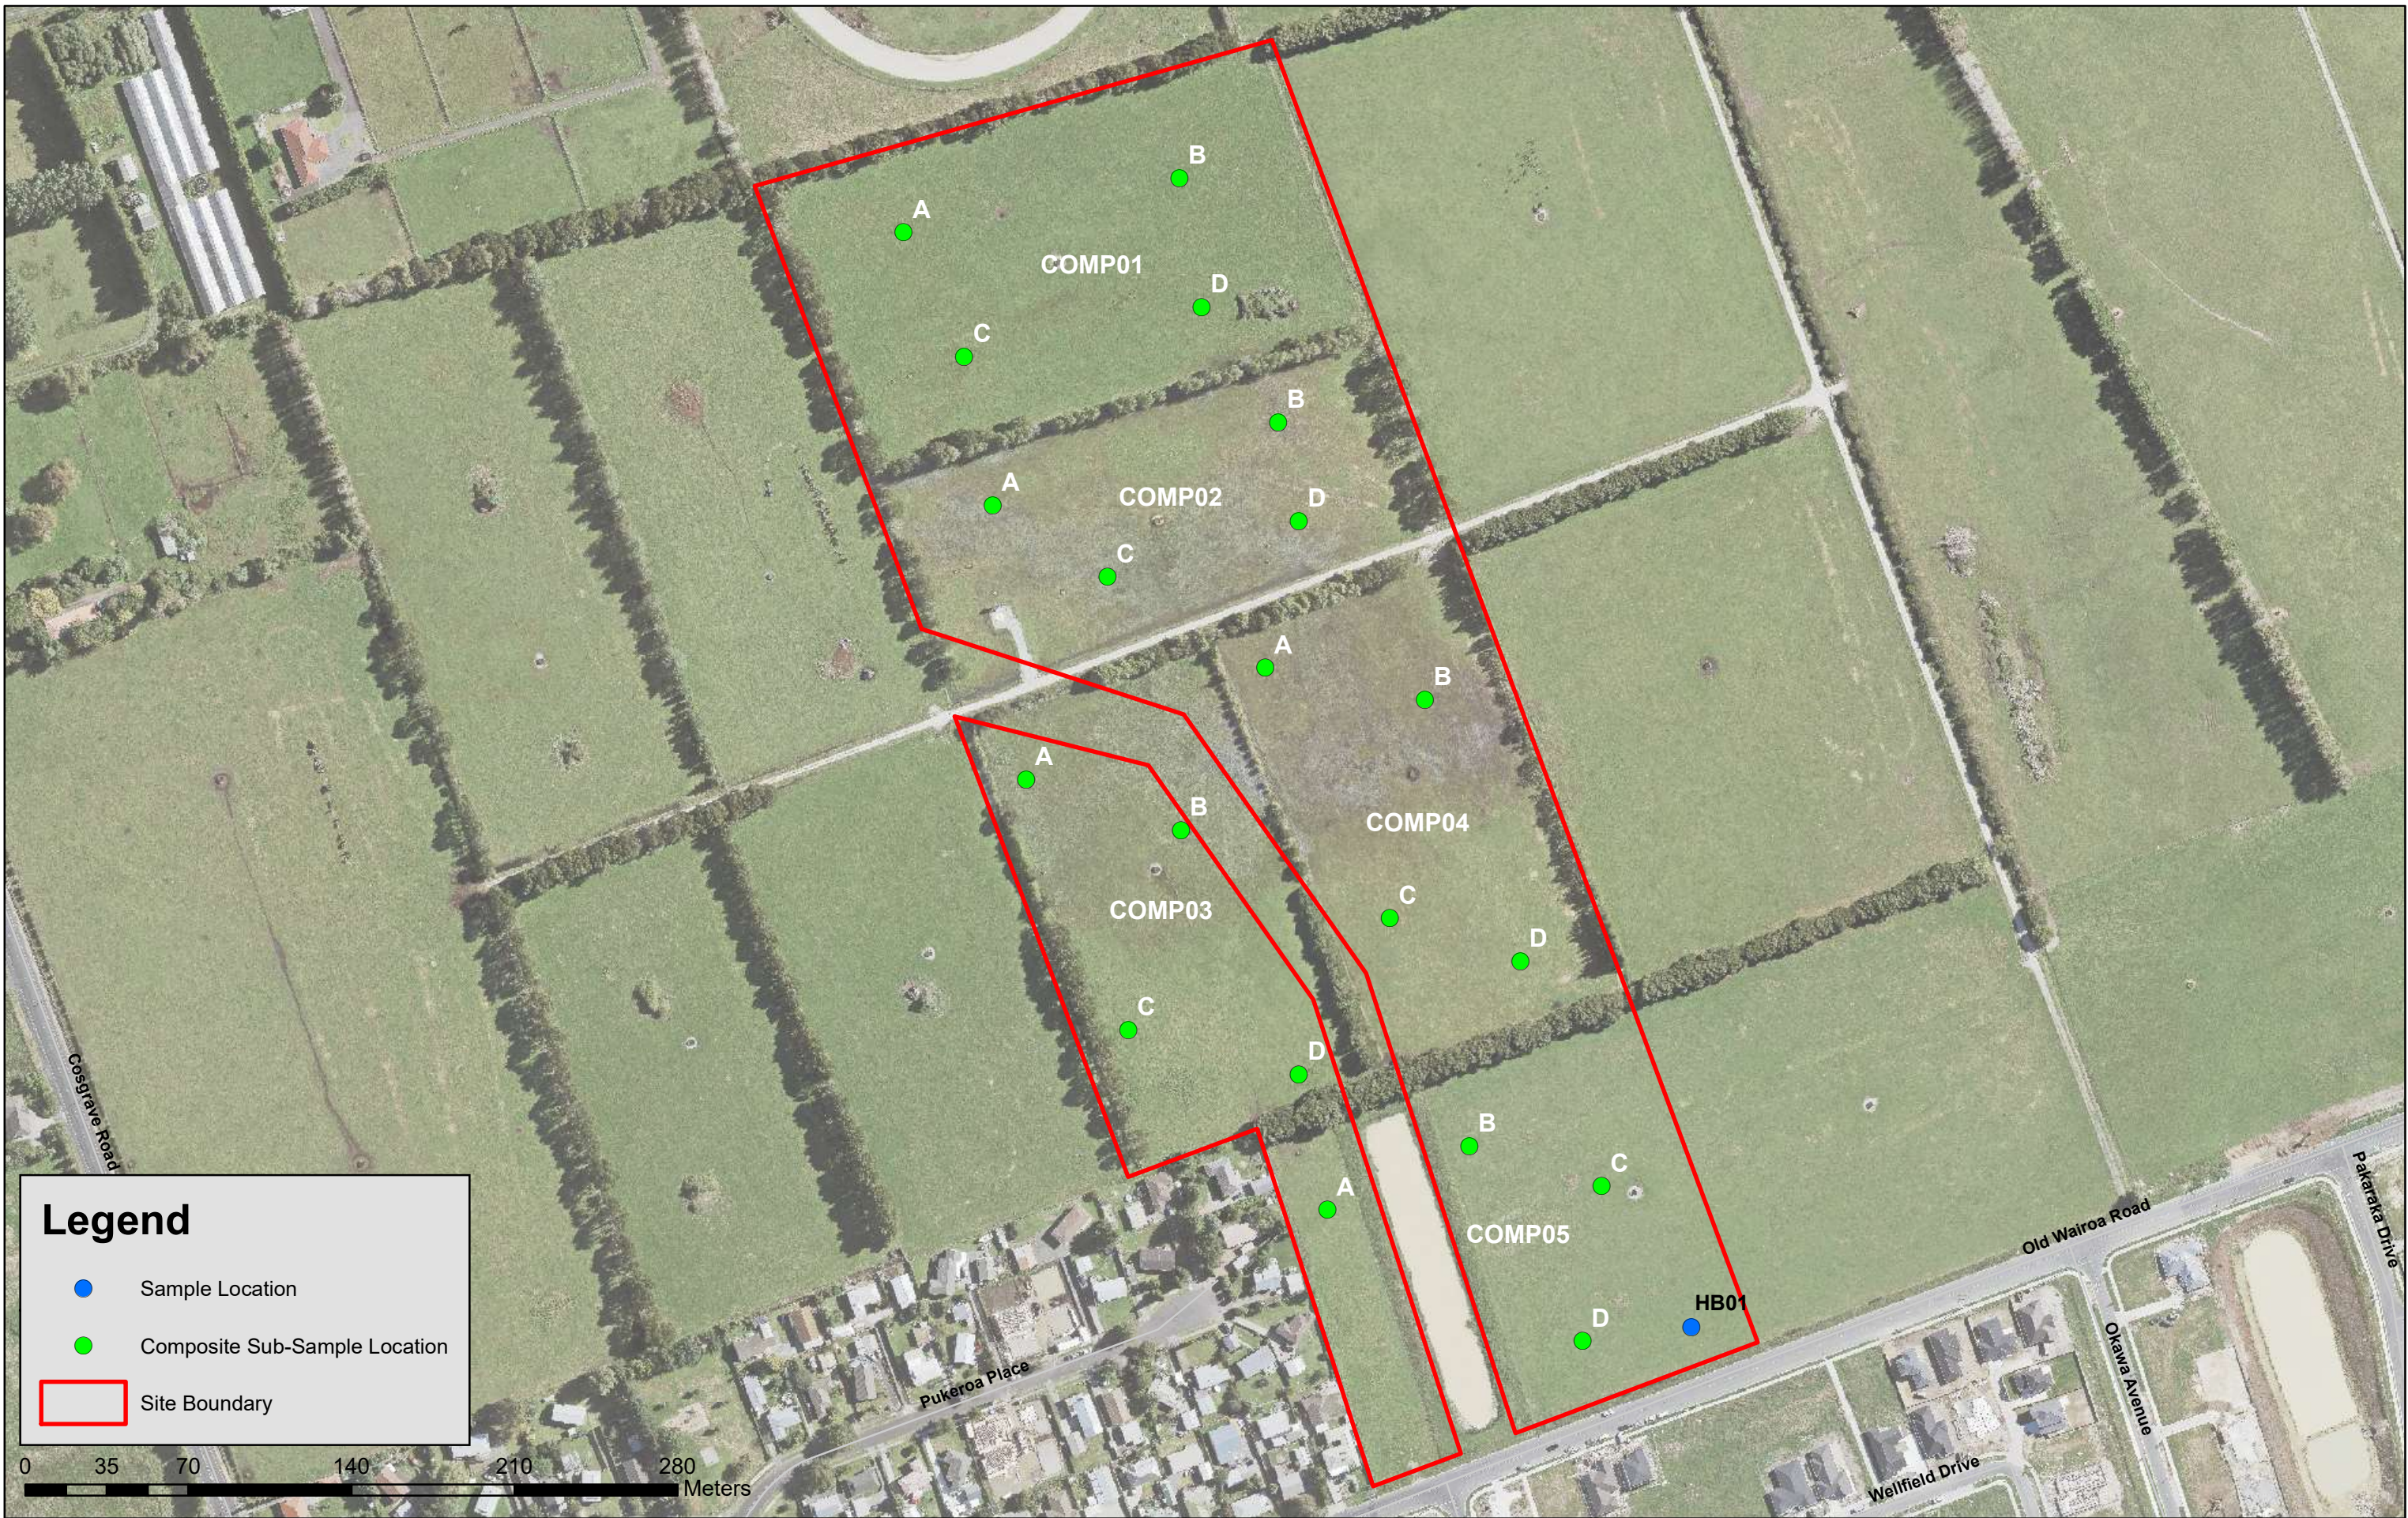
<p>Focus Environmental Services Limited PO Box 11455 Ellerslie Auckland 1542</p> <p>Ph: +64 9 579 4155 www.focusenvironmental.co.nz</p>	<p>Winton Land Limited Sect 5 SO 495342, Sect 6 SO 495342 Old Wairoa Road Sunfield Urban Development Area Papakura Auckland</p>	<p>Figure 3: Sample Location Plan Detailed Site Investigation</p>

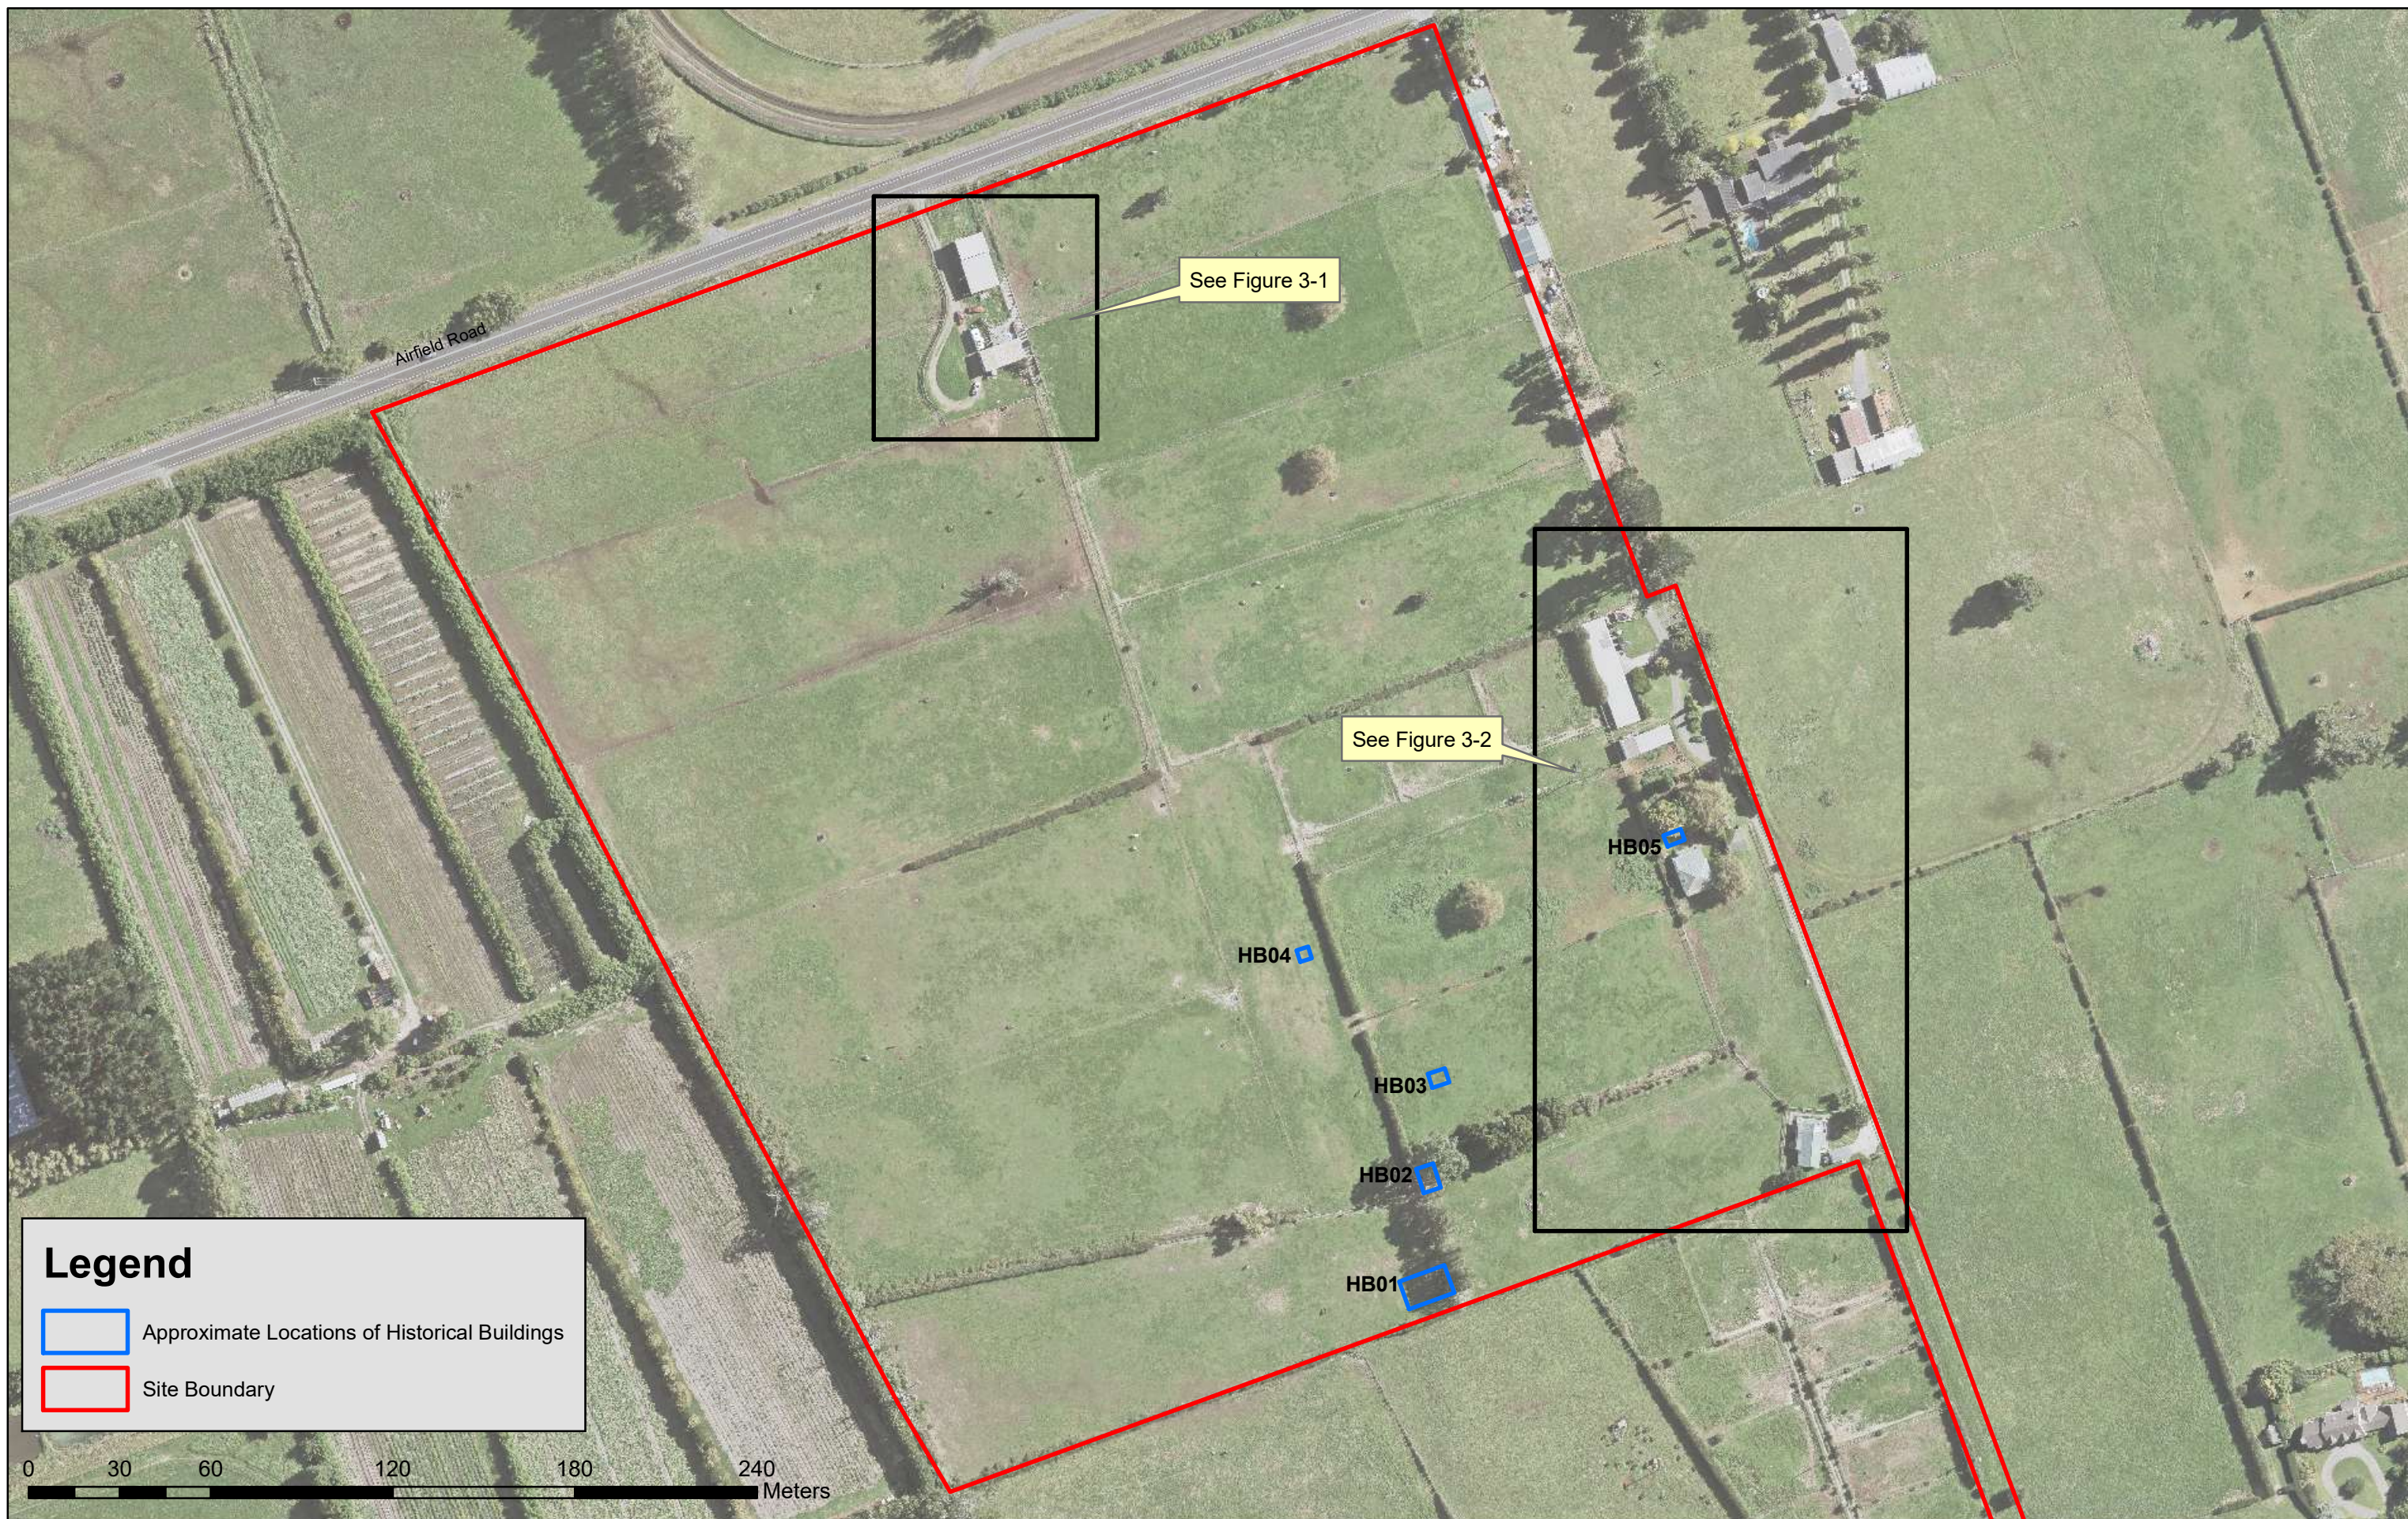
- Approximate Locations of Historical Buildings
- Site Boundary

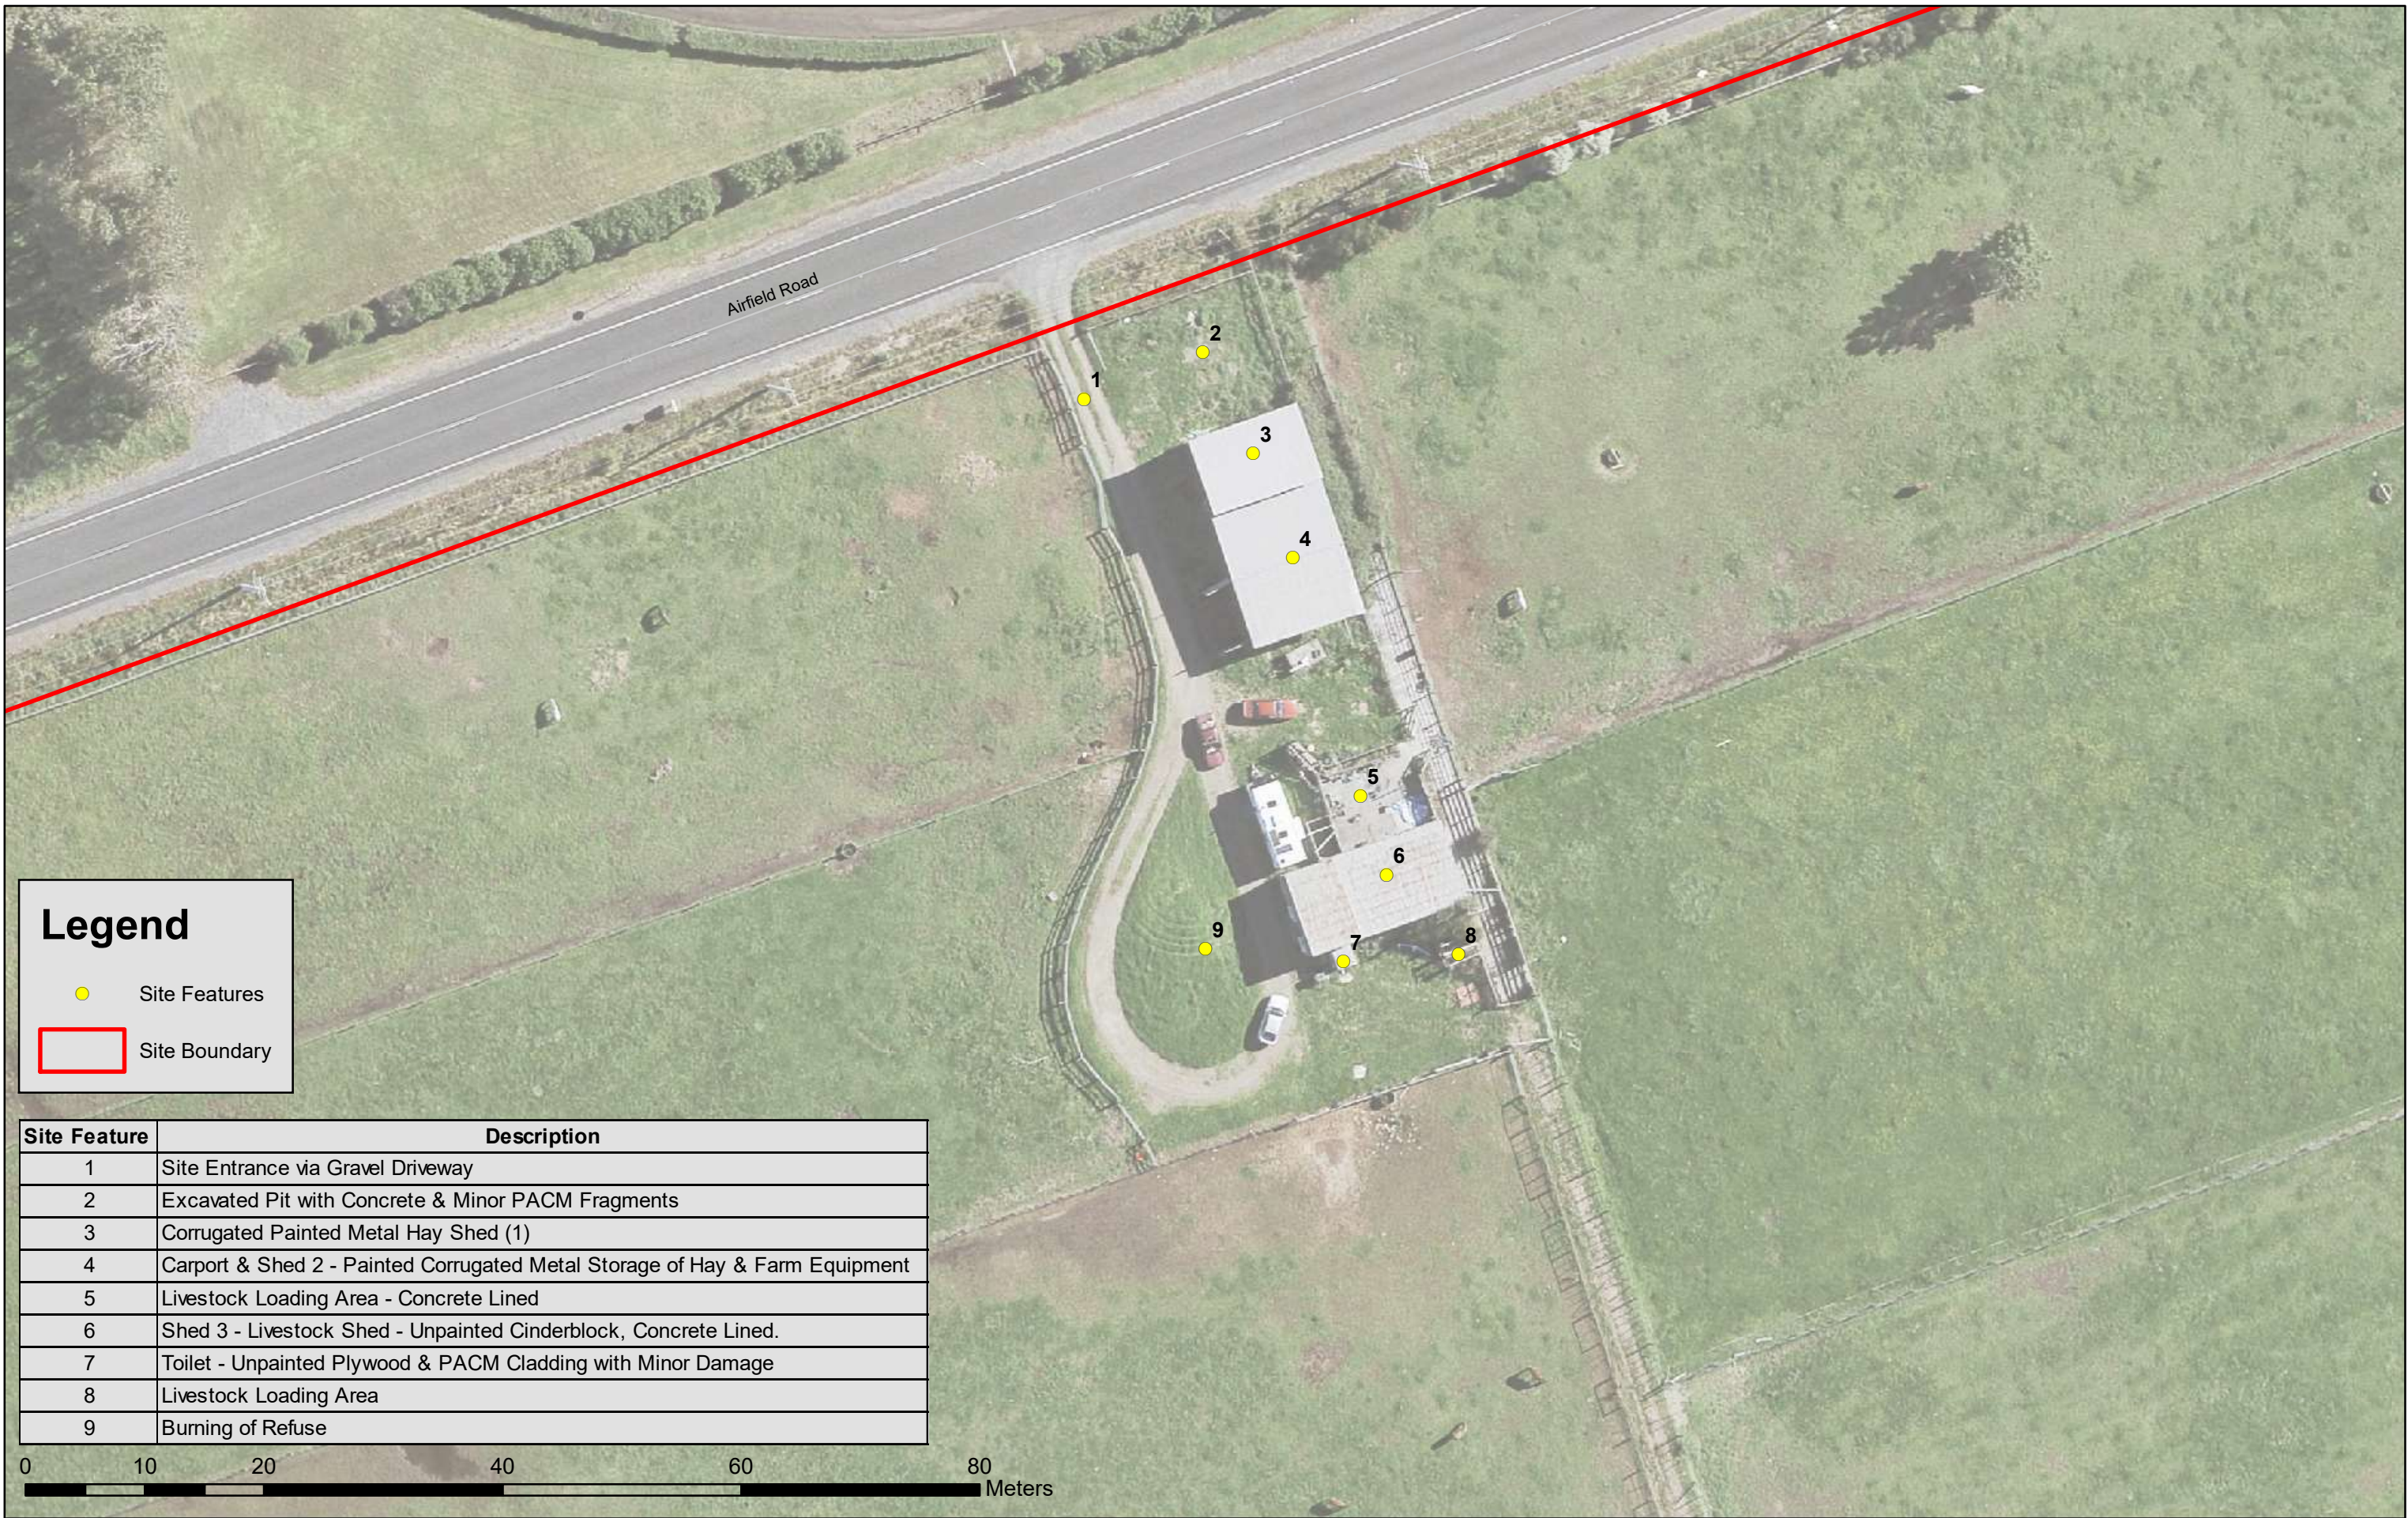
Site Feature	Description
1	Site Entrance via Gravel Driveway
2	Excavated Pit with Concrete & Minor PACM Fragments
3	Corrugated Painted Metal Hay Shed (1)
4	Carport & Shed 2 - Painted Corrugated Metal Storage of Hay & Farm Equipment
5	Livestock Loading Area - Concrete Lined
6	Shed 3 - Livestock Shed - Unpainted Cinderblock, Concrete Lined.
7	Toilet - Unpainted Plywood & PACM Cladding with Minor Damage
8	Livestock Loading Area
9	Burning of Refuse

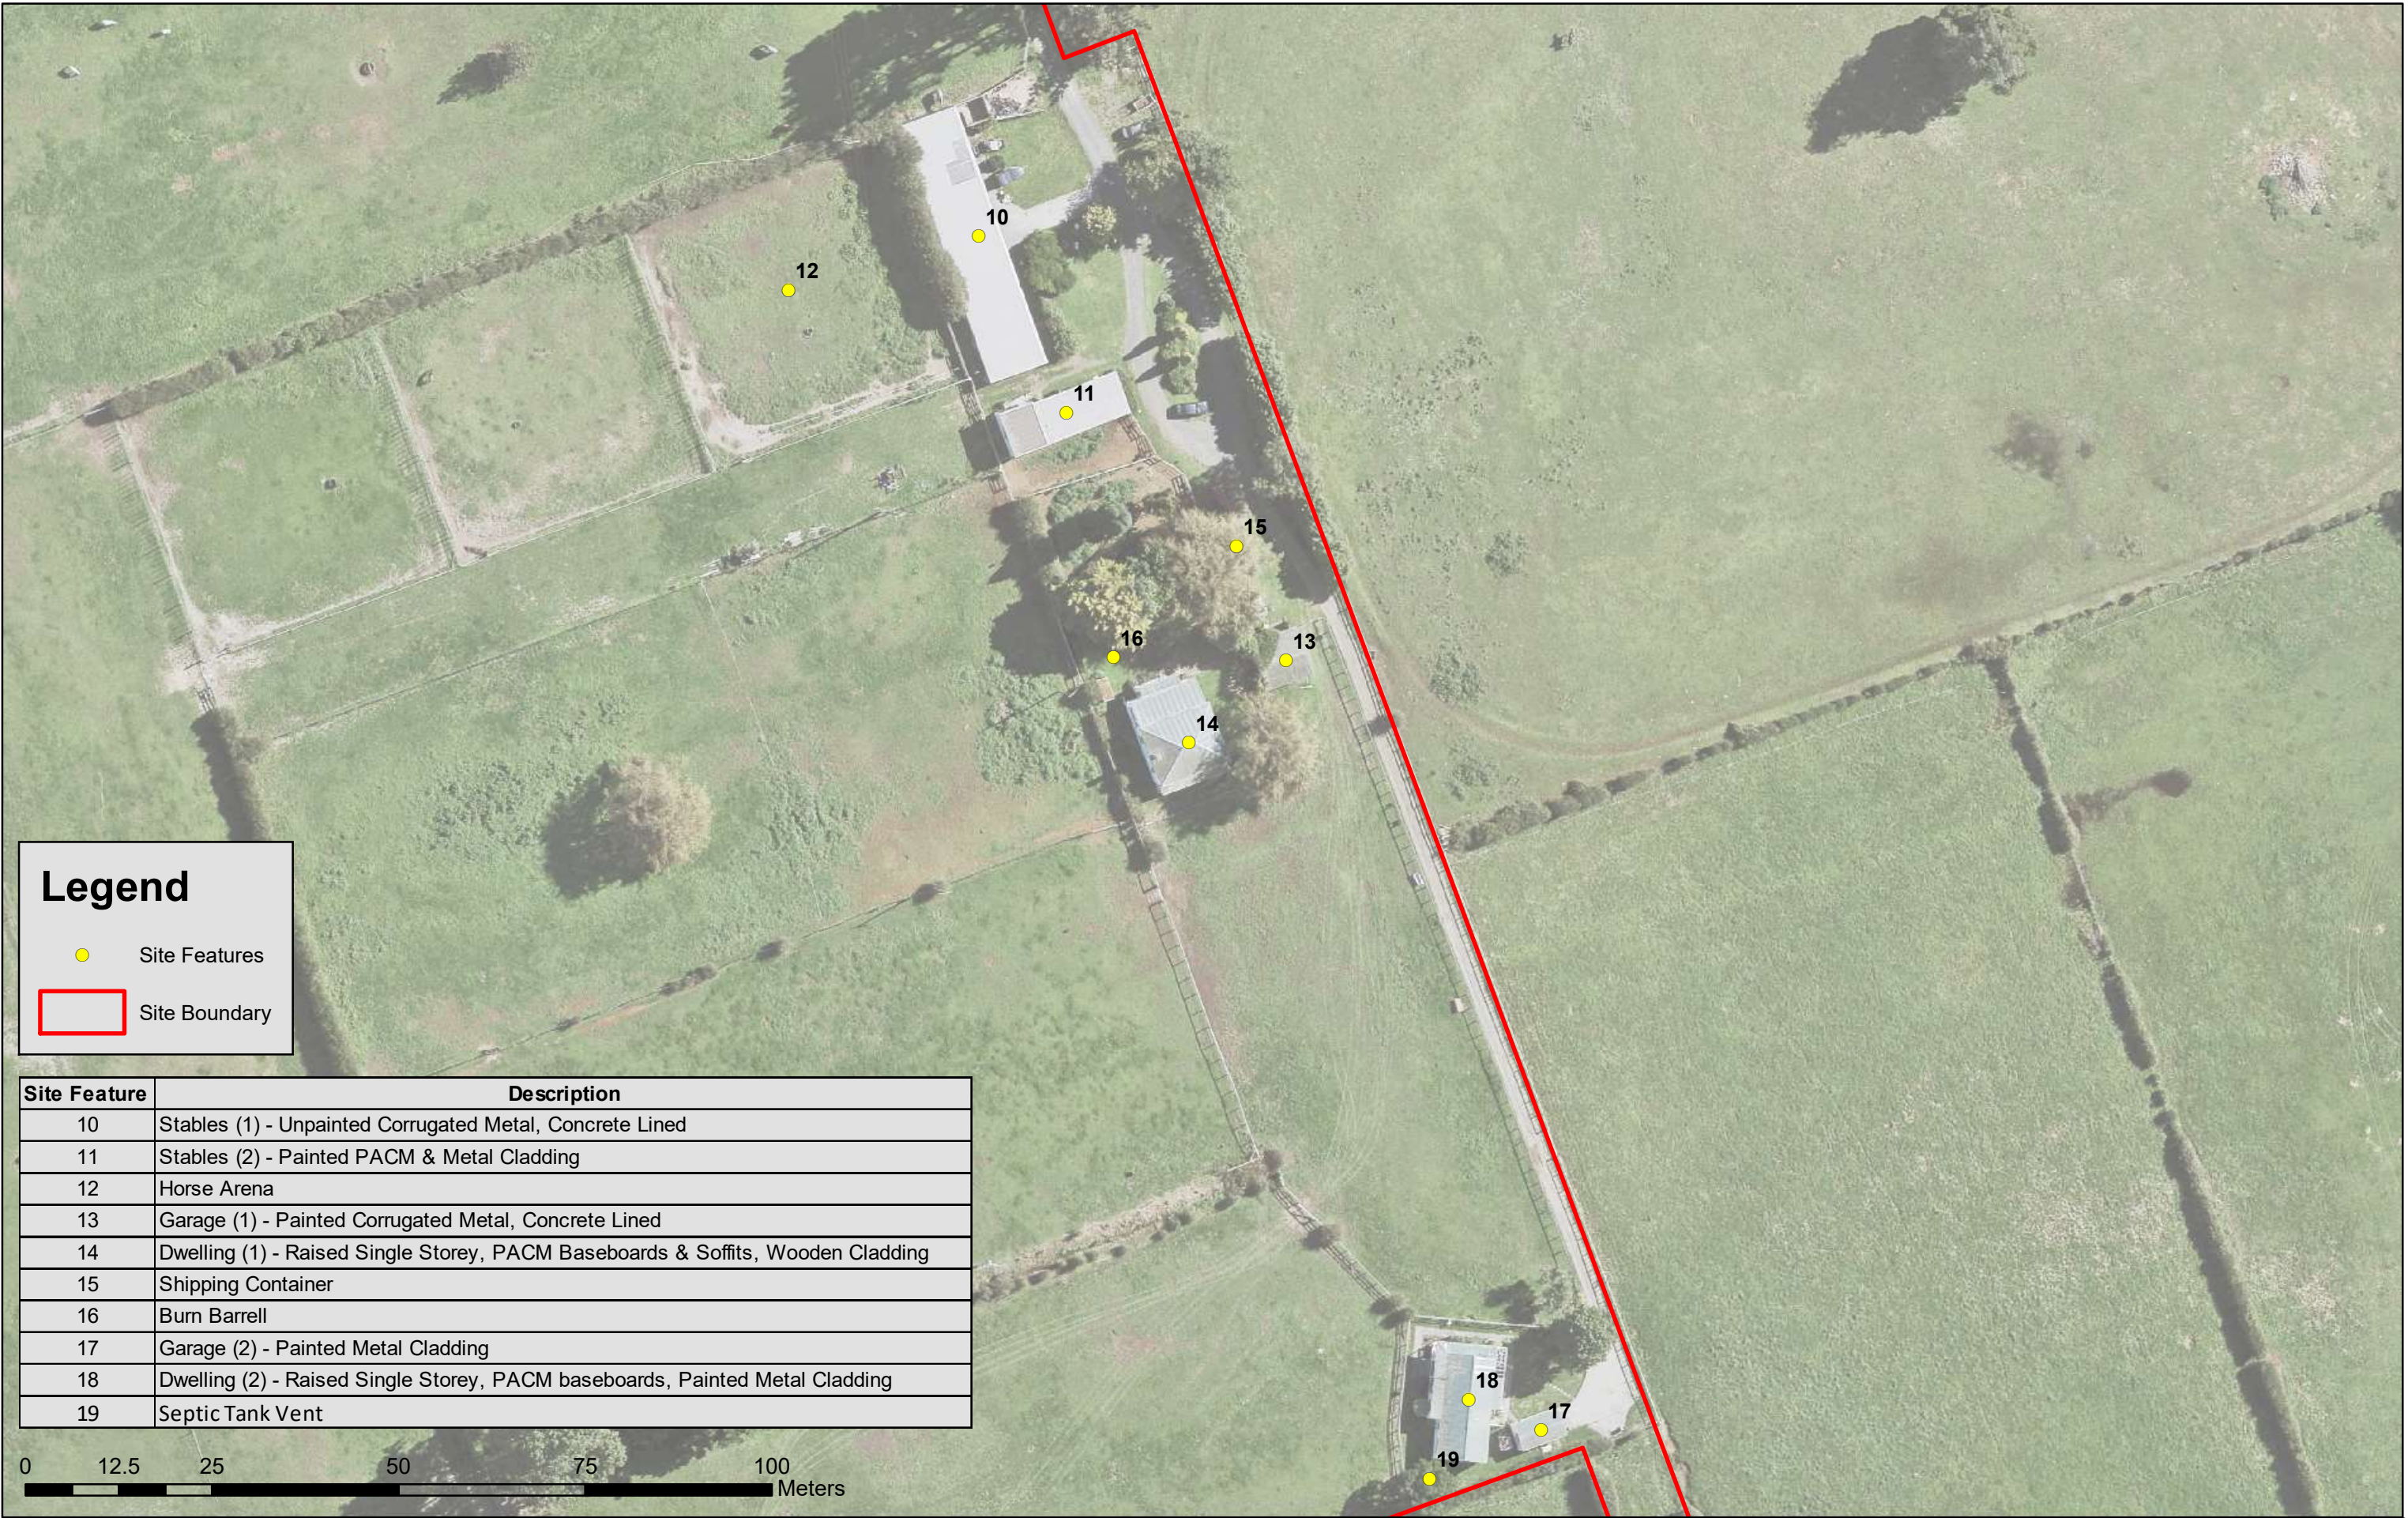
Site Feature	Description
10	Stables (1) - Unpainted Corrugated Metal, Concrete Lined
11	Stables (2) - Painted PACM & Metal Cladding
12	Horse Arena
13	Garage (1) - Painted Corrugated Metal, Concrete Lined
14	Dwelling (1) - Raised Single Storey, PACM Baseboards & Soffits, Wooden Cladding
15	Shipping Container
16	Burn Barrell
17	Garage (2) - Painted Metal Cladding
18	Dwelling (2) - Raised Single Storey, PACM baseboards, Painted Metal Cladding
19	Septic Tank Vent
