***DETAILED SITE INVESTIGATION
LOT 1 DP5548 COSGRAVE ROAD
ARDMORE
AUCKLAND***

Reference: FES 1443.011 December 2023 (R5)

Winton Land Limited – Lot 1 DP 55480, Cosgrave Road, Ardmore

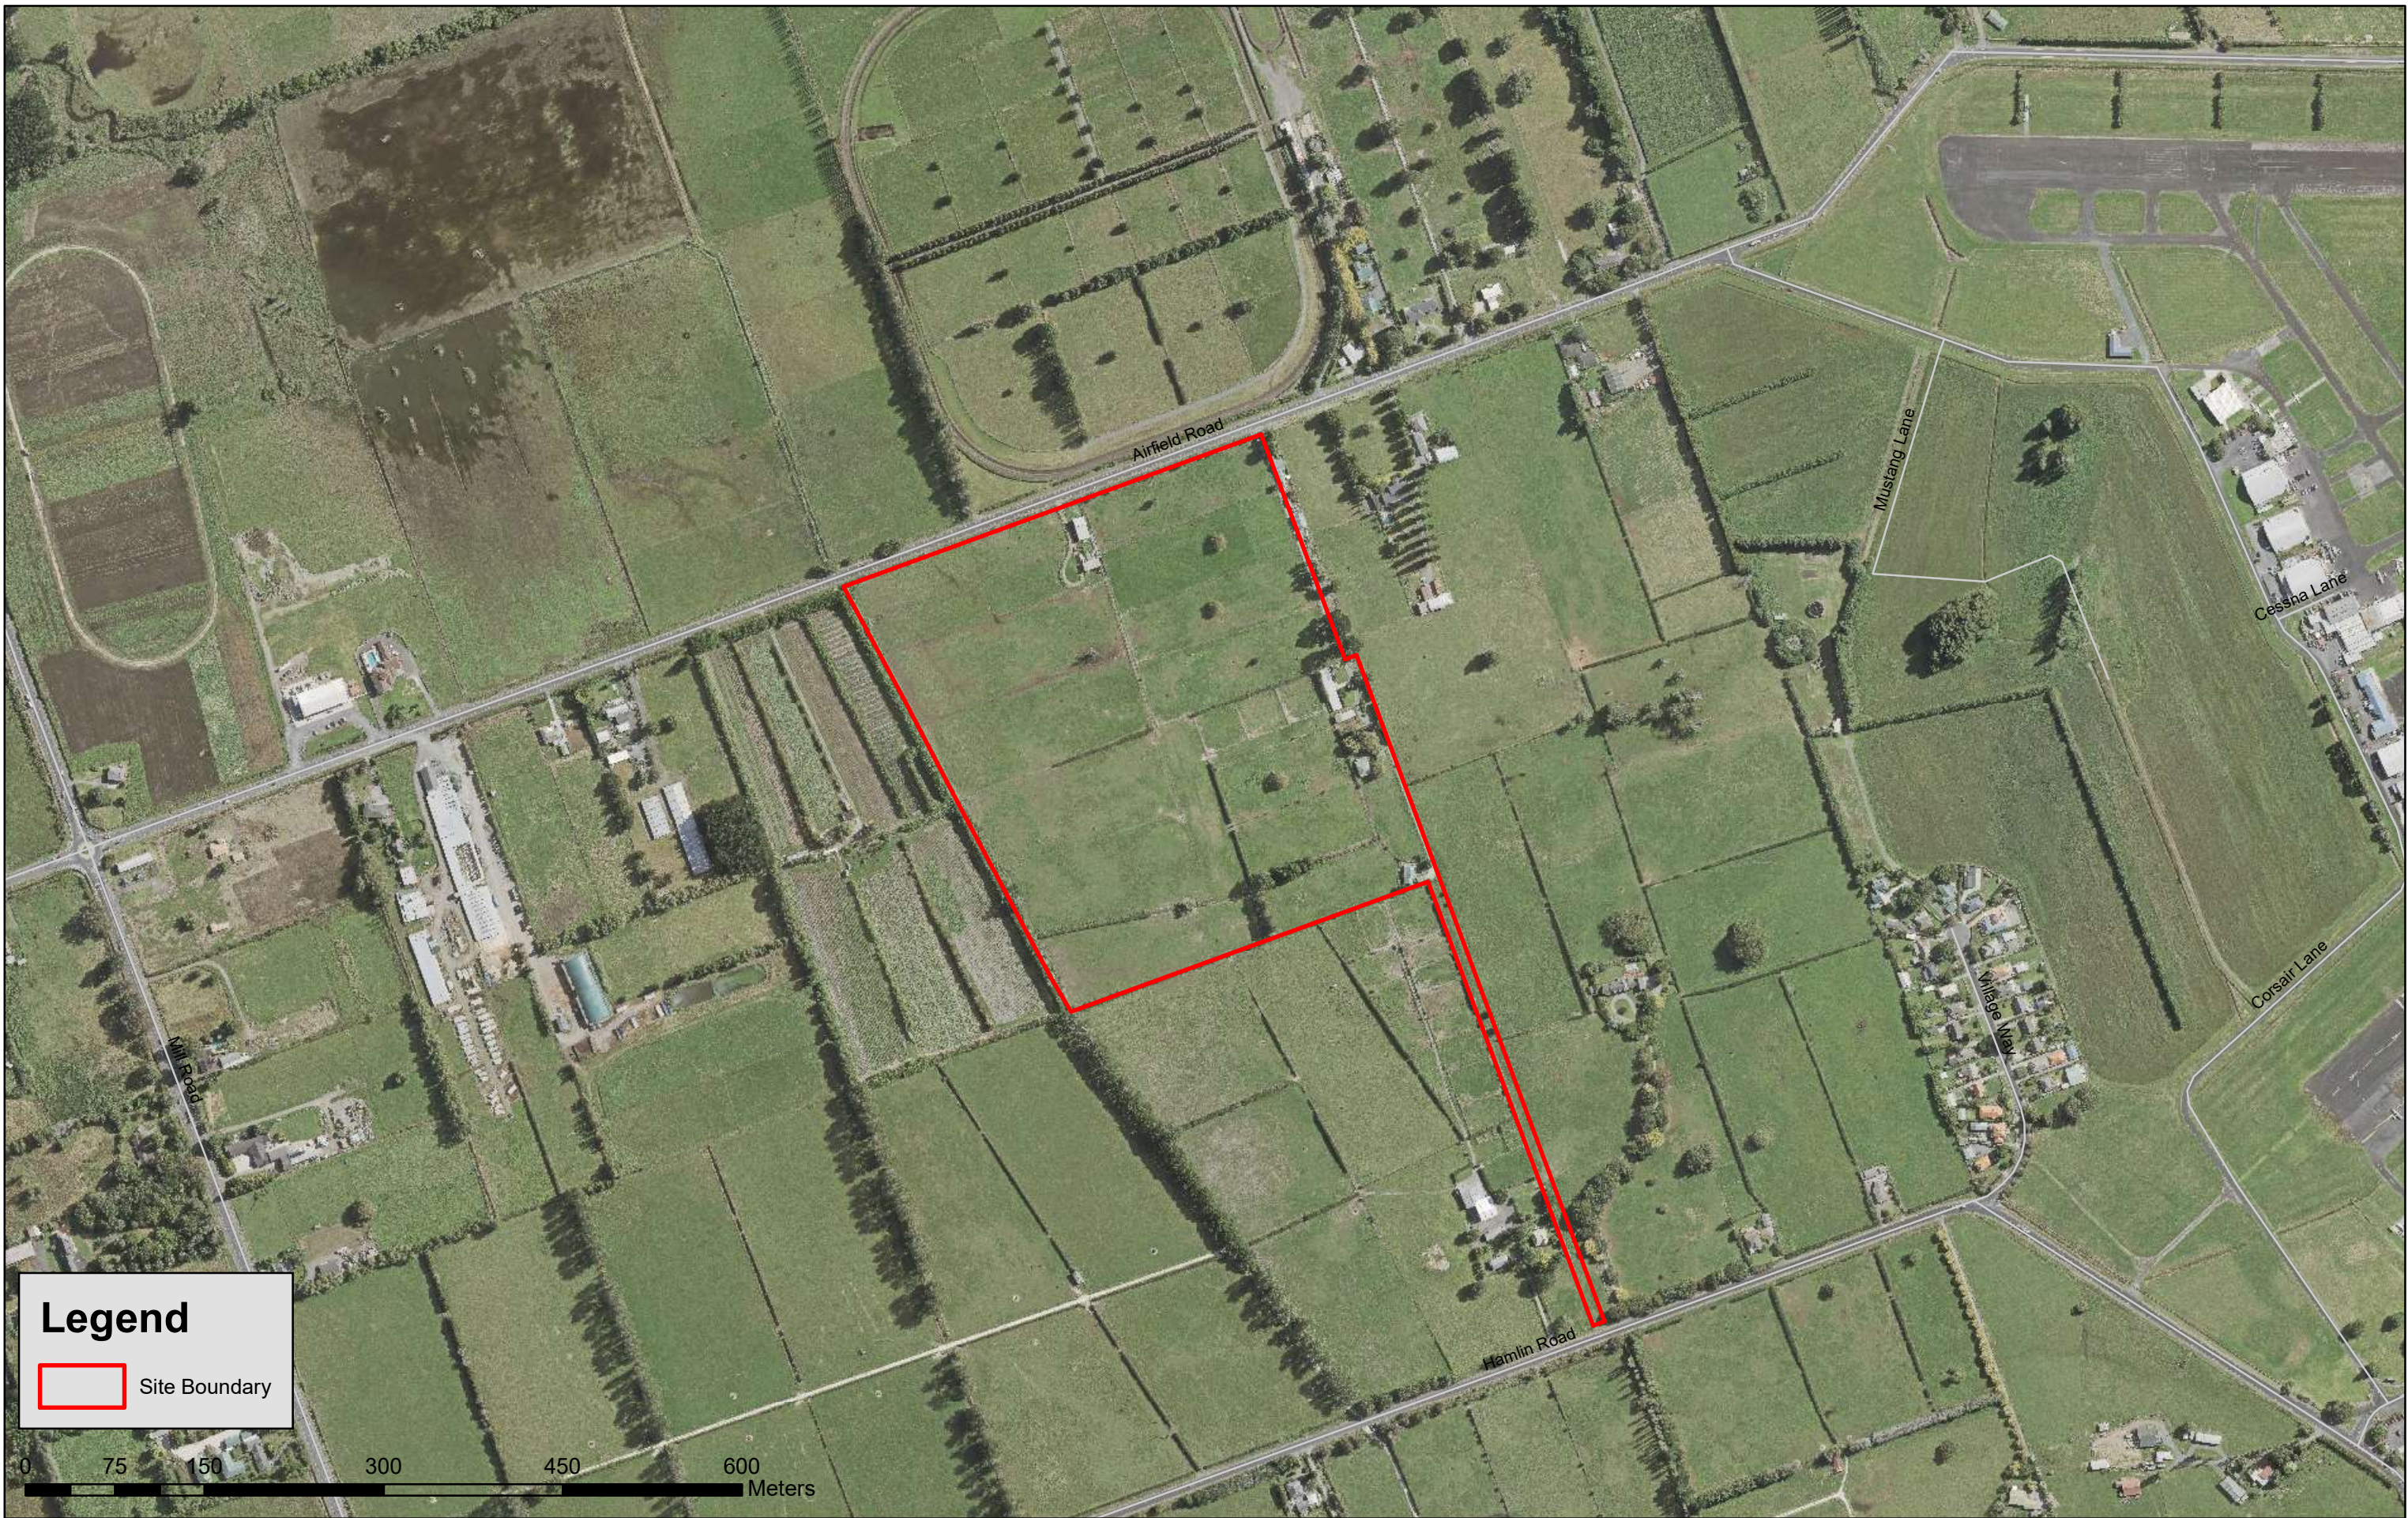
Site Feature	Description
10	Stables (1) - Unpainted Corrugated Metal, Concrete Lined
11	Stables (2) - Painted PACM & Metal Cladding
12	Horse Arena
13	Garage (1) - Painted Corrugated Metal, Concrete Lined
14	Dwelling (1) - Raised Single Storey, PACM Baseboards & Soffits, Wooden Cladding
15	Shipping Container
16	Burn Barrell
17	Garage (2) - Painted Metal Cladding
18	Dwelling (2) - Raised Single Storey, PACM baseboards, Painted Metal Cladding
19	Septic Tank Vent

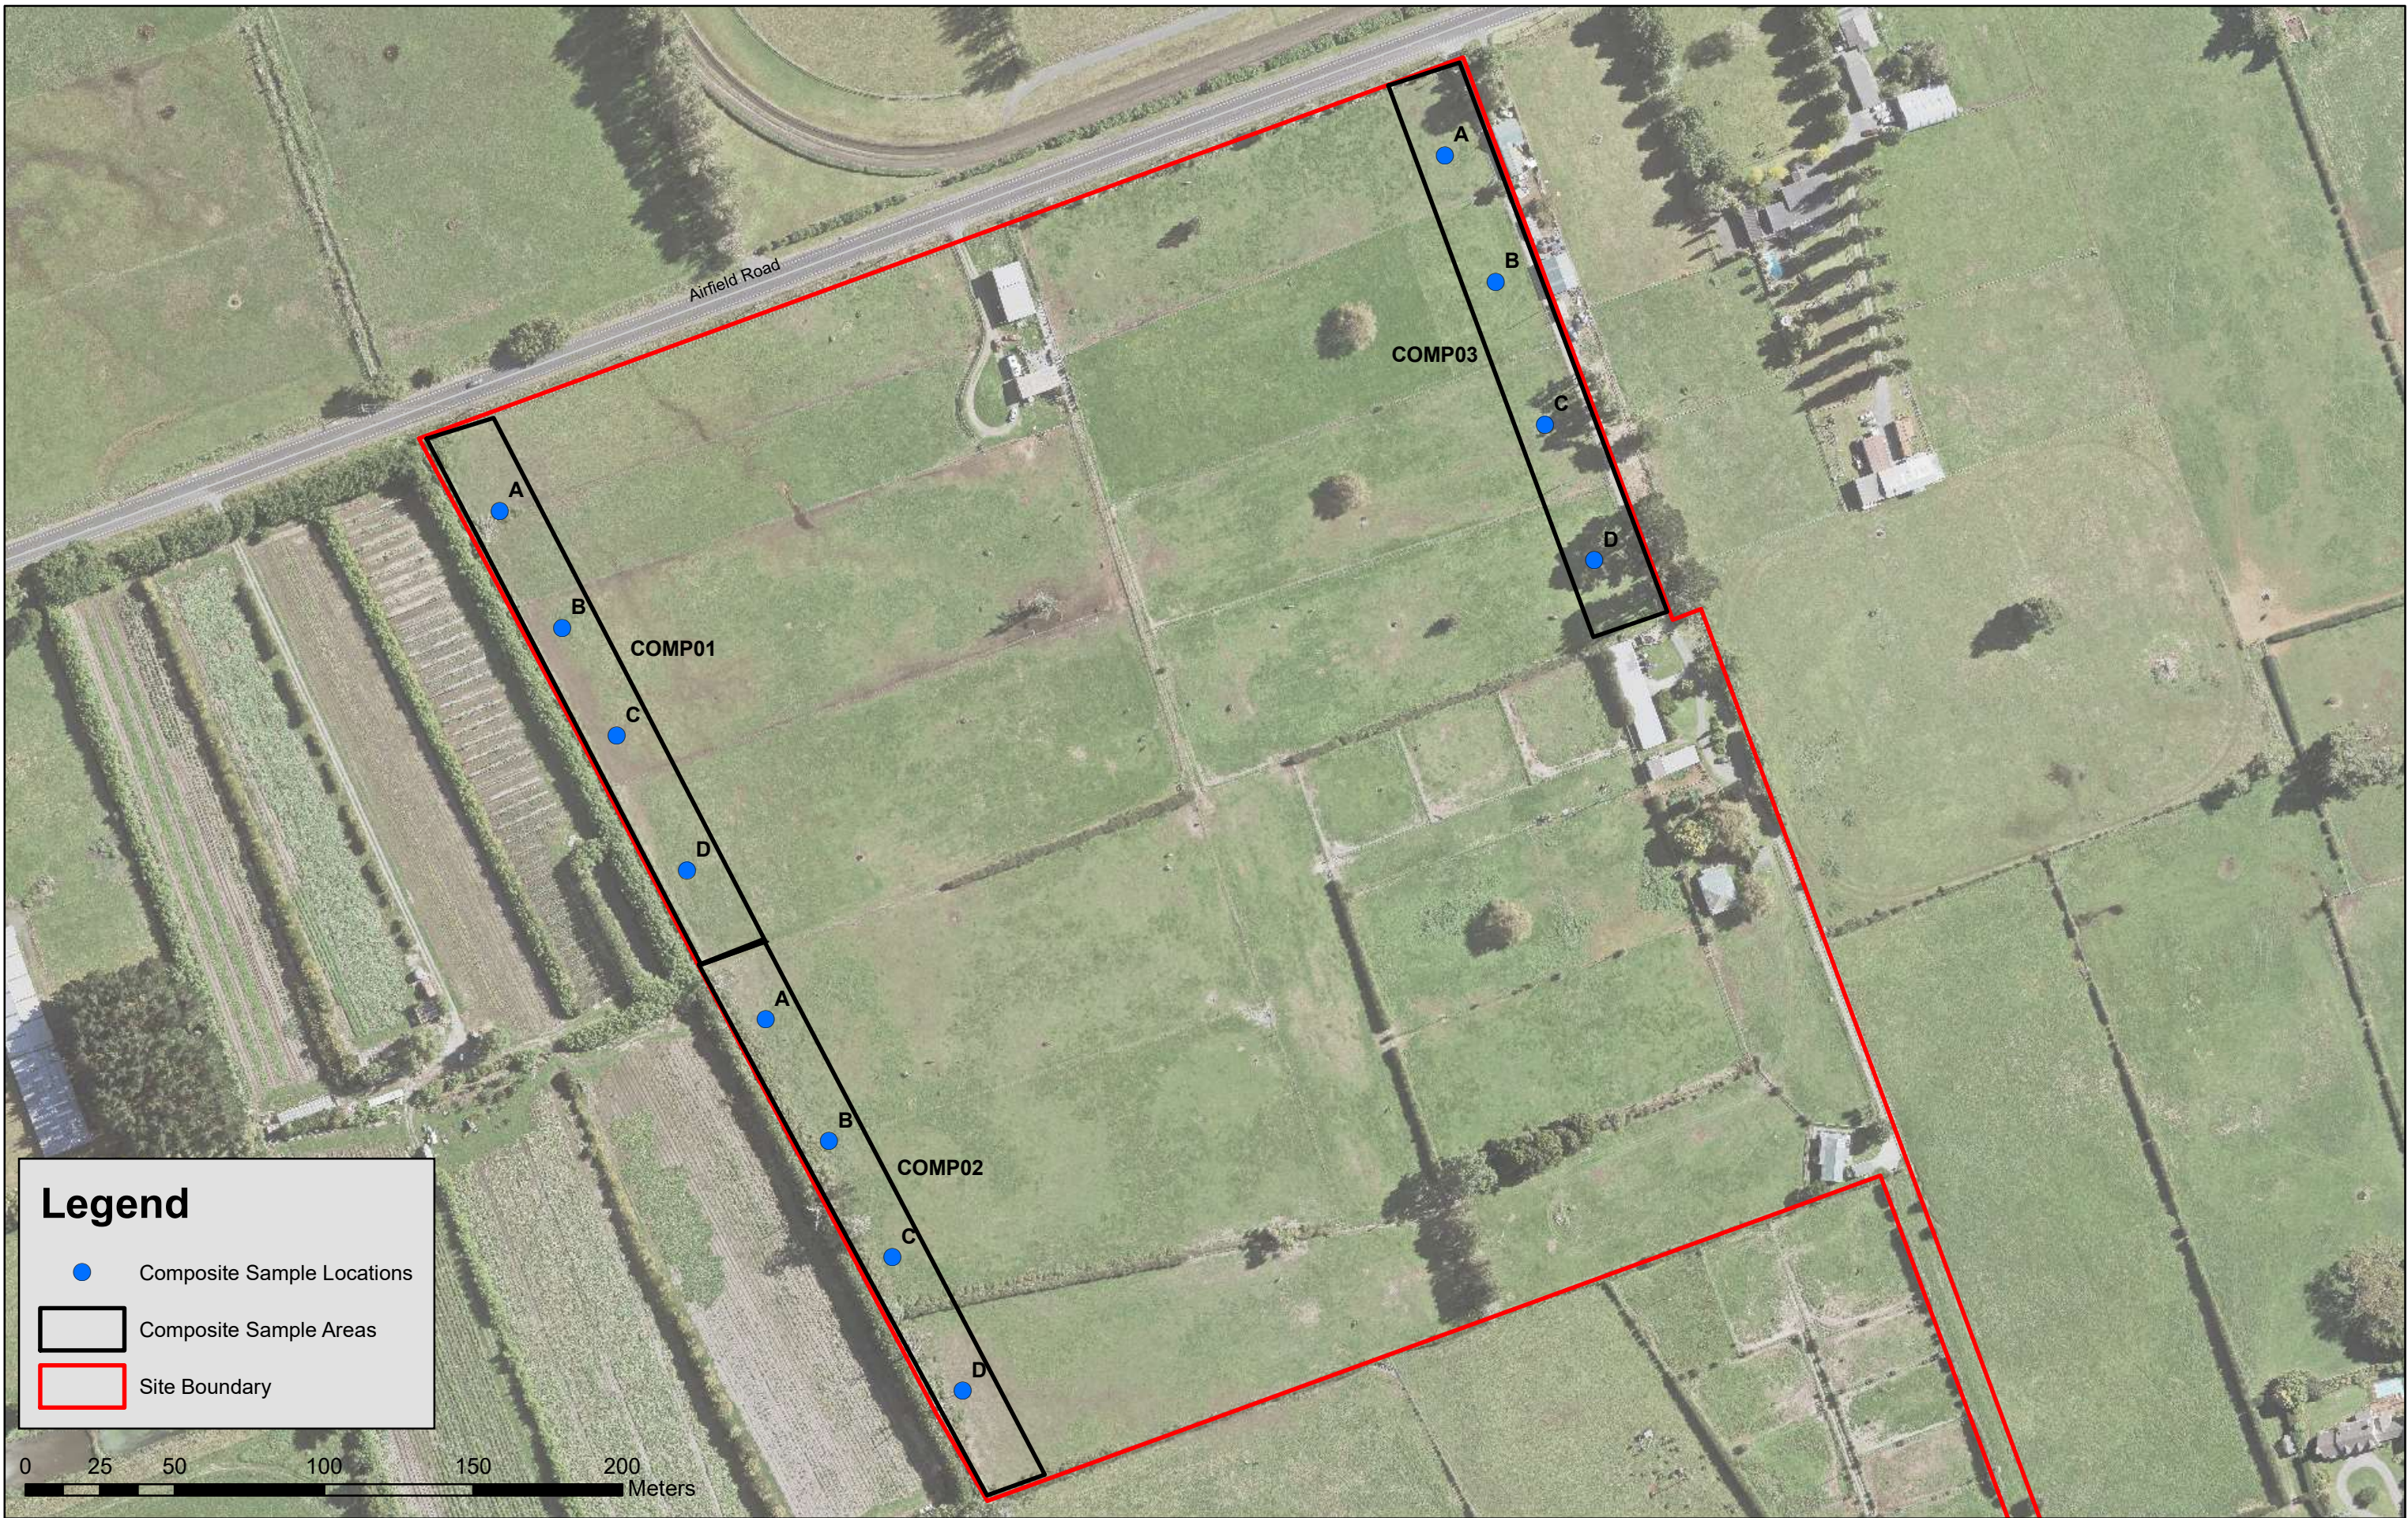
● Composite Sample Locations

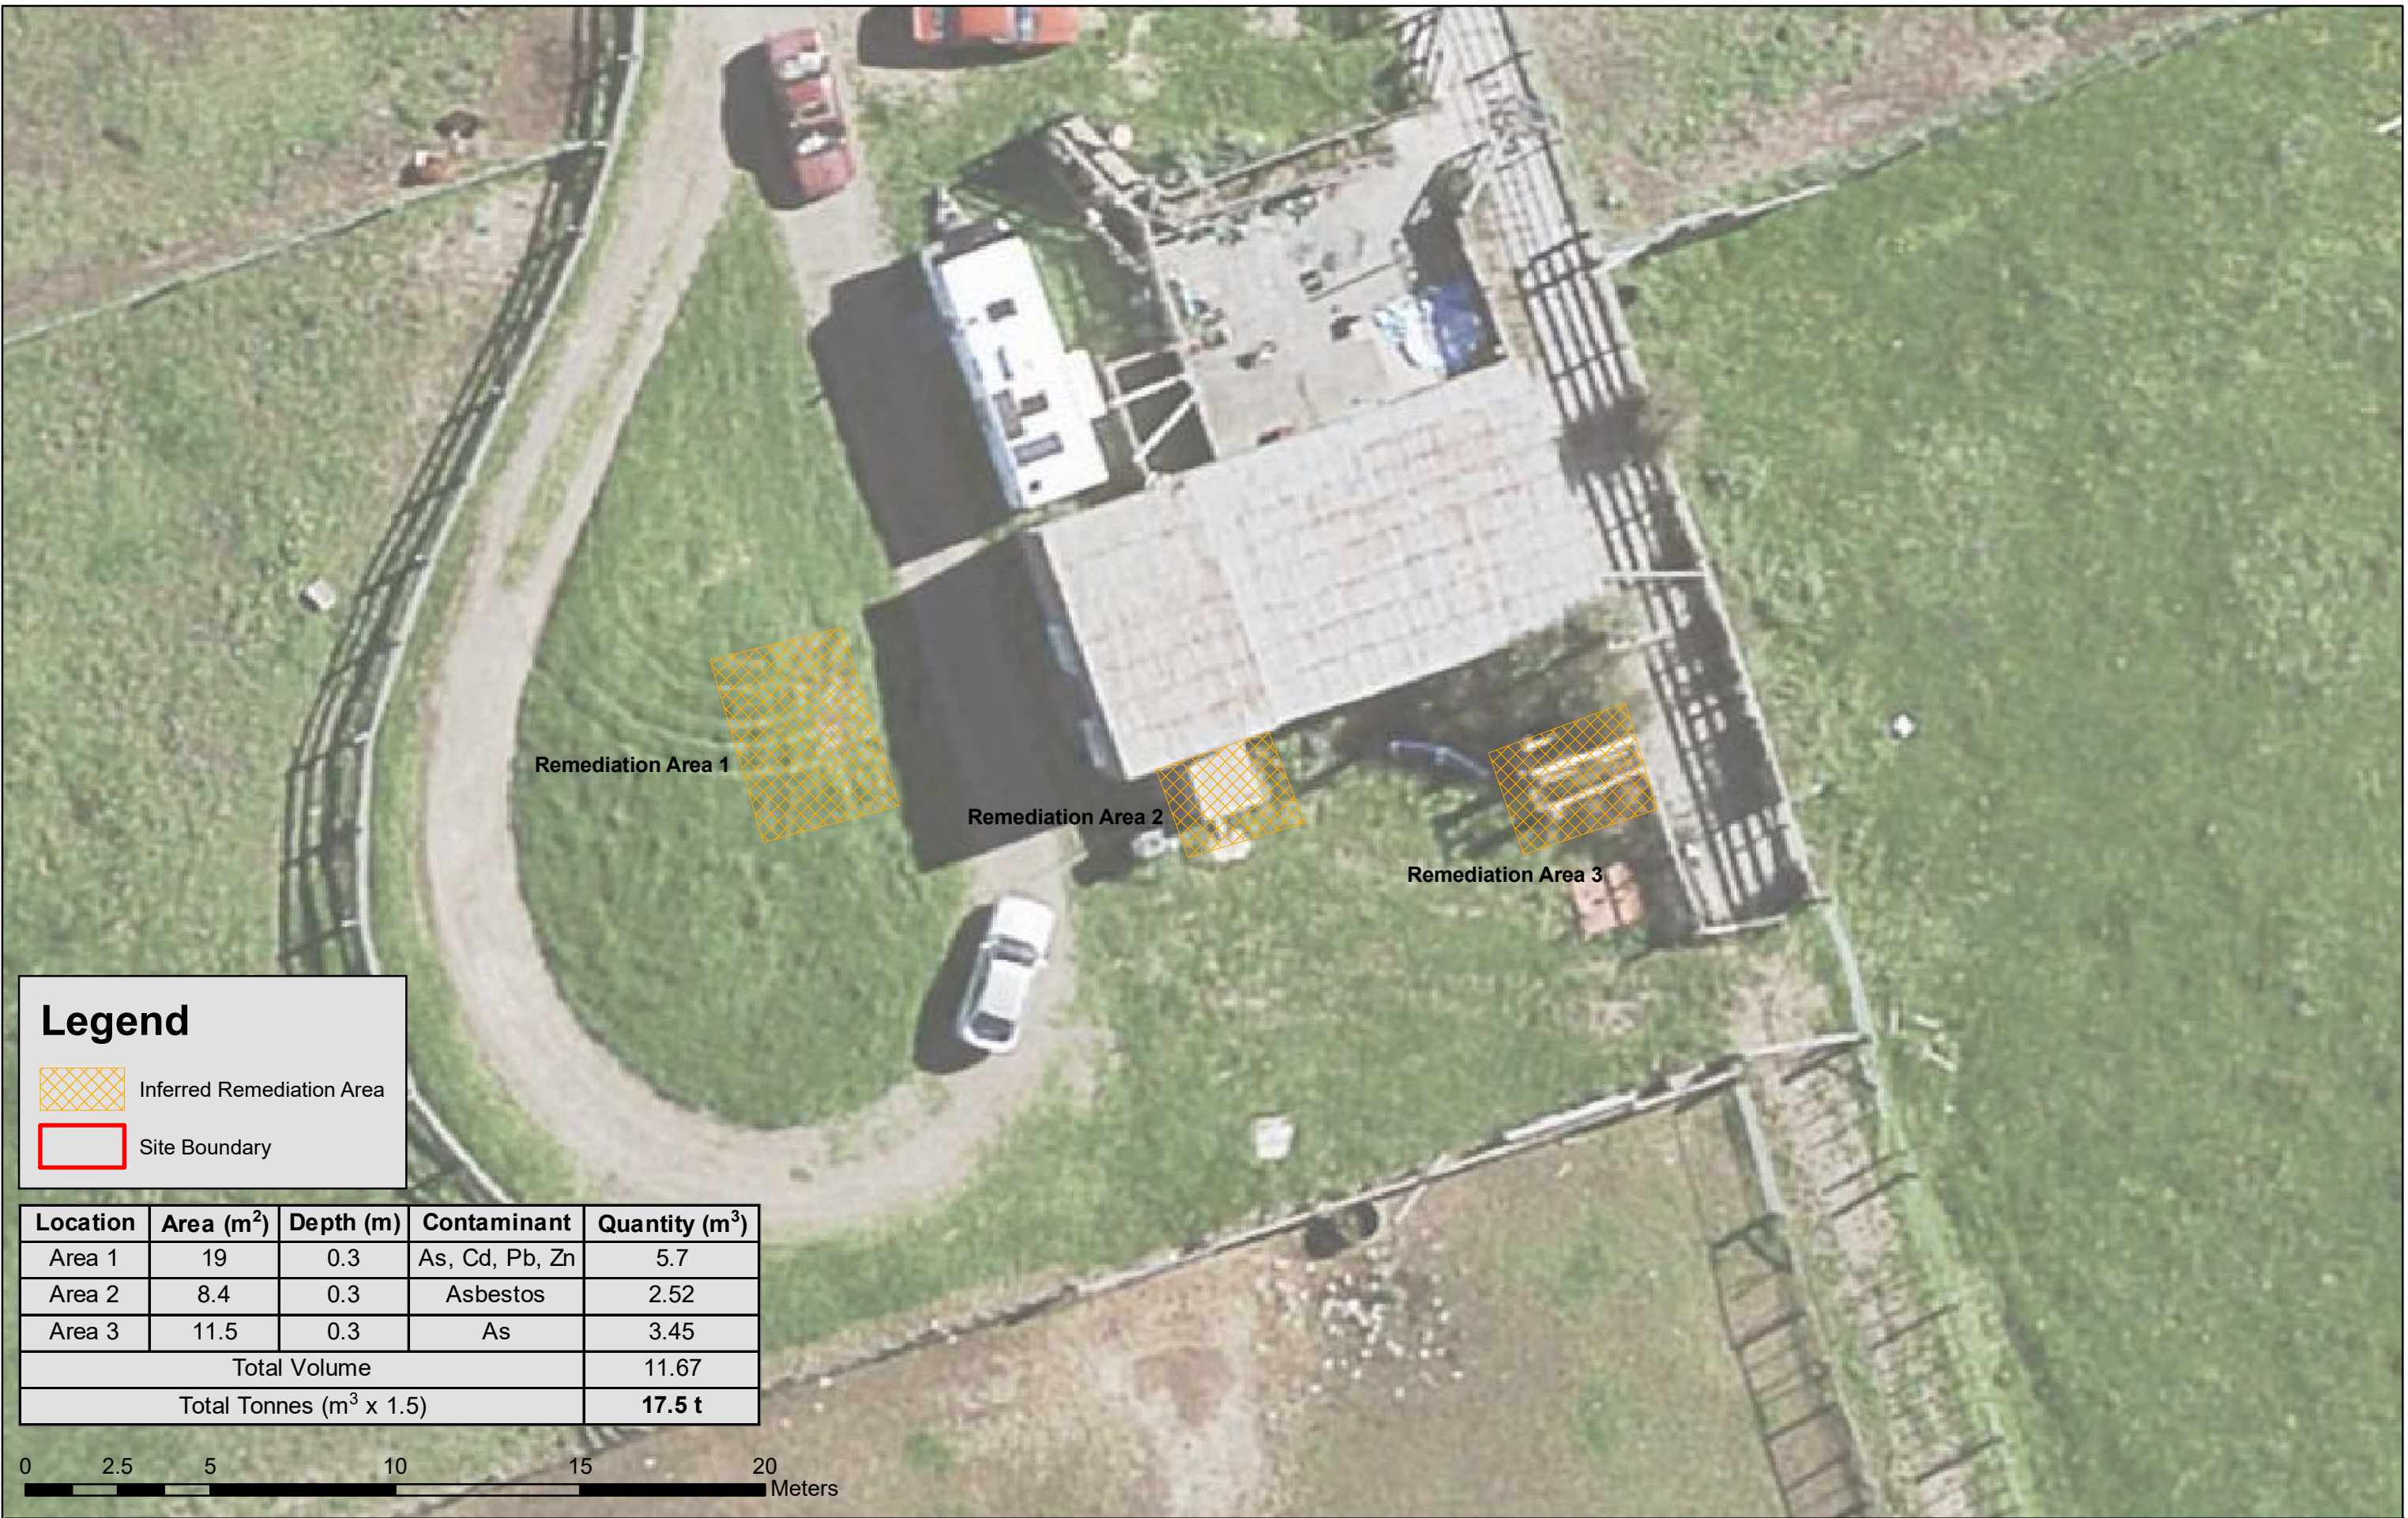
Location	Area (m ²)	Depth (m)	Contaminant	Quantity (m ³)
Area 1	19	0.3	As, Cd, Pb, Zn	5.7
Area 2	8.4	0.3	Asbestos	2.52
Area 3	11.5	0.3	As	3.45
Total Volume				11.67
Total Tonnes (m ³ x 1.5)				17.5 t

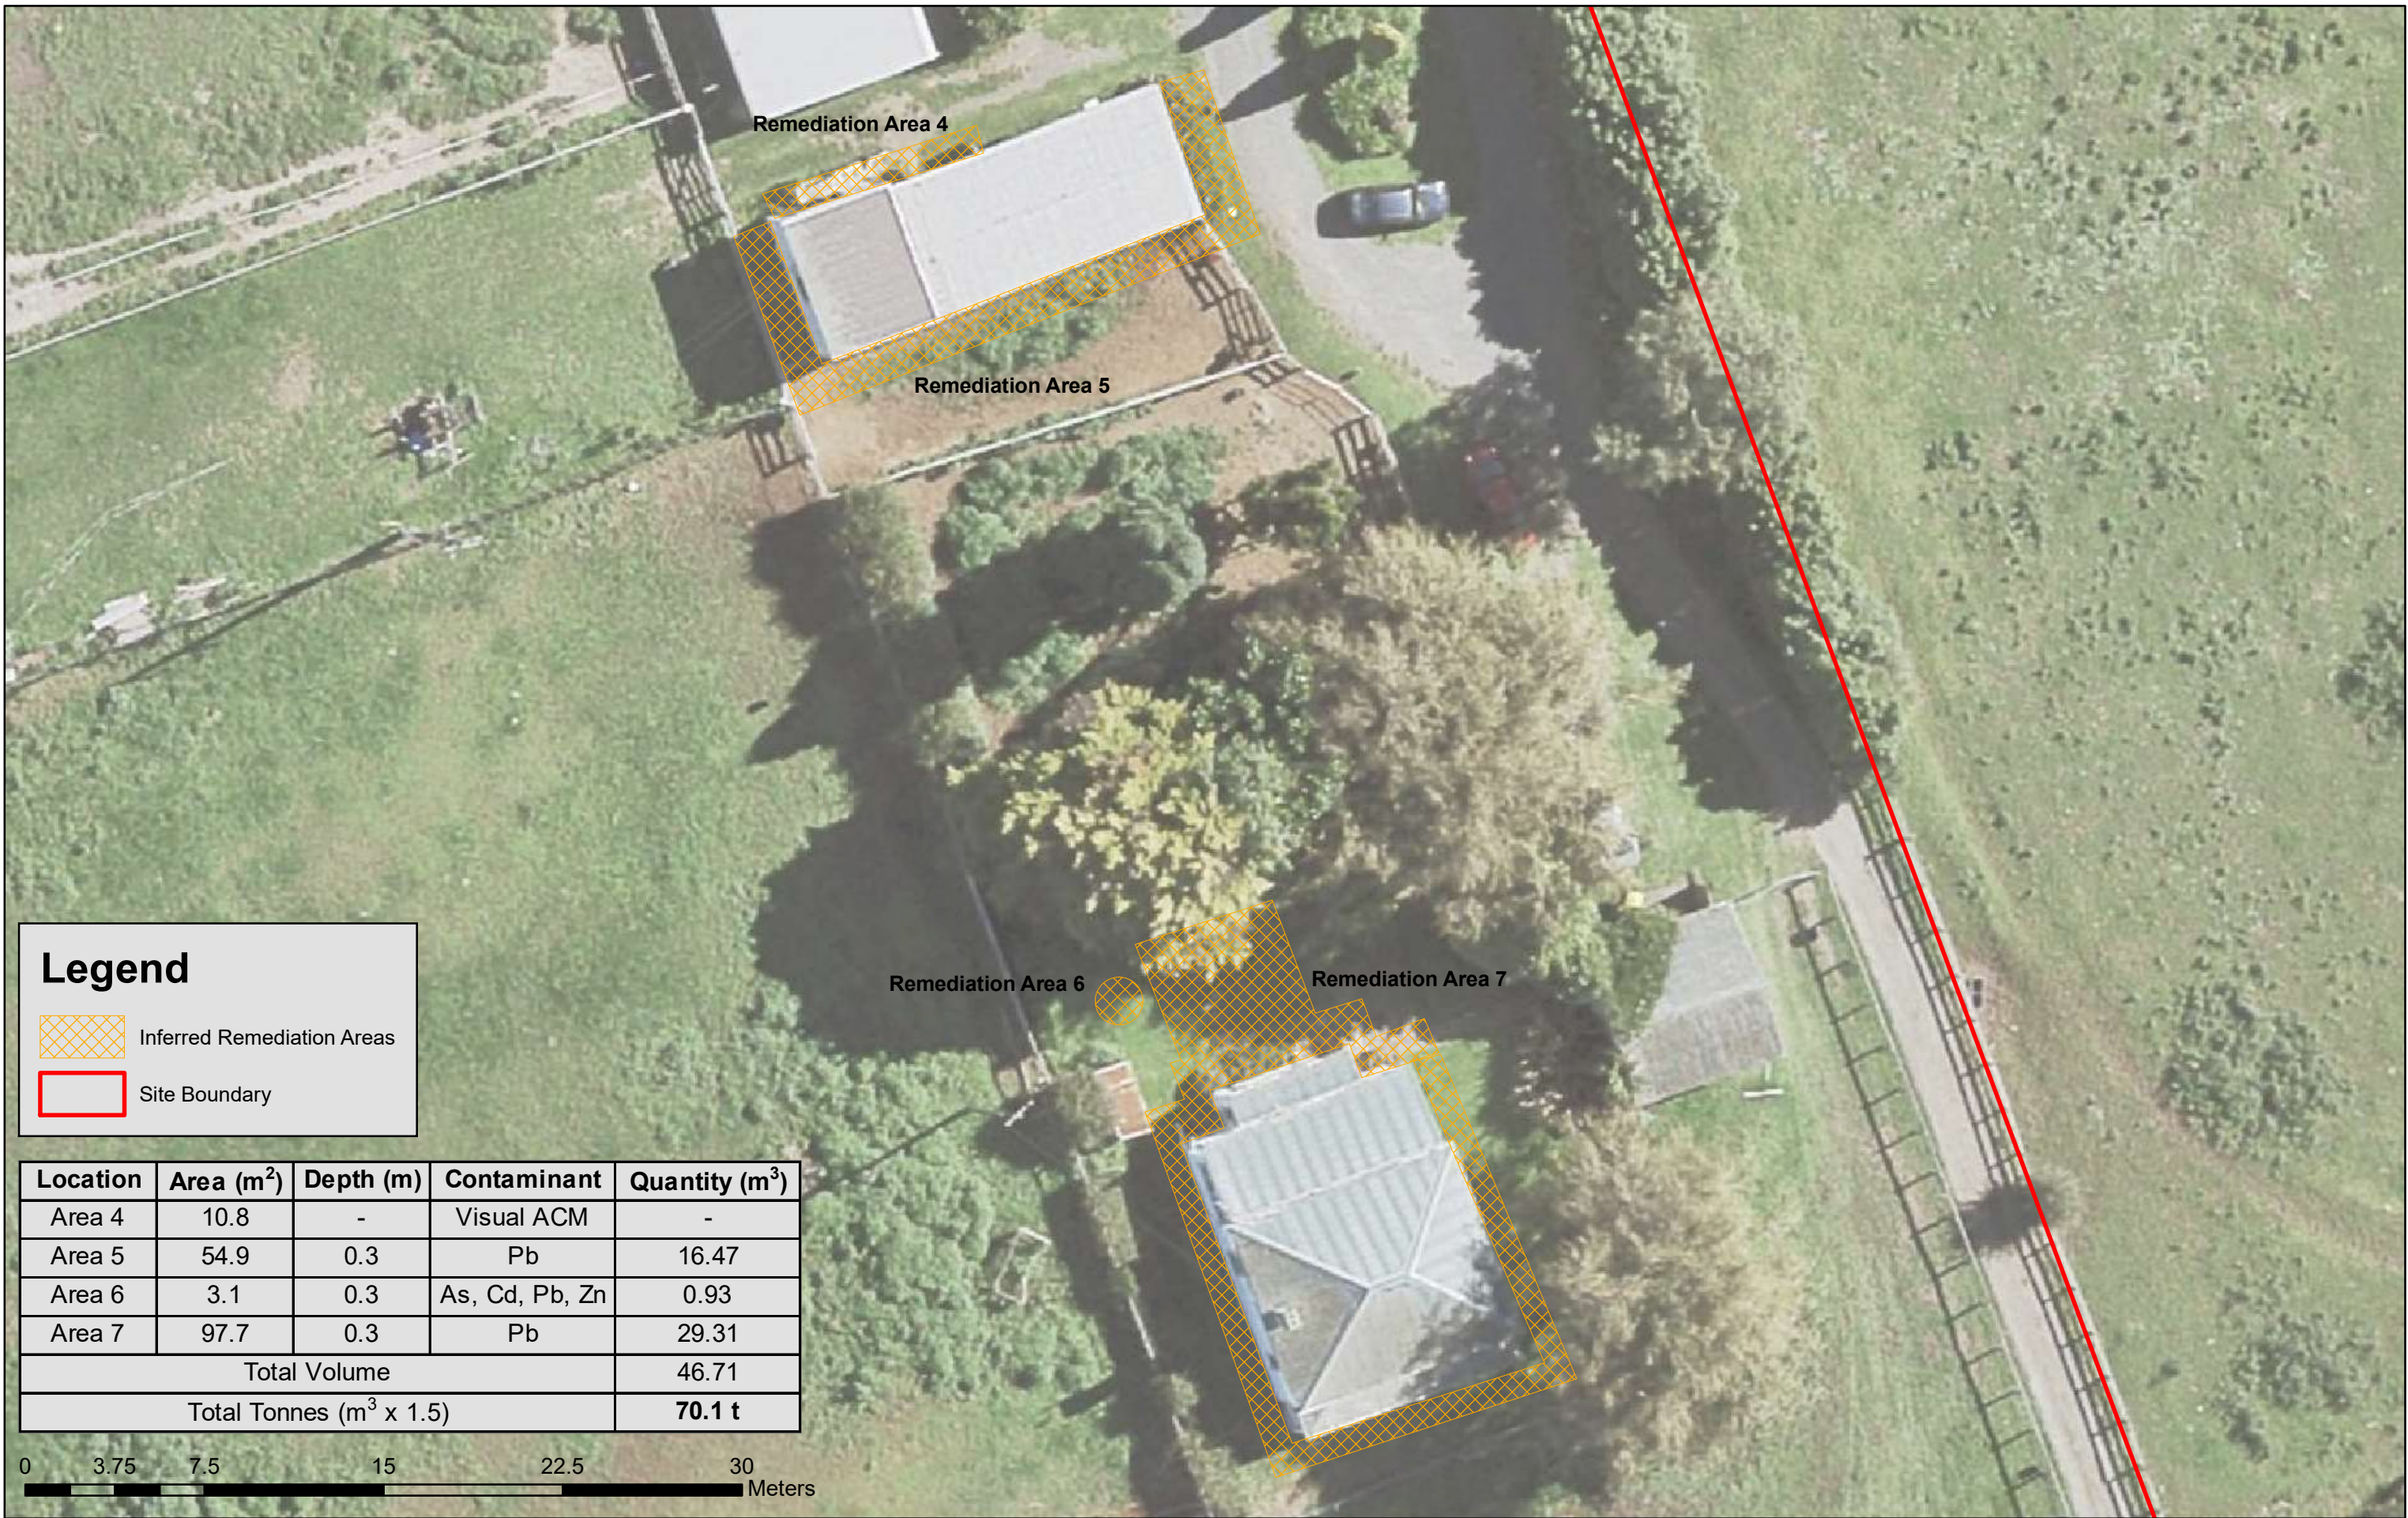
Location	Area (m ²)	Depth (m)	Contaminant	Quantity (m ³)
Area 4	10.8	-	Visual ACM	-
Area 5	54.9	0.3	Pb	16.47
Area 6	3.1	0.3	As, Cd, Pb, Zn	0.93
Area 7	97.7	0.3	Pb	29.31
Total Volume				46.71
Total Tonnes (m ³ x 1.5)				70.1 t

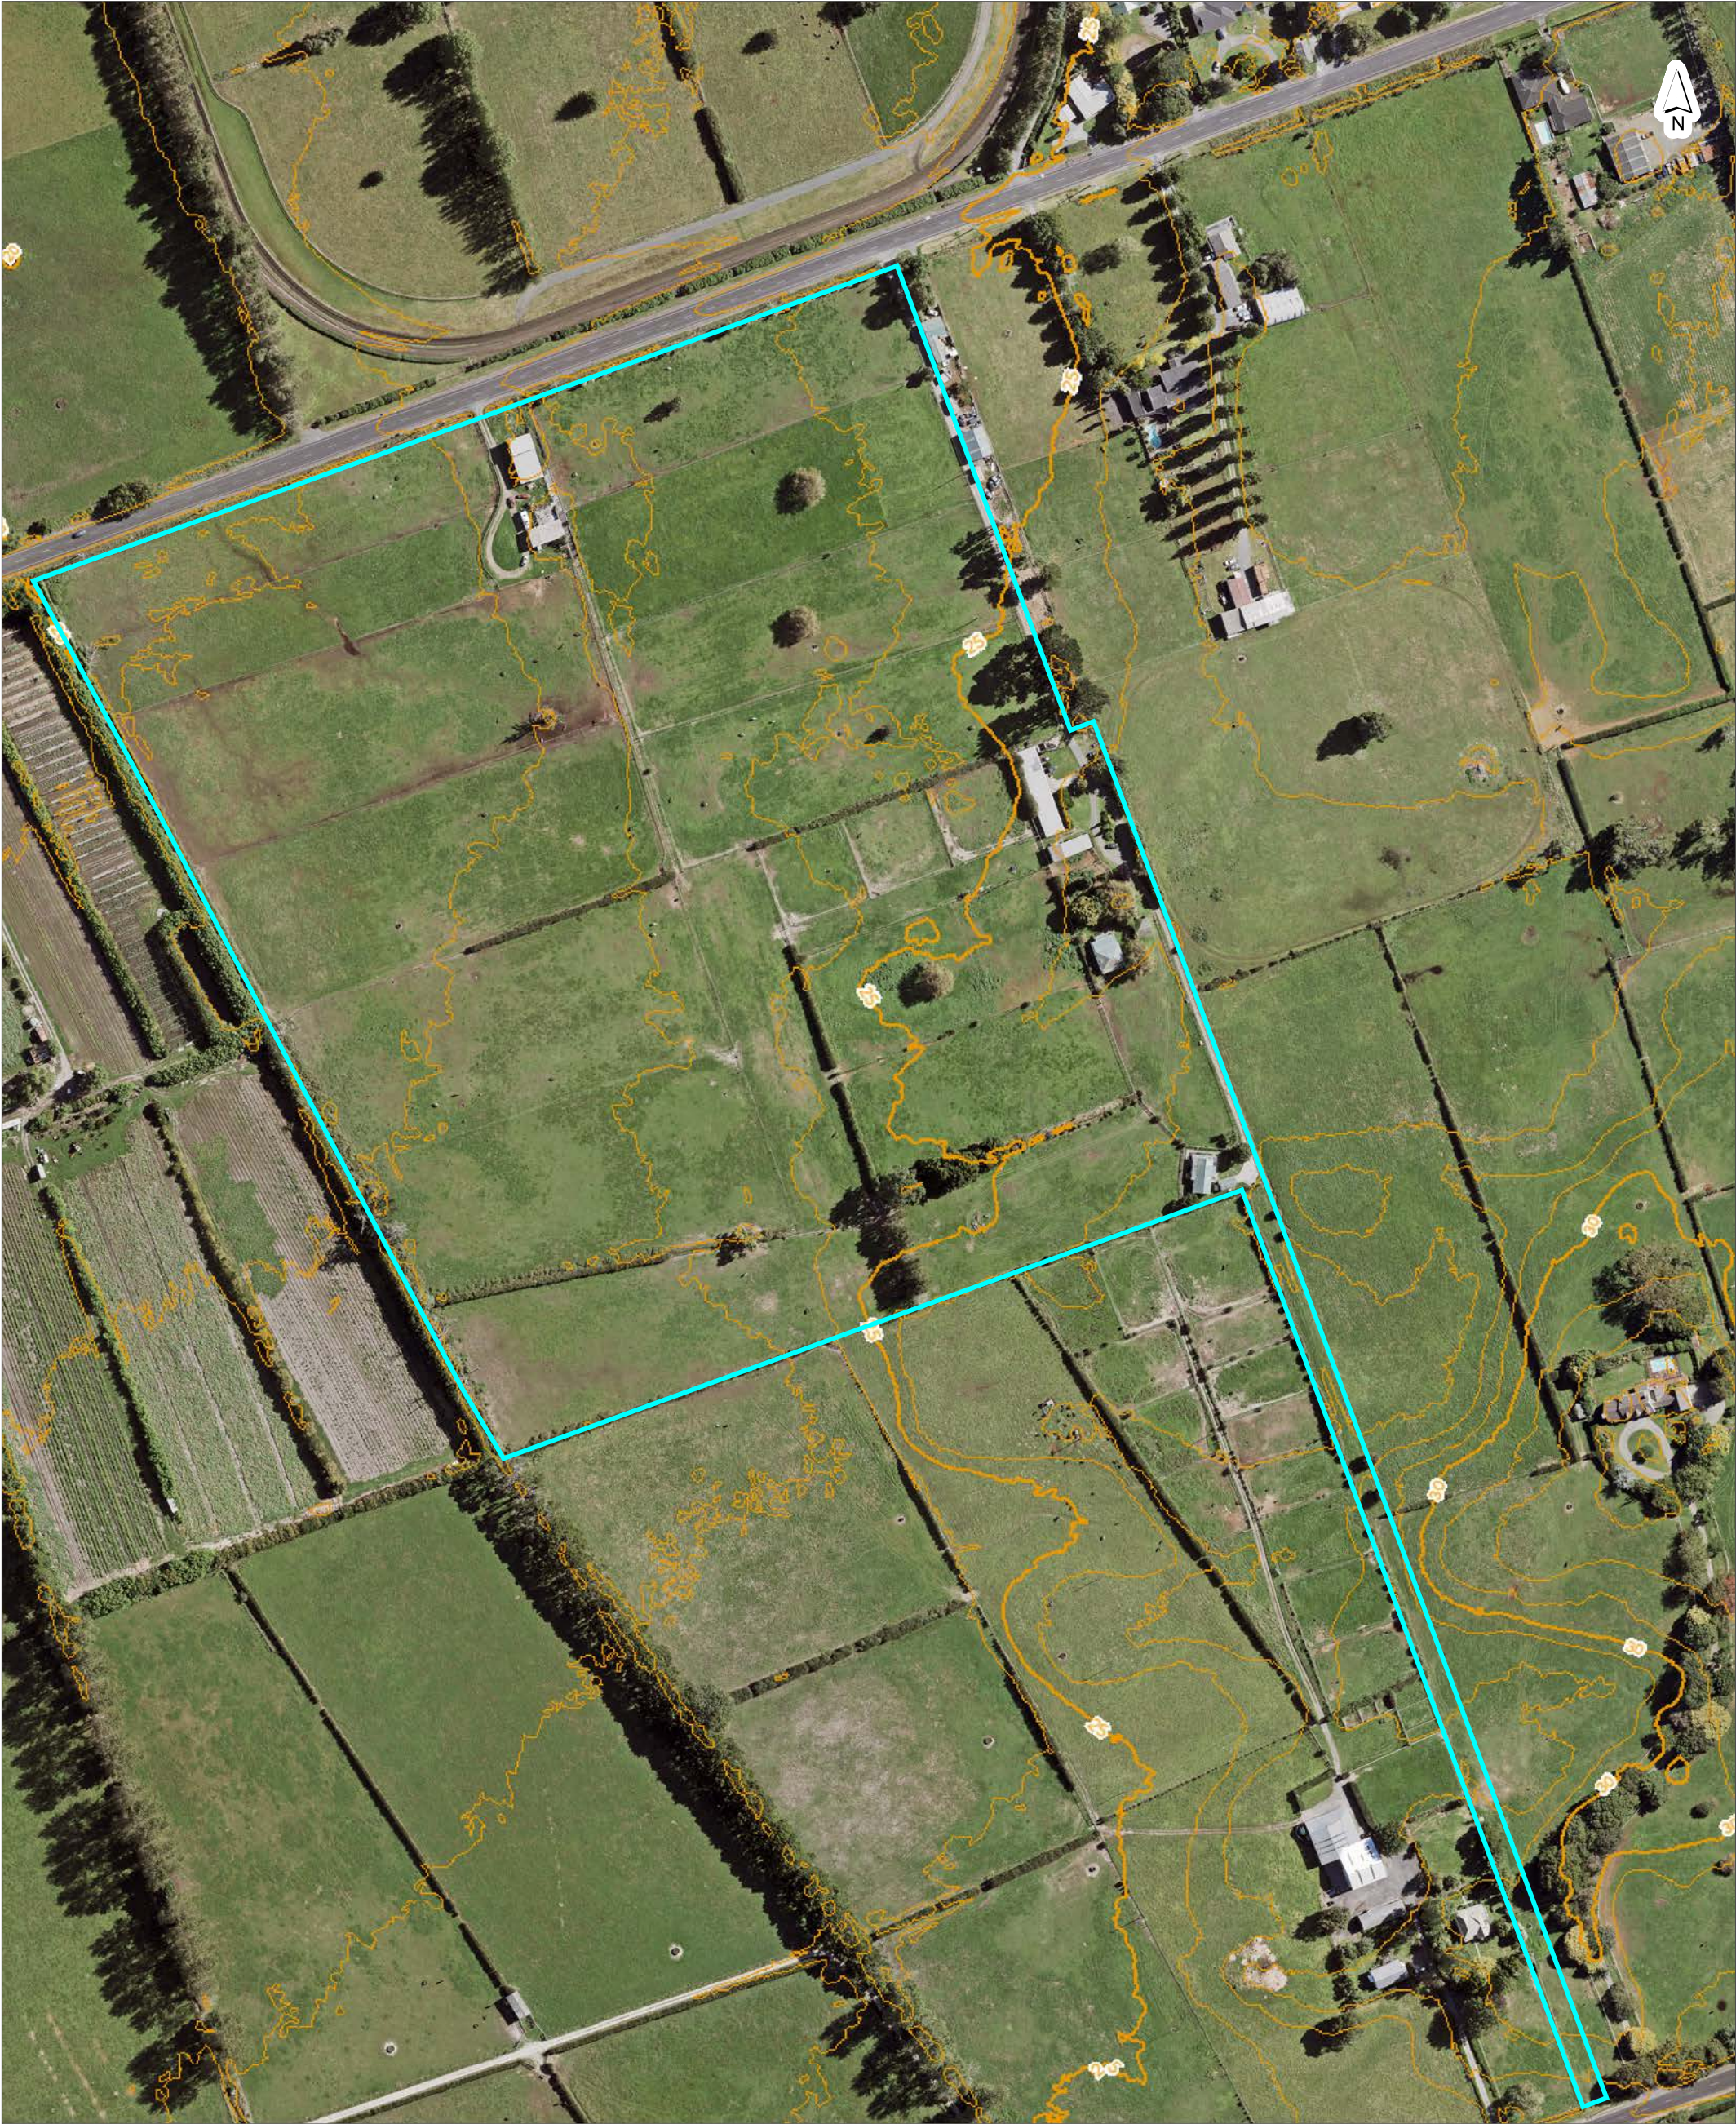
Appendix B – Site Contour Plan

Site Contour Plan
